# ARMY ENGINEER DIVERS: FIRST IN PORT-AU-PRINCE HARBOR

By Captain Scott Sann, Captain Jerry M. Hallman, and Dr. David J. Ulbrich

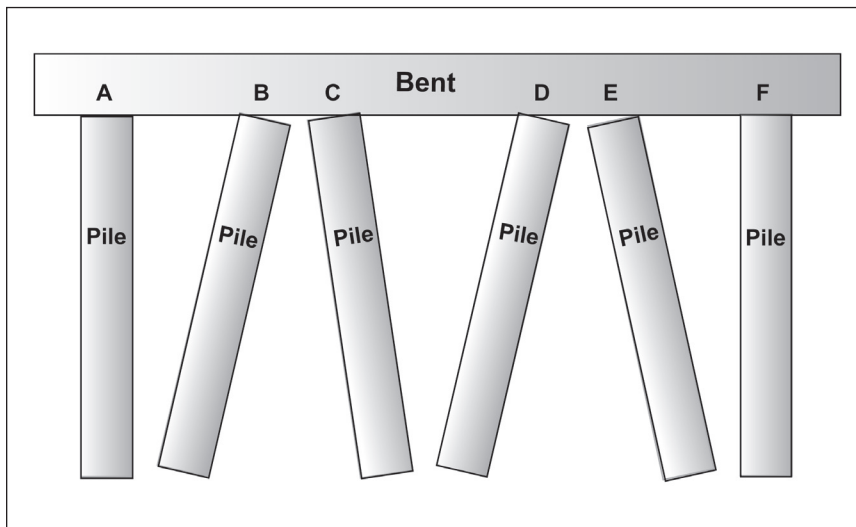
**Figure 2. Diagram of bent/piles before earthquake**

Each of these bents consisted of 6 piles in a row across the width of the pier. The 2 outermost piles stood vertically at 90-degree angles, while the 4 inner piles alternated at steep angles (Figure 2).

On 24 January, the completion of Combined Task Group 42.1’s laydown area in the Port-au-Prince main terminal established a C2 node for the entire operation. Beginning that same day, Army divers made a Level 2 Assessment, which more comprehensively surveyed the structural integrity of the pier. They also consulted with the NAVFAC engineers on how best to strengthen the 800 feet of the south pier still above water. No less than 39 bents (each with 6 piles) needed either minor repairs or complete replacement. The pier was supported by several dozen bents reaching along the length of the pier to the harbor floor.

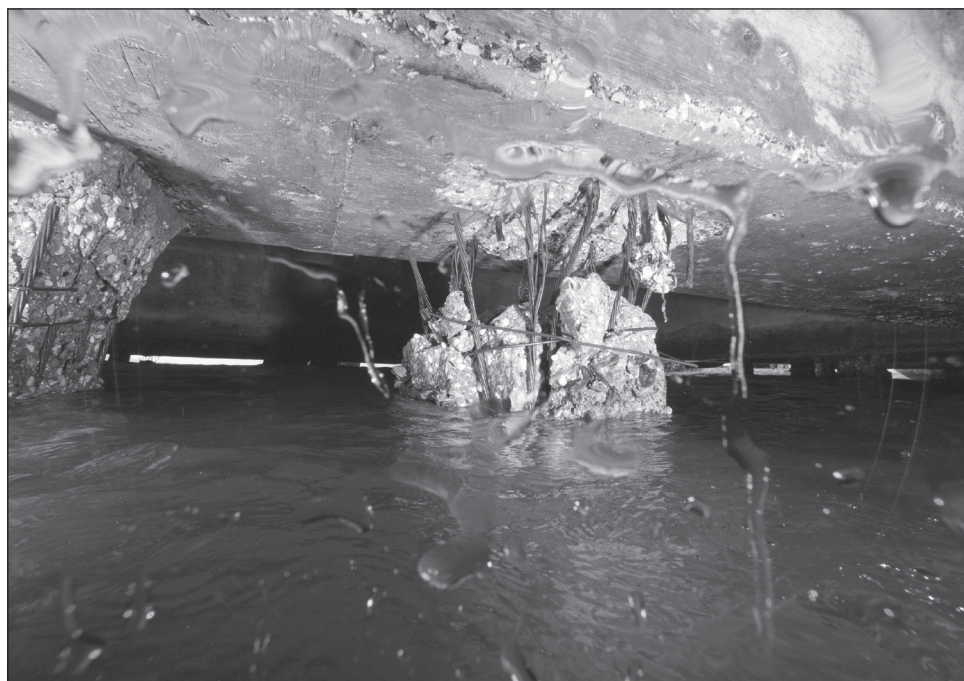
With the assessments and other shaping actions completed, the 544th spent part of 31 January resting and part of it determining the composition of dive teams, while prioritizing tasks to streamline work flow. Some piles retained partial structural contact with the pier above, and thus small gaps could be easily and quickly reinforced by filling them with grout spread by divers using hand trowels. However, most piles in most bents were sheared completely away from the pier above, requiring complete reconstruction to the upper portions of

the piles (see photo below). Rehabilitation work on the south pier began on 1 February and lasted for the next 7 weeks. A multistep process developed over time, in which the 17 Army and 7 Navy divers worked together closely and effectively.

**Divers found many severely damaged piles like this one.**

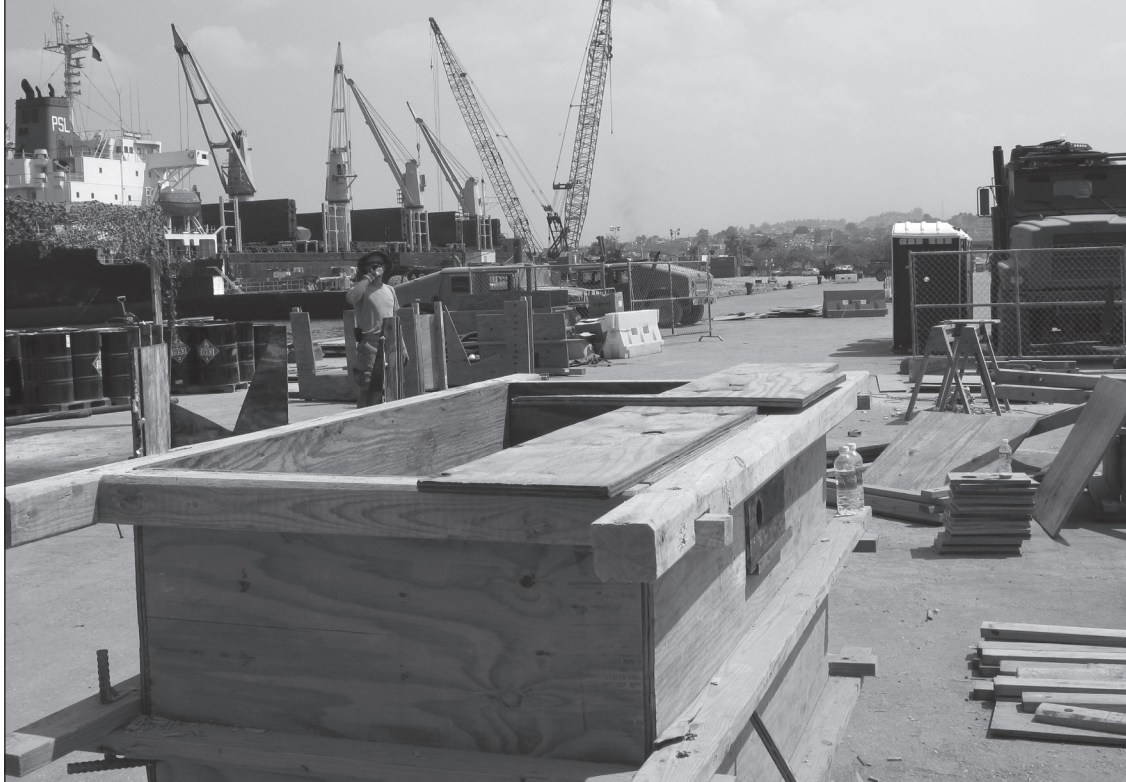
**This prefabricated wooden form was emplaced around a rebar cage at the top of damaged piles to hold concrete until it cured. This created the pile caps reinforcing the structure.**

Once holes were drilled, another set of divers injected epoxy into the holes and inserted 6-gauge rebar, which extended downward and overlapped with the tops of the piles below. Next, the divers wrapped 3-gauge rebar horizontally around the vertical rebar to create a cage that would give strength to the pile once the concrete was poured. This step was completed in a few minutes for each pile. Last, a prefabricated wooden form was emplaced around each cage on the piles, and concrete was pumped into the form. After 24 hours, the concrete had sufficiently cured, connecting the new pile to the cap above. The wooden form could then be removed and used again on other piles and bents. The process of pumping the concrete was by far the most time-consuming, because it required half a workday for each bent.
