AFRL-RX-TY-TR-2011-0025-01

## **FULL-SCALE EXPERIMENTAL EVALUATION OF PARTIALLY GROUTED, MINIMALLY REINFORCED CONCRETE MASONRY UNIT (CMU) WALLS AGAINST BLAST DEMANDS**

November 2010

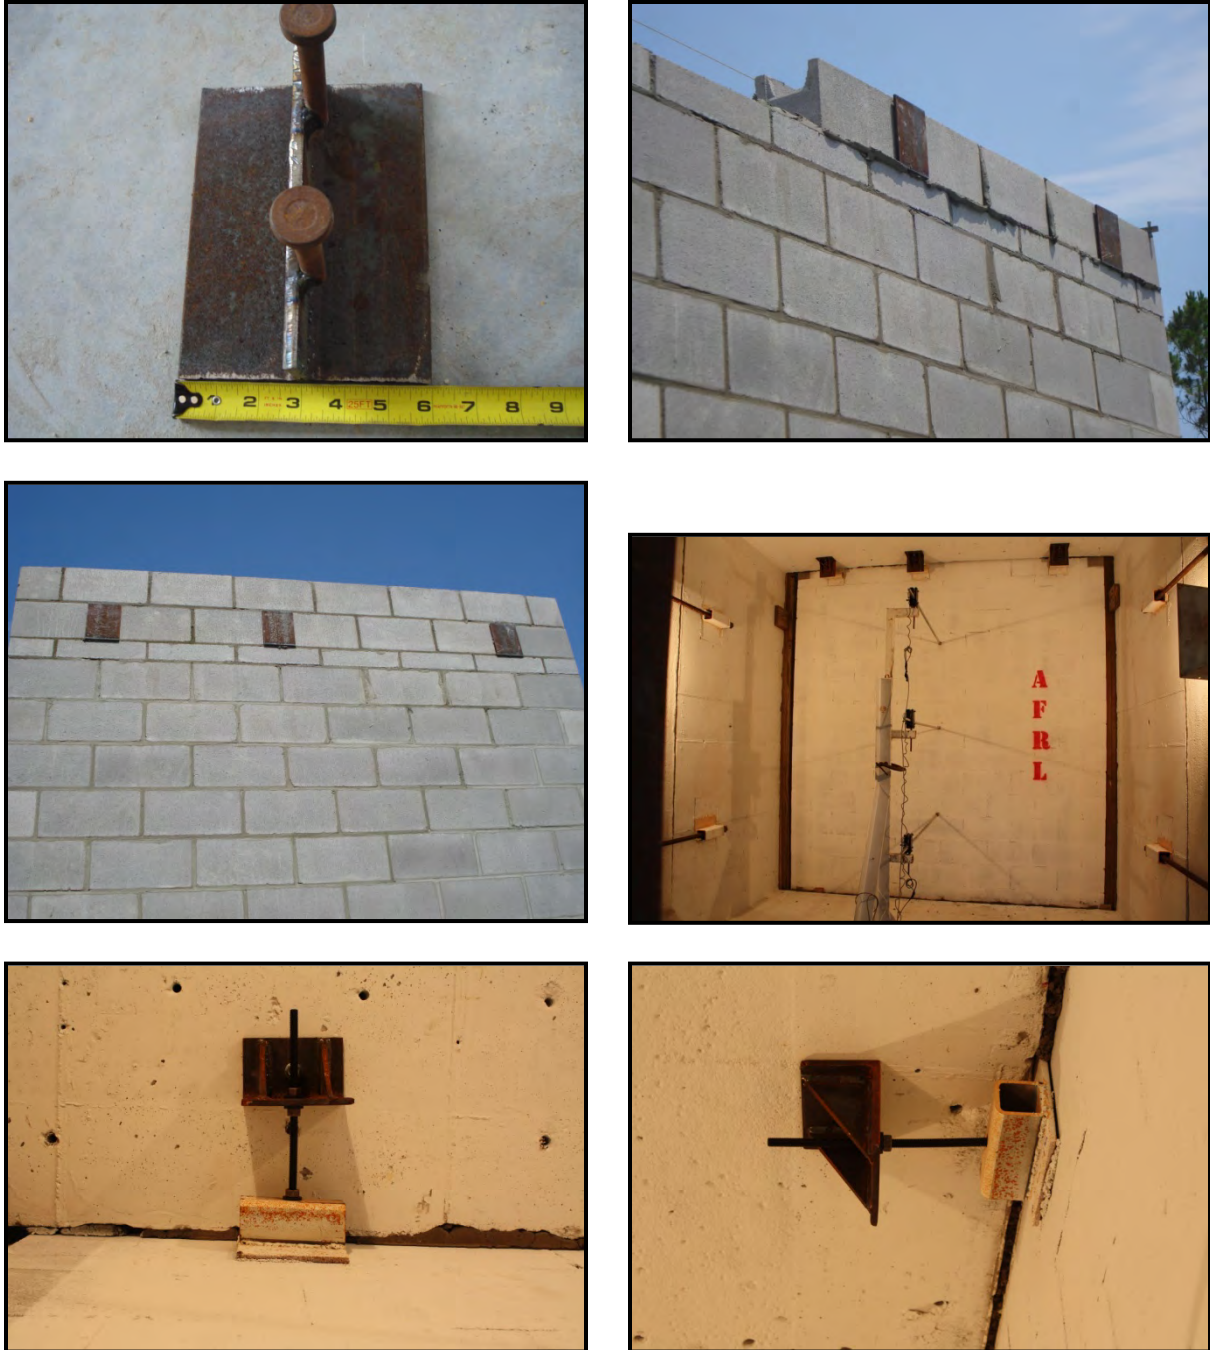
**Figure 11. Interior Embed**

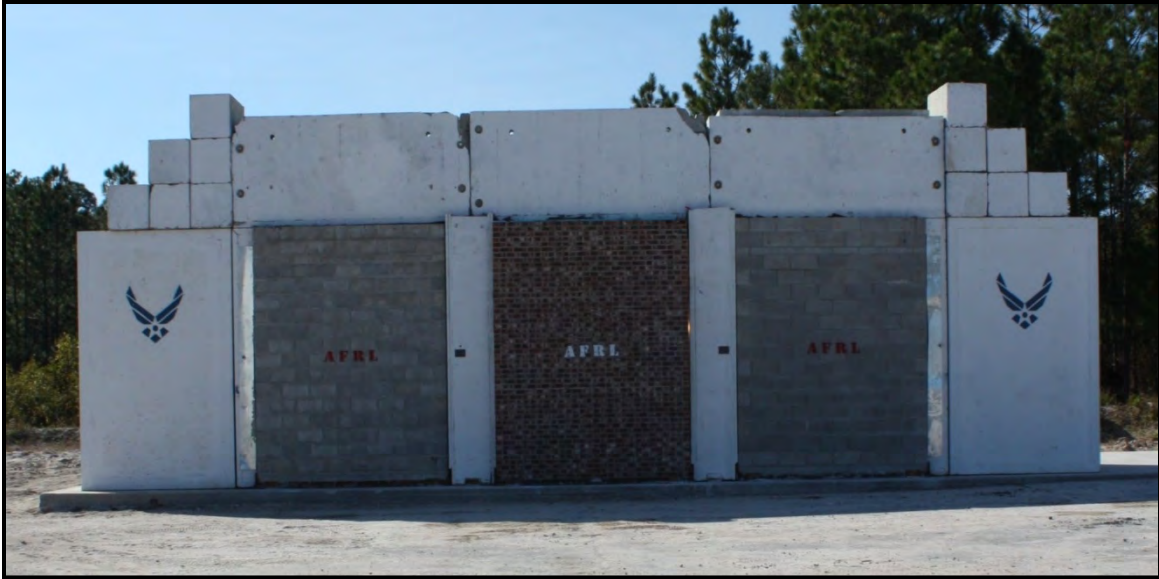
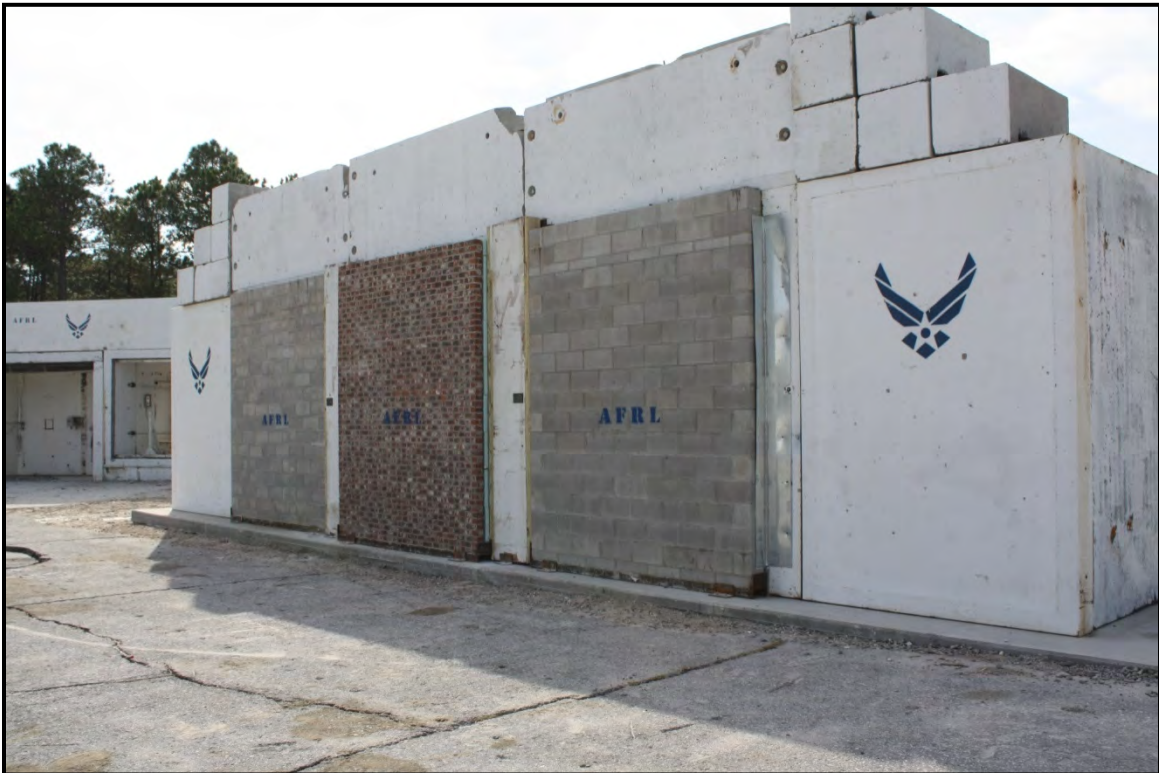
**Figure 12. Panels in Reaction Structure Ready for Testing**

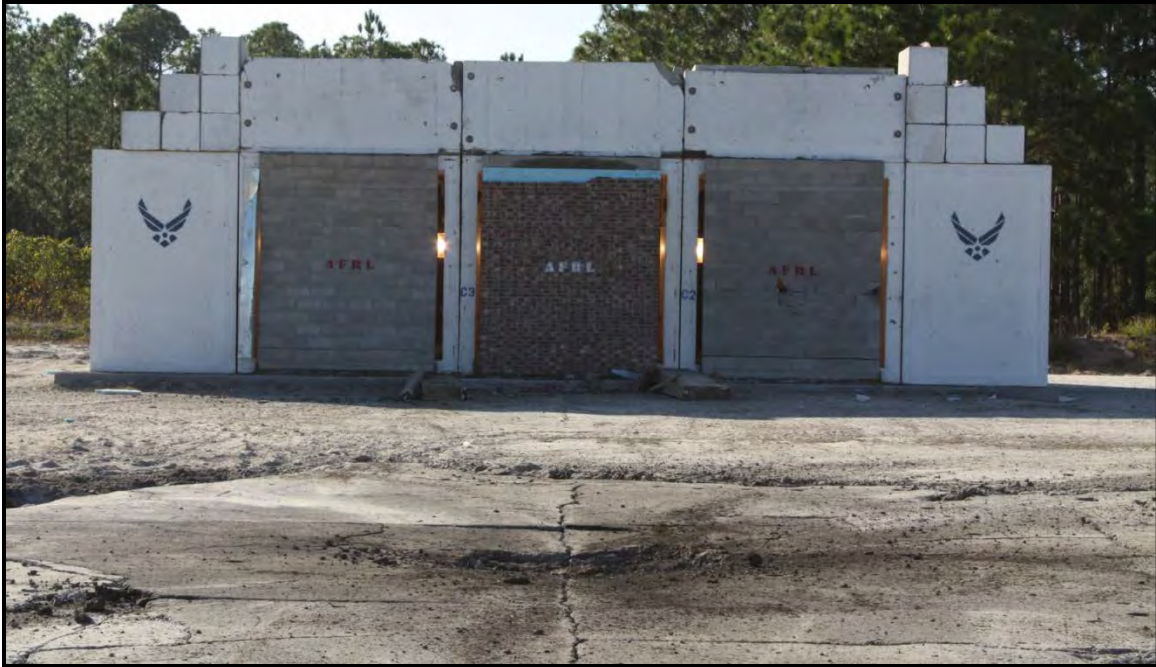
**Figure 17. Experiment 1 Post-detonation Front View**

Exterior views of the residual condition of all three test panels are depicted in Figures 17 and 18.

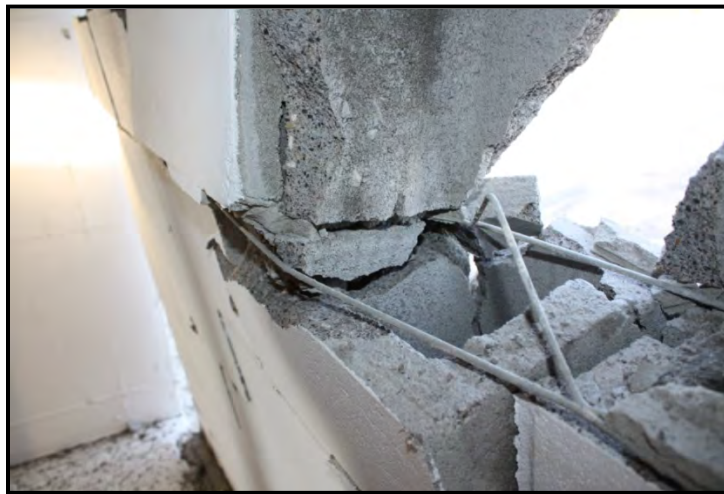
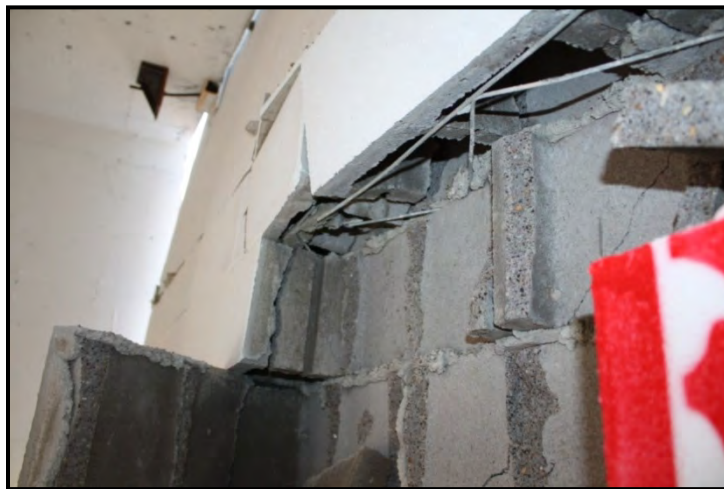
**Figure 25. Experiment 1 Breaching Failure of the 8-inch CMU Panel**

The deflection gauge measurements are shown in Figure 22. The maximum dynamic deflection at mid-span of the panel was 8.1 inches. Selected still images captured from high-speed video illustrating the progression of failure are provided in Figure 23. Interior and exterior views of the residual condition of the 8-inch CMU panel are provided in Figure 24. The response is characterized by flexural cracks initiating across the fifth-from-bottom and fourth-from-top mortar joints, then progressing to a spalling failure of the inside face shell of six CMUs in the ungrouted/unreinforced region near the center of the panel (Figs. 25-27). The maximum rotation was approximately 7.7 degrees. A residual plastic deflection of approximately 7 inches was retained. Complete breaching of an approximately 10 in<sup>2</sup> area occurred.

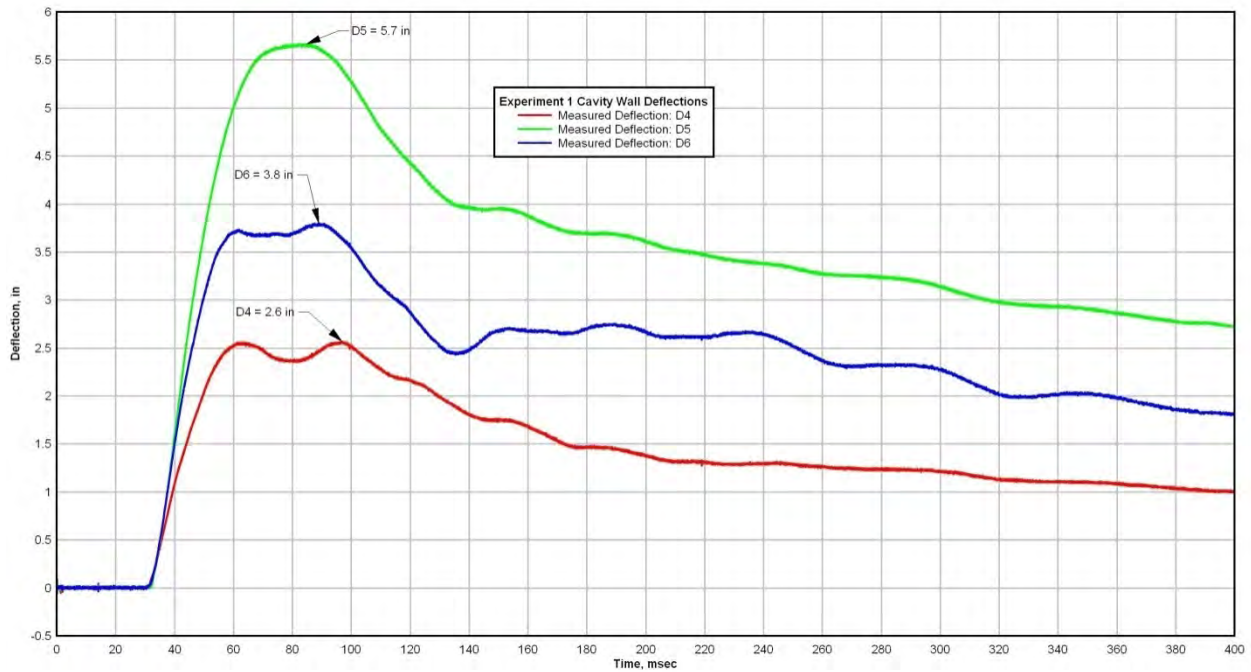
The deflection gauge measurements are shown in Figure 26, where the maximum dynamic deflection at mid-span of the panel of 5.7 inches was observed. Selected still images captured from high-speed video illustrating the progression of failure are provided in Figure 27. Interior and exterior views of the residual condition of the cavity wall panel are provided in Figure 28. The response is characterized by flexural tension cracking along the center one-third mortar joints, with a prominent step pattern in early timing. The maximum rotation was approximately 5.4 degrees. A residual plastic deflection of approximately 3 inches was retained. There was no significant fracturing of the CMUs, such as occurred in the comparable wall without veneer (8-inch CMU Panel). The upper five courses of brick veneer collapsed in front of the panel, but much of the veneer remained attached and stable.

Figure 26. Experiment 1 Cavity Wall Deflections

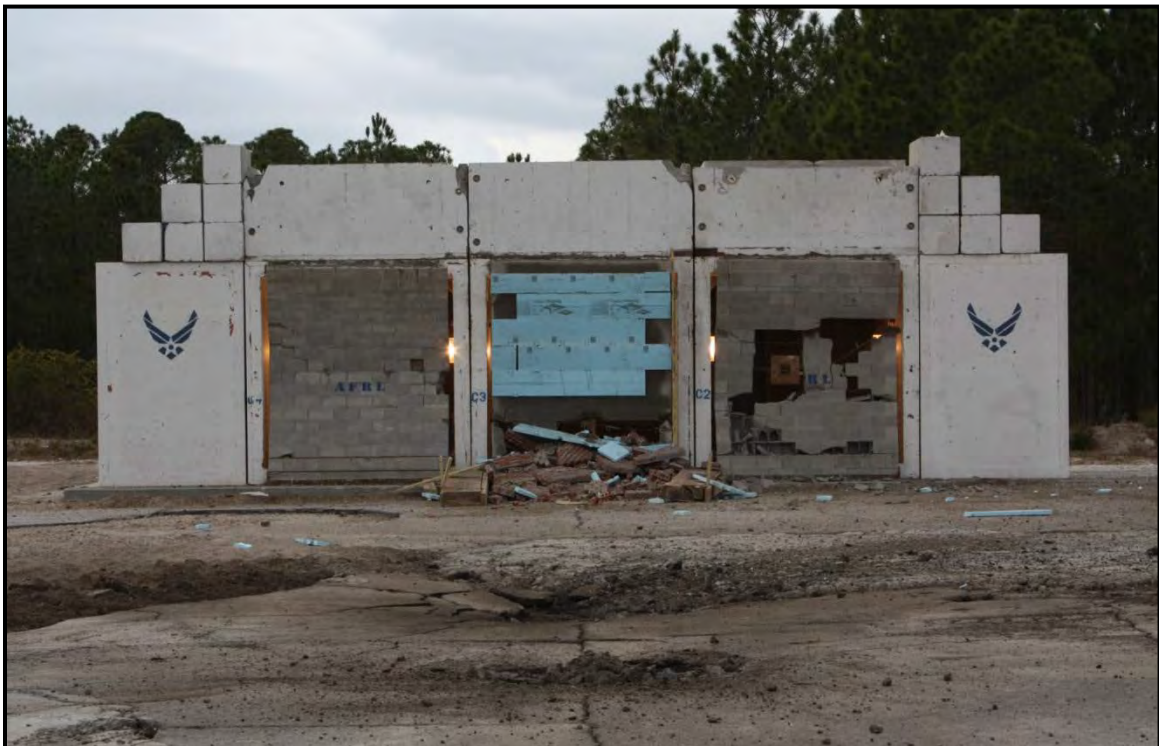
**Figure 29. Experiment 2 Post-Detonation Front View**

Exterior views of the residual condition of all three test panels are depicted in Figures 29 and 30.

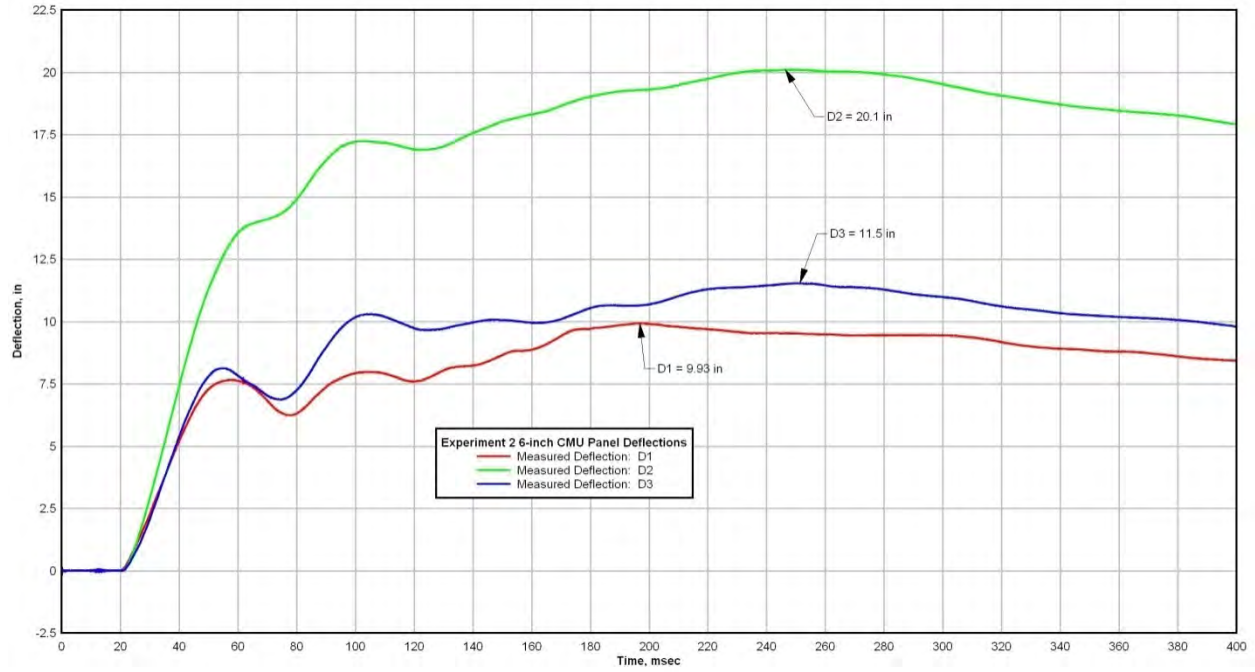
The deflection gauge measurements are shown in Figure 31, where the maximum dynamic deflection at mid-span of the panel of 20.1 inches was measured. Selected still images captured from high-speed video illustrating the progression of failure are provided in Figure 32. Interior and exterior views of the residual condition of the 6-inch CMU panel are described in Figures 33 and 34. The response is characterized by flexural cracks uniformly initiating across the center 50% of the mortar joints, then progressing to a large joint opening at mid-span of the panel. Spalling of one half-CMU face shell and complete breaching of another half-CMU occurred. There was no significant fracturing of the exterior surface of the panel. The panel remained stable after a maximum rotation of approximately 19 degrees. A residual plastic deflection of approximately 18 inches was retained.

**Figure 31. Experiment 2 6-inch CMU Panel Deflections**

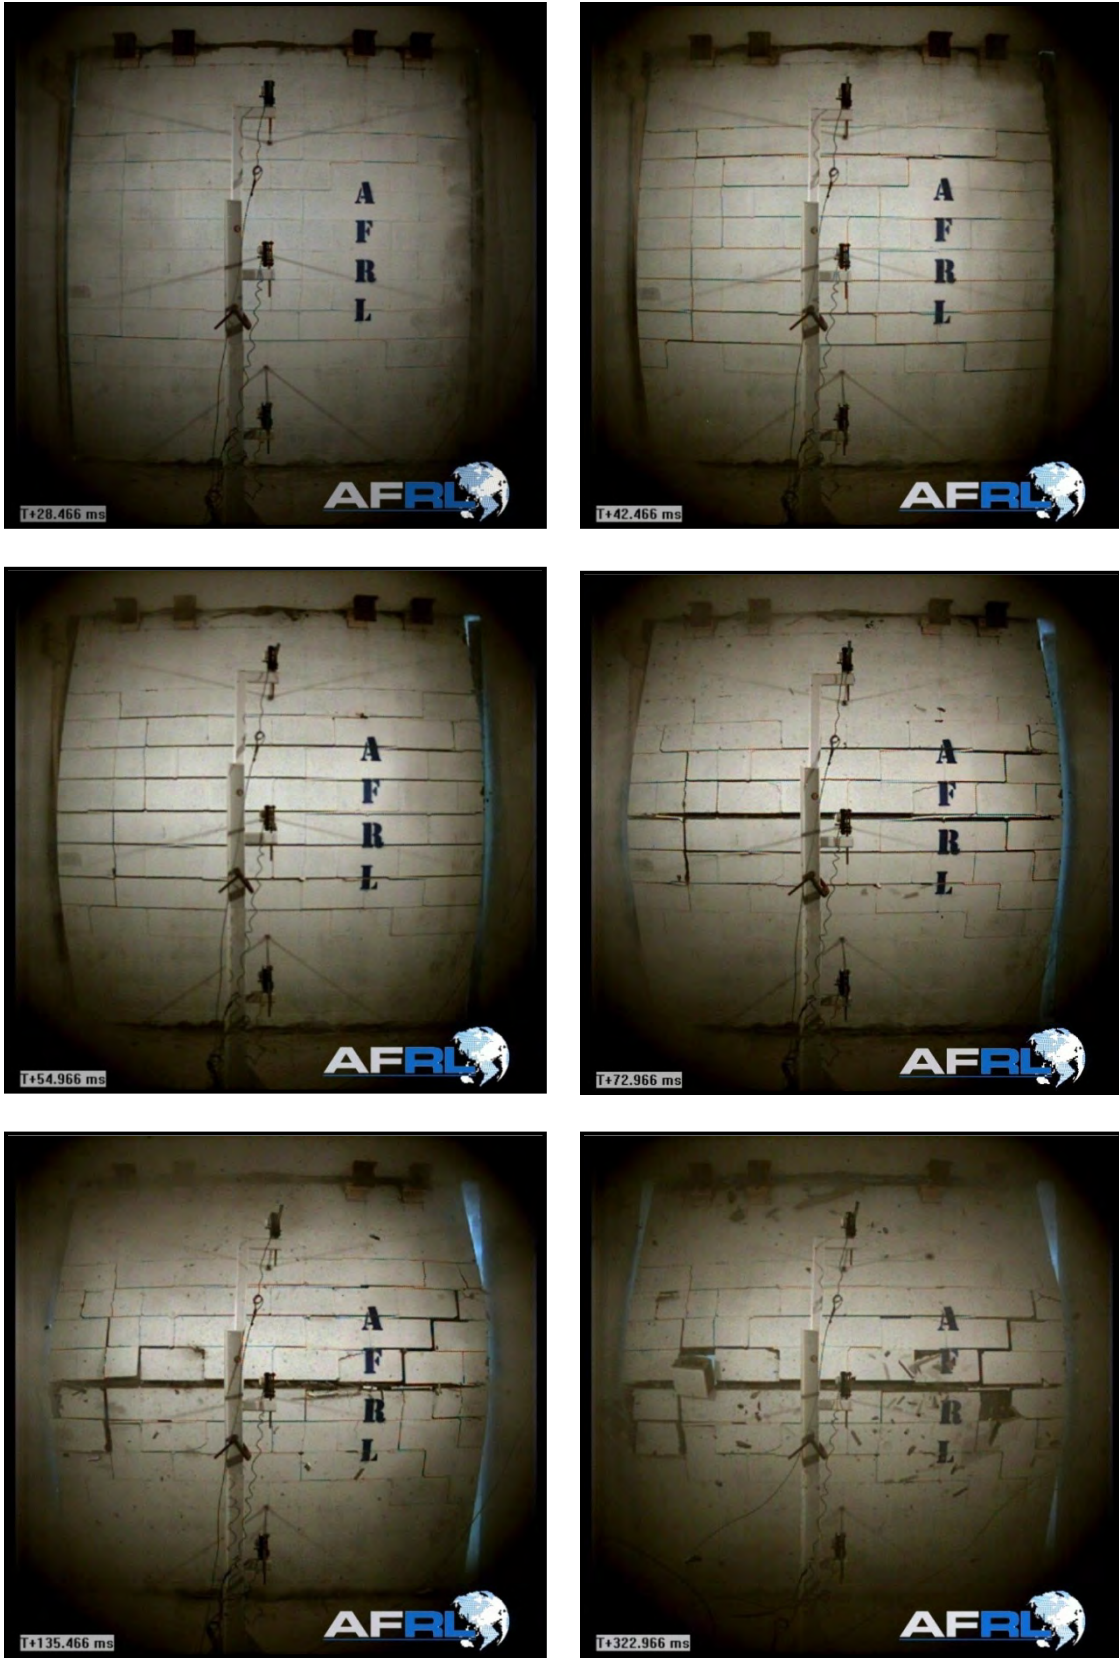
Figure 32. Experiment 2 6-inch CMU Panel Interior Images

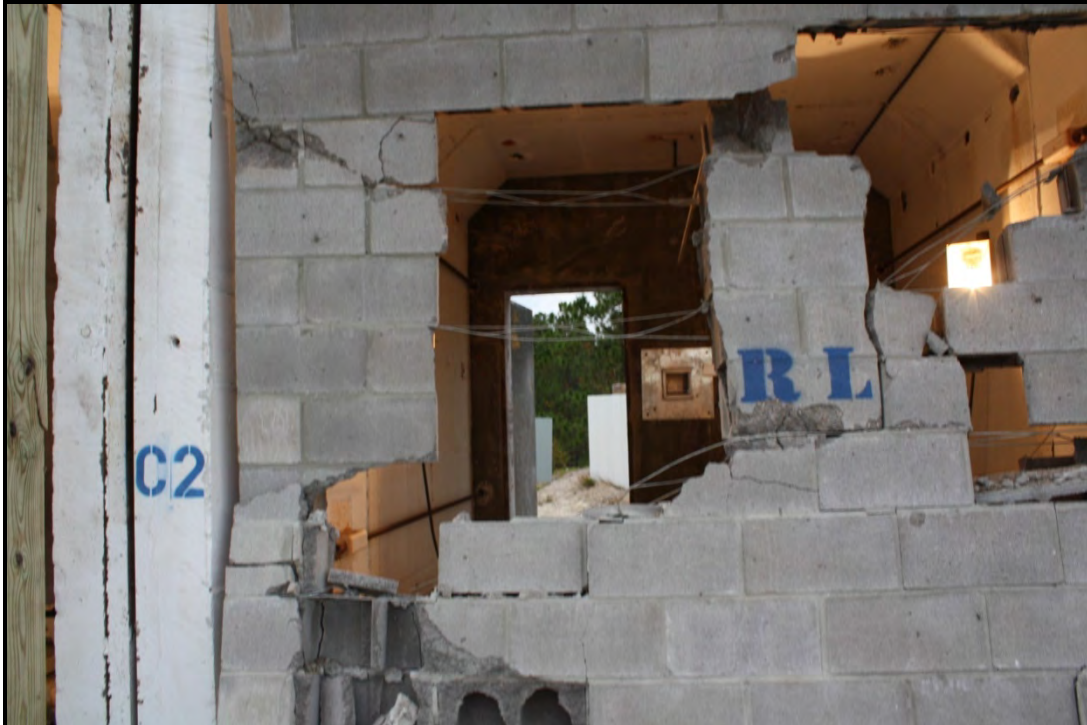
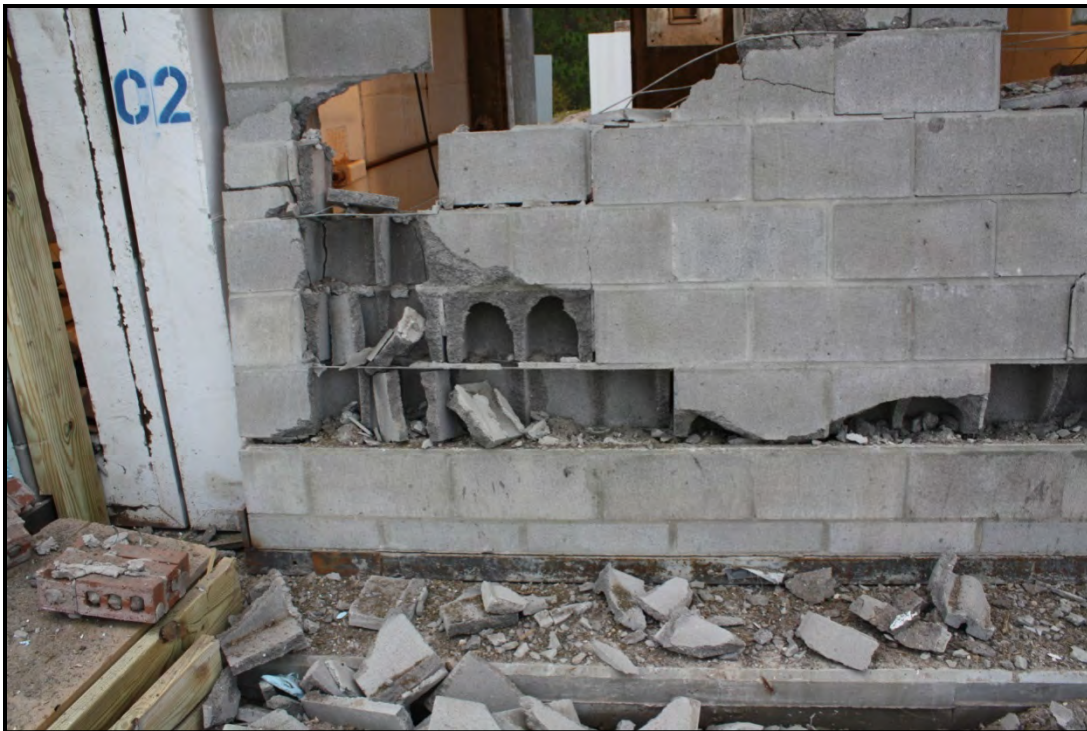
**Figure 38. Experiment 2 Post-detonation 8-inch CMU Panel CMU Damage**

**Experiment 2 8-inch CMU:** There was significant breaching of the 8-inch CMU panel during Experiment 2. The measured deflection is significantly lower, because the resistances used were lower than the measured resistances. Also, fracturing and breaching perhaps provided some load relief. The calculation using the measured static resistance function also resulted in higher overall displacement response, likely be due to assumptions regarding contributing mass and geometric and material strength differences between the static test article and the dynamic test article. There is a notable difference between the SBEDS simple support results and the WAC results; because the static resistance functions were similar, these differences are caused by input

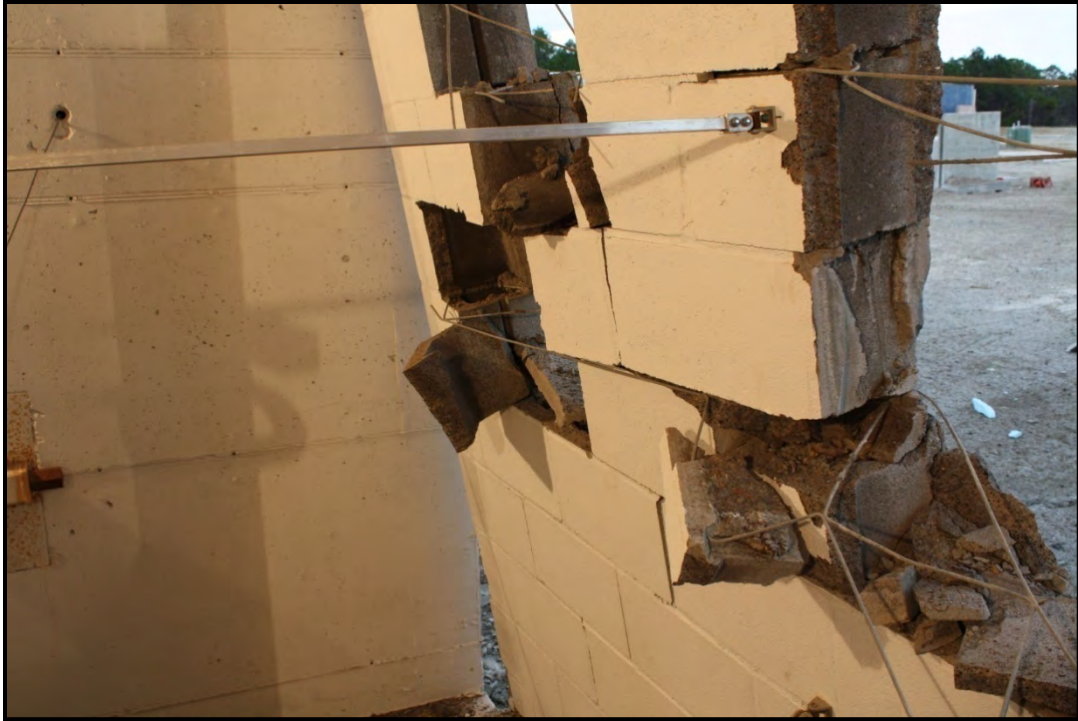
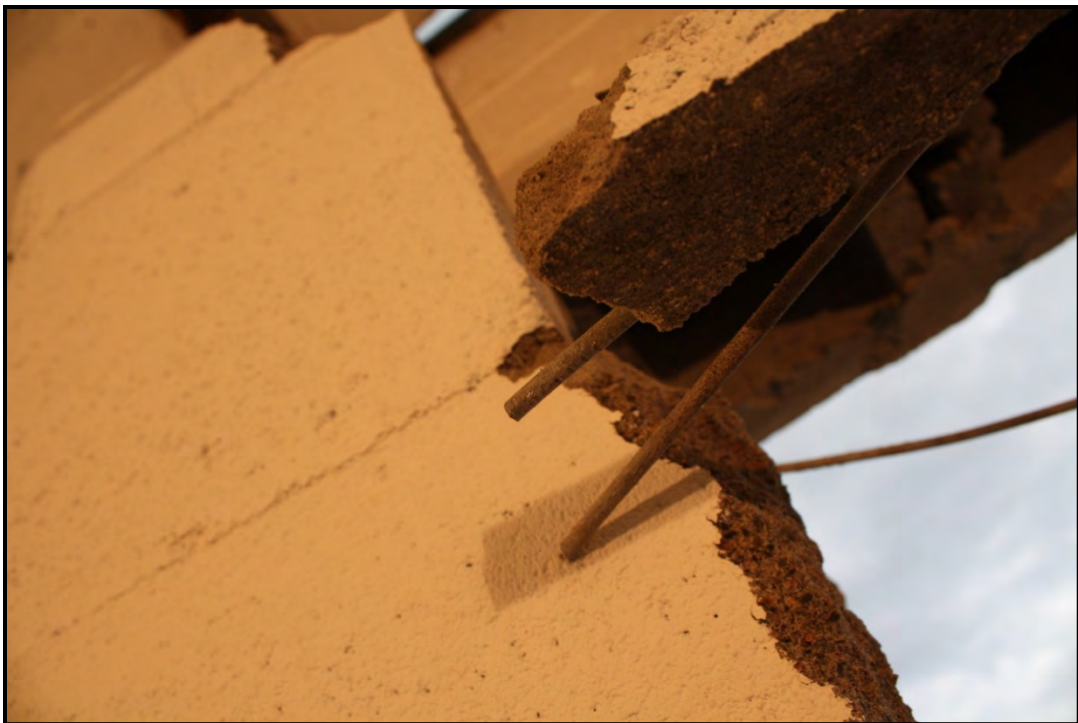
**Figure 39. Experiment 2 Post-detonation 8-inch CMU Panel CMU Damage**

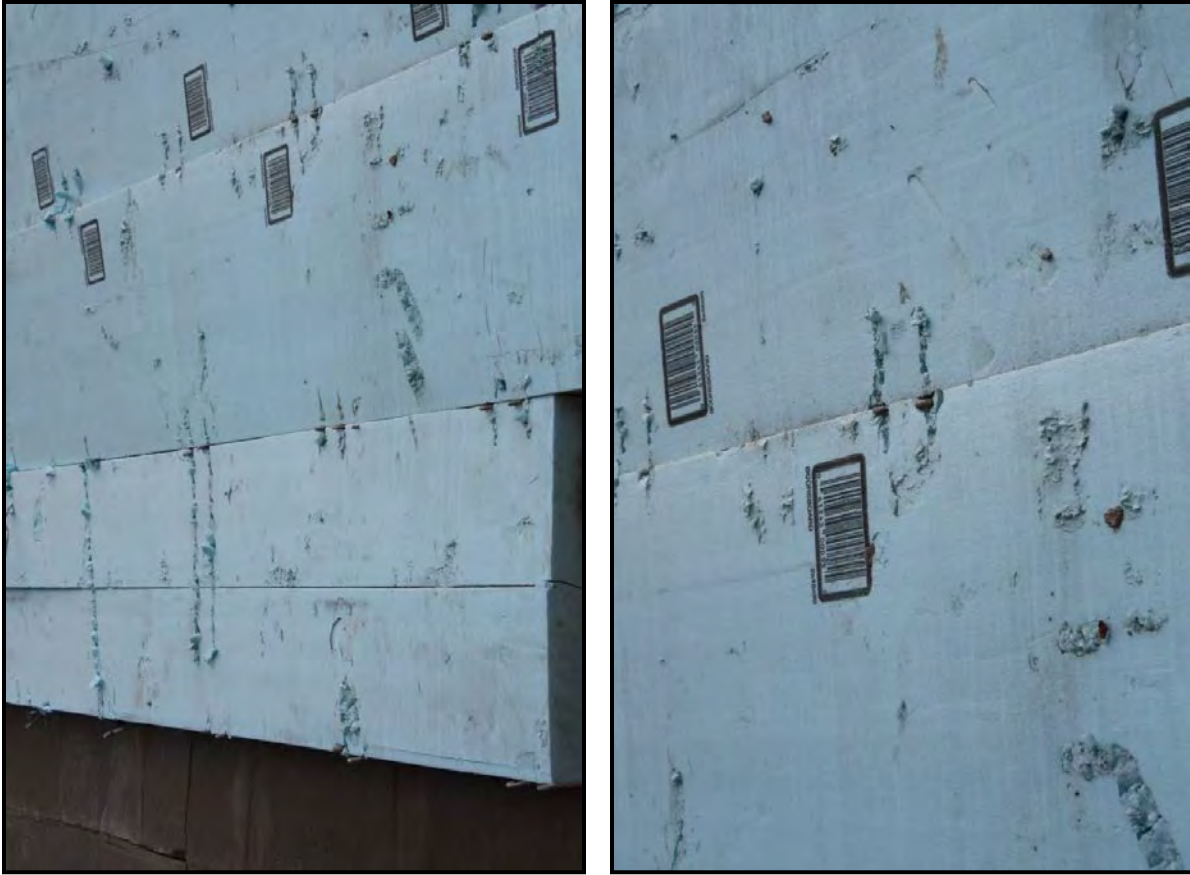
**Figure 43. Experiment 2 Post-detonation Cavity Wall Foam Damage**

- The brick veneer tended to fracture extensively and fall to the outside of the structure.
- The foam insulation of the cavity wall panels was fractured extensively during Experiments 2 and 3, but did not appear to have been significantly crushed. Its effectiveness in absorbing energy and thereby reducing the maximum dynamic displacement and tendency for catastrophic failure mechanisms was not discernable. As discussed extensively in the Series I masonry tests [Browning et al. 2008], the veneer ties have robust axial load capacity, and likely transfer most of the force from the veneer to the structural wythe, thereby precluding significant energy absorption by the foam insulation.

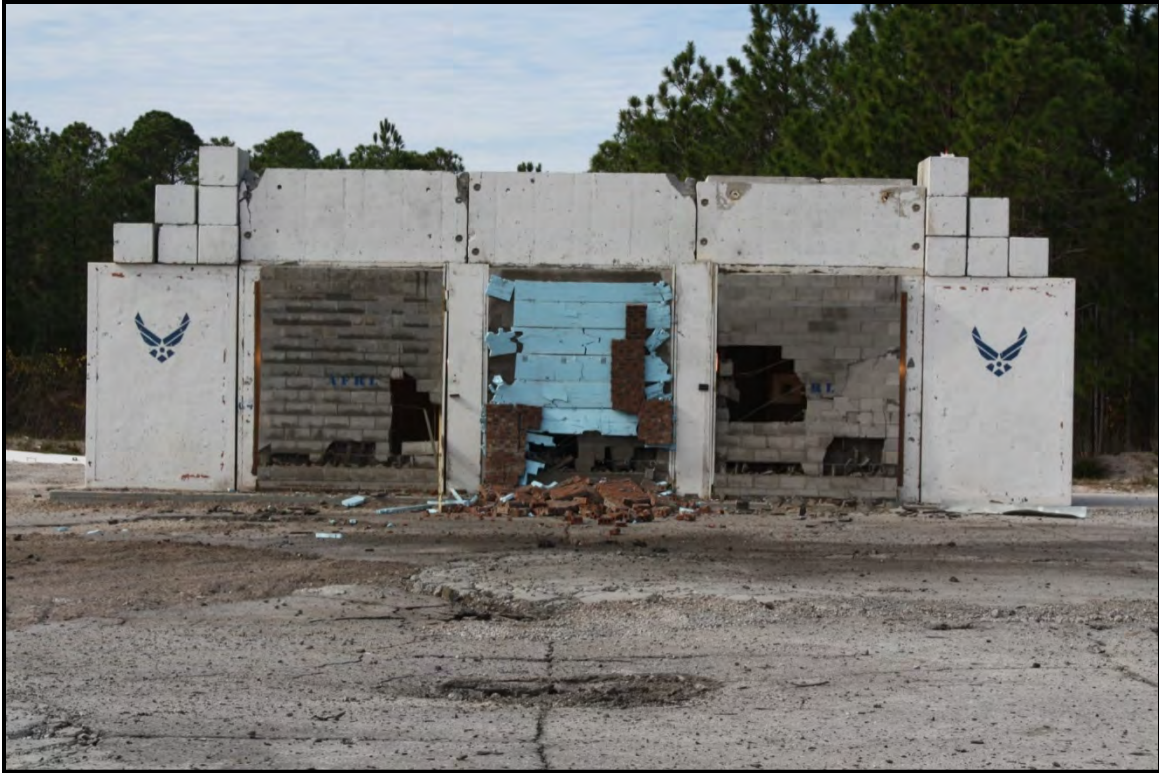
**Figure 44. Experiment 3 Post-detonation Front View**

Exterior views of the residual condition of all three test panels are depicted in Figures 44 and 45.

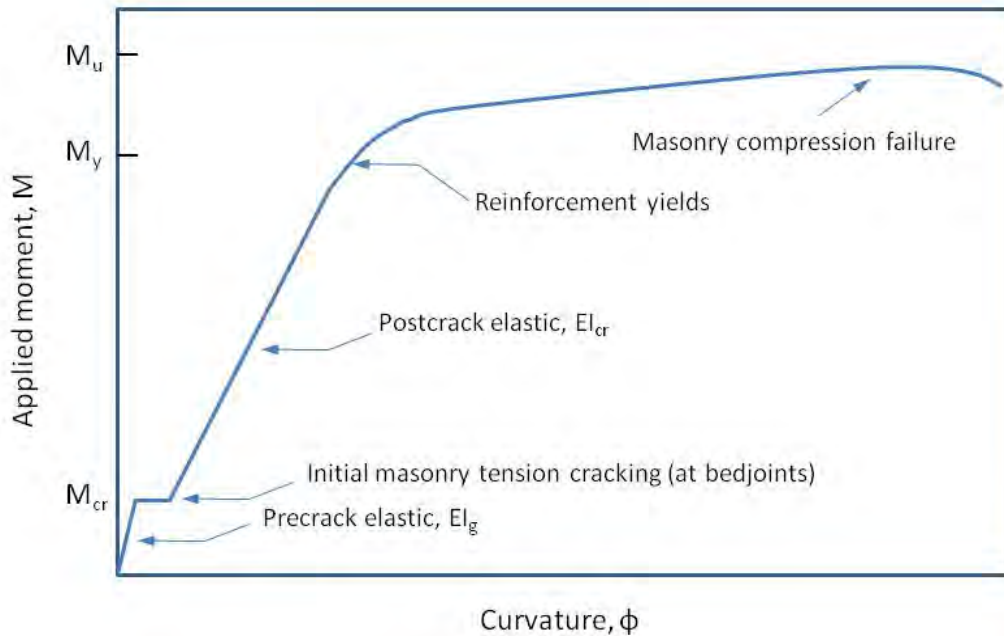
A generic moment-curvature representation for an under-reinforced masonry section is provided in Figure 60. Prior to cracking, the resistance is defined by net section properties of the uncracked section; the minimal contribution of the steel reinforcement can be ignored. Furthermore, for minimally reinforced sections, it is typical that one line of vertical reinforcing bars be placed at the thru-thickness center of the wall, and therefore would not significantly contribute to the gross uncracked moment of inertia. After cracking has occurred but while elastic behavior continues, the properties of the transformed section are used to define the stiffness. The resulting compression zone is either rectangular or a T-section, depending on the location of the neutral axis and whether the section is solid, hollow, partially grouted, or fully grouted. For lightly reinforced sections, the neutral axis is typically within the face shell of partially grouted hollow masonry; therefore, a rectangular section is used in the analysis. Calculations for the effective moment of inertia similar to those used for reinforced concrete can be used for deflection calculations; however, the deflection calculations become increasingly inaccurate with increasing displacement. After yielding of the reinforcement, increases in the externally applied moment result in a shift in the neutral axis toward the compression face. The increased moment is resisted by the increased moment arm due to movement of the compression force resultant. The decreased depth of the compression zone requires an increase in the maximum compressive stress to maintain equilibrium. Finally, as large deformations and crack openings occurs, the crushing strain of the masonry is reached at the extreme compression fiber of the masonry, and spalling of the masonry units or crushing of the grout, or both, occurs. The design-based resistance-displacement relationship is described in Figure 61.

**Figure 60. Moment-curvature Relationship for Reinforced Masonry Beams**

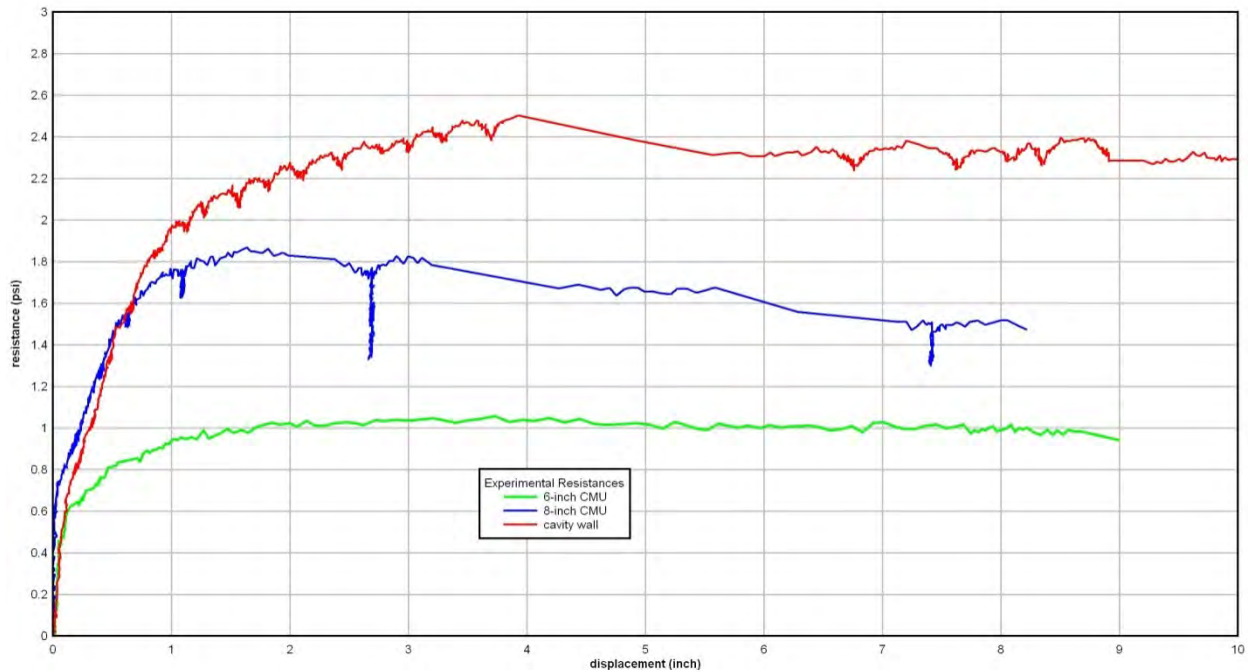
Figure 62 provides the resistance functions determined experimentally using comparable panel designs and dimensions [Salim et al. 2010]. Figures 63 and 64 compare the experimental and analytical static resistance functions for the 6-inch CMU panel and 8-inch panel designs considered in this test series. As can be noted, the SBEDS and WAC resistances for both the 6-inch and 8-inch CMU panels are closely aligned, but significantly lower than the test resistance. There is a slight difference between WAC and SBEDS resistances, which are due to input differences, rather than resistance definition differences. The design-code based resistances are further below the SBEDS and WAC generated resistances. From a design resistance standpoint, the veneer does not increase the resistance and the cavity wall resistance is therefore not shown in the comparison. However, a significant stability effect or vertical load resistance effect provided by the veneer can be interpreted from Figure 62.

Figure 62. Experimental Static Resistance Results

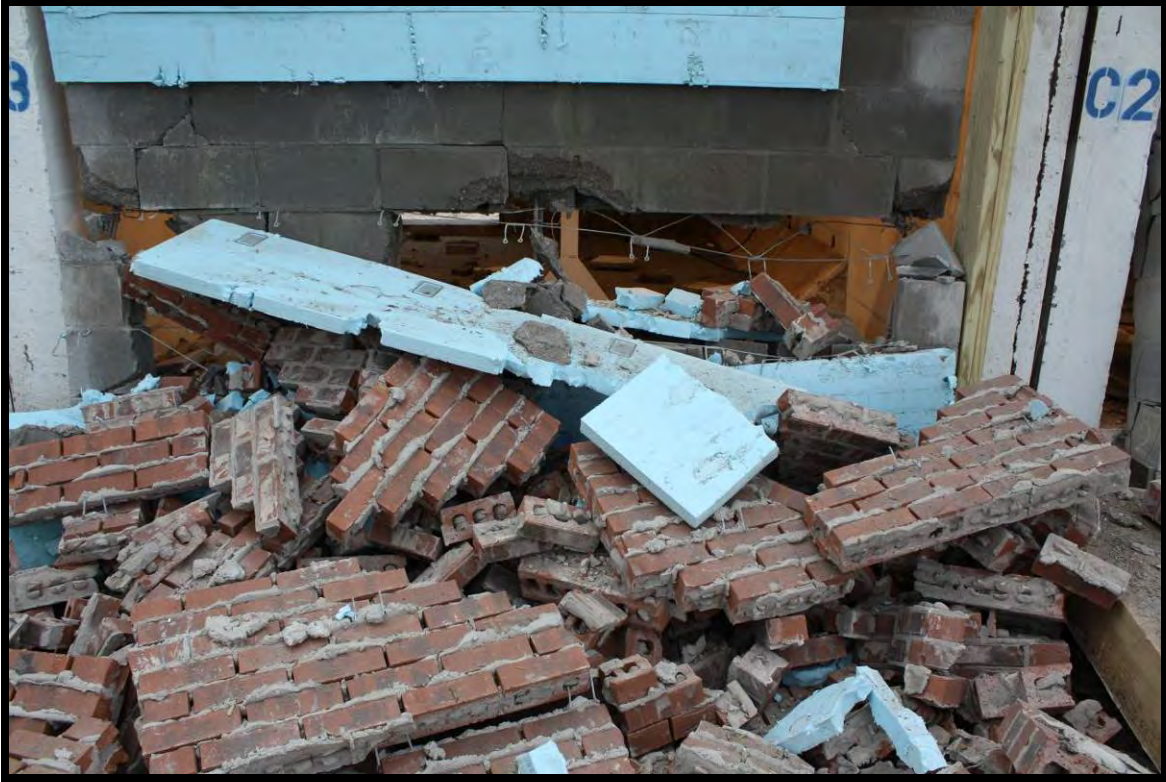
**Figure C-39. Experiment 2 cavity wall panel veneer failure**

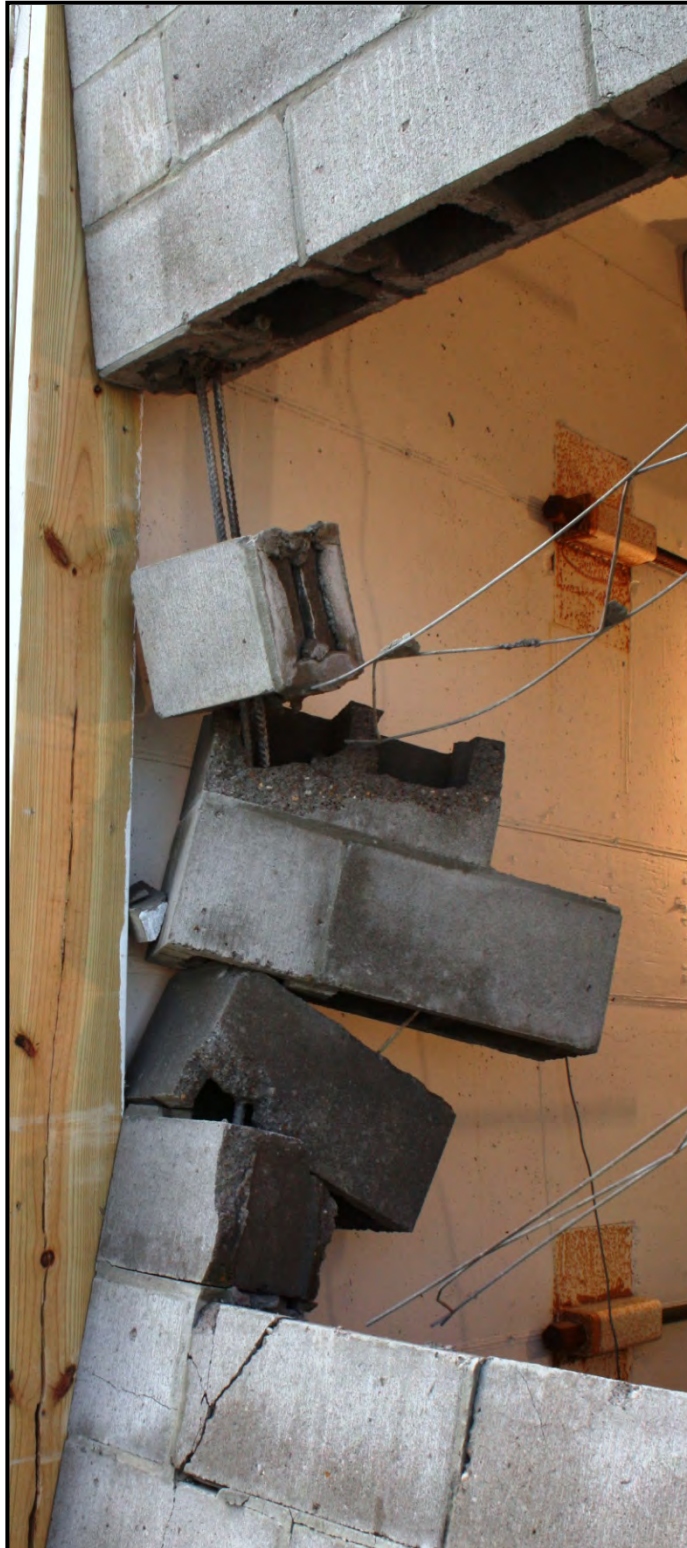
**Figure C-51. Experiment 3 8-inch CMU panel breaching exterior view, improperly grouted reinforced cells**

**Experiment 3 8-inch CMU:** Experiment 3 loading also resulted in very extensive fracturing and breaching of the 8-inch test panel, which was exacerbated by grout voids in cells at the edge of the panel. The overall analytical results trends are the same as described for the 6-inch CMU panel in the previous paragraph.

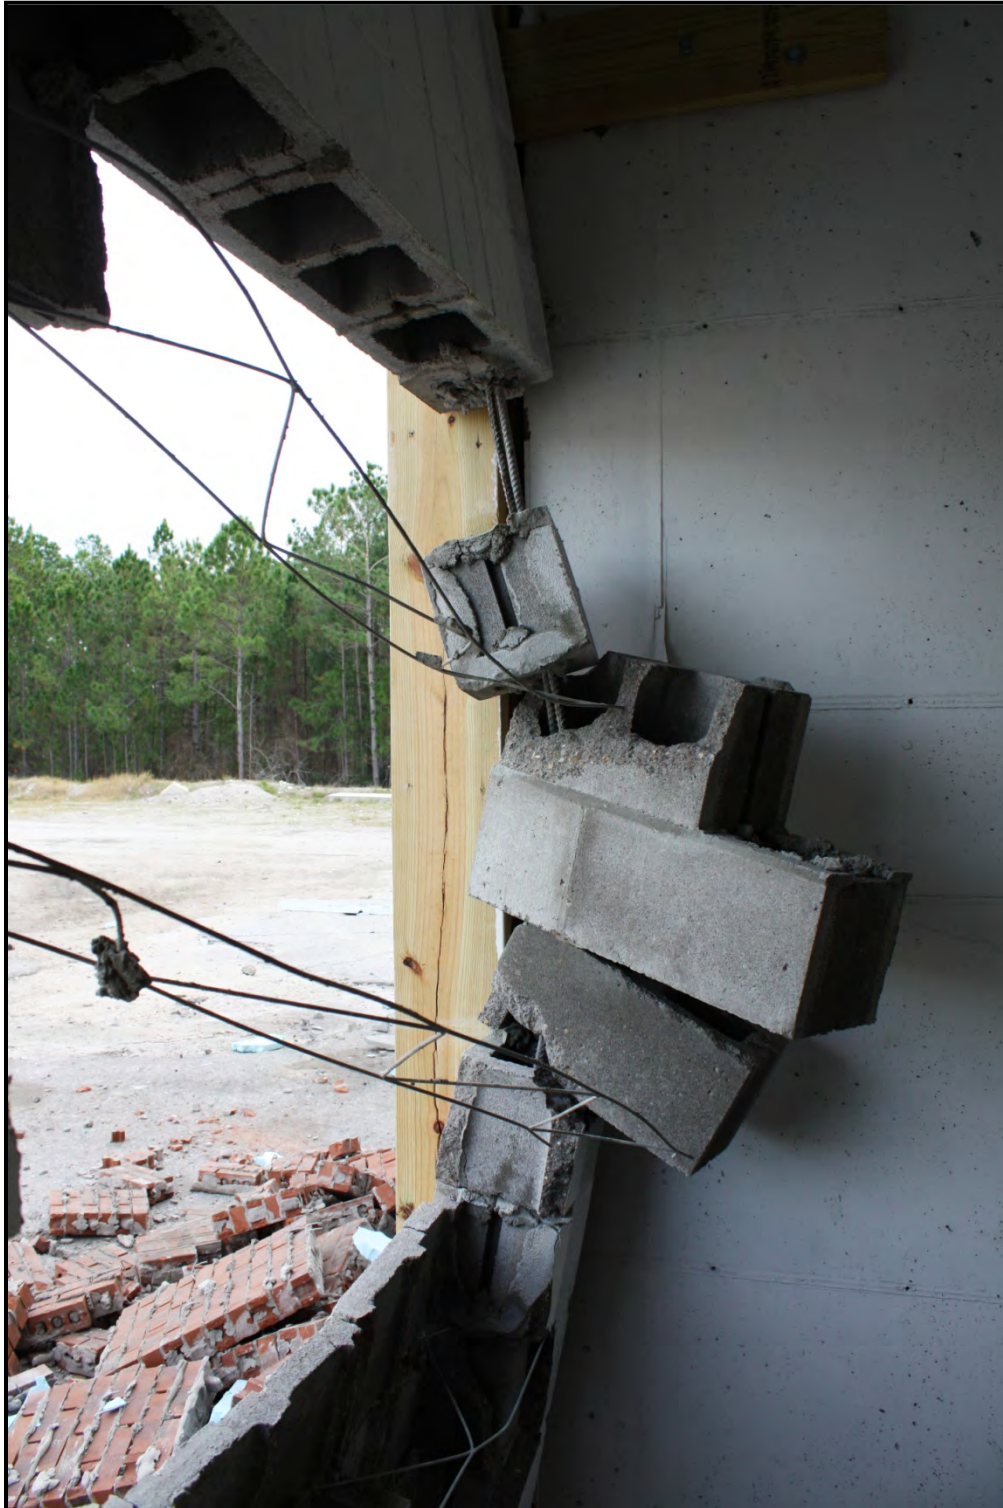
**Figure C-56. Experiment 3 8-inch CMU panel breaching interior view, improperly grouted reinforced cells**

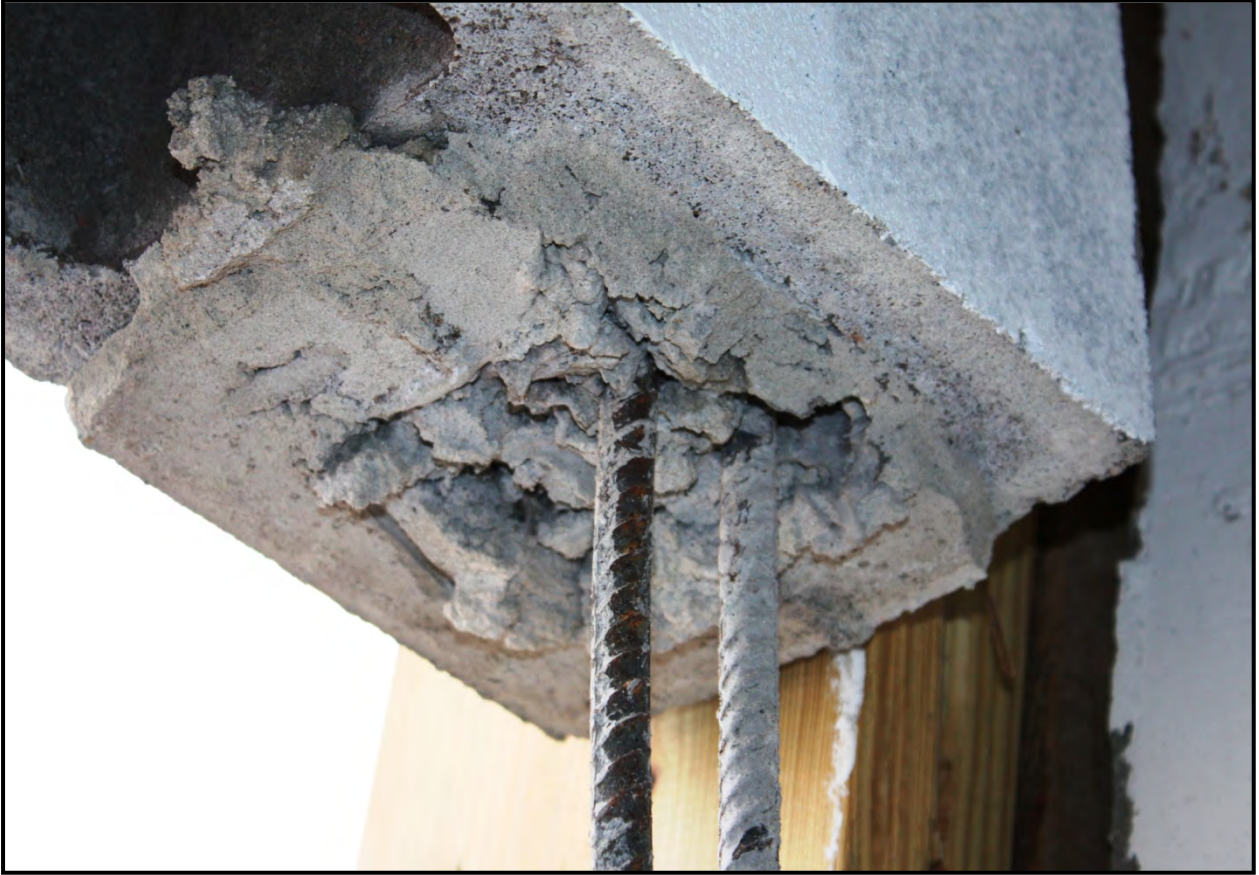
**Figure C-57. Experiment 3 8-inch CMU panel breaching interior view, improperly grouted reinforced cells**
