AFRL-RX-TY-TR-2011-0025-01

## **FULL-SCALE EXPERIMENTAL EVALUATION OF PARTIALLY GROUTED, MINIMALLY REINFORCED CONCRETE MASONRY UNIT (CMU) WALLS AGAINST BLAST DEMANDS**

November 2010

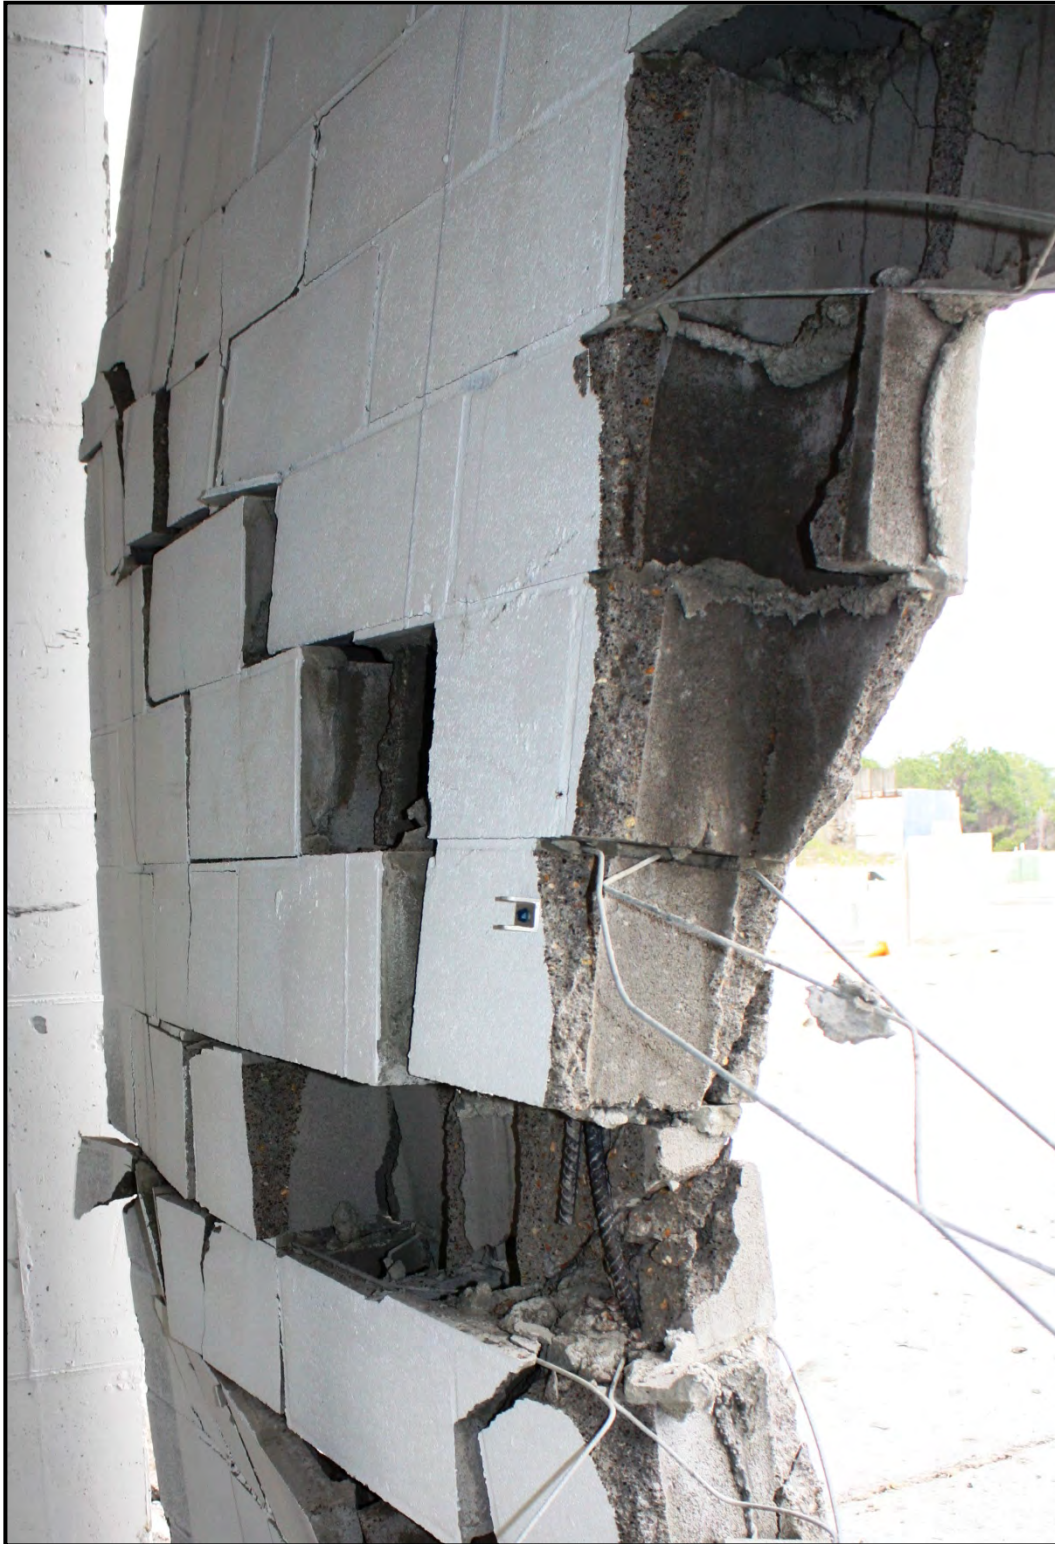
**Figure C-58. Experiment 3 8-inch CMU panel breaching interior close-up view**

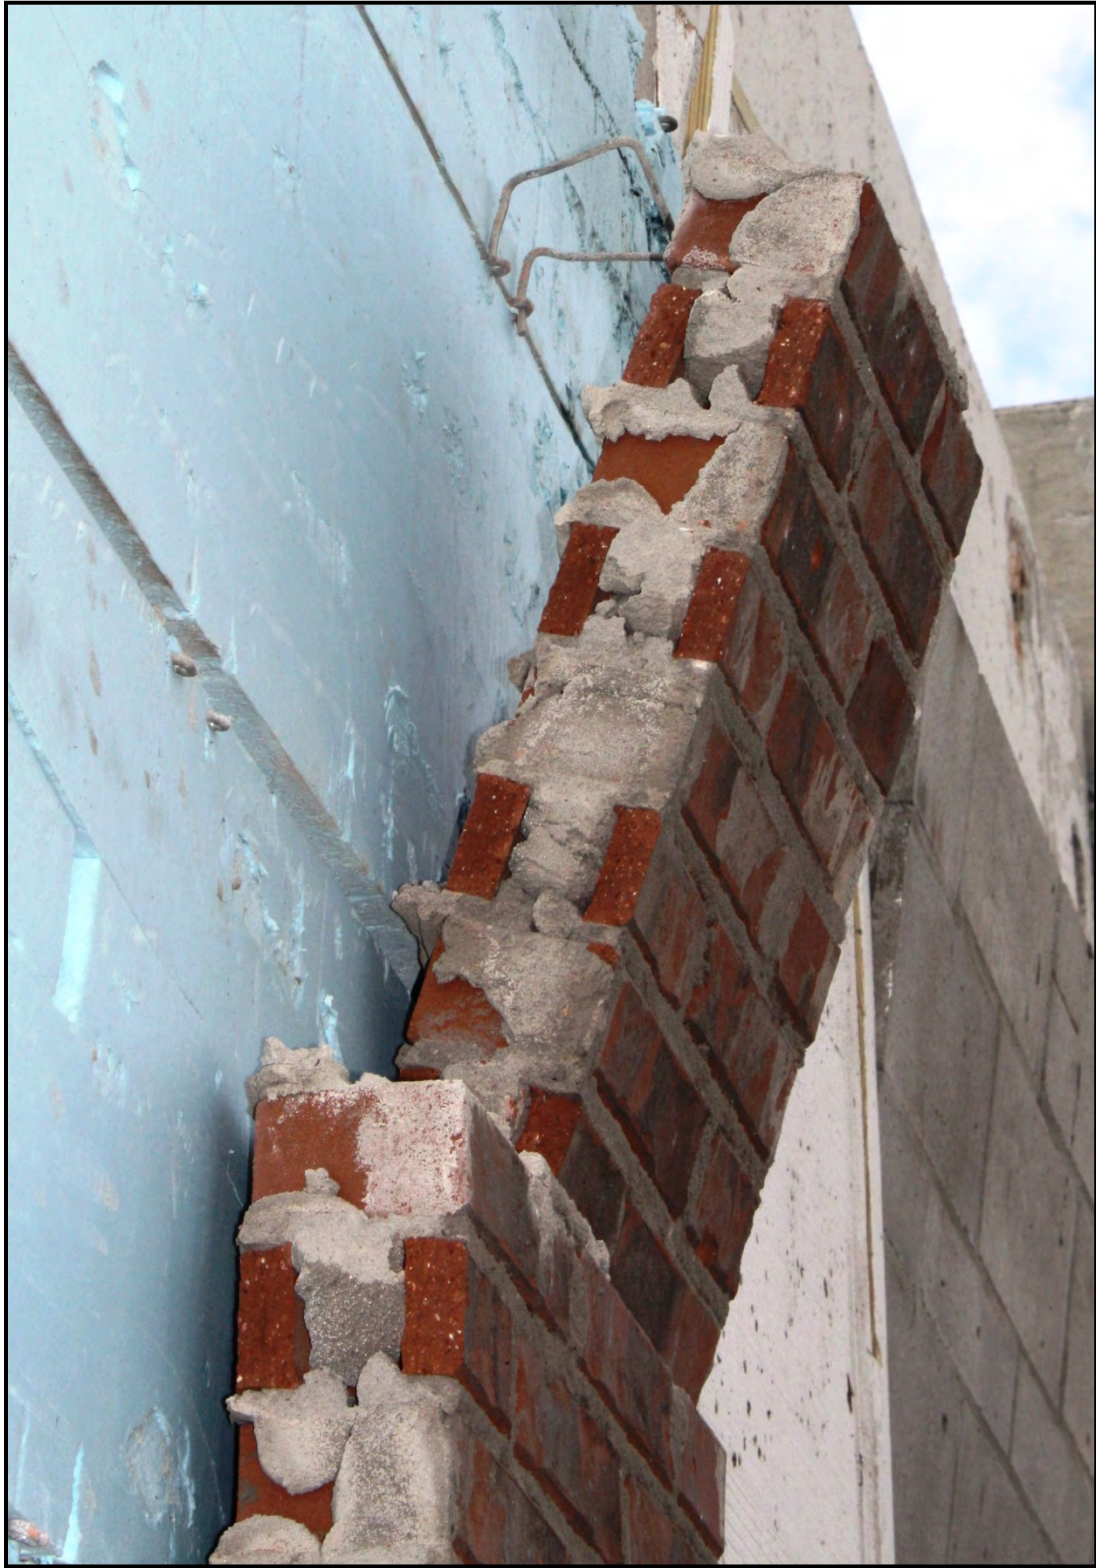
**Figure C-64. Experiment 3 cavity wall panel veneer close-up**
