AFRL-RX-TY-TR-2011-0051
DOT/FAA/AR-11/15

TEST AND EVALUATION OF NEXT GENERATION 65-FOOT, HIGH-REACH EXTENDABLE TURRET

Keith Bagot
Federal Aviation Administration
William J. Hughes Technical Center
Airport and Aircraft Safety Research and Development Group
Airport Technology Research and Development Team
Atlantic City International Airport, NJ 08405

November 2011

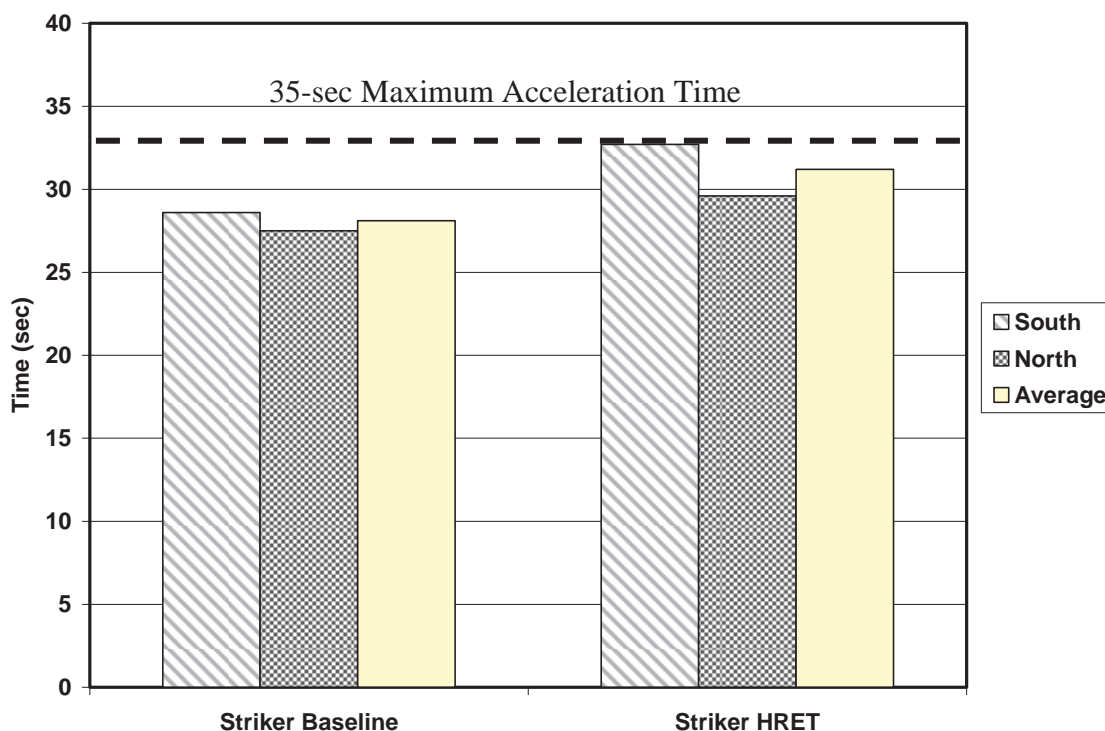
Figure 2. Acceleration Test Results

compared with the FAA Striker HRET (31.2 sec average). Both FAA Striker configurations passed the test. The test was run on the taxiway in both the north and south directions to account for any topographical changes in grade.

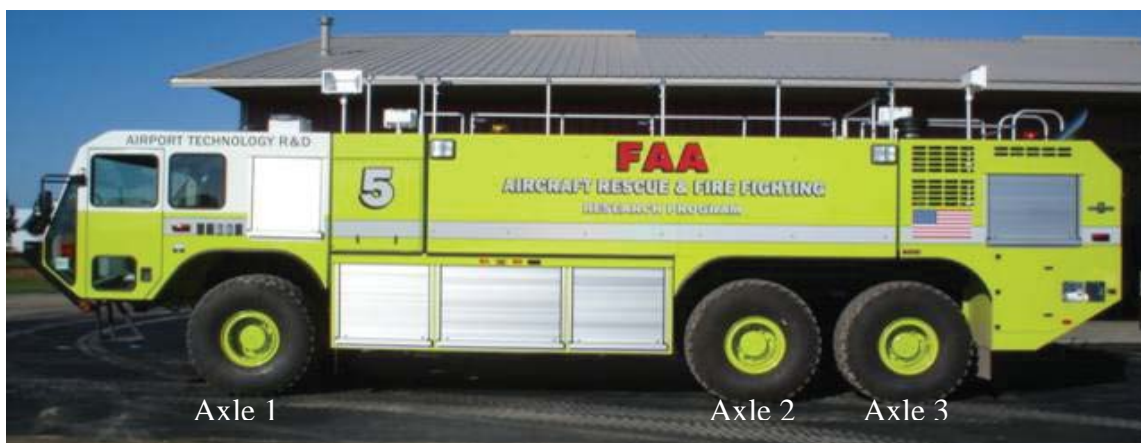
Figure 3. The FAA Striker 6X6 ARFF Vehicle Showing Axle Designations

Figure 3 shows the left side of the FAA Striker with axle numbers designated from front to rear. Table 1 shows the weight of each individual wheel on each axle before and after the installation of the HRET. The overall distribution of the weight for each tire did not change after the installation of the HRET; however, the heaviest total axle weight did change (figure 4). Axle 1 increased 4520 lb, axle 2 increased 1650 lb, and axle 3 decreased 380 lb. Axle 3 was the heaviest on the FAA Striker baseline and axle 1 was the heaviest on the FAA Striker HRET. Both configurations of the FAA Striker were within the 29,000-lb vehicle specification weight limit per axle for all three axles. Both FAA Striker configurations failed the axle percent weight difference. The FAA Striker baseline had an 11% difference between the heaviest (3) and lightest (1) axle, while the AC [1] specified a maximum of 10%. The FAA Striker HRET had a 6.6% difference between the heaviest (1) and the lightest (3) axle, while the AC [1] specified a maximum of 5%.

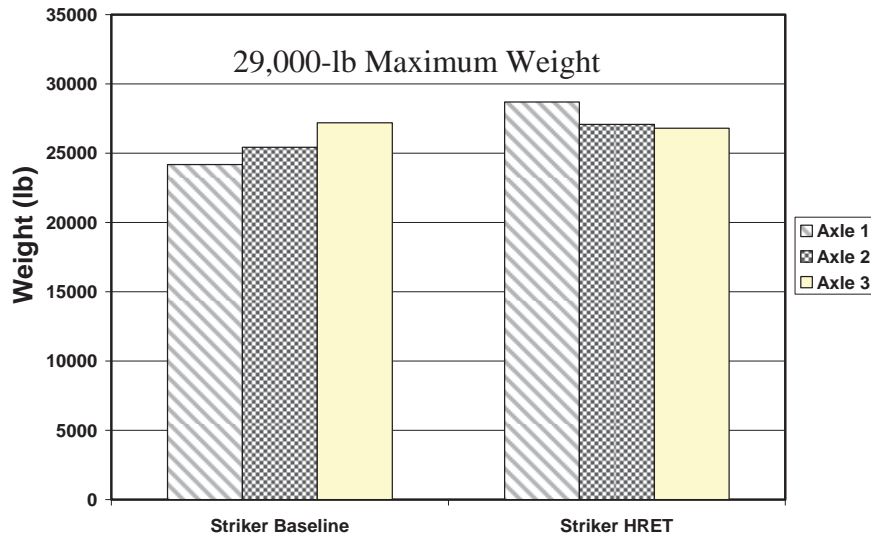
Figure 4. Total Axle Weight

Axle	Baseline Configuration (lb)	HRET Configuration (lb)
1 (right)	12,520	14,780
1 (left)	11,660	13,920
2 (right)	12,630	13,390
2 (left)	12,800	13,690
3 (right)	13,250	12,870
3 (left)	13,940	13,940

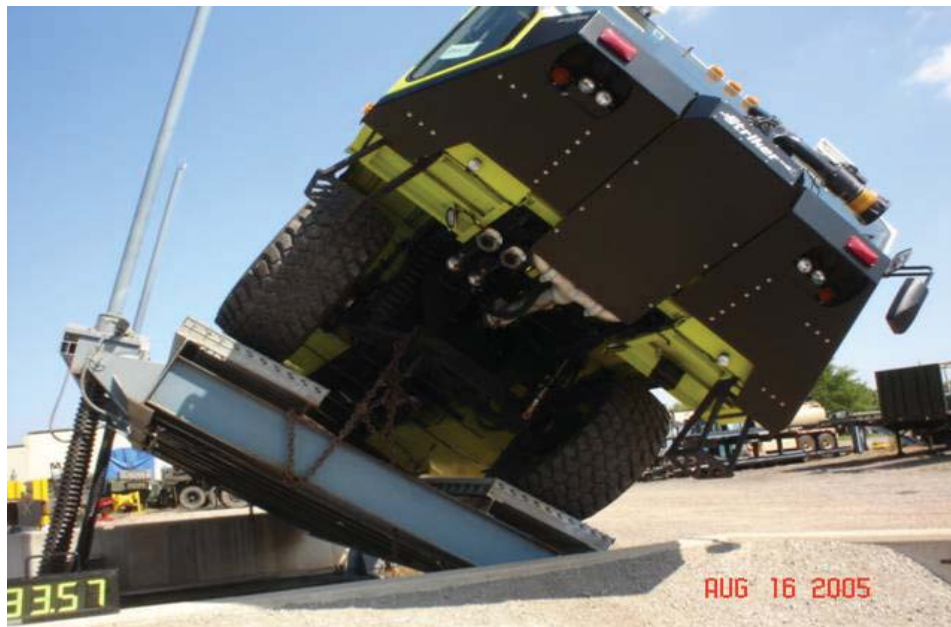
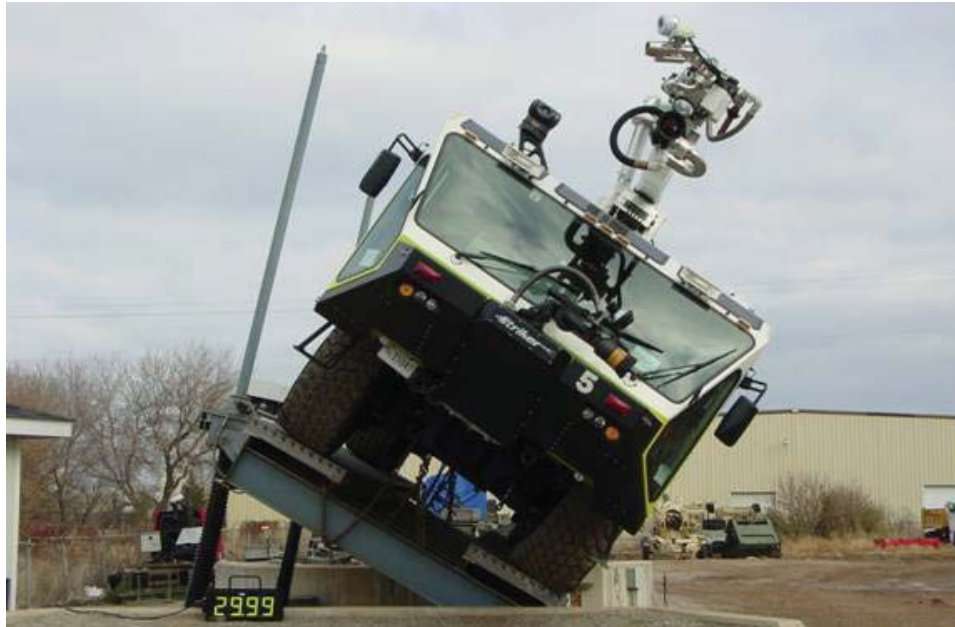
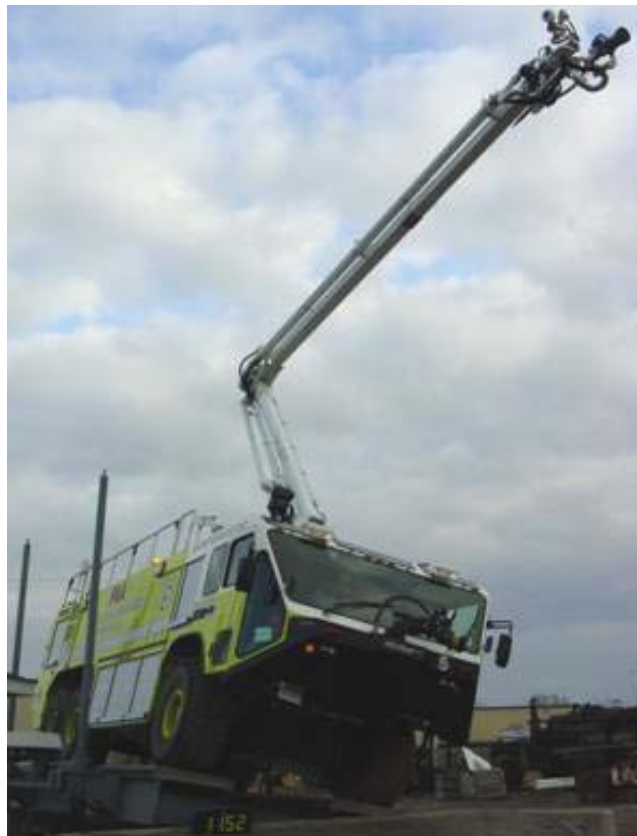
Static [1, section 20b]	HRET Elevated [1, section 85]
AC 150/5220-10C Requirement [1]	30°	11°
FAA Striker baseline	33.5°	Not applicable
FAA Striker HRET	31.55°	11.52°

Figure 6. Tilt Table Test Without the HRET

Figure 7. Tilt Table Test With the HRET

Figure 8. Tilt Table Test With the HRET Elevated

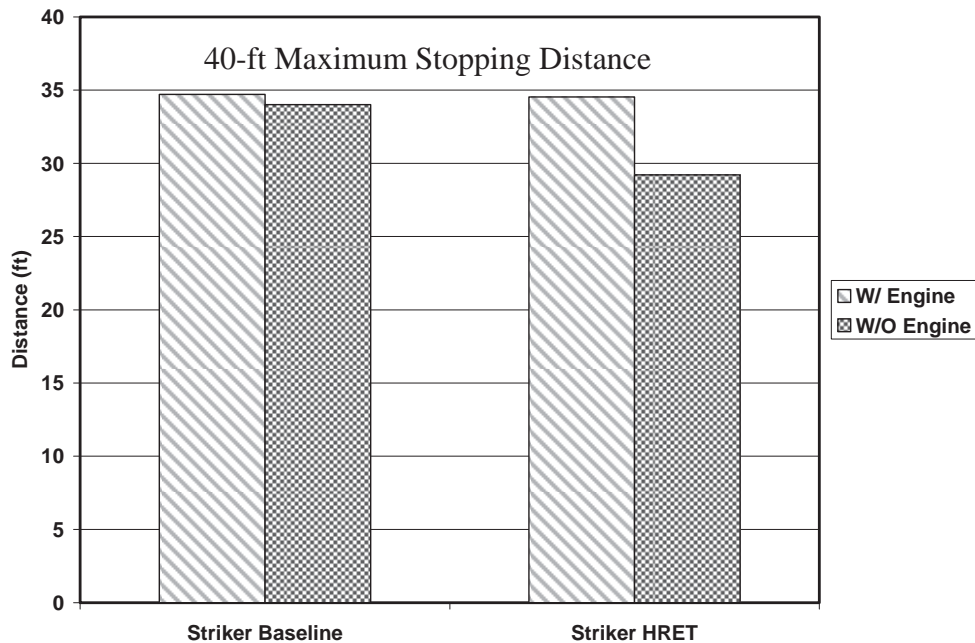
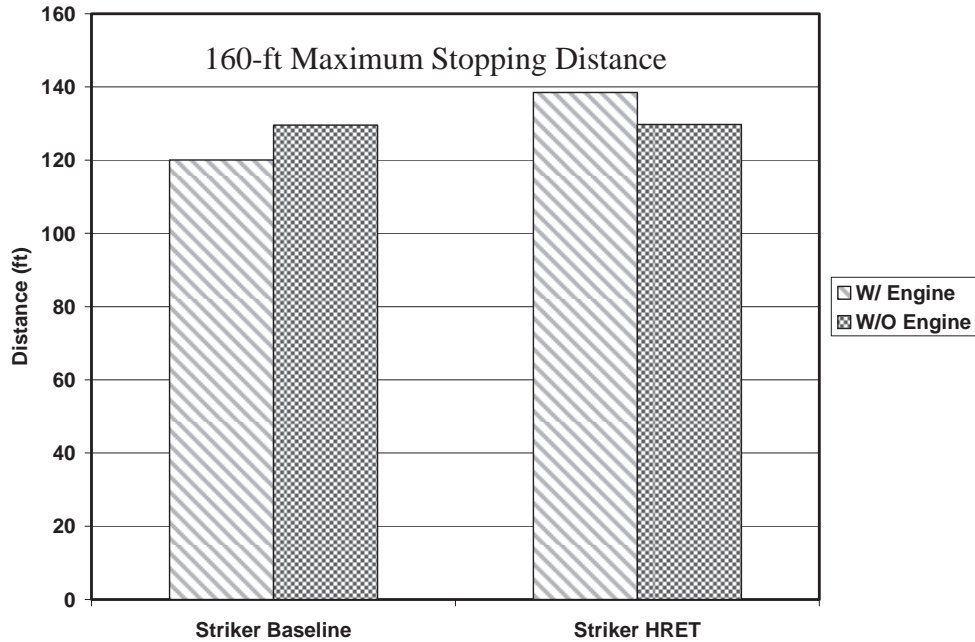
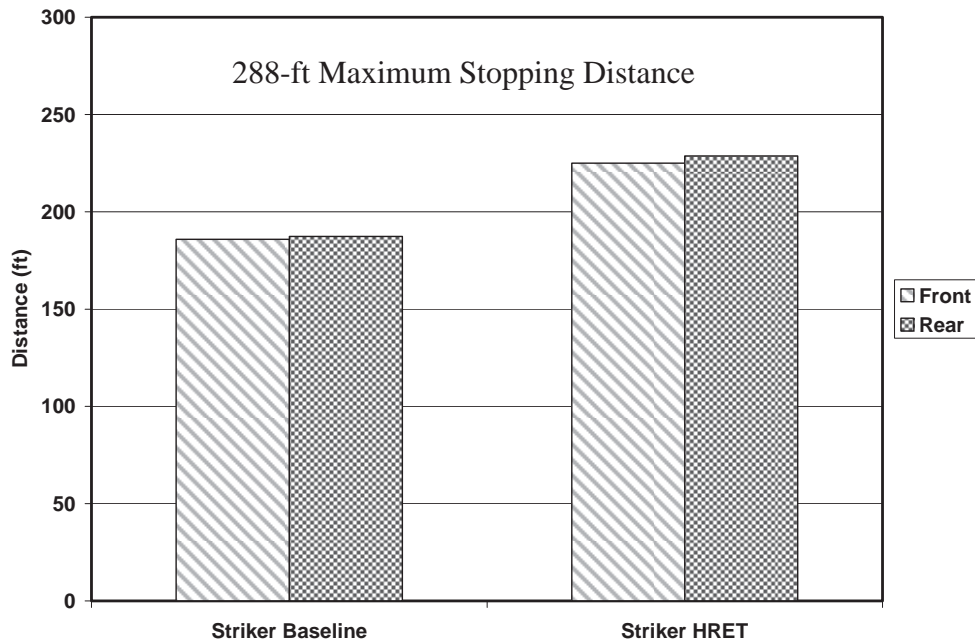
Stopping distance tests for service and emergency brake systems were completed on the FAA Striker baseline and FAA Striker HRET [1, sections 32b, 32d, table 2]. The AC states that, at 20 mph, the service brakes must be able to stop the fully loaded vehicle within 40 feet, with and without the engine running. The service brakes must be able to stop the fully loaded vehicle travelling 40 mph within 160 feet, with and without the engine running. At 40 mph, the emergency brakes must be able to stop the fully loaded vehicle within 288 feet. A data acquisition system, with a global positioning system, was used to record the stopping distances. Figures 9 through 11 show that the FAA Striker passed all three tests in both the baseline and HRET configurations. At 20 mph, the FAA Striker HRET exceeded the performance of the baseline tests. The service brake stopping distance at 40 mph ranged from 20 to 42.5 feet less than the maximum requirement; the emergency brake stopping distance ranged from 55 to 108 feet less than the maximum requirement.

Figure 9. Service Brake Stopping Distance From 20 mph

Figure 10. Service Brake Stopping Distance From 40 mph

Figure 11. Emergency Brake Stopping Distance From 40 mph

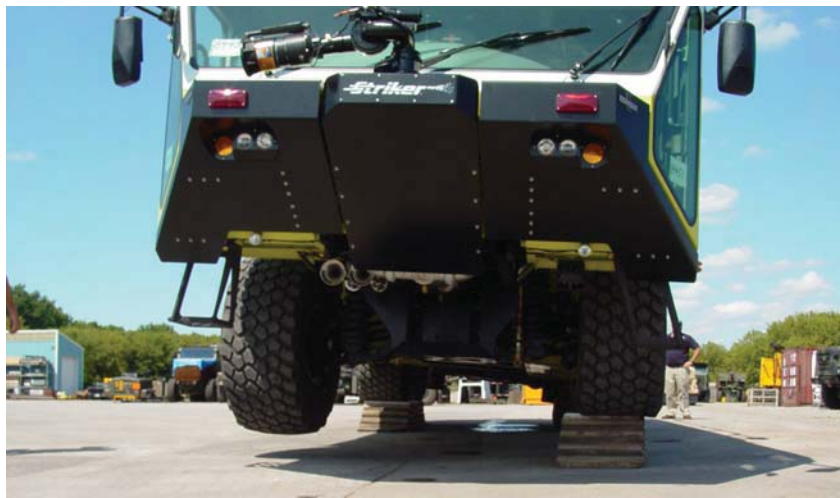
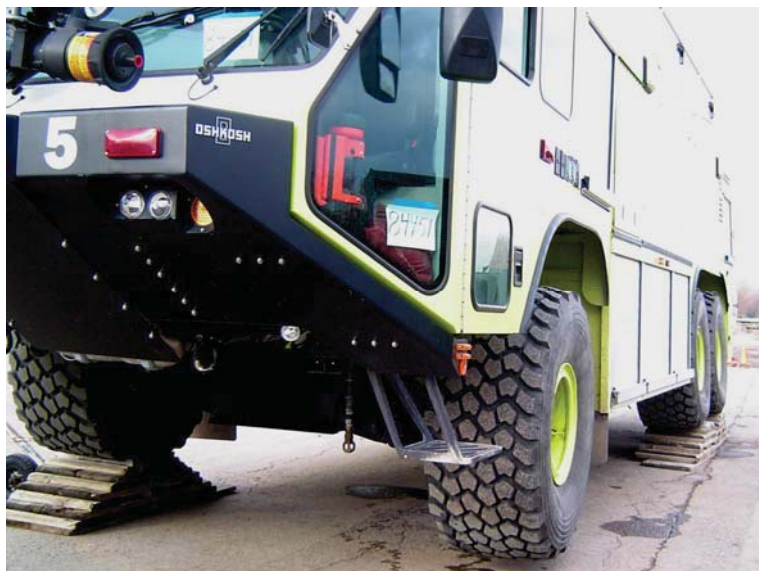
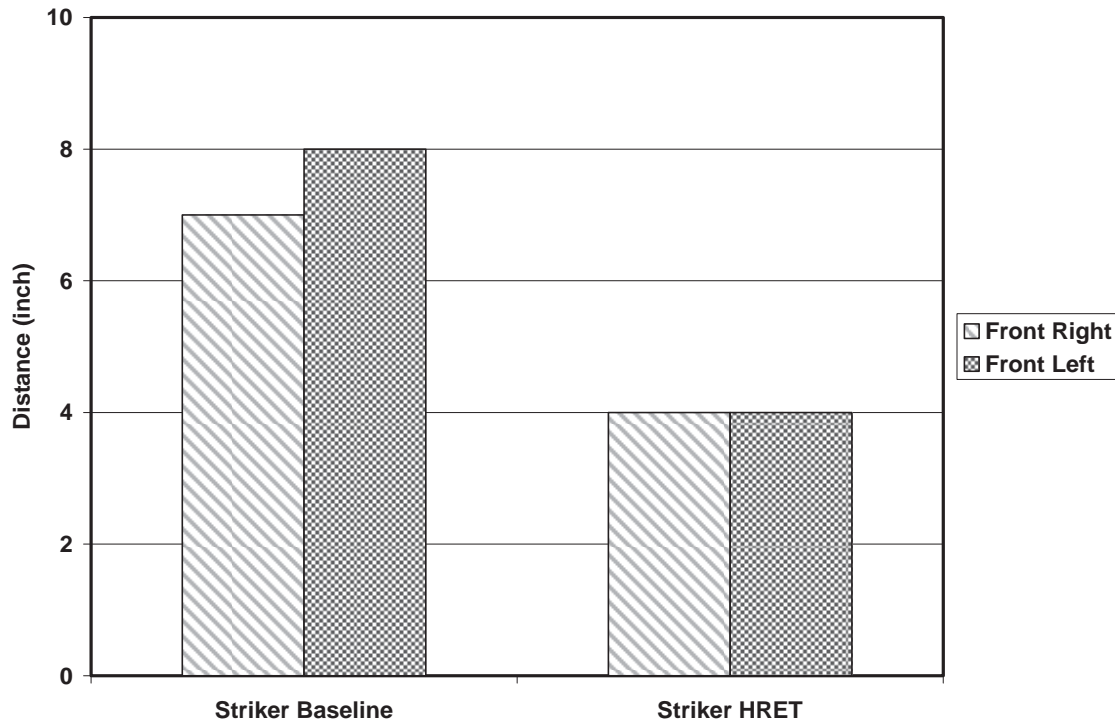
all systems must function properly, and all tires must stay in contact with the ground. Two rear wheels on the same side of the vehicle and one front wheel on the opposing side of the vehicle were placed on 14-inch blocks. All six tires were inspected and any tires not in contact with the ground were measured. After the body and chassis were inspected, the vehicle was cross-articulated with the opposite wheels. Figure 12 shows the FAA Striker baseline cross-articulated with the left-front and right-rear wheels on blocks. Figure 13 shows the FAA Striker HRET cross-articulated with the right-front and left-rear wheels on blocks. Figure 14 shows the distance from the ground of the front tire not on blocks. While results improved with the addition of the HRET, which added weight to the front of the vehicle, the FAA Striker did not pass the flexibility test in either configuration. The FAA Striker baseline test measured a distance of 7 (right) to 8 (left) inches, and the FAA Striker HRET test measured a distance of 4 inches for both the left- and right-front tires.

Figure 12. The FAA Striker Baseline Chassis Flexibility Test

Figure 13. The FAA Striker HRET Chassis Flexibility Test

Figure 14. Tire Distance to Ground During Cross-Articulation

Body and chassis flexibility tests were conducted on both the FAA Striker baseline and the FAA Striker HRET [1, section 10]. The tests were conducted according to NFPA 414 6.3.9 [2], and the results were compared to the requirements outlined in AC 150/5220-10C [1]. The AC states that when the vehicle is cross-articulated on 14-inch blocks, no damage to vehicle components,

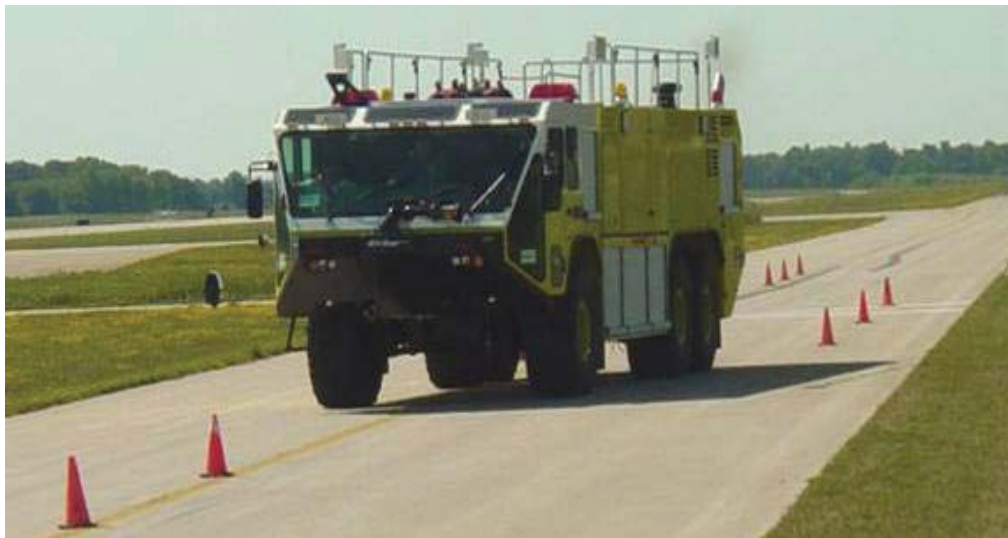
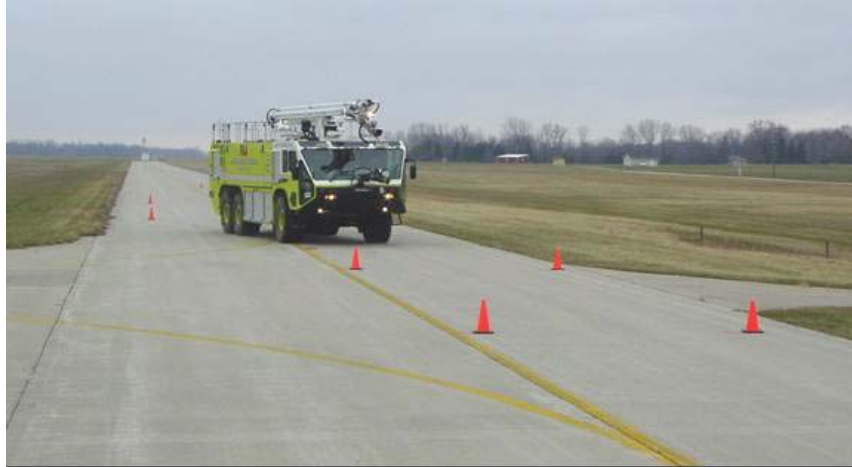
The North Atlantic Treaty Organization (NATO) Lane Change Tests were completed on both configurations of the FAA Striker [1, table 2]. The vehicle accelerated to a minimum speed of 35 mph while traveling through the cones without losing control or stability. A double-lane change course (figure 15) was marked per NATO AVTP 03-160W [3]. The vehicle was driven in both configurations through the course at speeds up to 40 mph without losing of control, exceeding the 35-mph minimum requirement. Figures 16 and 17 show the vehicle in each configuration as it was maneuvered through the course.

Figure 15. The NATO Lane Change Course Diagram and Calculations [3]

Figure 16. The FAA Striker Baseline During NATO Lane Change Test

Figure 17. The FAA Striker HRET During NATO Lane Change Test

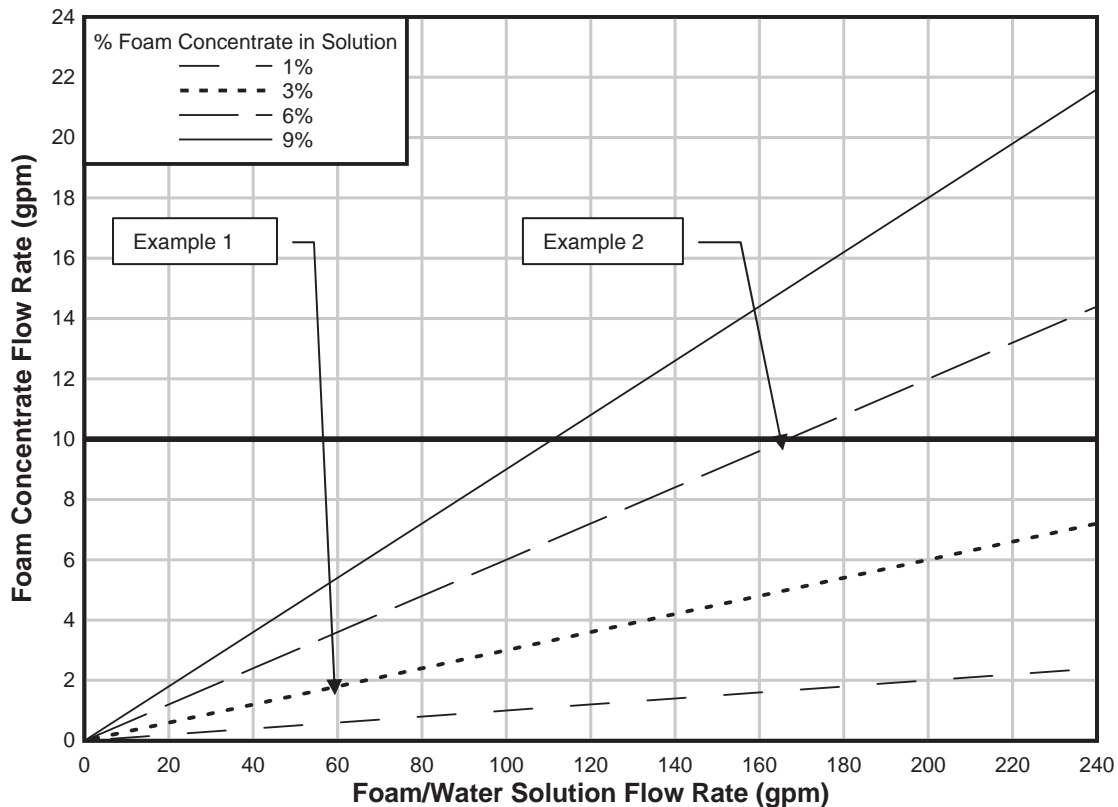
Figure 19. Foam Concentrate Flow Rate Variation

The flow sensor on the 2-inch line that supplies foam concentrate from the foam tanks is rated by the manufacturer for a recommended flow rate range of 10-300 gpm. The flow sensor on the 6-inch water/foam solution discharge line from the pump is rated for a recommended flow rate range of 90-2650 gpm. Figure 19 shows how the foam concentrate flow rate from the concentrate tank varies with the desired percent foam concentration and with the flow rate of the foam/water solution from the pump to the selected turret or hand line. For example, at a foam concentration of 3% and a foam/water solution flow rate of 60 gpm, the foam concentrate flow rate to the suction side of the pump would be slightly less than 2 gpm (see “Example 1” in figure 19), about 8 gpm below the manufacturer’s recommended range. Therefore, there is potential that the system may not accurately meter the concentrate at such a low flow rate. In figure 19, the heavy black line at the 10-gpm foam concentrate flow rate coincides with the minimum recommended flow rate for accurate operation of the 2-inch flow sensor installed on the foam concentrate supply line. Any water/foam solution flow rate combined with a foam concentrate below this line could cause the electronic foam proportioning system to inaccurately meter the foam concentrate. For example, the Nordic Foam Boss may not be able to meter the correct amount of foam concentrate for a 6% foam solution set at the ECU when the water/foam solution flows from the turret or hand line is less than about 167 gpm (see “Example 2” in figure 19).

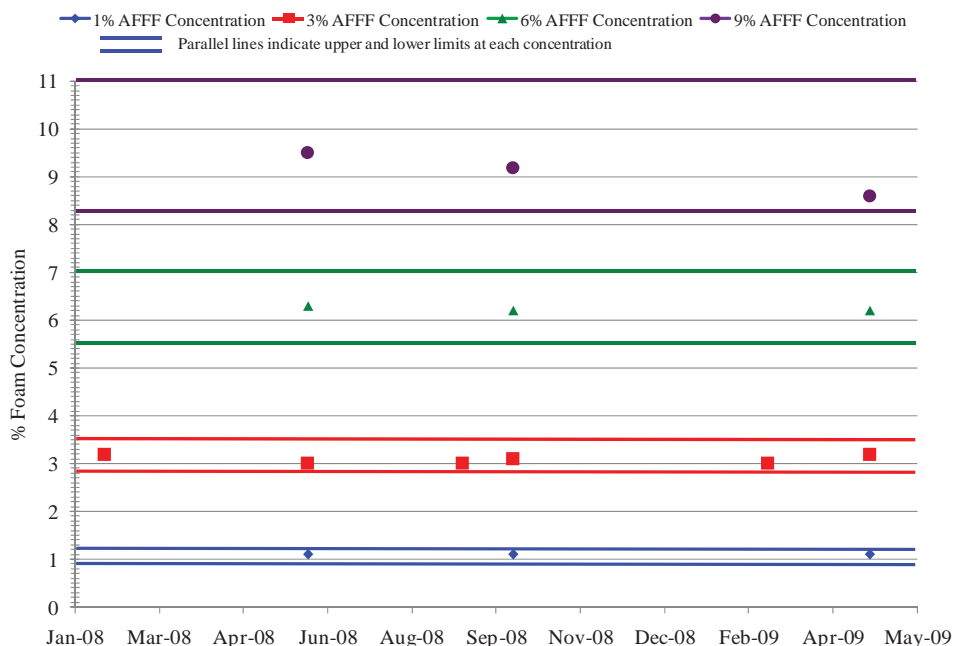
Figure 21. Base Turret Foam Concentration History

Figure 21 shows the results of the foam concentration checks for the 1000-gpm base turret. The results are represented graphically over time for the four test concentrations. The results indicate no significant degradation in performance over time. The results were within specifications at all four concentrations for every sample. The system performed well even at the very low mixture concentration of 1%, for which the extrapolated acceptance band was just 0.9%-1.2%.

In conclusion, the Nordic Foam Boss electronic foam proportioning system performed well over the 16 months it was tested. No repairs were required to the system over the test duration.

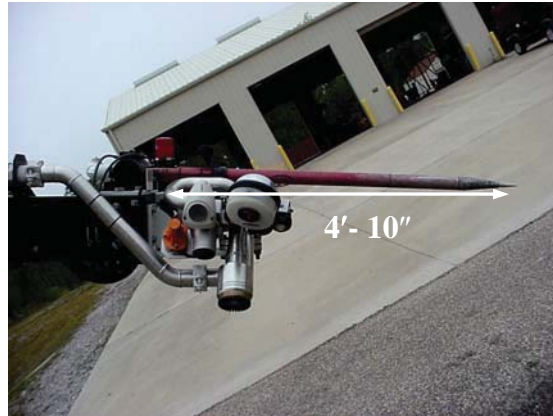
an inclinometer with a magnetic base was used to level the boom for the measurements in maximum extension.

Figure 23. Penetrator Length

Figure 24. Tip Turret Length

Figure 25. Below Grade Measurement

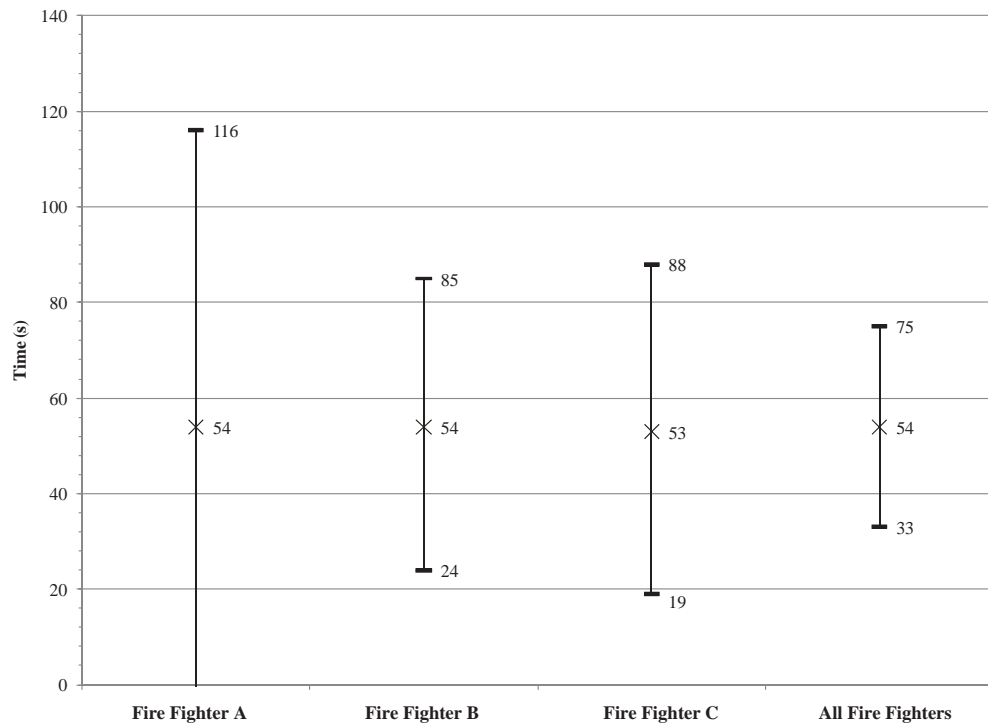
Data for the timed deployment trials is given in appendix B. Figure 26 shows the average deployment time (marked by an ×) for all operators and the 95% confidence intervals for each of the four levels. The 95% confidence interval is the time period in which 95 of the 100 trials would be expected to fall based on the data taken. Figures 27 through 30 show the averages and 95% confidence intervals for each level by individual fire fighter. The ranges of some data in figures 27 and 28 are less than zero because the sample standard deviation in those data sets was such that the two-sided 95% confidence level range extended to less than zero. It is impossible for the HRET to be deployed in zero seconds or less. The average deployment time was 54 sec for the lower passenger deck and for full-up extension. Data for the full-up extension showed the least variation, which was expected since there was no penetration involved; therefore, it was more of a test of the equipment than operator skill. Average deployment time for the cargo deck was 80 sec, and average deployment time for the upper passenger deck was 62 sec.

Figure 26. Average Deployment Times for Each Deck

Figure 27. Cargo Deck Average Deployment Times by Fire Fighter

Figure 28. Lower Passenger Deck Average Deployment Times by Fire Fighter

Figure 29. Upper Passenger Deck Average Deployment Times by Fire Fighter

Figure 30. Full-Up Extension Average Deployment Times by Fire Fighter

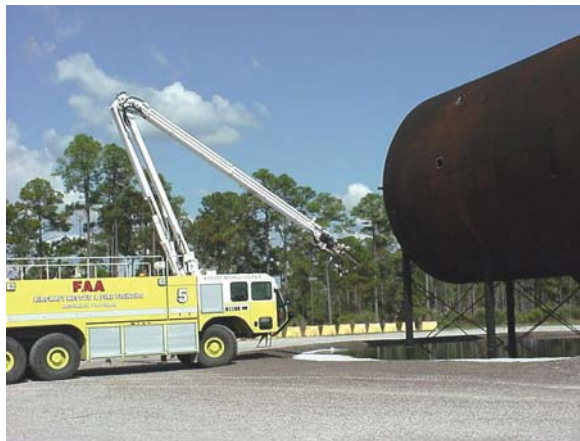
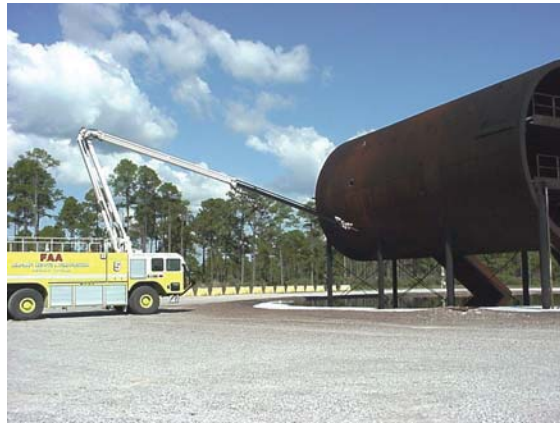
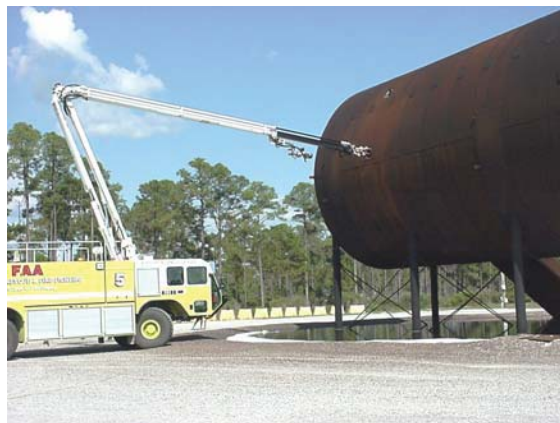
Penetration times for the cargo deck were longer because more manipulation of the boom was required to line up the penetrator with the target at the cargo deck than for the other two decks. Elevation of the lower boom cannot be controlled independently of the upper boom. To position the boom for penetrating the cargo deck, the joystick was held in the low attack position until the lower boom reached its maximum elevation (figure 31). At the same time, the upper boom was partially extended, but care had to be taken to not extend it so far that it would bump against the fuselage while the boom was still moving into the low attack position. Once the lower boom was fully extended, the upper boom had to be alternately raised and extended in several steps until the penetrator was properly aligned to pierce the target (figure 32). The iterative process of raising and extending was time-consuming and was the direct cause of the excessive time it took to penetrate the cargo deck.

Figure 31. Extending the Lower Boom for low Attack

In contrast, penetrating the lower passenger deck required the least amount of time because it required the least amount of fine adjustments to align the penetrator with the target. To position the boom for penetrating the lower passenger deck, the joystick was held in the high attack position until the lower boom reached its maximum elevation. There is a programming code in the controls that pauses the boom in the midpoint pierce position when raising the boom. At this pause point, the boom is in close proximity to the lower passenger deck, which is roughly the same as the main cabin height of single passenger deck aircraft. In the high attack mode, while the lower boom is elevating, the upper boom remains approximately level with the ground and does not begin to elevate until the lower boom is fully raised. Releasing the joystick once the lower boom reached full extension, and then extending the inner boom, puts the penetrator almost in the proper position to pierce the target without much additional manipulation of the boom (figure 33). For this reason, the fortuitous height of the lower passenger deck in relation to the boom when the lower boom is fully extended, the average penetration times for the lower passenger deck were less than for the other two decks.

Figure 32. Penetrating the Cargo Deck

Figure 33. Penetrating the Lower Passenger Deck

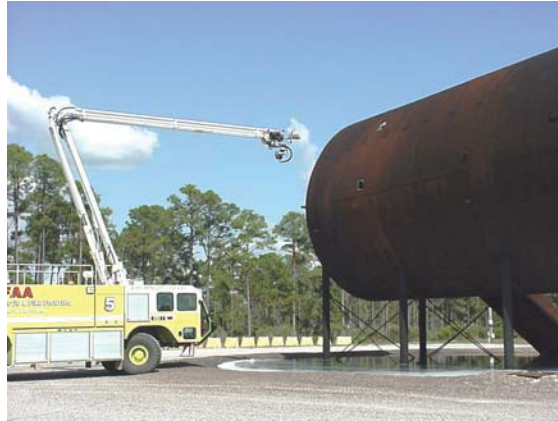
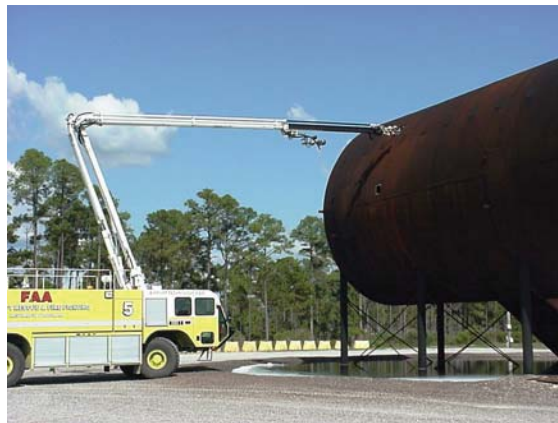
two decks. First, the lower boom was raised to its fully raised position (figure 34). Then the upper boom was simultaneously raised to near horizontal and extended, taking care to not contact the side of the fuselage with the penetrator. Finally, the boom was alternately raised and extended to position the penetrator to pierce the target (figure 35).

Figure 34. Extending the Boom for High Attack

Figure 35. Penetrating the Upper Passenger Deck

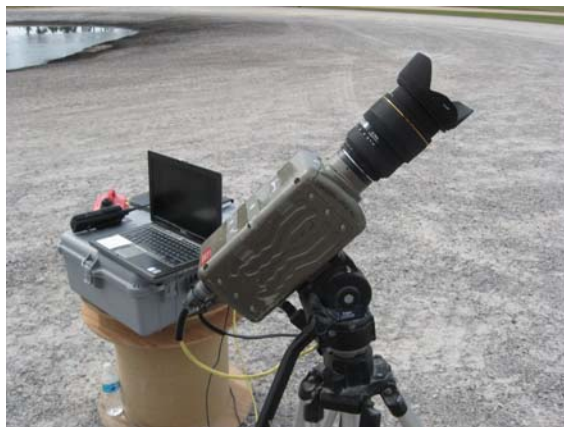
Figure 36. High-Speed Camera and Data Computer

A high-speed camera was used to record boom motion, and then analysis software was used to determine the amplitude of boom displacement and the average speed of the boom during the initial oscillation. Video was recorded using a Phantom[®] v7 color high-speed camera set to record at 100 frames/sec, with a frame exposure interval of 1 ms and a resolution of 800 by 600. Video footage was downloaded to a Dell[™] Latitude[™] D630 laptop and analyzed using the Phantom Camera Control version 9.2 software package. The camera and data acquisition computer are shown in figure 36.

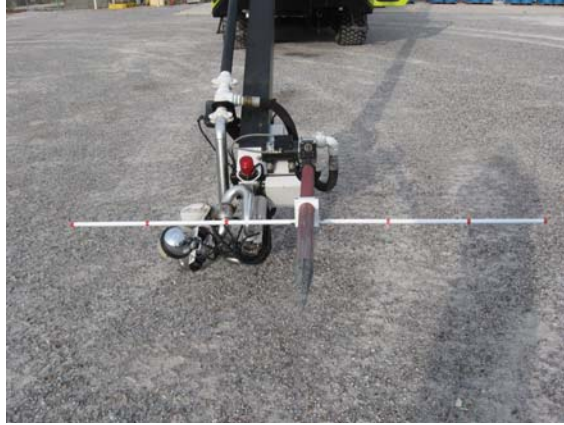
Figure 37. Distance Reference for Measuring Oscillation Magnitude

The displacement analysis software required an object of known length in the recorded video for calibration. A 6-ft length of small diameter polyvinyl chloride (PVC) pipe was used to give the known length. Figure 37 shows the PVC pipe attached to the end of the boom. The mass of the PVC pipe was insignificant in comparison to the mass of the boom and therefore had a negligible effect on the boom response.

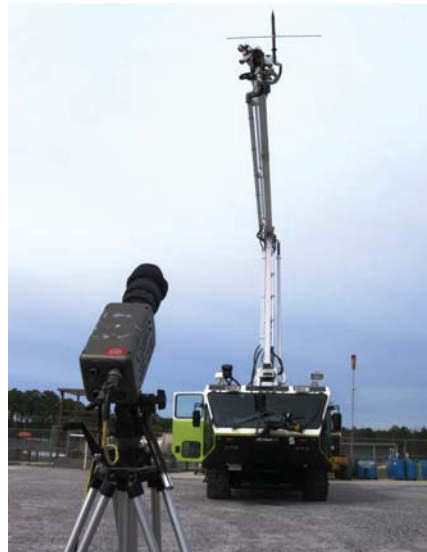
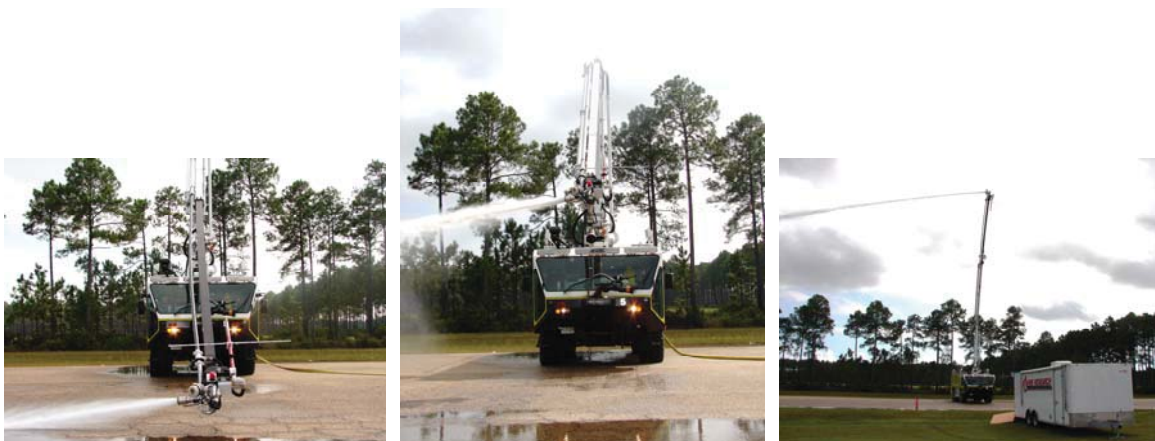
Figure 38 shows a typical test setup. Figure 39 shows the boom during the test while water was sprayed from the tip turret (note the curve in the boom due to the water flow).

Figure 38. Typical Test Setting for Boom Oscillation Tests

Figure 39. Oscillation Tests With Water Spray

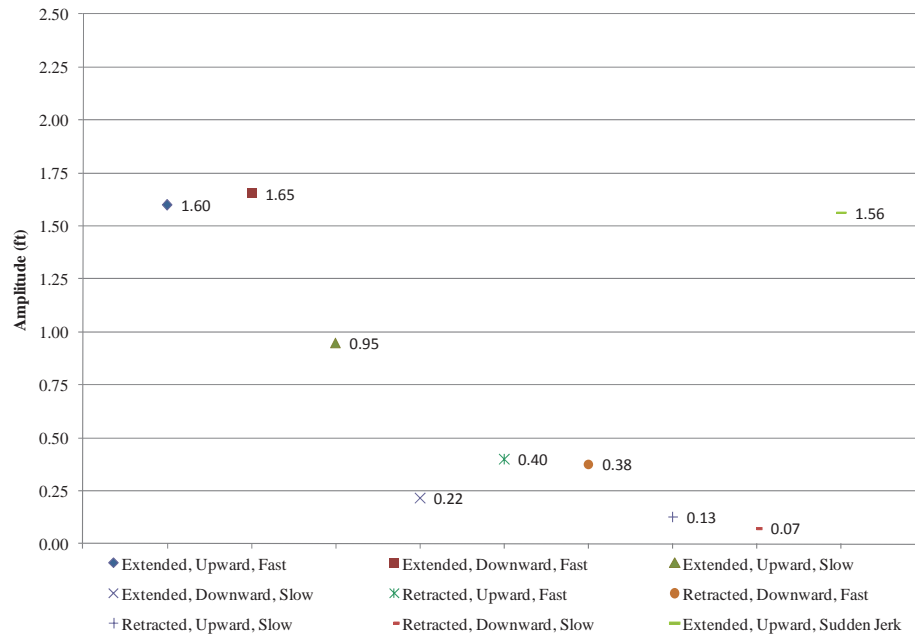
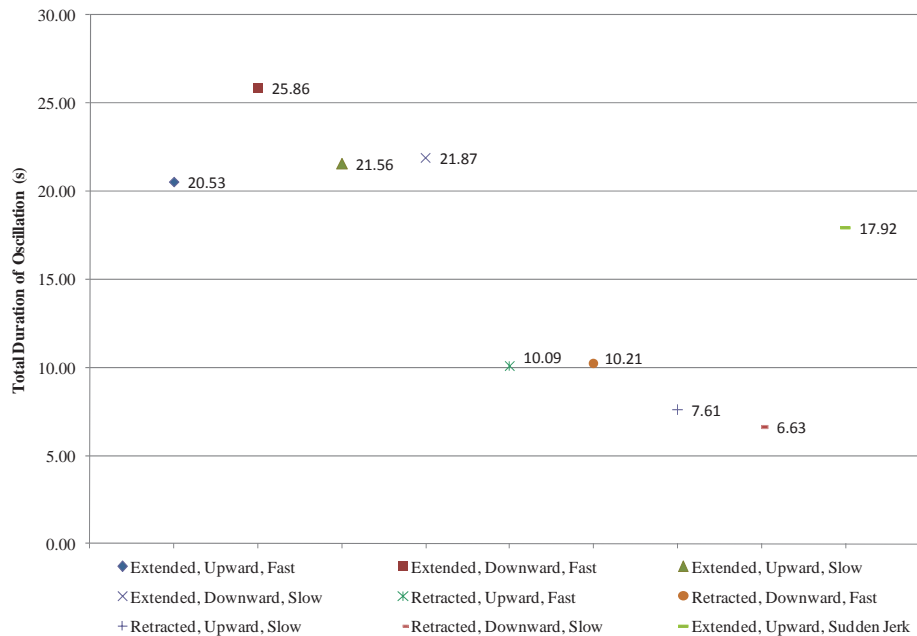
Displacement data for oscillatory motion of the boom, when operated in the up and down directions, are shown graphically in figure 40. Data for the total time duration of oscillation of the boom, when operated in the up and down directions, are shown graphically in figure 41. The averages for each data set are shown in the figures for each boom configuration. The complete data sets are given in tables C-1 and C-2 in appendix C. In the tables, the terms “extended” and “retracted” refer to the position of the inner boom. “Upward” and “downward” refer to the direction the boom was rotated for the test. “Fast” and “slow” refer to the speed at which the boom was rotated. It should be re-emphasized at this point that the joystick for the boom provides for proportional control; the speed of rotation is proportional to how far the joystick is moved from its normal position. Fast-speed operation can be attained by moving the joystick to its maximum extent. Slow operation, on the other hand, is not as straightforward because it requires the operator to very slowly move the joystick until it reaches a position to cause the boom to rotate. There is some play in the joystick, and there is some threshold position that must be passed before motion begins. Therefore, a precise slow-speed operation is difficult to duplicate. Appendix C shows that the data for most of the test conditions were tightly grouped, except the trials when the extended boom was rotated upward slowly and when a sudden upward jerk was applied. The relatively wider range of data in the case of the boom being rotated upward slowly is most likely attributable to the difficulty in precisely replicating slow-speed operation. In the case when a sudden upward jerk was applied, it is likely that the operator did not position the joystick at the same speed and to the same extent in both trials. This sudden bump check was not part of the test plan, it was done simply to provide additional information concerning boom operation; therefore, only two runs were done. Generally, the data showed that oscillations were larger when operated in fast speed than when operated in slow speed and when operated with the inner boom extended rather than retracted. The data also indicated that applying a quick bump to the joystick caused about the same magnitude of oscillation as when operated in fast speed.

Figure 40. Amplitude Data for Up and Down Oscillation

Figure 41. Total Oscillation Time for Up and Down Motion
