AFRL-RX-TY-TR-2011-0051
DOT/FAA/AR-11/15

TEST AND EVALUATION OF NEXT GENERATION 65-FOOT, HIGH-REACH EXTENDABLE TURRET

Keith Bagot
Federal Aviation Administration
William J. Hughes Technical Center
Airport and Aircraft Safety Research and Development Group
Airport Technology Research and Development Team
Atlantic City International Airport, NJ 08405

November 2011

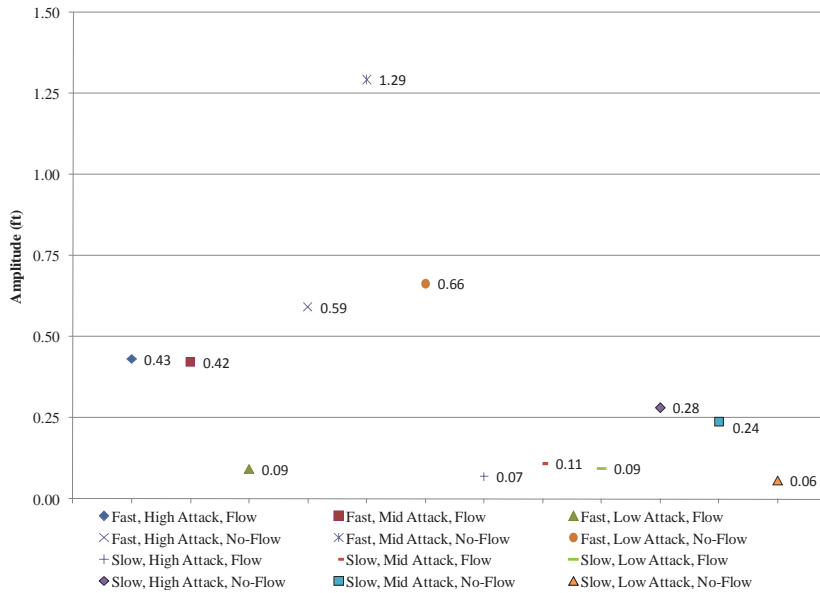
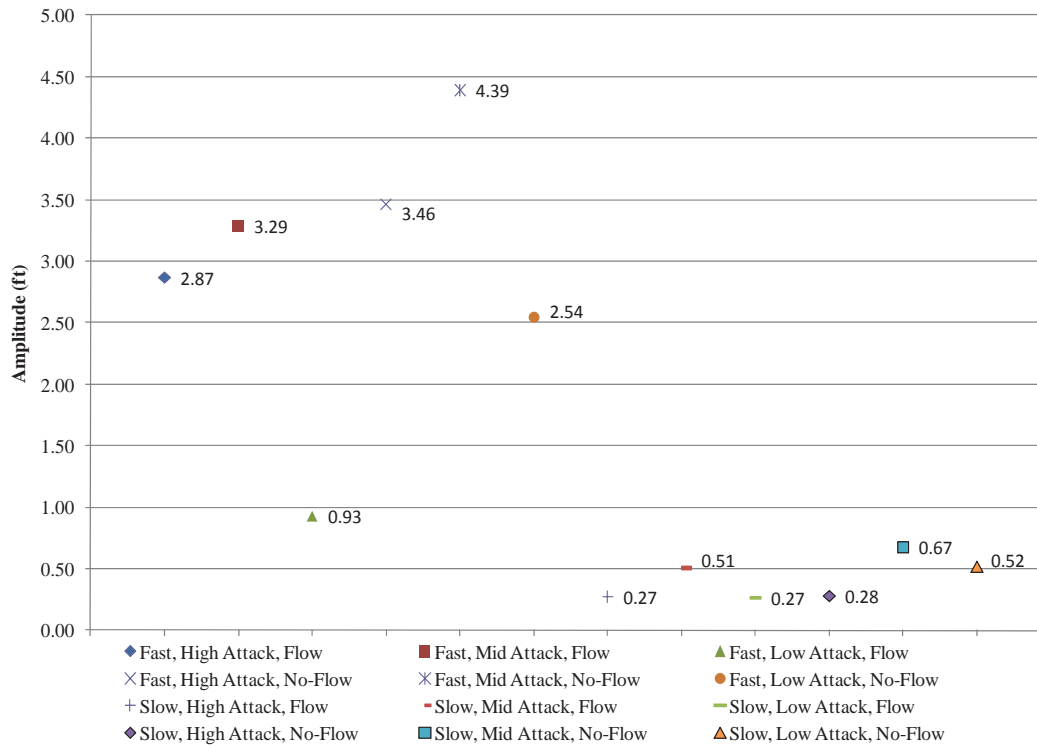
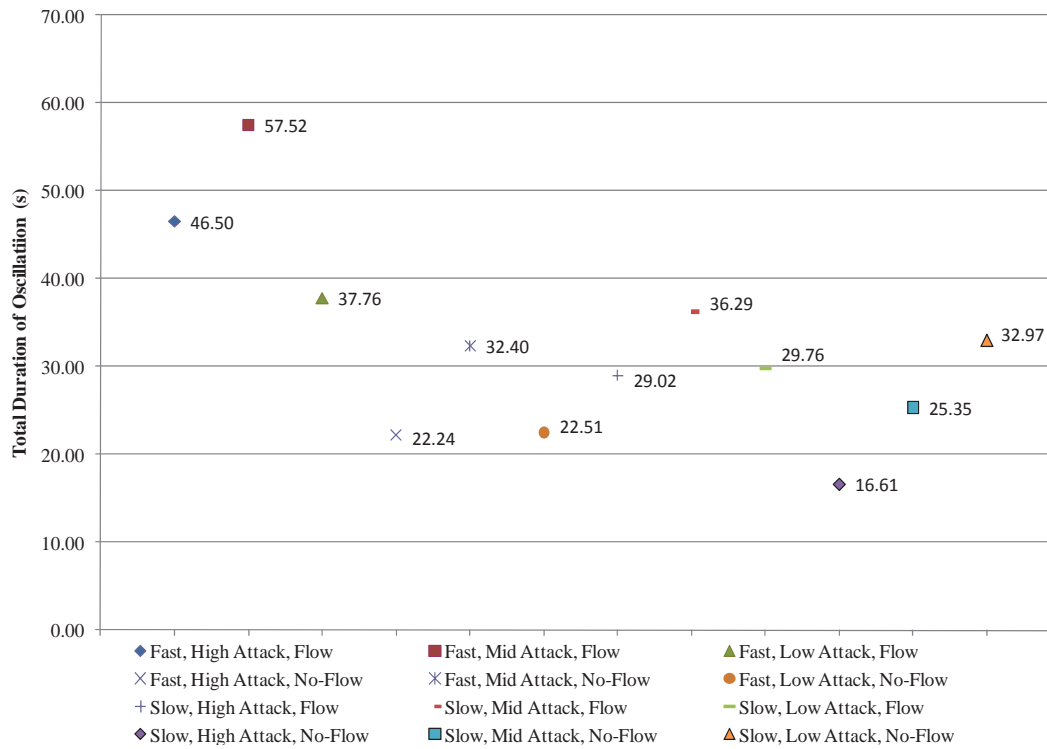
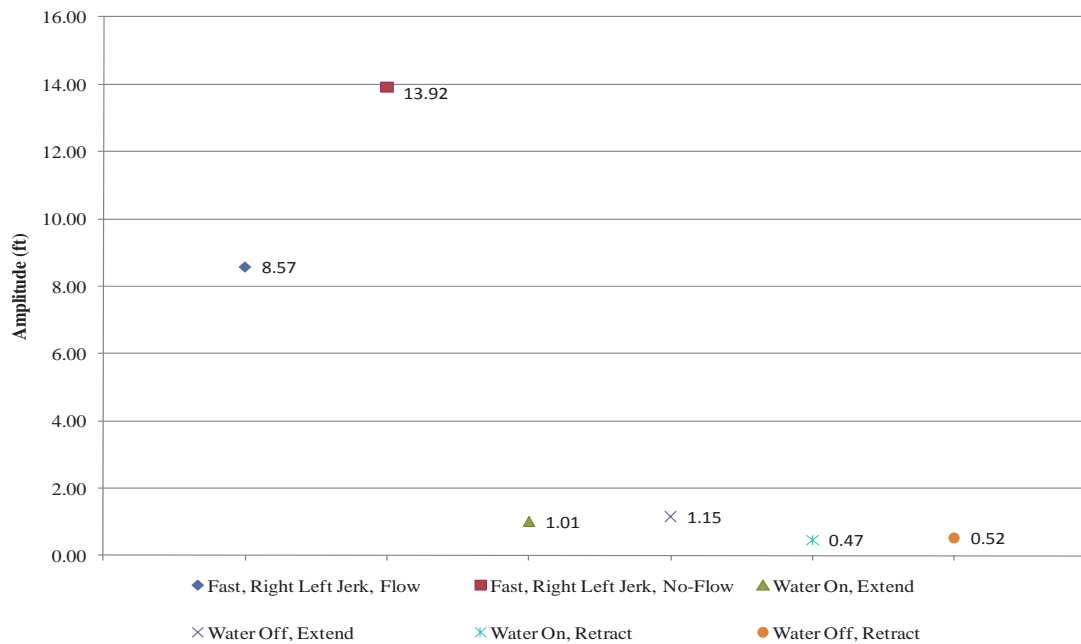
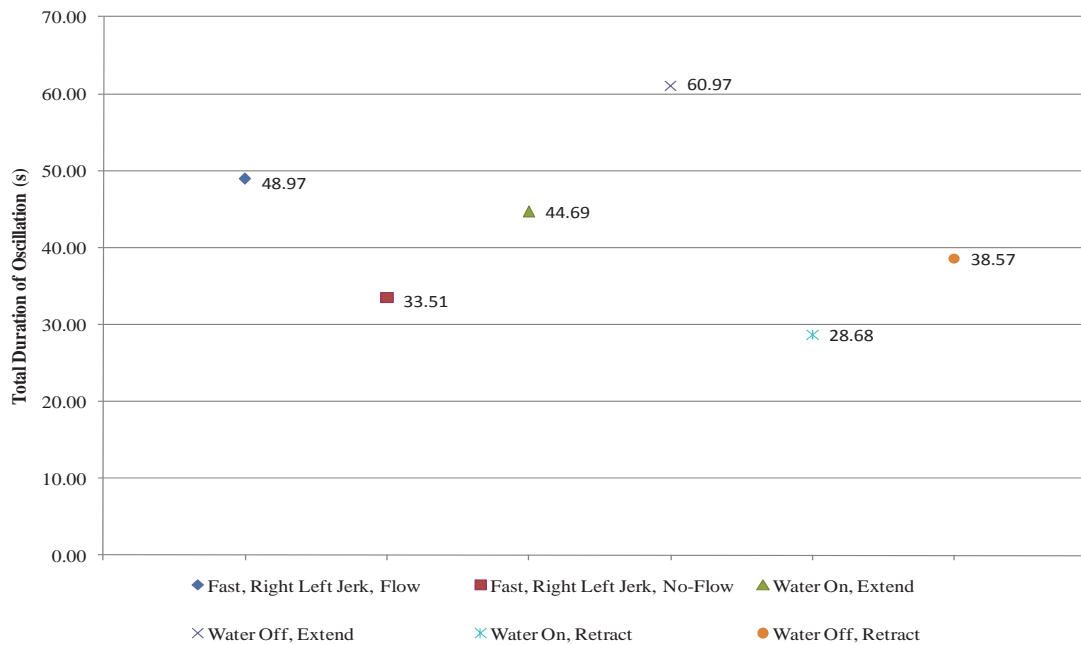
Figures 42 through 47 are grouped in pairs, respectively, to show (1) the displacement data for side-to-side motion and (2) the corresponding data for total oscillation time durations for the various HRET conditions, i.e., the inner boom retracted, the inner boom extended, and for transient operations. Transient operations included tests for which a sudden bump was applied to the joystick (in the right-to-left direction) and tests for which water was turned on or off to the tip turret while the turret was oriented 90° to the side of the boom. For all transient operations tests, the inner boom was extended and the HRET was in the maximum extension posture (refer to

The maximum overshoot observed in all tests was 15.1 ft. This occurred during transient operations tests when the joystick was given a fast bump to the high-speed position while no water was flowing from the tip turret. This type of operation might be used by an operator attempting to apply fine corrections to the boom position in preparation for penetrating the aircraft or for manipulating the boom between obstacles in a debris field to better position the tip turret to reach hidden fires. For the same conditions but with water spraying from the tip turret, the maximum overshoot observed was 9.7 ft.

Figure 42. Oscillation Amplitude With Inner Boom Retracted, Horizontal Motion

Figure 43. Total Oscillation Time With Inner Boom Retracted, Horizontal Motion

Figure 44. Oscillation Amplitude With Inner Boom Extended, Horizontal Motion

Figure 45. Total Oscillation Time With Inner Boom Extended, Horizontal Motion

Figure 46. Oscillation Amplitude for Transient Operations, Horizontal Motion

Figure 47. Total Oscillation Time for Transient Operations, Horizontal Motion

In summary, in normal operations with the inner boom extended, operating at fast speed and with no water flowing from the tip turret, overshoot of about 2 ft was observed in up-and-down operation and about 5 ft in side-to-side operation. With water flowing from the tip turret oriented 90° to the boom in side-to-side operation, overshoot dropped to about 3 1/2 ft. For normal operations with the inner boom retracted, operating at fast speed and with no water flowing from the tip turret, overshoot of about 1/2 ft was observed in up-and-down operation and about 1 1/2 ft in side-to-side operation. With water flowing from the tip turret oriented 90° to the boom in side-to-side operation with the inner boom retracted, overshoot decreased to about 1/2 ft. For all operations in slow speed, overshoot was 1 ft or less with the inner boom retracted or extended, water off or water on, and in up-down or side-to-side operations. The worst situation observed occurred when the joystick was rapidly bumped to fast speed (full travel) and immediately released, for which an overshoot of about 15 ft was observed when water was not flowing from the tip turret.

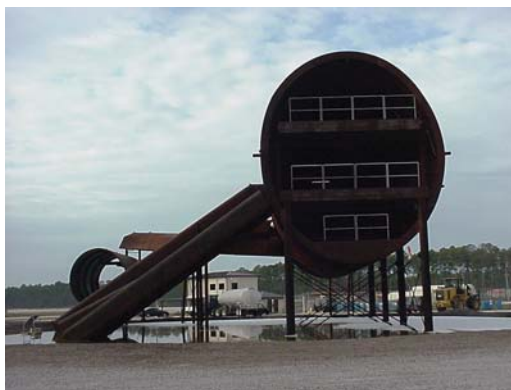
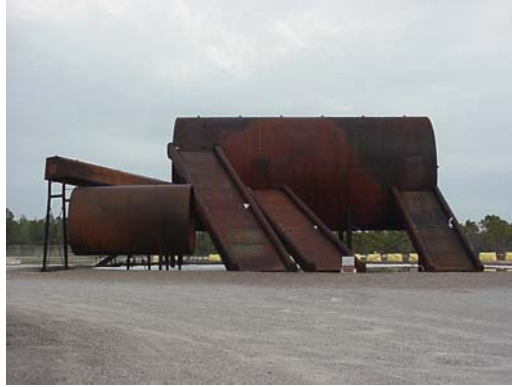
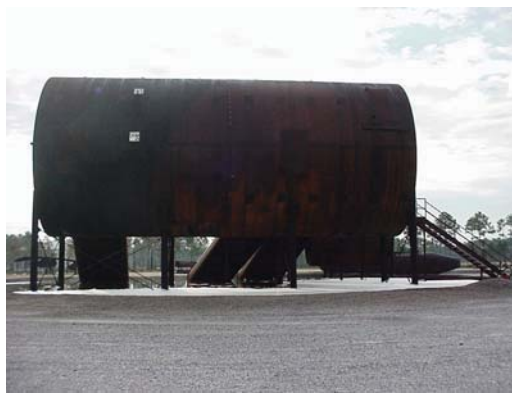
Figure 48. Front View of Mockup, Facing Southwest

Figure 49. Back View of Mockup, Facing Northeast

Figure 50. View of Right Side, Facing Northwest

Figure 51. View of Left Side, Facing Southeast

Figure 52. Mockup Orientation

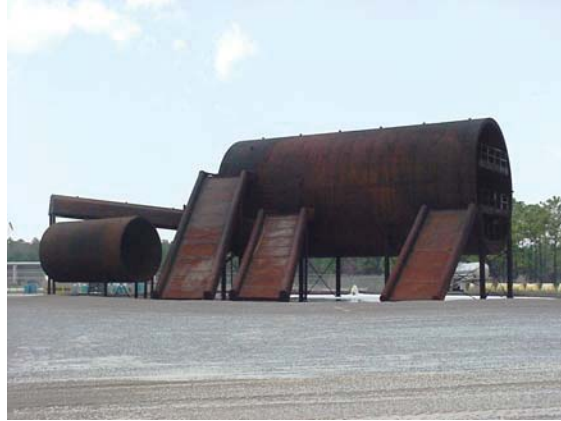
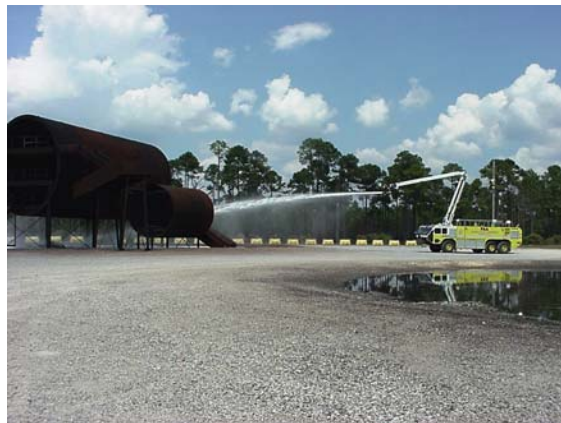
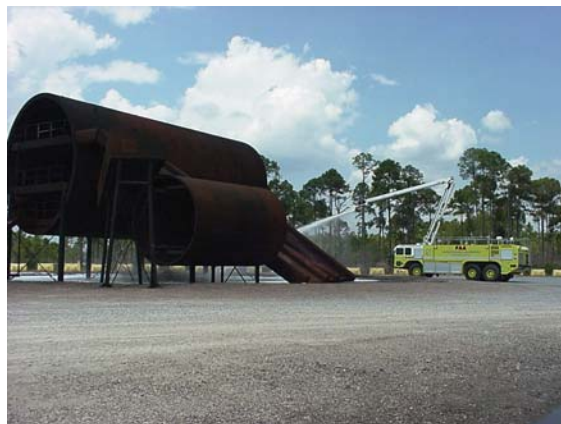
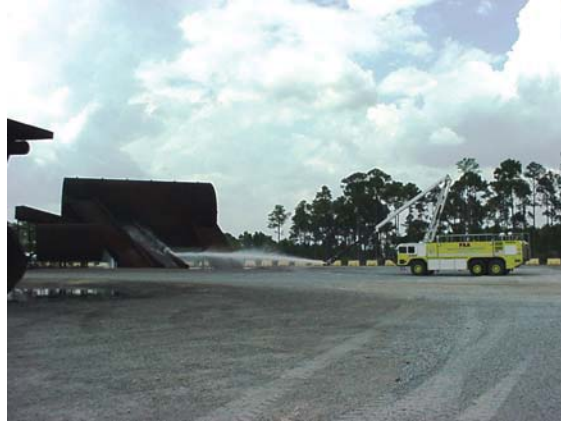
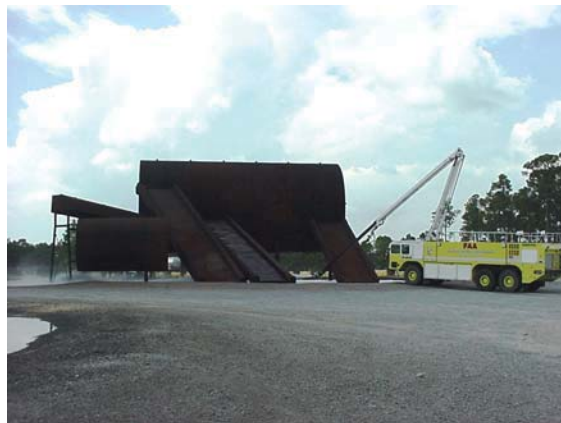
The approach for the fires extinguished using the base and the tip turrets were from the east, on a line of approach toward the front starboard quarter of the mockup. Figure 53 shows the mockup from this line of approach. From this direction, the slides and engine nacelle presented challenging impediments to targeting the agent onto the fire. For the base turret fire tests, after the fire fighter had extinguished all the fire that could be reached from the direction of the initial approach (figure 54), he was instructed to maneuver the truck and manipulate the base turret as necessary to aggressively extinguish the fires as quickly as possible behind obstacles. In those cases when 100% of the fire was not extinguished on the initial approach, the fire fighter drove the truck counter-clockwise (looking down from above) around the edge of the pool while rotating and elevating the turret as necessary to reach the remnants of the fires (figure 55). For the base turret live fires, the HRET was in the extended position, as shown in figures 54 and 55.

Figure 53. Approach for Base and Tip Turret Live Fires

Figure 54. Base Turret Initial Approach

Figure 55. Base Turret Follow-Up Attack

fire fighter was permitted to use only the tip turret during the approach and attack of the fire. After the fire fighter had extinguished all the fire that could be reached from the direction of the initial approach with the extendable boom only partially extended, he was instructed to fully extend the boom to place the tip turret between the two forward-most slides and rotate and elevate the tip turret as necessary to aggressively extinguish the fires behind the obstacles as quickly as possible (figure 57).

Figure 56. Tip Turret Initial Attack

Figure 57. Tip Turret Follow-Up Attack
