FINAL REPORT

Low Temperature Cure Powder Coatings

ESTCP Project WP-200614

Wayne Patterson David Piatkowski Science Applications International Corporation

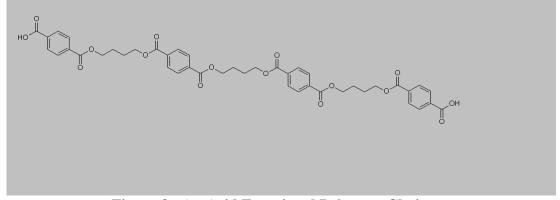
Figure 3. An Acid Functional Polyester Chain

The acid and alcohol constituents are blended in the presence of heat and a catalyst to create a long-chained acid functional polyester resin. A representative example is found in Figure 3.

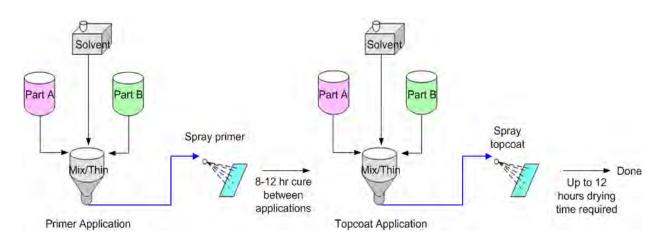
Figure 7. Conventional Solvent-Based Coating Process

Coatings currently in use on various non-flight critical components and ground support equipment are typically based upon a layered coatings approach. These coatings begin with substrate pretreatment, usually including a conversion coating (either a phosphate-type treatment for steel, or a chromated conversion coating for aluminum), to which a high-solids epoxy primer coating is applied (based on MIL-PRF-23377, MIL-P-53022, or MIL-P-53030), followed by a polyurethane topcoat (based on MIL-PRF-85285). Both the primer and topcoat are generally spray-applied. The conversion coating contributes to adhesion of subsequent coatings and provides limited corrosion resistance due to the hexavalent chromium content. The epoxy primer improves adhesion of the topcoat and offers excellent corrosion and chemical resistance while the topcoat typically provides the final finish color and appearance. The solvent-based coating process flow is displayed in Figure 7 while the resultant coating system is illustrated in Figure 8.

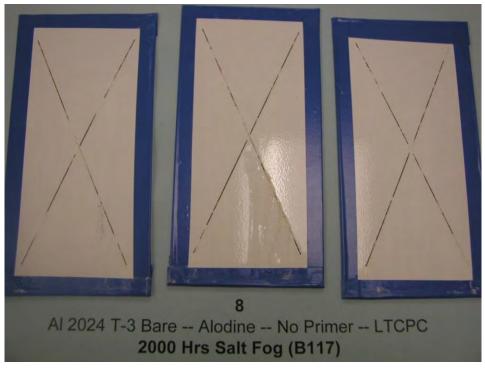
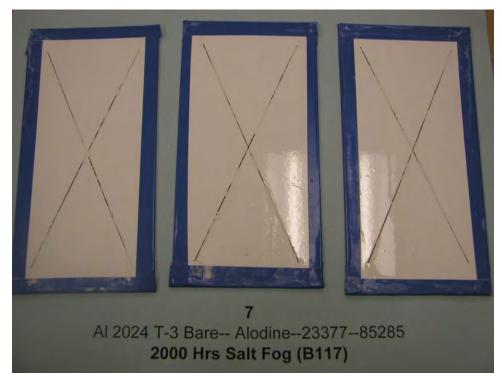
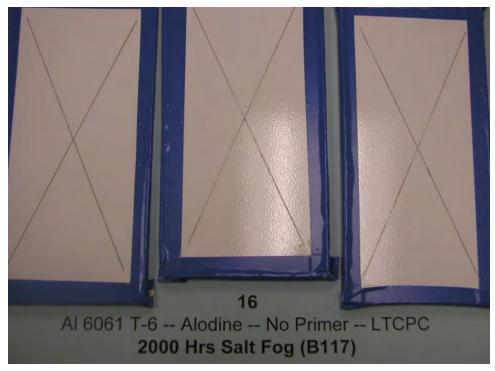
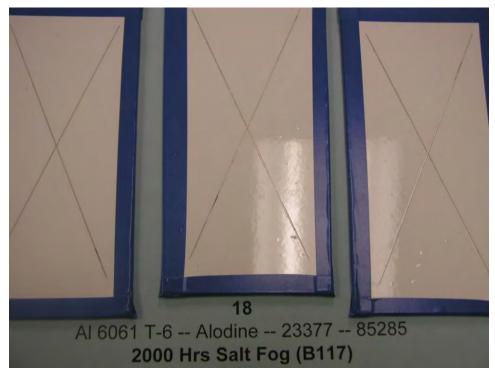
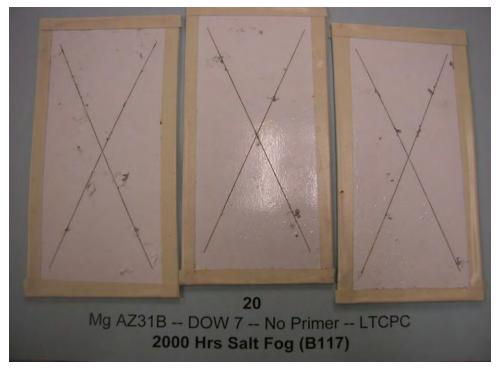
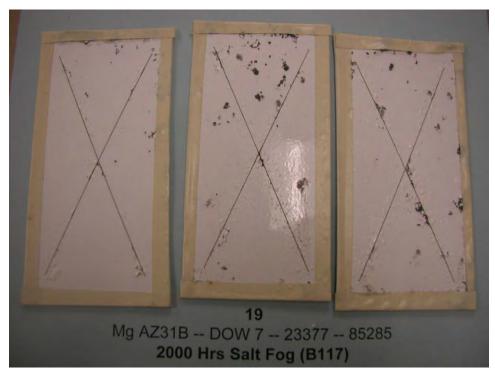
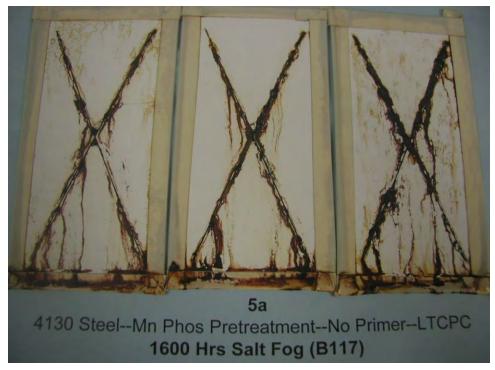
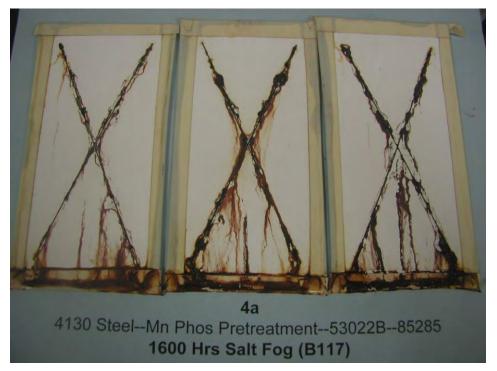
Figures 9 through 16 are of the test coupons following the neutral salt fog corrosion resistance testing.

Neutral salt fog corrosion resistance test results confirmed that LTCPC performs in a similar fashion as the baseline coating stack-ups when both are prepared and tested in a production-like environment. All of the Alodined aluminum coupons (both LTCPC and conventional wet

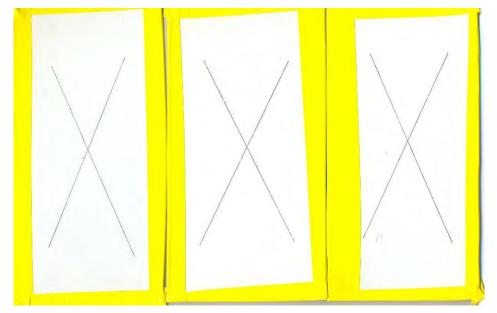
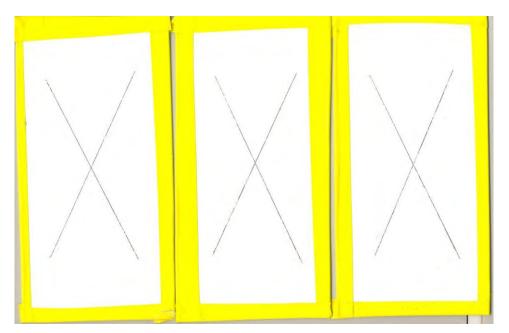
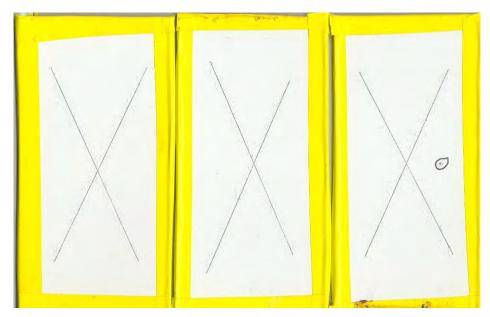
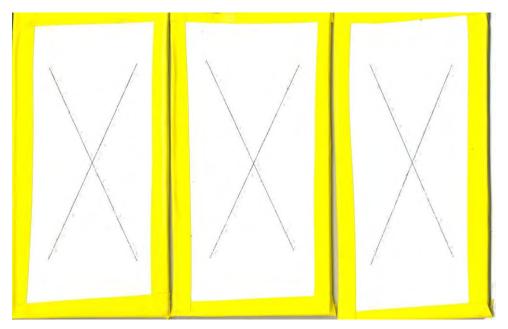
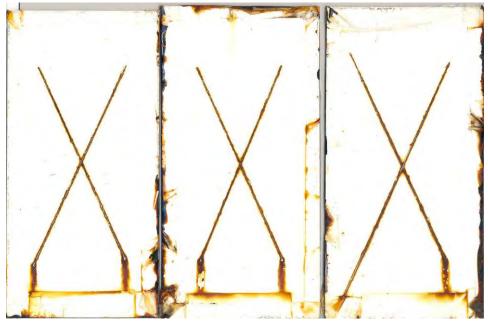
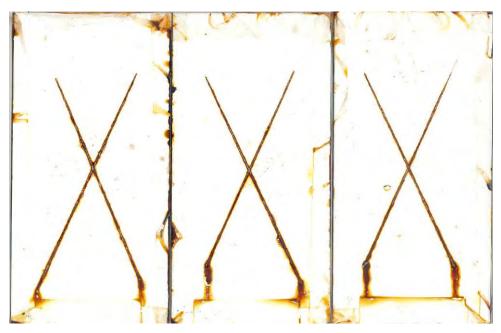
Figures 17 through 22 are of the test coupons following the SO₂ corrosion resistance testing.

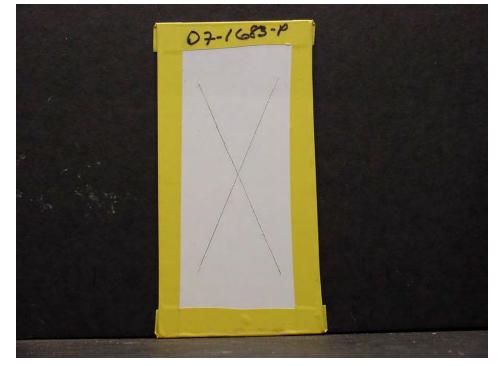
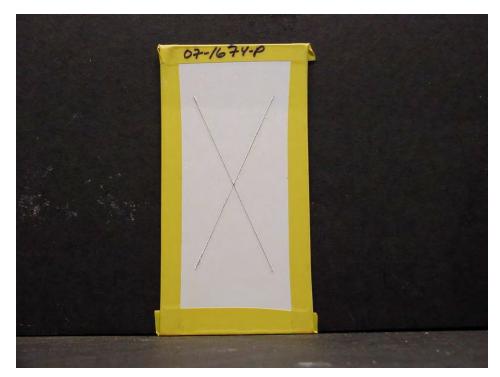
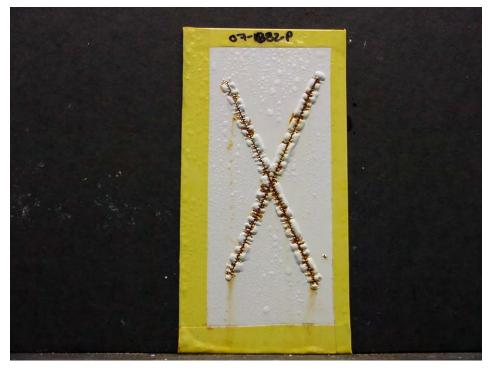
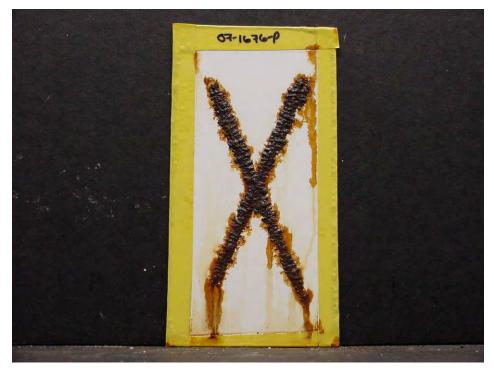
Figures 23 through 26 are of the test coupons following the cyclic corrosion resistance testing.

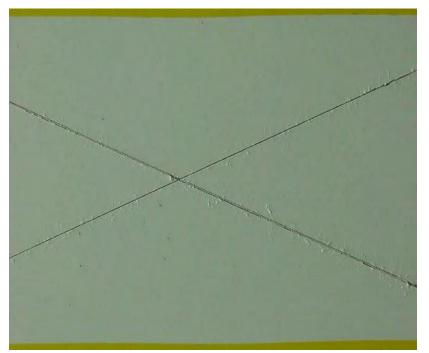
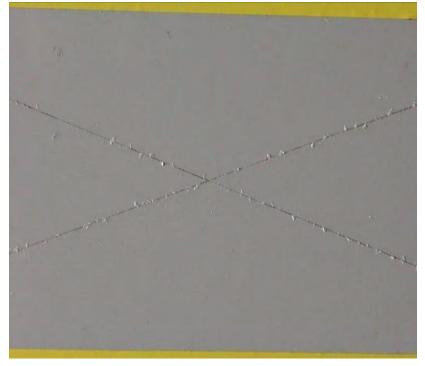
Figures 27 and 28 are photos of the test coupons following the filiform corrosion resistance retest.

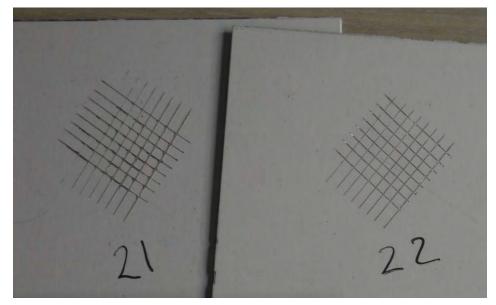
Figures 29 and 30 are of the test coupons following the cross-cut adhesion testing.

Figure 29. Acceptable Cross-Cut Adhesion Test Outcome

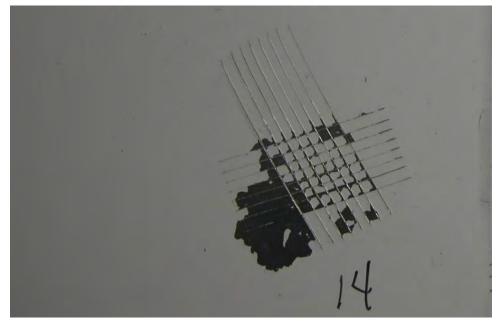
Figure 30. Unacceptable Cross-Cut Adhesion Test Outcome

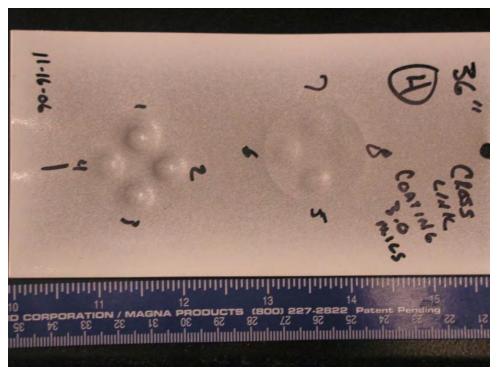
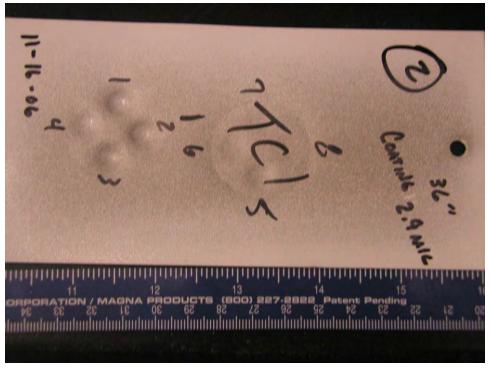
Figures 31 and 32 are from impact flexibility testing of the LTCPC and control coupons.

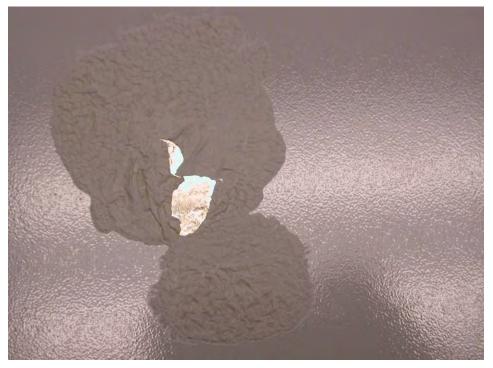
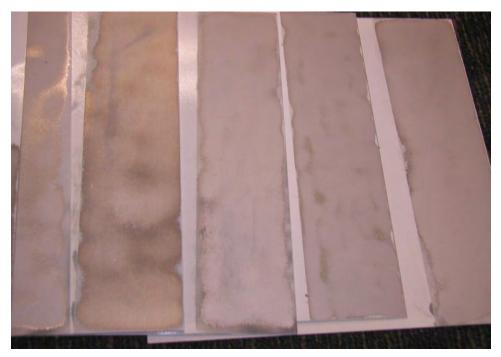
Figures 33 and 34 are of the test coupons following chemical and mechanical stripping. As can be seen for the chemical stripper test, an amount of the liquid was placed on a coated 12 in. x 12 in. panel. For a successful test, the coating softened and lifted from the substrate (in some cases, light fingertip abrasion could flake off the coating). For the mechanical stripping evaluation, a single three inch strip was media blasted on each panel.

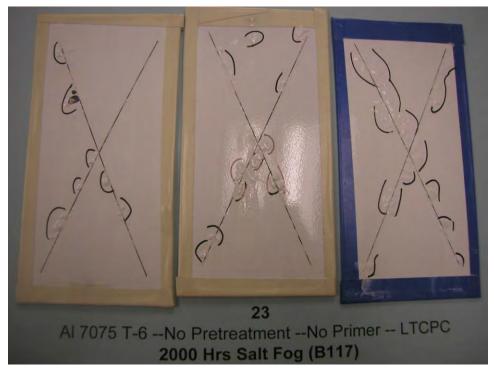
Figure 35. Salt Fog Corrosion Resistance (7075 Al) Test Outcome

Figure 35 is the test coupon at the conclusion of the salt fog corrosion resistance testing.

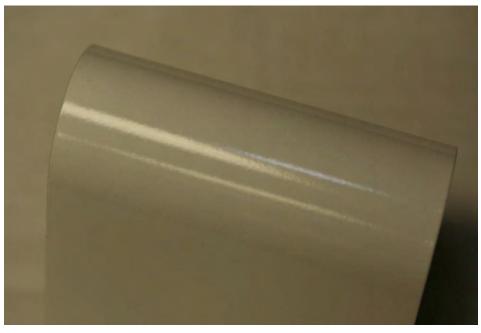
Figure 38. Acceptable LTCPC Low Temperature Flexibility Outcome

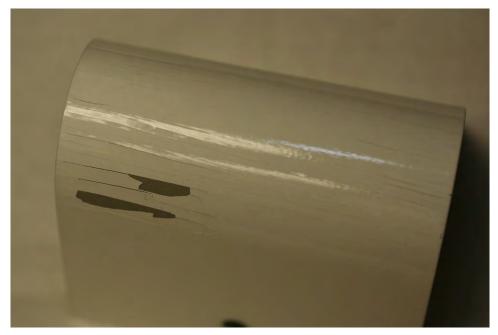
Figure 39. Unacceptable LTCPC Low Temperature Flexibility Outcome

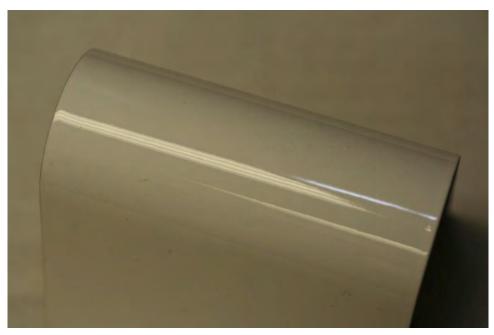
Figure 40. Control Coating Low Temperature Flexibility Outcome

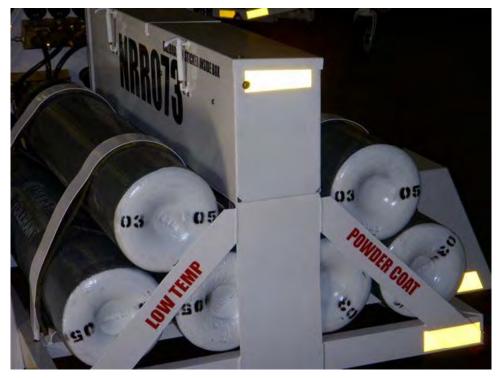
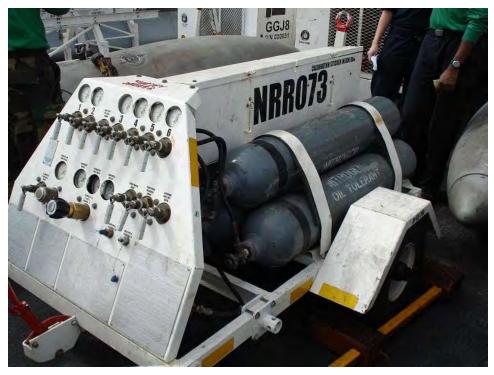
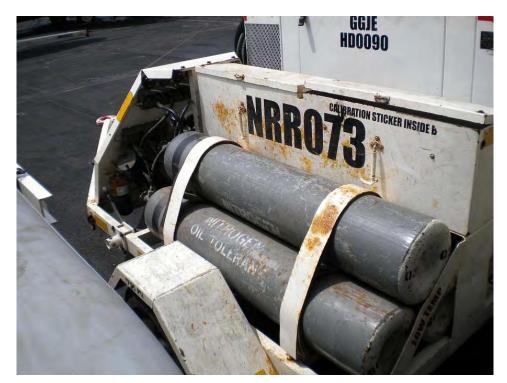
The following photographs were taken prior to deployment and over the course of the FSE aboard USN aircraft carriers.

Figure 41. Nitrogen Servicing Cart (SN: NRR073) Prior to Carrier Exposure

Figure 42. Nitrogen Servicing Cart (SN: NRR073) After 6 Months of Carrier Exposure

Figure 43. Nitrogen Servicing Cart (SN: NRR073) After 18 Months of Carrier Exposure

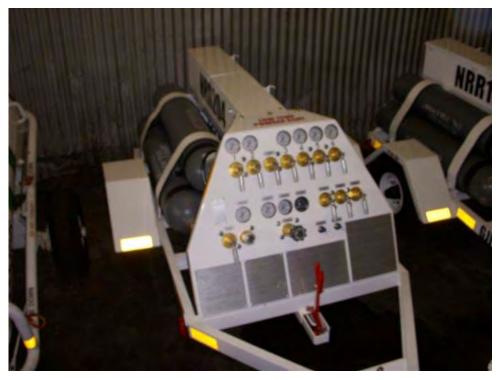
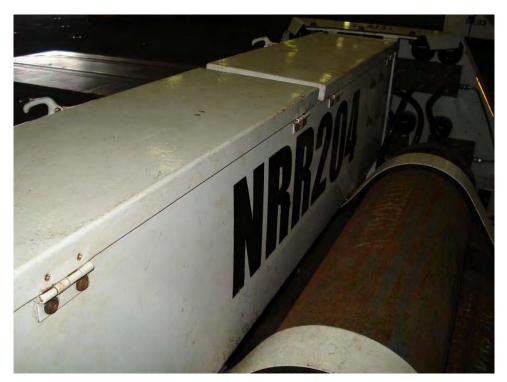
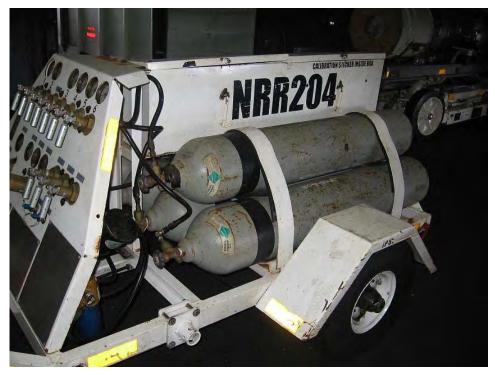
Figure 44. Nitrogen Servicing Cart (SN: NRR204) Prior to Carrier Exposure

Figure 45. Nitrogen Servicing Cart (SN: NRR204) After 6 Months of Carrier Exposure

Figure 46. Nitrogen Servicing Cart (SN: NRR204) After 18 Months of Carrier Exposure

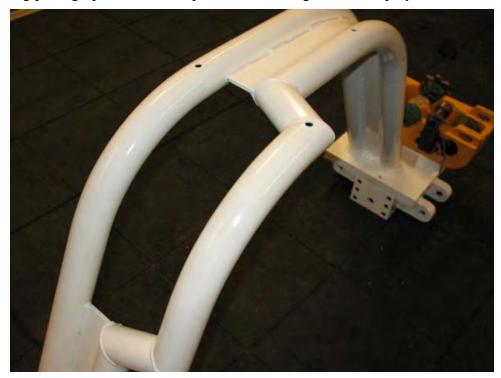
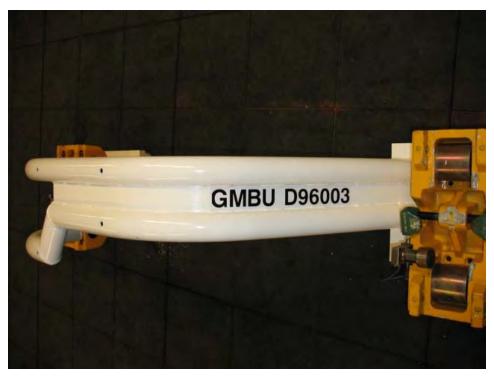
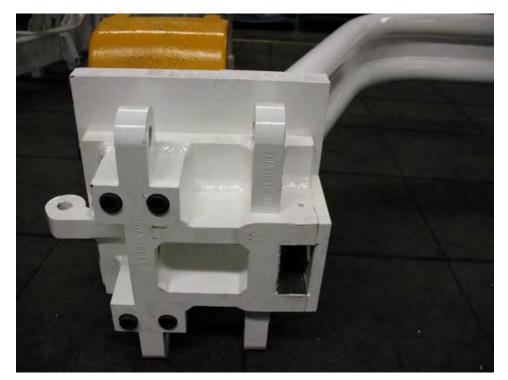
The following photographs were taken prior to use during the FSE deployment at FRCNW.

Figure 47. J52 Aft Engine Yoke (SN: P9H513) Prior to Coastal Exposure

Figure 48. J52 Aft Engine Yoke (SN: P9H513) Prior to Coastal Exposure

Figure 49. J52 Aft Engine Yoke (SN: P9H513) Support Prior to Coastal Exposure

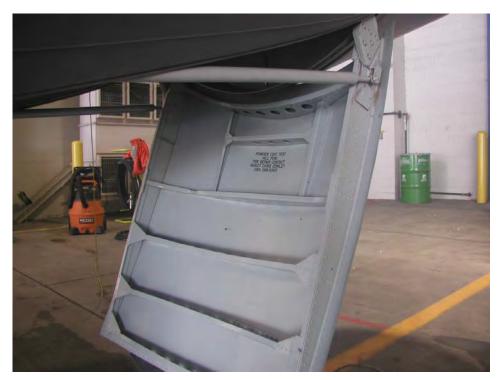
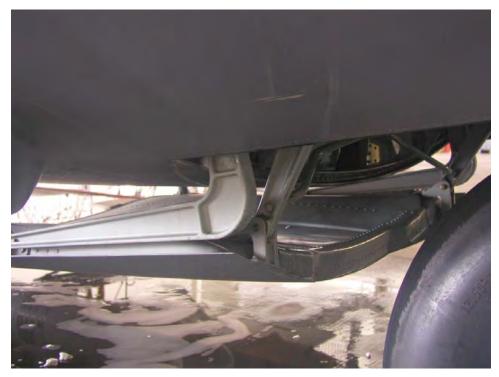
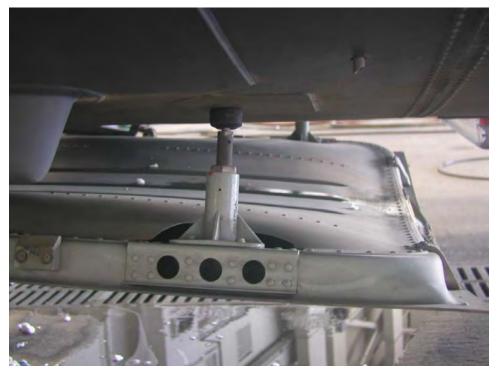
The following photographs were taken during the course of the FSE deployment to various theaters of operation.

Figure 50. C-130 Nose Landing Gear Forward Door (AC: 92-1534) After 12 Months of Exposure

Figure 51. C-130 Nose Landing Gear Aft Door (AC: 92-1534) After 12 Months of Exposure

Figure 52. C-130 Nose Landing Gear Aft Door (AC: 92-1534) After 12 Months of Exposure

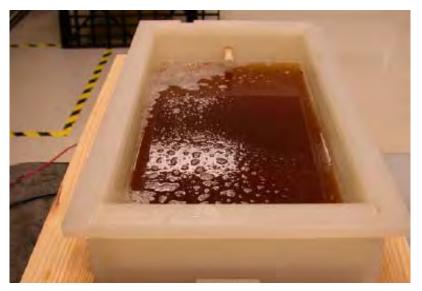
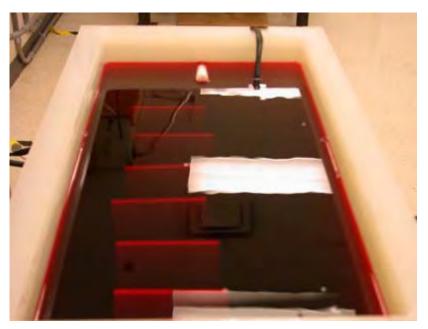
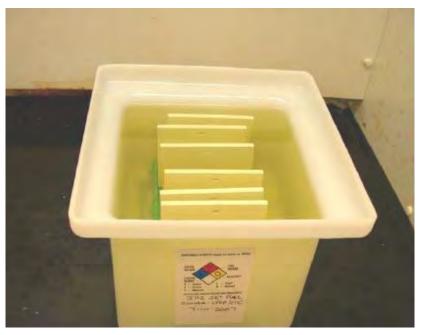
Figures 53 through 55 are of the immersion tanks utilized for this evaluation.

Figure 53. Lubricating Oil Immersion Tank

Figure 54. Hydraulic Fluid Immersion Tank

Figure 55. JP-5 Fuel Immersion Tank

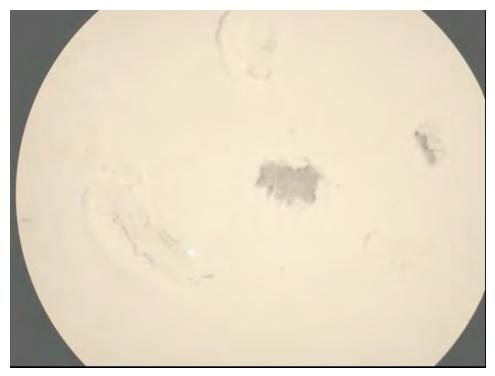
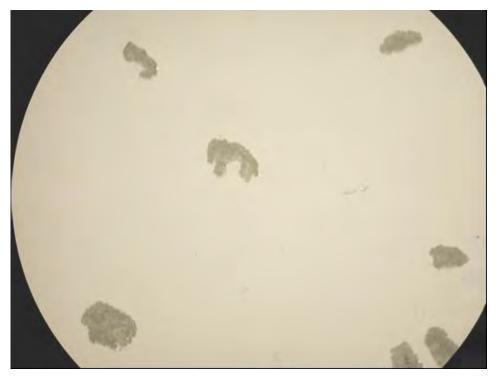
The use of a gravelometer to determine chipping resistance produced specimen coating damage comparable to the two coupons shown in Figures 56 and 57 under 10X magnification.

Figure 56. LTCPC Chipping Resistance Test Outcome

Figure 57. Control Coating Chipping Resistance Test Outcome
