# DOD SUPPLY CHAIN

## Suspect Counterfeit Electronic Parts Can Be Found on Internet Purchasing Platforms

1. REPORT DATE <b>FEB 2012</b>		2. REPORT TYPE		3. DATES COVERED <b>00-00-2012 to 00-00-2012</b>	
4. TITLE AND SUBTITLE <b>DOD Supply Chain: Suspect Counterfeit Electronic Parts Can Be Found on Internet Purchasing Platforms</b>				5a. CONTRACT NUMBER	
				5b. GRANT NUMBER	
				5c. PROGRAM ELEMENT NUMBER

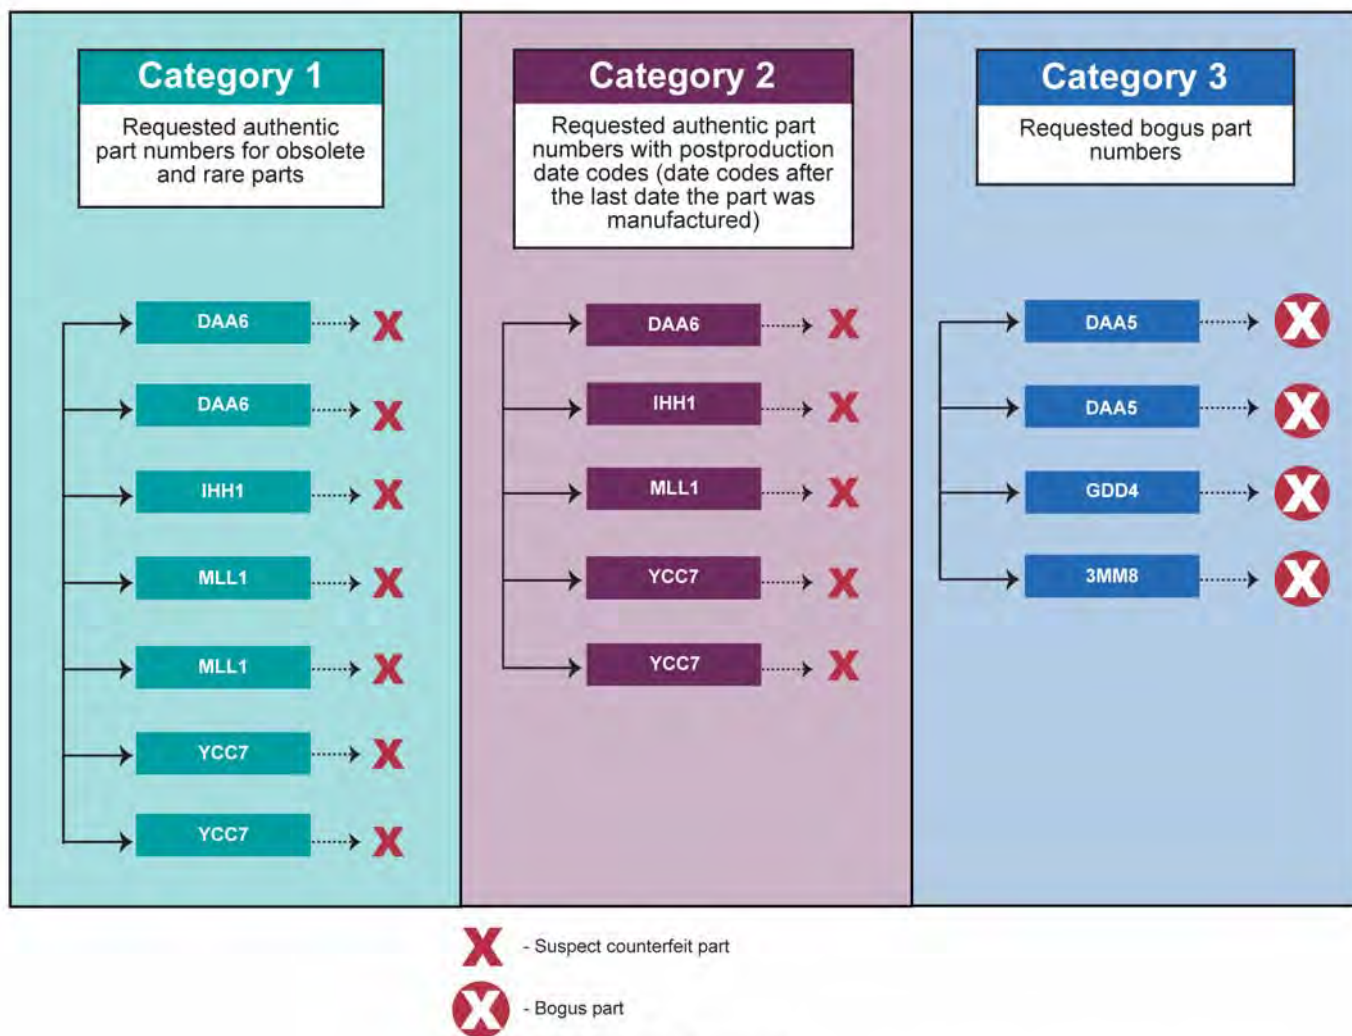
Figure 1: Status of Parts Purchased and Tested

As shown in figure 1, each of the 16 parts we purchased was either suspect counterfeit or bogus. Specifically, all 12 of the parts we received after requesting authentic part numbers (either with valid or invalid date codes) were suspect counterfeit, according to SMT Corp. In addition, vendors provided us with 4 bogus parts after we requested invalid part numbers, which demonstrates their willingness to sell parts that do not technically exist. The following sections detail our findings for each of the three categories of parts we purchased.

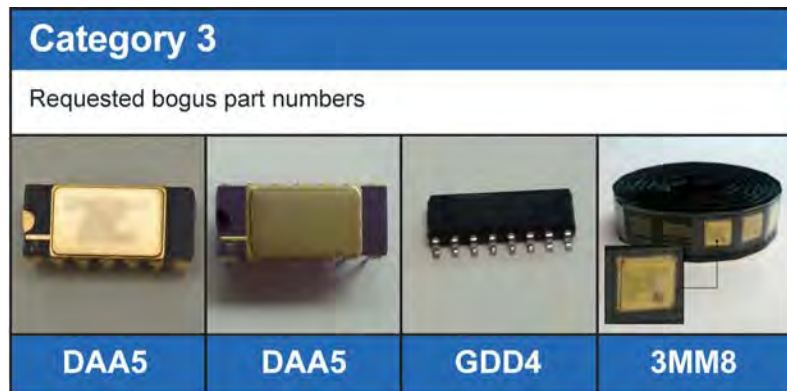
**Figure 4: Photos of Parts Received Despite Request for Invalid Part Numbers**

We received the four bogus parts after requesting invalid part numbers DAA5, GDD4, and 3MM8. We made two orders using DAA5, one from each Internet purchasing platform, which were fulfilled by different vendors. The parts we received from each vendor appeared similar, as shown in figure 4. The similarity may be due to a number of factors. For example, the vendors could have simply ignored the invalid portion of the

part numbers we requested (they did not contact us to inform us that the numbers were invalid). Another possible explanation could be that the parts happened to be fulfilled by the same vendor operating under two different names.
