Advanced Multifunctional Coating

2011 Air Force Corrosion Conference

John DeAntoni

Boeing Research & Technology

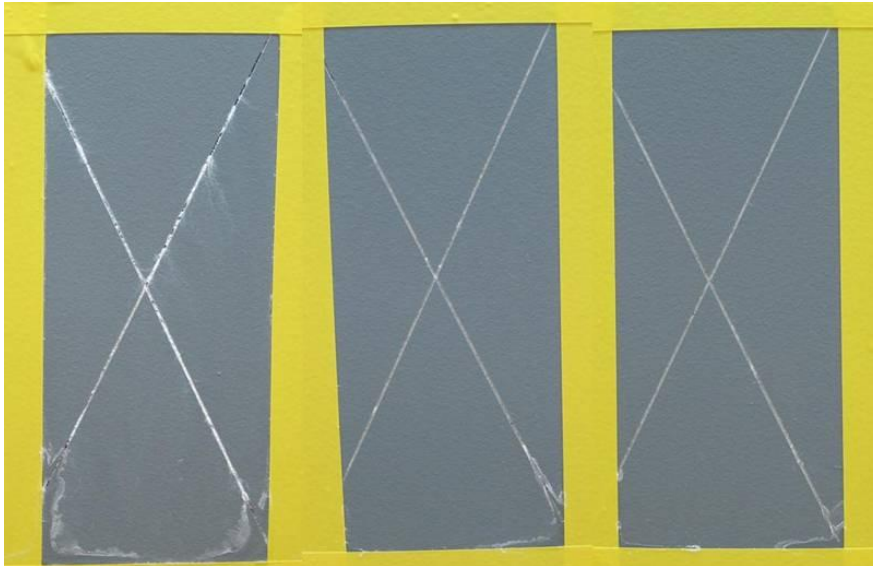
**2000-Hour Salt Spray – 2024 T-3 Bare, Alodine 1200
97GY160 Lab Batch # 2 vs. Current Coating System**

Chromate Primer + APC Topcoat

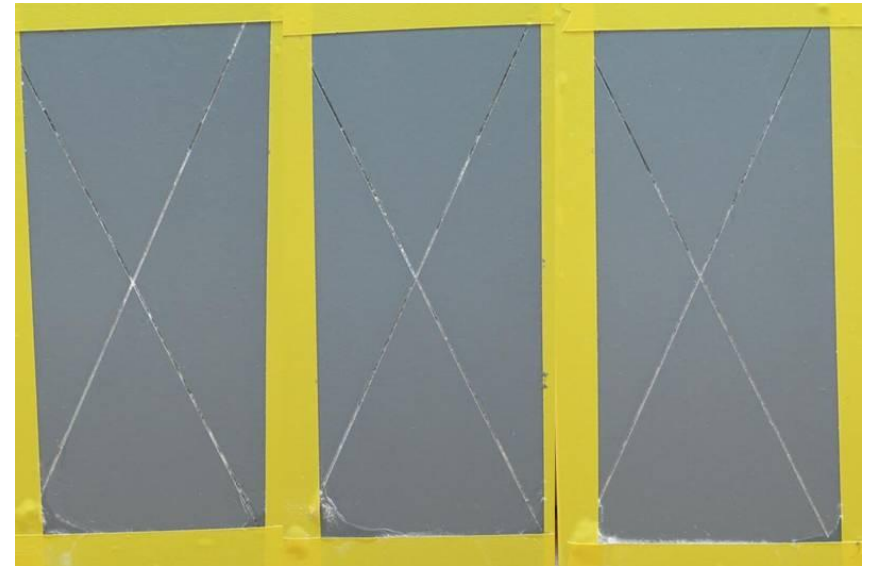
97GY160 AMC

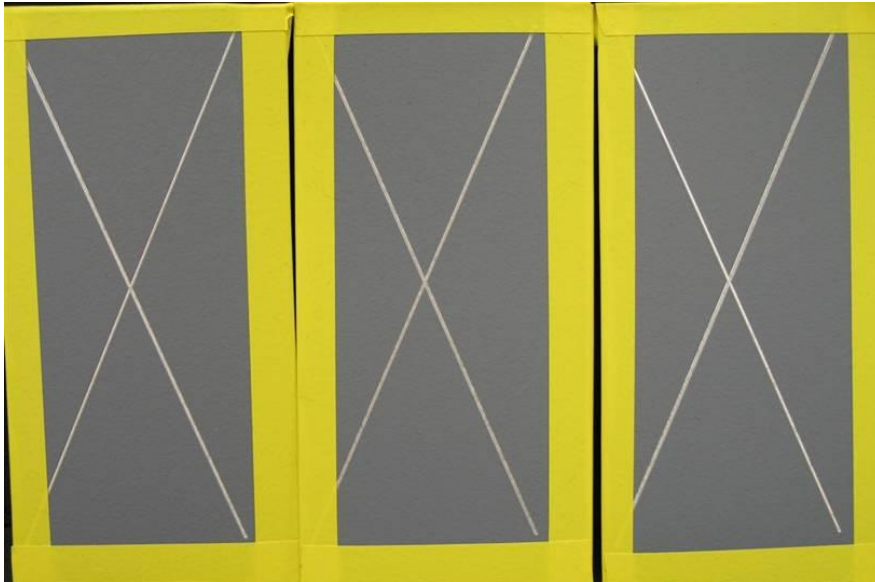
**2000-Hour Filiform – 2024 T-3 Clad, Alodine 1200
97GY160 Lab Batch # 2 vs. Current Coating System**

Chromate Primer + APC Topcoat

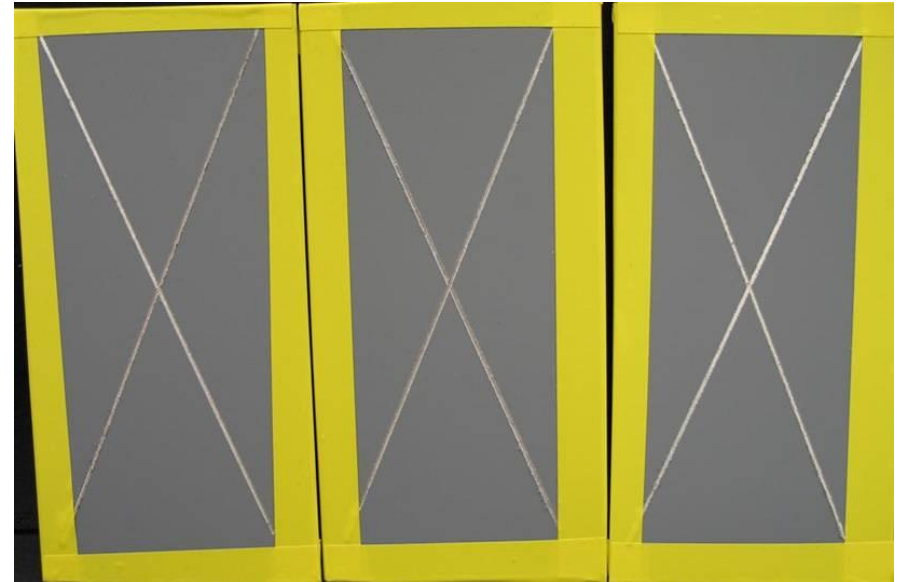
97GY160 AMC

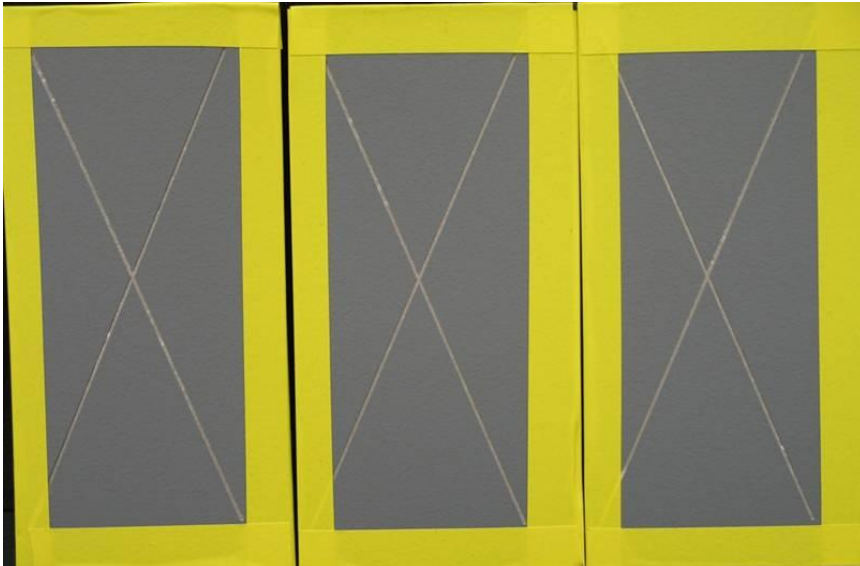
**2000-Hour Filiform – 7075 T-6 Clad, Alodine 1200
97GY160 Lab Batch # 2 vs. Current Coating System**

Chromate Primer + APC Topcoat

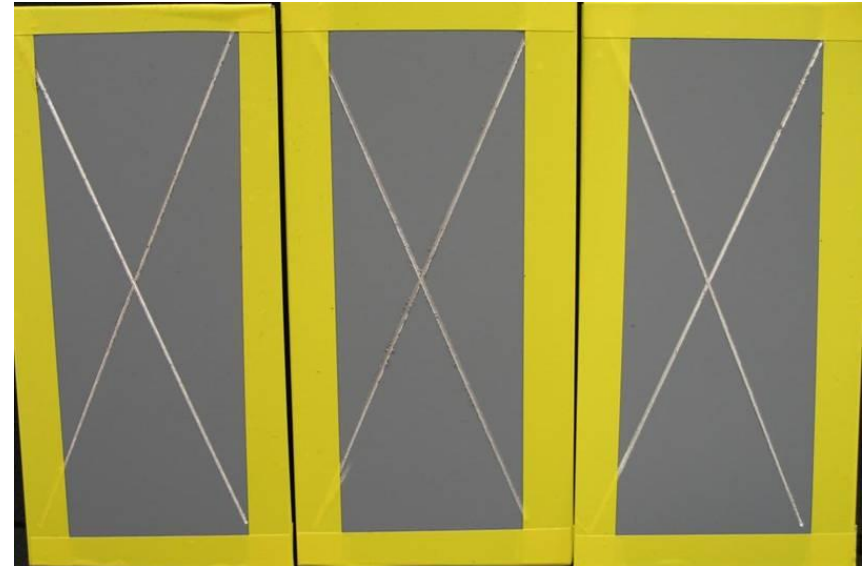
97GY160 AMC

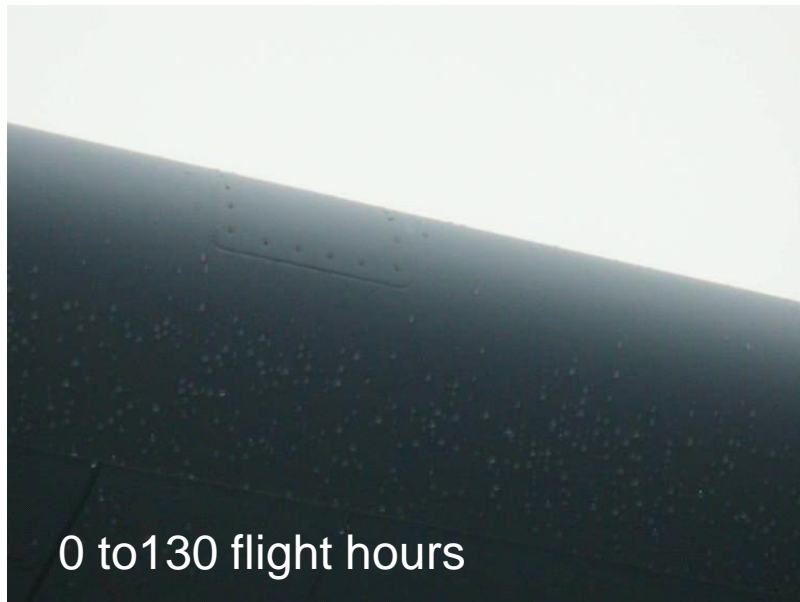
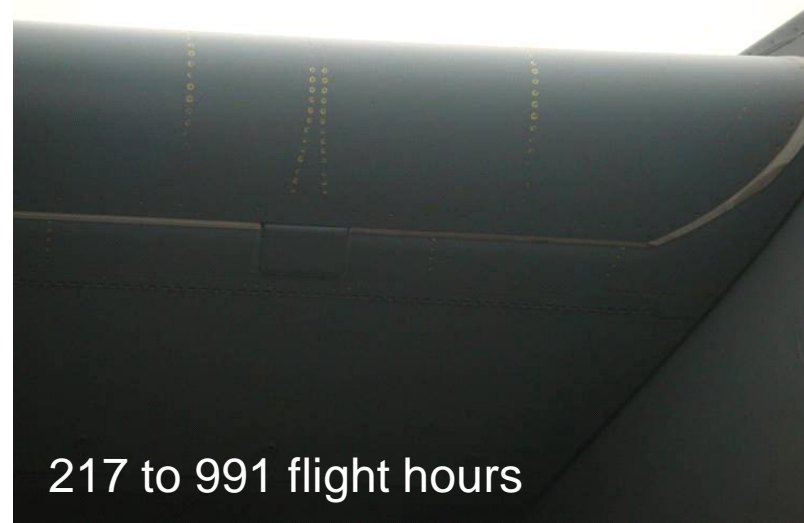
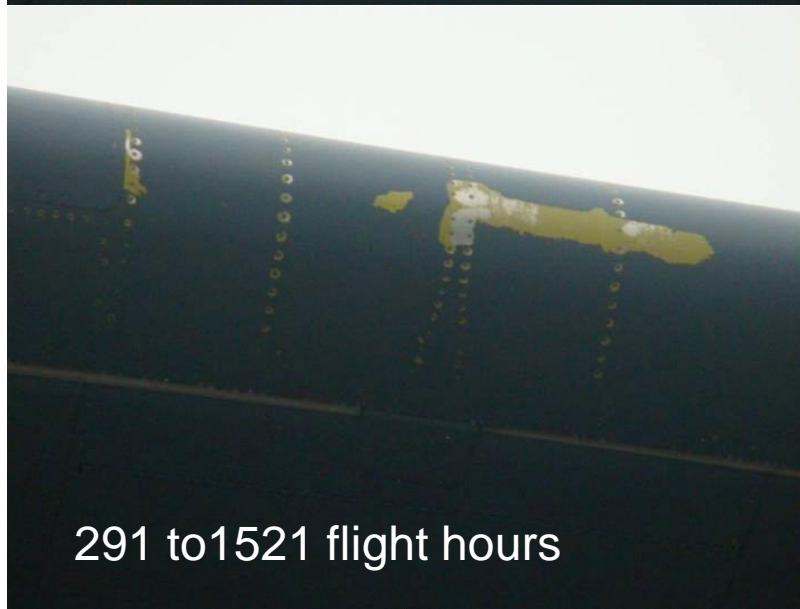
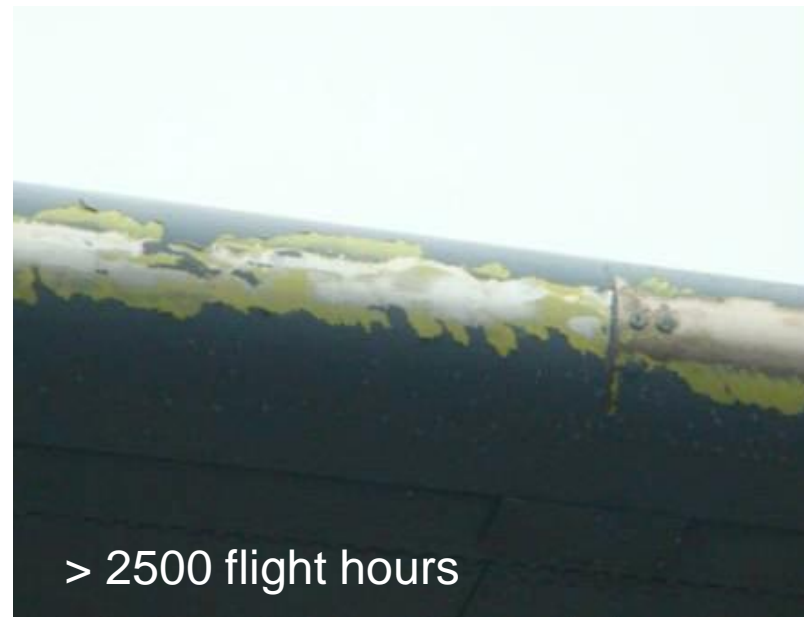
Leading edge erosion progression

Aircraft	Paint Job	Flight hours since last paint	Leading edge condition
P-190	OEM	130	No rain erosion or rivet rash
P-41	strip & repaint	217	No rain erosion, early isolated rivet rash and adhesion loss around access panels
P-45	strip & repaint	291	Moderate rain erosion left and right slat 4 and rivet rash all slats
P-188	OEM	320	Rivet rash all slats
P-190	OEM	730	Isolated slight rain erosion, start of rivet rash
P-187	OEM	603	Rivet rash all slats
P-184	OEM	880	Isolated slight rain erosion, start of rivet rash
P-189	OEM	897	Rivet rash all slats
P-185	OEM	991	Rivet rash all slats
P-98	scuff & overcoat	1057	Moderate rain erosion and isolated rivet rash. Leading edge failure to bare metal
P-188	OEM	1083	Rivet rash all slats. Some continuous vertical erosion along fastener rows/start of erosion
P-183	OEM	1250	Isolated moderate rain erosion, rivet rash all slats
P-182	OEM	1324	Isolated moderate rain erosion, rivet rash all slats

P-180	OEM	1521	Isolated moderate rain erosion, rivet rash all slats
P-181	OEM	1634	Isolated moderate rain erosion, rivet rash all slats
P-38	strip & repaint	1827	Moderate rain erosion and isolated rivet rash all slats
P-36	strip & repaint	2252	Severe rain erosion left hand slats 3 & 4

- Earliest leading edge failure around rivets after 217 flight hours (strip & repaint)
- Earliest failure across leading edge after 291 flight hours (strip & repaint)
- Based on this data it appears that leading edge erosion is slightly worse with strip and repaint than OEM paint with comparable flight hours
- Initial failure is not typical rivet rash
 - Failure moves out from around fastener
 - Fasteners still have paint on them
 - Non-continuous or thin paint around fastener/hole and seams fails from rain/sand erosion

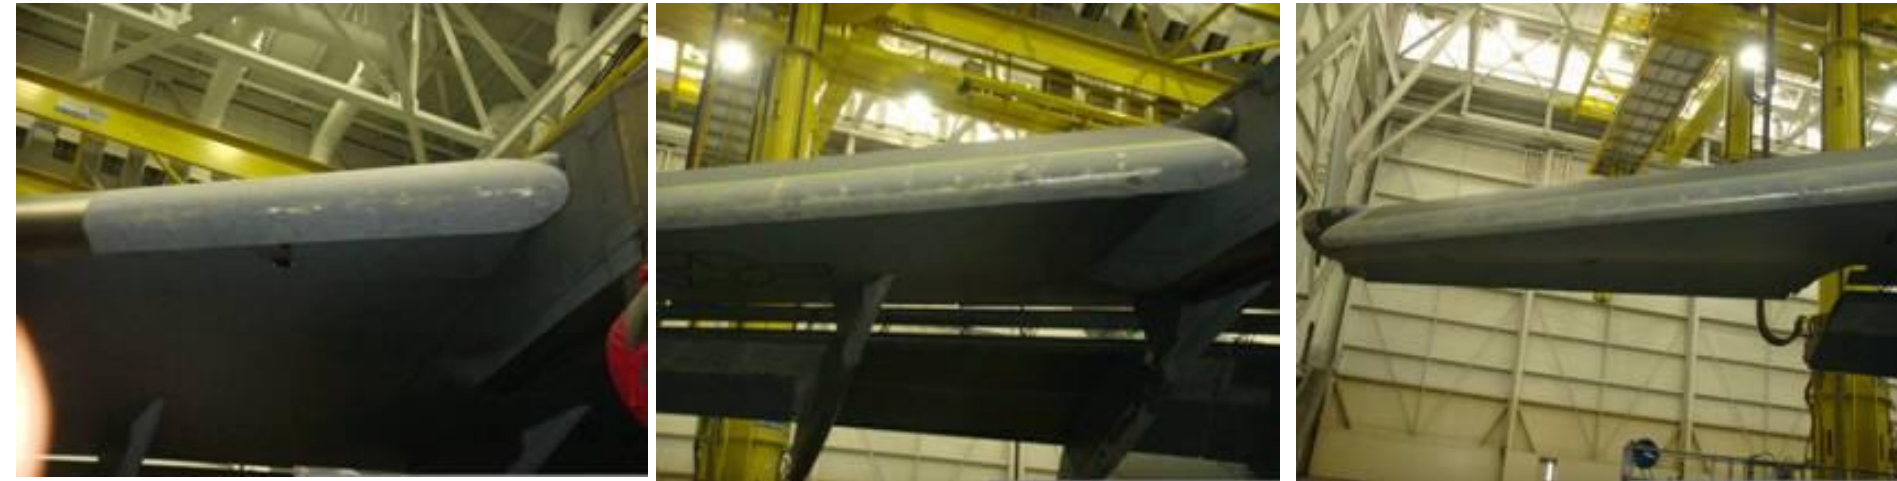
P-87 After Sanding

Test wing right side slats 2, 3 and 4 after sanding with 120 and 220 grit sand paper

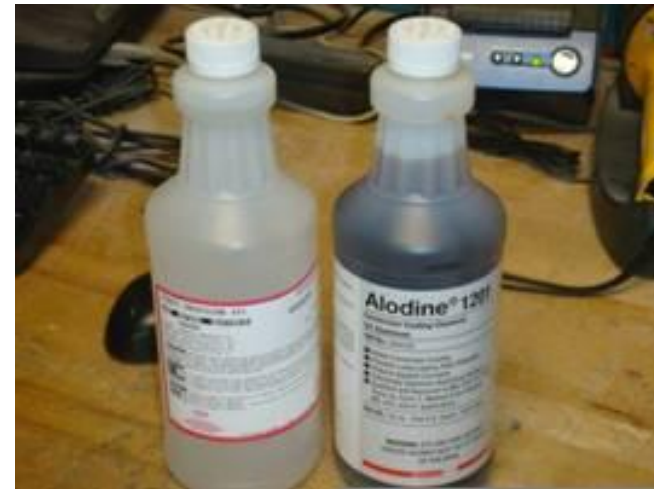
- Process per Henkel Surface Technologies Process Bulletin No. 234113
 - Deoxidine 605 scrub for 1-3 minutes
 - Water rinse
 - Alodine 1201 for 1-5 minutes
 - Water rinse
 - Dry

Alodine kit

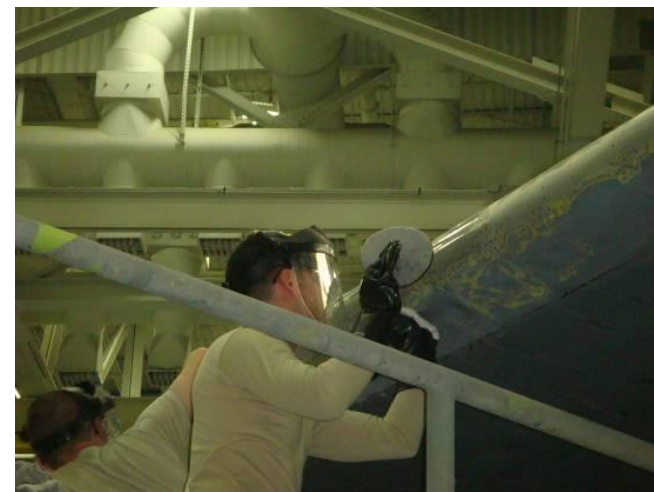
Deoxidine scrub

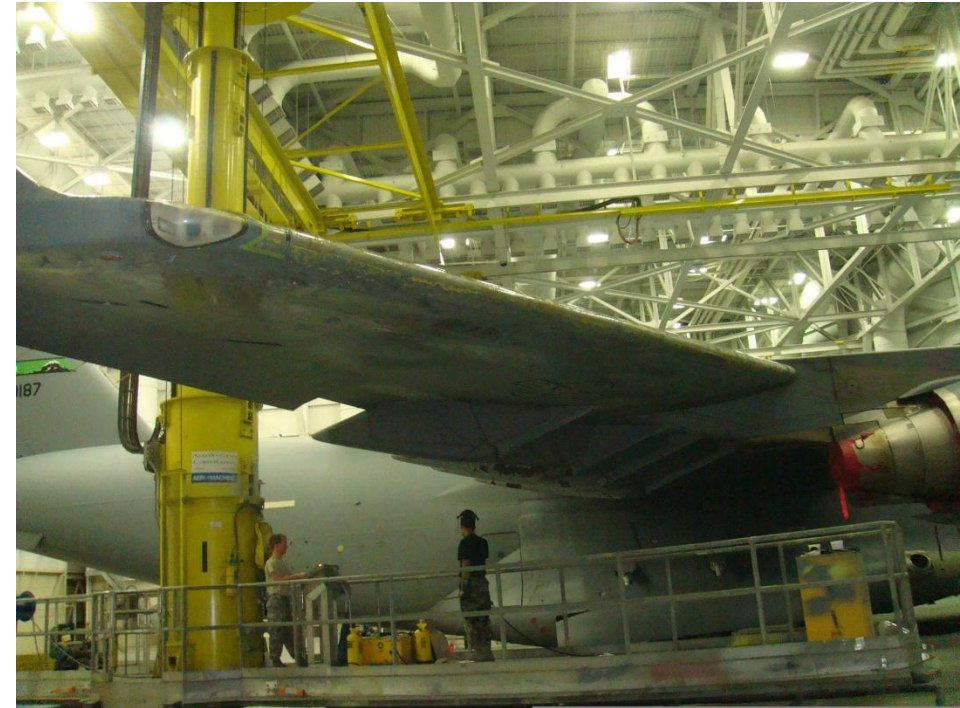
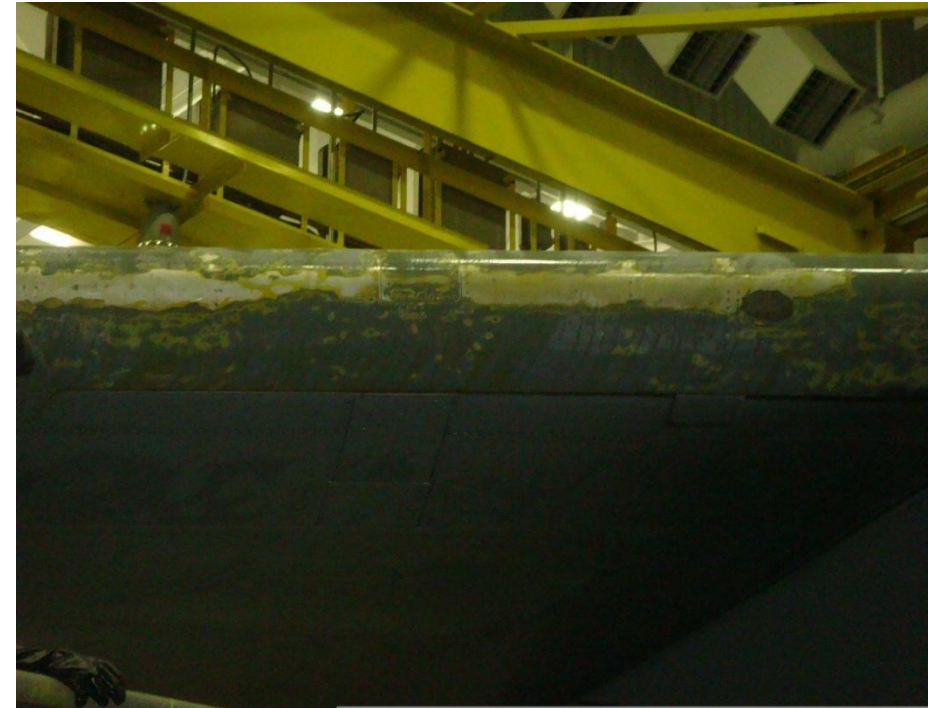
Test slats after alodine process

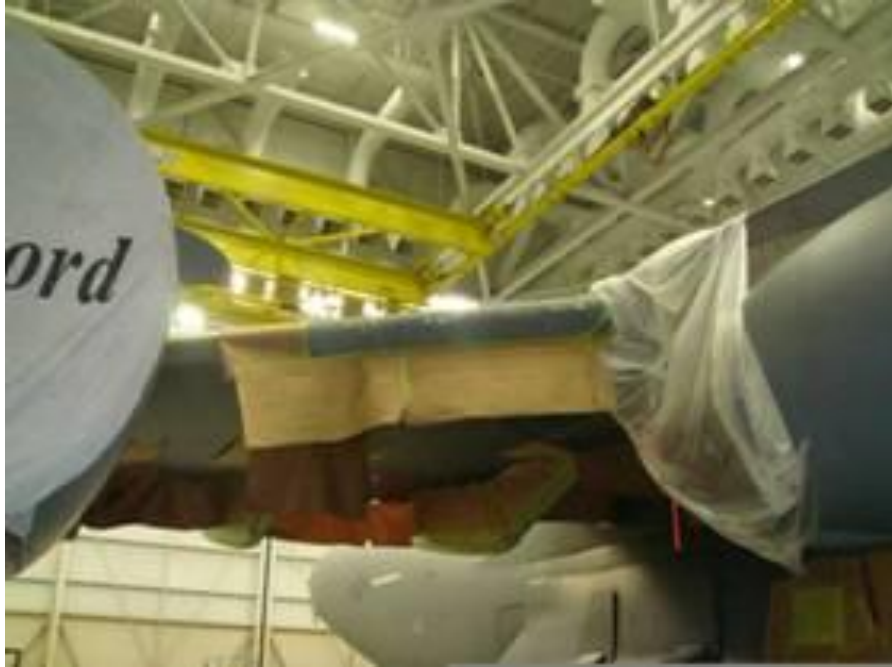
Test slat after masking

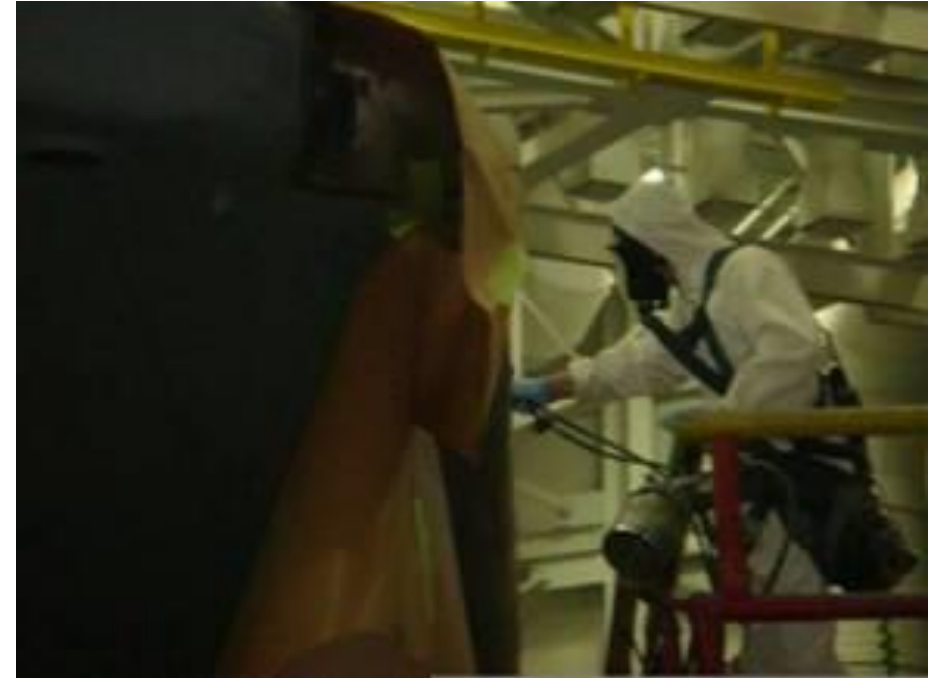
TSgt Nowak applying AMC

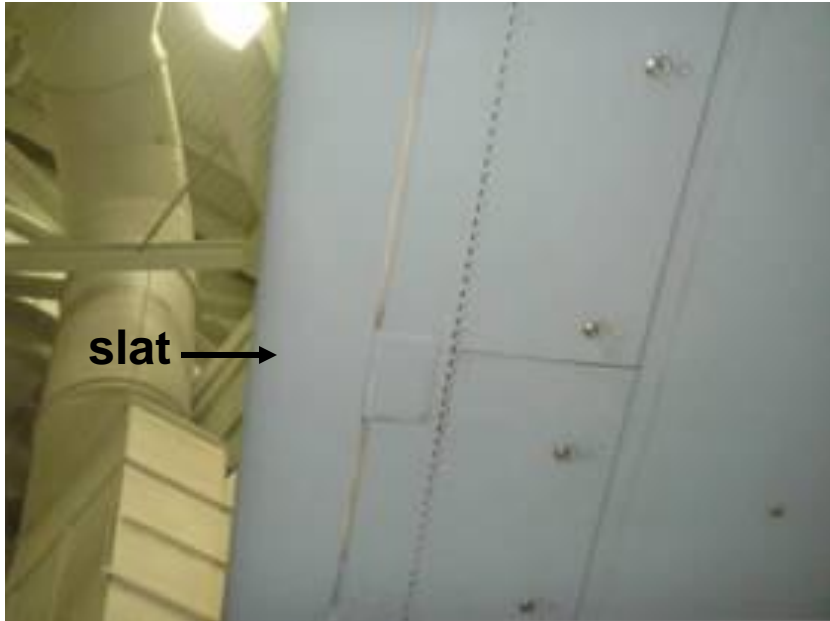
Good color match of AMC with wing

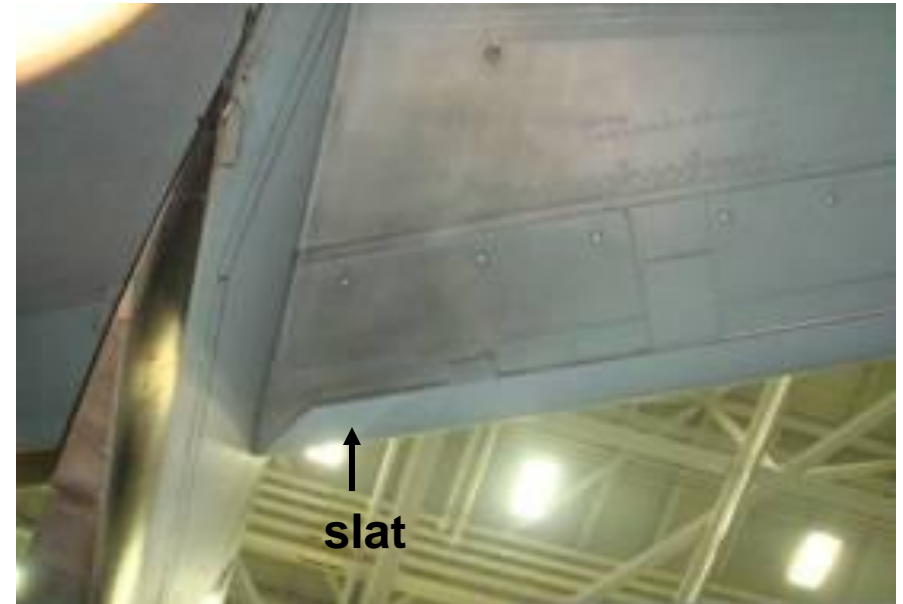
AMC next to soot covered wing

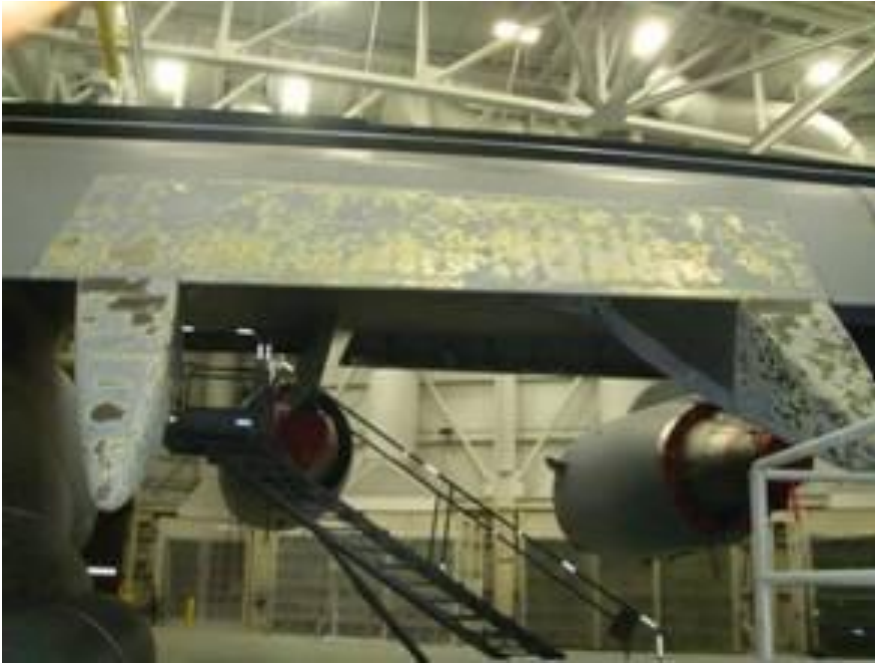
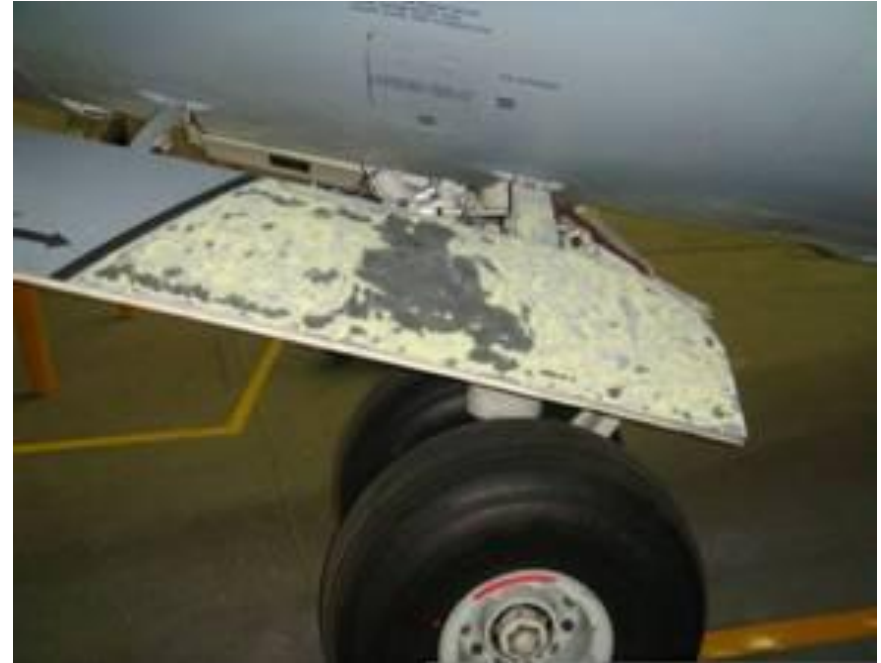
Note: Front main landing gear door to be protected from liquid oxygen system via Charleston AFB suggestion

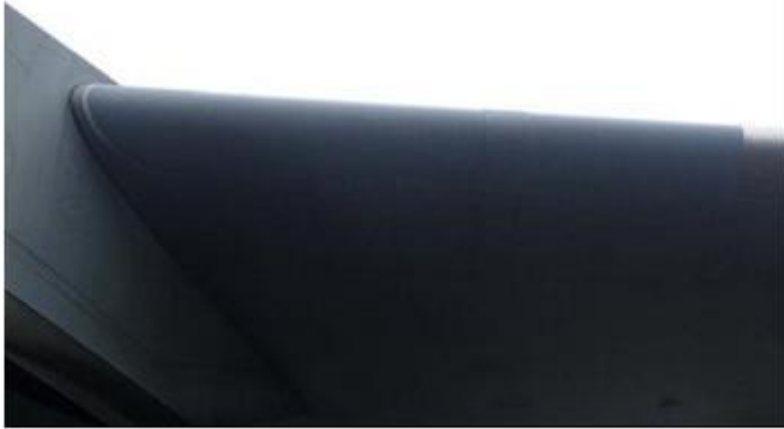
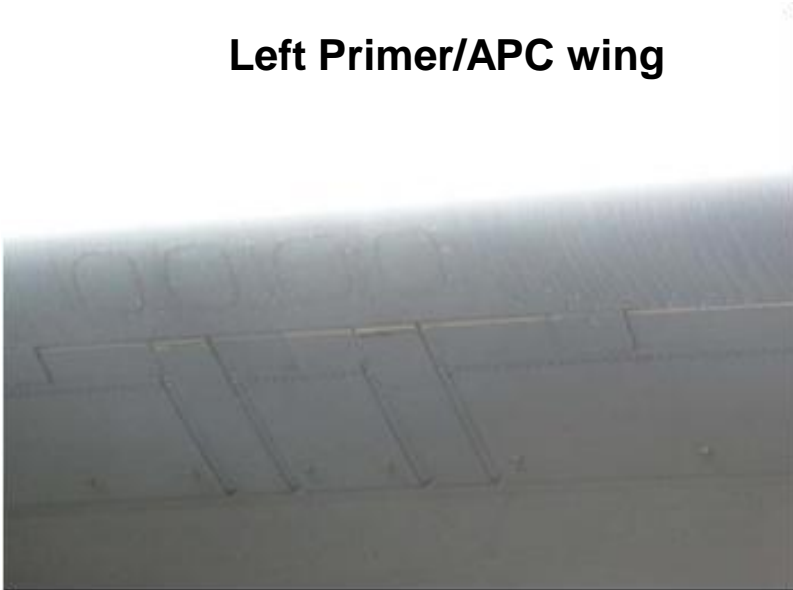
P-87 after 1064 Flight Hours

No discrepancies either wing

Left Primer/APC wing

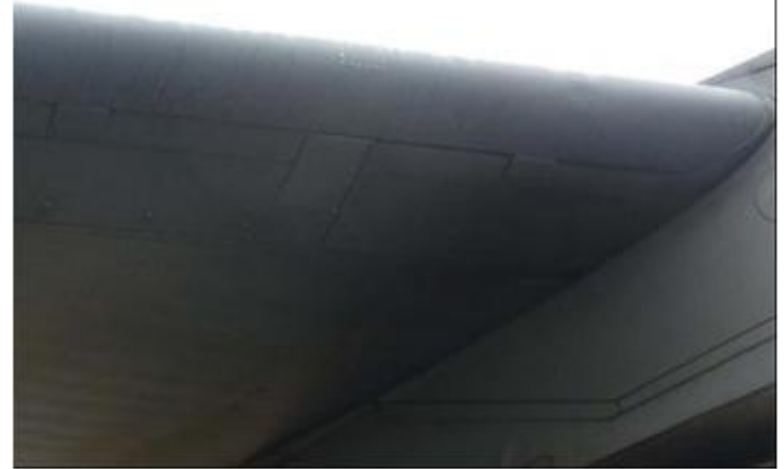
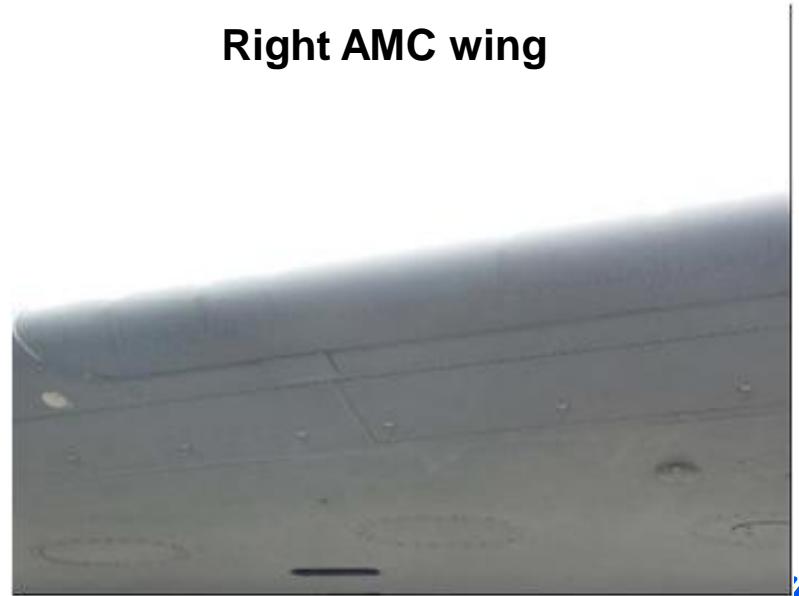
Right AMC wing

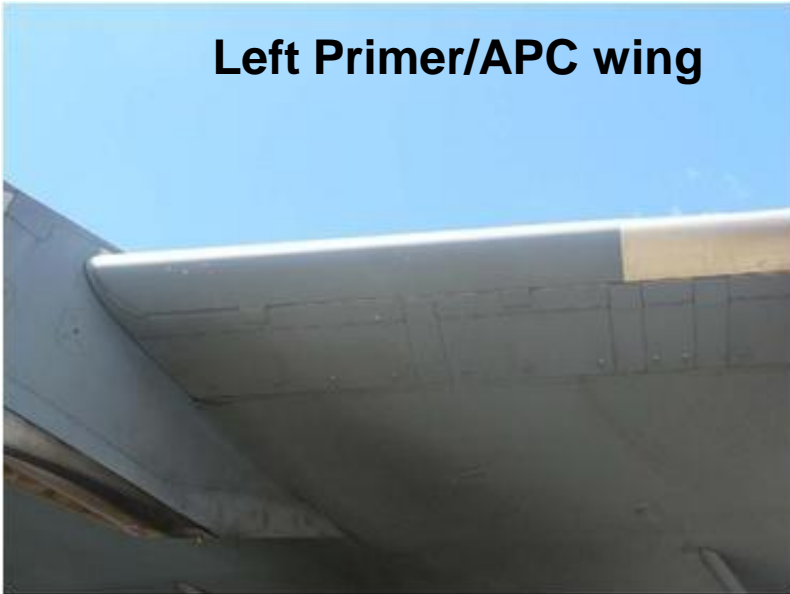
P-86 after 1306 Flight Hours

No discrepancies either wing

Left Primer/APC wing

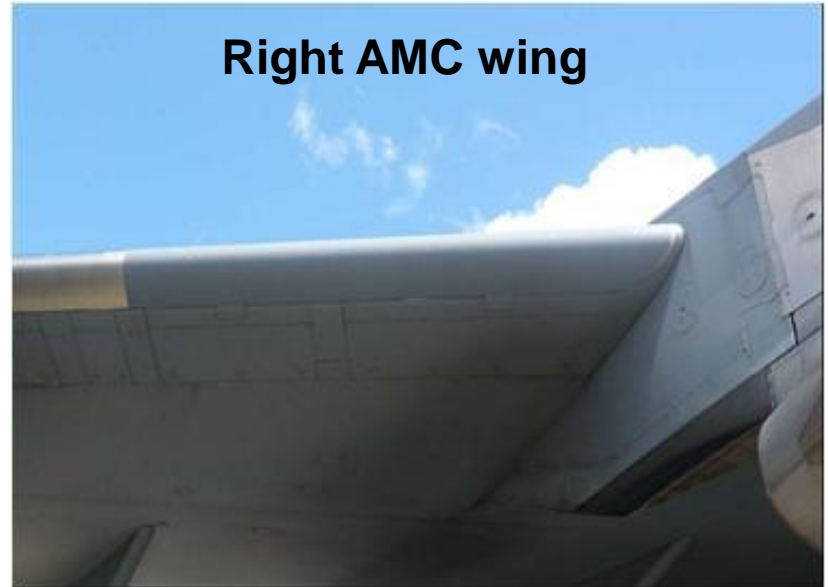
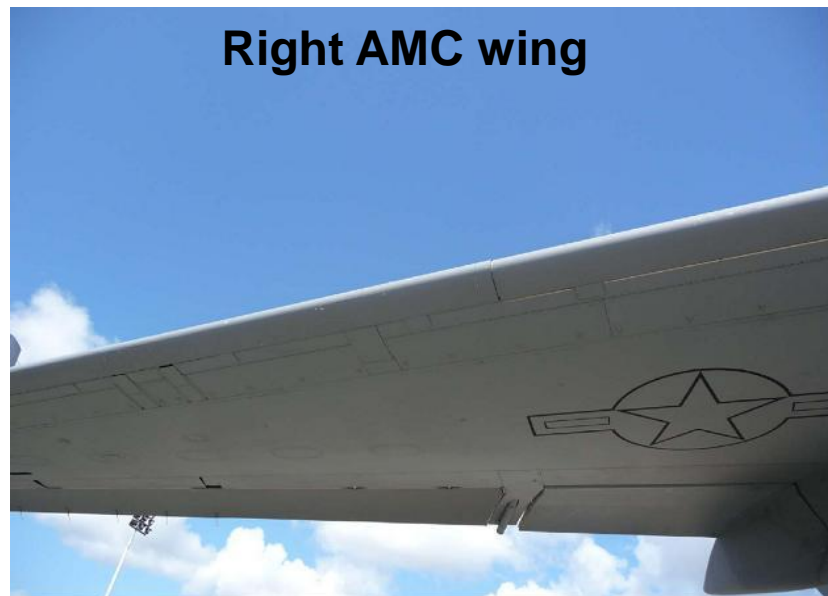
Right AMC wing

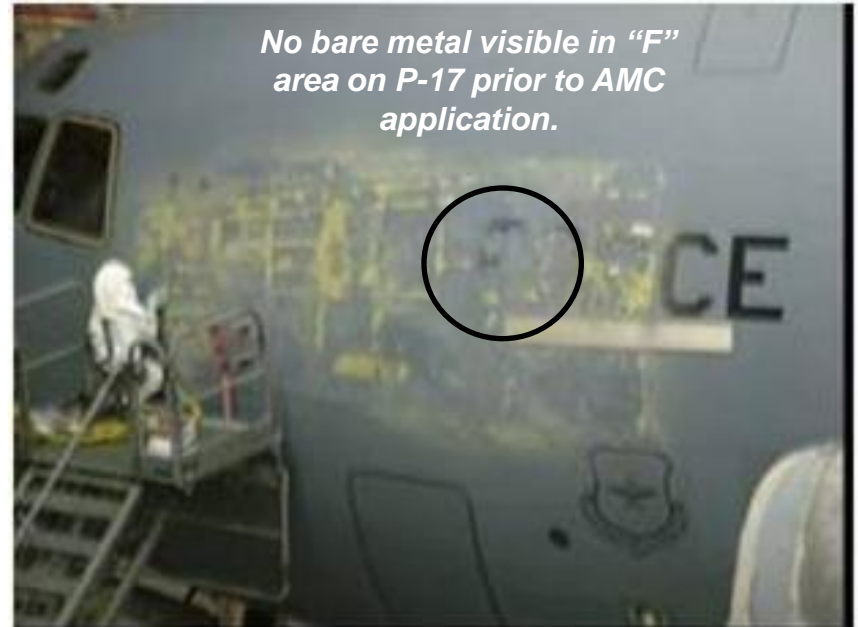
Discrepancy on P-17 after 956 Flight Hours

Discrepancy found during inspection at Warner Robins

- Eight fielded AMC aircraft
 - Over 5000 flight hours on fielded aircraft
 - Ten inspections
 - AMC performing very well !
 - One minor discrepancy identified
 - » P-17 after 956 flight hours

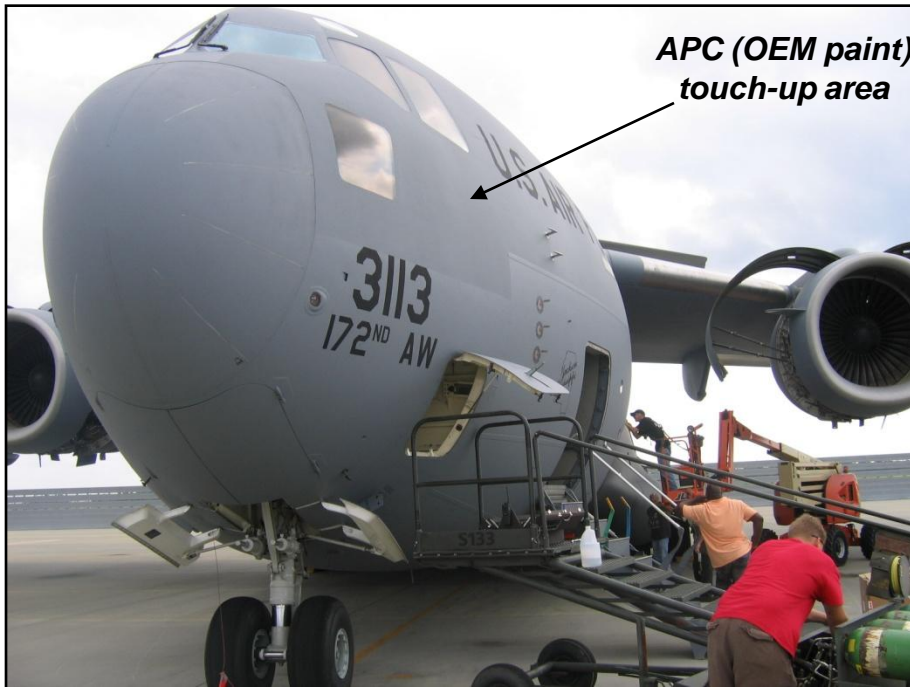
Color match issues

P113 recently touched-up with APC.
