Erosion Control and Environment Restoration Plan Development, Matagorda County, Texas

Phase 1: Preliminary Investigation

Robert Thomas and Lauren Dunkin

July 2012

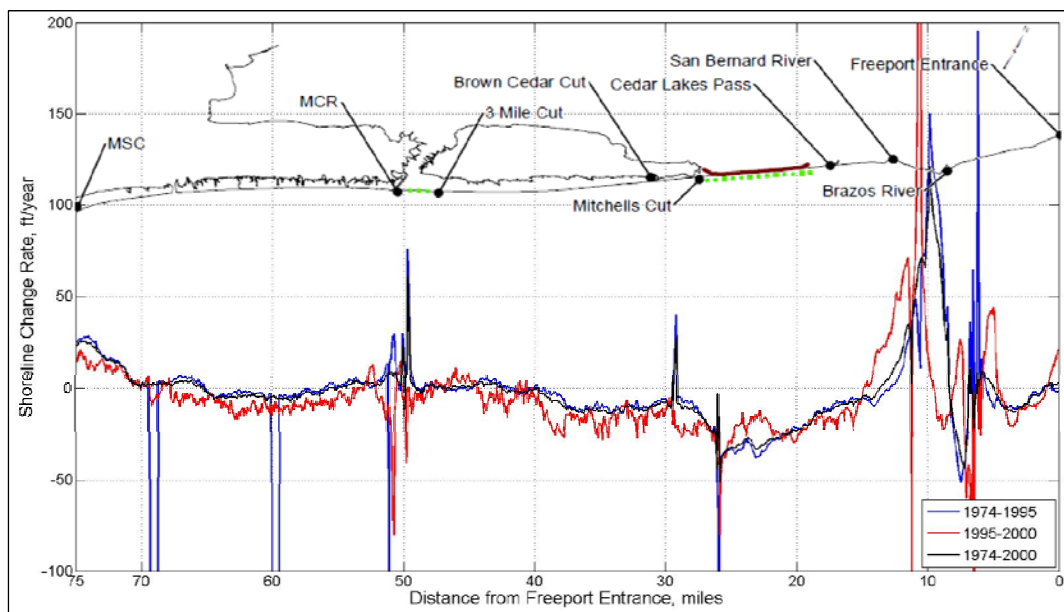
Figure 15. Modern shoreline change from Freeport to the MSC.

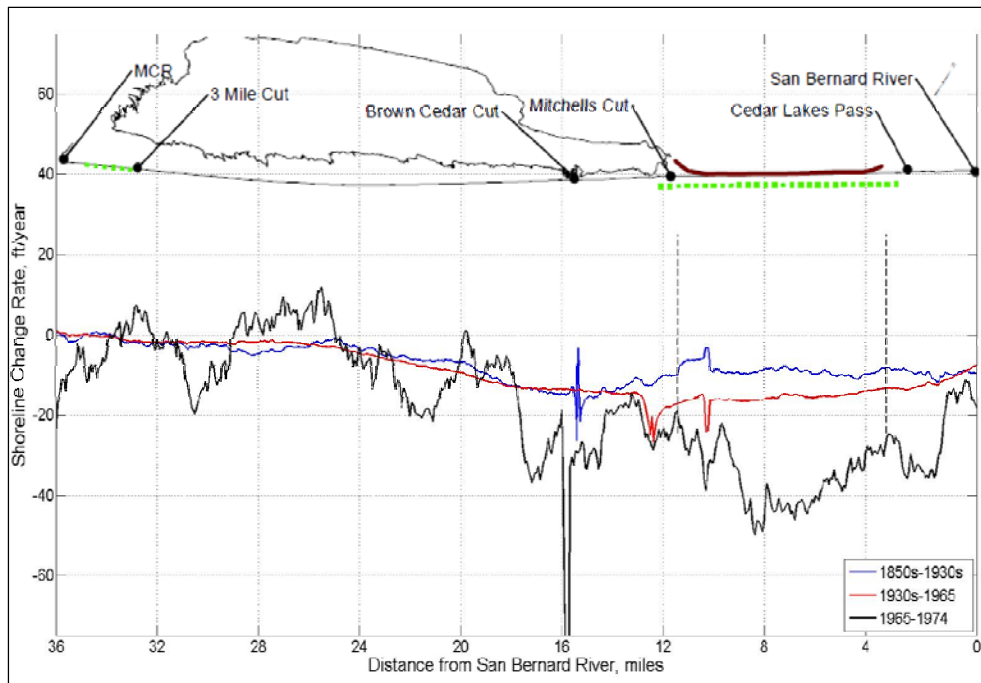
Figure 16. Historical shoreline change from SBR to MCR.

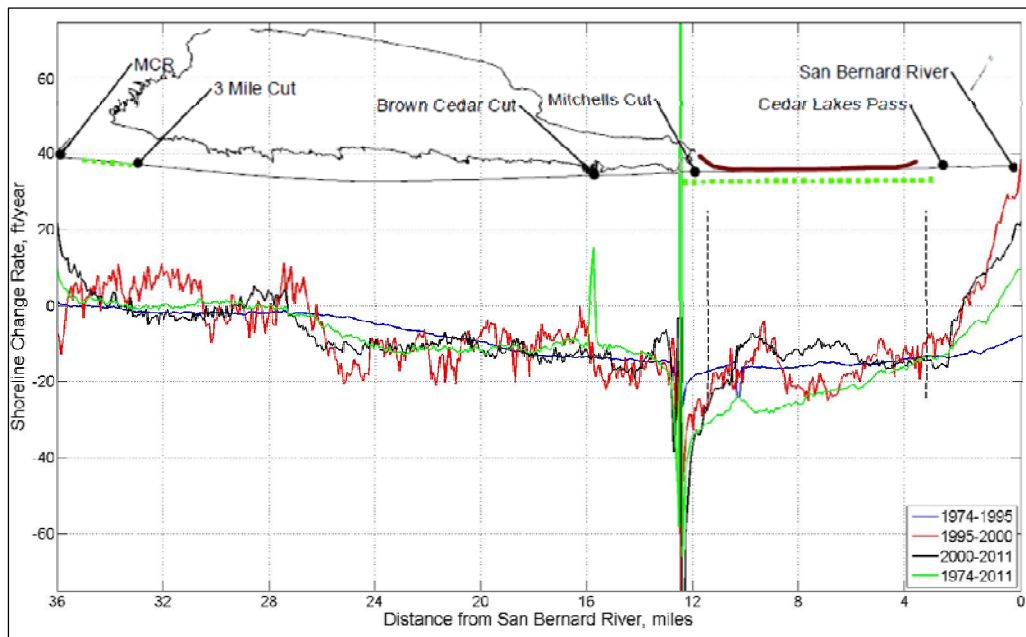
Figure 17. Recent and average shoreline change from SBR to MCR.

Shoreline change rates for the recent time period (1974-2011) for the 35 miles east of the MCR to the SBR are plotted in Figure 17. The long-term shoreline recession rate (1974-2011) near the revetment continues to be much greater than at other locations. Shoreline advance is observed at Cedar Lakes Pass to the Brazos River. The rates between 1995 and 2000 and between 2000 and 2011 provide the short-term shoreline change rates for the area.

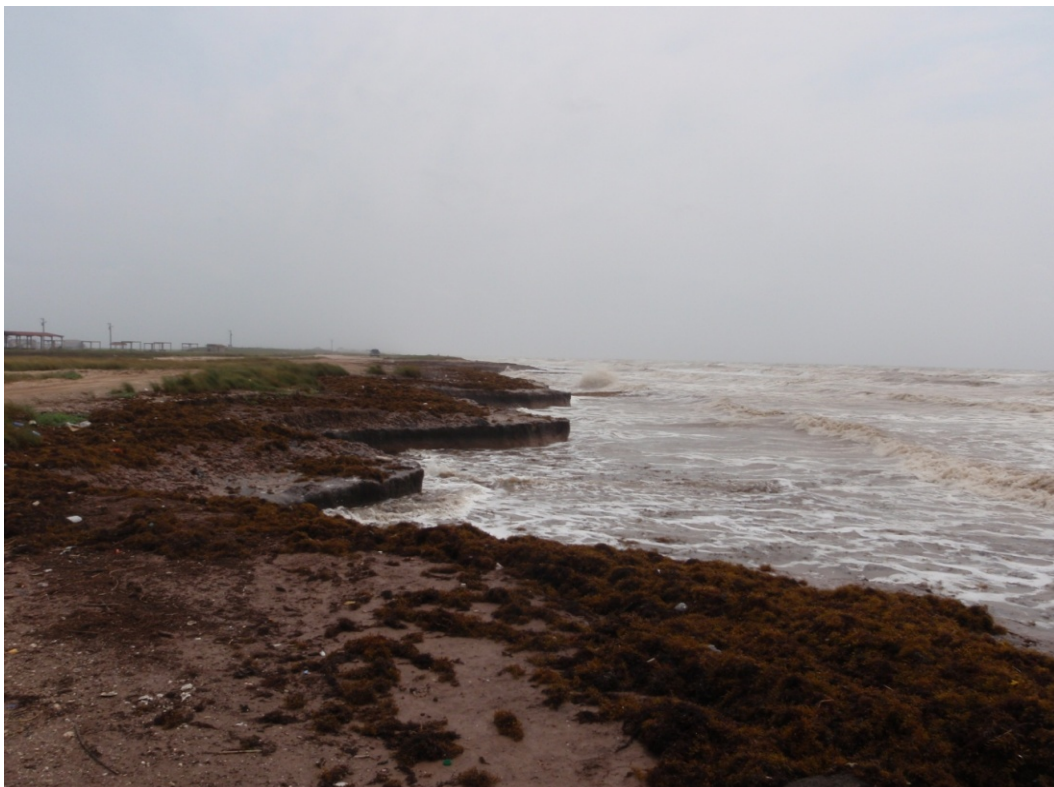
Figure 19. Sargent Beach near FM 457, facing northeast (May 2011).

alongshore observed in the data. New beach surveys were measured at both the Sargent Beach and Matagorda Peninsula project sites in September 2011, which will be analyzed and applied in Phase 2. Pictures of beaches in the region are shown in Figures 19 – 21 above.

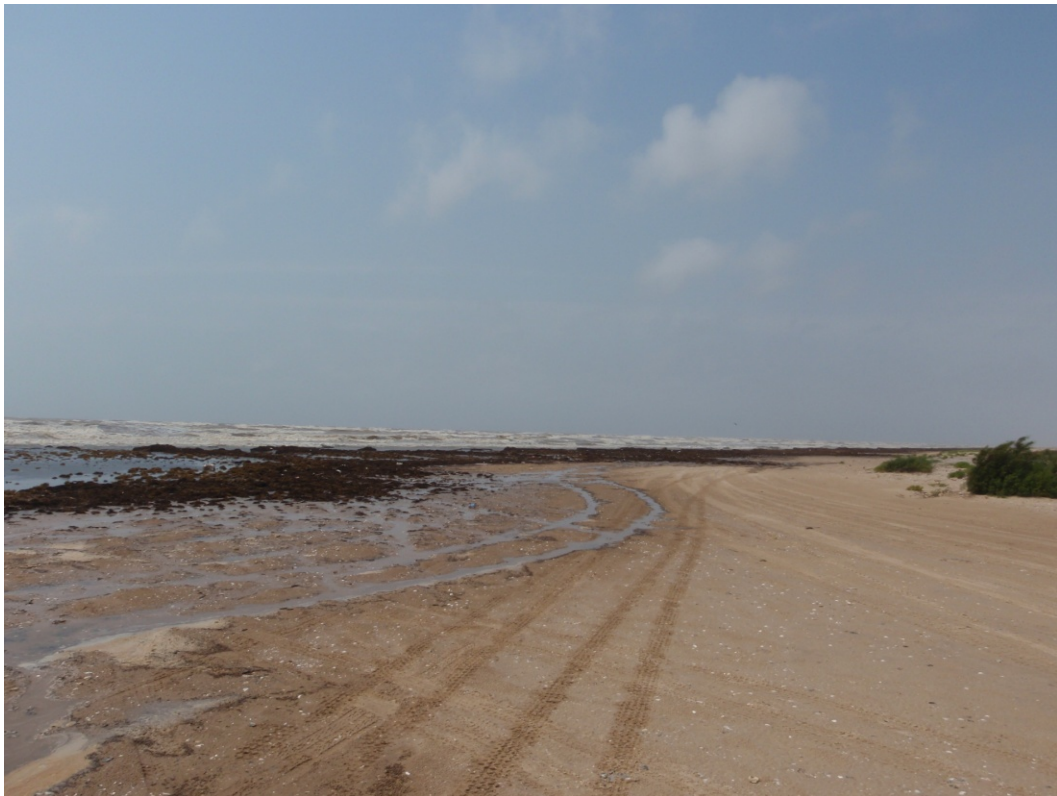
Figure 20. Cedar Lakes Pass, facing southwest (May 2011).

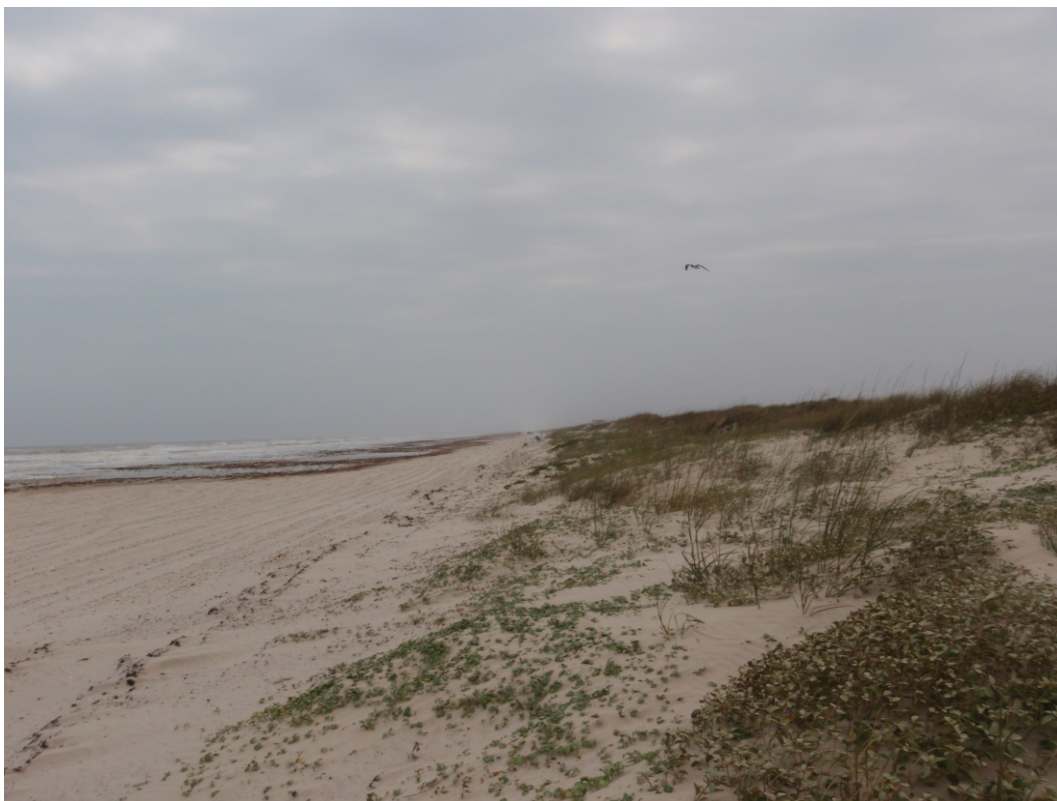
Figure 21. Matagorda Peninsula east of MCR, facing southwest (May 2011).

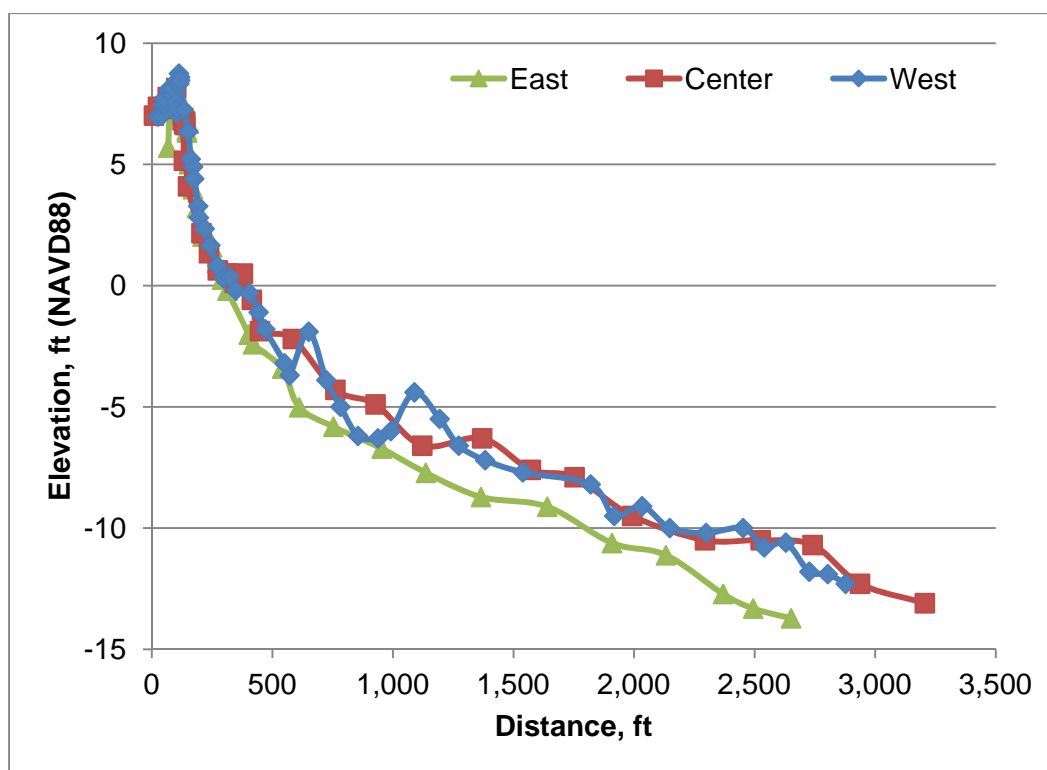
Figure 22. Recent beach surveys at Sargent Beach.

Beach profile shape is a function of sediment size and other characteristics, geology, environmental forcing, and anthropogenic factors. The most recent beach survey data available at Sargent Beach are shown in Figure 22, collected by Baker and Lawson in May 2010. The survey consisted of 11 transects from the boat ramp at Sargent Beach to the east approximately one mile. A detailed review of historic trends in beach profiles is included in Stauble et al. (1994). Recent beach profiles continue to maintain the same basic shape observed from 1937 through 1990, although there is variation

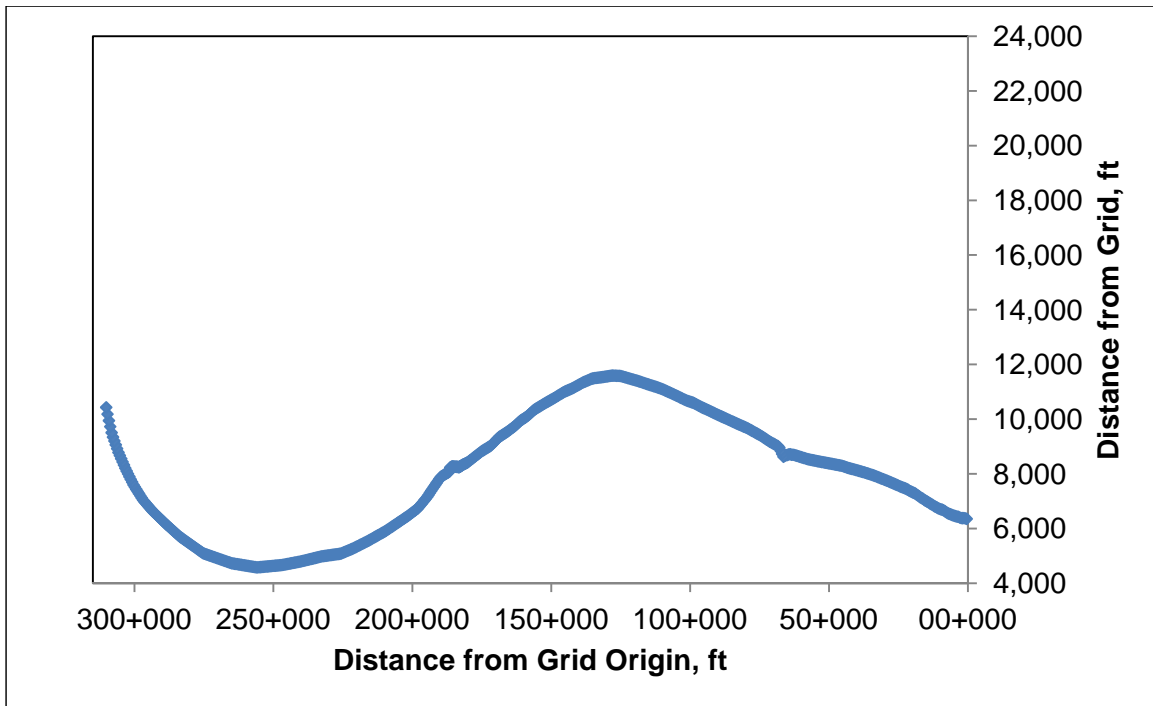
Figure 24. Initial GenCade shoreline position showing locations of key geographic features.

Figure 24 shows the initial shoreline position with key features labeled. Comparison between calculated net and gross longshore transport rates to those estimated by others are shown in Figures 25 and 26, respectively. Comparison between calculated and observed shoreline change rates are shown in Figure 27.

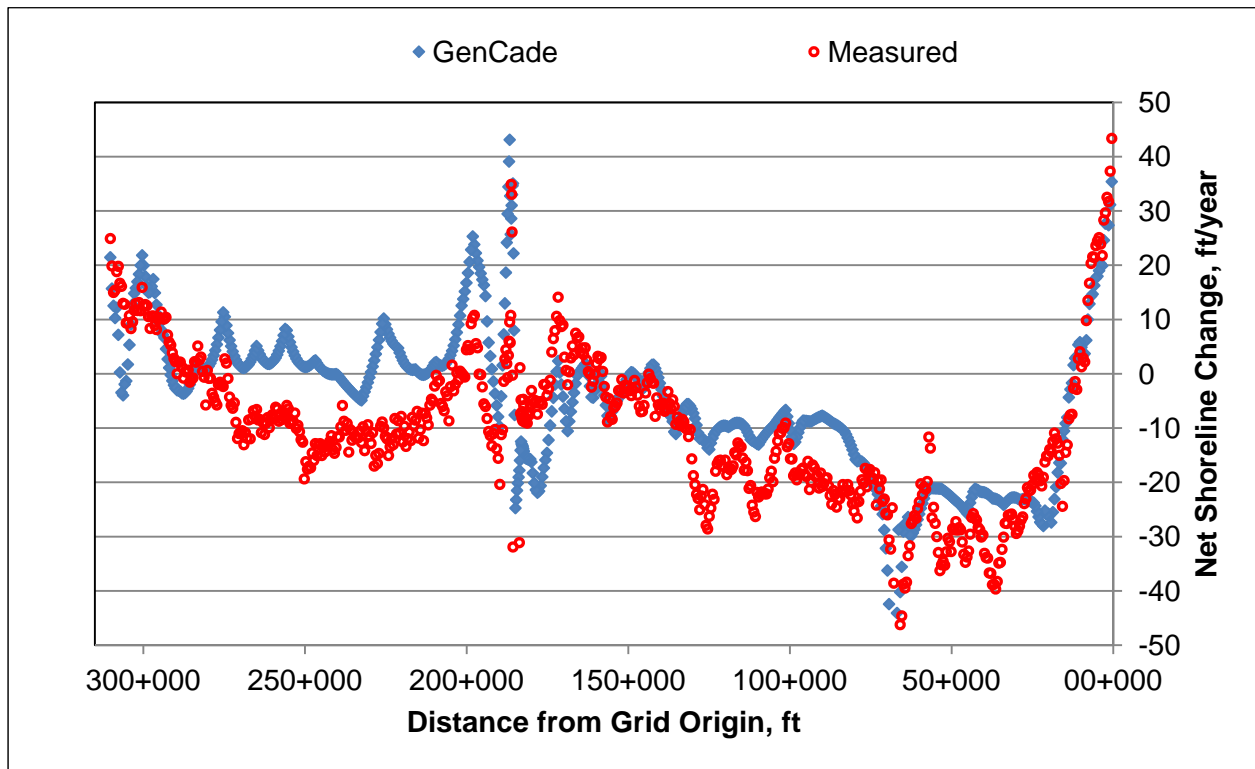
Figure 27. Shoreline change, model results versus published values for the calibration case.

Shoreline change is calculated reasonably well near Sargent Beach and on Matagorda Peninsula between Mitchells Cut and MCR. West of MCR, GenCade calculates advance where shoreline recession was observed and greater advance than observed farther south near the MSC.

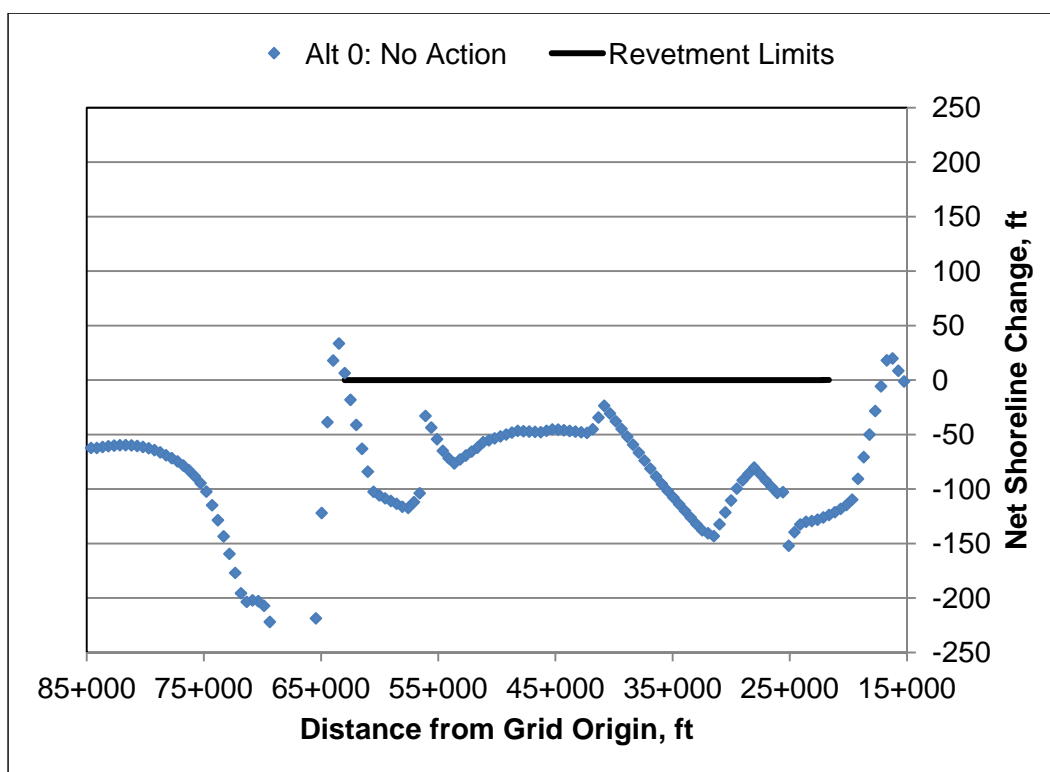
Figure 28. Sargent – Alt. 0: Net shoreline change after five years.

The GenCade model developed in Chapter 4 was applied to analyze shoreline change. The July 2011 shoreline was specified as the initial shoreline and the five year analysis period described in Chapter 5 was applied to calculate shoreline change. Figure 28 plots the net shoreline change after five years; negative values indicate erosion over the five year period and positive values indicate accretion. The model calculates that the shoreline will have reached the revetment within five years over more than half its length; from station 25+000 to 55+000 in Figure 28. Accretion calculated towards the west end of the revetment is an area not well represented in the model and these conditions will likely not occur in the future.

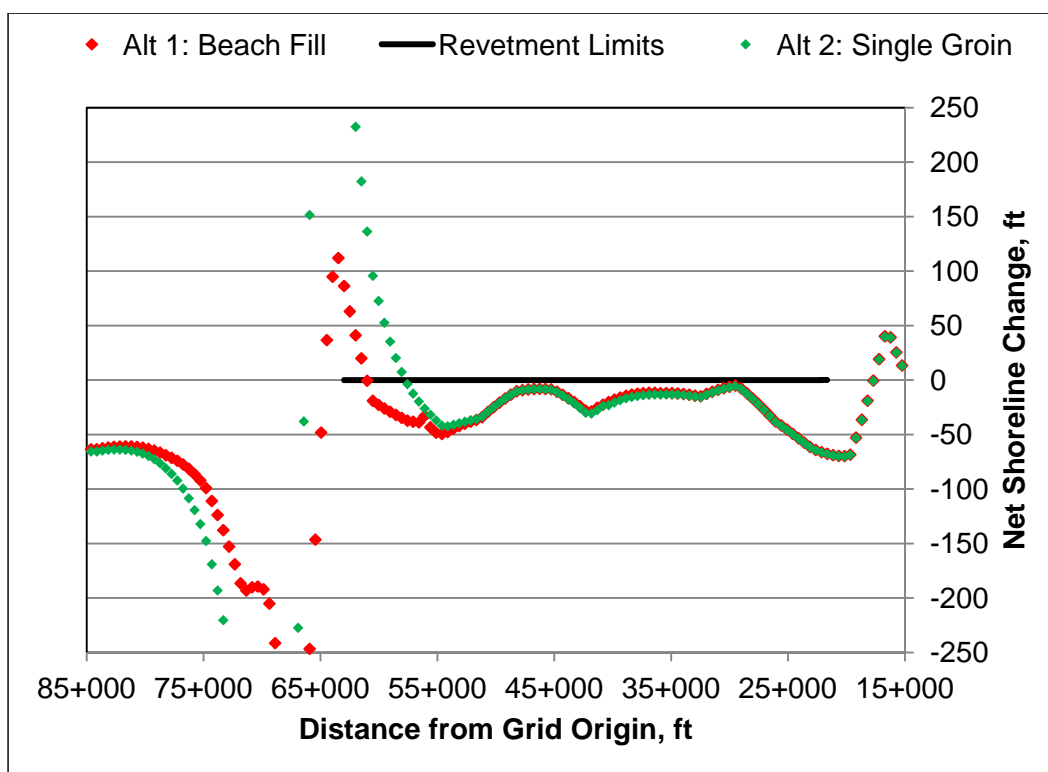
Figure 30. Sargent – Alt. 2: Net shoreline change after 5 years for long groin at Mitchells Cut and three million cu yd of beach fill.

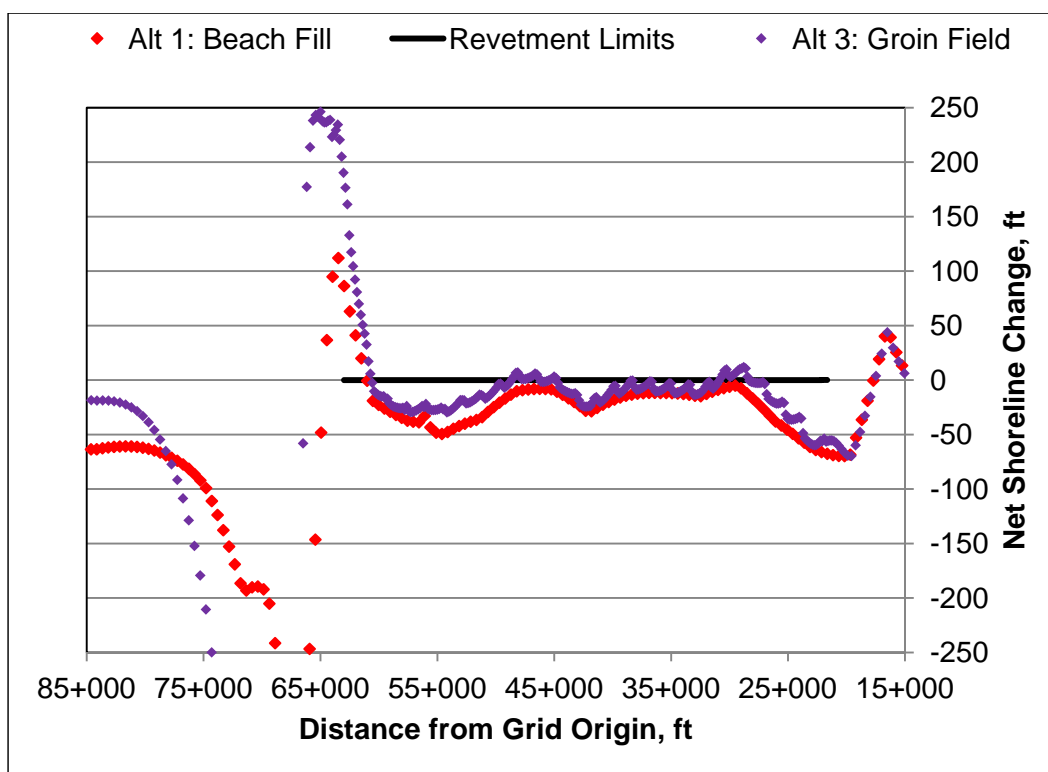
Figure 31. Sargent – Alt. 3: Net shoreline change after 5 years for groins plus three million cu yd beach fill.

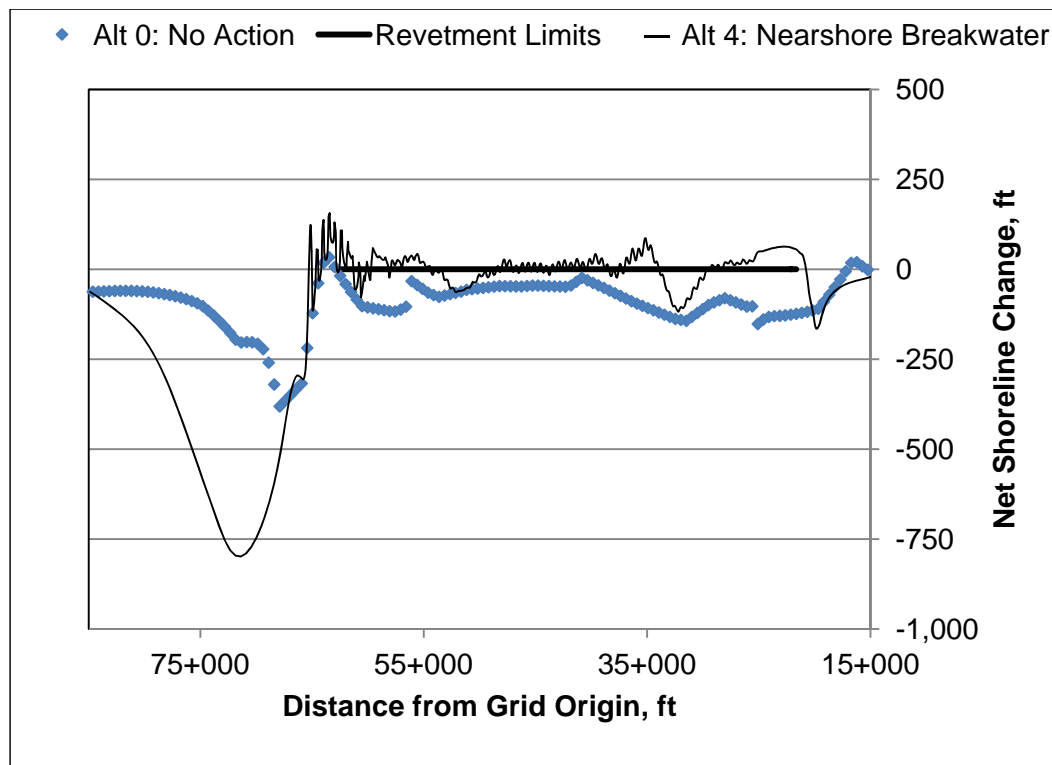
Figure 32. Sargent – Alt. 4: Net shoreline change after five years with detached breakwaters.

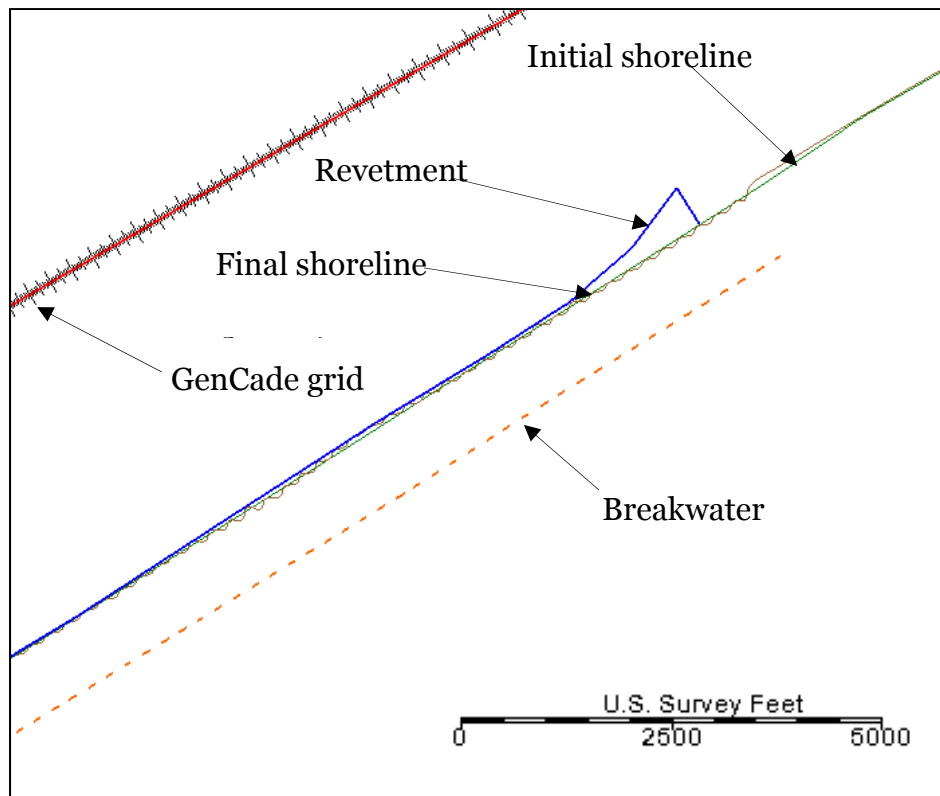
Figure 33. GenCade calculated shoreline after five years for Sargent - Alt 4 detached breakwaters.

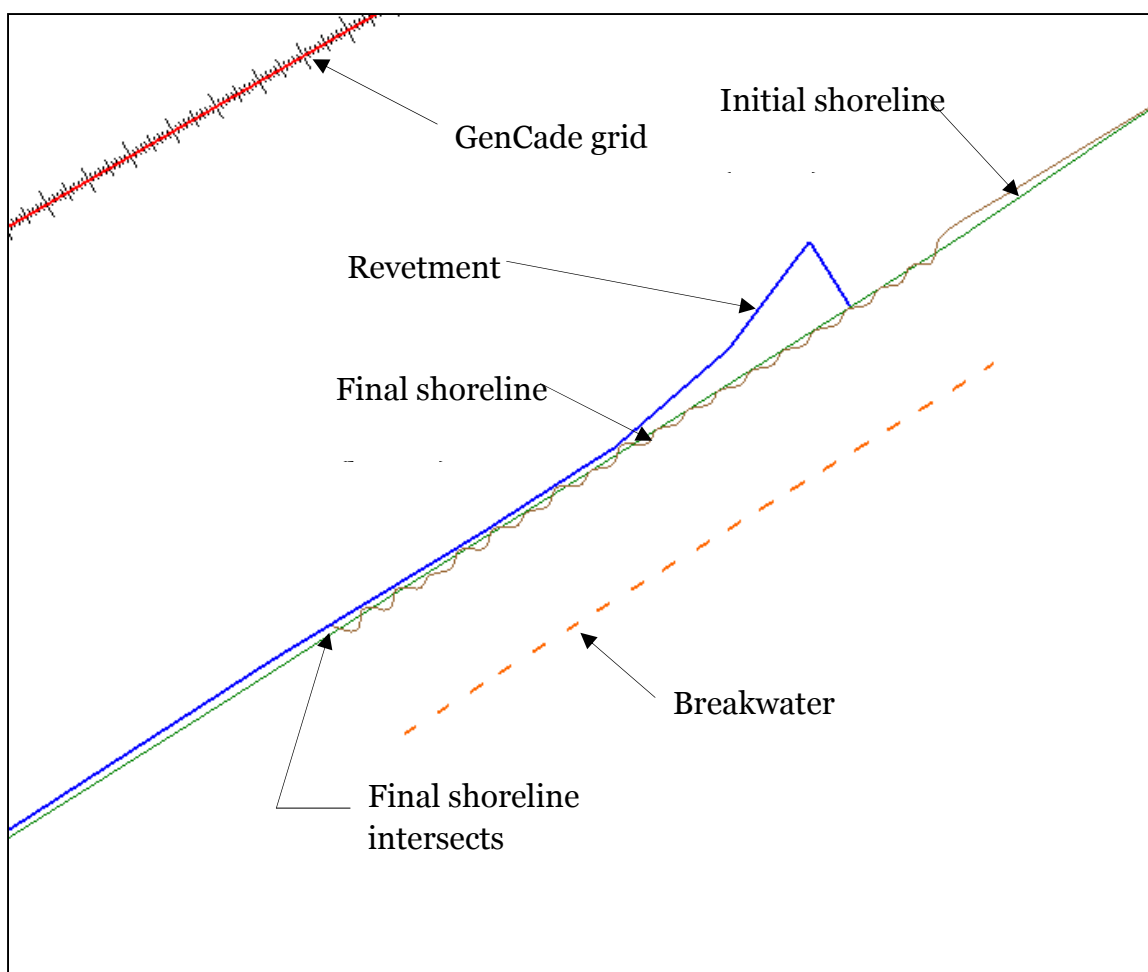
Figure 35. GenCade calculated shoreline after five years for Sargent East - Alt 5.

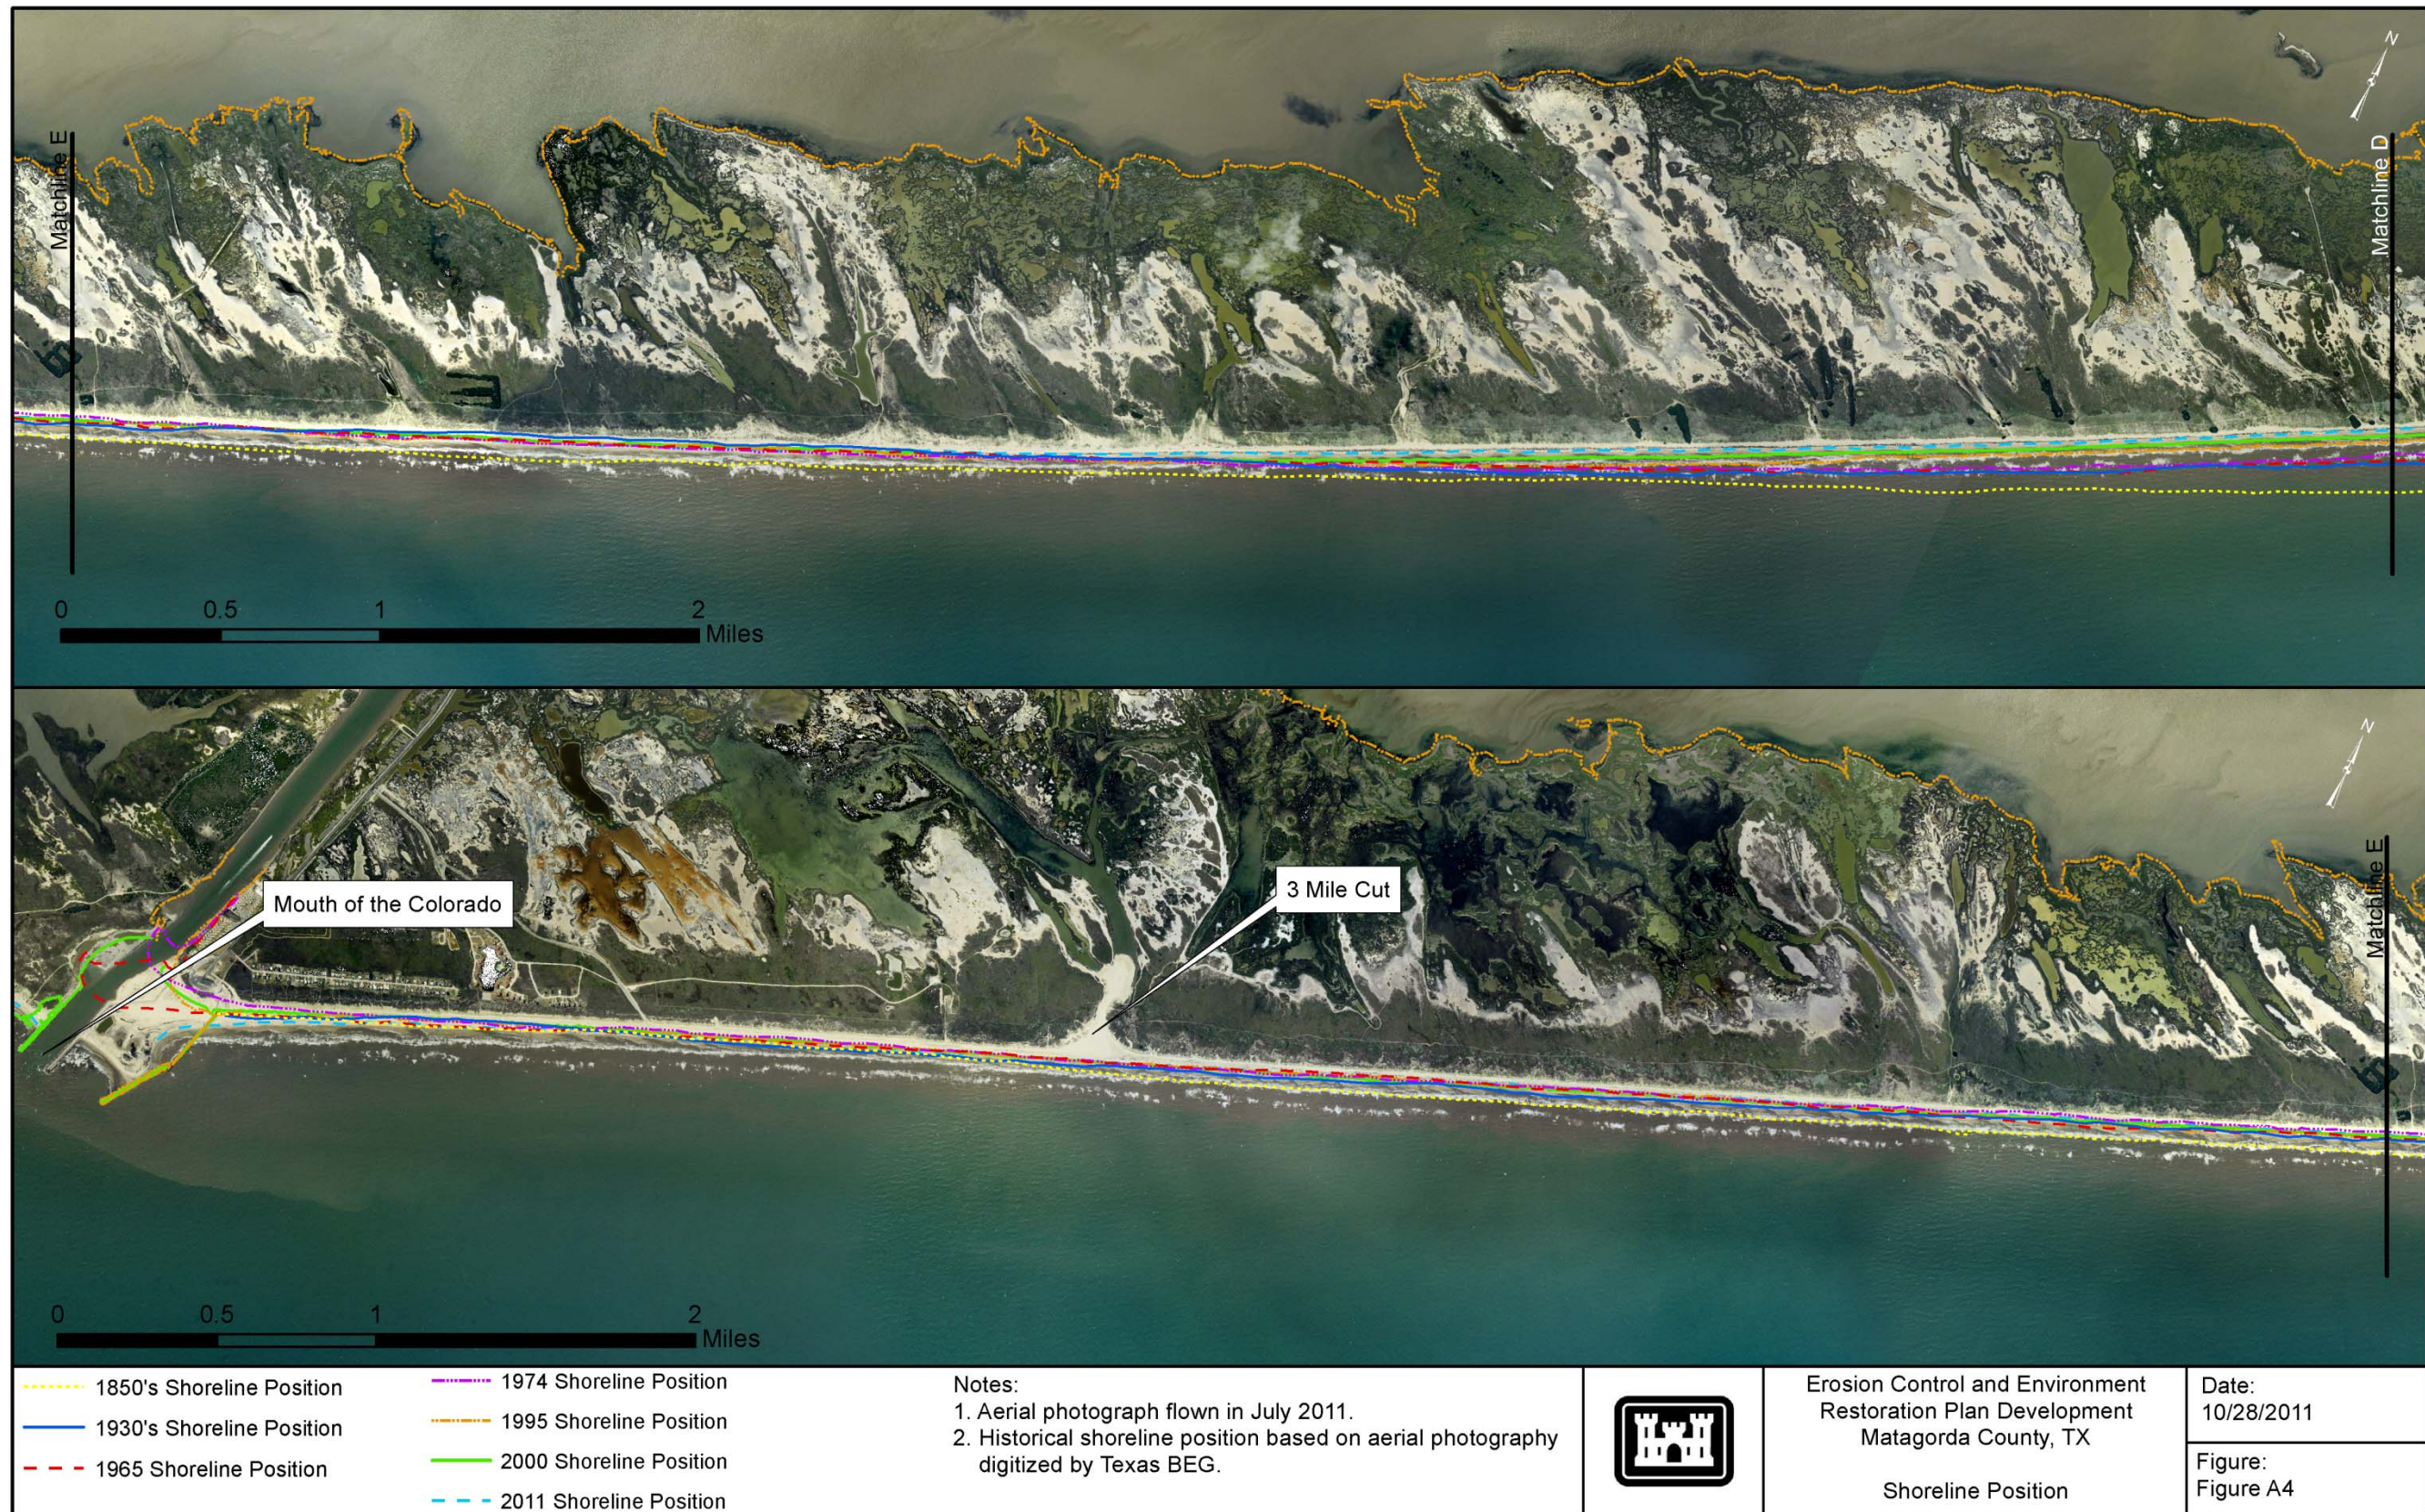
Figure A4. Erosion control and environmental restoration plan development, Matagorda County, TX – Shoreline position.

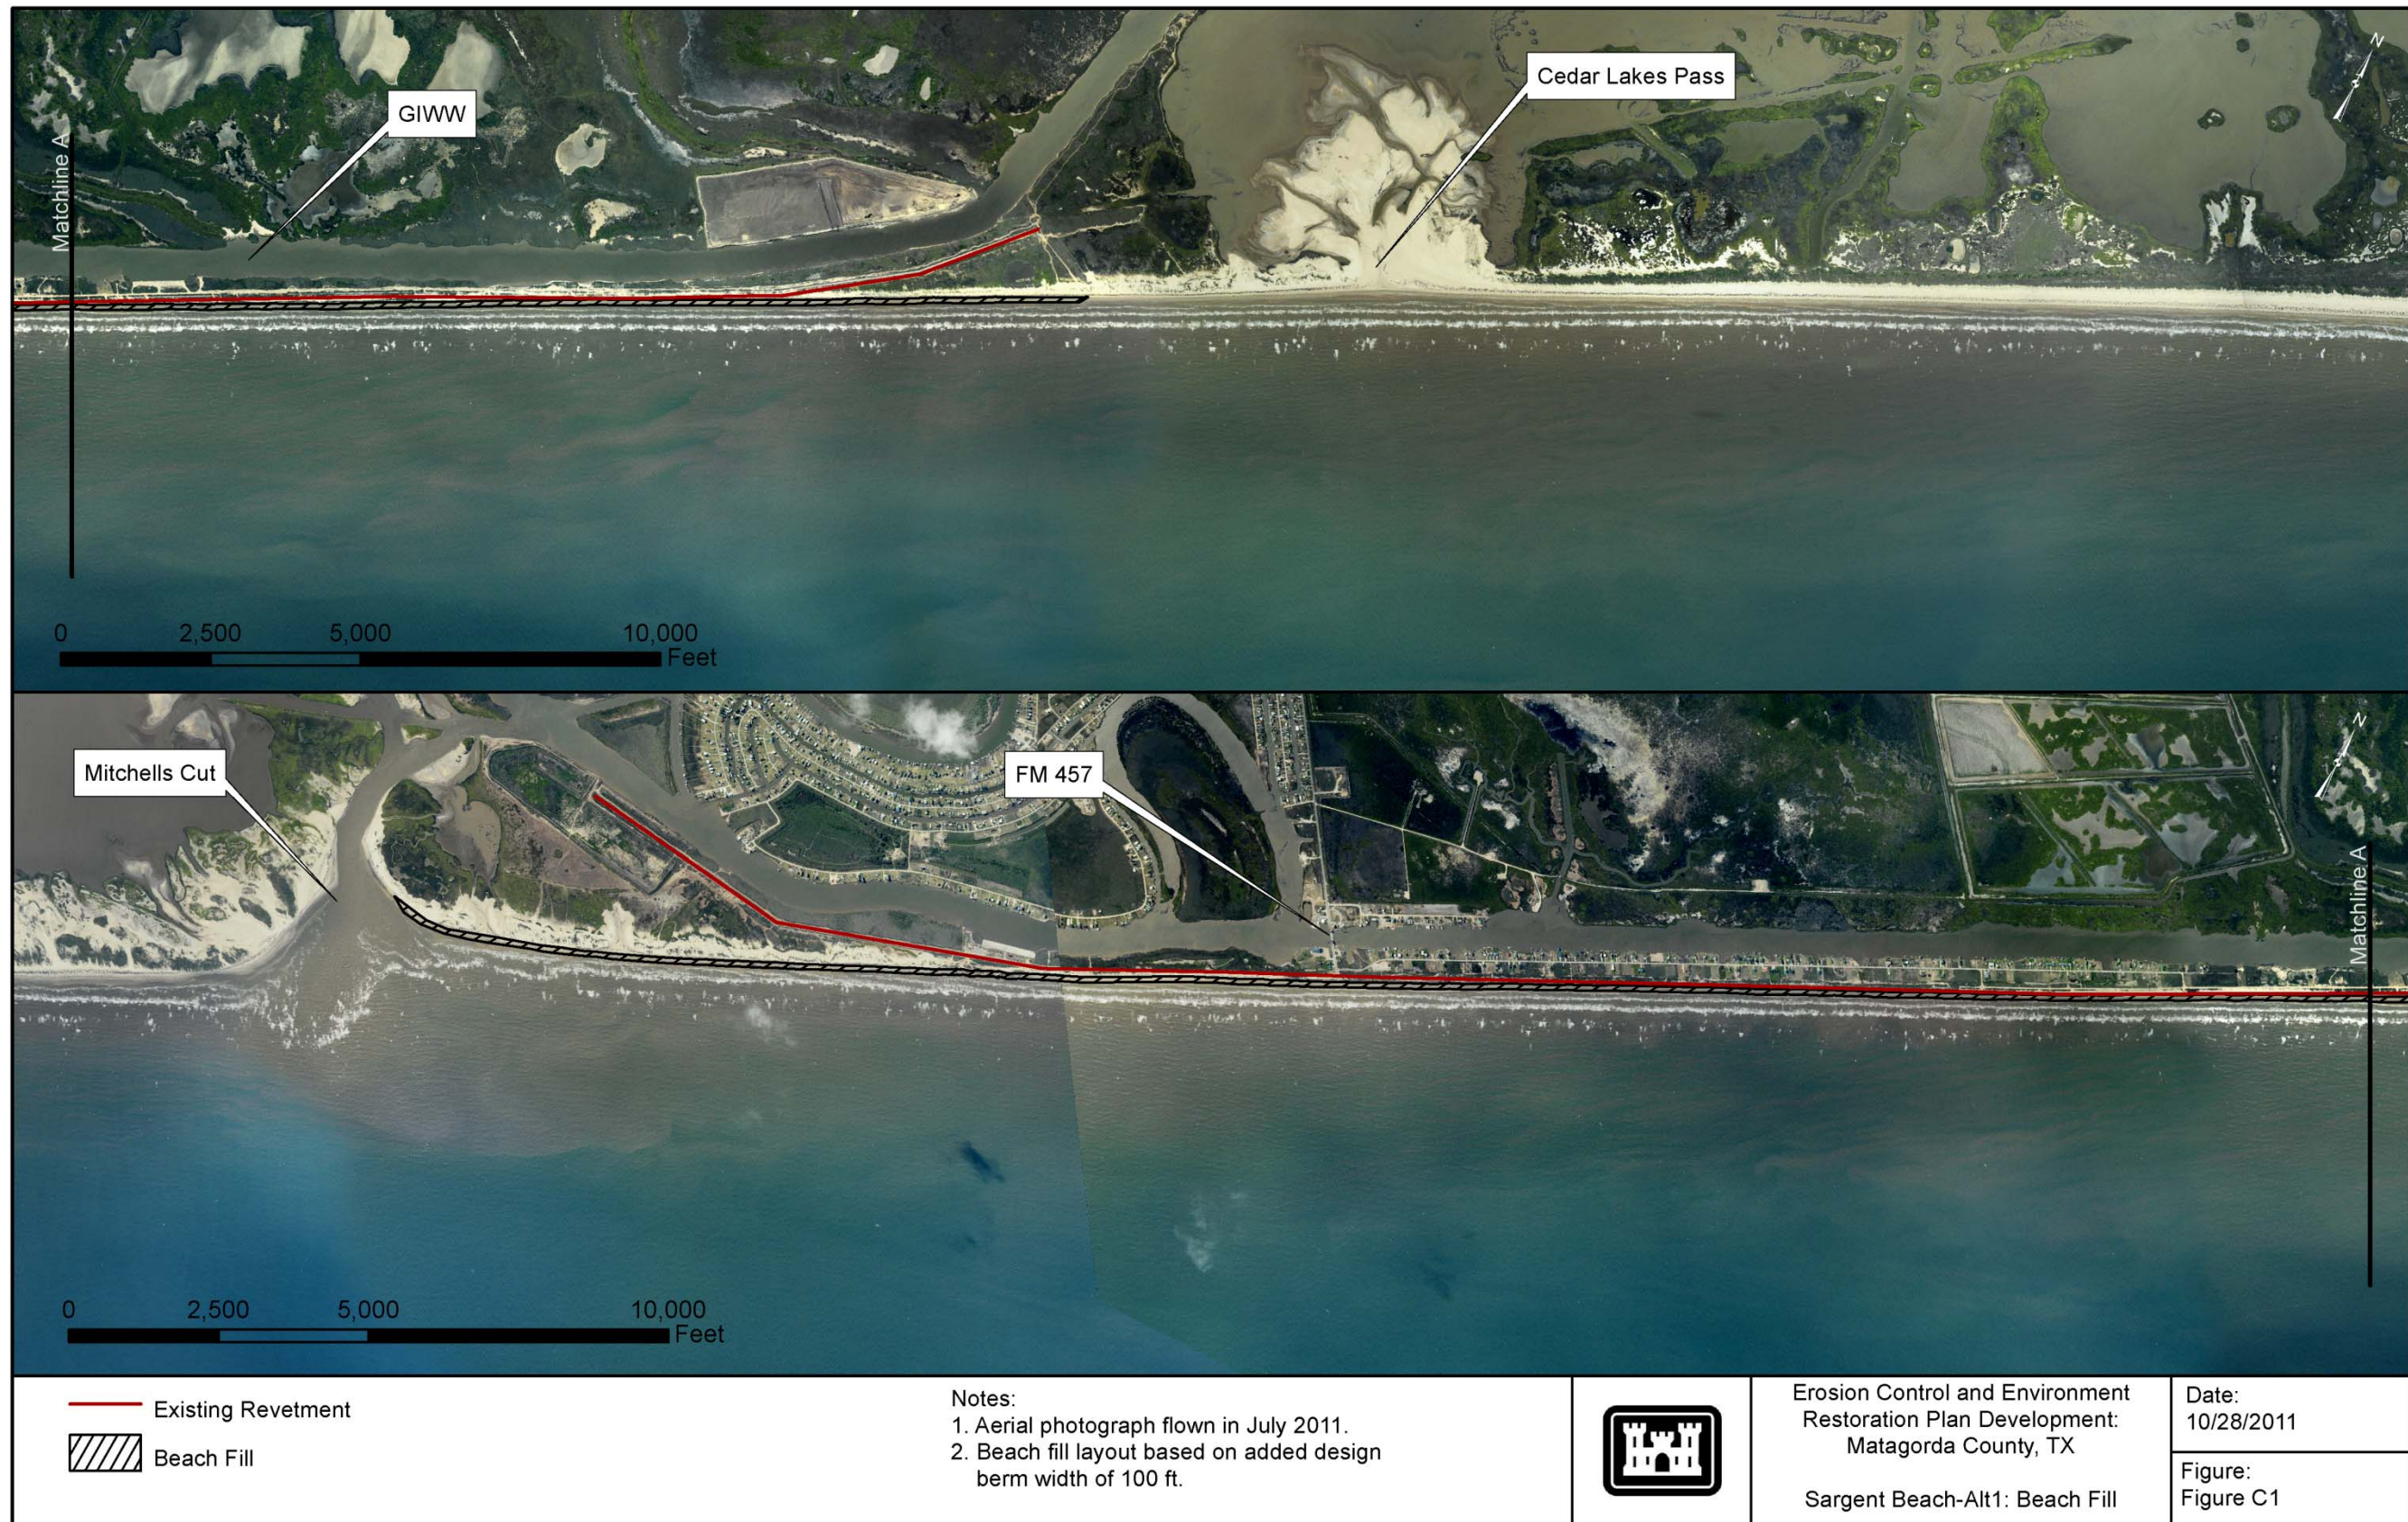
Figure C1. Erosion control and environmental restoration plan development, Matagorda County, TX – Sargent Beach-Alt 1: Beach fill.
