Erosion Control and Environment Restoration Plan Development, Matagorda County, Texas

Phase 1: Preliminary Investigation

Robert Thomas and Lauren Dunkin

July 2012

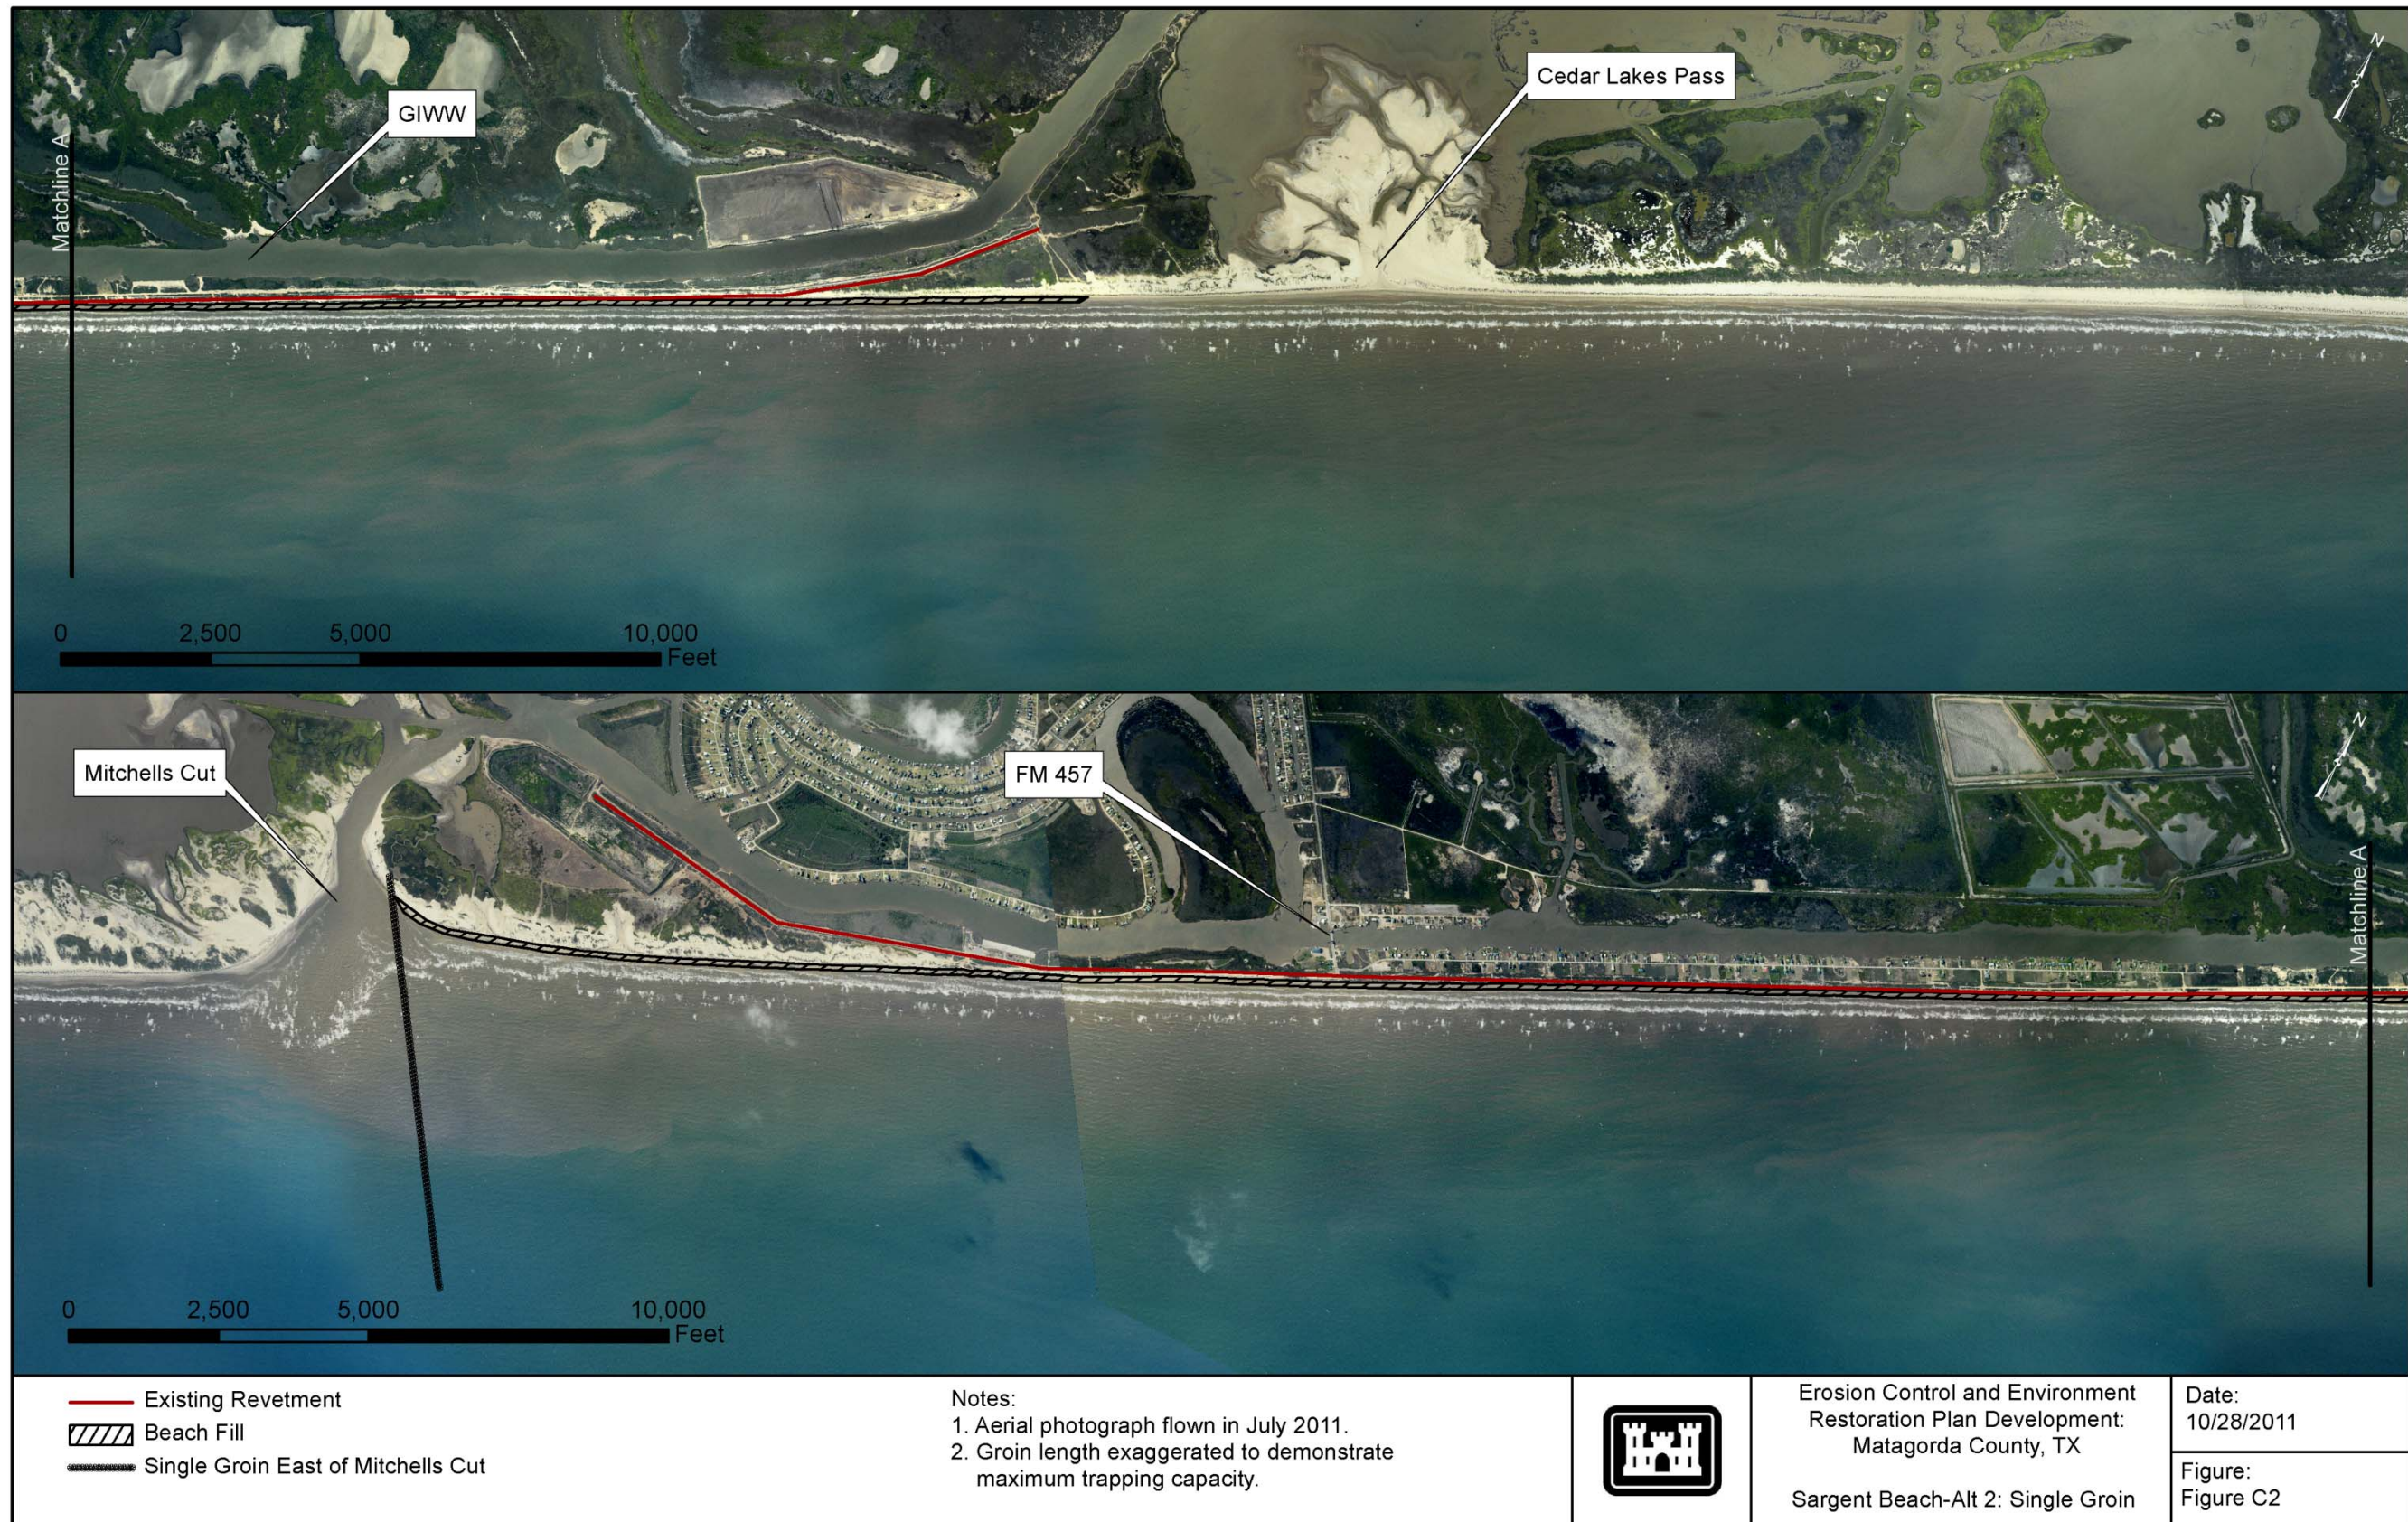
Figure C2. Erosion control and environmental restoration plan development, Matagorda County, TX – Sargent Beach-Alt 2: Beach fill.

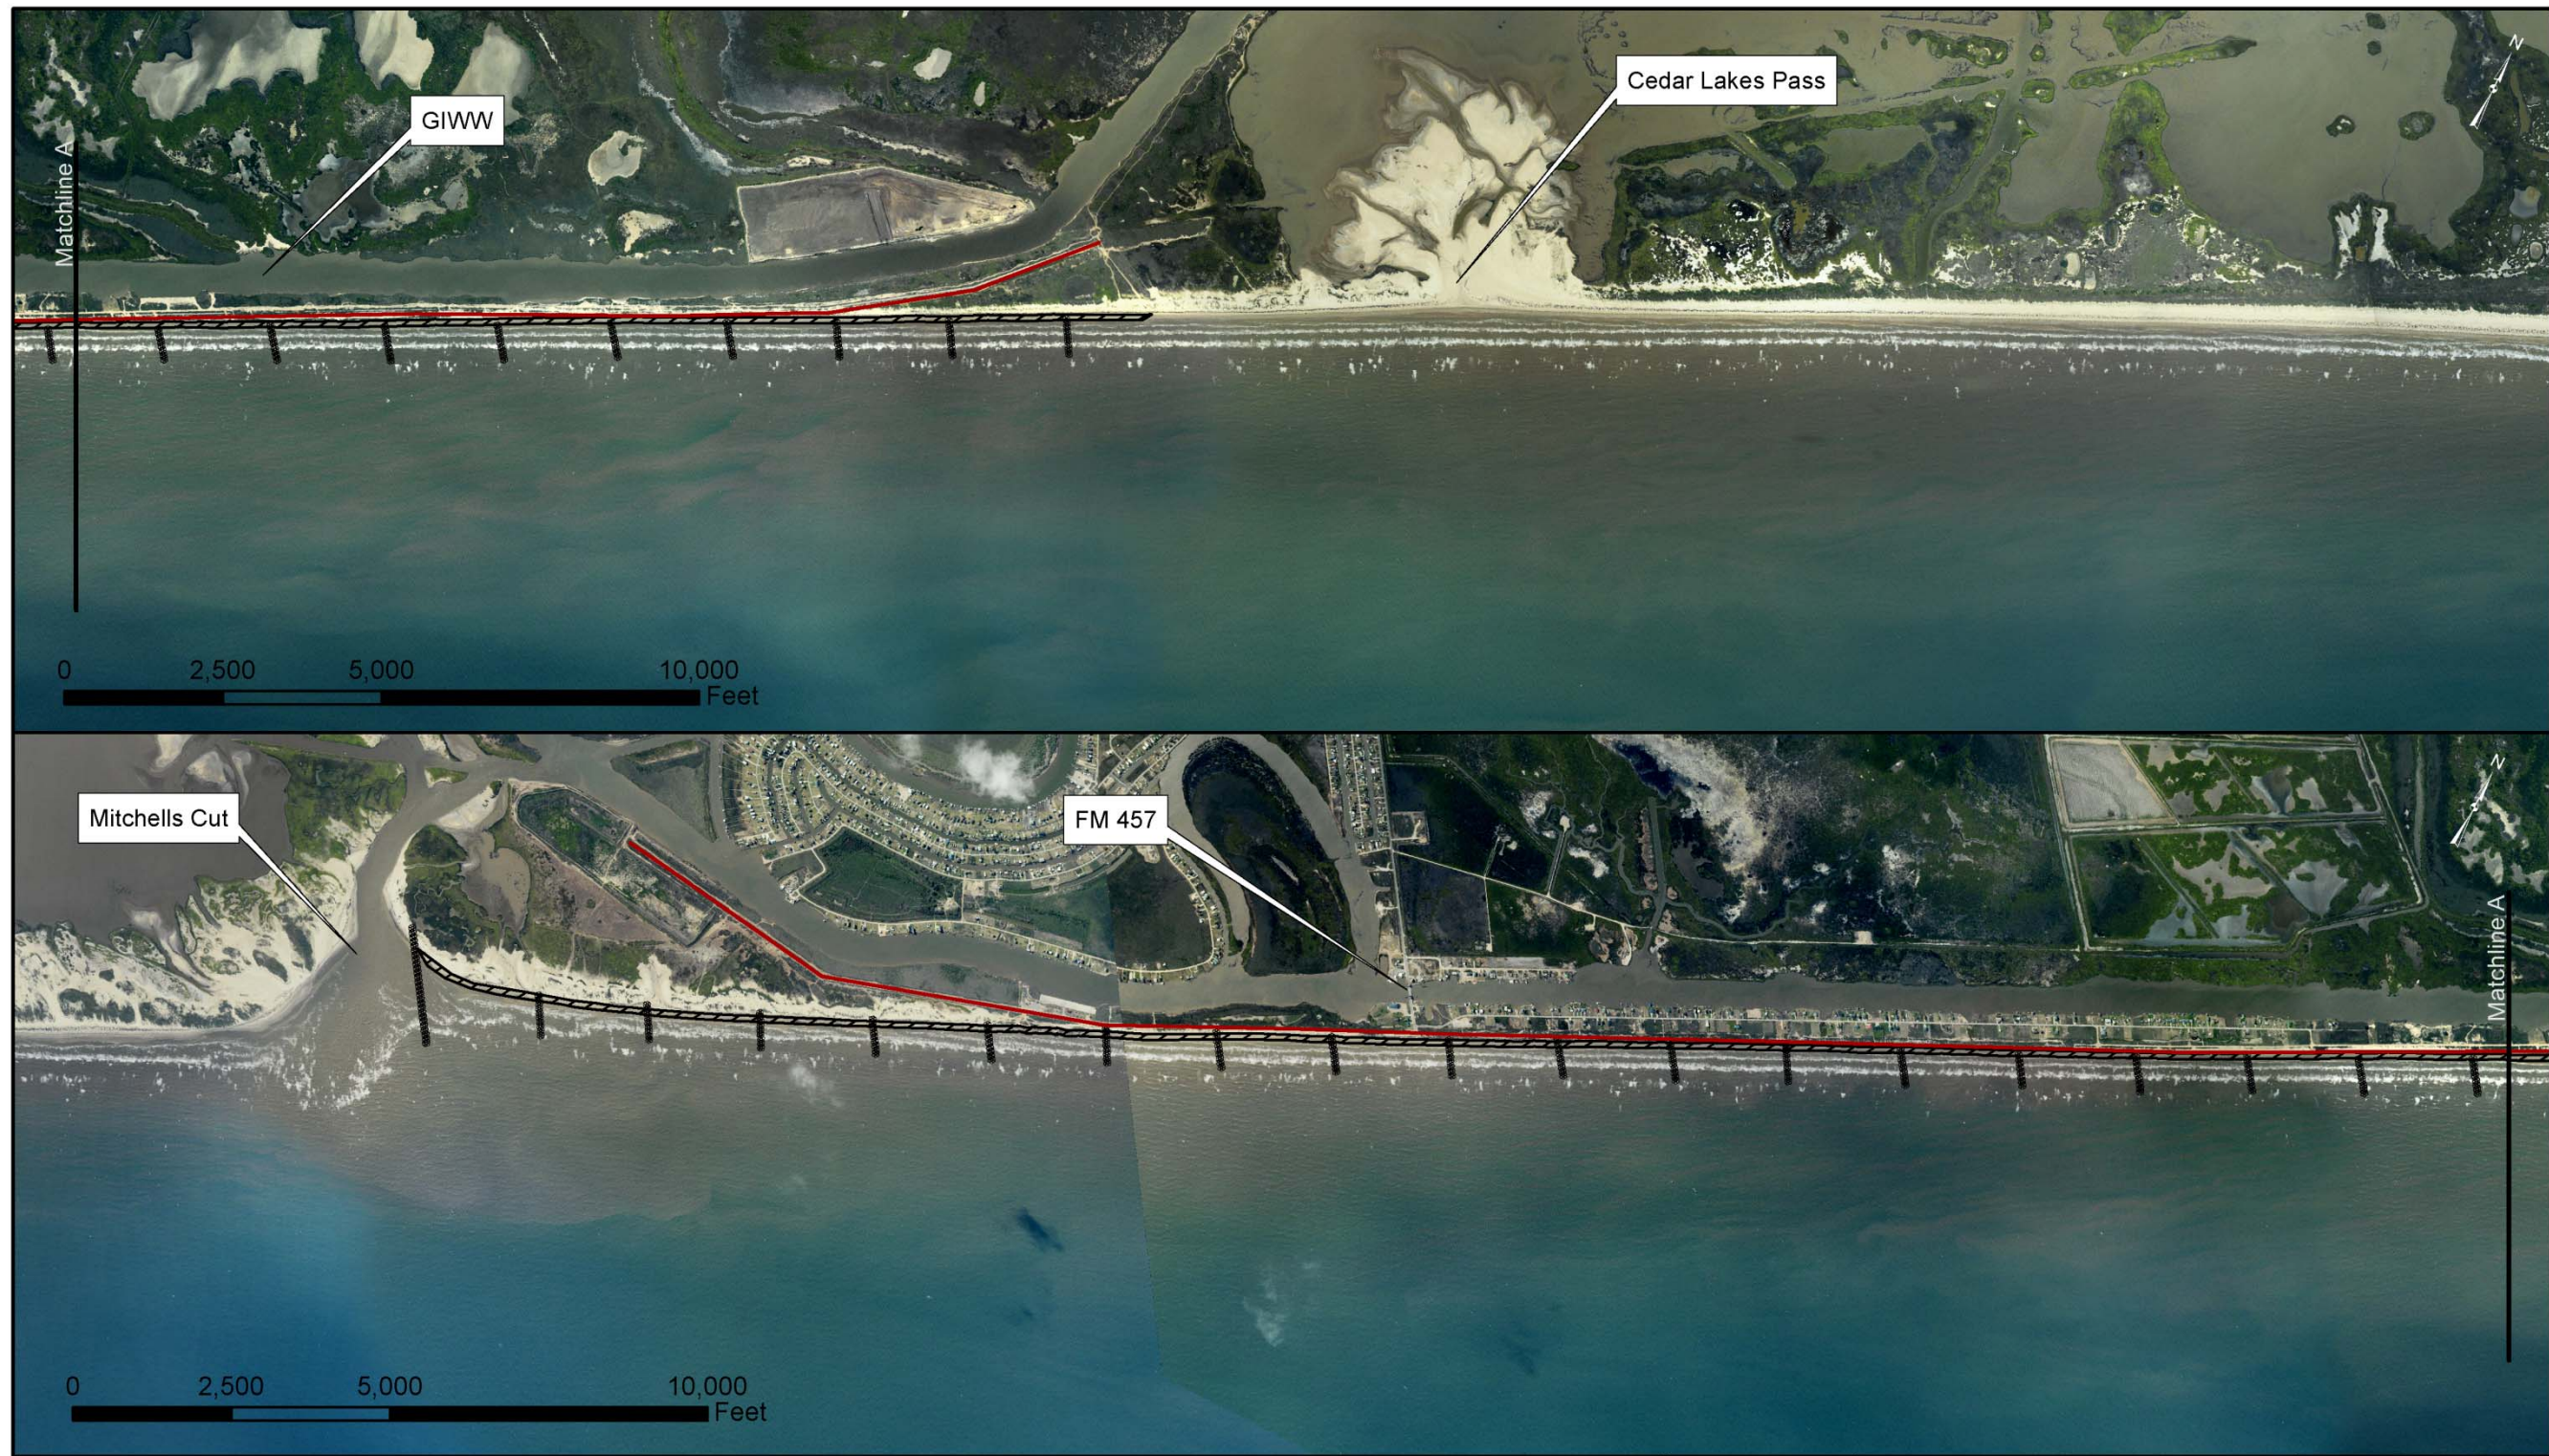
Figure C3. Erosion control and environmental restoration plan development, Matagorda County, TX – Sargent Beach-Alt 3: Groin field.

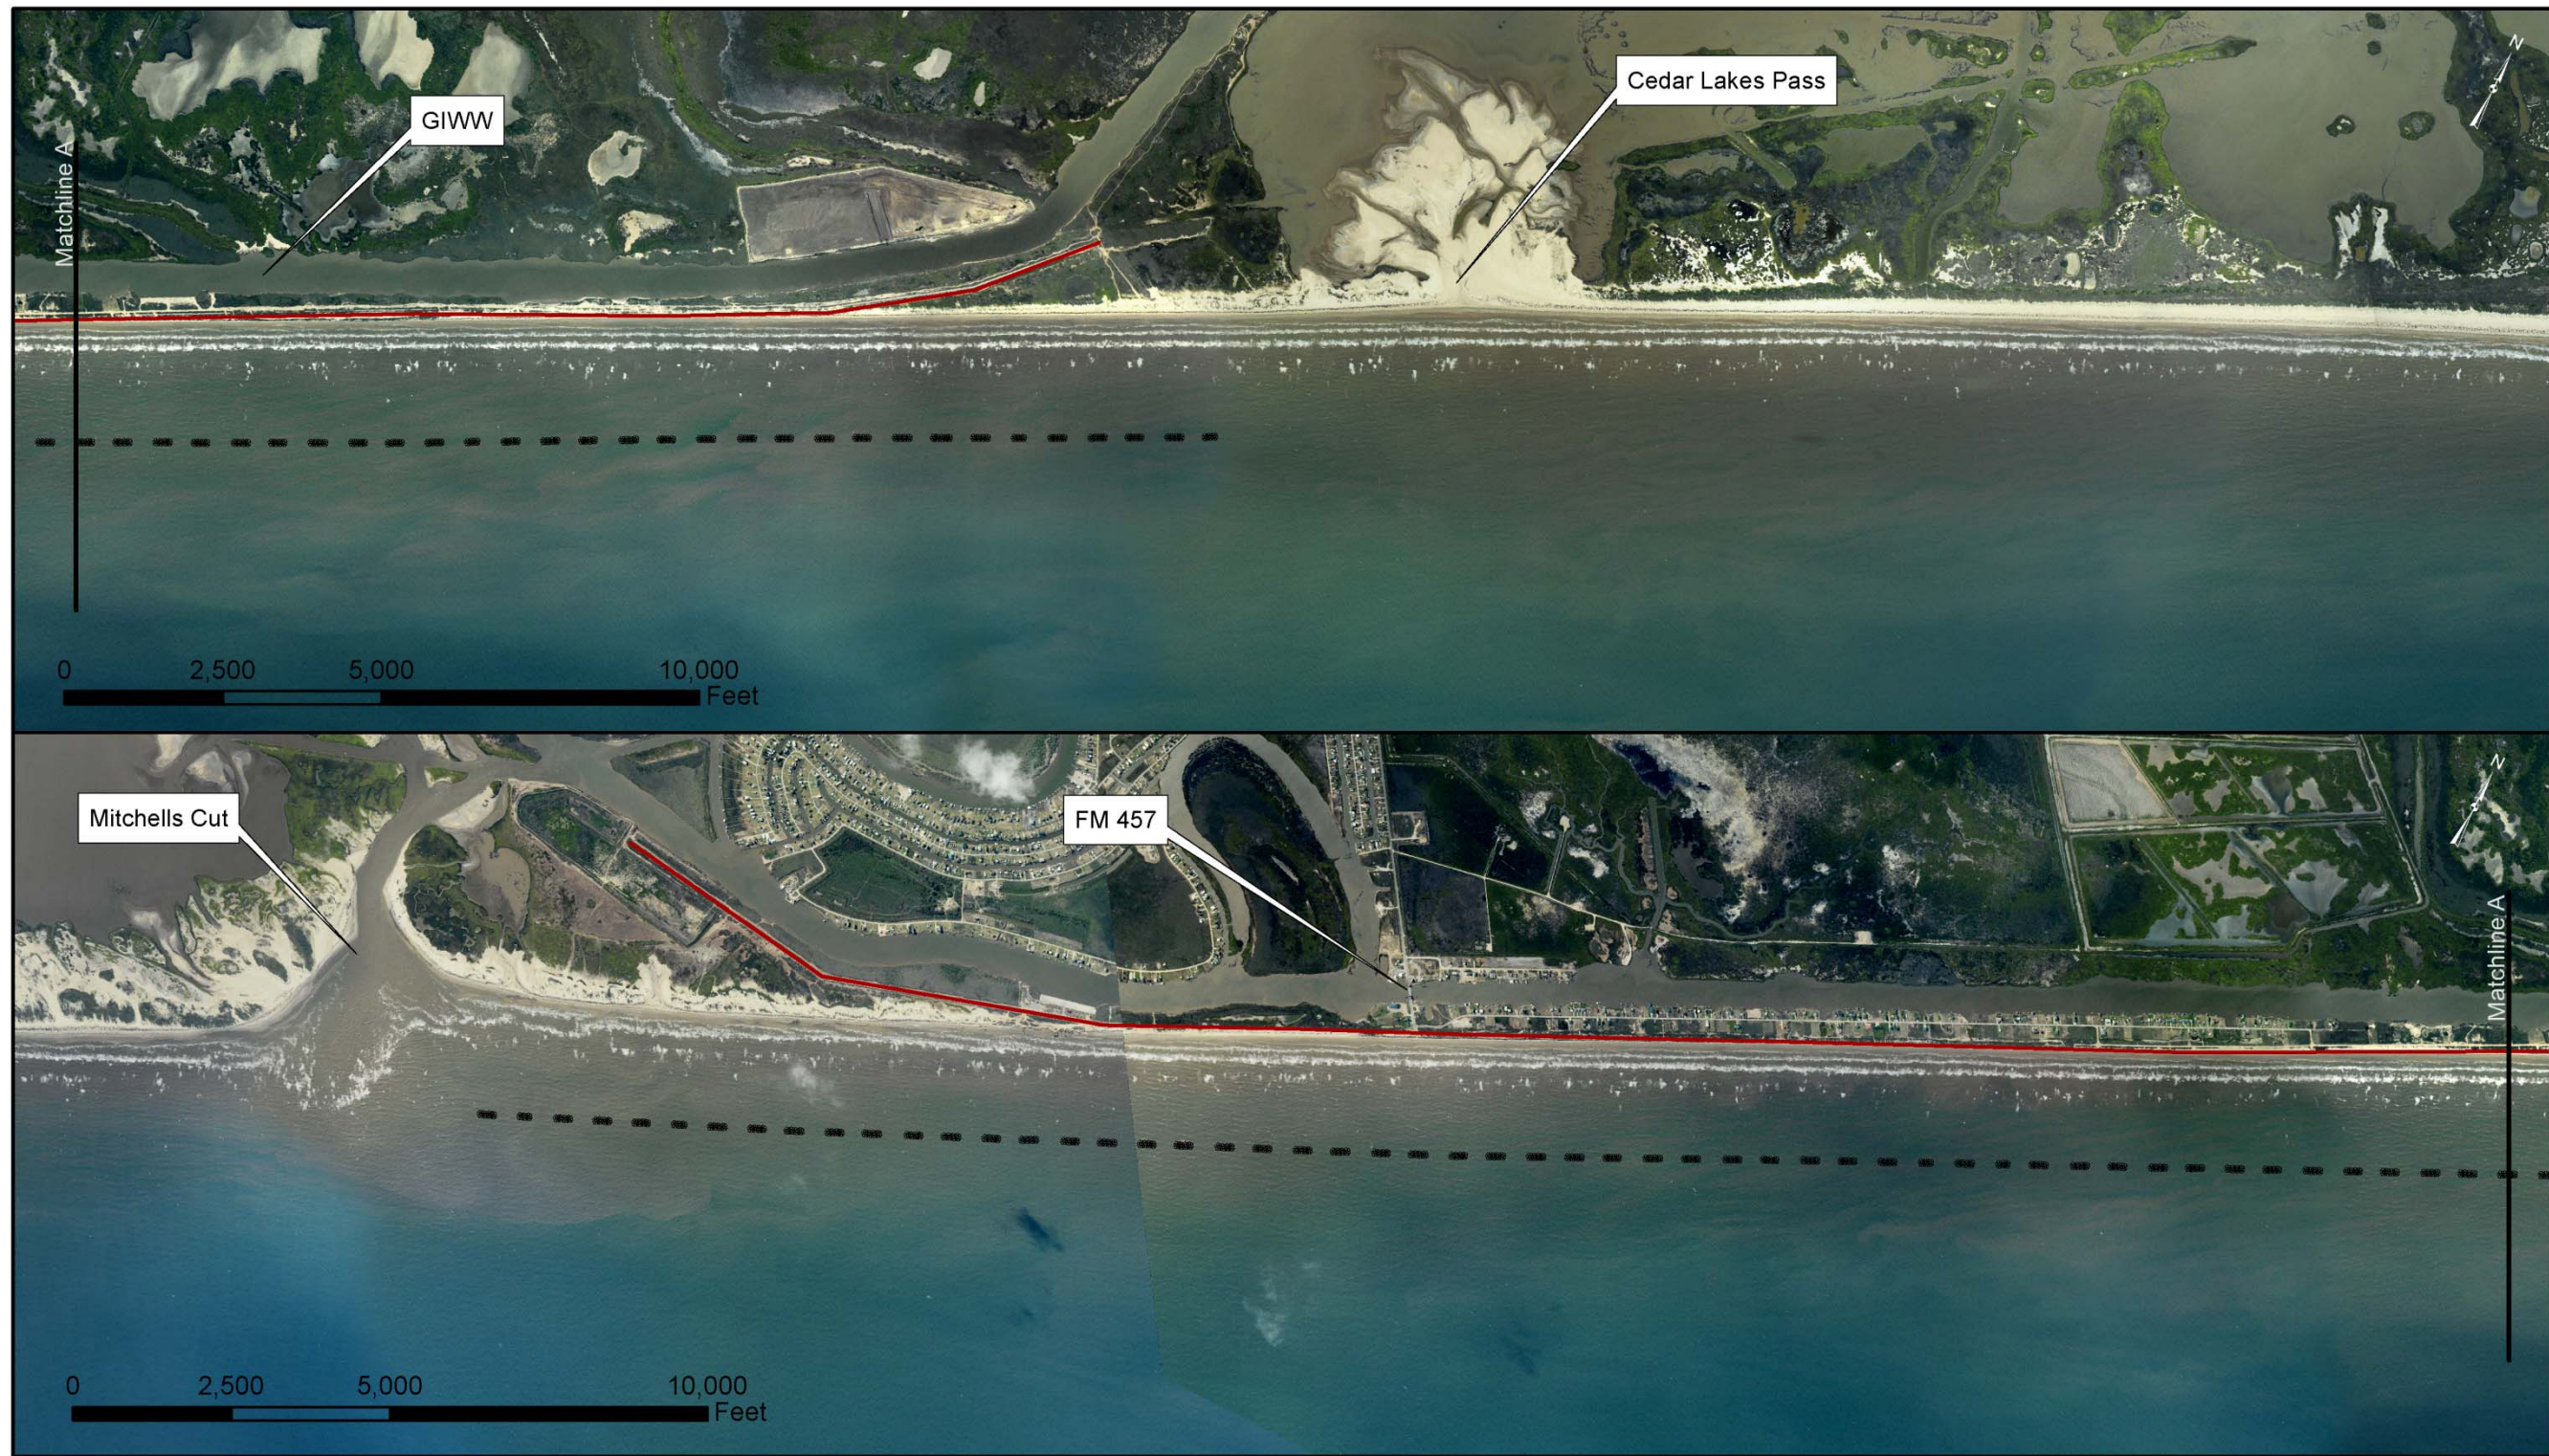
Figure C4. Erosion control and environmental restoration plan development, Matagorda County, TX – Sargent Beach-Alt 4: Breakwaters.
