ESTCP Cost and Performance Report

Application of a Solvent Emulsion Technology for PCB Removal from Older Structures on DoD Facilities

November 2011

Project: RC-200610

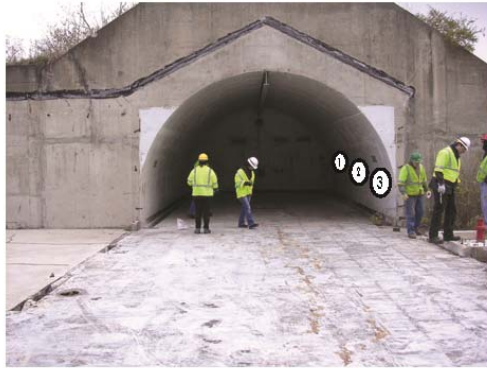
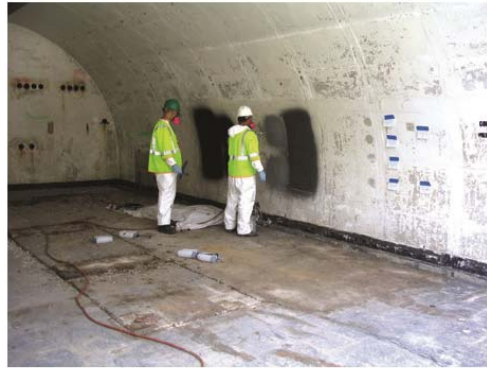
Bunker/Press House 6810-11 BTS Paste Application		Figure 5.2
Guelph	February 2010

① 68 10-11
Mg/Pd
VP

Figure 4. Bunker/Press house 6810-11.

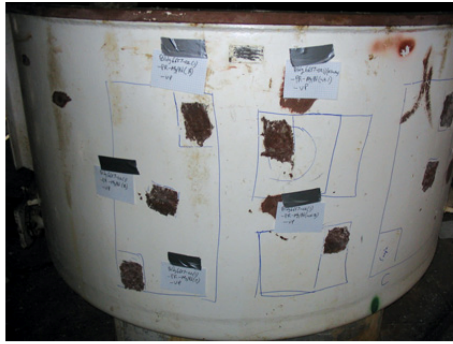
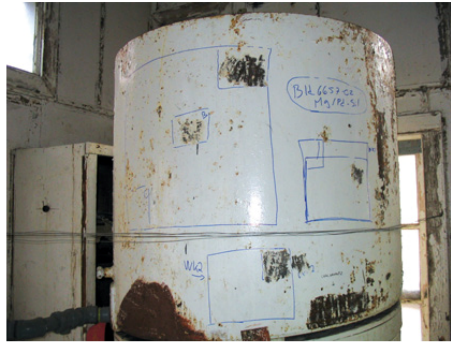
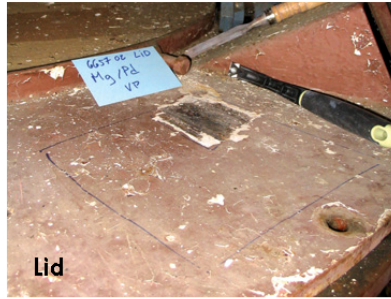
Nitrating House 6657-02 BTS Paste Application		Figure 5.4
Guelph	February 2010

Large Tank
Mg/PD and NM-VP

Small Tank
Mg/Pd Sil

Figure 6. Nitrating house 6657-02.

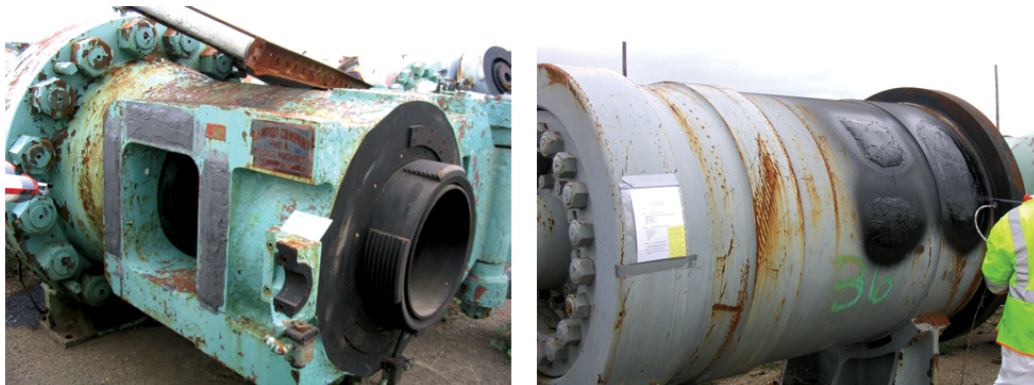
BTS Paste Applied to Presses BTS Paste Application		Figure 5.5
Guelph	February 2010

BTS Paste applied to various spots on press #4, 12, 14, 15, 36

Figure 7. BTS paste applied to presses.
