**US Army Corps
of Engineers®**
Engineer Research and
Development Center

ROOFER Inventory Procedures and Inspection Manual for Metal Panel Roofing

December 2012

Final report

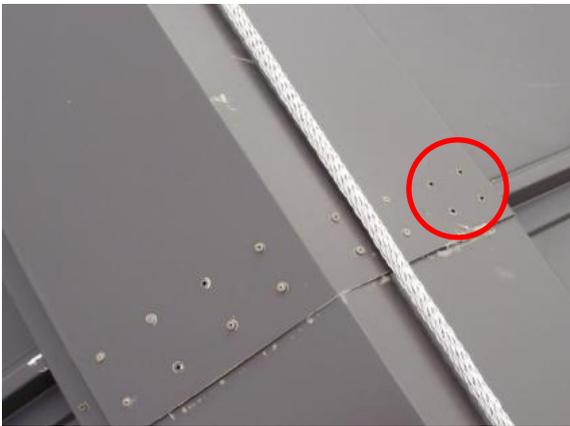
FF-H-1: Fastener or flexible gasket (where one was originally installed) is loose, deteriorated or missing and is allowing water to penetrate the roofing system; or fastener has an enlarged hole that is allowing water to penetrate the roofing system.

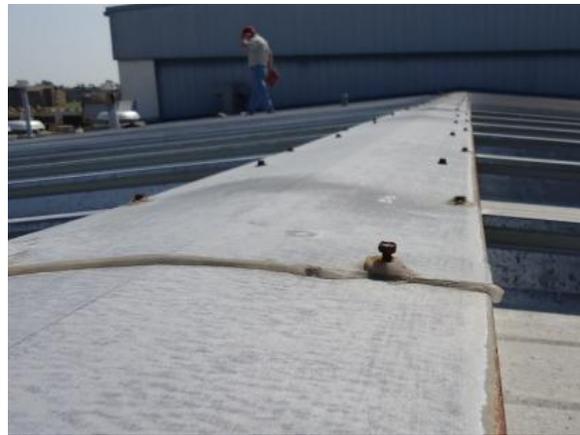
FF-H-1: Fastener or flexible gasket (where one was originally installed) is loose, deteriorated or missing and is allowing water to penetrate the roofing system; or fastener has an enlarged hole that is allowing water to penetrate the roofing system.

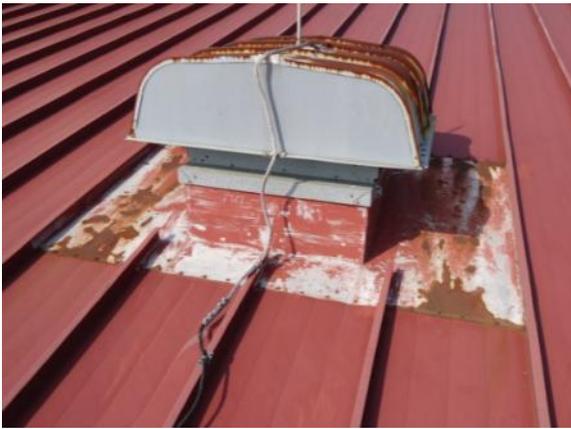
FD-M-1: Flashing has localized loss of applied finish or localized metal corrosion.

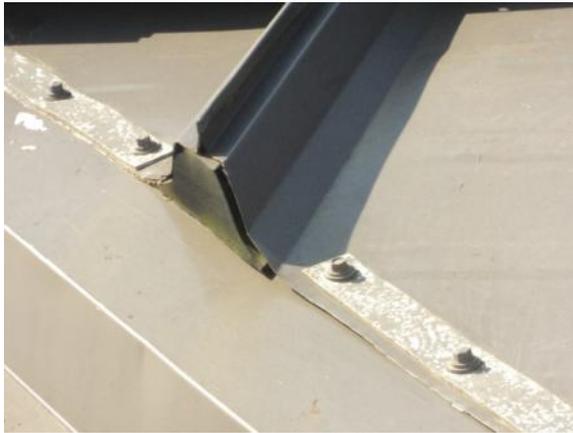
PC-M-1: Panel closure is misaligned but appears to be watertight.

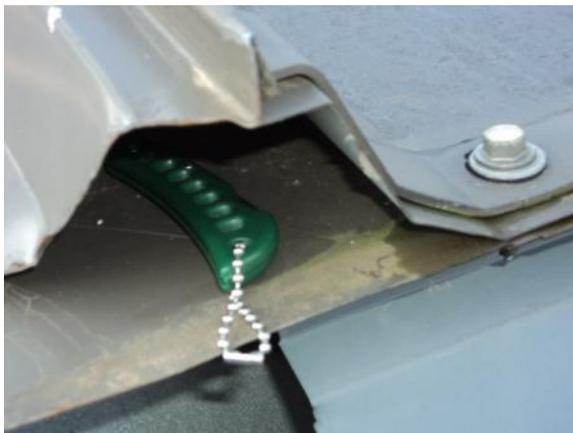
PC-H-1: Non-metal panel closure is deformed, misaligned, damaged or missing; allowing water to penetrate the roofing system.

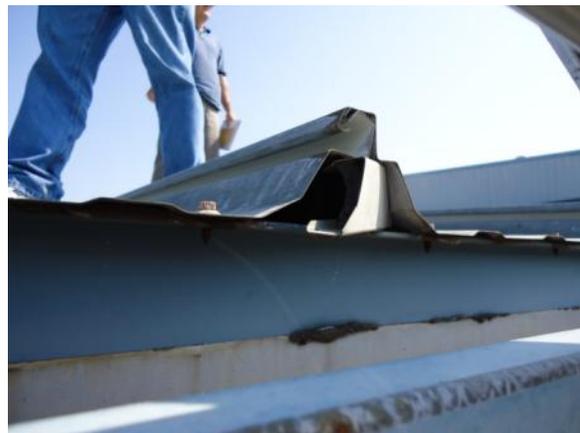
PC-H-1: Non-metal panel closure is deformed, misaligned, damaged or missing; allowing water to penetrate the roofing system.

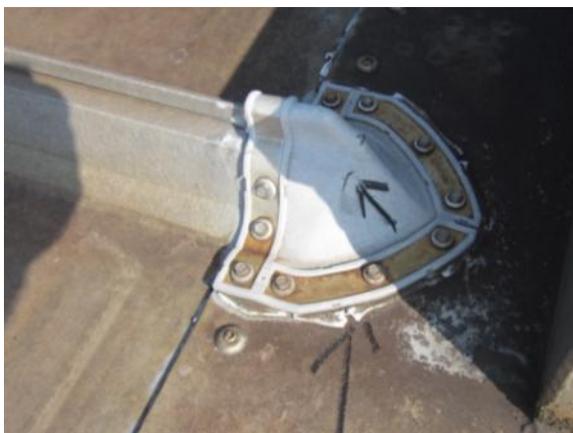
PC-H-2: Metal panel closure is deformed, misaligned, or missing; allowing water to penetrate the system.

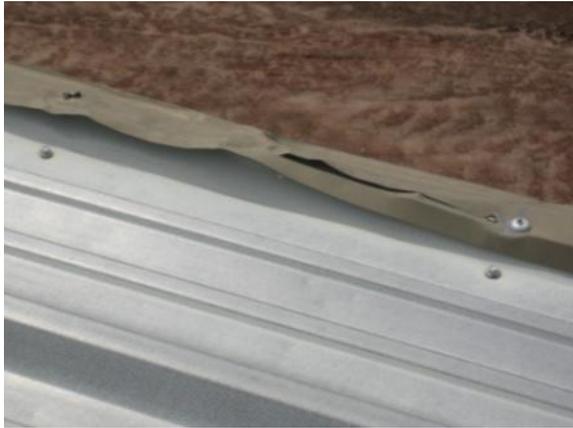
RE-H-1: Rake flashing has holes.

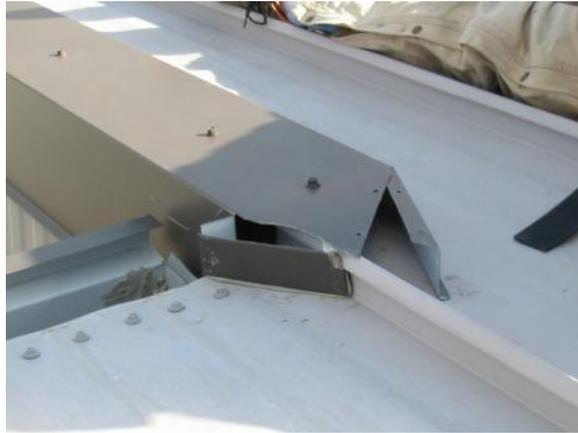
RE-H-2: Rake flashing is loose, displaced, or missing, allowing water to penetrate the roofing system and/or compromising panel securement.

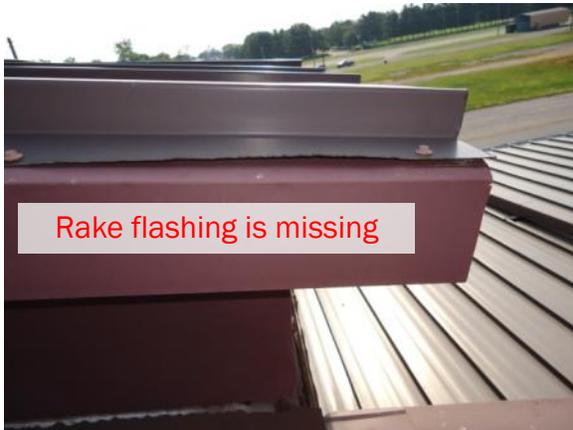
RE-H-2: Rake flashing is loose, displaced or missing, allowing water to penetrate the roofing system and/or compromising panel securement.

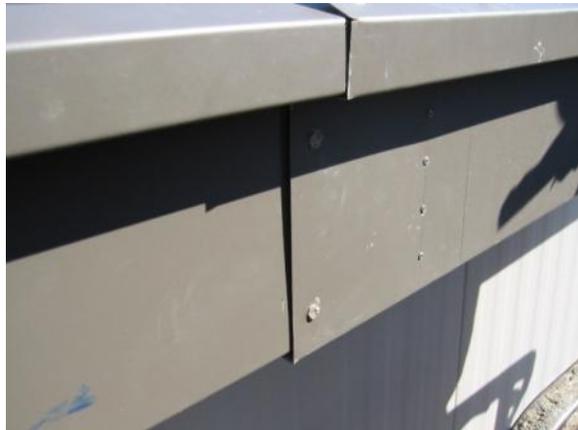
RE-H-4: Rake flashing has open joint or butt joints.

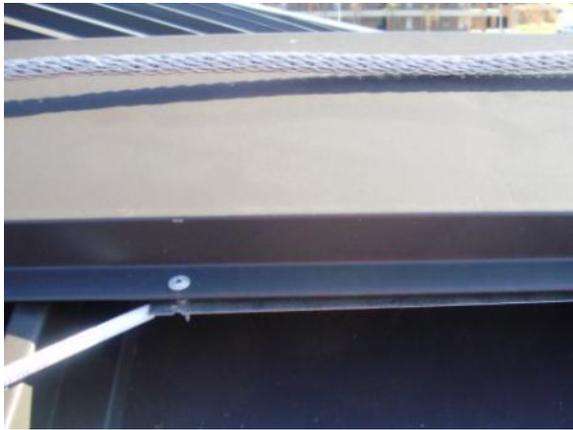
CP-M-1: Ridge or hip cap flashing is disengaged but appears to be watertight.

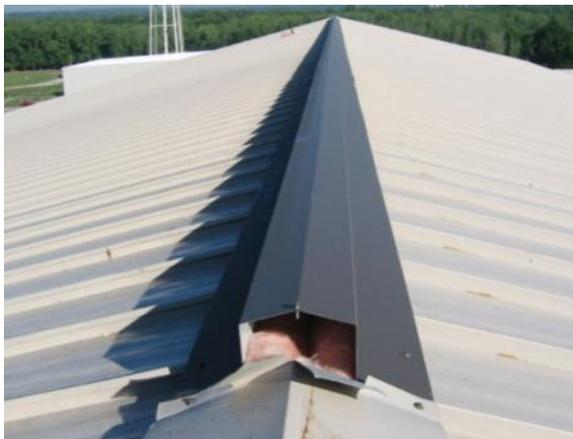
CP-H-3: Ridge or hip cap flashing is missing.

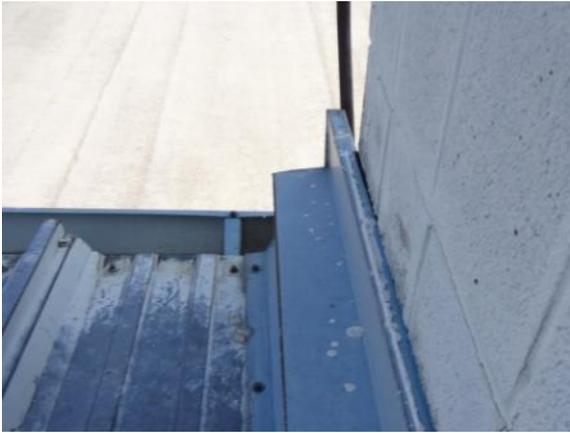
ST-H-2: Transition flashing is disengaged or loose and is allowing water to penetrate the roofing system.

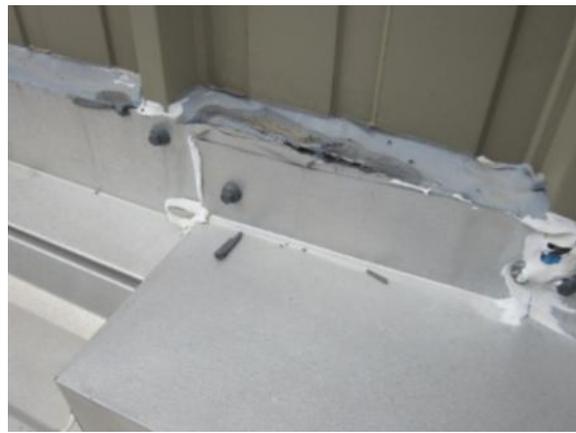
ST-H-3: Transition flashing has open joints or butt joints, or joints that are bucking water.

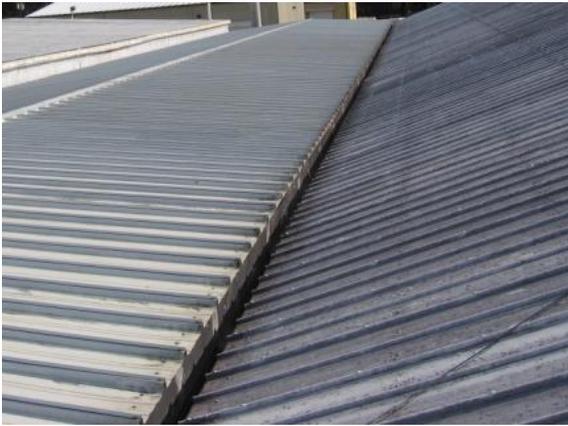
IG-L-1: Interior gutter is lined with elastomeric membrane or coating and appears to be watertight.

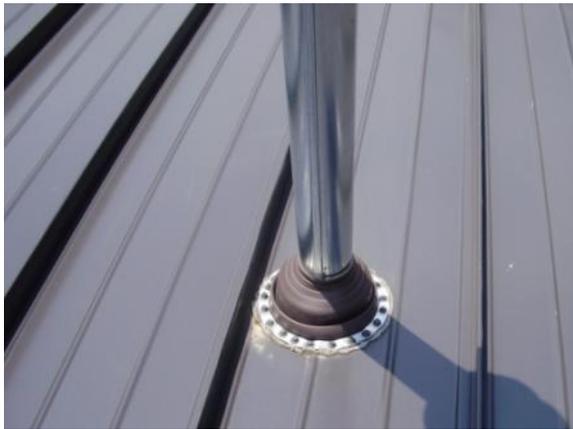
FB-L-1: Flexible boot flashings are rated low-severity as a minimum due to inherent maintenance problems.

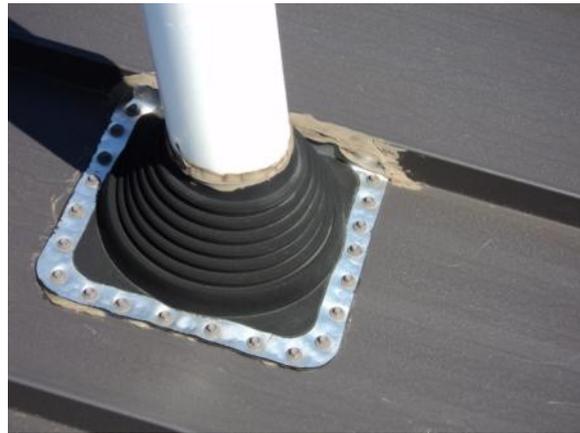
FB-M-1: Flexible boot flashing has loose, missing, corroded or misaligned draw band.

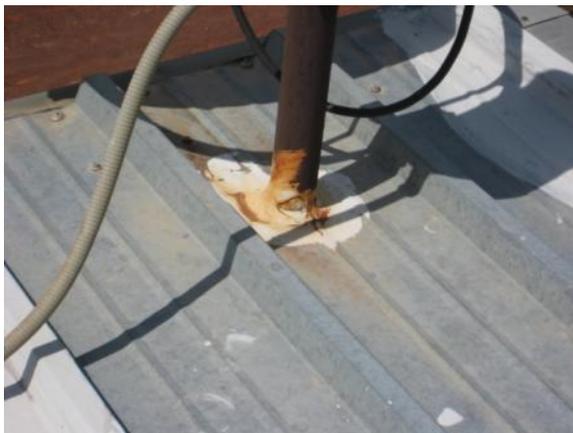
FB-H-1: Flexible boot is missing or has holes; or flexible boot flashing interferes with a panel seam and is allowing water to penetrate the system.

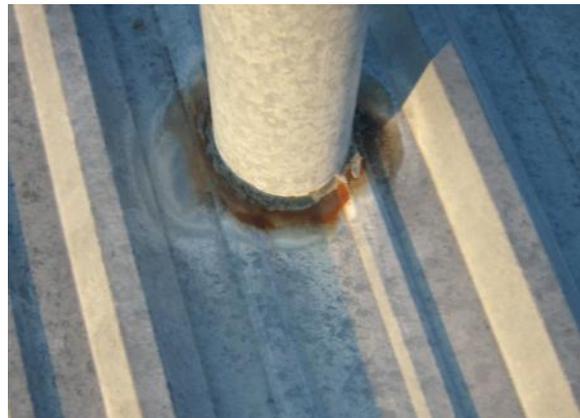
FB-H-1: Flexible boot is missing or has holes; or flexible boot flashing interferes with a panel seam and is allowing water to penetrate the system.

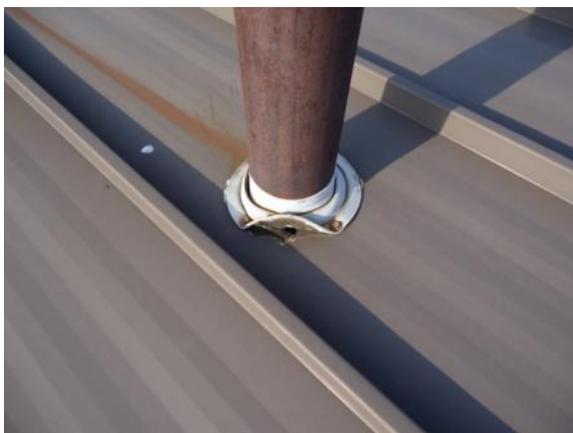
FB-H-2: Flexible boot flashing has deformed securement ring, allowing water to penetrate the roofing system.

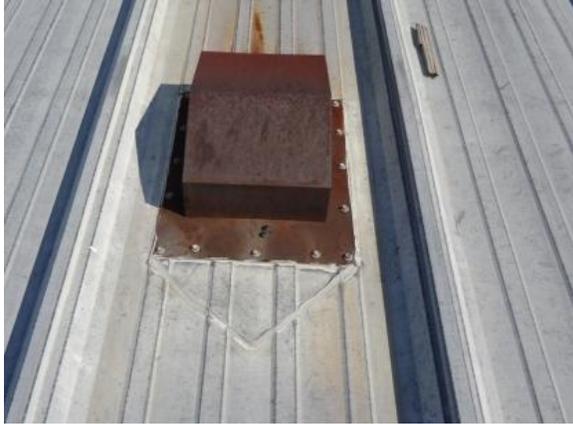
FM-M-1: Flashing flange on upslope side is mounted on top of panel, bucking water, but appears to be water-tight.

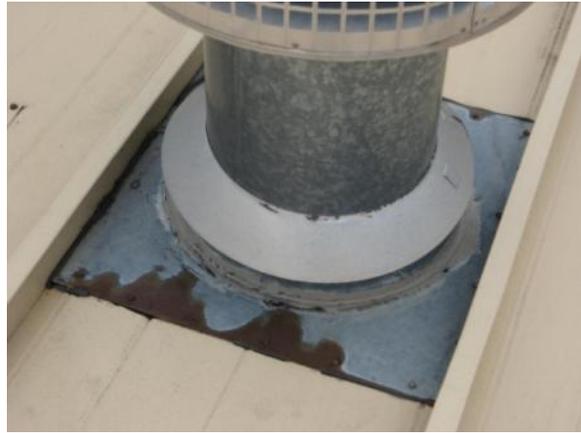
FM-H-9: Sealant around umbrella is missing or is allowing water to penetrate the roofing system.

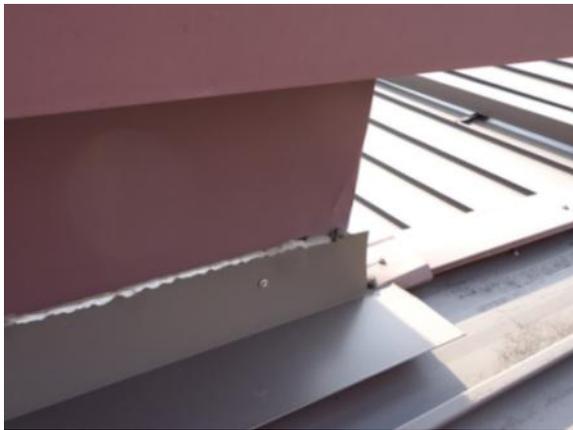
AF-H-6: Sealant at reglet, top of counterflashing, or sealed joint is missing or no longer functioning.

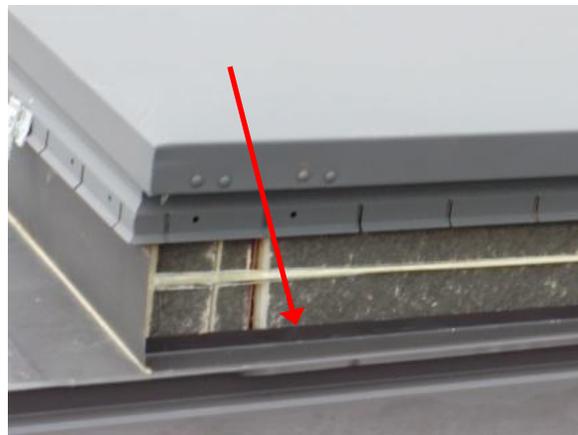
AF-H-9: Top of transition flashing is not properly counterflashed or terminated.

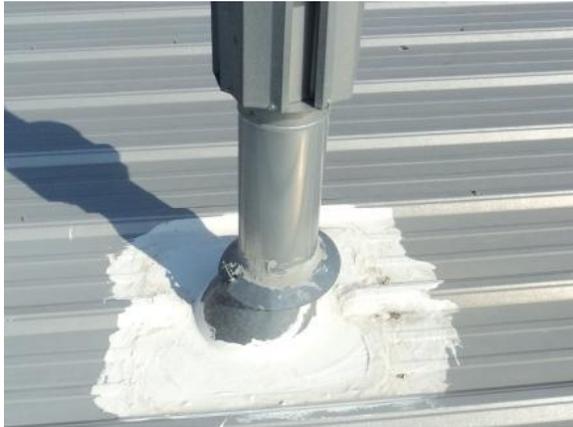
FR-L-1: Flashing patch appears to be performing a waterproofing function and appears to be watertight and does not require a more permanent repair.

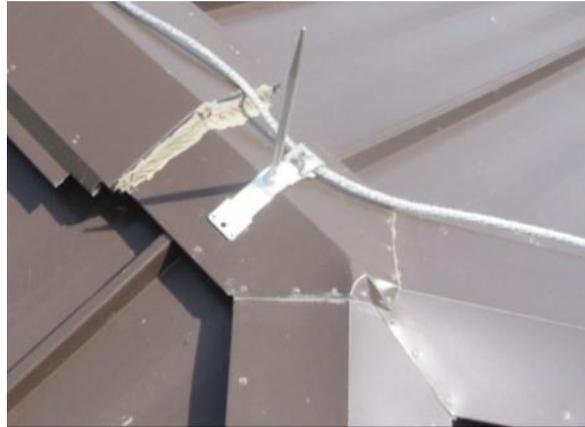
FR-M-1: Flashing patch, which appears to be performing a waterproofing function, appears to be watertight but requires a more permanent repair.

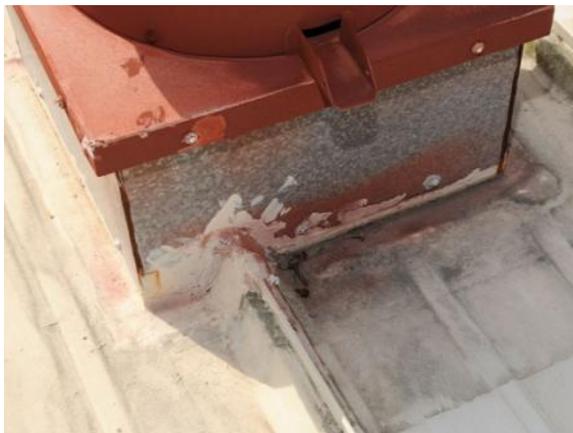
FR-M-1: Flashing patch, which appears to be performing a waterproofing function, appears to be watertight but requires a more permanent repair.

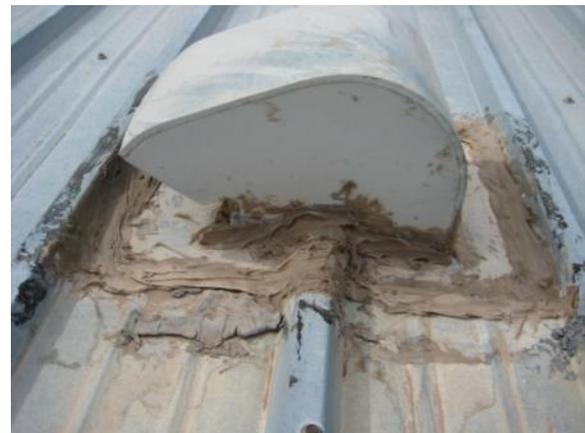
FR-M-1: Flashing patch, which appears to be performing a waterproofing function, appears to be watertight but requires a more permanent repair.

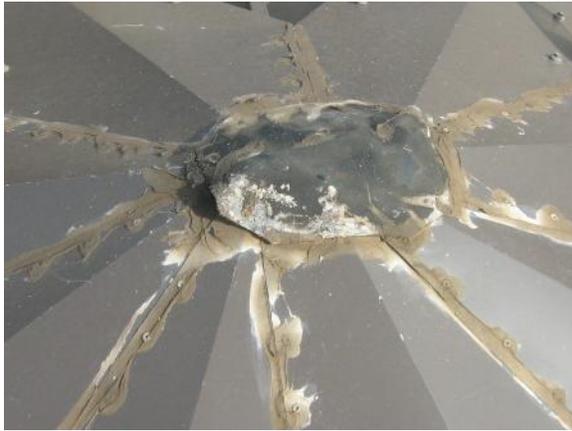
FR-H-1: Flashing patch is allowing water to penetrate the roofing system.

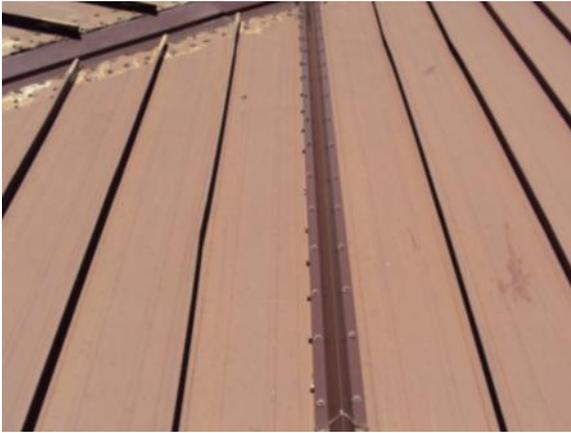
SW-L-1: Applied finish exhibits chalking, fading, or scratching over the entire roof section, but underlying corrosion is not apparent.

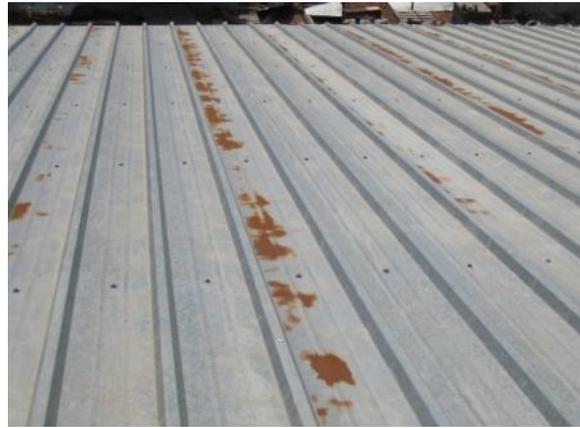
SW-M-1: Base metal or applied finish exhibits chalking, fading, or scratching over the entire roof section, requiring a coating or surface treatment repair.

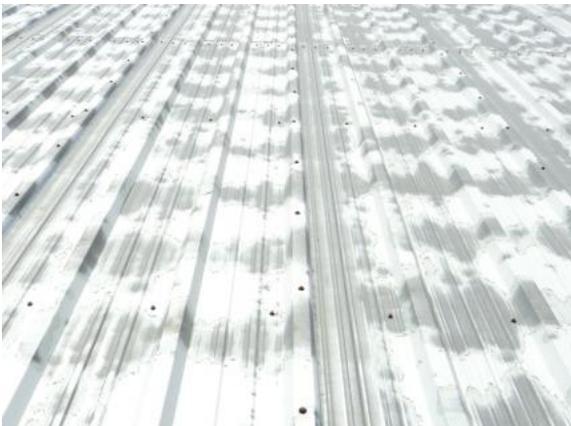
SW-M-1: Base metal or applied finish exhibits chalking, fading, or scratching over the entire roof section, requiring a coating or surface treatment repair.

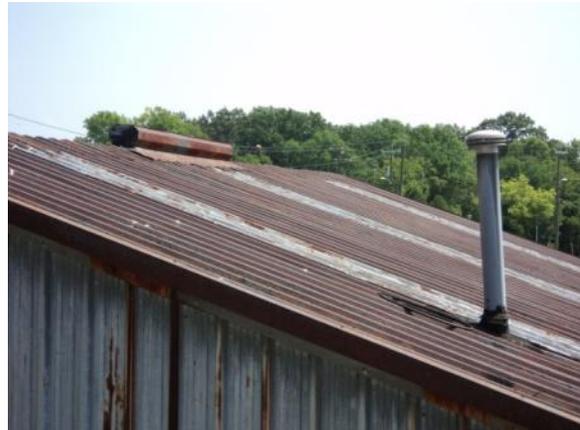
SW-H-1: Base metal exhibits corrosion over the entire roof section requiring a roof replacement.

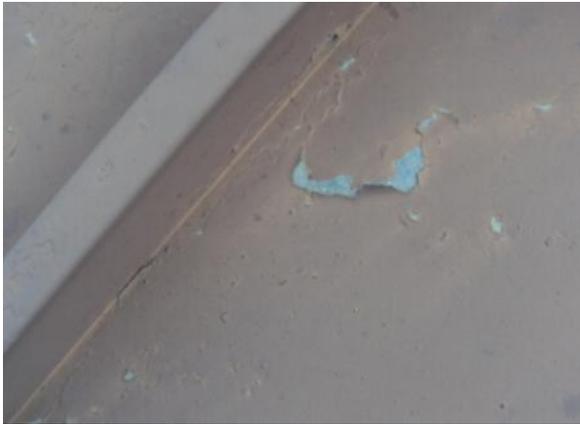
SD-M-1: Localized loss of applied finish or localized metal corrosion.

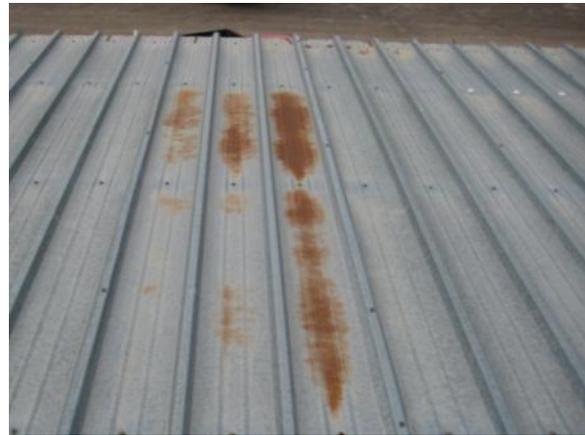
SD-M-1: Localized loss of applied finish or localized metal corrosion.

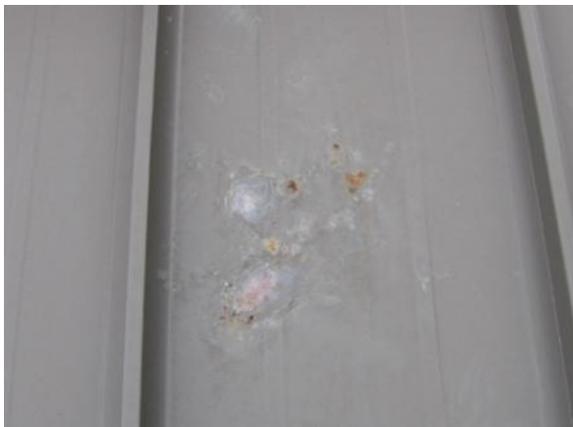
SD-H-1: For panel system that has mechanically interlocked seams, panel has corrosion holes that require localized repair .

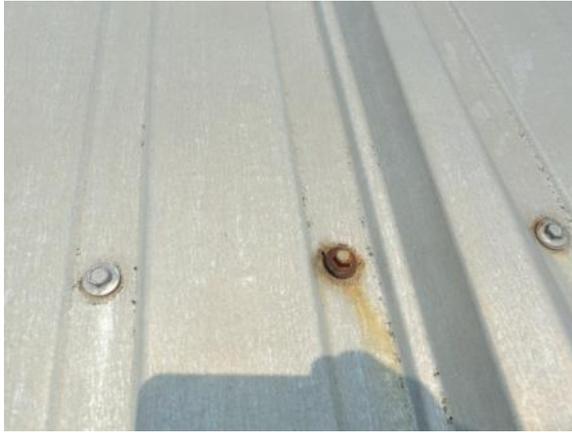
PF-M-1: Fastener has no flexible gasket (where one was originally installed) or has a flexible gasket that is deteriorating but appears to be watertight; or fastener is corroded, improperly seated, or has a sealant repair but appears to be watertight.

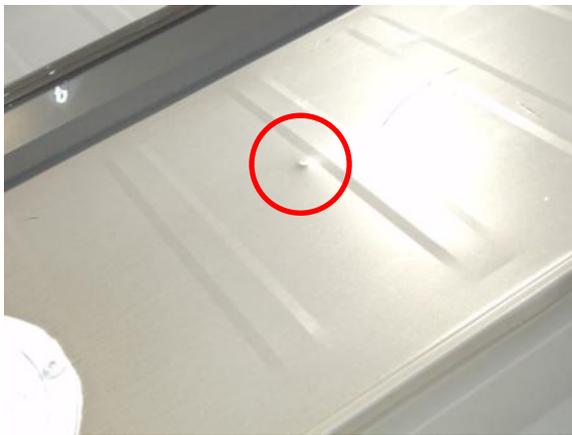
DP-L-1: Panel is dented, deformed, or kinked with no deformation of the seam, no loss of coating, and no corrosion; and appears to be watertight.

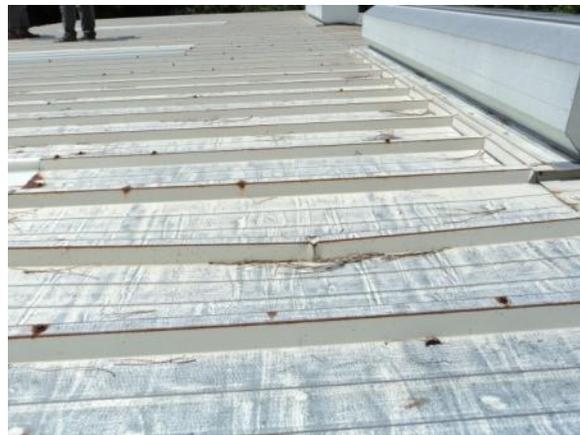
DP-M-1: Panel is dented, deformed or kinked, allowing ponding water and/or corrosion.

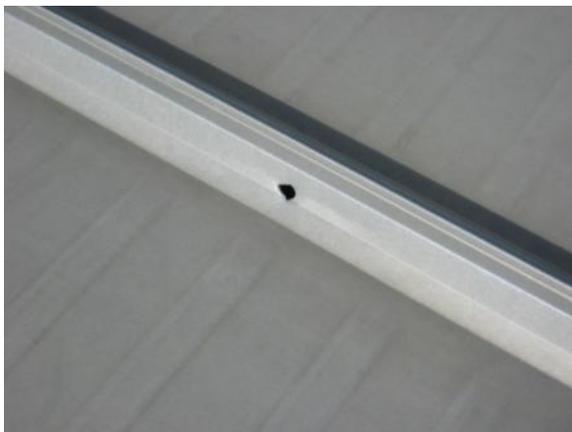
DP-H-1: For panel system that has mechanically interlocked seams, panel has holes, splits, or tears that require localized repairs.

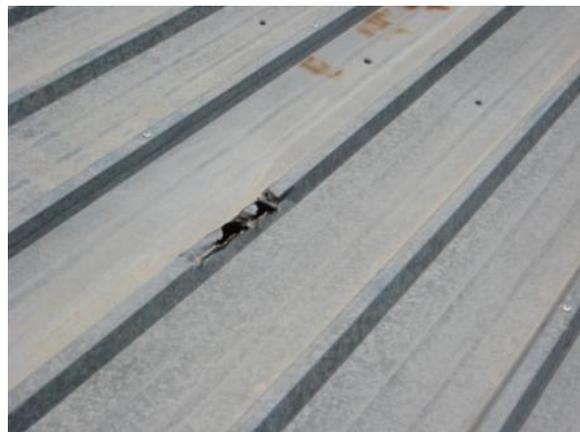
DP-H-2: For panel system that does not have mechanically interlocked seams; panel has holes, splits, or tears that require panel replacement.

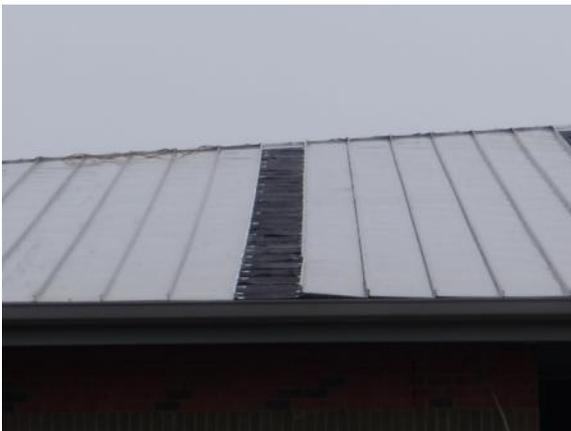
DL-H-2: Panel is missing and requires replacement.

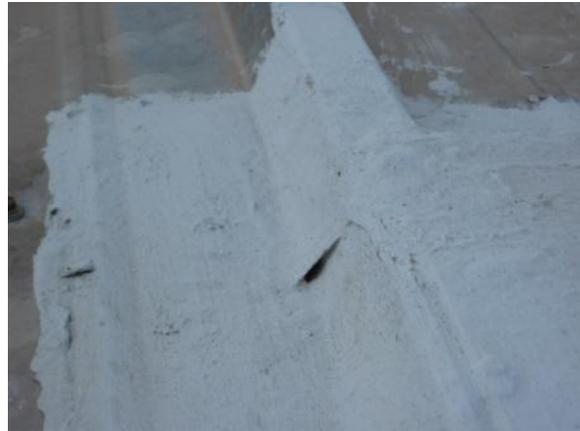
PA-H-1: Panel patch is allowing water to penetrate the roofing system.

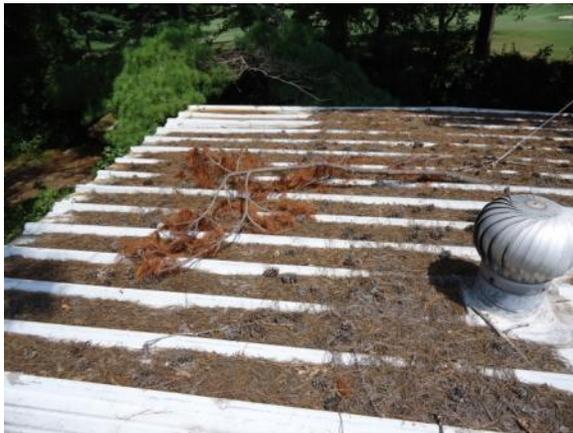
DV-M-1: A collection of foreign objects or vegetation not removed from the roof during the inspection; or grease, solvent, or oil drippings on the roof that cause no degradation of the panel's applied finish.

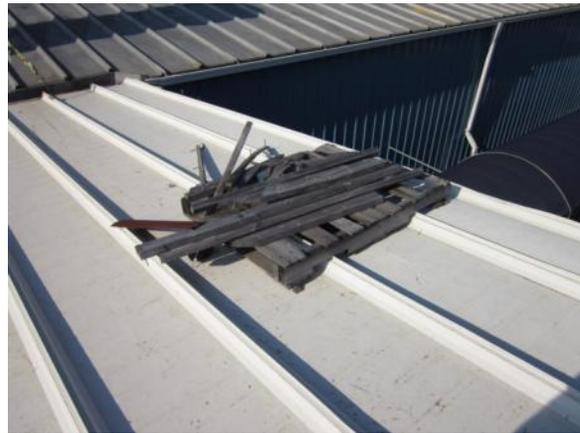
DV-M-1: A collection of foreign objects or vegetation not removed from the roof during the inspection; or grease, solvent, or oil drippings on the roof that cause no degradation of the panel's applied finish.

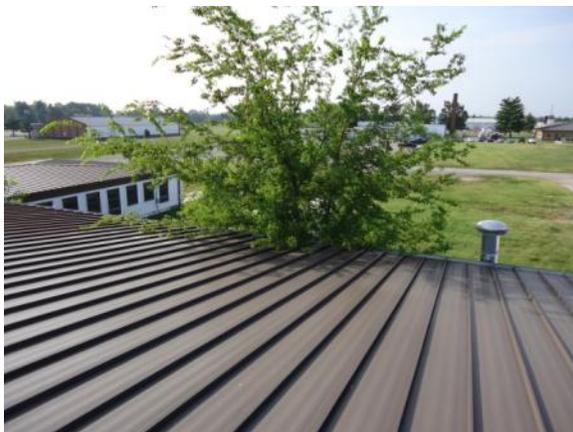
DV-M-2: Evidence of tree branches making contact with the roofing system.

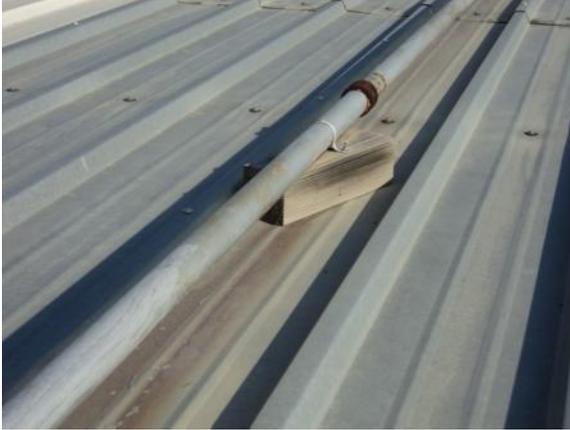
EQ-L-1: All improper equipment supports are rated low severity as a minimum due to the maintenance problems associated with them.

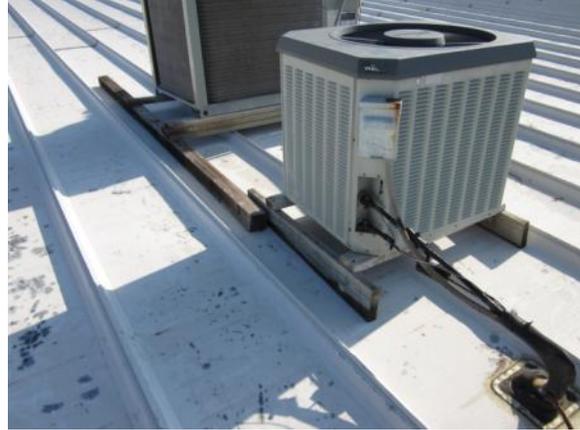
EQ-L-1: All improper equipment supports are rated low severity as a minimum due to the maintenance problems associated with them.

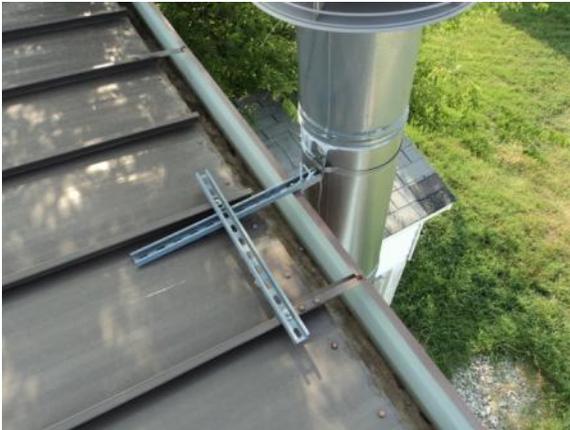
EQ-H-1: The equipment support is bolted or fastened through the metal panel seams or flashing and allowing water to penetrate the roofing system.

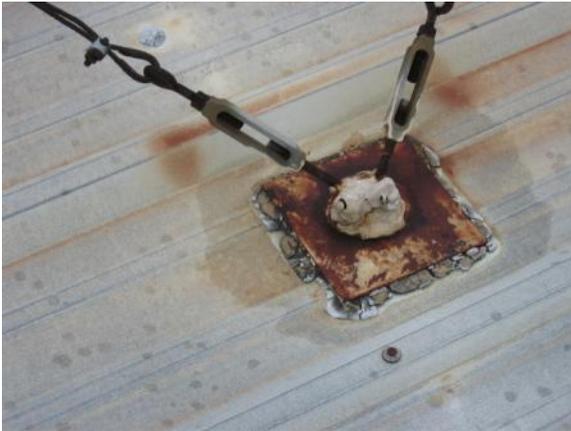
EQ-H-2: The equipment support has caused damage to surrounding panels and is allowing water to penetrate the roofing system.

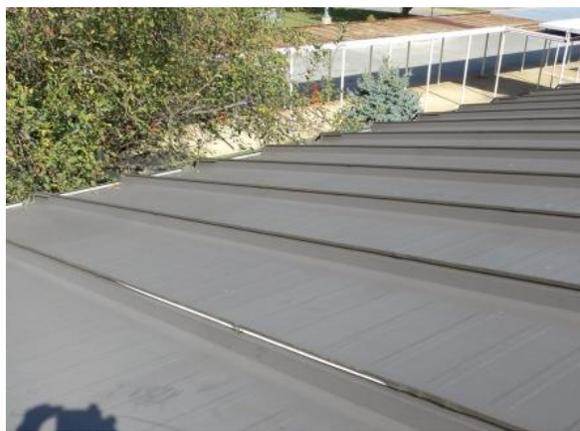
MS-H-1: Seam is open or allowing water to penetrate the roofing system; or seam is disengaged.

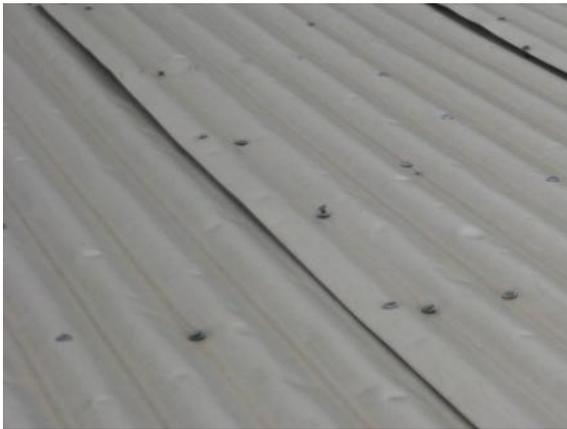
LS-H-1: Seam is open with no panel deformation, requiring localized repair.

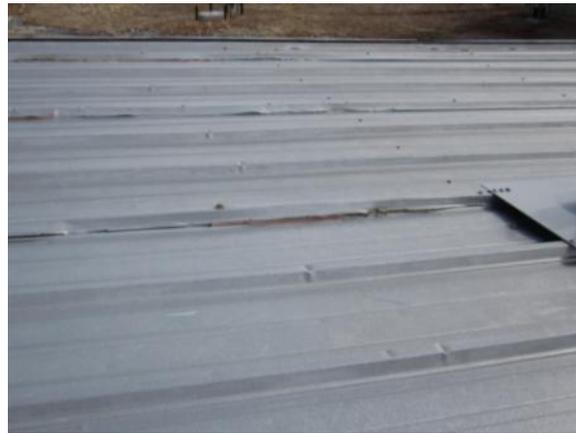
LS-H-2: Seam is open due to panel deformation, requiring panel replacement.

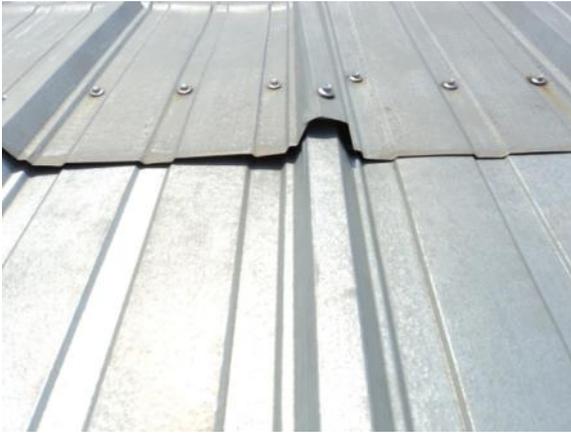
PL-M-2: End lap joint between panels has failed sealant or open fishmouths.

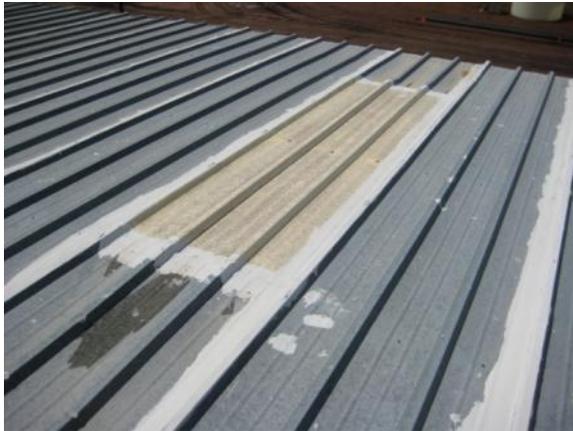
SP-L-1: Integrated skylight panels are rated low severity as a minimum due to their shorter service life as compared to the metal roofing system.

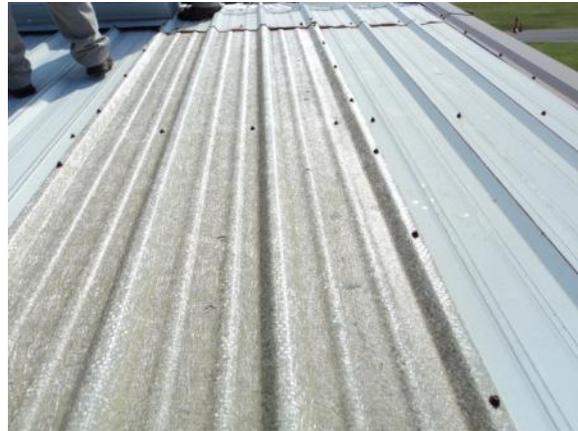
SP-M-1: Skylight composite material exhibits visible fibers, significant discoloration or other signs of degradation.
