Accelerated Aging Experiments for Prognostics of Damage Growth in Composite Materials

A. SAXENA, K. GOEBEL, C. C. LARROSA, V. JANAPATI, S. ROY
and F.-K. CHANG

13. SUPPLEMENTARY NOTES See also ADA580921. International Workshop on Structural Health Monitoring: From Condition-based Maintenance to Autonomous Structures. Held in Stanford, California on September 13-15, 2011 . U.S. Government or Federal Purpose Rights License.

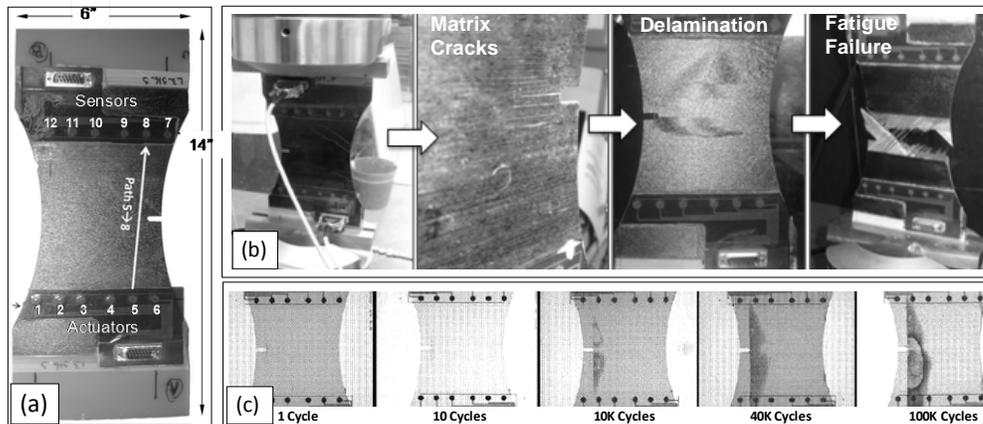
Figure 1(a) Coupon specimen, SMART Layers location, and diagnostic path from actuator 5 to sensor 8. (b) Development of matrix cracks and delamination leading to fatigue failure. (c) Growth in delamination area during the course of fatigue cycling experiment.

The fatigue cycling experiments serve several objectives– (i) ability to collect run-to-failure data with periodic system health data using health monitoring sensors, (ii) ability to collect ground-truth data for the damage to validate measurement data analysis, (iii) accounting variations between samples of same internal structure (layup), and (iv) characterizing variations between sample of different internal structures. Three symmetric layup configurations were chosen to account for the effect of ply orientation: *Layup 1*: $[0_2/90_4]$, *Layup 2*: $[0/90_2/45/-45/90]$, and *Layup 3*: $[90_2/45/-45]_2$. Torayca T700G uni-directional carbon-prepreg material was used for 15.24 cm x 25.4 cm coupons with dogbone geometry and a notch (5.08mm x 19.3mm) to induce stress concentration. Two six-PZT-sensor SMART Layer® from Acellent Technologies, Inc (Figure 1(a)). were attached to the surface of each sample. This configuration allows six actuators and six sensors to monitor wave propagation through the samples, Figure 1(a) shows one such path from actuator 5 to sensor 8 (path 5→8) that will be used as an example throughout this paper.

150-450 KHz, with an average input voltage of 50 volts and a gain of 20dB. These frequencies were selected so that the fundamental symmetric and anti-symmetric modes can be as distinguishable as possible based on the differences in their phase velocities. Static failure load (σ_s) was determined through static tests run-to-failure for two or three samples of each layup to determine maximum fatigue load (σ_f) that was set to 75-85% of σ_s . All tests were performed on an MTS machine with a load ratio (R) of approximately 0.14, following ASTM Standards D3039 and D3479 [11, 12]. The fatigue tests followed a sinusoidal load profile at a frequency of 5Hz. The fatigue cycling tests were stopped every 50,000 cycles to collect PZT sensor data for all paths and interrogation frequencies. X-rays of the samples were taken using a dye-penetrant to enhance X-ray absorption. The main goal of this test procedure is to be able to acquire sensor data as a function of damage progression; Figure 1(c) shows increasing level of damage in the X-ray images.

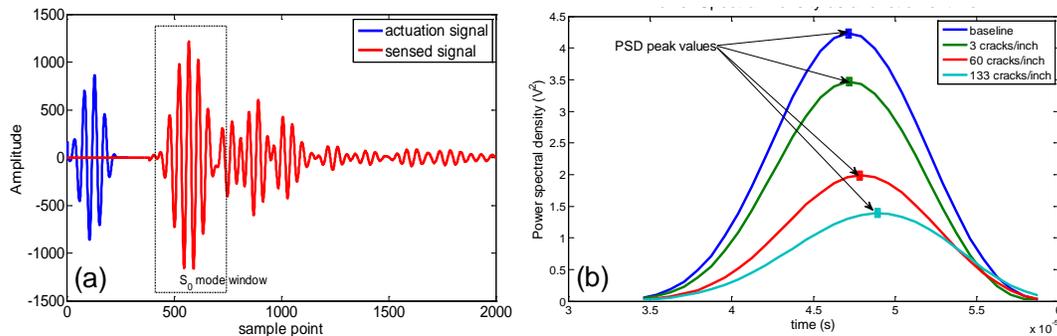
Figure 2(a) Isolating the first S_0 mode by windowing the sensed signal. (b) Change in Power Spectral Density curves with increasing matrix crack density.

sensor path lengths were used to approximate an S_0 mode window as shown in Figure 2(a). Following CIs were computed from the windowed signals.

Change in Power Spectral Density - Power Spectral Density (PSD) as a function of time for a given actuation frequency was extracted from Short Time Fourier Transform (STFT) for the signal. The peak value within the specified S_0 mode window decreases as a function of the matrix cracks that developed (see Figure 2(b)). Change in the PSD peak value normalized by the baseline PSD peak was computed. This feature, referred to as the Δ PSD throughout this paper, has been shown to correlate well to matrix micro-cracks on any given actuator sensor path [13].

Scatter Energy - Scatter energy measures wave energy dispersed into the medium along the path due to discontinuities and obstructions. Growth in delamination area increases the scatter proportional to the size of delamination. It is computed as the energy difference for the S_0 mode (Figure 2(a)) between the measured signal and the baseline signal (obtained initially in damage free condition). Normalized scatter energy is calculated as the ratio of scatter energy to baseline signal energy.

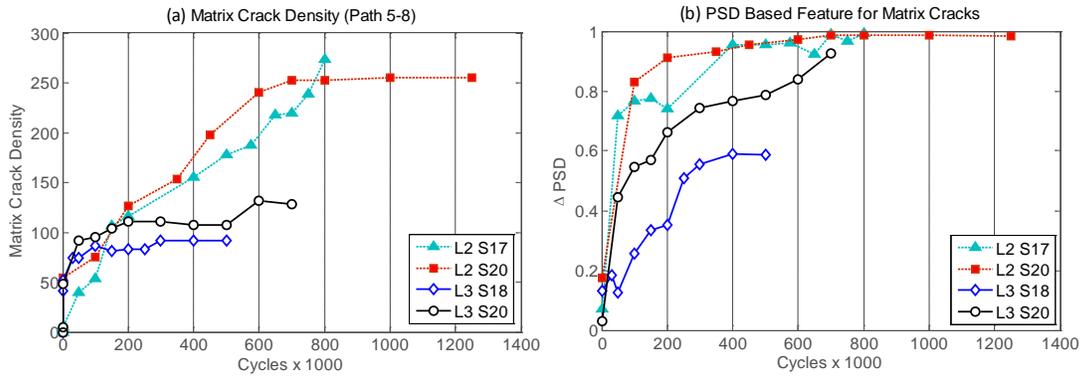
Figure 3. (a) Growth in matrix crack density as observed from X-ray images. (b) PSD based feature to track growth in matrix crack density.

In the search for increasing trends representing damage growth, several features were computed and compared to the trends obtained from X-ray analysis with increasing number of fatigue cycles. The X-ray analysis shows that matrix crack density grows very quickly initially and then flattens out for both layup types (Figure 3 (a)). The cracks grow rapidly again when the loads are ramped up; for instance at cycle 450K when load was increased from 6 to 7 kips for L3S20. The Δ PSD feature plotted in Figure 3(b) follows the same matrix crack density growth trends. It is also noticeable how the matrix crack growth difference between layups is captured by the Δ PSD.

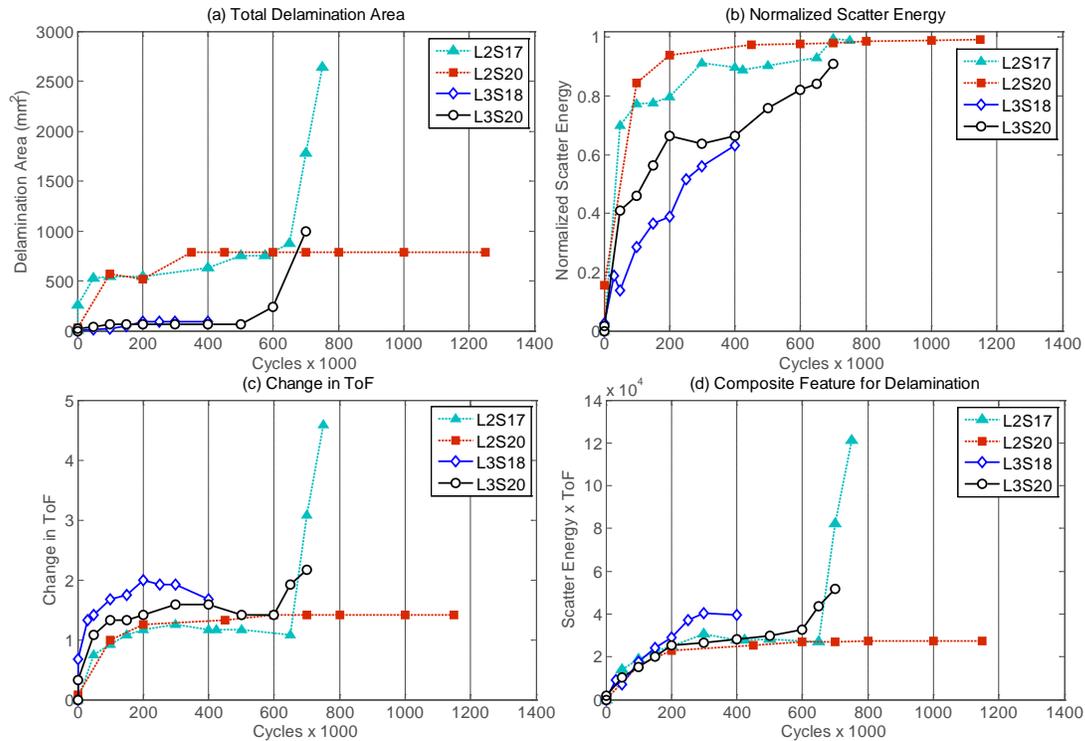
Figure 4. (a) Delamination area as observed from X-ray (b) Normalized scatter energy. (c) Time of flight and (c) Composite feature for delamination.

Figure 4 shows corresponding features extracted to track delamination growth. Figure 4(b) shows the normalized scatter energy through cycles for L_2 and L_3 layups. It was observed that the normalized scatter energy for L_2 Layup was relatively higher than that for L_3 layup, which is consistent with the delamination sizes shown in Figure 4(a), but the growth trend is not accurately captured. The change in ToF for L_2 and L_3 layups as a function of cycles is plotted in Figure 4(c). It was observed that the increase in ToF for L_3 Layup was relatively higher than that for the L_2 layup. This is due to the fact that in the case of L_3 layup, stiffness degradation comes from delamination at the $90/45$ ply interfaces and matrix cracking in the outer 90° plies. Whereas for L_2 Layup, the overall stiffness degradation is not as significant due to the presence of the 0° outer plies. Despite this mismatch, the monotonically increasing growth trends are observed, for example, L2S17 in Figure 4(a) delamination grows early, then flattens out and as the fatigue loading was ramped up after 600Kcycles, delamination increases significantly. From Figure 4(c) a very similar growth trend is seen in the change for ToF.

Even though these two parameters did not match well individually with the delamination area growth observed from the X-rays, they are promising as signatures of delamination growth trend. A preliminary study on combining these two features indicates that a composite feature such as a product of normalized scatter energy and Δ ToF (shown in Figure 4(d)) has well matching trends with delamination area growth. This composite feature shows good correlations to the trends observed in the X-rays for both L_2 samples (L2S17 & L2S20). Likewise for L_3 layups (L3S18 & L3S20) these trends look repeatable, for instance an increase in load at 600K cycles for L3S20 results in increased delamination area, which is also well reflected in the corresponding feature. However, the magnitudes of the delamination features do not correspond to the similar levels for the two layups, i.e. the feature shows similar values for very different magnitudes of delamination area. These differences could be attributed to several reasons that require further investigation: (i) difference in layup types, ($L_2:[0/90_2/+45/-45/90]_2$ vs. $L_3:[90_2/+45/-45]_{2s}$) and hence effect of delamination geometry and orientation on sensor signals, (ii) errors in the delamination area measurement from the X-ray images, especially if the delamination appears on different interfaces, which is not detectable from X-rays but still affects the signal significantly. Therefore, the layup type should be an important factor in interpreting the results and a good repeatability within a single layup type is desirable. Further studies need to be conducted to assess the accuracy of this composite feature.
