## Field Experience with Lock Culvert Valves

by *Richard L. Stockstill, E. Allen Hammack, Thomas E. Hood,  
and Jane M. Vaughan*

**INTRODUCTION:** The objective of this technical note is to identify lock culvert valve issues that challenge the US Army Corps of Engineers (USACE) as it continues to provide reliable transport at navigation projects. In order to accomplish this objective, navigation projects were visited to observe operations and discuss maintenance history with lock operations and maintenance personnel. The intent was to identify any common troubles that particular valve designs have presented. The personnel interviewed varied from area office engineers to maintenance contractors. Also, pertinent findings from previously published prototype lock studies are included. Particular attention was given to the valves on locks with lifts in excess of 30 ft which are classified as high-lift and very-high-lift locks (Headquarters, USACE 2006), since these projects have historically had the most issues.

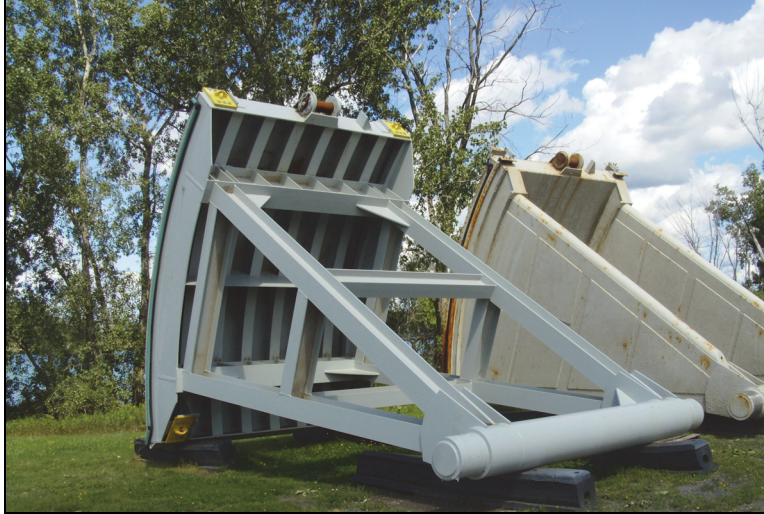
Figure 1. Valves on the Eisenhower and Snell Locks: new vertically framed design in foreground, existing double-skin-plate design in background.

**Eisenhower and Snell Locks.** The valves on the Eisenhower and Snell Locks, two locks operated and maintained by the SLSDC, are being replaced. The existing valves are of double-skin construction. This design has lack of access to interior structural members. They are being replaced with new valves of a vertical-frame design to improve the ability for inspection and maintenance of structural members. A photograph of two of the SLSDC valves is provided in Figure 1 in which a vertical-frame valve is in front of a double-skin-plate valve. The double-skin construction wraps structural members such that the valve is *streamlined* because fewer objects are exposed to the flow. However, the semi-circular top and bottom of the valve arms are subject to flow-control oscillations, which in turn tend to vibrate the entire valve. Vibration of the double-skin-plate valves led the SLDC to add lateral dampers (dynamic vibration absorbers). Dampers, attached to the valves, ride against the valve's wall seals as shown in Figure 2. The dampers remedied the vibration problems.

Two, new vertical-frame valves were furnished to the SLSDC in January 2011, and one was installed in the south filling-valve location at Snell Lock. An option for the SLSDC to order six more valves to complete the replacement was delayed because experience with the new vertical-frame valve currently in service revealed certain operational difficulties. Operation of the new valve exerted more load on the operating machinery than the double-skin-plate valve that it replaced, even though the new valve was significantly lighter. A hydraulic model study is currently underway to customize a vertical-frame valve design that meets SLSDC's requirements for hoist loads.

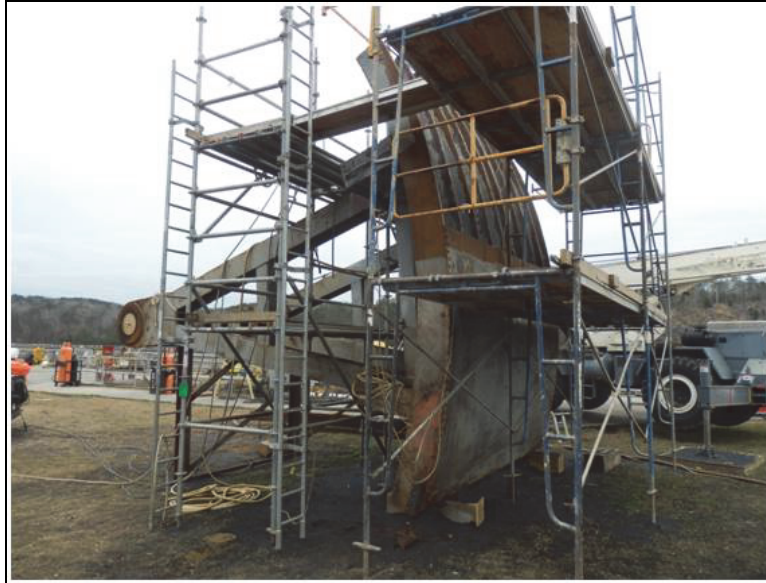
Figure 3. Replacing upper skin plate on Bankhead Lock valve.

**Bankhead Lock.** The Bankhead Lock valves have performed well, and their design is recommended by SAM operations personnel. Regularly scheduled maintenance is currently underway wherein each valve is removed, repaired, and reinstalled. Maintenance crews noticed damage to the downstream side of a valve. When the valve was removed from the culvert, it was found that the skin plate damage was much more extensive than originally thought. The top third of the valve skin plate was removed (Figure 3) and replaced. Evidence of cavitation damage, more common downstream of lock valves, was noticed on the skin-plate steel, which had sharp-edged pits. The location of damage on the Bankhead Lock valve suggests that at certain valve openings, most likely small openings, high-velocity flow passes between the downstream side of the skin plate and the soffit seal.

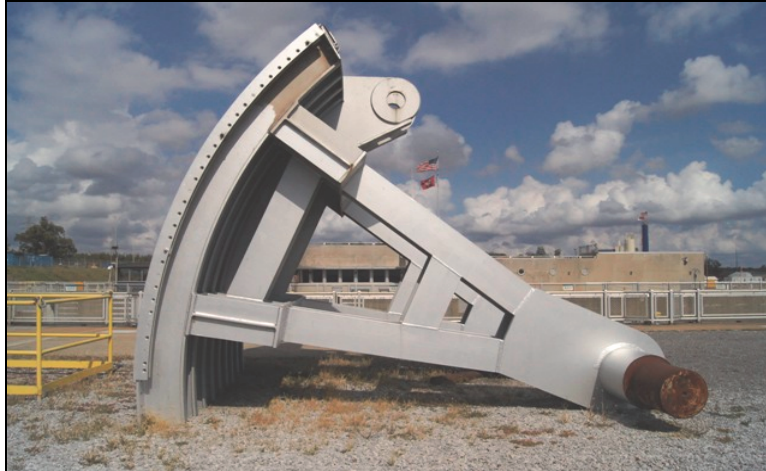
Figure 5. Kentucky Lock replacement valves.

**Kentucky Lock.** New replacement valves were constructed for the Kentucky Lock circa 2004 (Figure 5). However, after the problems that had occurred with the replacement valves on Watts Bar Lock, USACE, Nashville District (LRN) believed the risk of having similar problems on Kentucky Lock was too great. The valves sat on a lock wall until a better understanding of why some designs have problems with uplift and vibrations could be found.

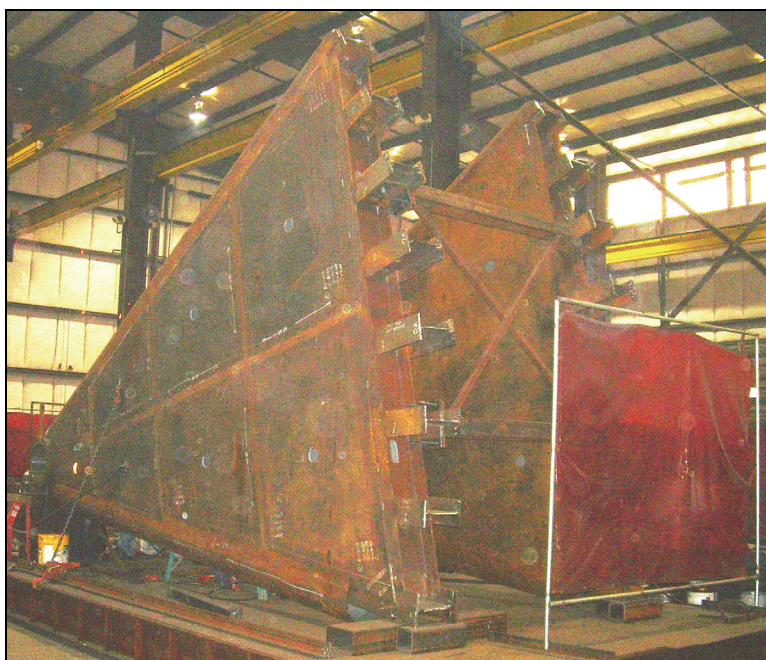
Figure 6. New John Day Lock culvert valve during fabrication.

The USACE, Portland District (NWP) is replacing the valves. A photograph of a new valve taken during fabrication is provided in Figure 6, and one of a completed valve is shown in Figure 7.

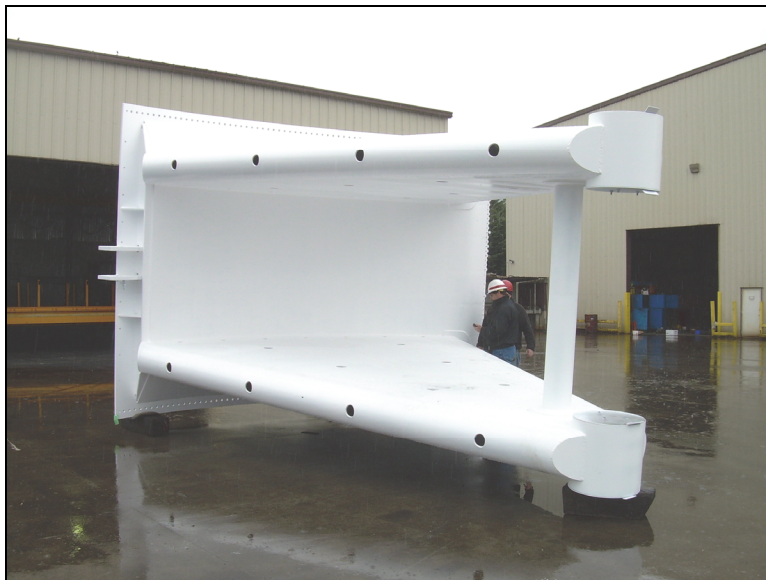
Figure 7. Newly fabricated John Day Lock culvert valve, turned on its side (top is on left).
