AFRL-RX-TY-TR-2011-0046

**FIREFIGHTING AND EMERGENCY RESPONSE
STUDY OF ADVANCED COMPOSITES
AIRCRAFT; OBJECTIVE 1: COMPOSITE
MATERIAL DAMAGE IN MINOR AIRCRAFT
FIRES**

**AIR FORCE RESEARCH LABORATORY
MATERIALS AND MANUFACTURING DIRECTORATE**

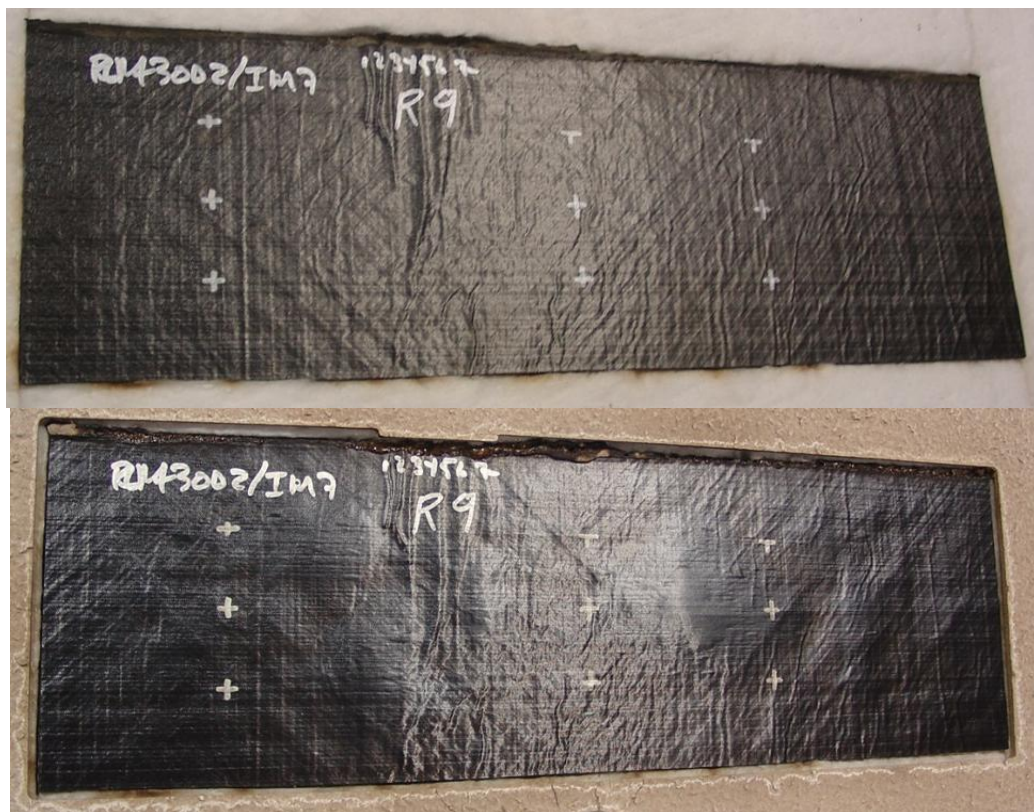
Figure 59. Plate R9 (0.4 percent Moisture Content) before (top) and after Exposure at 25.9 kW/m^2 for 201 s (bottom)

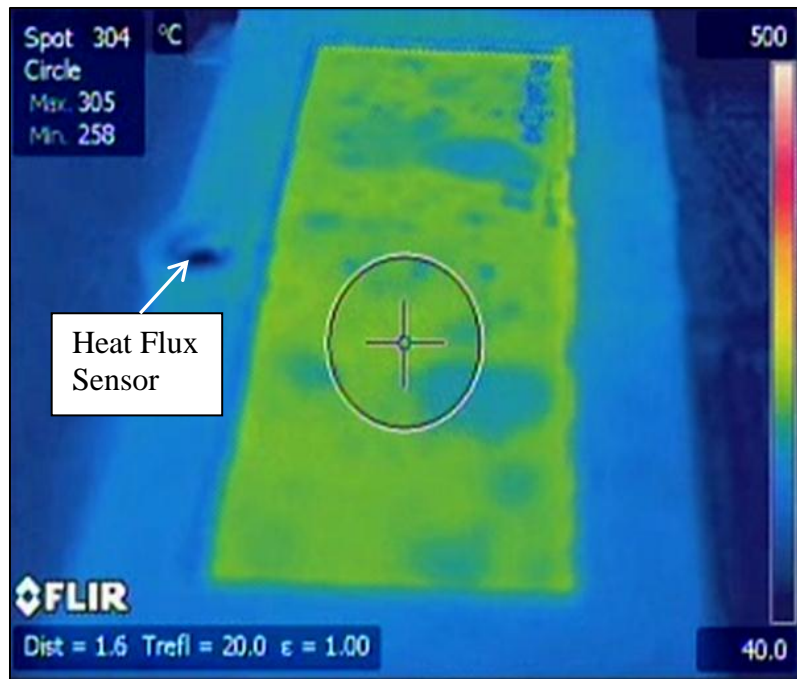
Figure 60. IR image of R8 Approximately 8 s after Removal from Heat Source

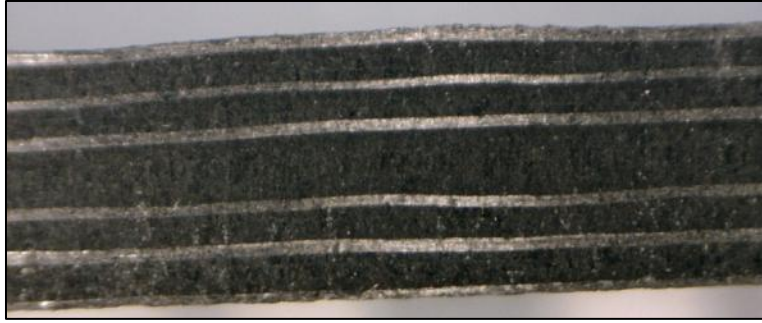
A cross section of the material prior to any heat exposure is shown in Figure 62. It shows good consolidation with no evidence of large voids or pre-existing delaminations. Cross sections of the heat-exposed plates are shown in Figure 63 to Figure 67. When delaminations occurred, small and large delaminations are seen through the thickness of the plate. Note small delaminations between plies in polished samples not readily seen in the water-jet cut surface (e.g., Figure 65). There is no apparent pattern with regard to the extent of delaminations towards the hot or cooler side of the plate. This is true in both dry samples and with moisture (cf. plate R2 in Figure 63 and R9 in Figure 67). No damage is seen in plates that did not delaminate (Figure 64).

Figure 62. Cross-section of IM7/RM3002 Plate after being Cut with a Water-jet
