# ESTCP Cost and Performance Report

## Validation of HVOF Thermal Spray Coatings as a Replacement for Hard Chrome Plating on Hydraulic/Pneumatic Actuators

December 2007

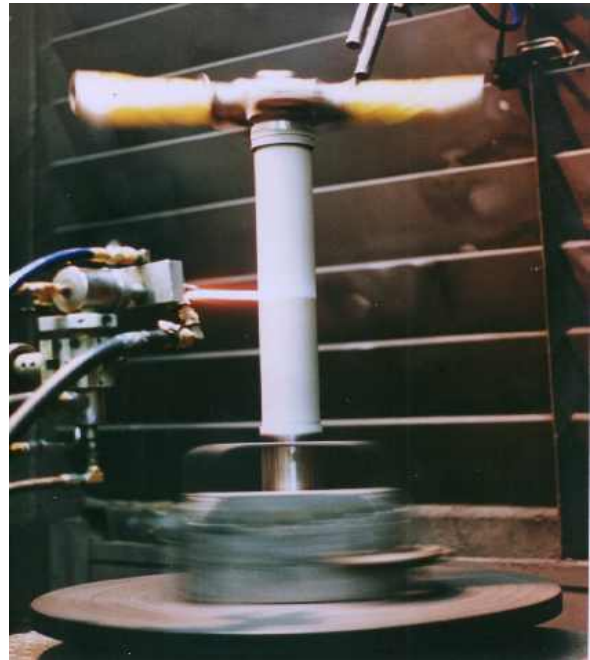
**Figure 2. HVOF Spray of Landing Gear Inner Cylinder.**

**Installation and Operation:** The HVOF gun can be hand-held and used in an open-fronted booth. However, the supersonic gas stream is extremely loud and requires that the operator use very good ear protection. For this reason the unit is usually installed on a six-axis robot arm in a sound-proof booth, programmed and operated remotely. Most depots already use this type of booth for their existing plasma spray operations. Since the method is frequently used for cylindrical items, the most common arrangement is to rotate the component on a horizontal rotating table and move the gun up and down the axis. This is illustrated in Figure 2 which shows the HVOF spraying of a landing gear inner cylinder. A similar setup would be used for the spraying of hydraulic actuator piston rods.

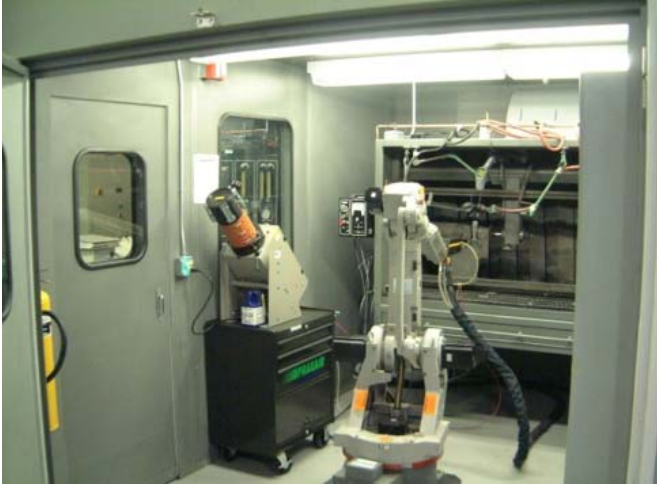
**Figure 3. Inside of HVOF Spray Booth at OO-ALC Showing Air Handler in Background and Robot on which HVOF Spray Gun is Mounted Directly in Front.**

OO-ALC has two TAFA JP-5000 HVOF thermal spray systems that are capable of production operation. Figure 3 shows the inside of one of the HVOF spray booths with the air handler in the background, the robot on which the spray gun is mounted directly in front, and the powder feeder at the left. Figure 4 shows the application of an HVOF coating onto a C-5 pitch cylinder
