# HVOF as a Hard Chrome Replacement

**Jon L. Devereaux**

**NADEP Jacksonville  
Materials Engineer**

13. SUPPLEMENTARY NOTES <b>25th Replacement of Hard Chrome and Cadmium Plating Program Review Meeting, March 15-17, 2005, Greensboro, NC. Sponsored by SERDP/ESTCP.</b>

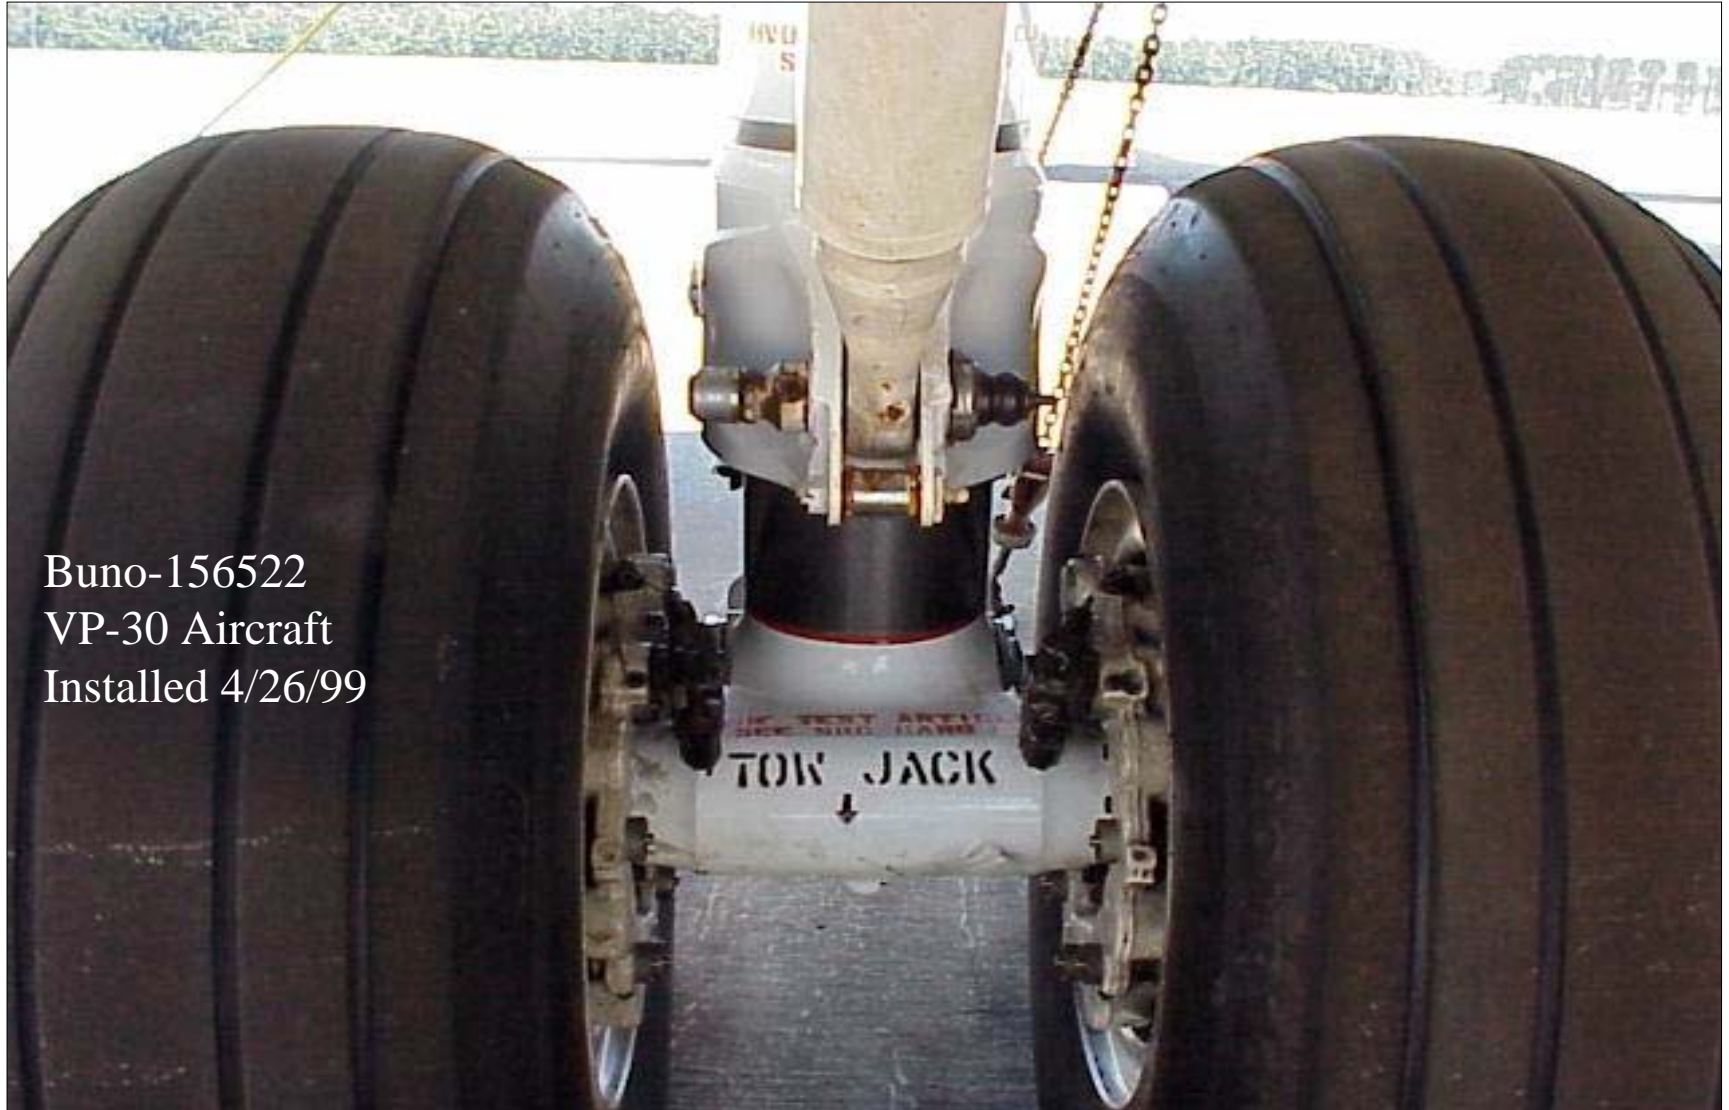
Buno-156522  
VP-30 Aircraft  
Installed 4/26/99

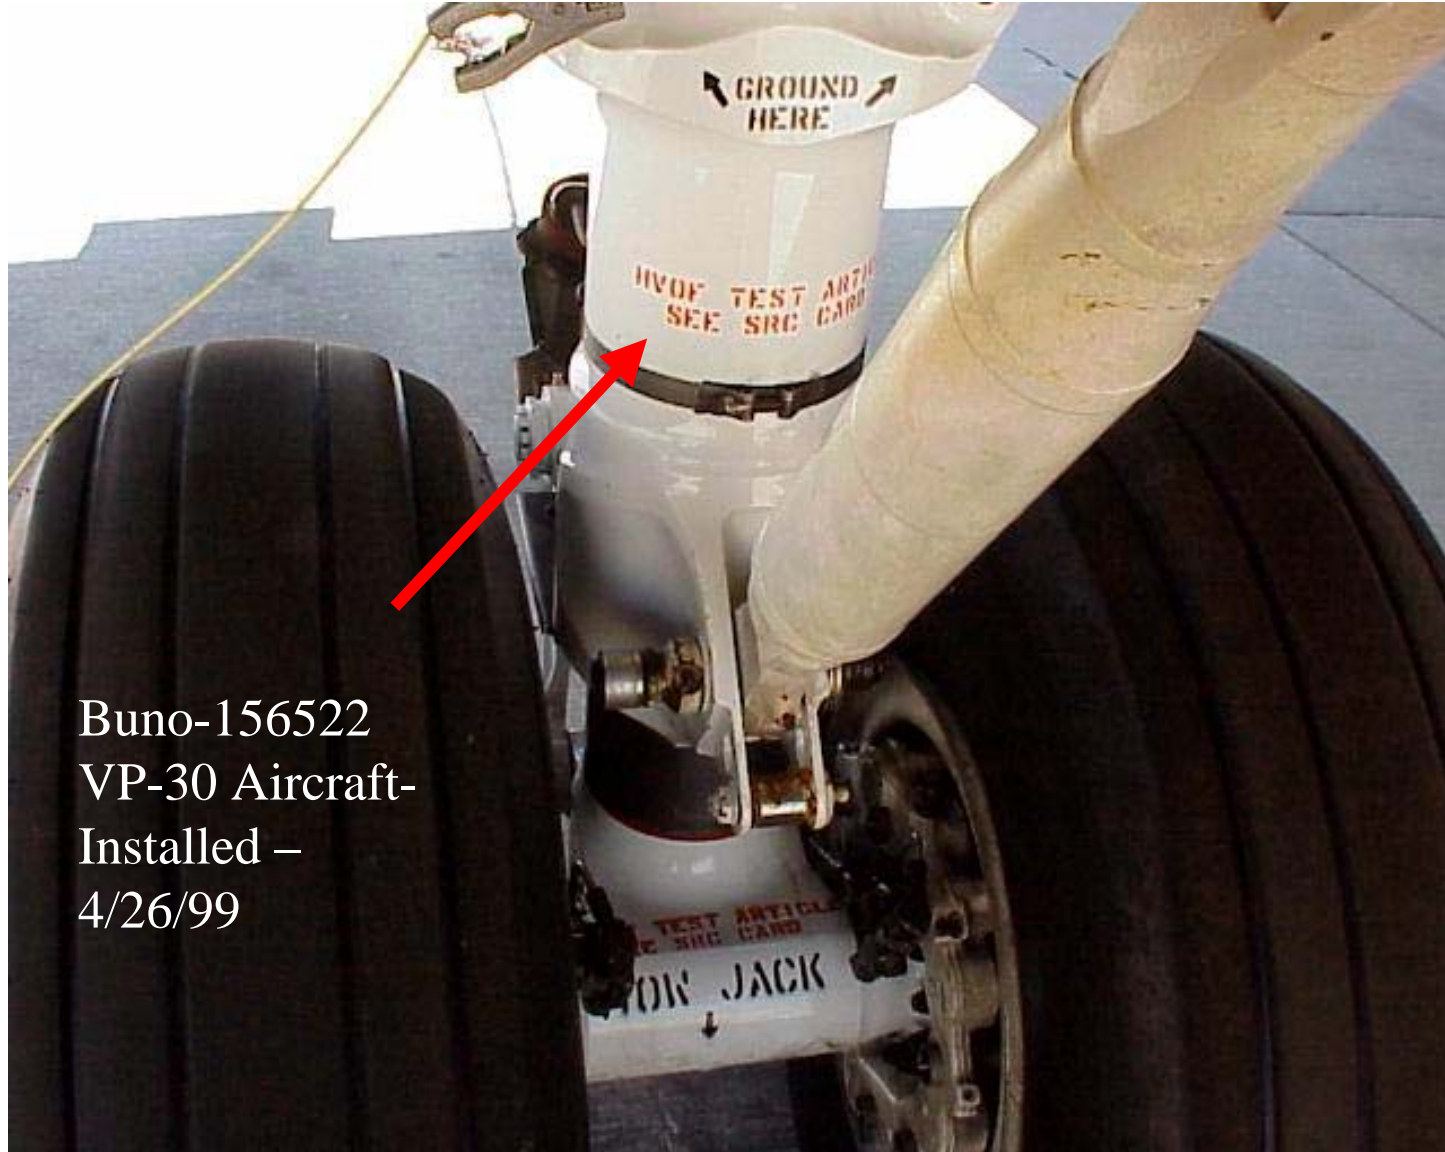
Buno-156522  
VP-30 Aircraft-  
Installed –  
4/26/99

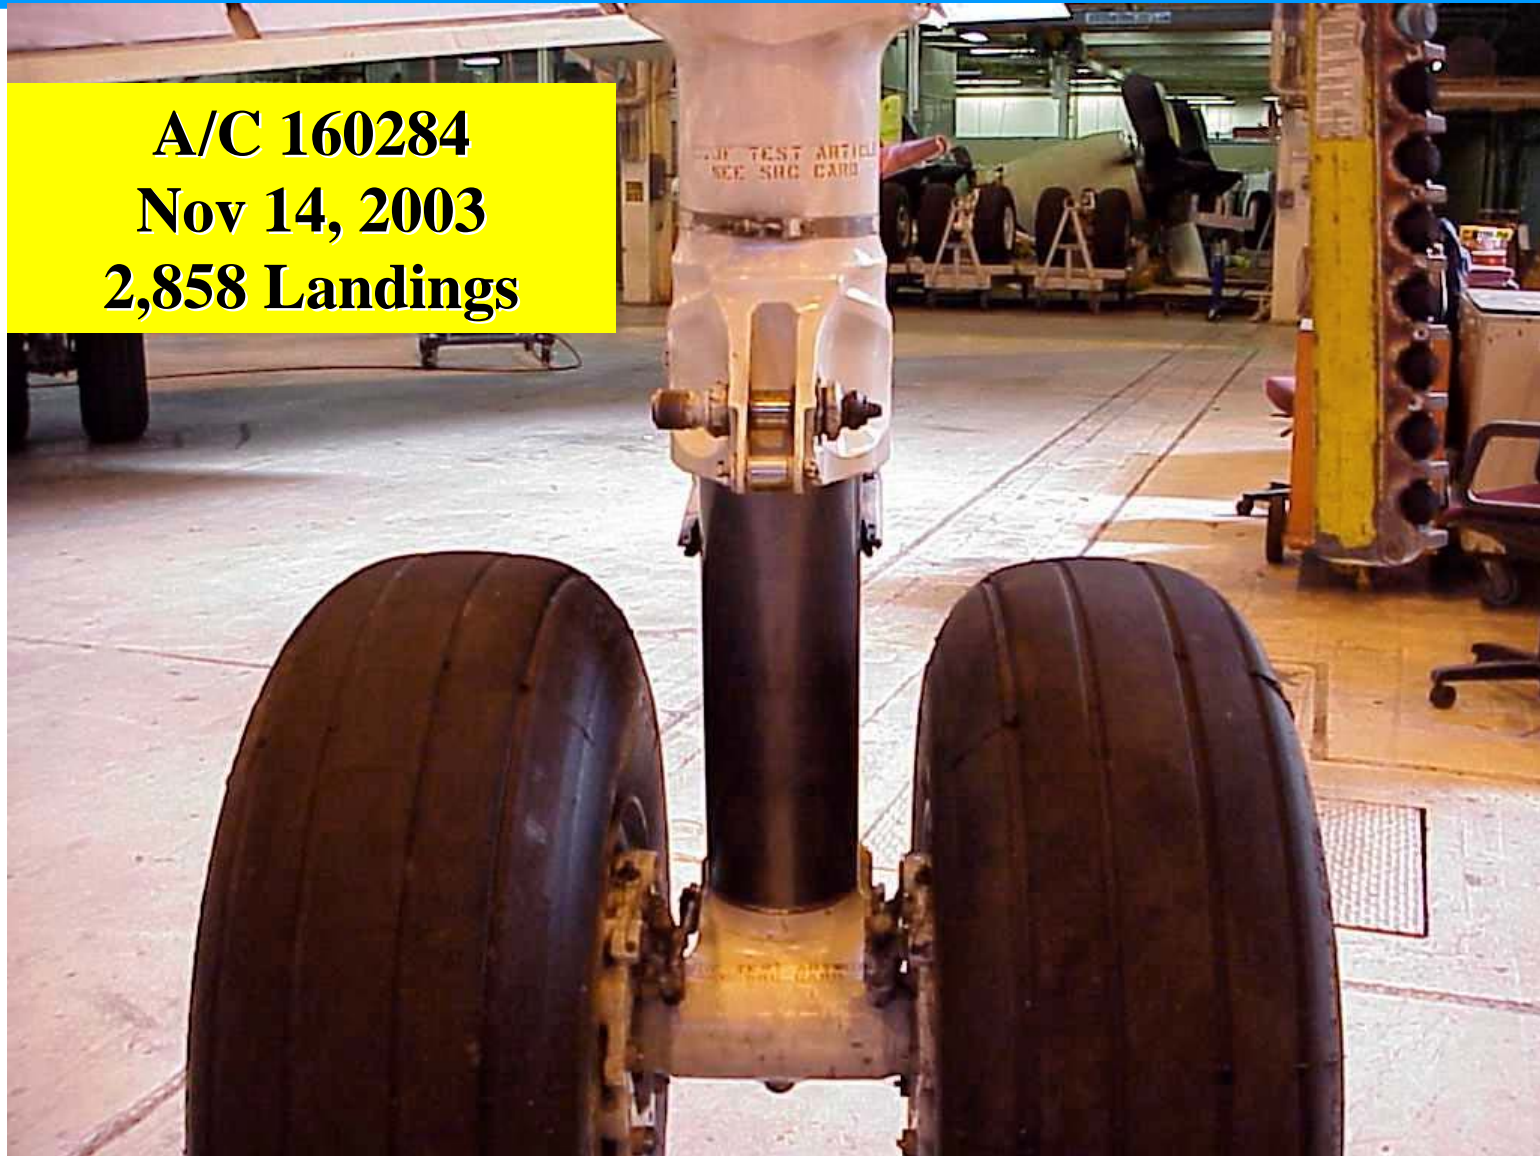
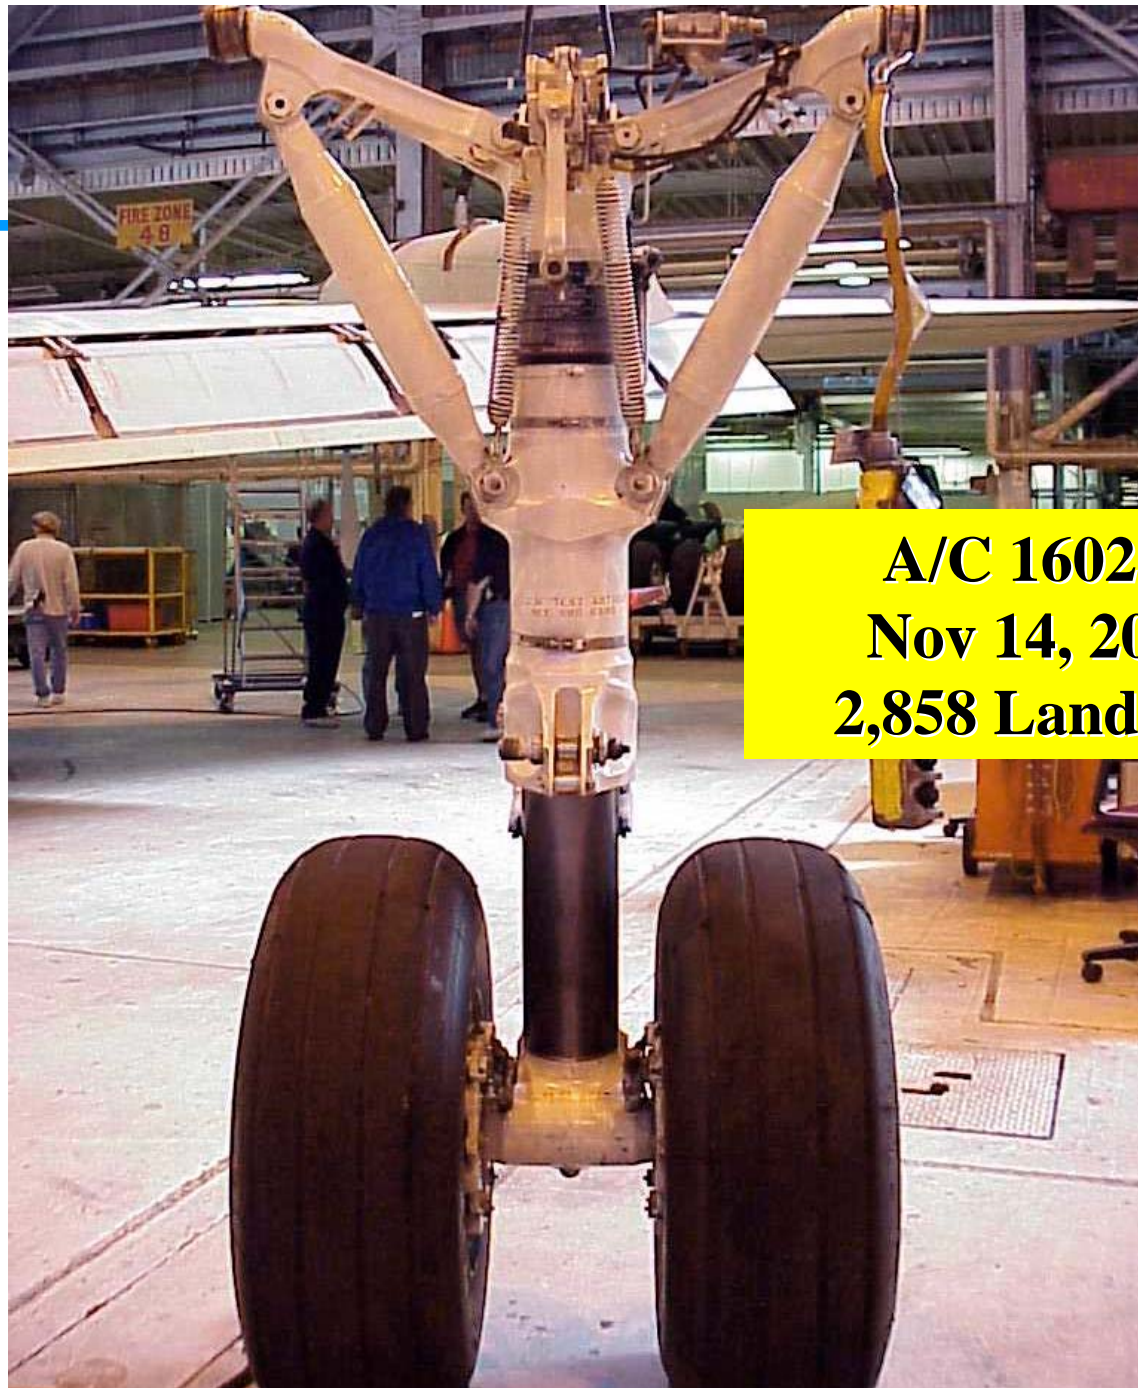
**A/C 160284**  
**Nov 14, 2003**  
**2,858 Landings**

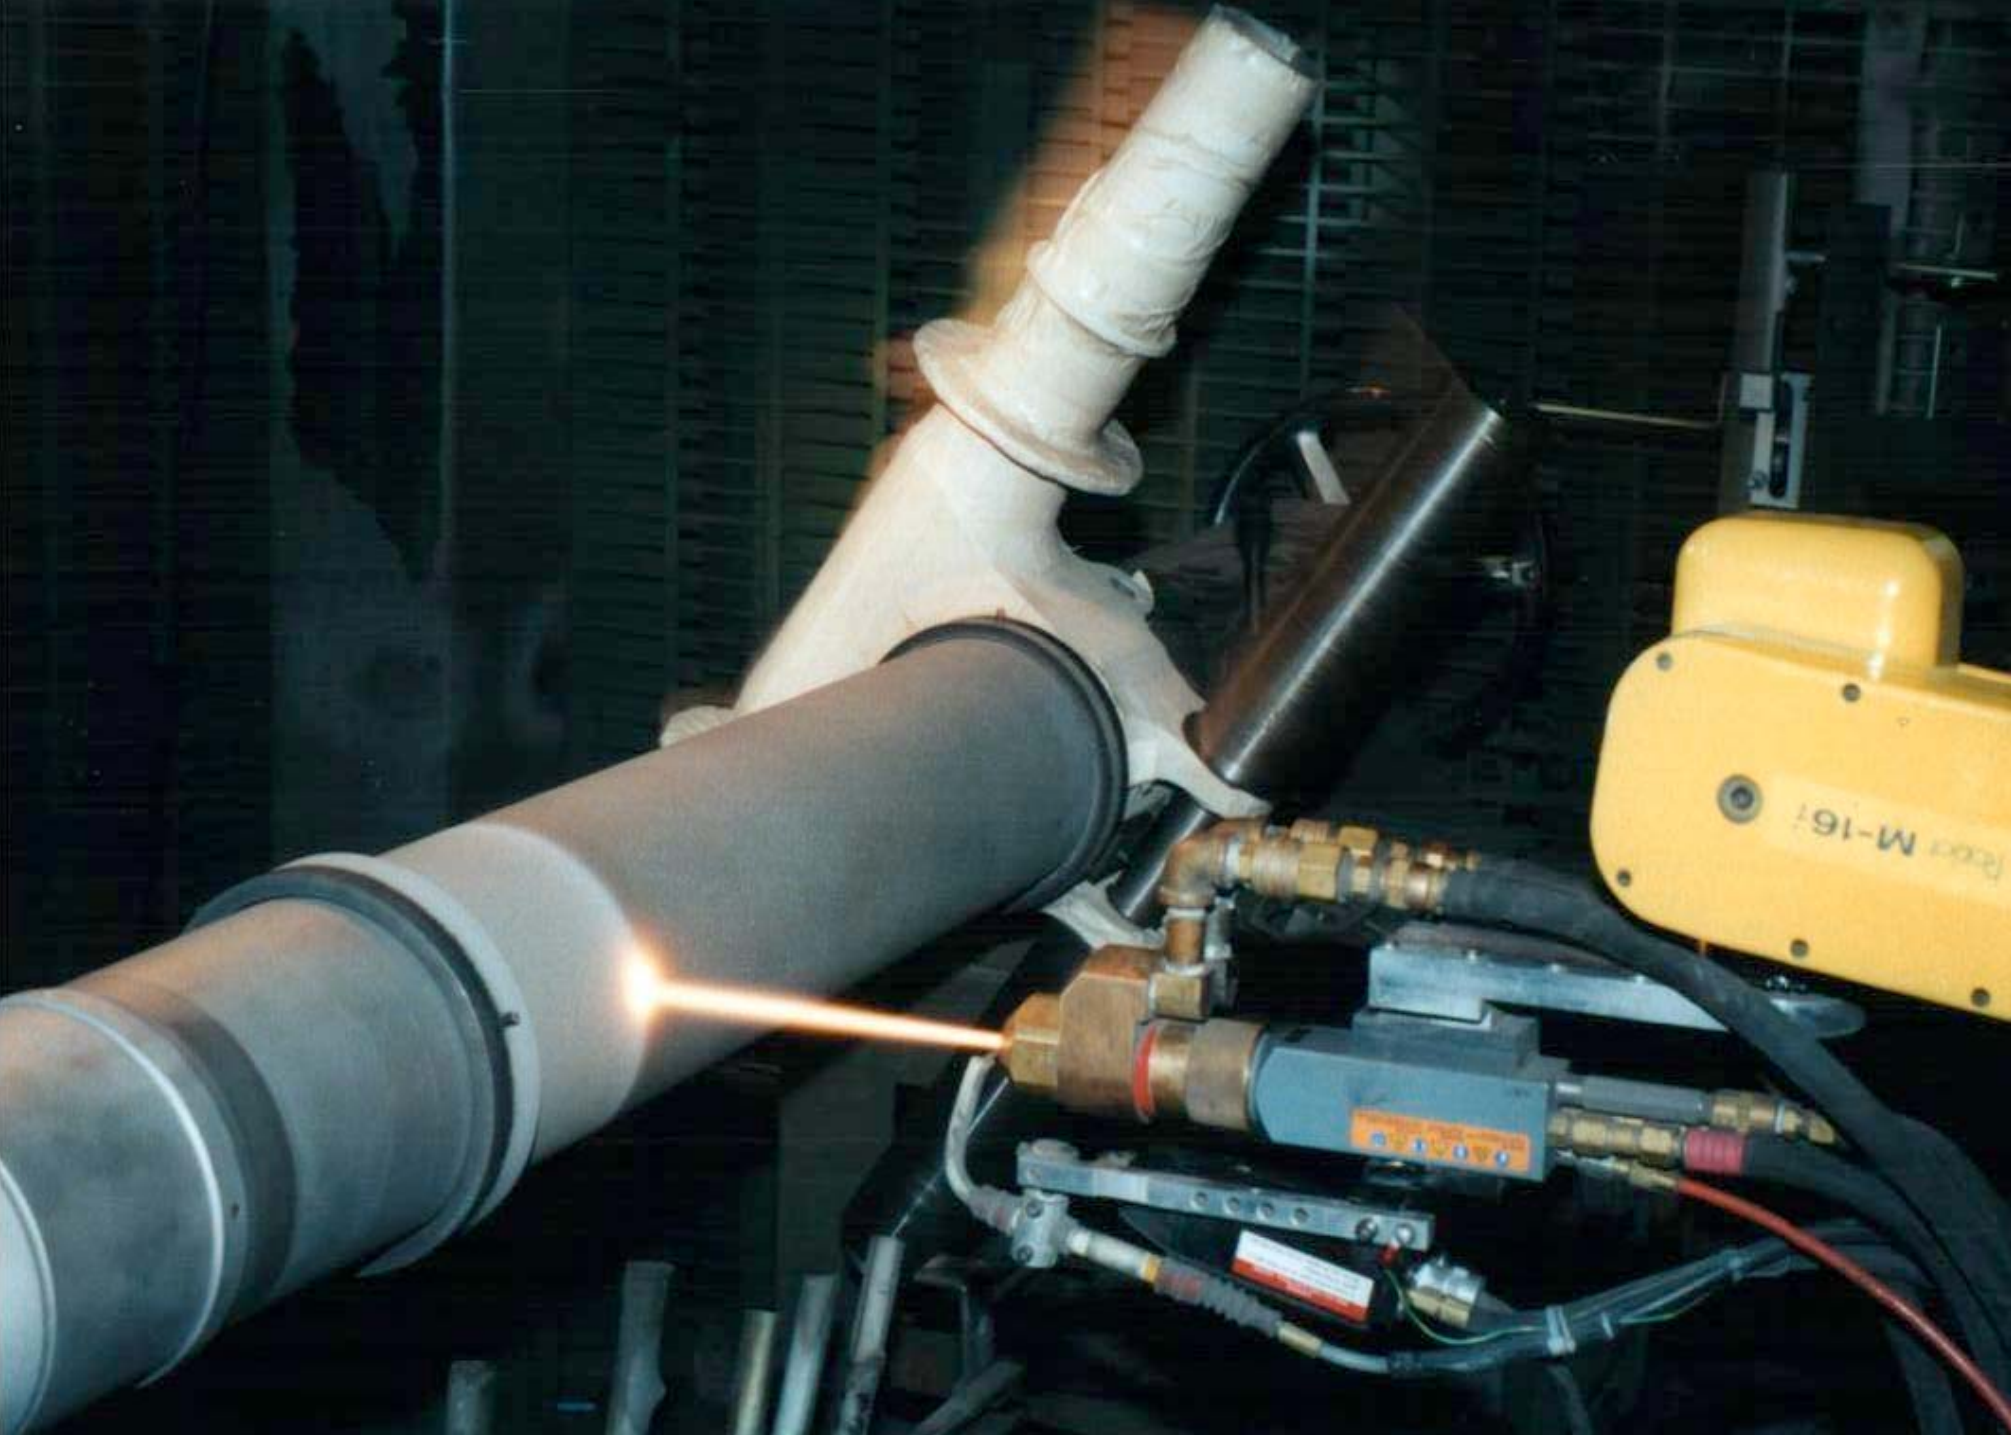
## Second P-3 MLG Piston coated with HVOF WC/Co 83/17

- 26,000 CTH initially planned
- Test extended to 38,000 CTH - some of airframe not tested sufficiently
- 200-250K cycles on LG representing 47,000 Landings
- Test represents two fatigue lifetimes
- If this testing doesn't break the landing gear or HVOF coating, then nothing will!
- Landing gear shows no sign of failure or coating problems
- Test Completed with a "BANG!" on 4 March 2003
- Landing Gear removed April 2003 for inspection

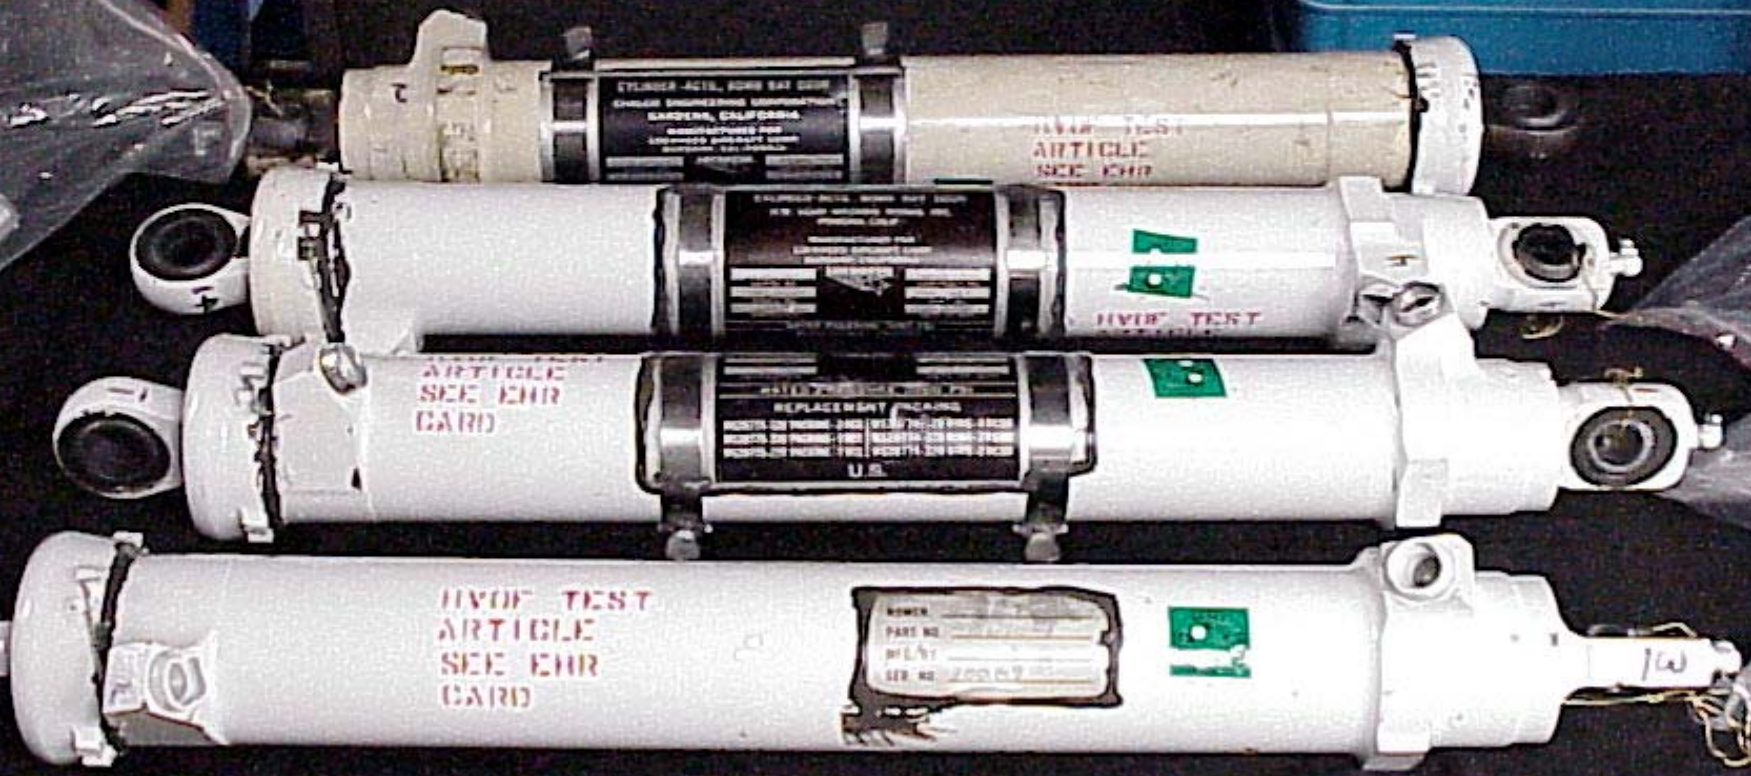
- **P-3 Bomb Bay Door Actuator Pistons coated, ground, & superfinished**
- **Four HVOF coated P-3 Bomb Bay Door Actuator Assemblies RFI and installed on VP-30 Aircraft BuNo 156510 July 2001**
- **Aircraft undergoing PDM at JAX July 2001**
- **A/C delivered back to VP-30 on 7 Sept 01**
- **91 Flight Hours on HVOF coated actuators (01 Feb 02)**
- **232 Flight Hours on HVOF coated actuators (05 Sept 02)**
- **704 Flight Hours on HVOF coated actuators (28 March 03)**
- **869 Flight Hours on HVOF coated actuators (24 Sept 03)  
(Aircraft currently at Whidbey Is. for AEB 003)**

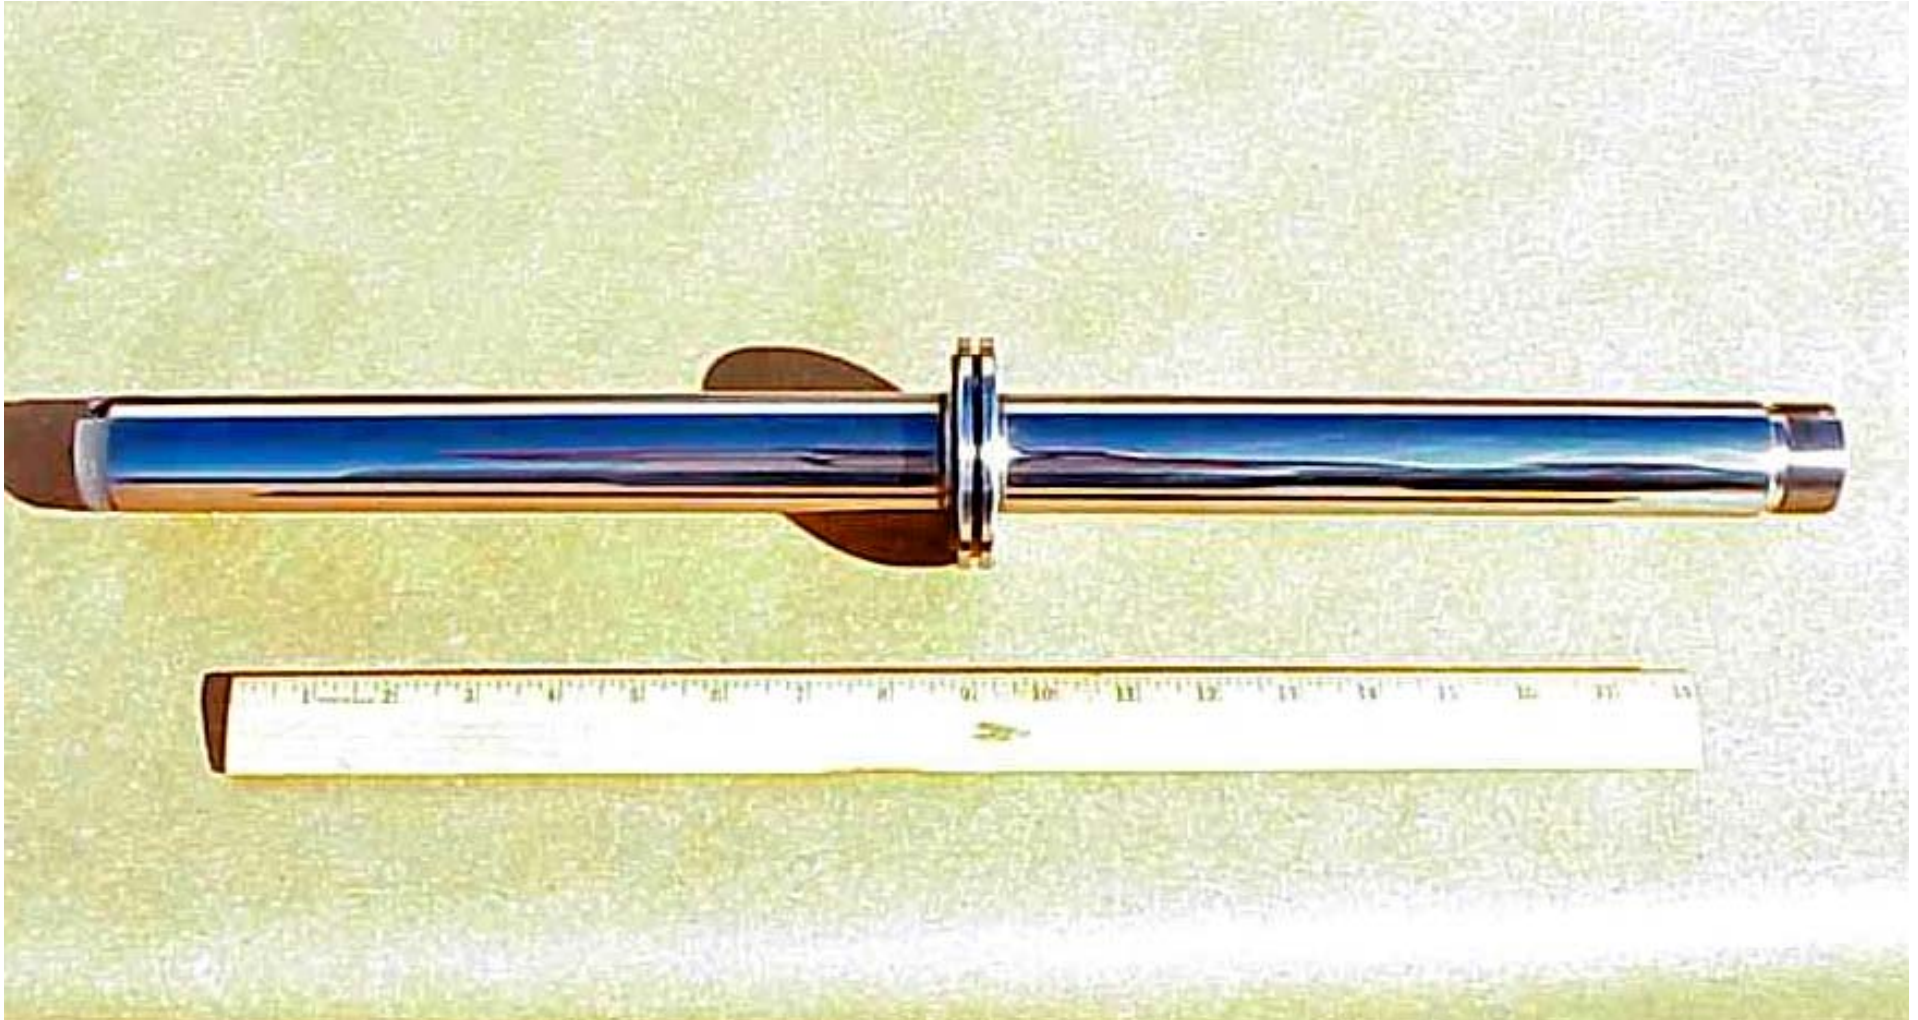
## F/A-18 Horizontal Stabilator Piston Rod

**HVOF Coat short external end with WC/Co/Cr 86/10/4**

**HVOF Coat longer internal end with WC/Co 83/17**

**Grind to 8 - 16  $\mu\text{in}$  Ra finish**

**Superfinish to  $\leq 2$   $\mu\text{in}$  Ra finish**

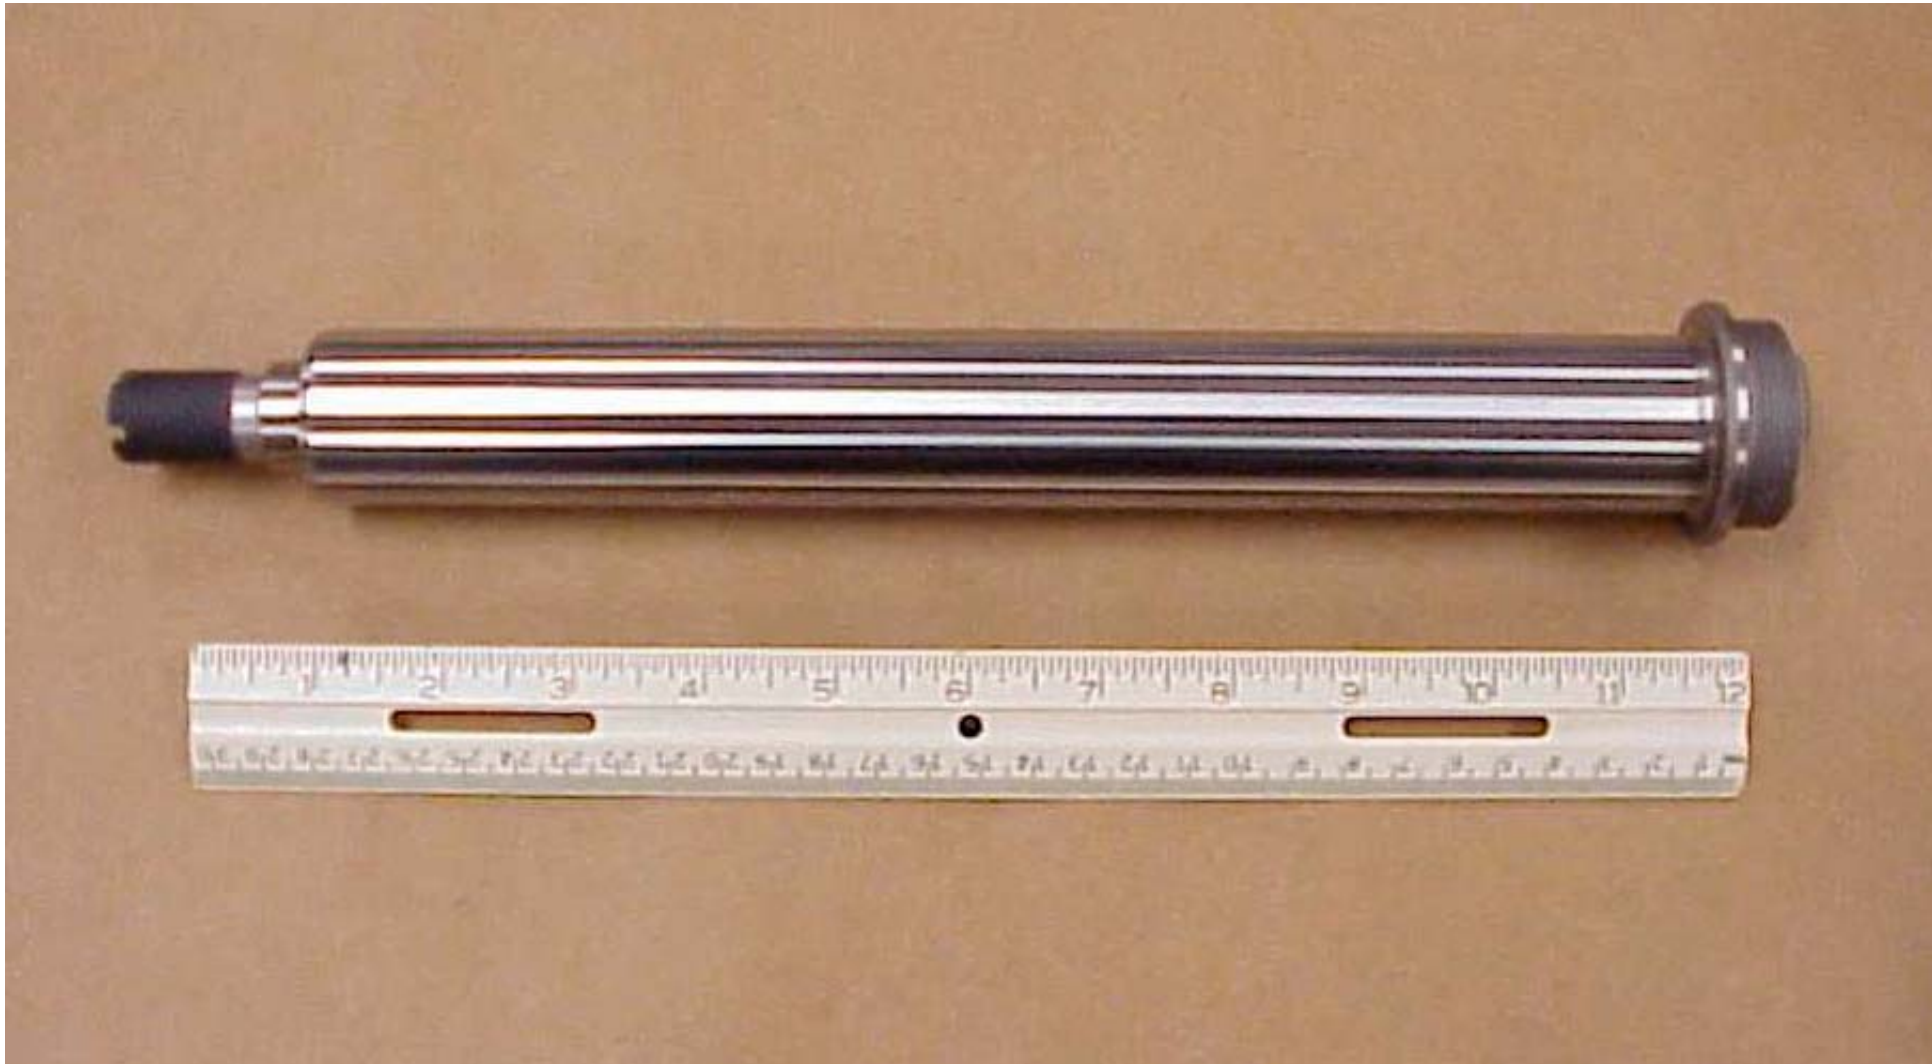
**F/A-18 Trailing Edge Flap (TEF) Actuator Piston Rod  
P/N 303247-3 (Vendor Code 82106) - Parker Hannifin  
HVOF Coat OD of Piston Rod with WC/Co/Cr 86/10/4**

**Grind to 8 - 16  $\mu$ in Ra finish**

**Superfinish to  $\leq$  2  $\mu$ in Ra finish**

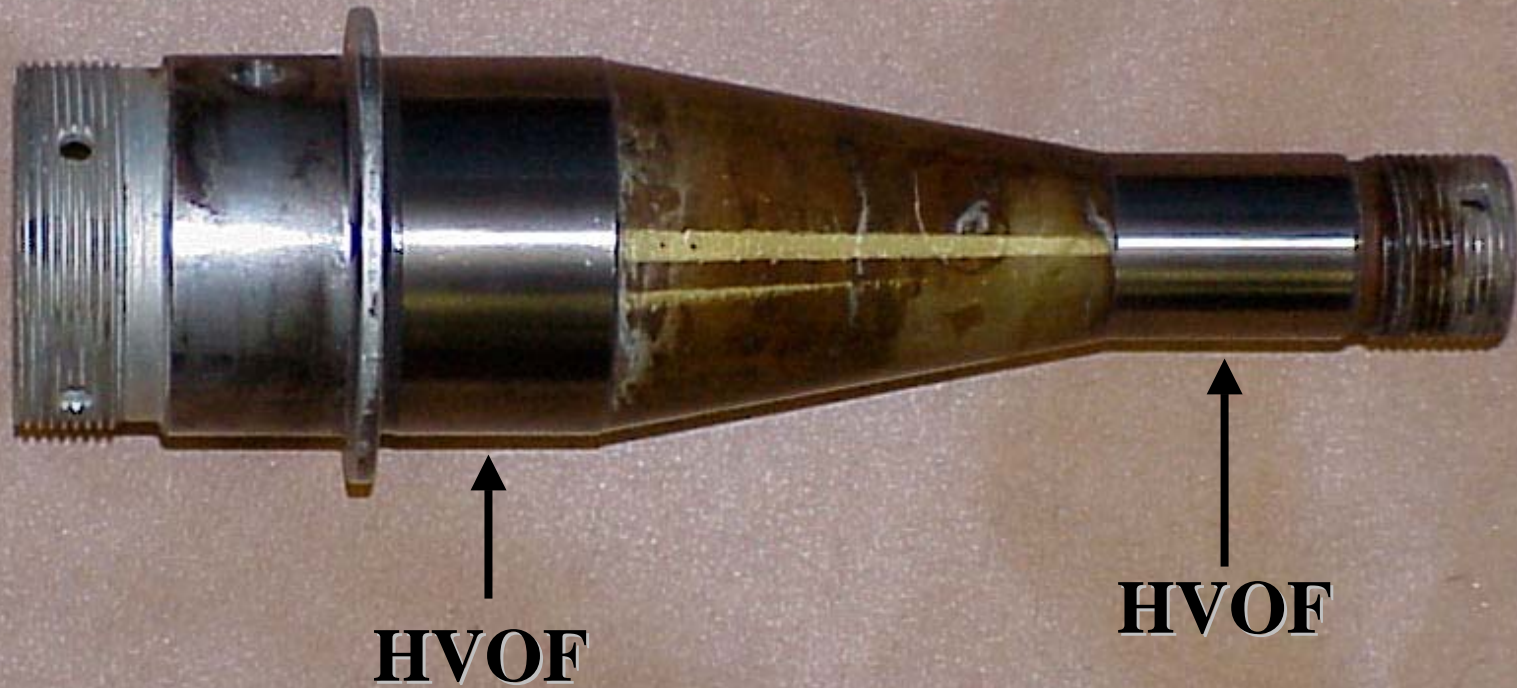
**E-6A MLG Lock Hook Shaft P/N 9-45196**

**Two HVOF coated E-6A MLG Uplock Hook Shafts  
installed 10 March 99 on A/C 164388**

**One HVOF coated E-6A MLG Uplock Hook Shaft  
installed on Aircraft 162784 in Feb. 2000**

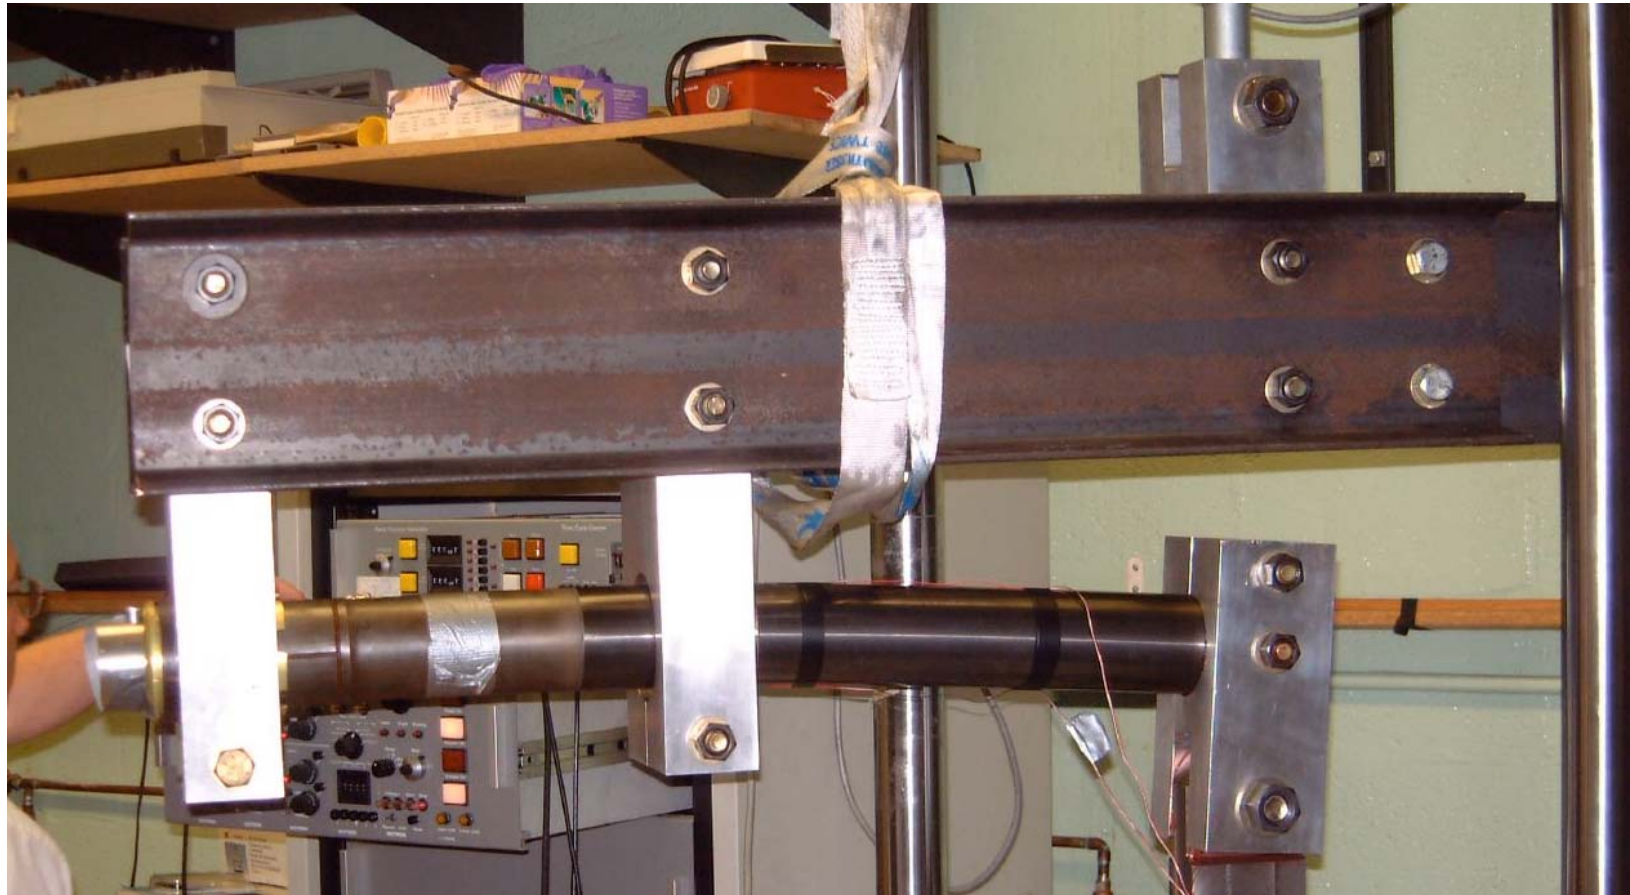
**A-10 NLG Piston**

**Coating spalled at 260 KSI - Permanent yielding of the piston observed at this stress level**

**Air Force bend tests on actual A-10 NLG hardware concluded that HVOF applied WC/Co coatings 0.010” thick would remain intact at any stress level up to the yield strength of the substrate being tested**

**Air Force data at more severe condition of  $R = - 0.33$  shows 0.010” coating good up to 260 KSI**

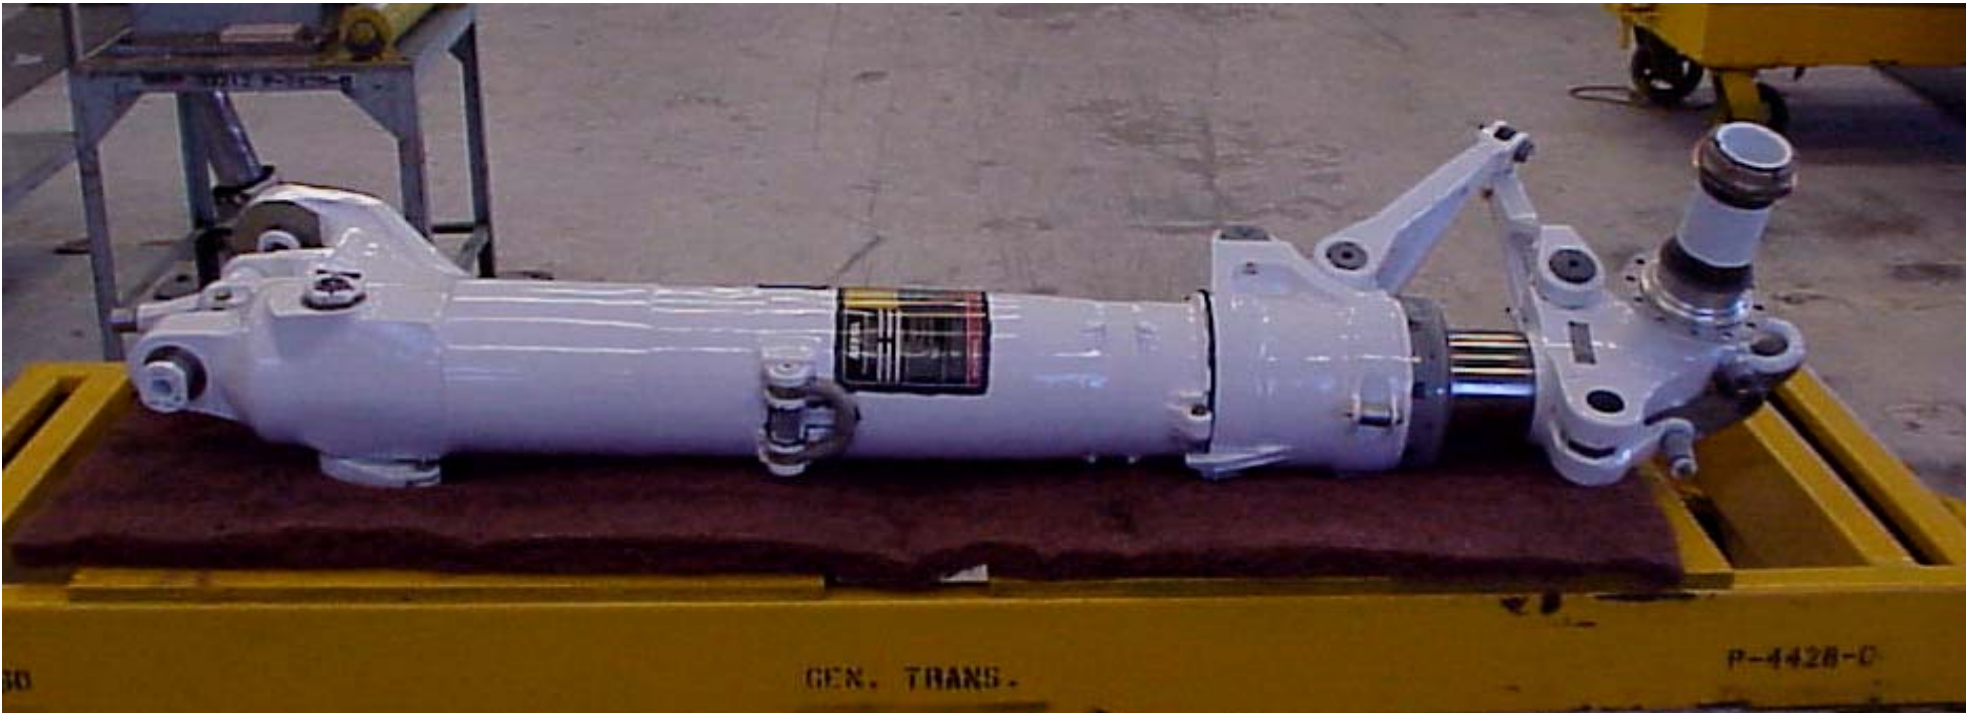
**This NAVAIR asset has a replacement cost of \$315,858 and has been collecting dust for three years. Based on stress levels provided by the OEM that designed the gear and the successful AF tests that simulated actual bending stress application in service, the test flying of this EA-6B gear is considered to have minimal risk. It is therefore requested that a flight clearance be issued.**
