HCAT PROJECT

***FUNCTIONAL ROD/SEAL TESTING AND QUALIFICATION
OF HVOF COATINGS ON NAVY ACTUATORS***

Jeff Gribble & James Magno

January 24, 2006

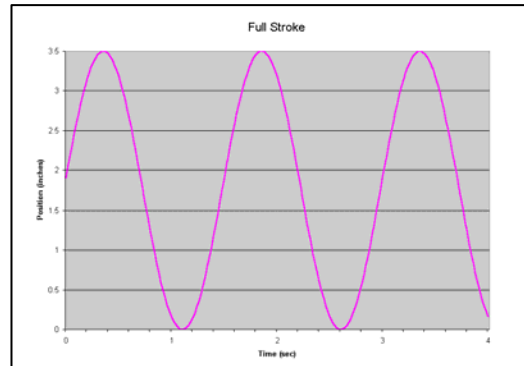
- Full Stroke (3.5” Stroke, 1.3 second Period, 15 Minute Duration per Hour)

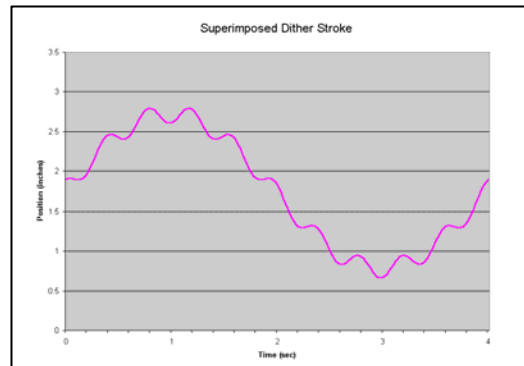
- Superimposed Dither (2” Main Stroke, 0.25” Dither stroke, 2.4 second Period, 3 Hz Frequency, 21 Minute Duration per Hour)

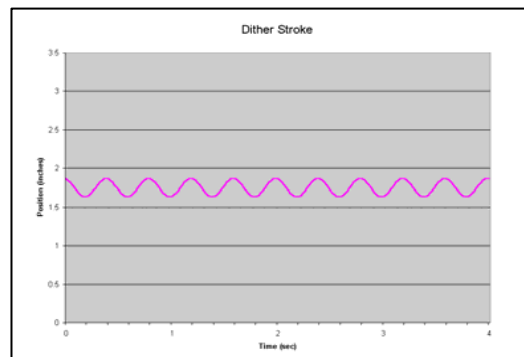
- Dither (0.25” Dither stroke, 3 Hz Frequency, 24 Minute Duration per Hour)

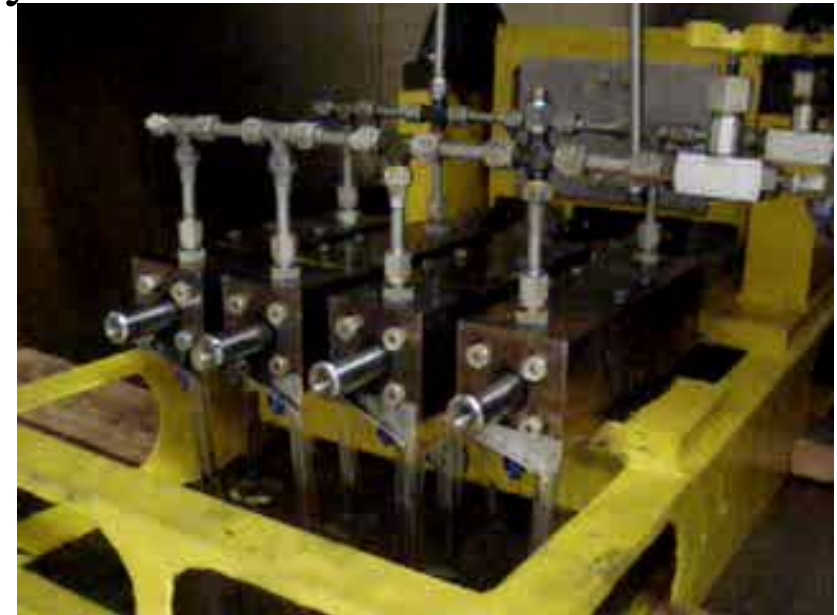
Test Rod and Seal Layout

- One seal configuration used in each of the 8 blocks. The 4 rod halves allow 2 data points per rod/seal configuration.
- Primary position (test seals) indicated in blue and the secondary (scraper seals) in magenta. Primary and secondary seals are similar.

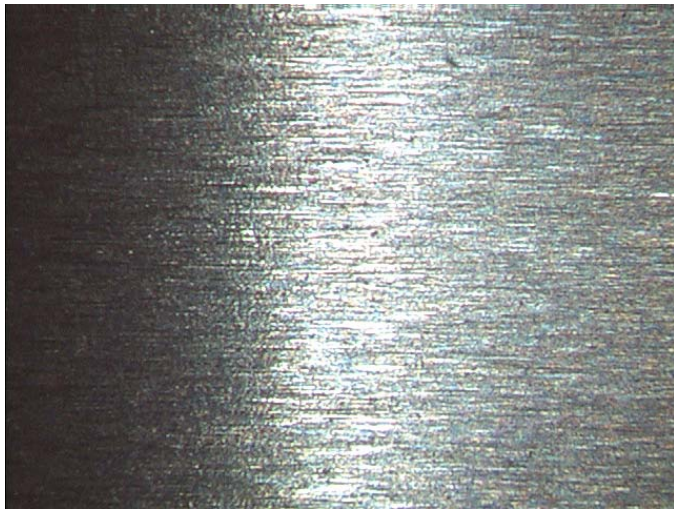
Rod 6a - Pre-Test (100x)

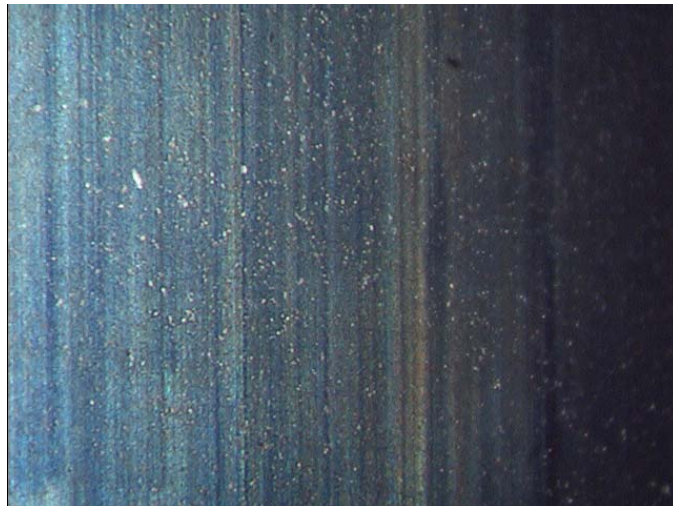
Rod 11a - Post-Test (100x)

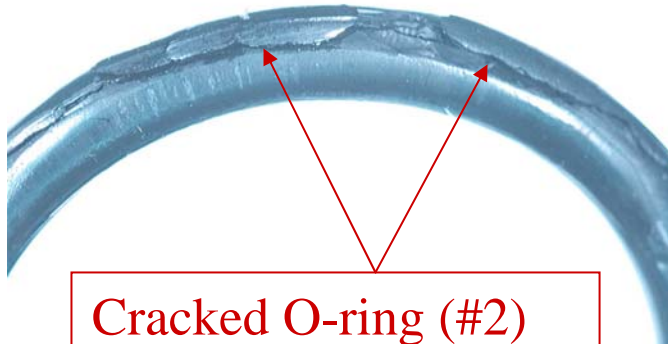
Cracked O-ring (#2)
