*Regional Sediment Management (RSM) Program*

## **Hawaii Regional Sediment Management Needs Assessment**

Thomas D. Smith and Linda S. Lillycrop

July 2014

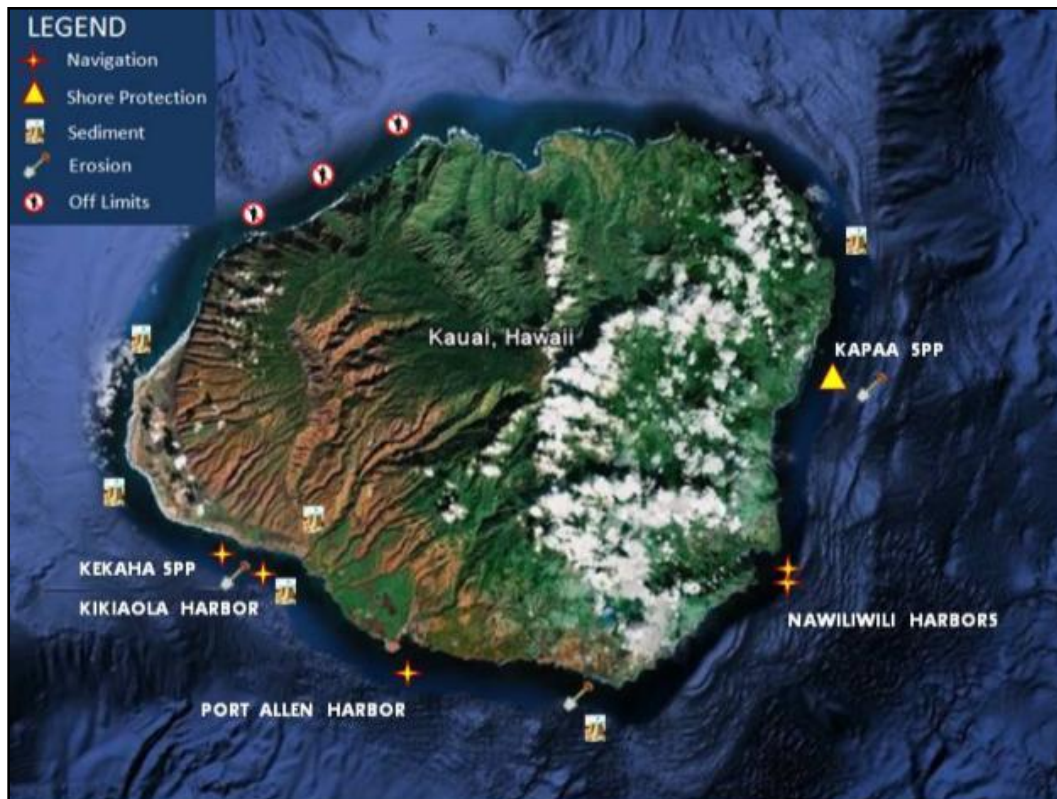
Figure 2. Locations of federally authorized navigation projects (stars) and shore protection projects (yellow triangles) on Island of Kauai that could benefit from RSM activities.

The federally authorized projects of interest on Island of Kauai include (a) Kikiaola Shallow Draft Harbor, (b) Port Allen Deep Draft Harbor, (c) Nawiliwili Deep Draft Harbor, (d) Nawiliwili Small Boat Harbor, (e) Kapaa Shore Protection Project, and (f) Kekaha Shore Protection Project.

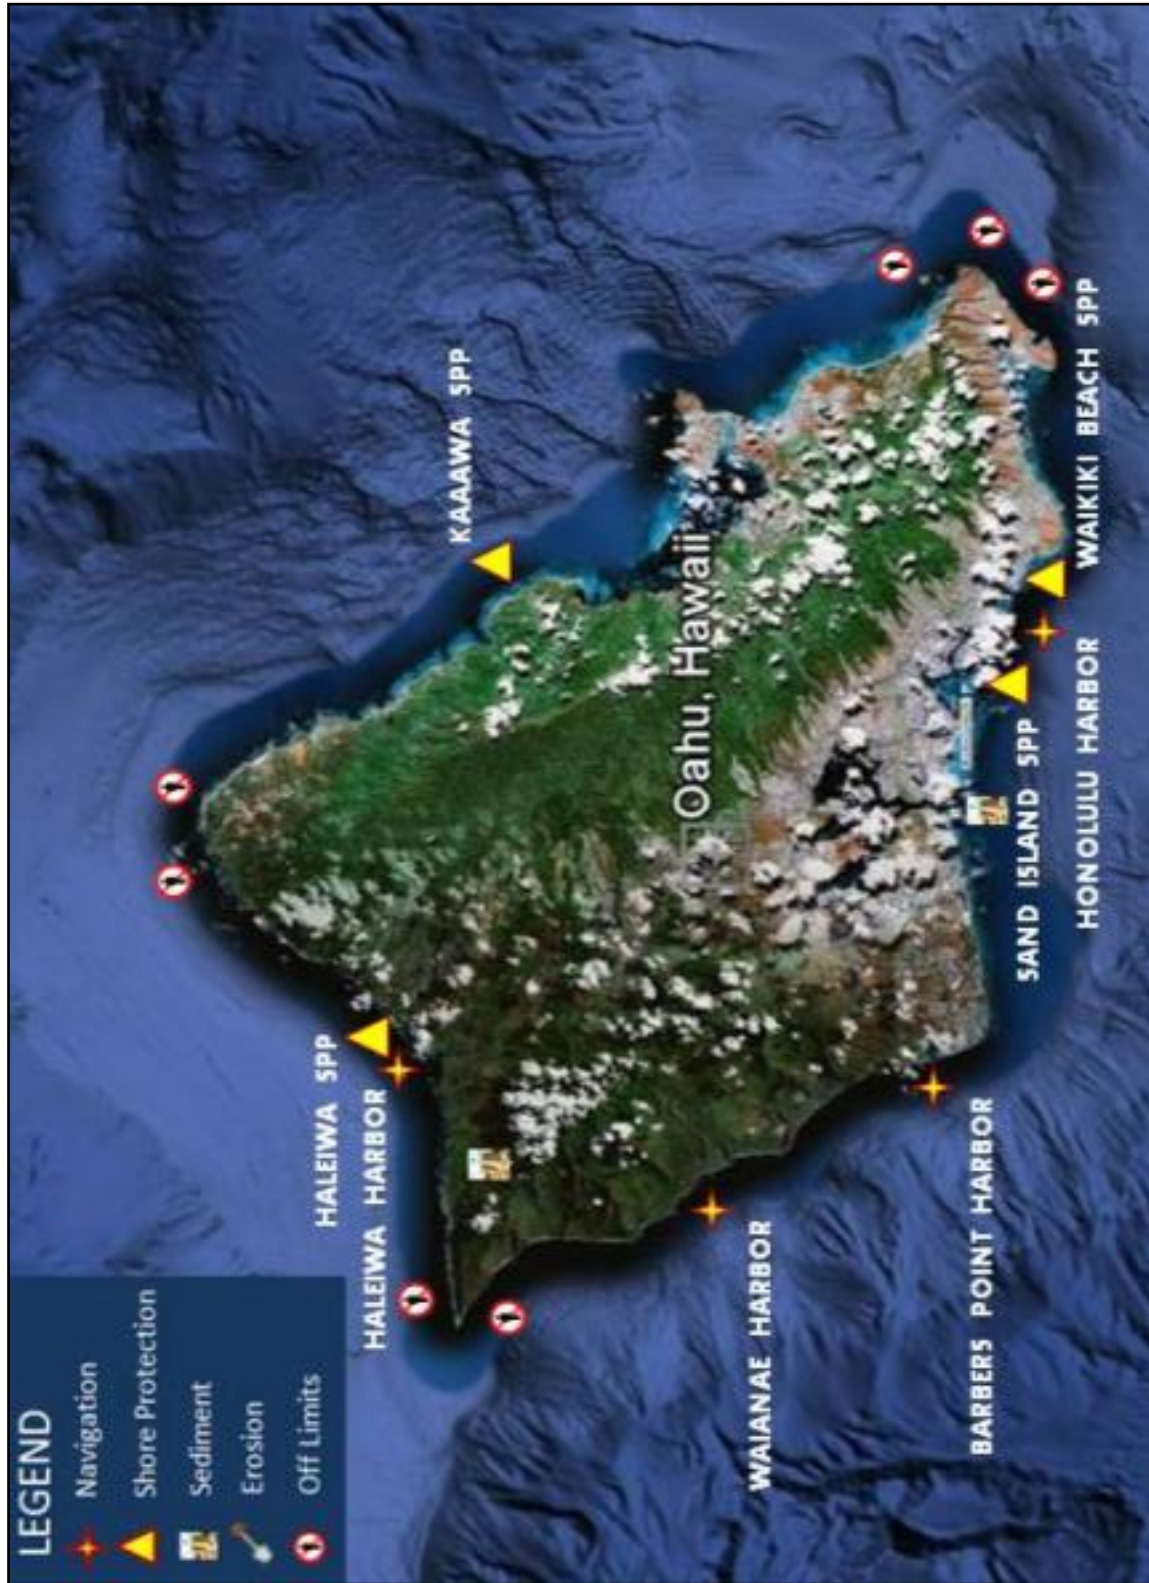
Figure 8. Locations of federally authorized navigation projects (stars) and shore protection projects (yellow triangles) on island of Oahu that could benefit from RSM activities.

Figure 8 provides approximate locations of the federally authorized navigation and shore protection projects on the Island of Oahu. The figure also indicates areas where sediment might be available, portions of shoreline that are experiencing erosion in the short term, and places that could potentially be off limits to RSM activities for various reasons.

The federally authorized projects of interest on the Island of Oahu include (a) Honolulu Deep Draft Harbor, (b) Barbers Point Deep Draft Harbor, (c) Waianae Small Boat Harbor, (d) Haleiwa Small Boat Harbor, (e) Haleiwa Shore Protection Project, (f) Kaaawa Shore Protection Project, (g) Waikiki Beach Shore Protection Project, and (h) Sand Island Shore Protection Project.

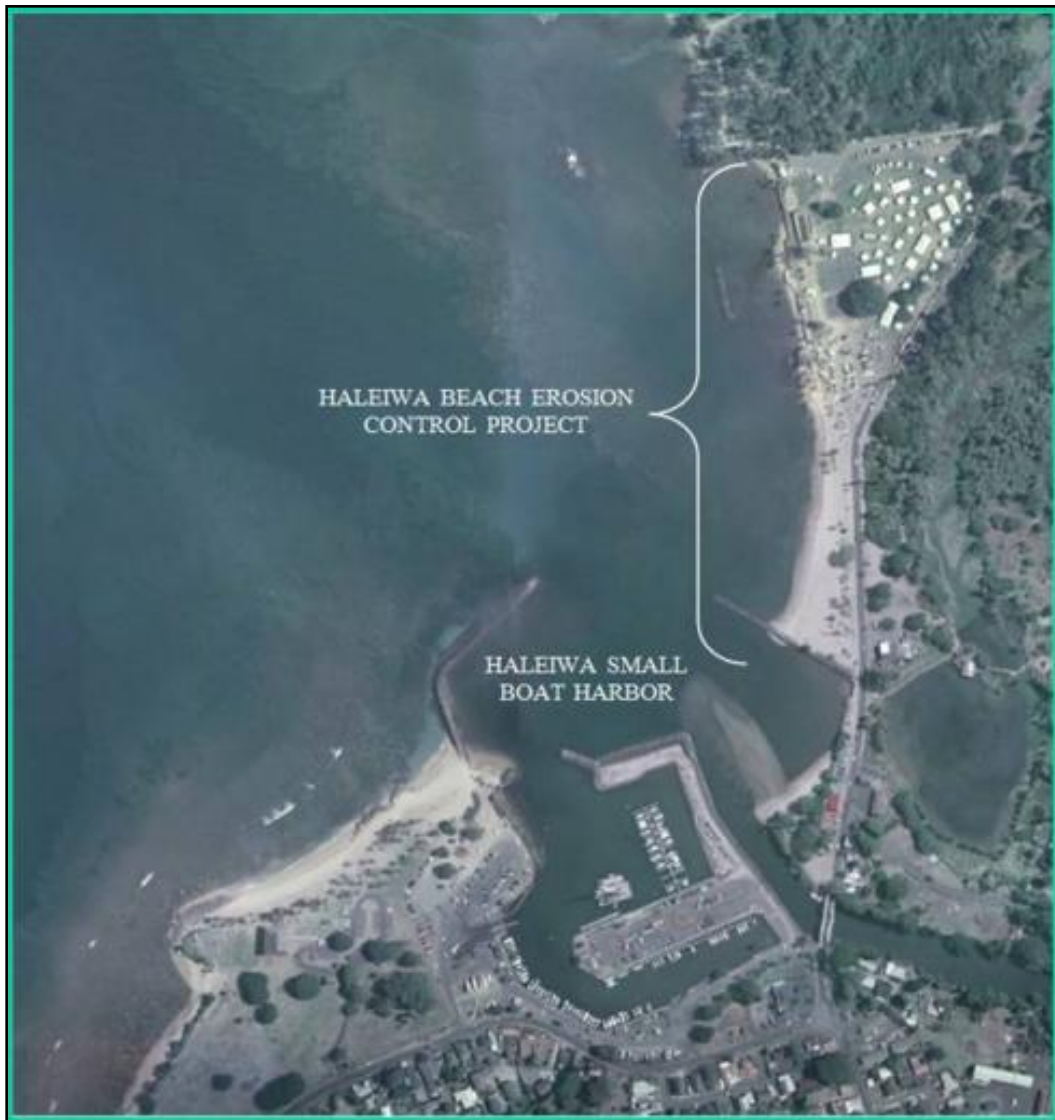
The federally authorized Haleiwa Shore Protection Project includes a 520 ft-long groin, a 160 ft-long offshore breakwater, and beach fill backed by a vertical seawall (Figure 11). Currently, erosion is threatening bathing and restroom facilities located behind the offshore breakwater. Regional sediment management techniques could be used to alleviate the erosion problems currently being experienced at Haleiwa Beach Park.

Figure 11. Google image (30 July 2006)–Haleiwa Small Boat Harbor and the Haleiwa Shore Protection Project.

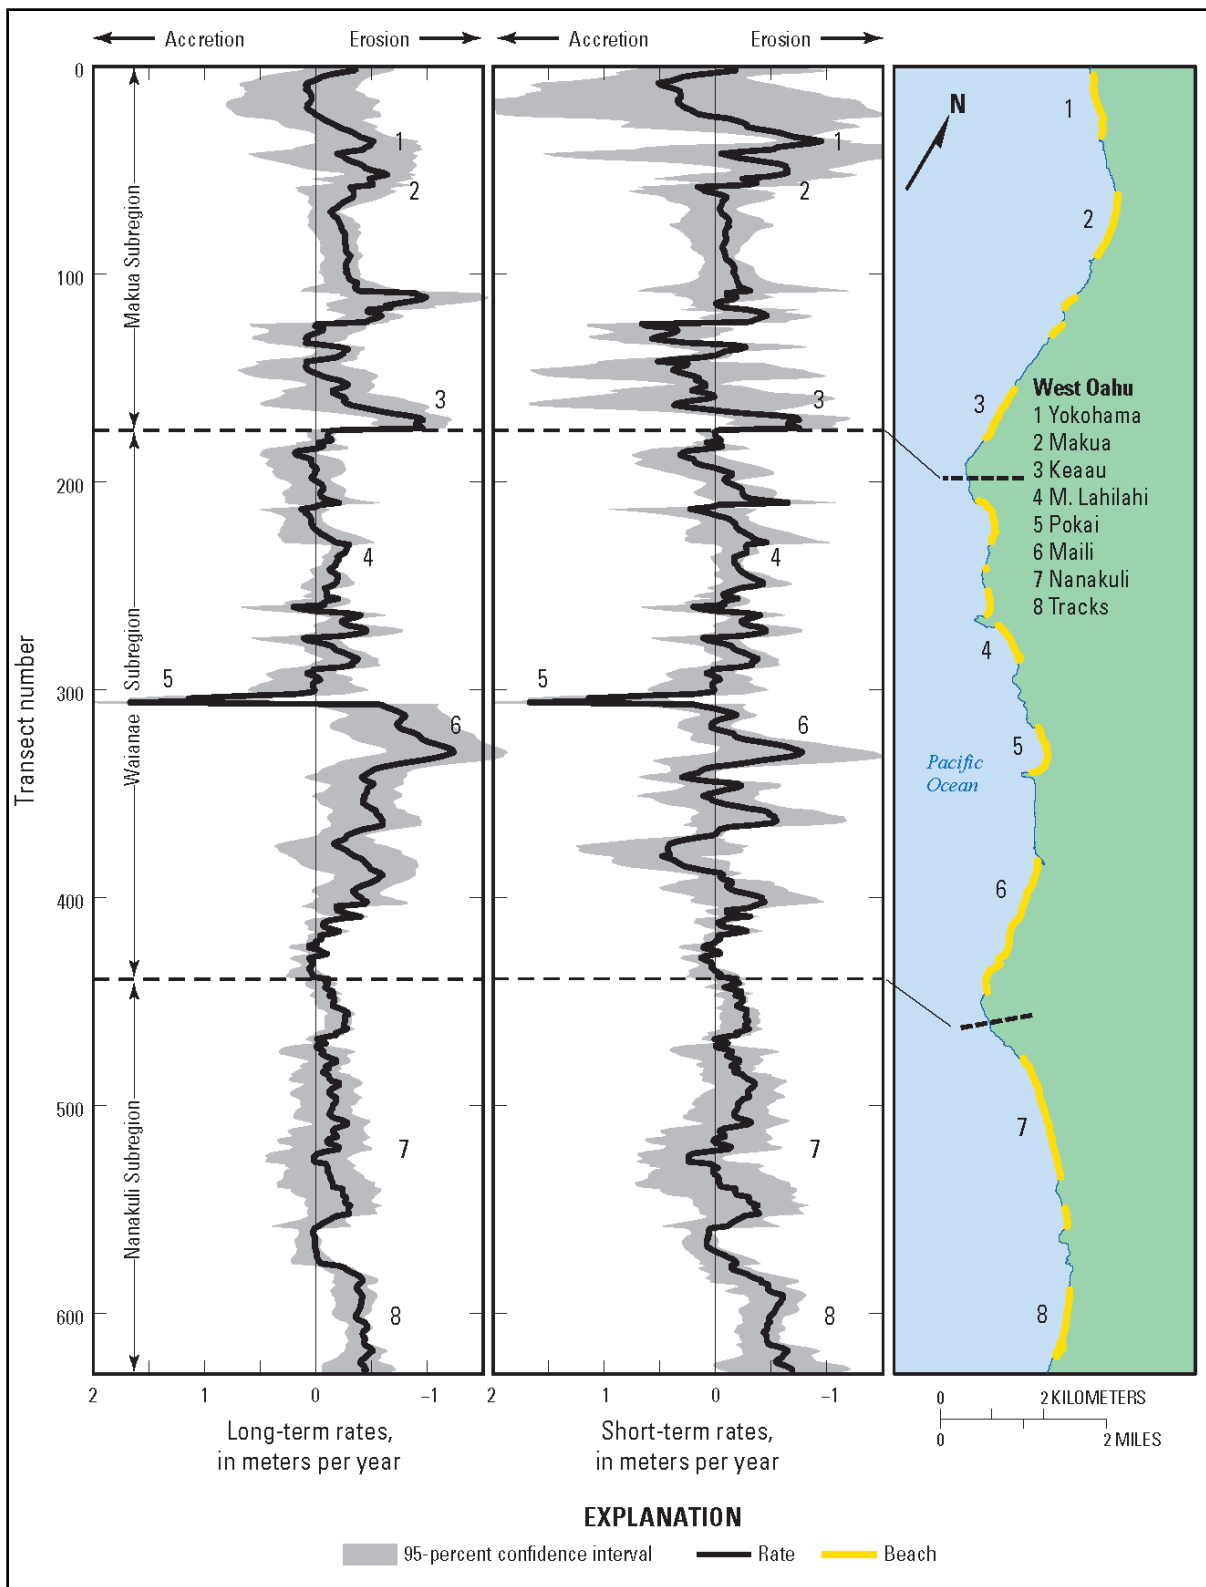
The maximum accretion rate ( $1.7 \pm 0.6$  m/yr) was found in the southern part of Pokai Bay [Figure 14]. This section of beach has been accreting since the construction of a breakwater in the 1950s. The short-term rates at Yokohama, Keaau, and Maili are less erosive than the long-term rates, indicating that shoreline recession may have slowed since sand-mining operations ceased.<sup>1</sup>

Figure 14. Long-term (all available years) and short-term (1940s to present) shoreline change rates, West Oahu (location shown in Figure 9) (Figure 30 of Fletcher et al. 2012; by permission).

West Oahu is the most erosional region of the Island, with an average long-term rate of  $-0.25 \pm 0.01$  m/yr and 83% of transects indicating erosion in the long term. The maximum long-term erosion rate ( $-1.2 \pm 0.5$  m/yr) was found in the northern part of Maili Beach. The maximum accretion rate ( $1.7 \pm 0.6$  m/yr) was found in the southern part of Pokai

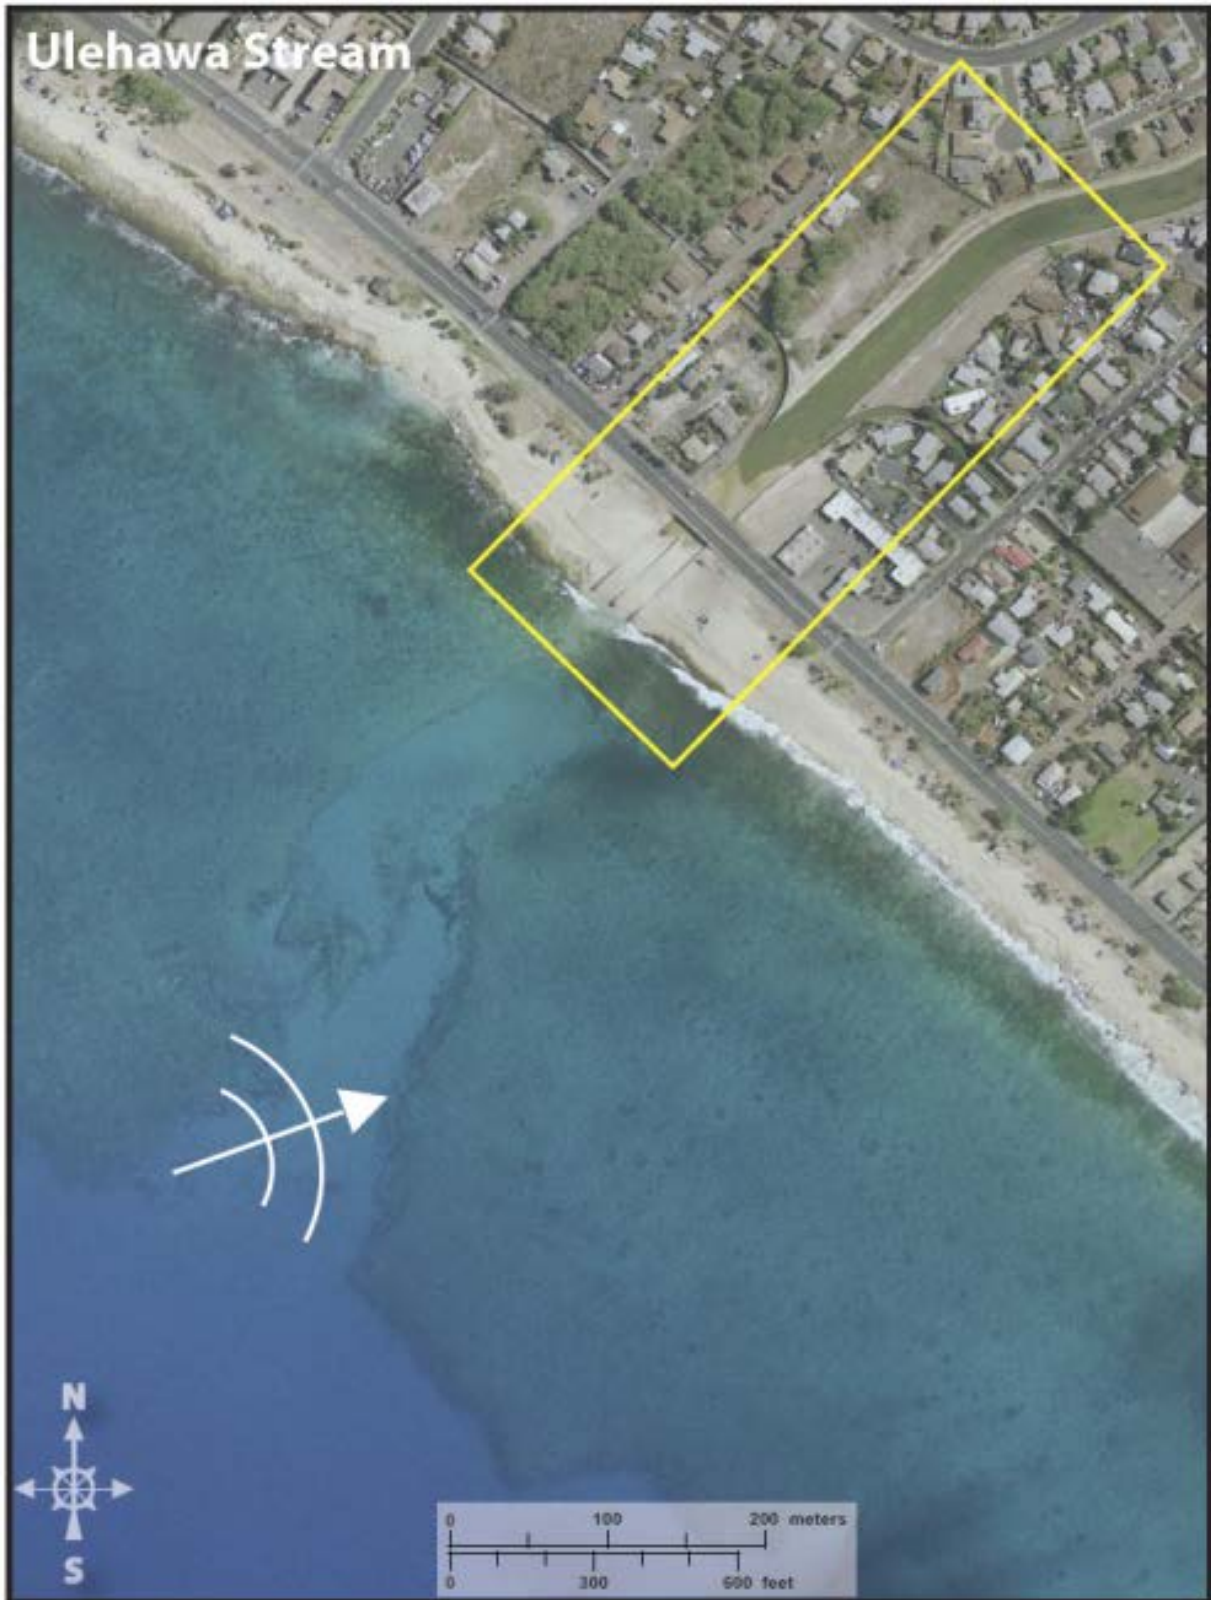
Figure 15. Aerial image of Ulehawa Stream showing sediment clogging the stream mouth.

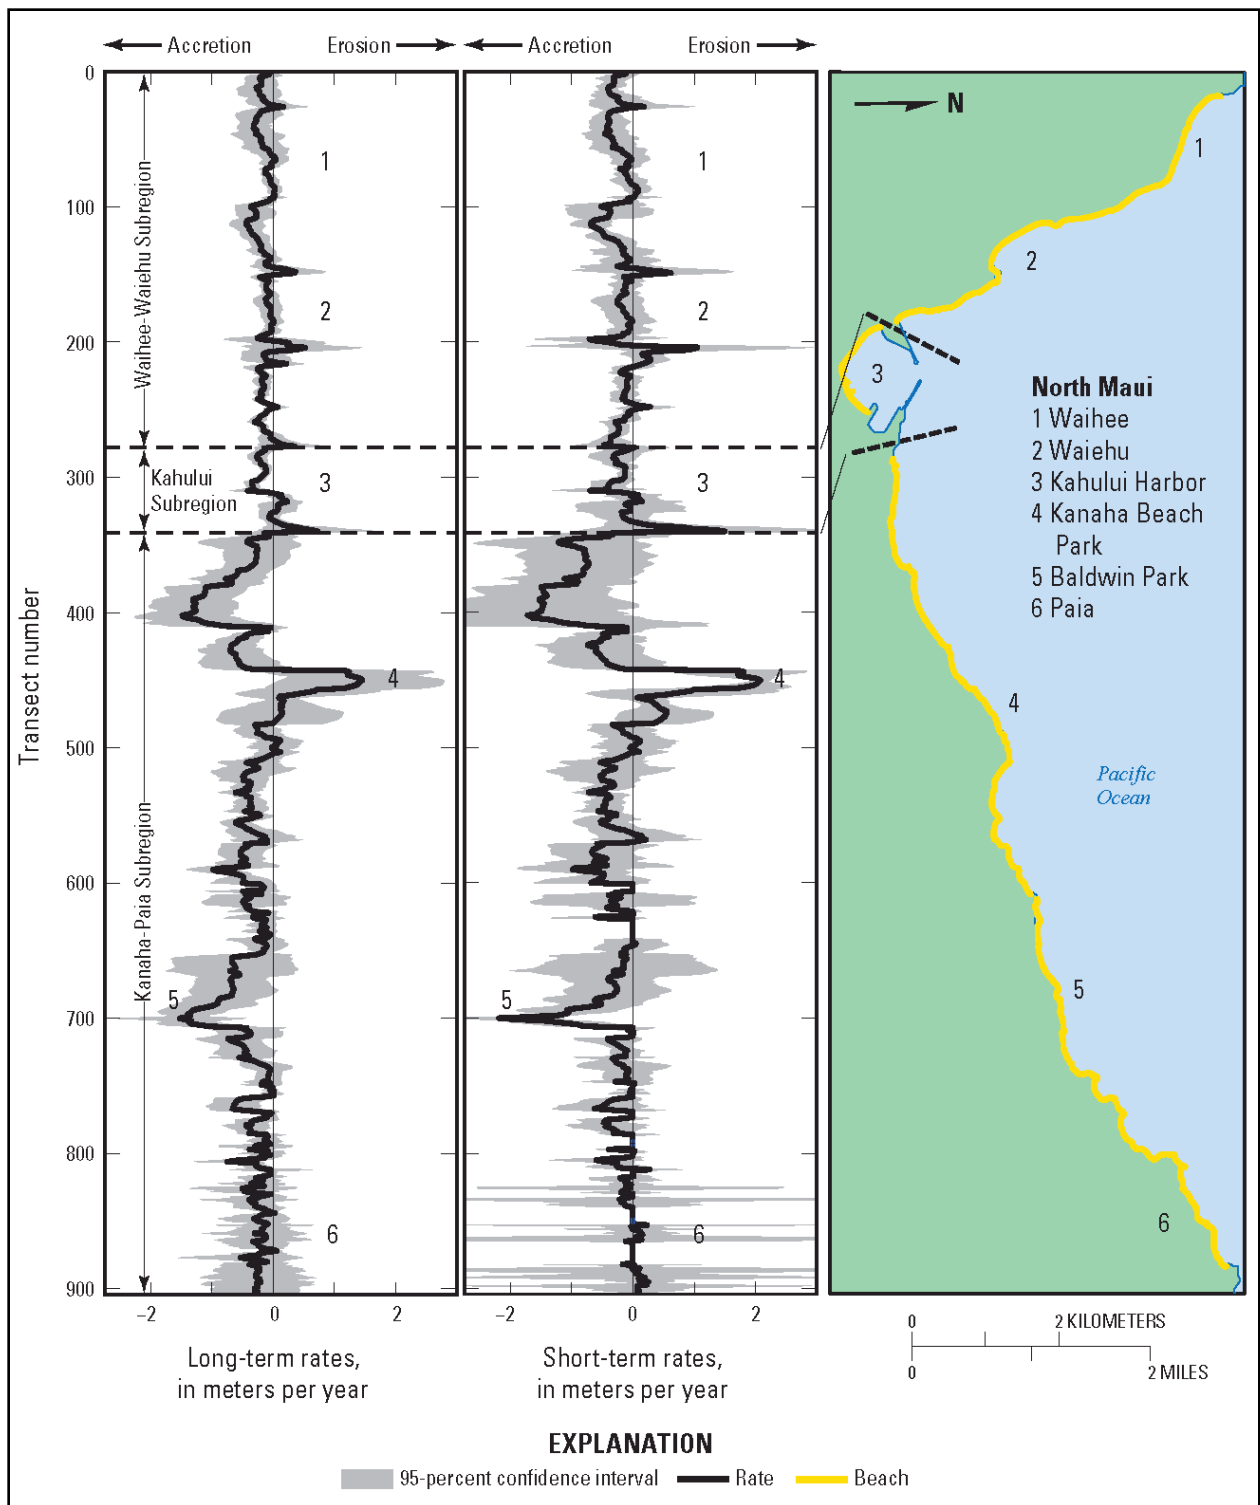
The maximum erosion rate ( $-1.5 \pm 1.1$  m/yr) was found in front of an offshore rock bench at Baldwin Park [Figure 19]. Shoreline recession at Baldwin is, in part, the result of sand-mining operations for a now-defunct lime kiln. A bench of beach rock was previously linked to the beach by a tombolo, but is now isolated offshore (Genz et al. 2009). Other areas of significant erosion were found at Waiehu Beach Park (up to  $-0.5 \pm 0.3$  m/yr, long term) and Kanaha Beach Park (up to  $-1.5 \pm 0.7$  m/yr, long term). The maximum long-term accretion rate ( $1.5 \pm 1.3$  m/yr) was measured between two groins at Kanaha Beach Park.

The average short-term shoreline change rate for North Shore beaches,  $-0.22 \pm 0.03$  m/yr, is roughly the same as the average long-term rate. Seventy-four percent of the beach is erosional in the short term. The maximum short-term erosion rate ( $-2.2 \pm 1.1$  m/yr) was found in the same location as the maximum long-term erosion rate (Baldwin Park). The maximum short-term accretion rate ( $2.1 \pm 0.2$  m/yr), like the maximum long-term accretion rate, was found in Kanaha Beach Park. Short-term and long-term rates follow a similar pattern, though uncertainty is higher in the short-term rate because of the truncated data set.

Figure 19. Long-term (all available years) and short-term (1940s to present) shoreline change rates, North Maui (location shown in Figure 18) (Figure 33 of Fletcher et al. 2012; by permission).

The maximum erosion rate ( $-1.5 \pm 1.1$  m/yr) was found in front of an offshore rock bench at Baldwin Park. Other areas of significant erosion were found at Waiehu Beach Park (up to  $-0.5 \pm 0.3$  m/yr, long term) and Kanaha Beach Park (up to  $-1.5 \pm 0.7$  m/yr, long term). The maximum long-term accretion rate ( $1.5 \pm 1.3$  m/yr) was measured between two groins at Kanaha Beach Park.

The average short-term shoreline change rate for North Shore beaches,  $-0.22 \pm 0.03$  m/yr, is roughly the same as the average long-term rate. The maximum short-term erosion rate ( $-2.2 \pm 1.1$  m/yr) was found in the same location as the maximum long-term erosion rate (Baldwin Park). The maximum short-term accretion rate ( $2.1 \pm 0.2$  m/yr), like the maximum long-term accretion rate, was found in Kanaha Beach Park.

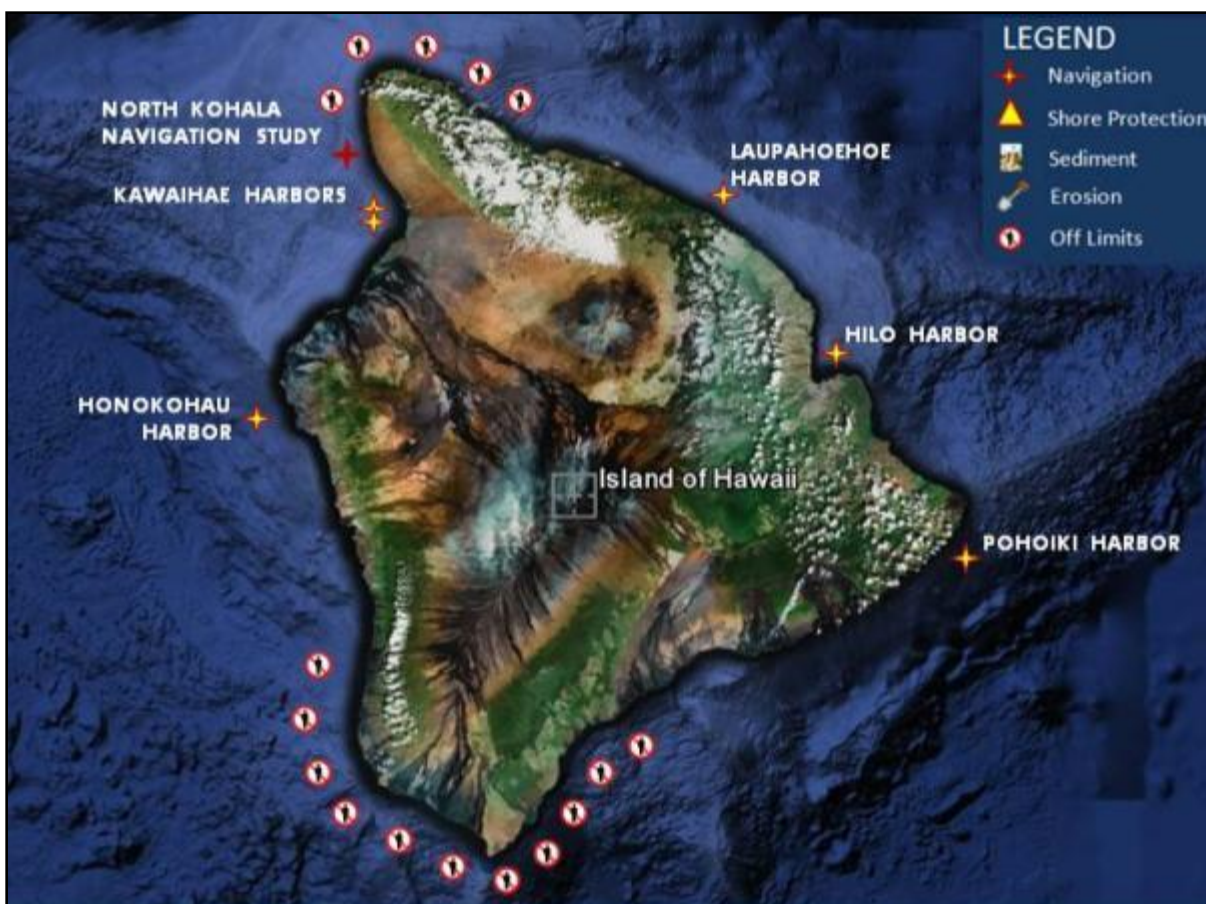
Figure 22. Locations of federally authorized navigation projects (stars) on Island of Hawaii that could potentially benefit from RSM activities.

The Island of Hawaii is 93 miles across in its greatest dimension and has a land mass of 4,028 sq miles. Measured from its sea floor base to its highest peak, Mauna Kea is the world's tallest mountain, taller than Mount Everest is above sea level. Figure 22 displays federally authorized projects in Hawaii County that could potentially benefit from implementation of RSM principles and practices. Areas that could potentially be used as sediment sources, areas of chronic erosion, and portions of the shoreline that may be off limits to RSM activities are also indicated.

The federally authorized studies and projects of interest on the Island of Hawaii include (a) Hilo Deep Draft Harbor, (b) Kawaihae Deep Draft Harbor, (c) Kawaihae Small Boat Harbor, (d) Honokohau Small Boat

Harbor, (e) Laupahoehoe Navigation Improvements, (f) Pohoiki Navigation Improvements, and (g) North Kohala Navigation Study.

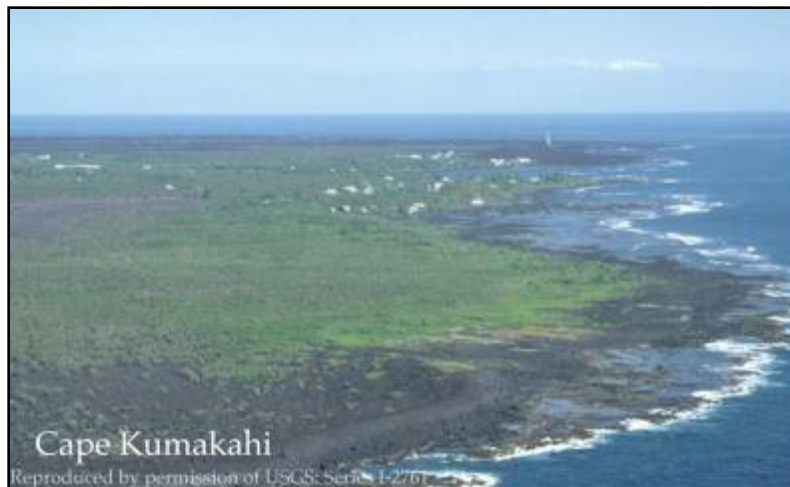
Figure 24. Cape Kumakahi, a broad, rocky point with a shallow slope at the coast (uncaptioned figure of UH CGG 2012; by permission).

The Puna District comprises the eastern most corner of the Big Island, reaching out at Cape Kumakahi, a broad, rocky point with a shallow slope at the coast [Figure 24]. This area was resurfaced during the 1960 flow originating from Kilauea's east rift zone. The flow narrowly missed the navigational light on the point as it remarkably divided into streams and flowed around the lighthouse (Clark 2002).

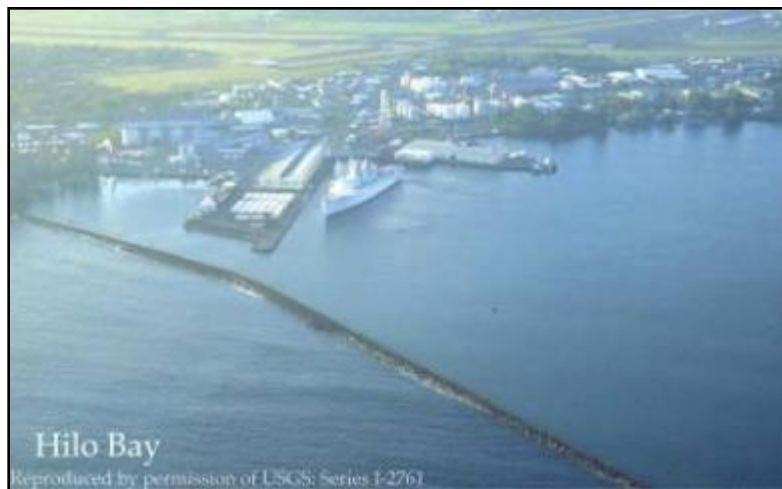
Figure 25. Hilo Harbor breakwater and berthing areas, Island of Hawaii. The Hilo Small Boat Harbor is also visible in the upper left portion of the photograph (uncaptioned figure of UH CGG 2012; by permission).

The Hilo Harbor breakwater is nearly 2 miles long and affects the circulation within the Bay. Modification of the breakwater is recommended by County staff to improve circulation and ultimately water quality within the Bay. Future deepening of various channels and berthing areas in Hilo Harbor are being considered. Additionally, POH plans to conduct maintenance dredging at all deep-draft harbors in the State that are below project depth in FY15. Material dredged during these and other operations should be considered for beneficial use.

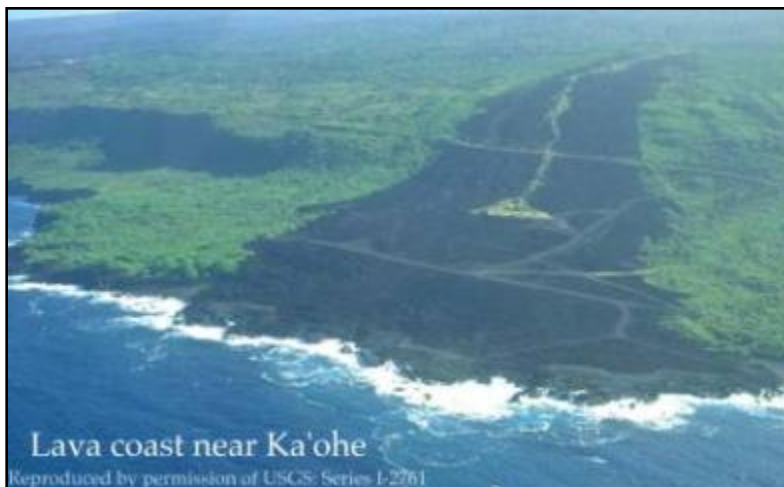
Figure 31. Recent lava flow remains mostly un-vegetated near Ka'ohe (uncaptioned figure of UH CGG 2012; by permission).

Between Ka‘ohe and Moili‘i, streaks of relatively recent flows (1950’s) extend to the coast from the volcano [Figure 31]. Here, tide pools at the shoreline are generally formed of lava spits in various stages of erosion. These areas are mainly accessible by four-wheel-drive off-road vehicles, and are devoid of development.

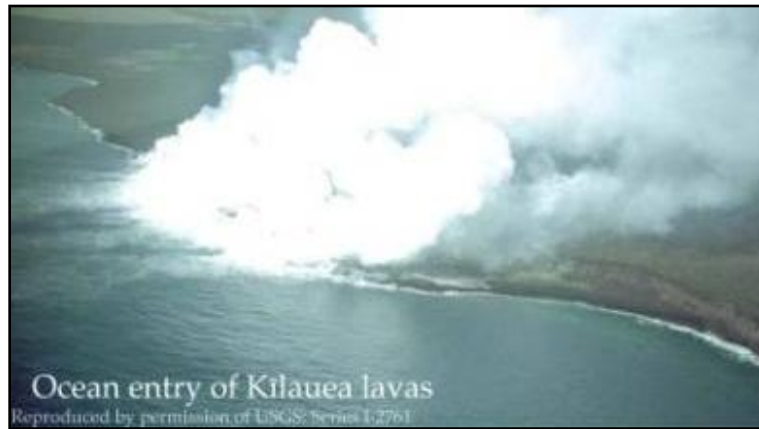
Figure 32. Steam rising as lava enters the ocean from the Kilauea flow (uncaptioned figure of UH CGG 2012; by permission).

Lava benches such as at Wilipea are a mechanism of the Island's growth. These form as lava builds up repeatedly into thick and wide benches at the coast [Figure 32]. Lava benches may collapse suddenly into the ocean, leaving behind sharp cliffs, and creating steam plumes of lava haze as seawater boils and vaporizes on contact with the rocks that may be hotter than 1,100° C. These collapses may release water vapor, sulfur dioxide, chlorine gas, and fine shards of volcanic glass. Activity at the surface of
