Torsionmeter Removal and Reinstallation Procedure

Michael Brincat, Peter Vincent and Mark Ciacic

DSTO-TN-1238

Armidale Class Patrol Boat Torsionmeter Removal and Reinstallation Procedure

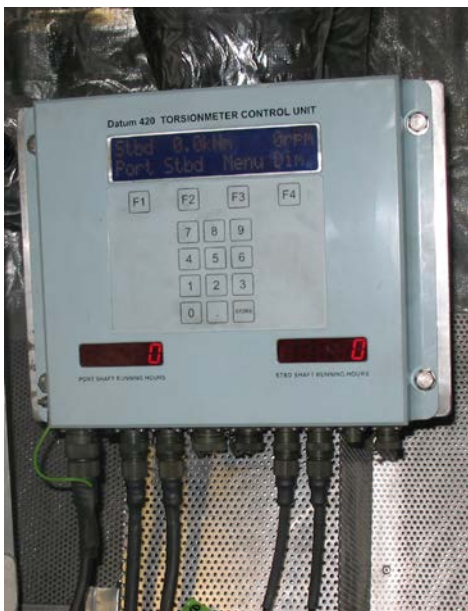
Figure 1 – Torsionmeter control unit, mounted in engine room on HMAS GLENELG.

The torsion meters are commercial off the shelf Type 420 Marine Torsionmeter, supplied by DATUM Electronics, and have been used extensively throughout the Royal Navy's fleet [3]. The system consists of a torsionmeter controller shown in Figure 1, two torsionmeters (port & starboard) and a remote display shown in Figure 2. The torsionmeter units consist of a stator and rotor. The controller receives data from the torsionmeters and displays the shaft speed, torque and calculated engine power of each unit.

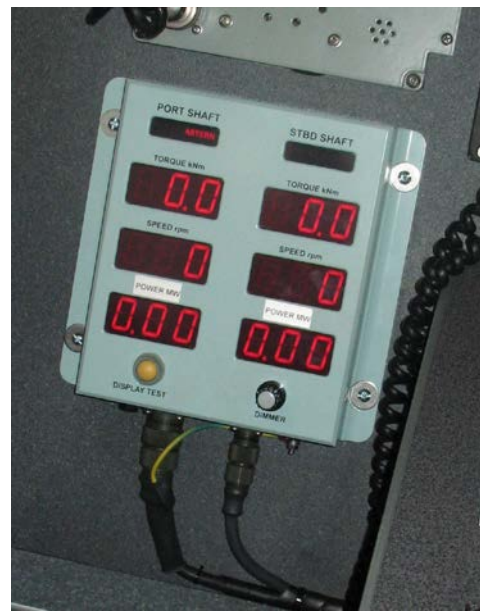
Figure 2 – Torsionmeter remote display unit, mounted in bridge on HMAS GLENELG
