August 1943 as
Advance Restricted Report 3H24

**DEVELOPMENT OF THERMAL ICE-PREVENTION EQUIPMENT
FOR THE B-17F AIRPLANE**

By Alun R. Jones and Lewis A. Rodert

Ames Aeronautical Laboratory
Moffett Field, California

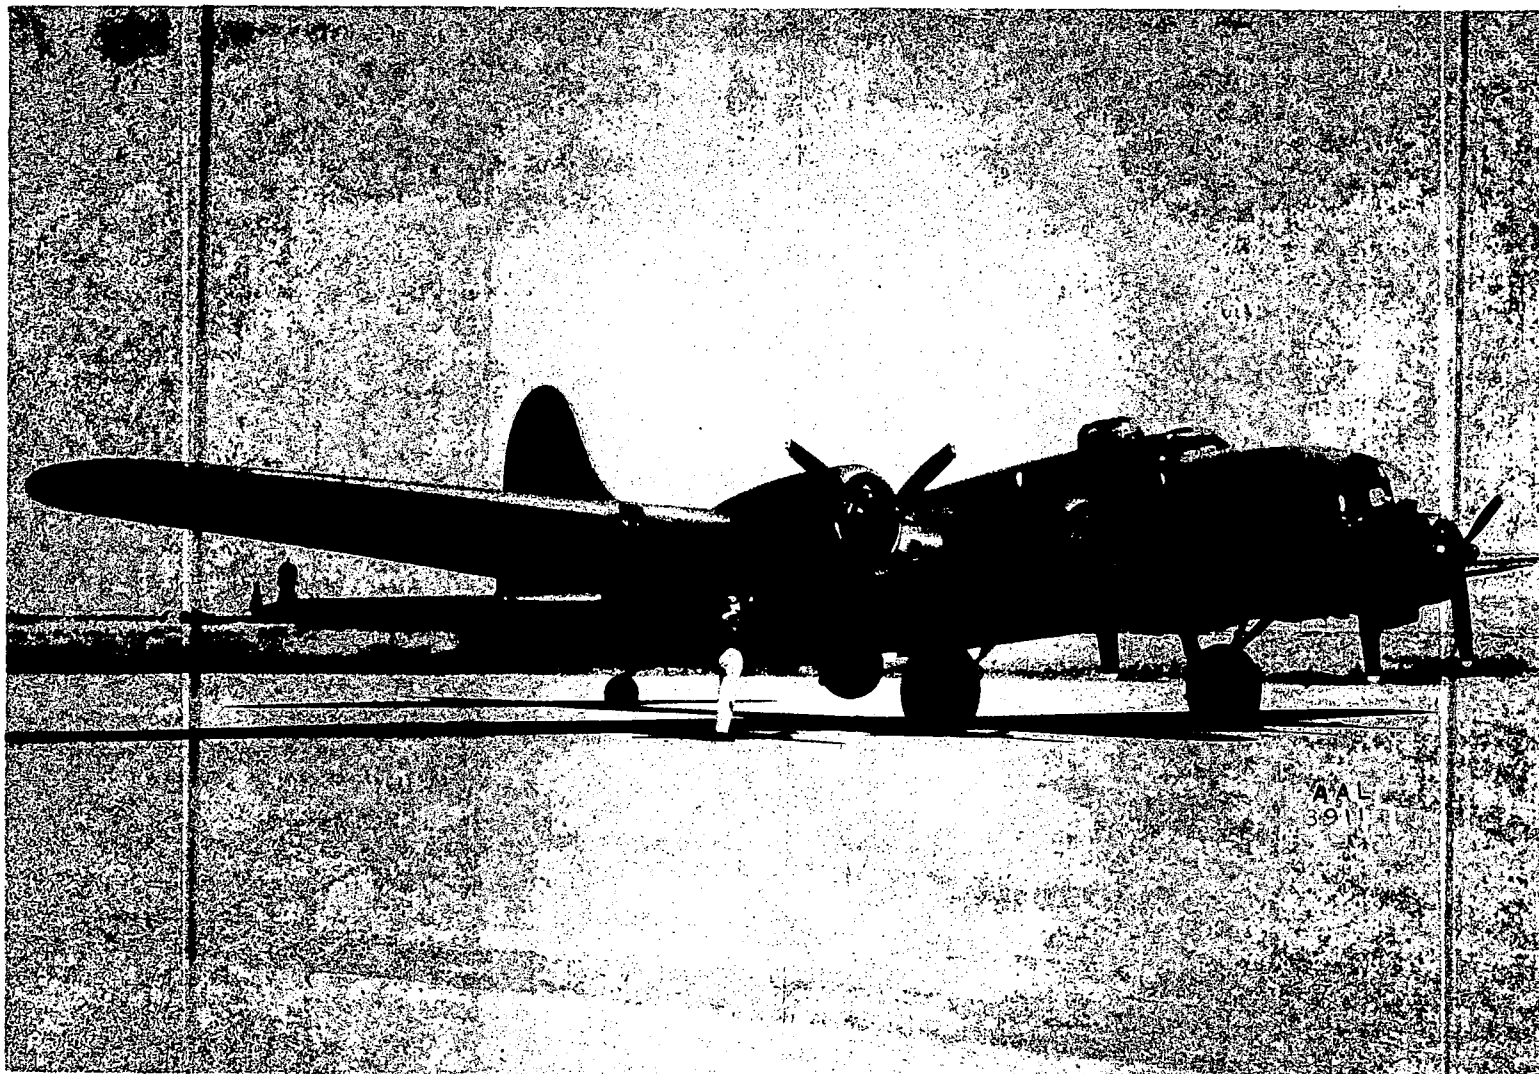
Figure 1.- The B-17F airplane in which thermal ice-prevention equipment was installed and tested.

The B-17F airplane is shown in figure 1. The airplane is a midwing monoplane of the heavy bombardment type, powered by four Wright model R-1820-97 engines, having a sea-level rating of 1000 horsepower. Each engine is equipped with an exhaust-driven type B-2 turbosupercharger.

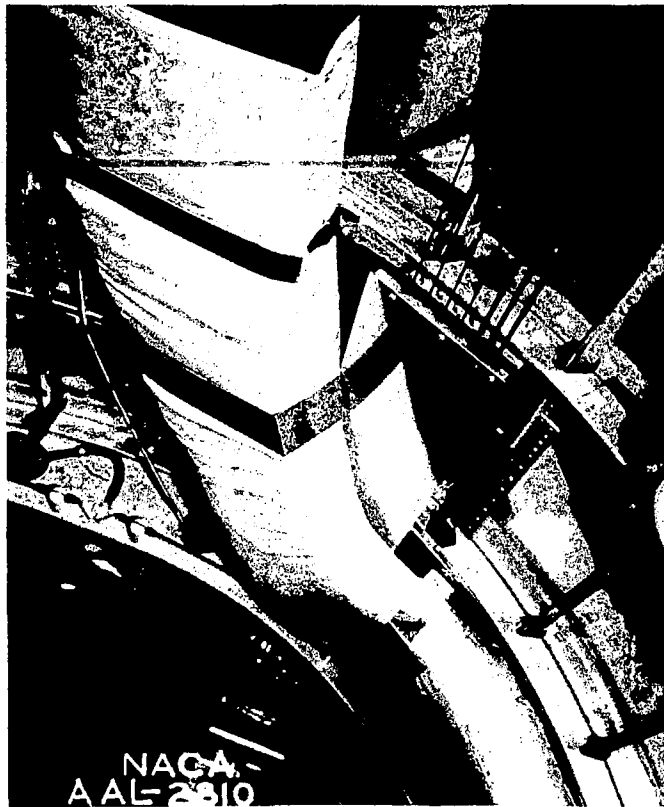
Figure 10.- View inside fuselage of empennage heated- air supply duct.

The primary function of the heat exchanger in nacelle 3 is to furnish heated air for the empennage. The supply duct from nacelle 3 to the empennage is indicated in figure 2. Portions of the duct inside the right wing, and inside the fuselage, are shown in figures 9 and 10. The entire duct line from the nacelle to the empennage was insulated with a 1-inch thick blanket of rock-wool type material and covered with linen cloth.
