COMPLETION

**REPORT**

# **OPERATION REDWING**

U. S. ATOMIC ENERGY COMMISSION CONTRACT AT-(29-2)-20 PACIFIC PROVING GROUND 1954 - 1956 1.11

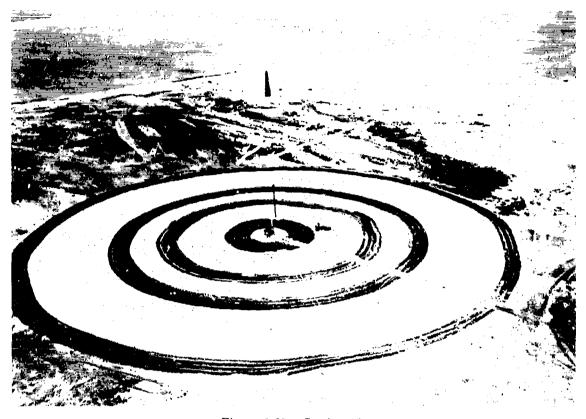
Figure 2-35. Station 18

STATIONS:	18 and 19
PURPOSE:	Ground Zero (Airdrop
	target)
SITES:	18 Charlie, 19 Yvonne
USER:	LASL
CONSTRUCTION:	Station 18, 2-23-56/4-25-
	56; Station 19, 6-10-56
	6-15-56

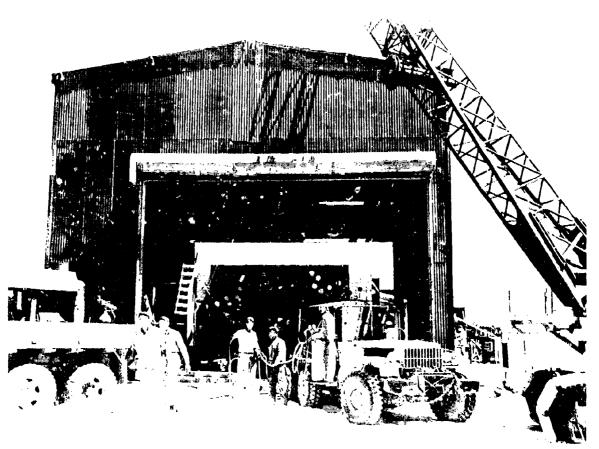
Figure 2-38. Station 24 - 55% Complete

STATION:	24
PURPOSE;	Ground Zero
SITE:	Yvonne
USER:	LASL
CONSTRUCTION:	1-11-56/4-24-56

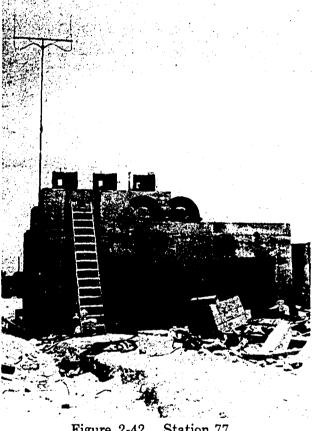
Figure 2-42. Station 77

A survey was made of the condition of the existing stations which determined Operation REDWING work requirements. As a result, the following stations were modified and rehabilitated: 70 site Nan; 71 site Elmer; 72.02 site Ursula; 7304 site Irene; 73.06 site Tare; 74 site Oboe; 75.02 site How; and 76 site George. The rehabilitation of these stations consisted of replacing conduits and providing additional circuits and outlets. Radio loads were critical at Station 70. Therefore, a 20 KW generator was installed for auxiliary power. An automatic transfer switch provided for changeover to this auxiliary power in case of low volt-ages in the main island system.

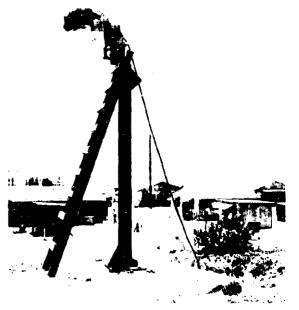
Figure 2-59. Station 815.01

STATION:	815.01
PURPOSE:	Thermal Radiation
	Measurements
SITE:	Yvonne
USER:	DOD-8
PARTICIPATION:	24
CONSTRUCTION:	4-7-56/4-23-56

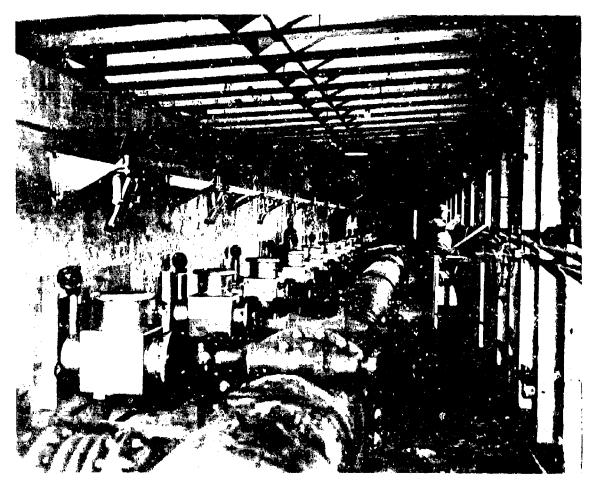
Figure 2-84. Interior Mirror Shed - Station 1524

This station consisted of a two-story building  $324' \ge 12'-6''$  wide and 17' high, forming a pump and mirror house from which a 38 vacuum pipe array led to the working point of Station 24, a distance of 500 feet. The first story of the building consisted of six pump houses spaced along the length of the building; the second floor consisted of a  $313' \ge 10'$  room which housed the vacuum manifold and mirrors for each pipeline. The mirrors, located at elevation plus 20'-6'', reflected light from the mirrors at the 38 pipe ends and in turn sent this reflection to camera Station 1520 through openings in the front wall of Station 1524. Beginning at Station 1524 and progressing toward Station 24, the 38 pipes were 12-inch diameter for a distance of approximately 410 feet, later changed to 10-inch diameter for an additional distance of approximately 76 feet, and then reduced to 7-inch pipe for the remaining distance of approximately 25 feet, to the working point of Station 24.

The mirrer house structure rested on the pump houses and on intermediately-spaced columns at the rear wall facing away from Station 24. The second story roof and floor and rear walls of both stories were wood framed. Since the pump houses were 32 feet apart, the secondstory rear walls were suported on 12-inch Ibeams which spanned to 6-inch steel pipe columns spaced between the pump houses. The front walls of both stories consisted of 18-inchthick reinforced concrete, and the span between

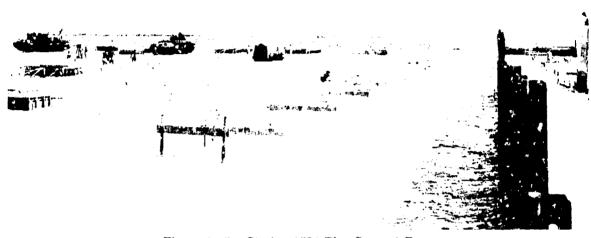
Figure 2-85. Station 1524 Pipe Support Bases

the pump houses consisted of a reinforced concrete 1-beam the height of the second story. The concrete flanges of the I-beam were used to give lateral stability to the 32-foot span and were extended the full length of the building. To give lateral stability to the entire building, the end walls of the pump houses were extended 2'-6'' to form buttresses. Because the building utilized mirrors, settlement was a critical consideration.

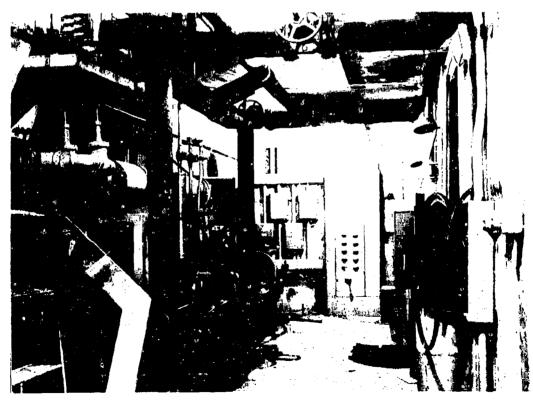
Figure 2-98. Station 2201 - Utility Room

STATION:	2201
PURPOSE:	Recorder Station
SITE:	Sally
USER:	UCRL
PARTICIPATION:	1, 2, 3 and 4
CONSTRUCTION:	10-3-55/4-27-56

Existing CASTLE Station 2201 was rehabilitated and known by the same identification

number for this Operation. It was necessary to remove the earth cover over the station prior to effecting rehabilitation.

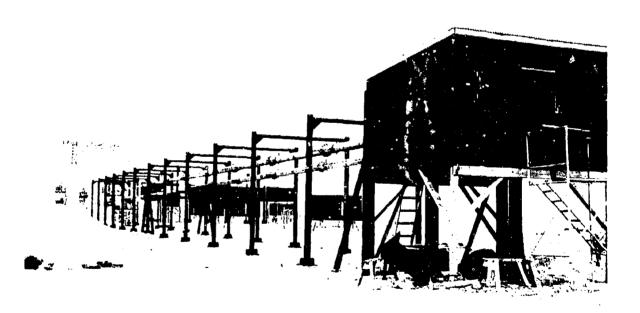
Figure 2-111. Station 2310

Station 2310 consisted of the following: two 300-foot vacuum pipes which emanated from the front wall of Station 22; a mirror house at which the 300-foot pipes terminated; four vacuum pipes with approximate lengths of 81', 72', 63' and 54' which emanated from the north wing wall of Station 22; and four mirror houses at which the four vacuum pipe array terminated.

The 300-foot vacuum pipes consisted of 4", 8" and 12"-diameter thin wall steel pipe, supported and braced in Station 22 by a steel column, hangers at the front wall of Station 22, and 14 steel H-frame supports. Provisions were made in the support system to resist the lateral thrust of the vacuum pipes, to allow for longitudinal movement by use of expansion bellows, and for horizontal and vertical adjustment of the pipes. The approximate size of the supports was 17' high by 10' wide. On the side of and about midway along the pipe lengths, a concrete base and wood shelter were provided for two vacuum pumps.
