OPERATION HARDTACK

**Project 3.3—Shock Loading in Ships from Underwater Bursts and Response
of Shipboard Equipment**

H. L. Rich	W. E. Carr
R. L. Bort	R. E. Converse, Jr.
F. T. Habib	K. T. Cornelius
R. E. Baker	F. Weinberger
David Taylor Model Basin	
Washington, DC

30 September 1961

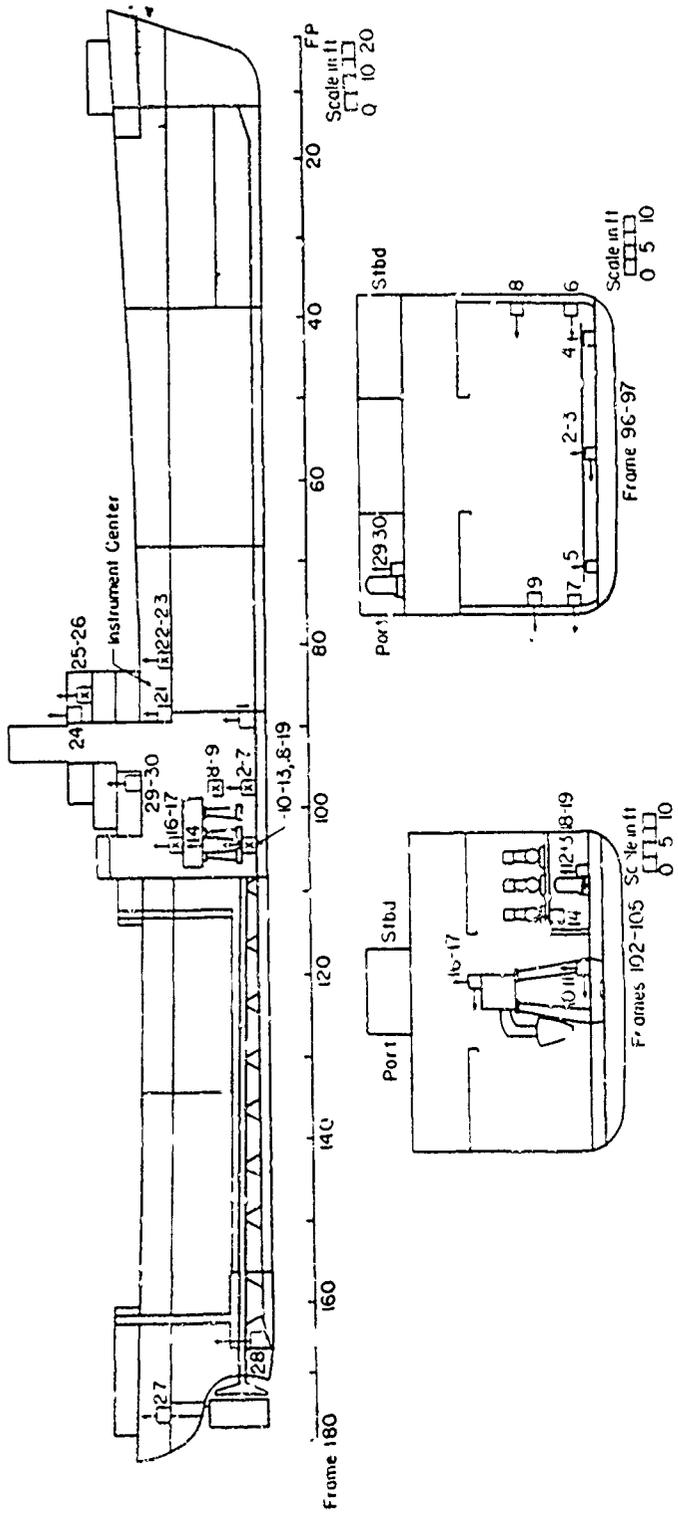
Figure 2.4 Inboard profile and section views, showing approximate locations of shock-measuring instruments on EC2.

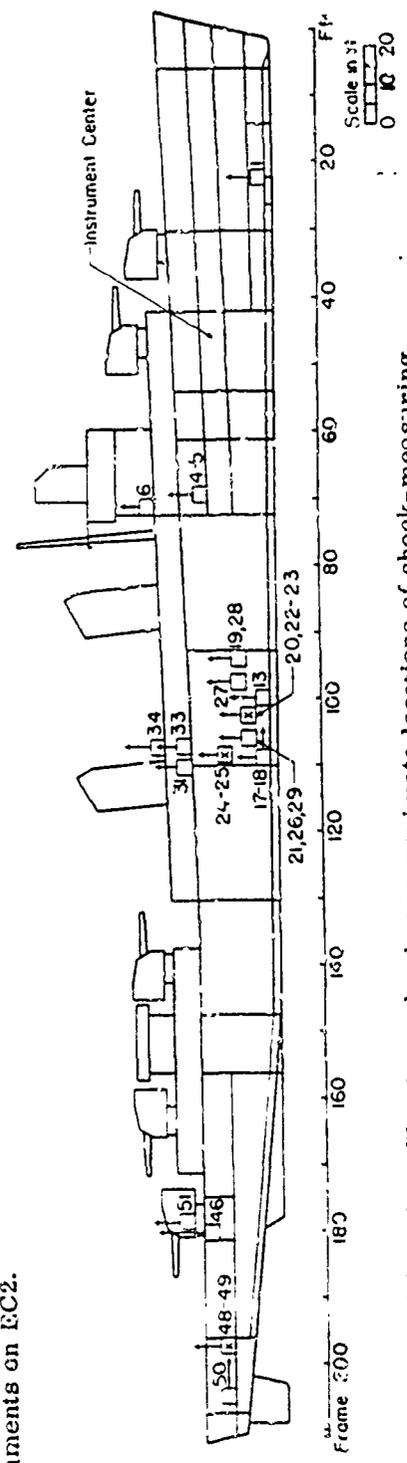
Figure 2.5 Inboard profile view, showing approximate locations of shock-measuring instruments on DD474 and DD593.

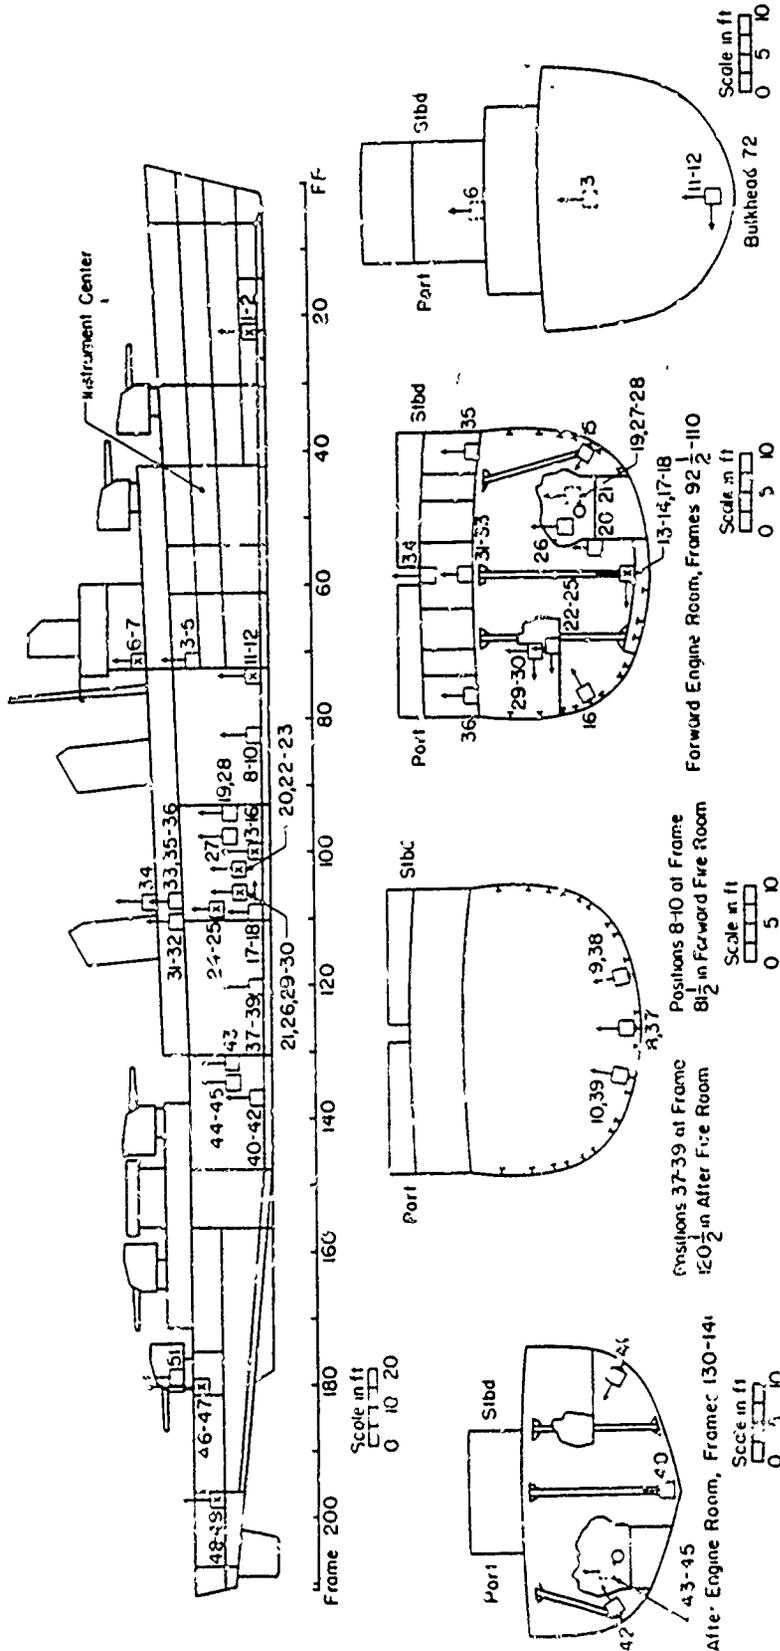
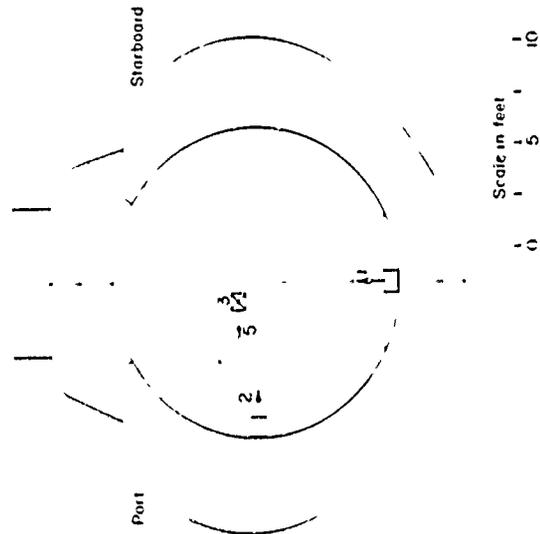
Figure 2.6 Inboard profile and section views, showing approximate locations of shock-measuring instruments on DD592.

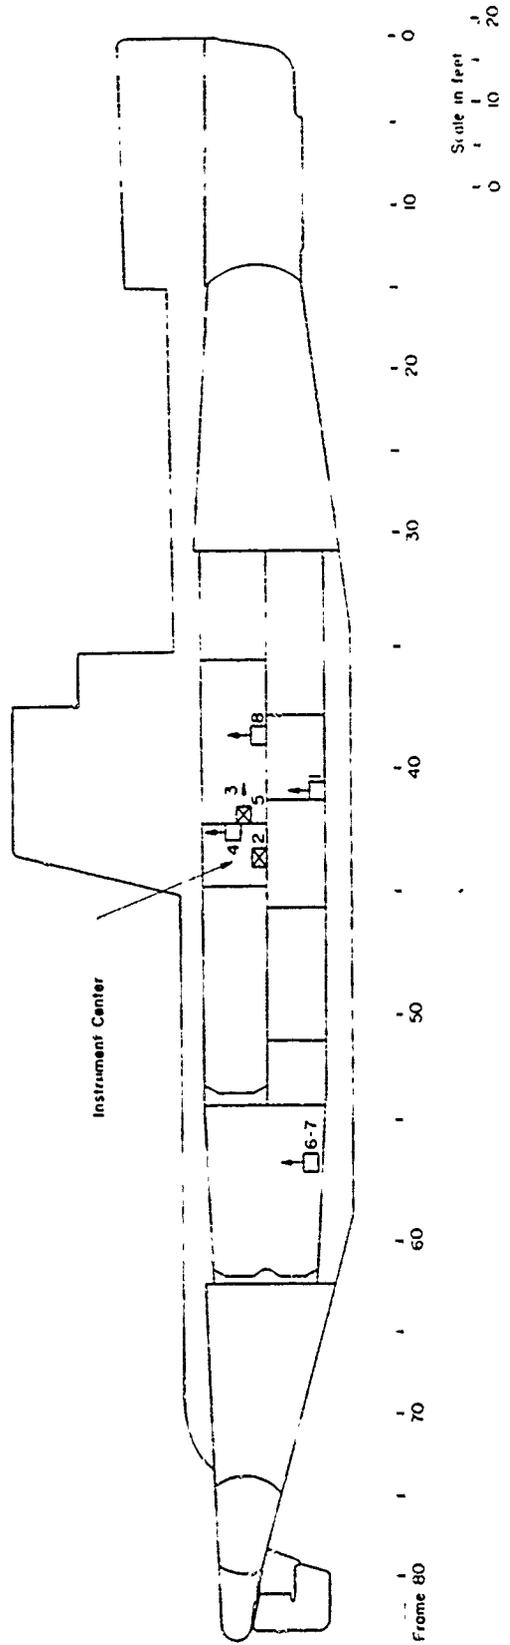
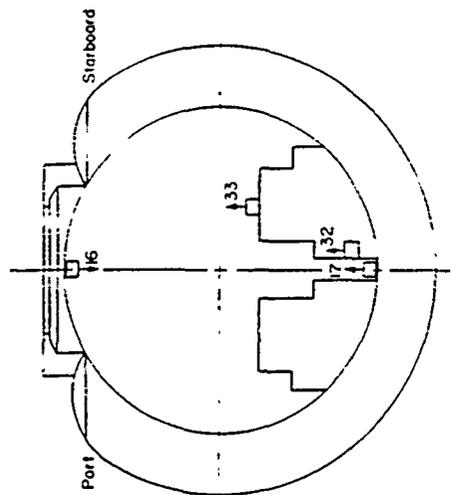
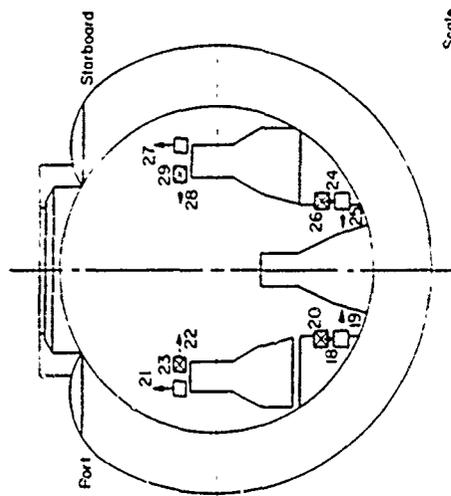
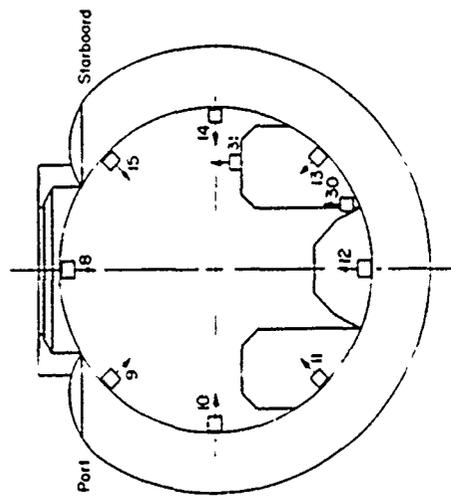
Figure 2.7 Inboard profile and section views, showing approximate locations of shock-measuring instruments on SSK3.

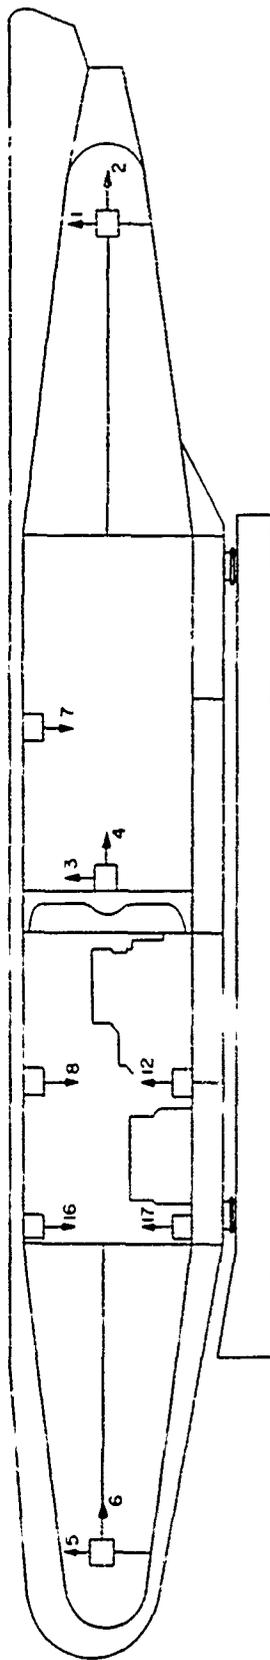
Figure 2.8 Inboard profile and section views, showing approximate locations of shock-measuring instruments on Squaw 29.

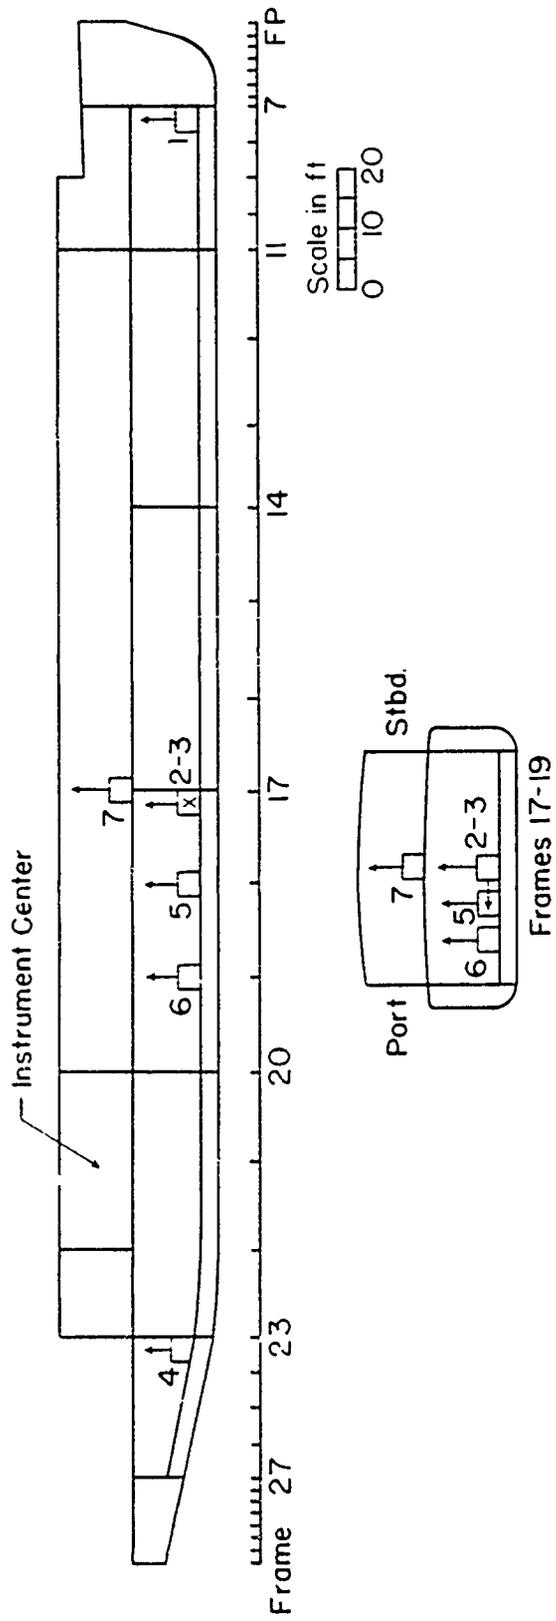
Figure 2.9 Inboard profile and section views, showing approximate locations of shock-measuring instruments on YFNB12.

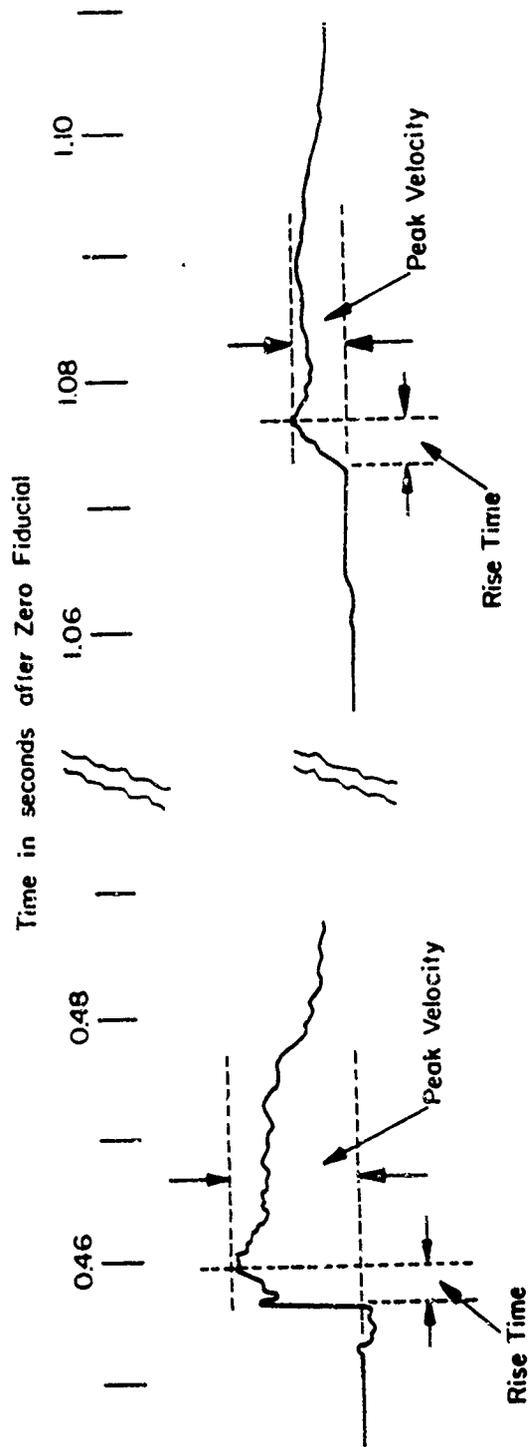
Figure 3.1.4 Tracing of a velocity-time record, showing method of reading peak velocity and rise time. The record was obtained from Position 2 on SS Michael Moran, and shows the motions resulting from the direct and reflected shock waves during Shot Wahoo. Note that the zero line for determining the velocity was carried through from the portion of the record immediately preceding the shock motion, and that the largest (not necessarily the initial) peak of velocity was read. The rise time was read from zero velocity to peak velocity. Average acceleration is peak velocity divided by rise time and expressed in multiples of the acceleration of gravity, g .

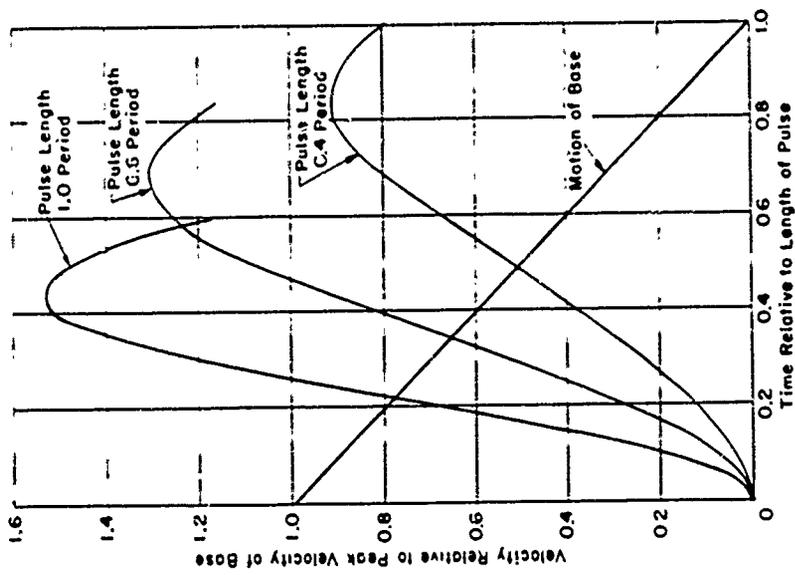
Figure 5.8 Response of a simple spring-mass system to a triangular pulse of velocity.

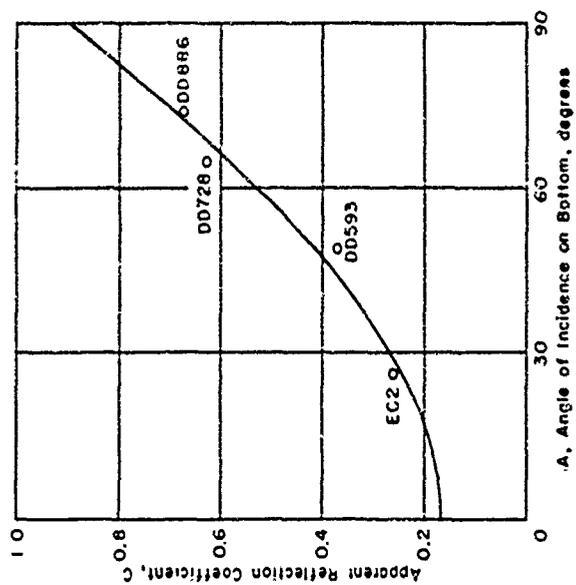
Figure 5.15 Apparent reflection coefficient for shock wave reflected from ocean bottom, Shot Wahoo. Coefficients were obtained from peak upward velocities recorded on surface ships in response to the reflected wave. The points have been fitted to the curve $C = 0.89 - 0.72 \cos \lambda$. (See Section 5.9.)

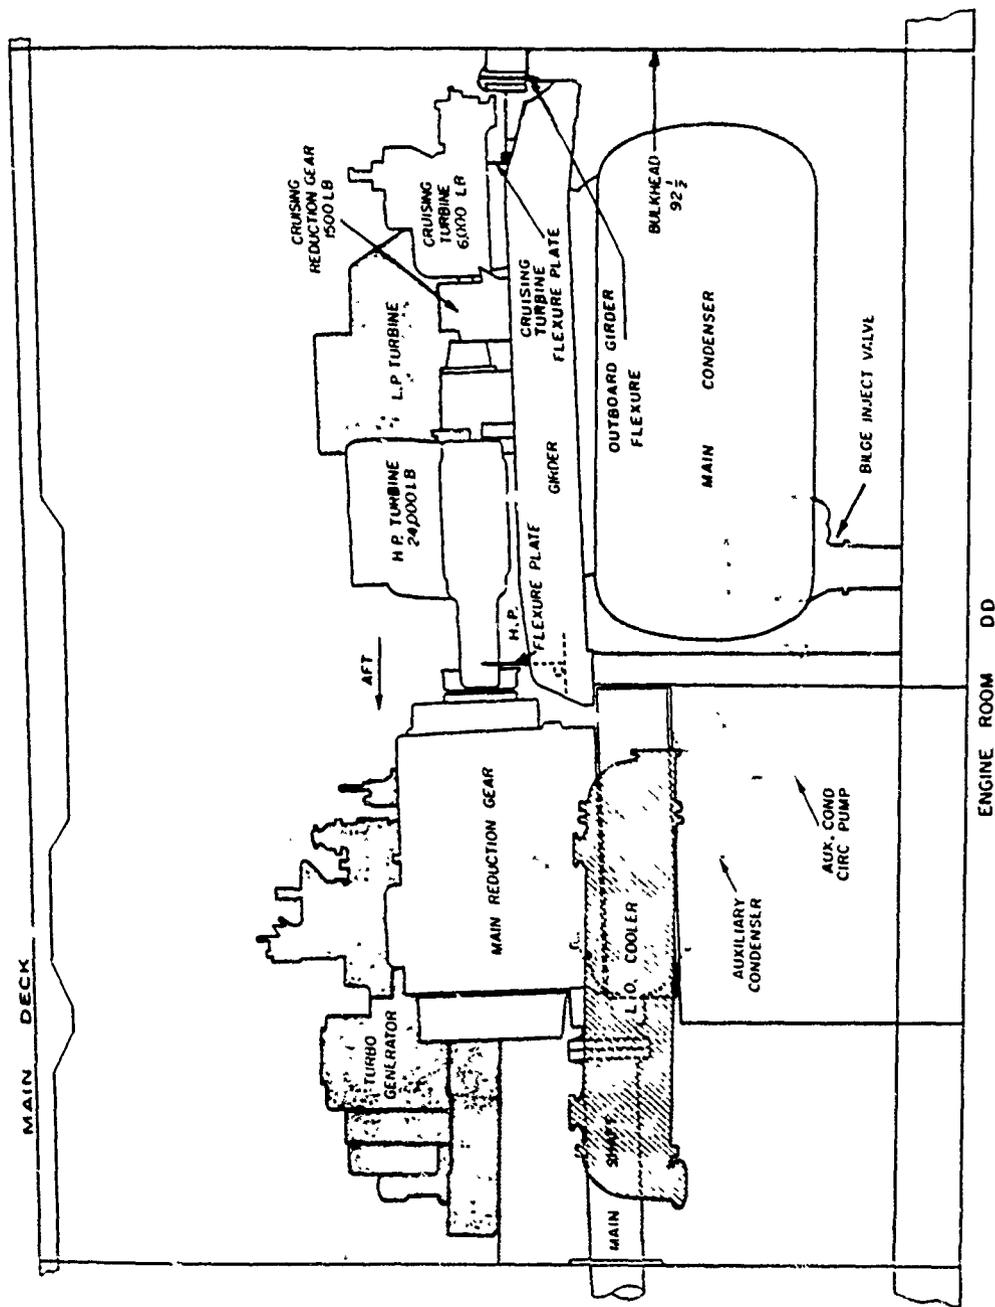
Figure 7.1 Profile view of propulsion plant in forward engine room of DD-474. The outboard girder that supports the high-pressure and cruising turbines is suspended from the bulkhead at the right by means of a flexure plate. The plate is bolted to a fixture, which is fastened to the bulkhead. At the left end the girder rests on and is bolted to a rigid foundation.

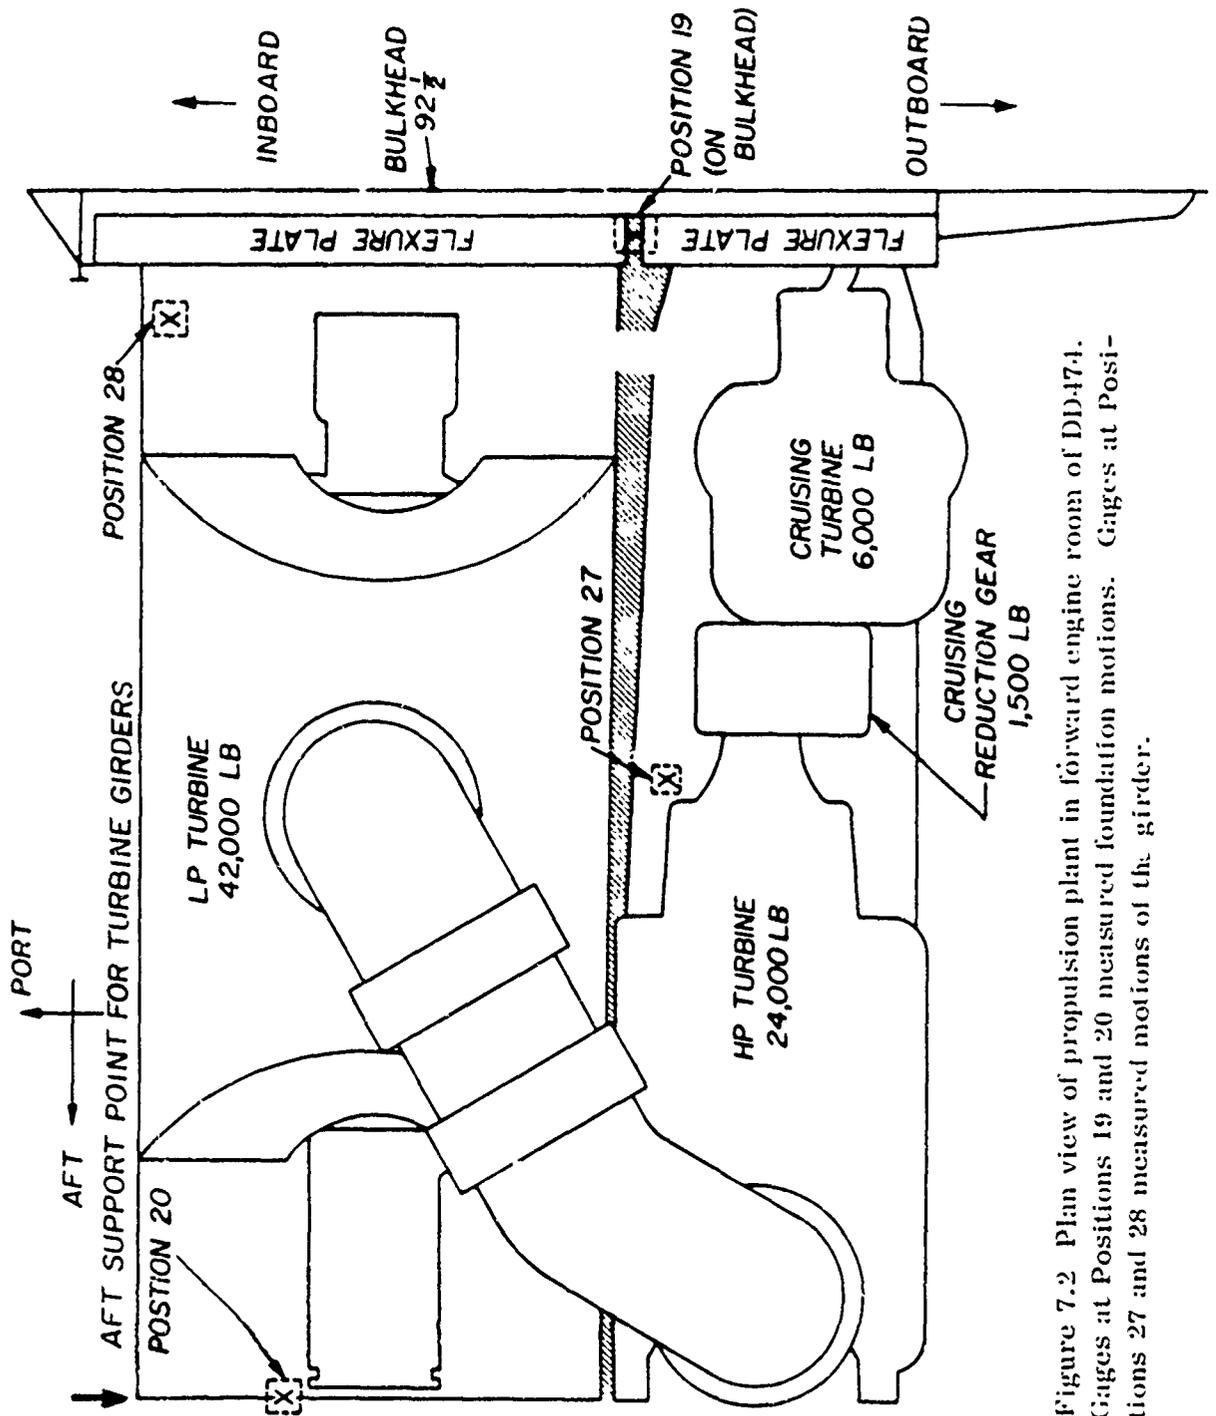
Figure 7.2 Plan view of propulsion plant in forward engine room of DD-474. Gages at Positions 19 and 20 measured foundation motions. Gages at Positions 27 and 28 measured motions of the girder.

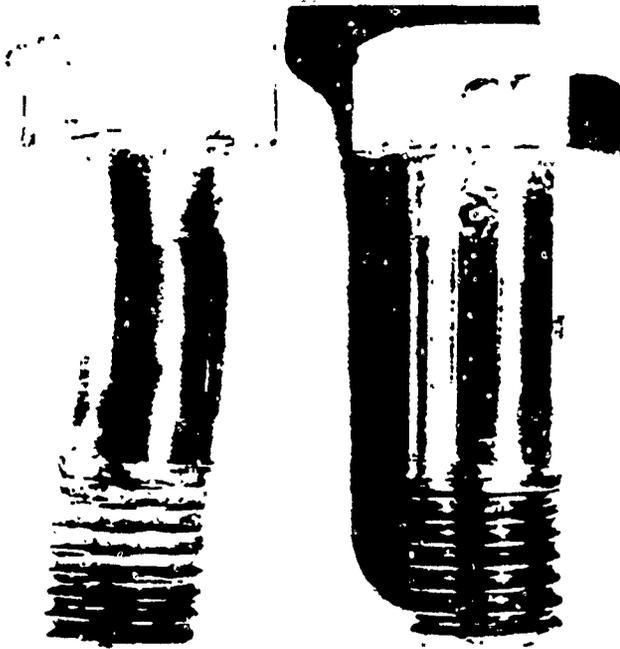
Figure 7.8 Bolts supporting flexure plate for inboard girder after Shot Wahoo. The deformed bolt is of Class B steel, and the undamaged bolt is of Alloy 2 steel.

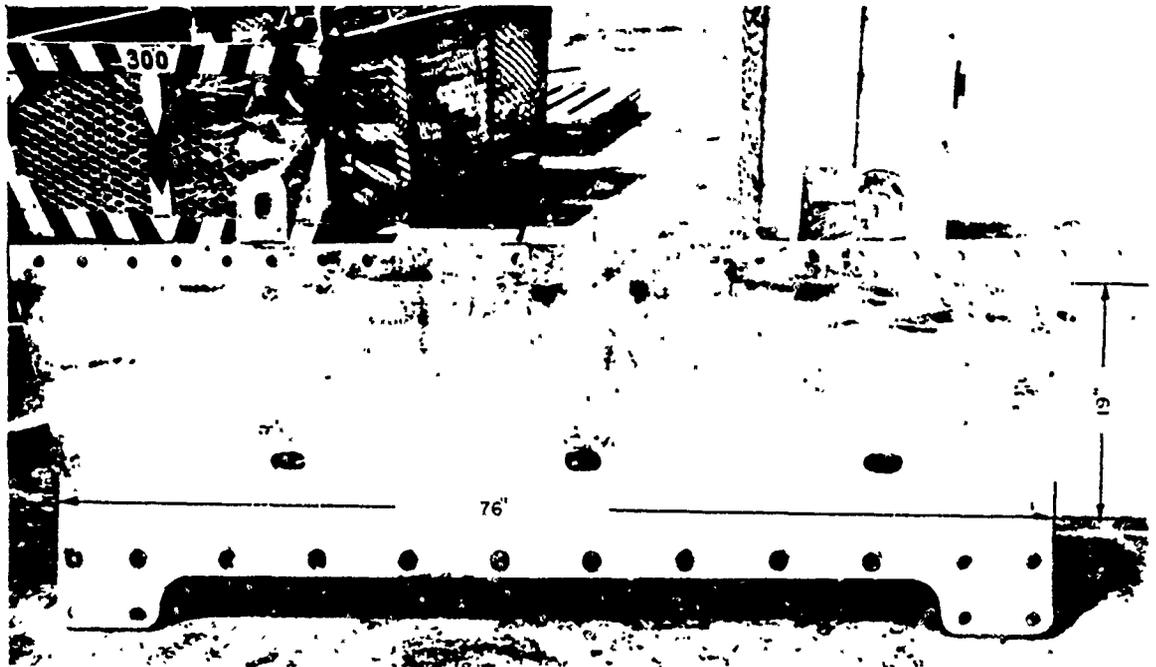
Figure 7.9 Front view of flexure plate supporting inboard girder. Maximum deformation occurred at the section through the holes; see Figure 7.10.

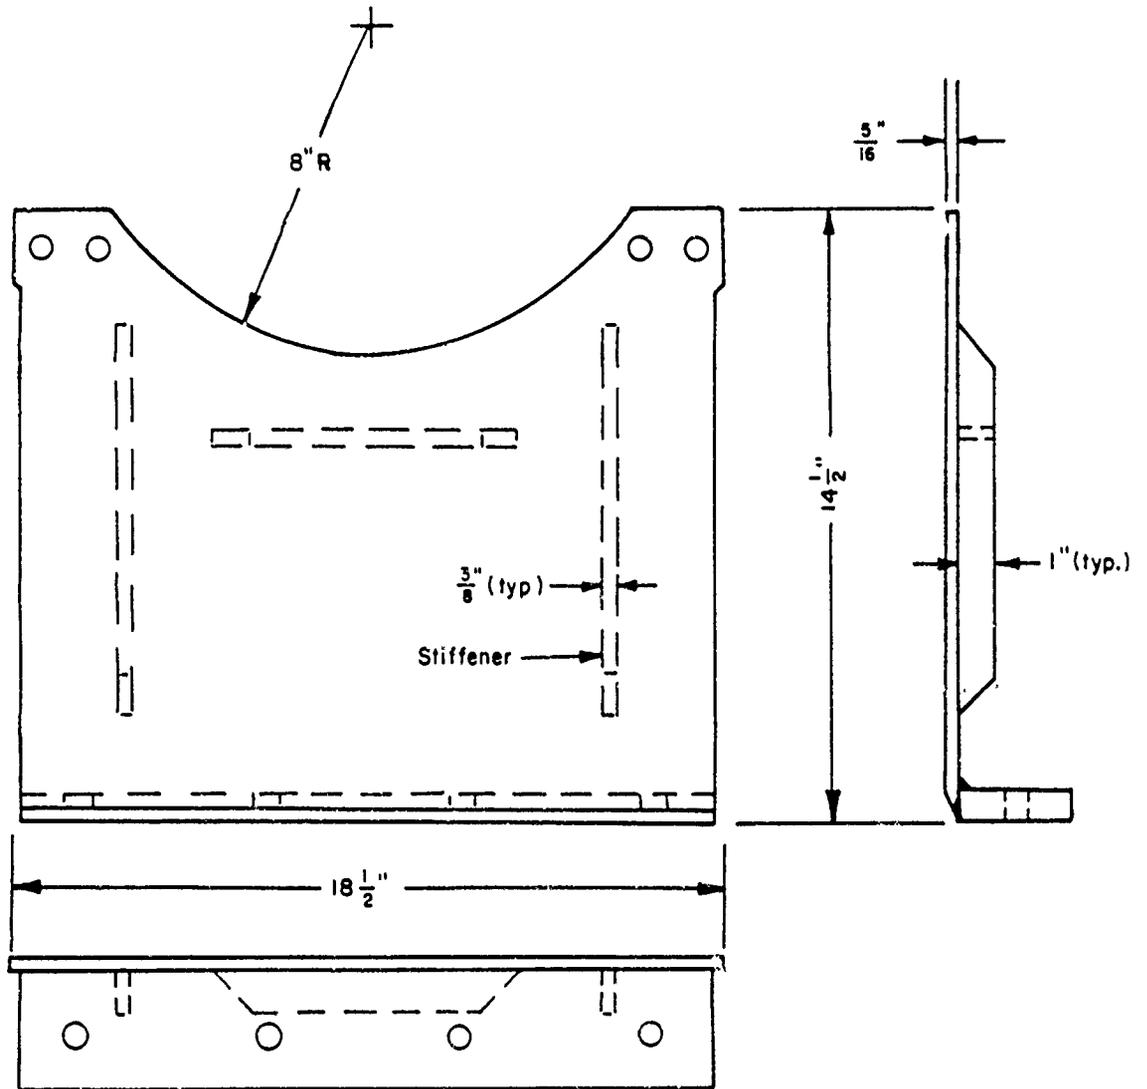
Figure 7.13 Flexure plate supporting forward end of cruising turbine. Note the stiffeners, which increased the buckling strength.

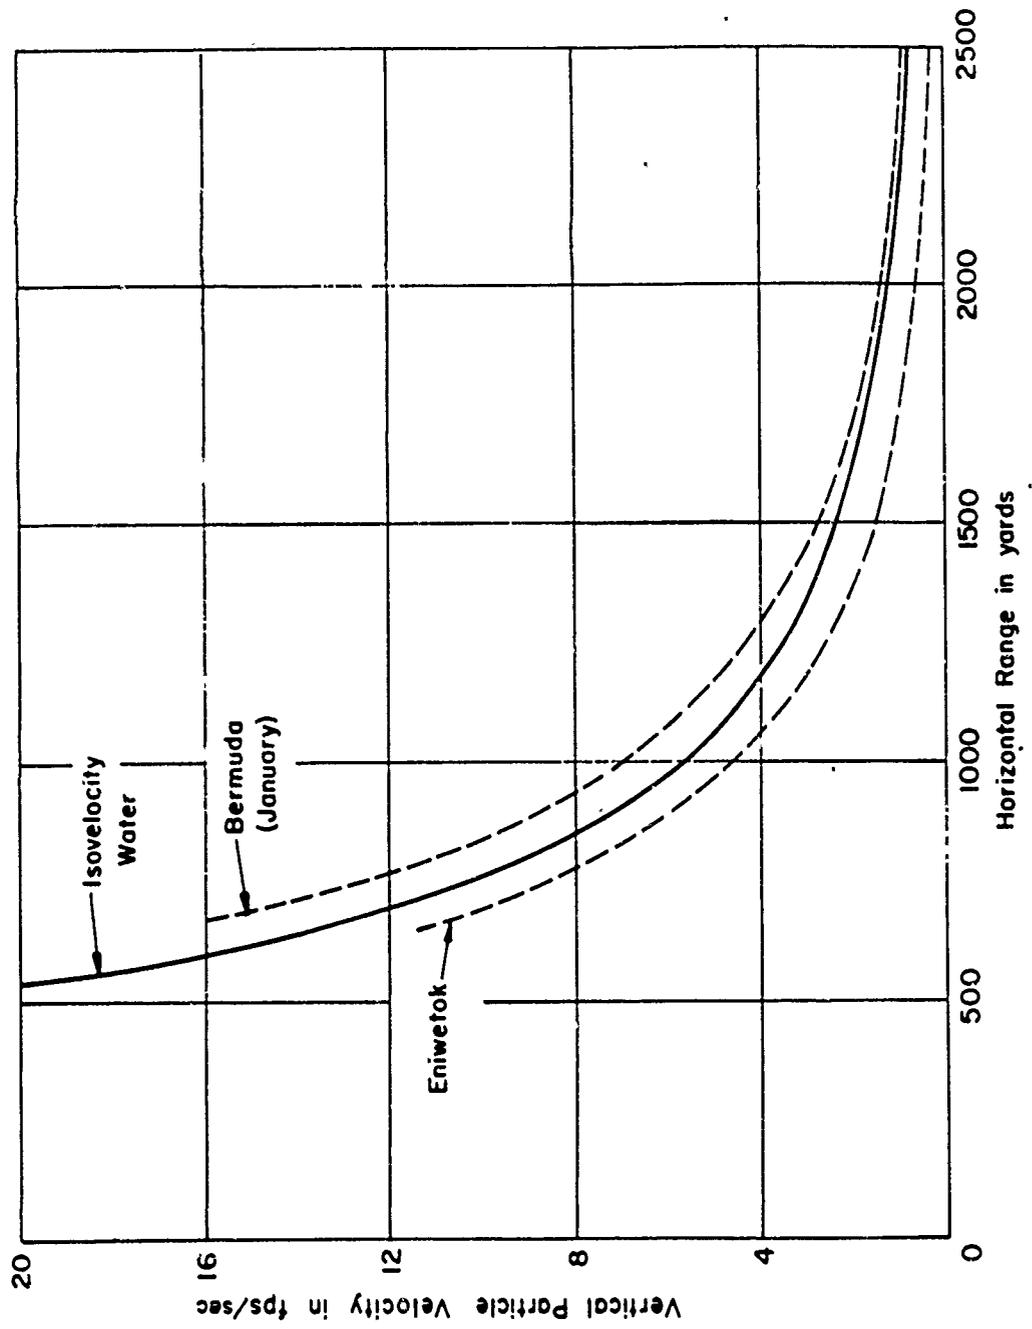
Figure 8.6 Vertical particle velocity as a function of range for selected oceanographic conditions

The data is summarized from ray calculations charge fired at depth of 500 feet under various typical oceanographic conditions. The variation of the velocity of sound with depth in the North Atlantic was taken from Reference 42, and the ray calculations for Bermuda from Reference 43.
