EVALUATION OF THE THIOKOL TE-M-640 SOLID-PROPELLANT ROCKET MOTOR UNDER THE COMBINED EFFECTS OF SIMULATED ALTITUDE AND ROTATIONAL SPIN

R. M. Brooksbank
ARO, Inc.

ENGINE TEST FACILITY
ARNOLD ENGINEERING DEVELOPMENT CENTER
AIR FORCE SYSTEMS COMMAND
ARNOLD AIR FORCE STATION, TENNESSEE 37894

November 1974

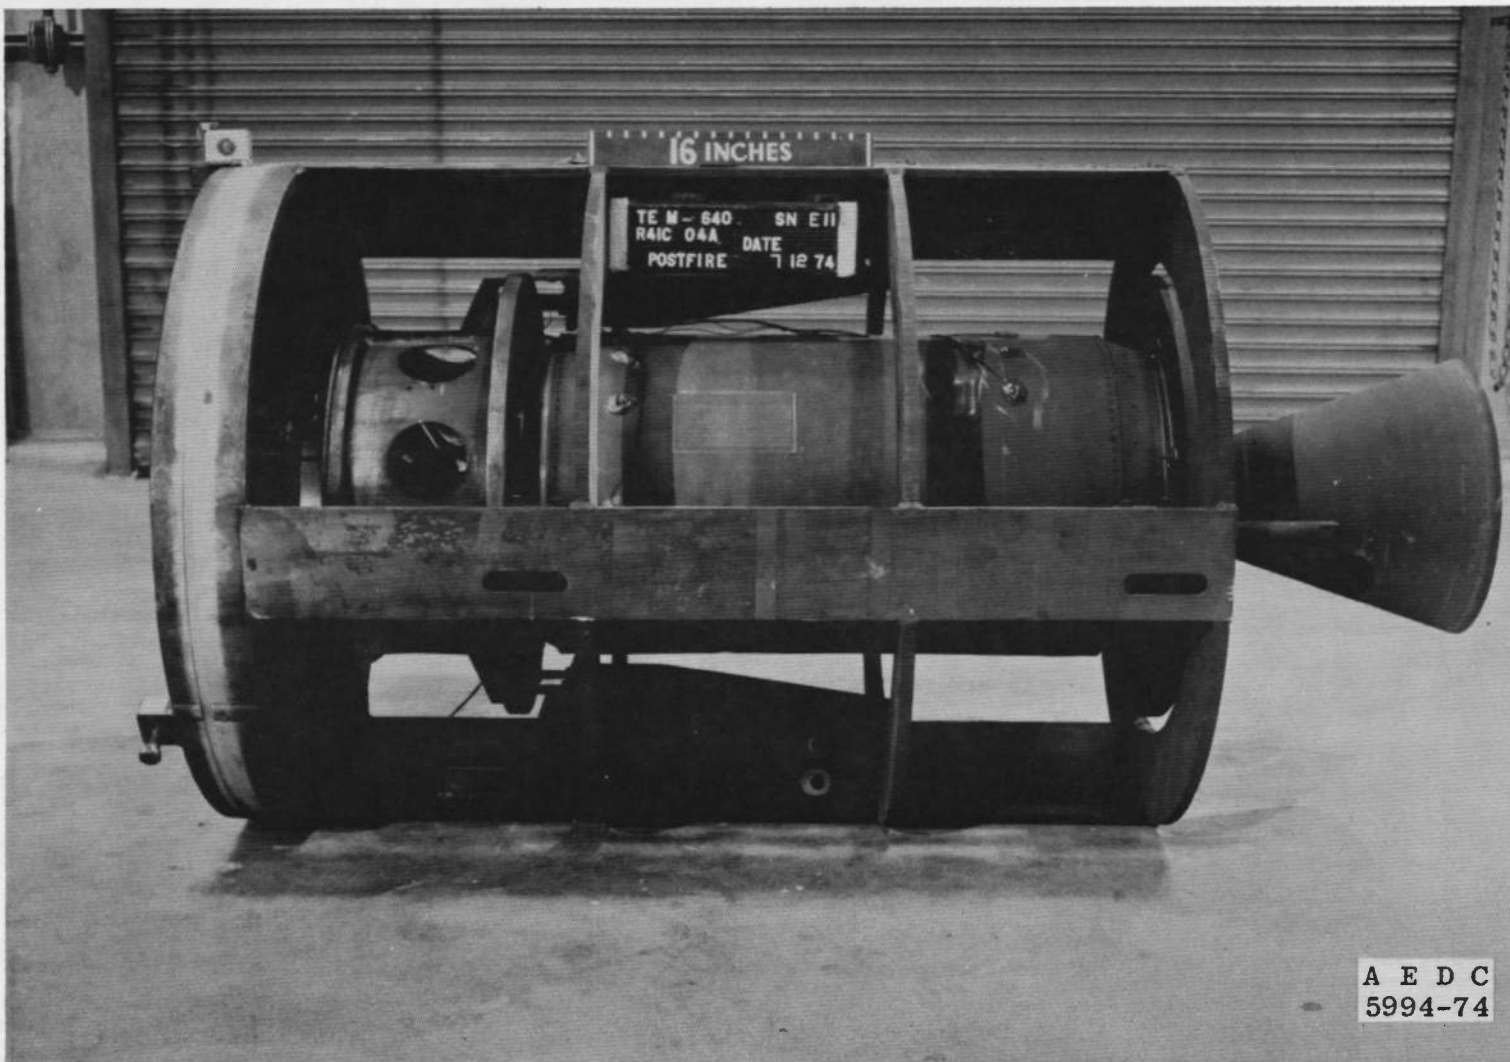
Postfire examination of the motor case and nozzle revealed structural integrity to be satisfactory. No case delaminations or discolorations were observed (Fig. 18).

Figure 18. Postfire photograph of motor S/N E11.

2. Postfire examination of motor S/N E11 revealed the motor case and nozzle structural integrity to be satisfactory.
3. The maximum motor case temperature measured at 200 sec following motor burnout was 408°F for motor S/N E11, which was below the specification maximum of 500°F.
