AFML-TR-73-90

# LONG LIFE ELASTOMERIC AIRCRAFT HYDRAULIC SEALS

*PARKER HANNIFIN CORPORATION  
SYSTEMS DIVISION & SEAL GROUP*

FINAL REPORT COVERING PERIOD 15 FEBRUARY 1973 to 15 MARCH 1974

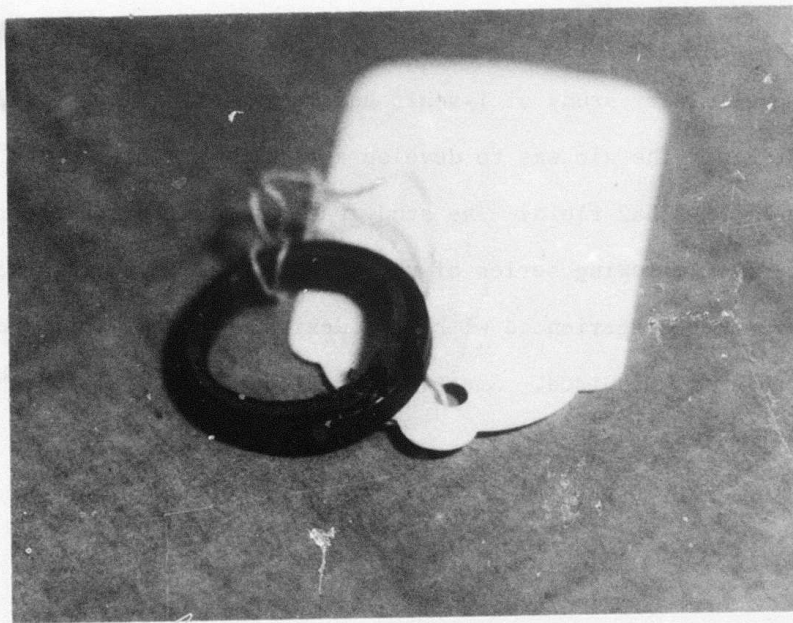
Photograph 1.

As can be seen in Photograph No. 1 serious damage occurred after 30,600 cycles 350°F/4000 psig.

V747-75 T-Seal 30,600 cycles 350°F/4000 psig

An examination of the seals and back-ups showed excessive extrusion had occurred which resulted in total failure of the seal.

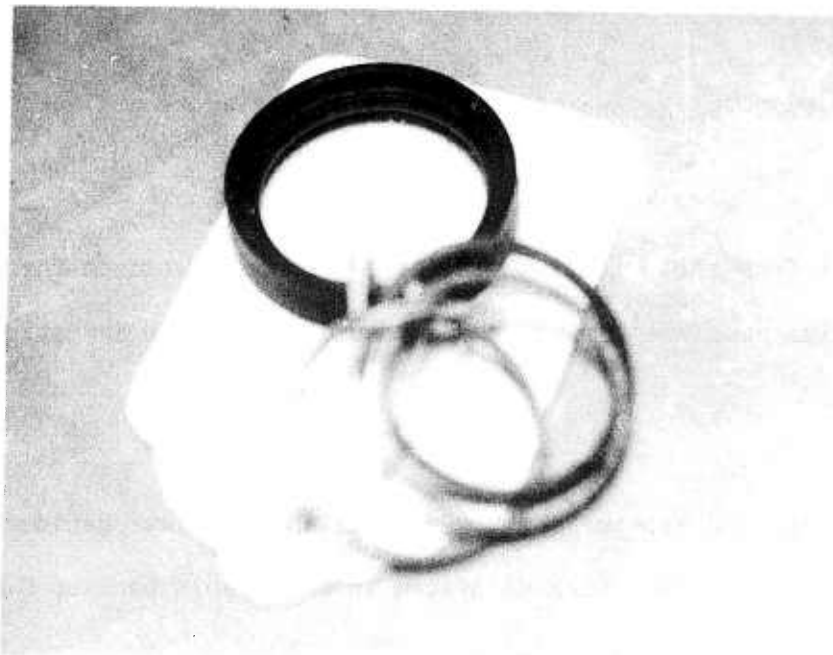
The results of this short term test were more encouraging as shown in Photograph 5. The combination of the extrusion resistant brass and the sacrificial Revonoc 18158 withstood the 4000 psig/350°F conditions, but an examination of the seal indicated some nibbling and cutting of the seal where it was in contact with the brass back-up ring.

V720-75 T-Seal in 0.304" Groove Using Combined Brass/Revonoc 18158 Back-up System

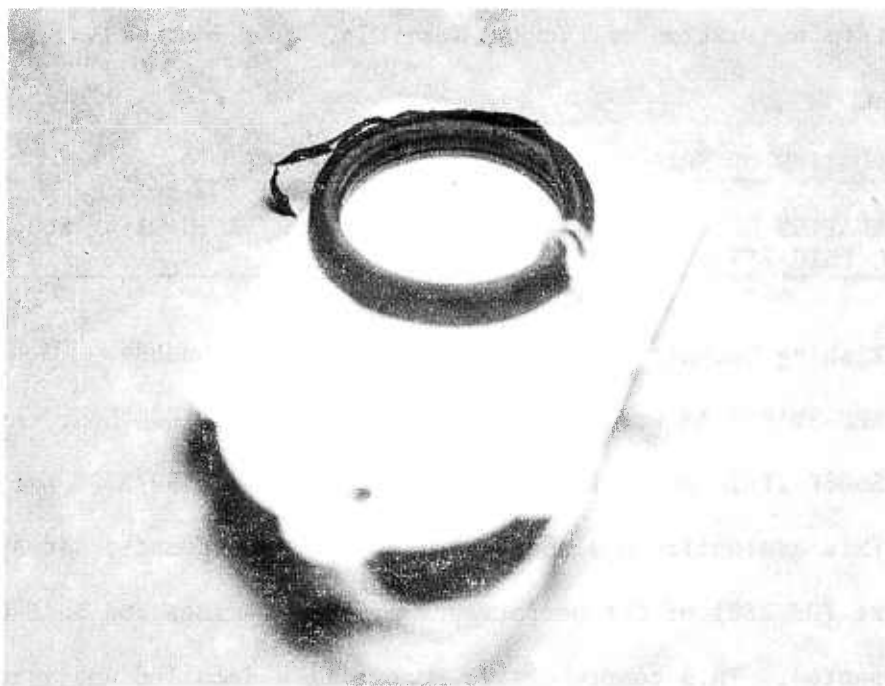
Photograph 6.

While this combination was found to give excellent protection to the seal in the sealing area, but Photograph 6 shows the damaged which occurred to the heel of the T-seal. Excessive cutting occurred in the area of contact of the T-seal heel and the cast-iron outer diameter.

V720-75 Single T-Seal in 0.304" Groove Using Cast-Iron Spacer Back-up and Revonoc 18158 Back-up
