AMMRC CTR 77-20

**BRITTLE MATERIALS DESIGN,  
HIGH TEMPERATURE GAS TURBINE**

Arthur F. McLean, Ford Motor Company, Dearborn, Michigan 48121  
Eugene A. Fisher, Ford Motor Company, Dearborn, Michigan 48121

Interim Report Number 11, July 1, 1976 to December 31, 1976

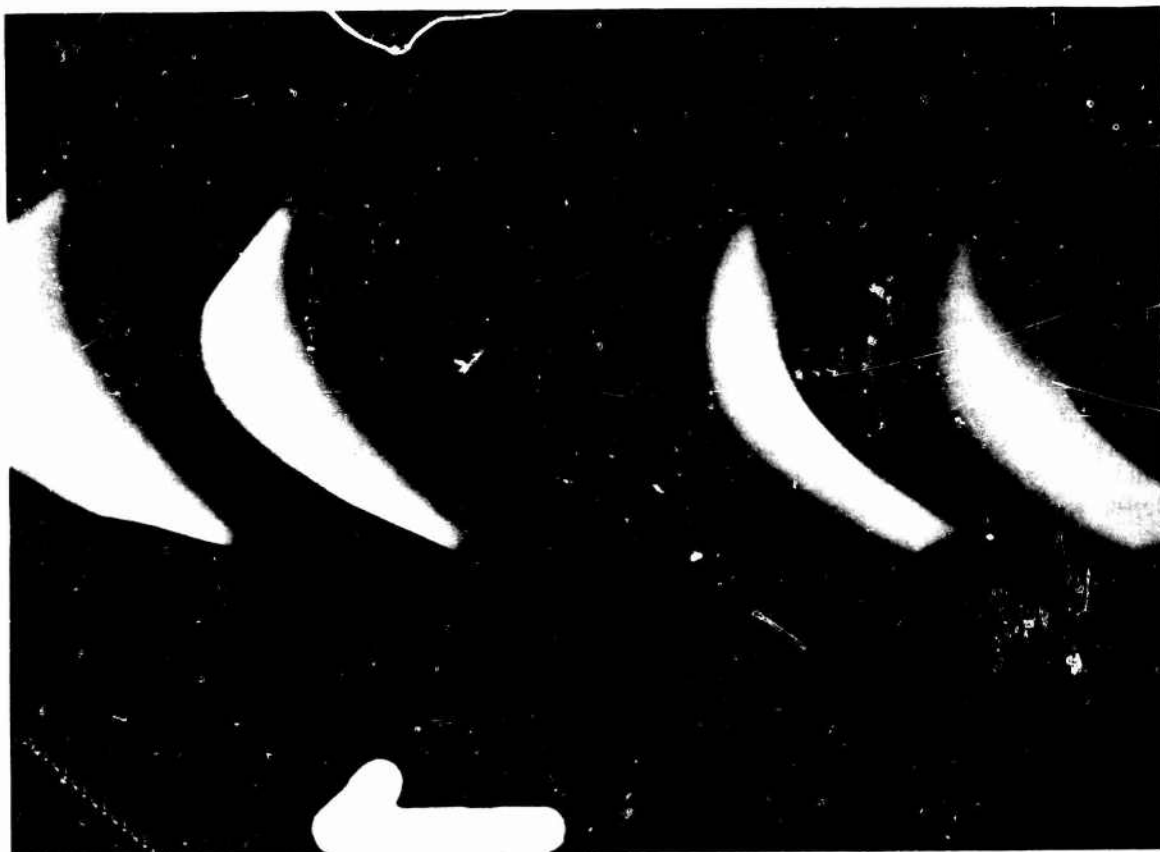
**Figure 3.19 — Simulated Radial Panoramic View of Turbine Rotor Blade Ring Made Using Microfocus X-Ray Equipment**

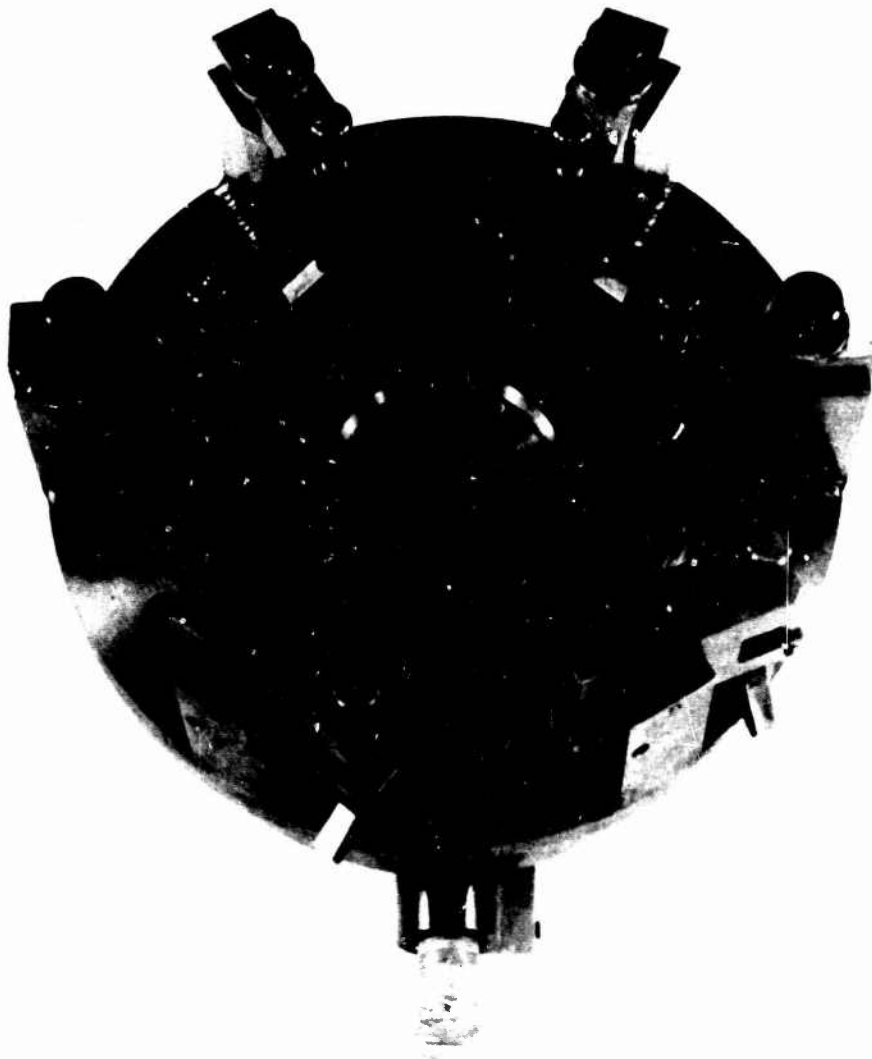
**Figure 3.28 — Stator Vane Mechanical Test Fixture**

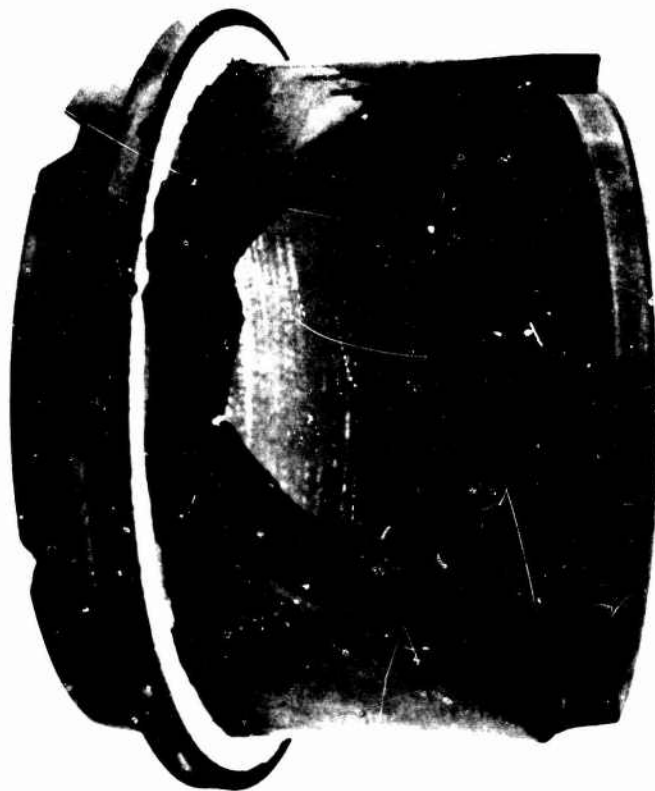
Figure 3.38 — Typical Failure of Original Design Adaptor Tube

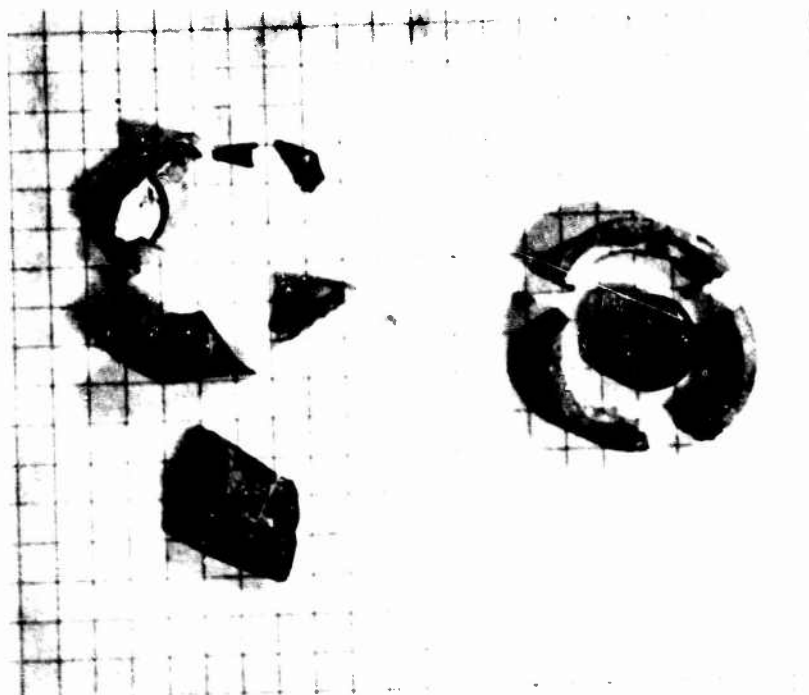
**Figure 4.21 — Broken Rotor Blade and Ring After Hot Isostatic Pressing**
