**WC/C-130J Human Vibration
Investigation**

January 2002

Interim Report for February 2001 to September 2001

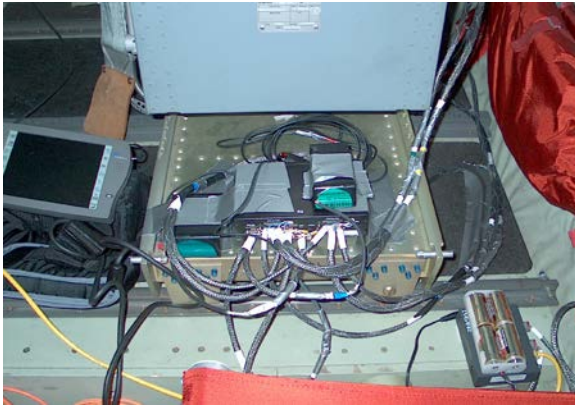
Figure 1 DAU Locations in WC/C-130J Aircraft

a. WC-130J (Weatherbird)

b. C-130J (Slick)

Two Remote Vibration Environment Recorders (REVERs) were used to collect the acceleration data at specified locations. Figure 1a shows the location of the first recorder mounted to the seat platform in back of the ARWO seat (Weatherbird aircraft). This recorder collected all ARWO station data. The second recorder was secured underneath the lower bunk located in the cockpit and was used to collect both bunk and copilot data. For the C-130J (Slick) aircraft, the first

recorder was mounted next to the left (port) side passenger seat as shown in Figure 1b. The second recorder remained in the cockpit for collecting bunk and copilot data.

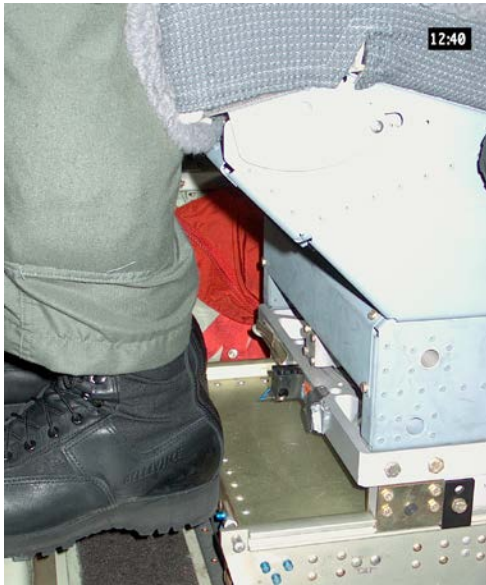
a. ARWO Seat Base Accelerometer Pack

Each 16-channel data acquisition unit (DAU) measured approximately 16.5 cm x 10 cm x 4 cm. The DAU enclosure was fabricated using Delrin and T6-6061 aluminum and provided EMI (electromagnetic interference) shielding. Two types of battery packs were available for use depending on the flight time. The first was rated at 12 volts/2.1 amp-hours and measured approximately 5 cm x 9 cm x 3 cm. The battery operated for up to two hours. The second was rated at 12 volts/3.5 amp-hours and measured approximately 7 cm x 9 cm x 3 cm. This battery operated for up to 3.5 hours. Two battery packs were connected to each DAU to extend the operation time. The total system weighed 1.4 kg - 1.6 kg (3.0 - 3.5 lbs) depending on the battery selection. Triaxial accelerometer packs and pads were attached to selected sites for measuring accelerations in the fore-and-aft (X), lateral (Y), and vertical (Z) directions as listed in Measurement Sites and Directions and shown in Figures 2a - g. Each accelerometer pack measured 1.9 cm in diameter and 0.86 cm in thickness and weighed approximately 5 gm (25 gm with connecting cable) (Figures 2a, 2c, 2d, 2f, 2g.) Triaxial seat pads were used for measuring the vibration transmitted to the occupant via the seat pan and seat back in accordance with the ANSI S3.18-1979 (1) (also International Standards Organization "Mechanical Vibration and Shock - Evaluation of Human Exposure to Whole-Body Vibration - Part I: General

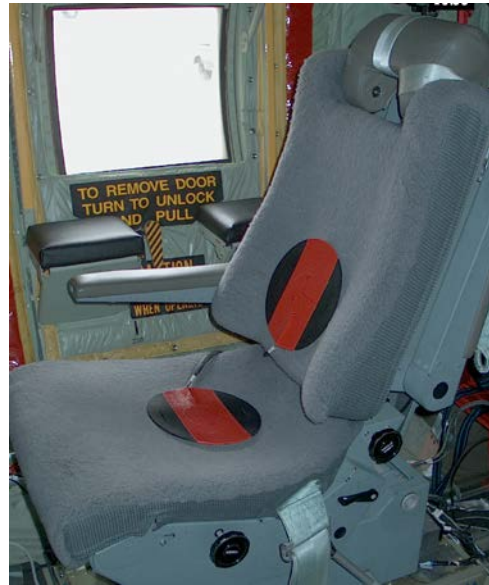
b. ARWO Seat Pan and Seat Back Accelerometer Pads

Requirements (ISO 2631-1: 1997) (2)) (Figures 2b, 2e, 2f, 2g.) The pad consisted of a flat rubber disk approximately 20 cm in diameter and weighing 355 gm (with connecting cable).

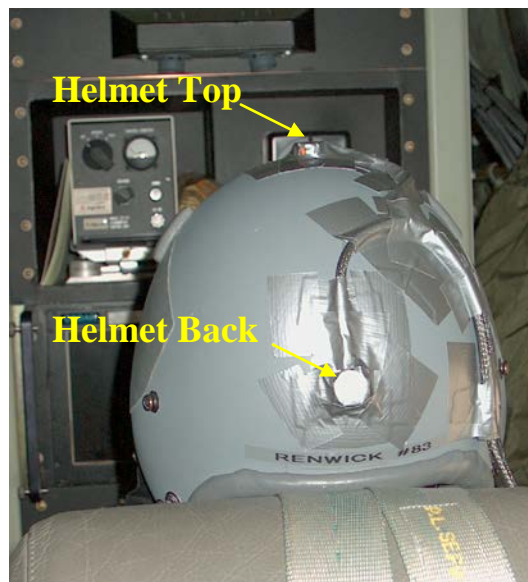
c. ARWO Helmet Top and Helmet Back Accelerometer Packs

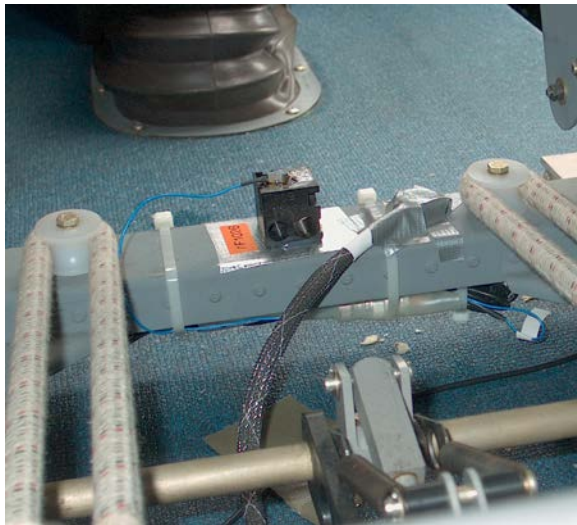
e. Copilot Seat Base Accelerometer Pack
(located on lower front seat cross-beam)

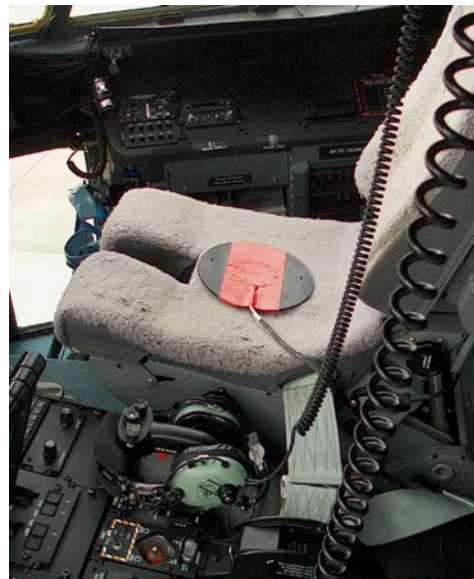
f. Copilot Seat Pan Accelerometer Pad

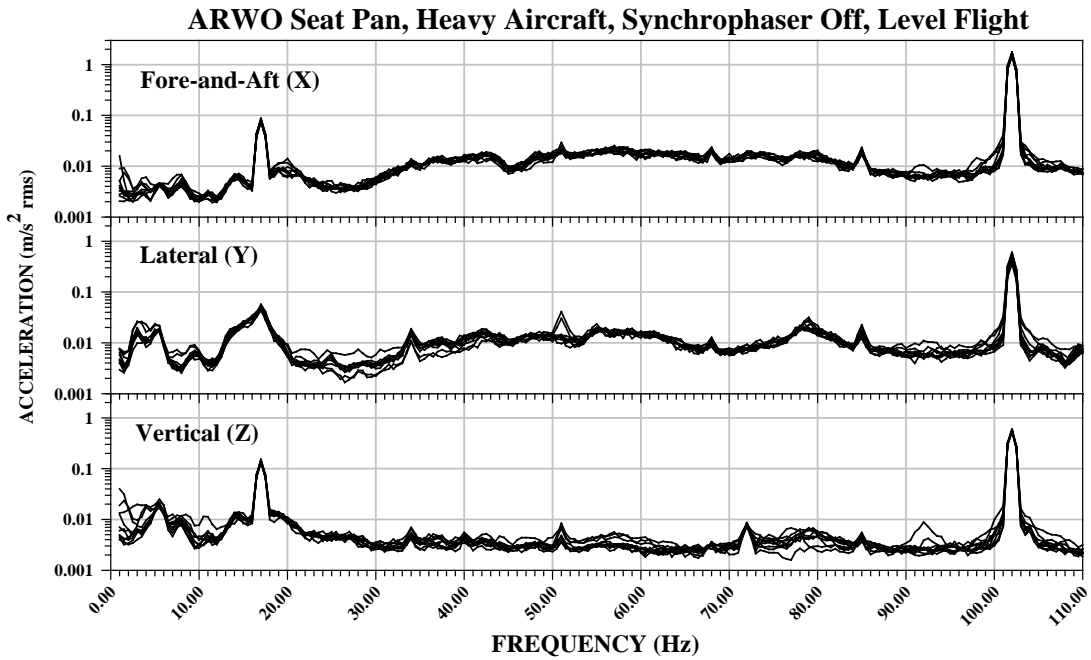
Figure C-1. ARWO Seat Pan Vibration Responses During Level Flight: a. One-Third Octave Frequency Bands; b. Constant Frequency Bandwidth, 0.5 Hz

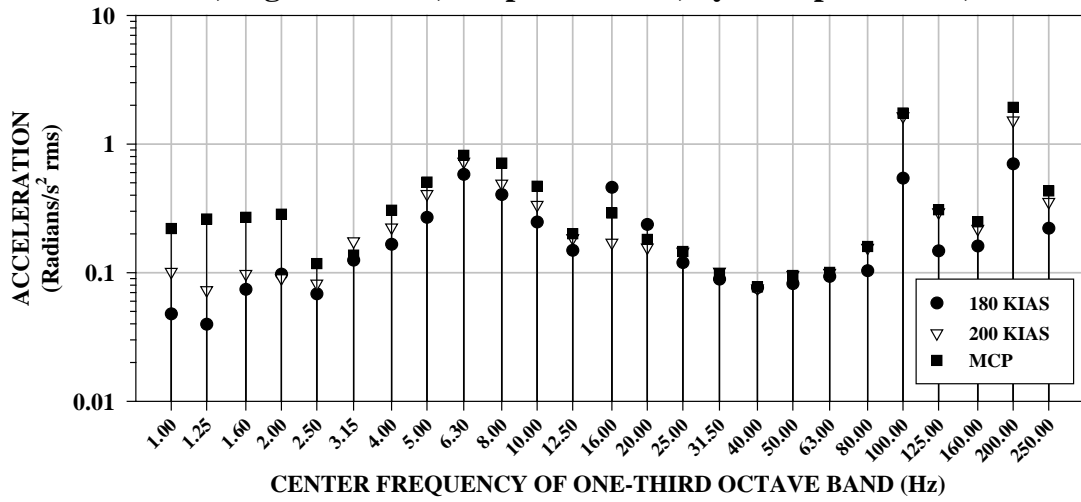
Helmet Pitch, Light Aircraft, Props Balanced, Synchrophaser On, 24000 Ft PA

Figure C-6. ARWO Helmet Pitch One-Third Octave Band Accelerations

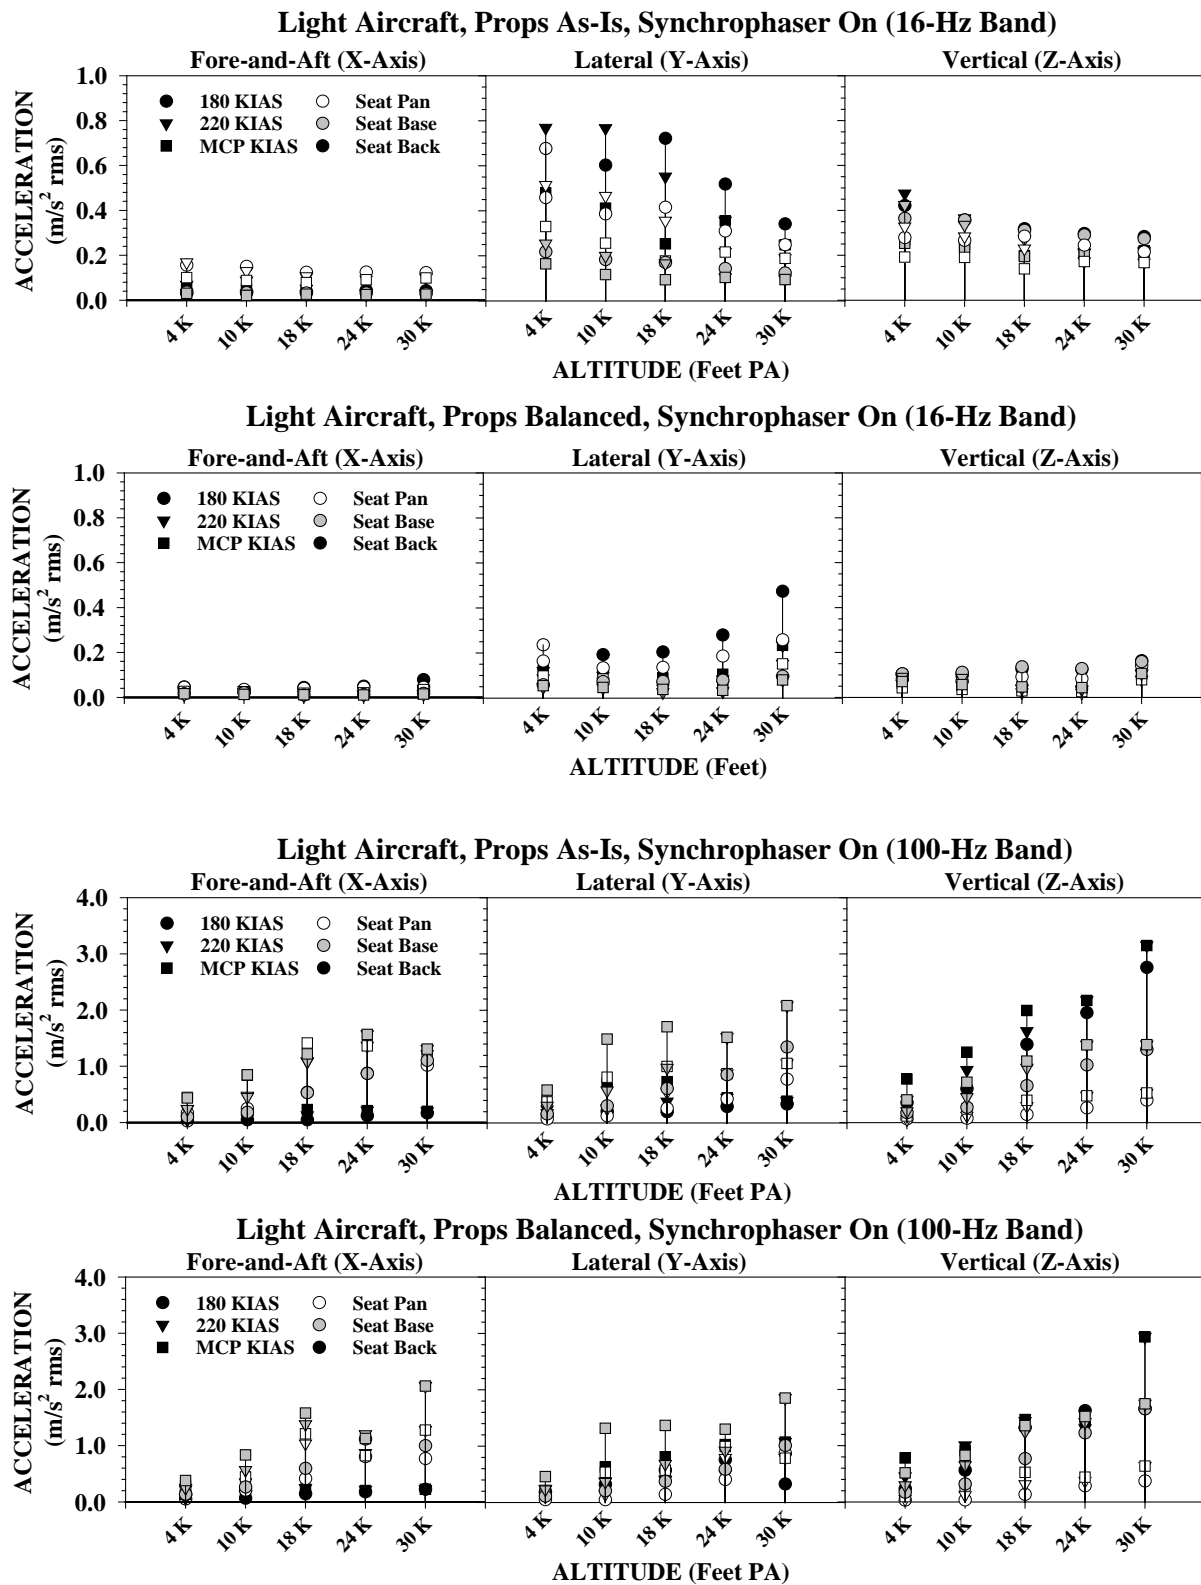
Figure C-7. ARWO Seat 16-Hz and 100-Hz One-Third Octave Band Accelerations

Propeller Balance (WC-130J ARWO). Figures C-7, C-8, and C-9 show that the 16-Hz band vibrations at the ARWO seat, helmet, and display were reduced to varying degrees with the props balanced configuration for most vibration directions, aircraft altitudes, and airspeeds. Table B-1 lists the seat pan accelerations in all three directions for the three sustained speeds for the props as-is and props balanced configurations. Also listed are the highest and lowest reductions occurring once the props were dynamically balanced. No obvious effects of prop balancing were observed in the 100-Hz band. Figure C-11 illustrates the effect of balancing the propellers on the frequency response at the seat pan in the lateral (Y) direction. The figure shows the isolated effect in the 16-Hz band. The reductions seen below 10 Hz have not been fully investigated but were not necessarily observed at other altitudes and airspeeds. Again, turbulence or buffeting was shown to affect the low frequency response.

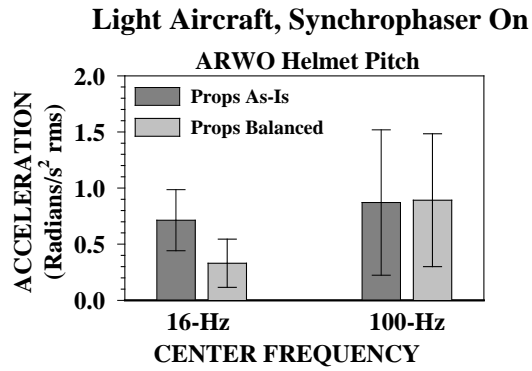
Figure C-9. Mean ARWO Helmet Pitch 16-Hz and 100-Hz One-Third Octave Band Accelerations +/- One Standard Deviation

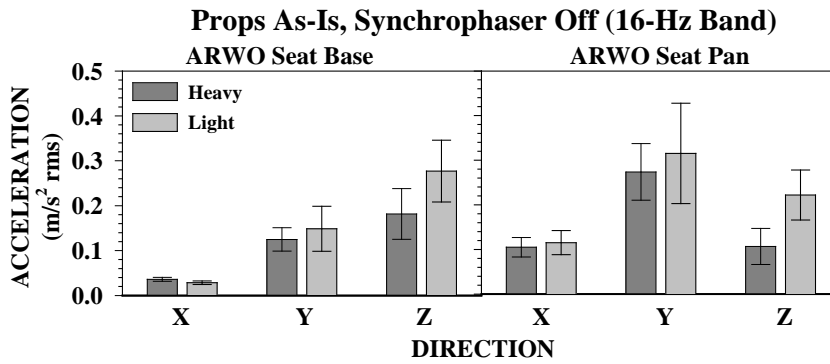
Figure C-10. Comparison of Heavy vs Light Aircraft, Mean 16-Hz One-Third Octave Band Accelerations +/- One Standard Deviation

Aircraft Weight (WC-130J ARWO). As shown in the mean data depicted in Figure C-10, higher accelerations were observed in the 16-Hz band vertical vibration for the light aircraft as compared to the heavy aircraft.

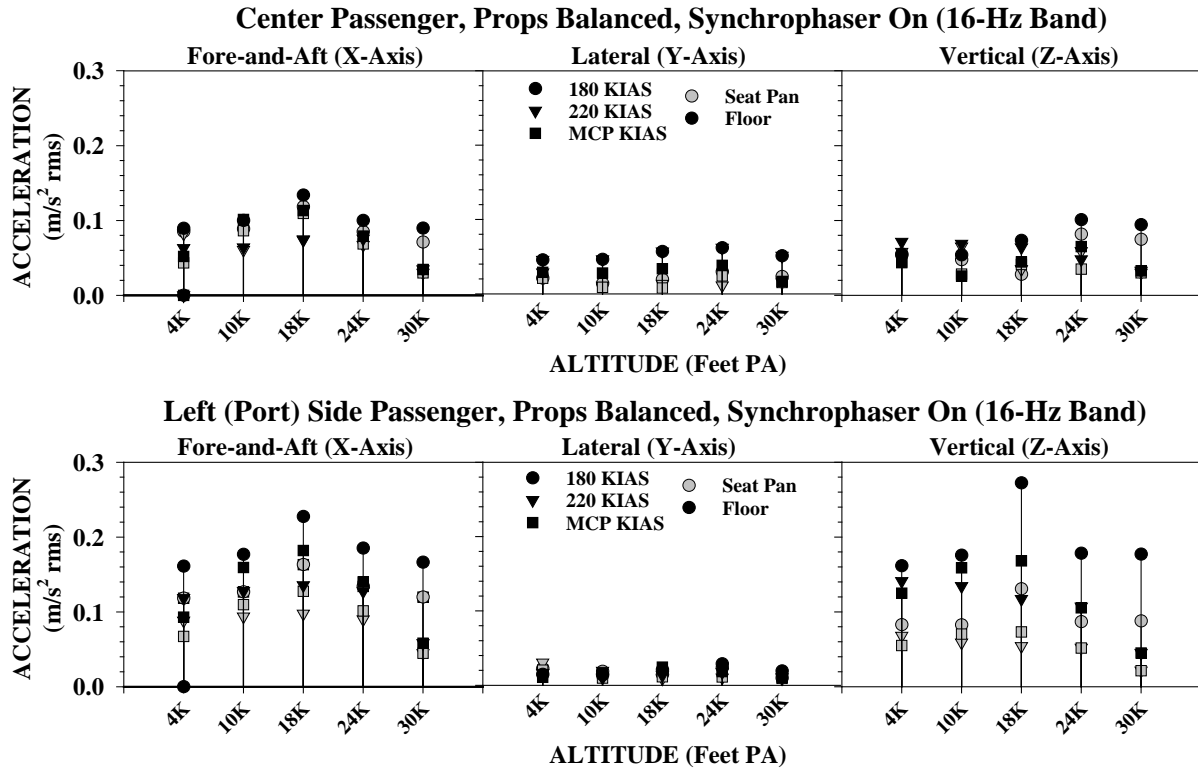
Figure C-13. C-130J (Slick) Center and Side Passenger 16-Hz One-Third Octave Band Accelerations

Figures C-13 and C-15 indicate that the lowest 16-Hz vibration occurred in the lateral (Y) direction at the passenger locations. (This direction corresponded to the fore-and-aft direction of the aircraft where low vibrations were observed at the ARWO station.) The figures also show no substantial differences between the center and side seat pan accelerations in the 16-Hz band for each respective direction. However, at the side floor site, the accelerations tended to be higher in the fore-and-aft and vertical directions, and lower in the lateral direction as compared to the center floor. The greatest differences between the vibrations at the two passenger locations

Altitude and Airspeed (C-130J Passengers). As depicted in Figure C-13, a similar trend was observed in the 16-Hz band for airspeed as described for the ARWO station, i.e., lower accelerations being associated with higher airspeeds. Likewise, in the 100-Hz band, higher accelerations were associated with higher airspeeds (Figure C-14). At 100 Hz, higher accelerations tended to occur at higher altitudes depending on the location and direction of the measurement.

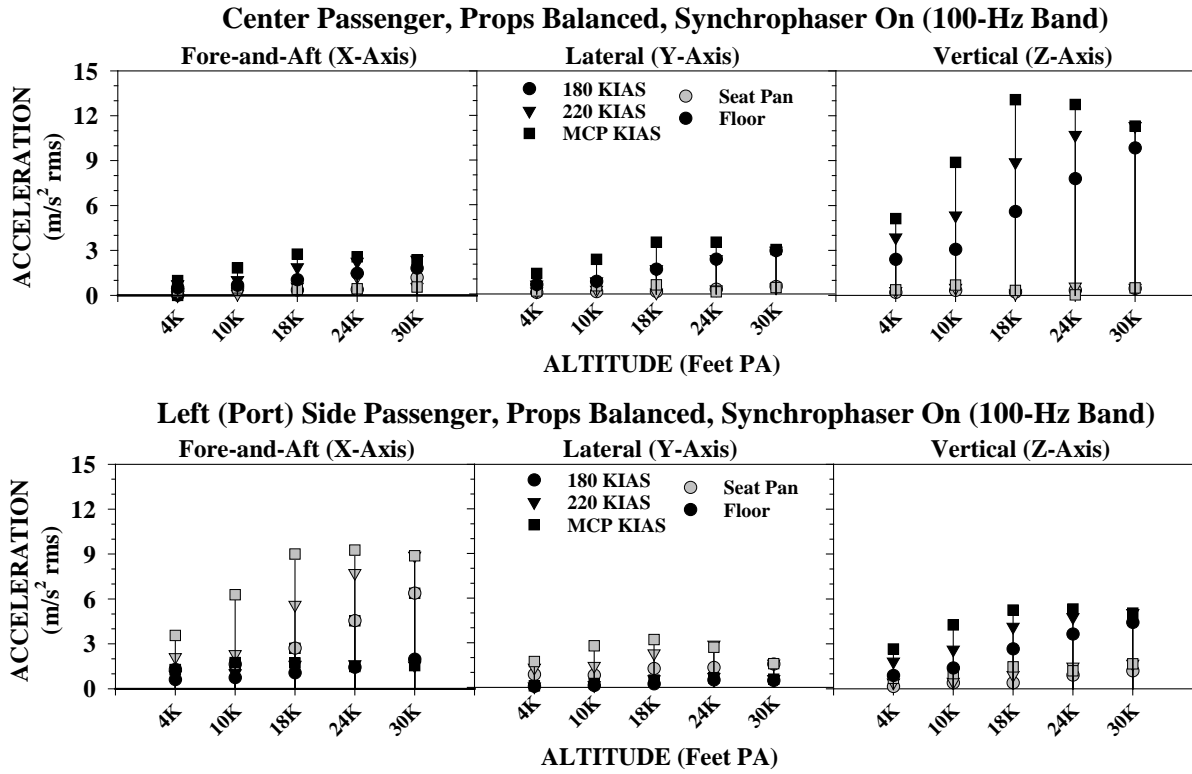
Figure C-14. C-130J (Slick) Center and Side Passenger 100-Hz One-Third Octave Band Accelerations

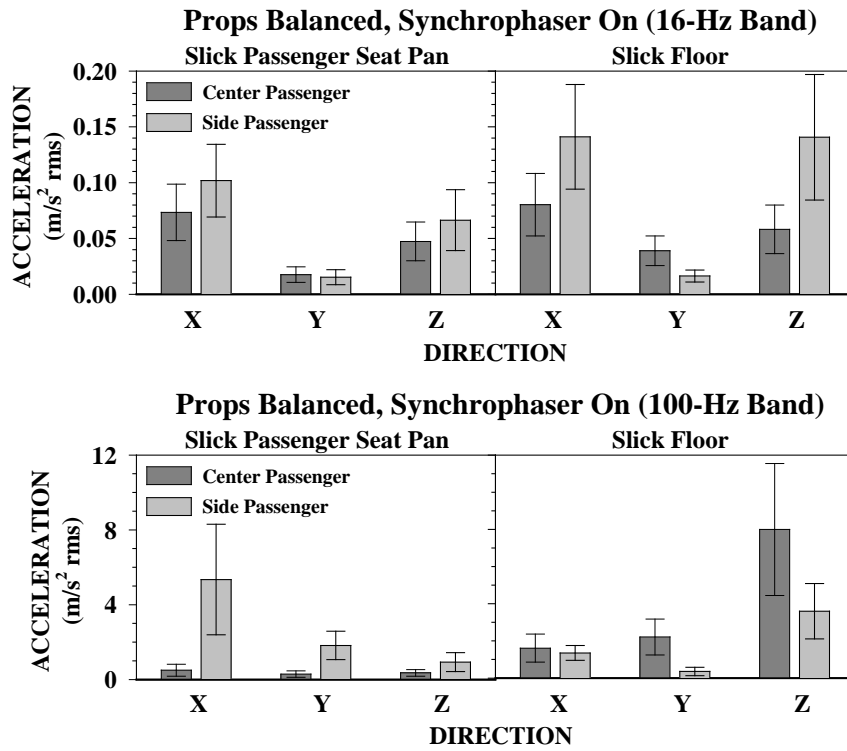
Figure C-15. C-130J (Slick) Center and Side Passenger Mean 16- and 100-Hz One-Third Octave Band Accelerations +/- One Standard Deviation
