NACA RM E53C26

DE-ICING AND RUNBACK CHARACTERISTICS OF THREE CYCLIC
ELECTRIC, EXTERNAL DE-ICING BOOTS EMPLOYING
CHORDWISE SHEDDING

By Robert S. Ruggeri

May 25, 1953

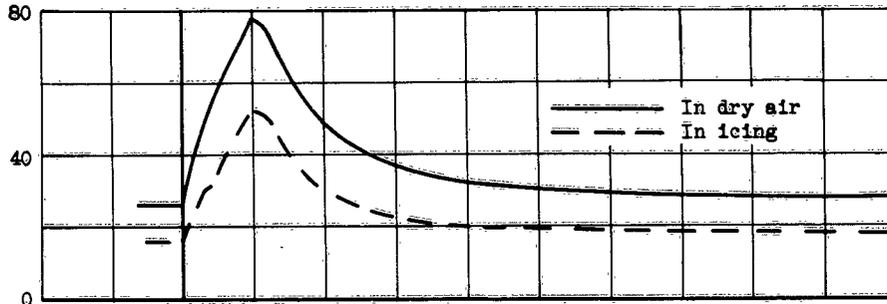
(a) Boot segment AU1. Surface distance/chord length, 3.63 percent.

(b) Boot segment BU1. Surface distance/chord length, 3.54 percent.

(c) Boot segment CU1. Surface distance/chord length, 3.07 percent.

Figure 8. - Typical variation of local surface temperature, upper and lower surfaces, measured in dry air and in icing for three boots. Free-stream total temperature, 15° F; free-stream velocity, 396 feet per second; liquid-water content, 0.57 gram per cubic meter; droplet diameter, 12 microns; angle of attack, 2°; heat-on time, 10.2 seconds; cycle ratio, 10.

(d) Boot segment AL1. Surface distance/chord length, 3.63 percent.

(e) Boot segment BL1. Surface distance/chord length, 3.54 percent.

(f) Boot segment CL1. Surface distance/chord length, 2.92 percent.

Several curves showing typical variations of measured local surface temperatures with time are presented in figure 8. The time-temperature curves were obtained with the boots operating in an icing condition identical to that presented in figure 7. The curves are presented for various points on the surface of the boots and represent a portion of the data from which the surface-temperature-distribution curves of figure 7 were obtained. The values of s/c listed correspond to the approximate center of the most forward segments, upper and lower surfaces, of the three boots. A comparison of figures 8(a), (b), and (c) shows that the peak surface temperatures measured on the most forward segments of the upper surface of the boots are lowered approximately 10° F by the presence of an icing cloud. This relatively small drop in surface temperature indicates the relatively small amount of impingement and runback occurring over a large portion of the upper surface at an angle of

attack of 2° . Comparison with figures 8(d), (e), and (f) shows that the temperature drop experienced on the lower surface of the boots is about 2.0 to 3.5 times as great as those measured on the upper surface for the values of s/c shown. The irregularities and breaks noted in figures 8(d), (e), and (f) occurred at random intervals and are associated with slow or incomplete shedding of ice, sliding of ice back over the thermocouple junctions, and freezing of water as the surface of the boot falls below the freezing level. For example, the time-temperature curve presented in figure 8(e) shows rapid changes occurring in both the heating and cooling portions of the curve. The abrupt rise in temperature experienced at 6.5 seconds indicates a sudden removal of ice from the surface at that time, while the break noted at 30 seconds is due to the freezing of water on the surface of the boot.
