REPORT NO 1136

**BOMBS AND ASSOCIATED COMPONENTS**

-----  
TEST OF M 77 MOD 0 BOMB (FIRE-750 LBS) WITH CANTED FINS

Test of Mk 77 Mod 0 Bomb (Fire-750 lbs.) with Canted Fins

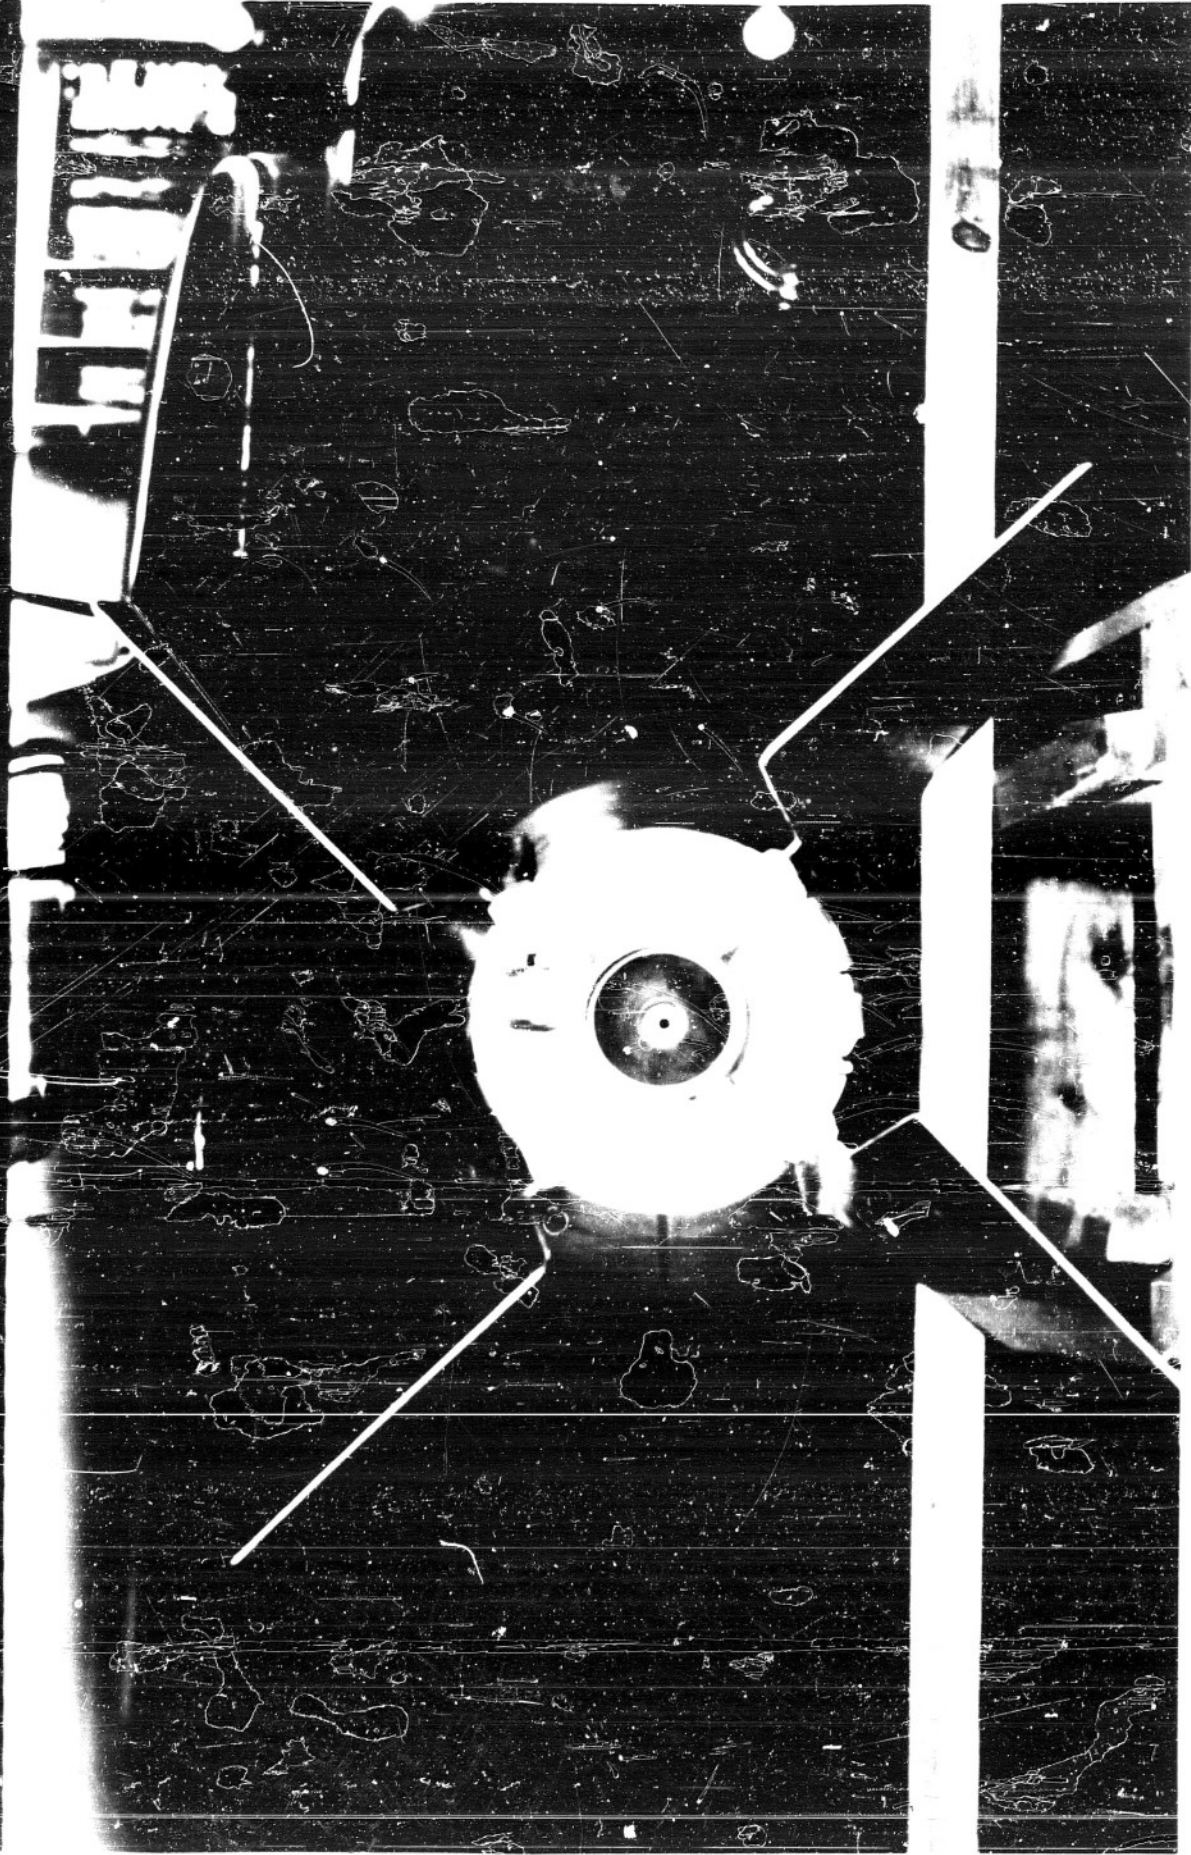
Mk 77 Mod 0 Fire Bomb, equipped with canted fins before modification, rear view.  
Figure 1

The bomb tested was a standard Mk 77 Mod 0 Bomb (Fire-750 lbs.) inert loaded and equipped with inert M23 Igniters and inert M173 Fuzes and further equipped with modified canted fins instead of the standard fins or fins and shrouds. The nose and tail cones were not installed. The fins are manufactured of ST aluminum, 3/16 inch in thickness and 18 inches in length along the root chord. The fins were welded at an angle to an adapter which bolted to the bomb. The angle of fin to the fore and aft centerline of the bomb, and to the adapter, is about 10 degrees. Actual measurements are given in Table I. Reference (c) authorized the modification of the fins as follows: The fins were strengthened by bolting a 3/8 inch steel rod 1-1/2 inches down and in from the outboard after corner of two (2) adjacent fins, and bolting rods between the next two (2) fins as close as practical to the bolts used in the first two (2) fins. Figures 1 through 4 show the bomb before and after modification.

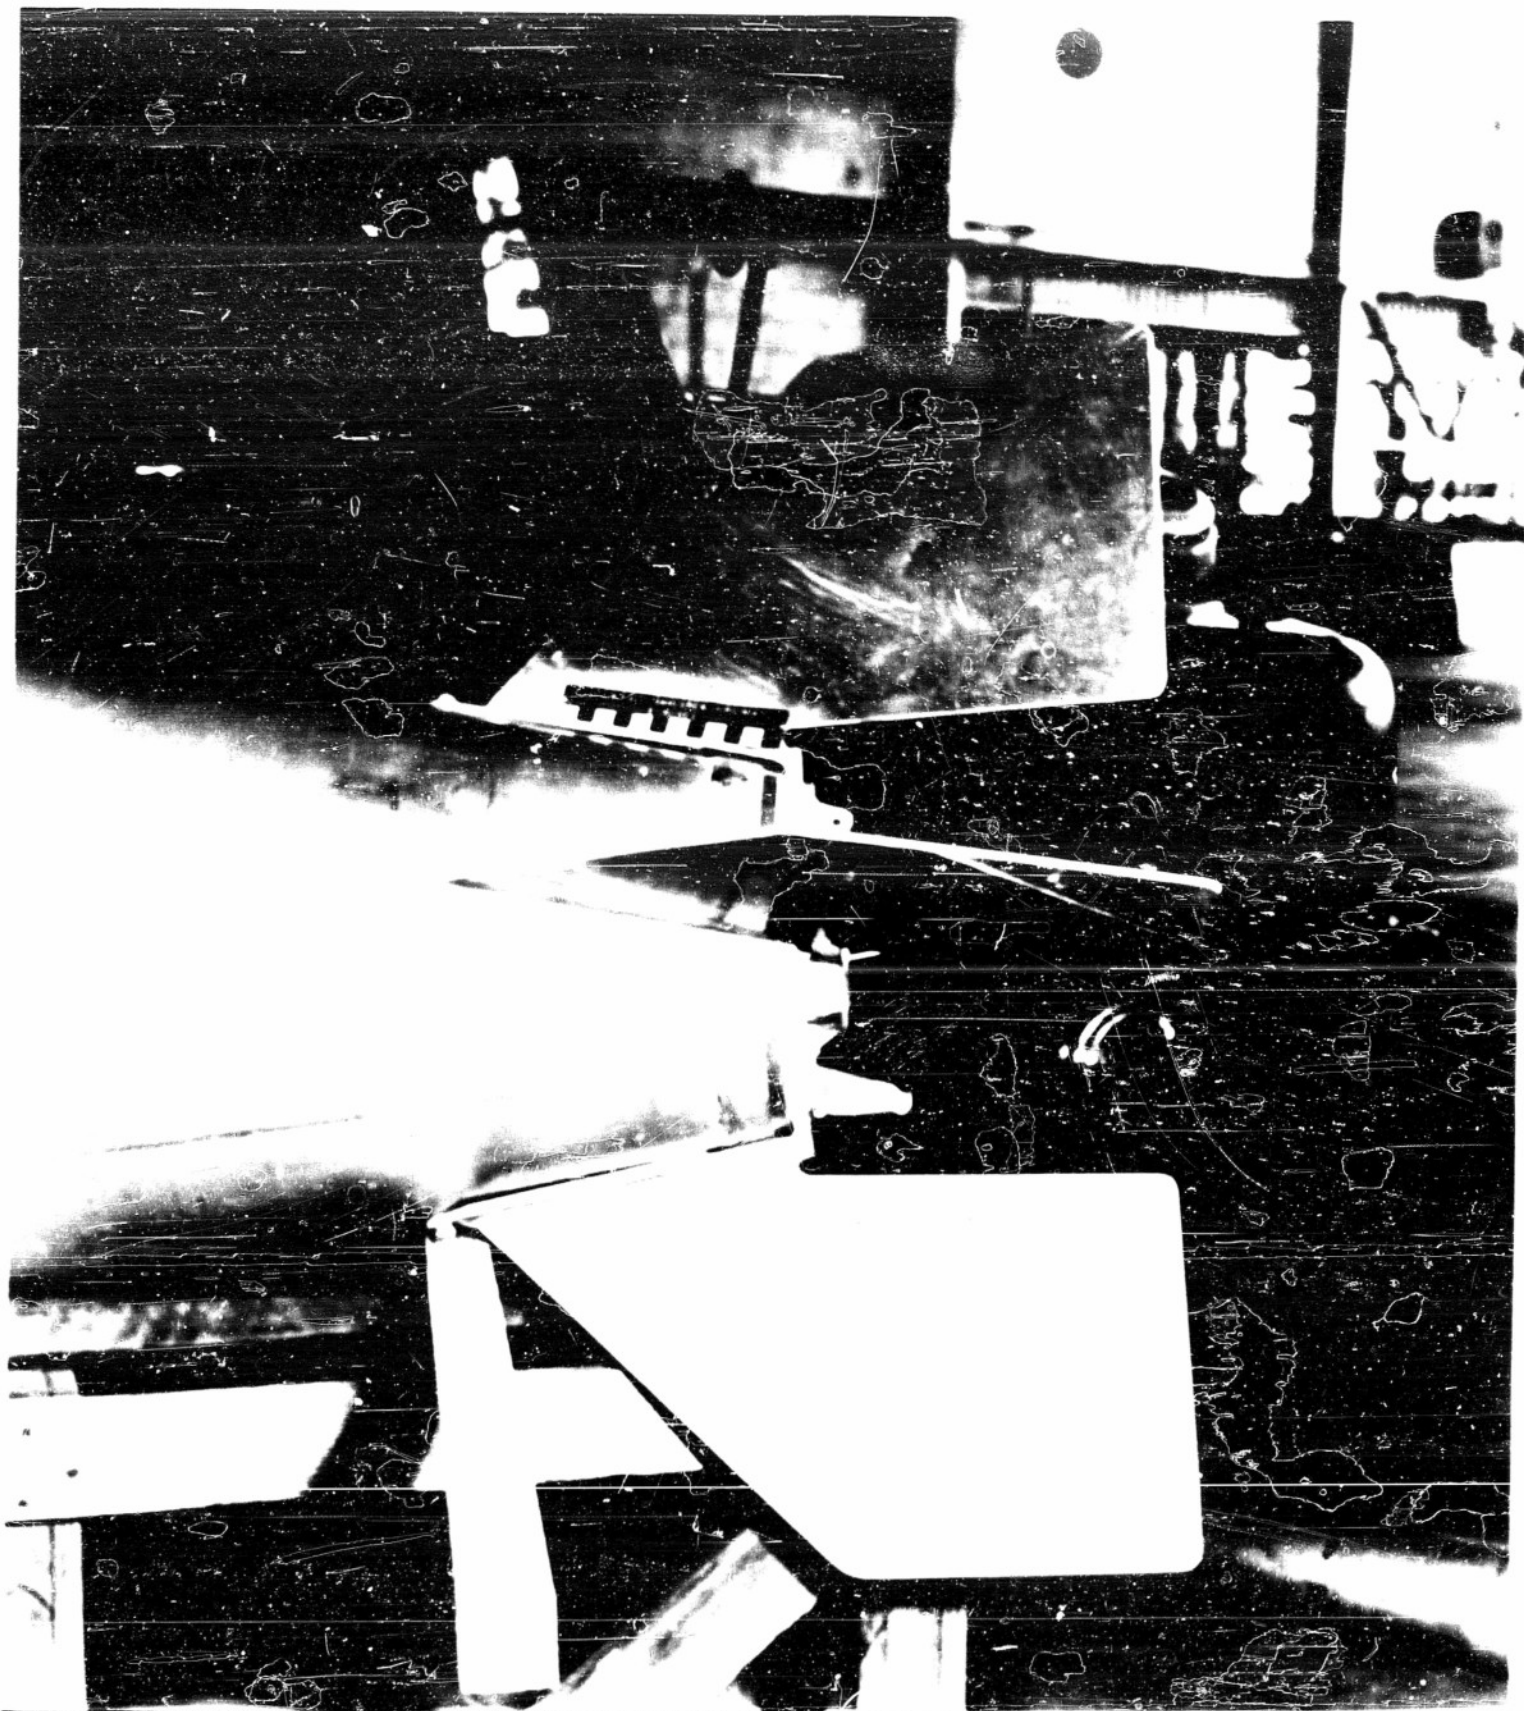
M7 Mod 0 Fire Bomb equipped with canted fins before modification,  
side view. Figure 2

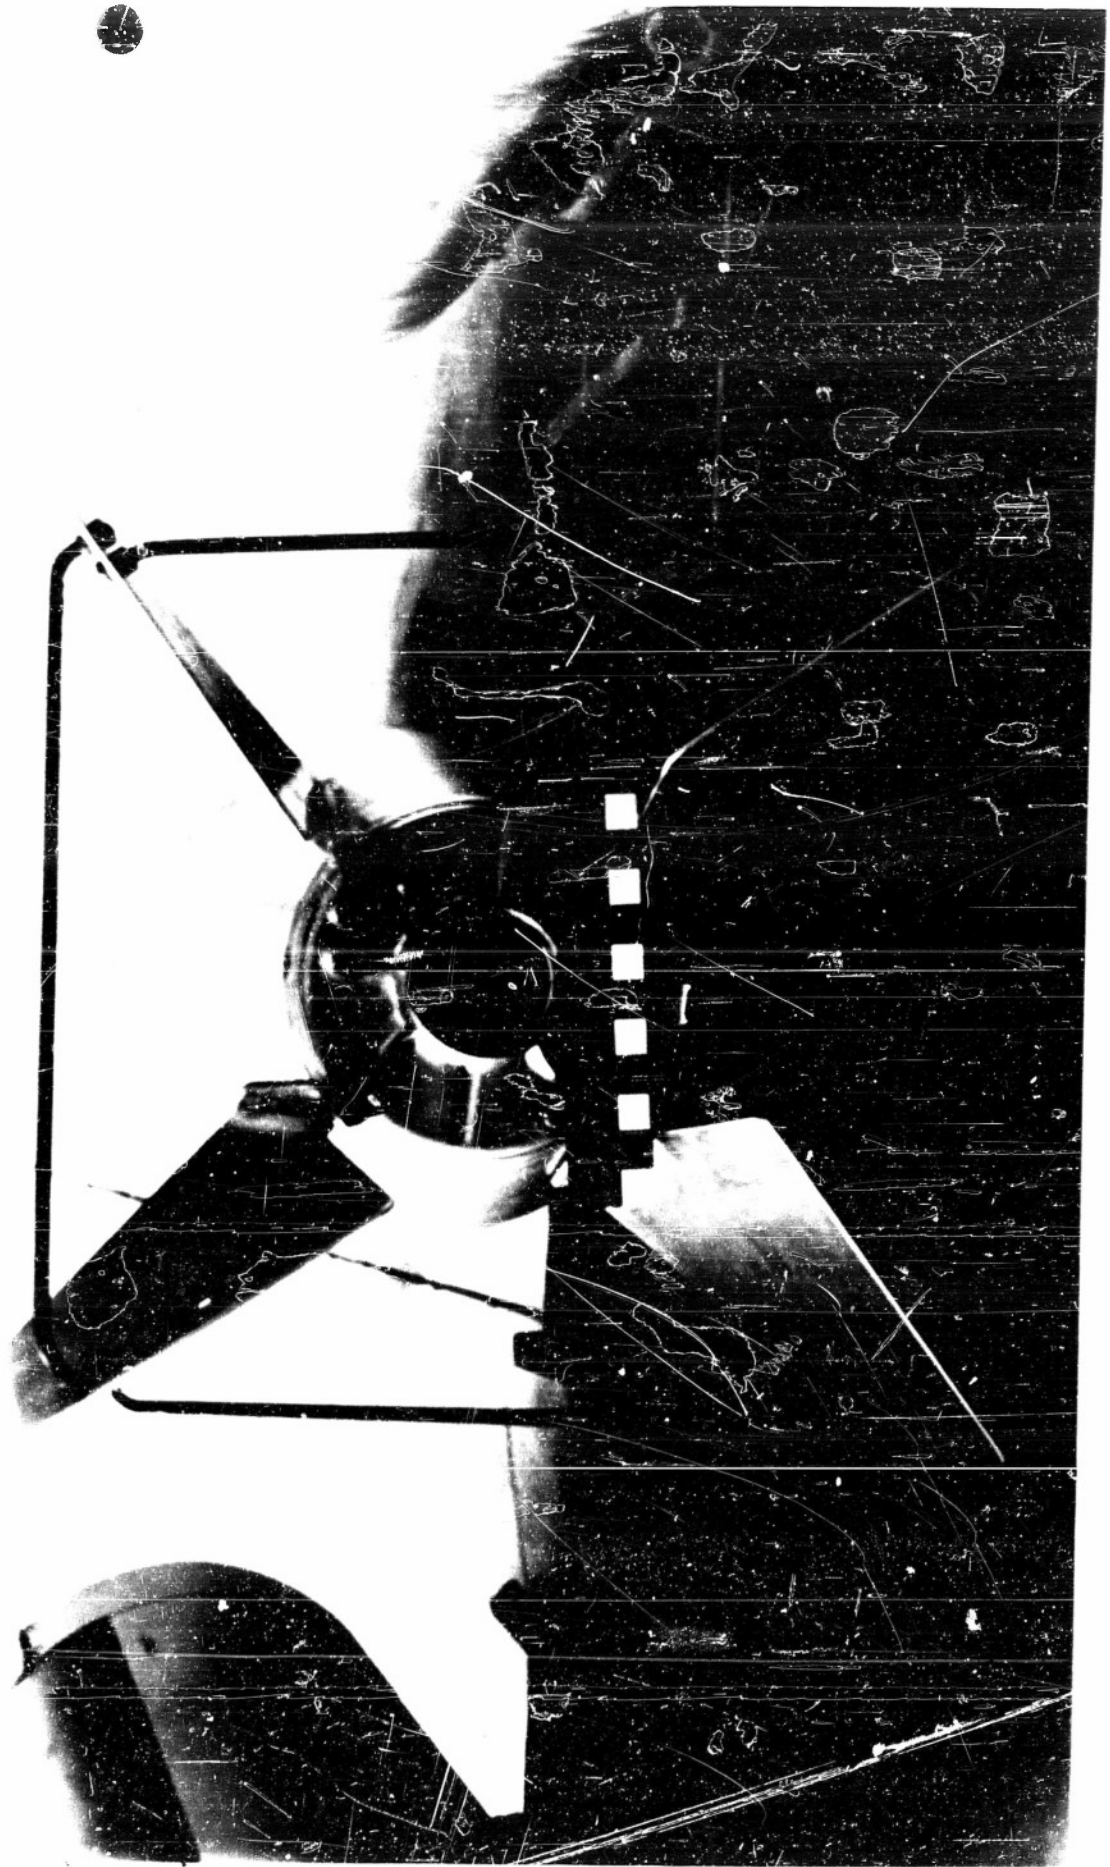
Mk 77 Mod C Piro Bomb equipped with canted fins, after modification, rear view.

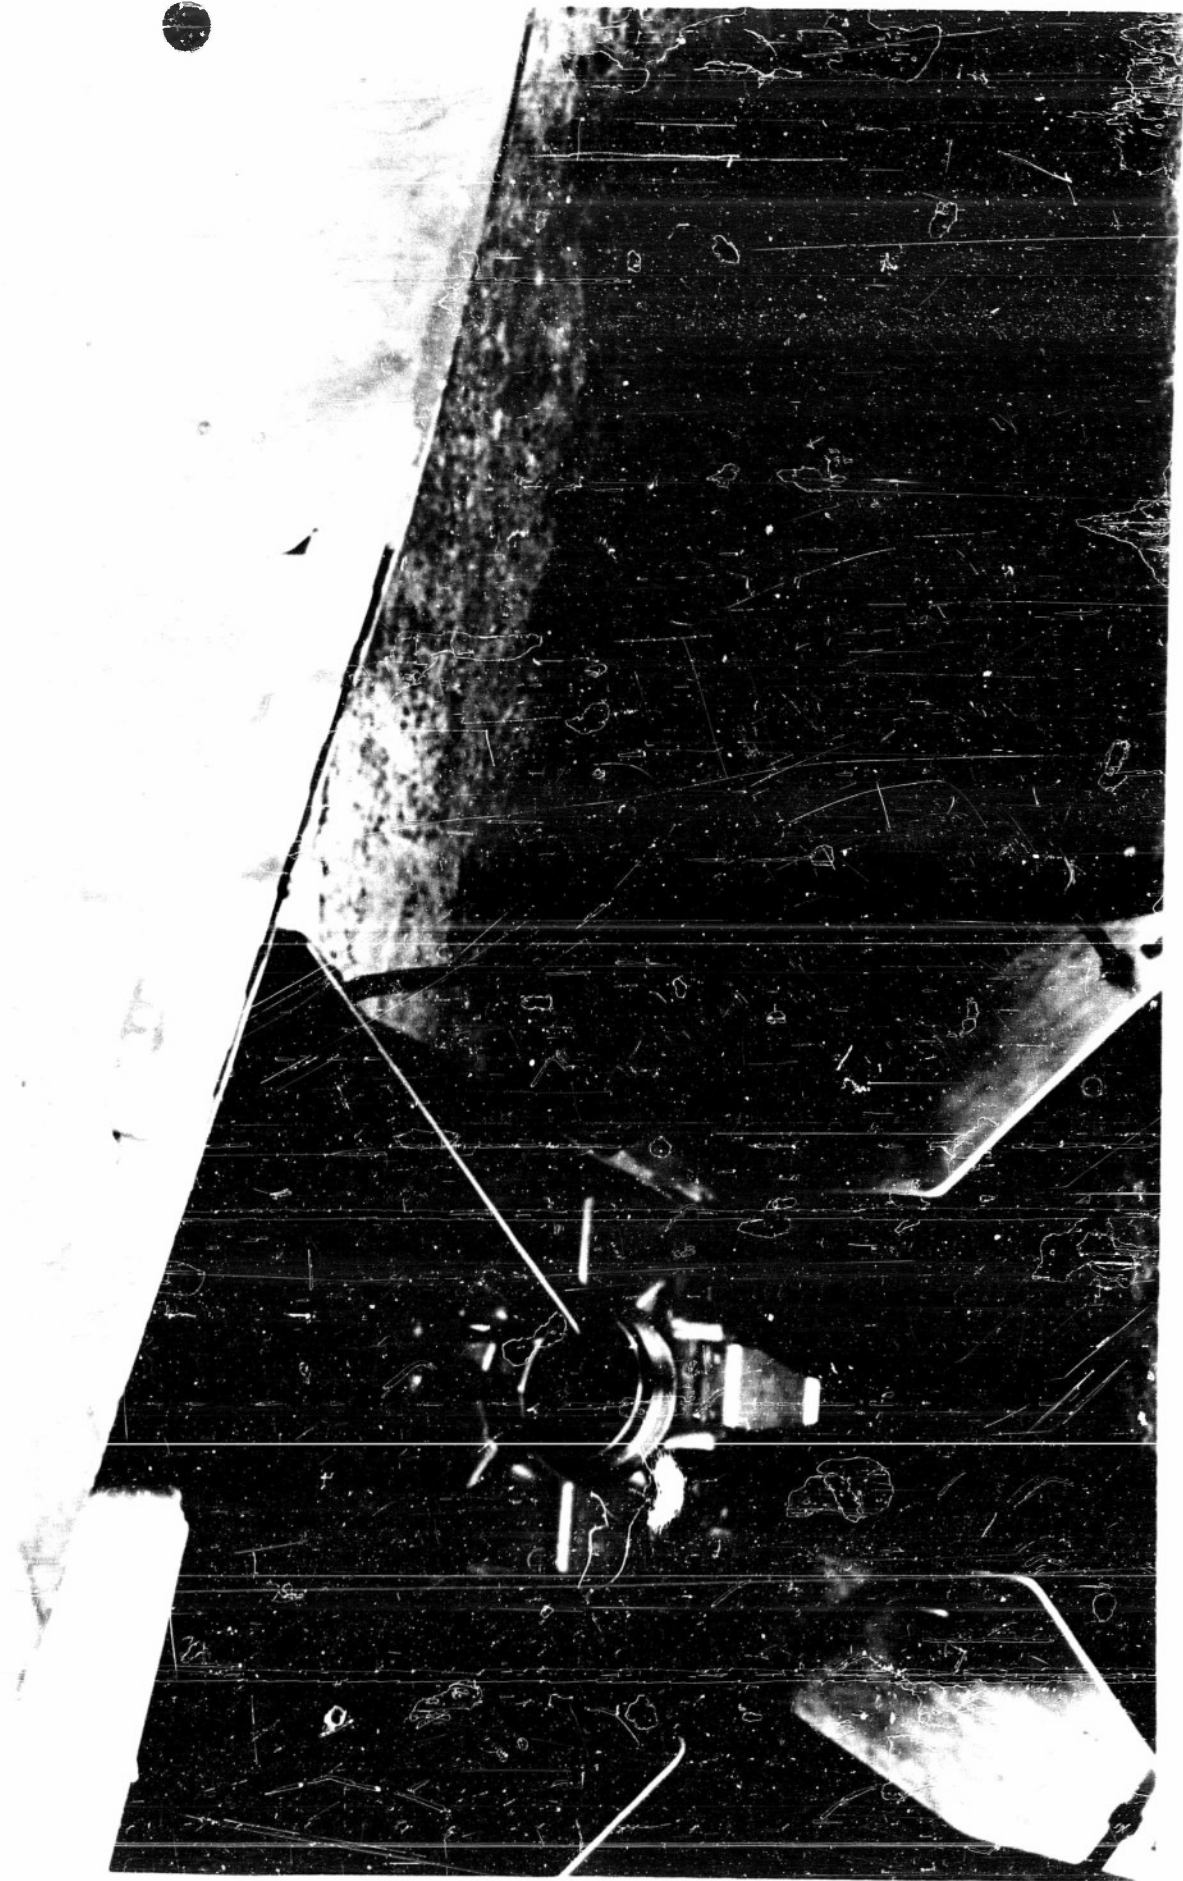
7 April 1953  
Figure 6

NP9-631137  
Mx 77 Mod C Fire Bomb with canted fins  
bare clearance.

RESTRICTED  
SECURITY INFORMATION  
F4U-5, flaps down 200

The following aircraft were used for these tests: F7F-3, AD-2, and F4U-5. On the F7F-3 and AD-2 aircraft, the bomb was hung on the center rack and one (1) wing rack. (The center rack of the F7F-3 has been changed at this activity to a Mk 51 Mod 11 Rack. This is not standard equipment.) On the F4U-5, the bomb was hung on one (1) pylon rack. The landing flaps were actuated on all aircraft.
