# ANPP CORROSION PROGRAM

Loop Testing of Inconel,  
Nickel, Monel and Bimetal  
Heat Exchangers

MND-E-2681

December 1961

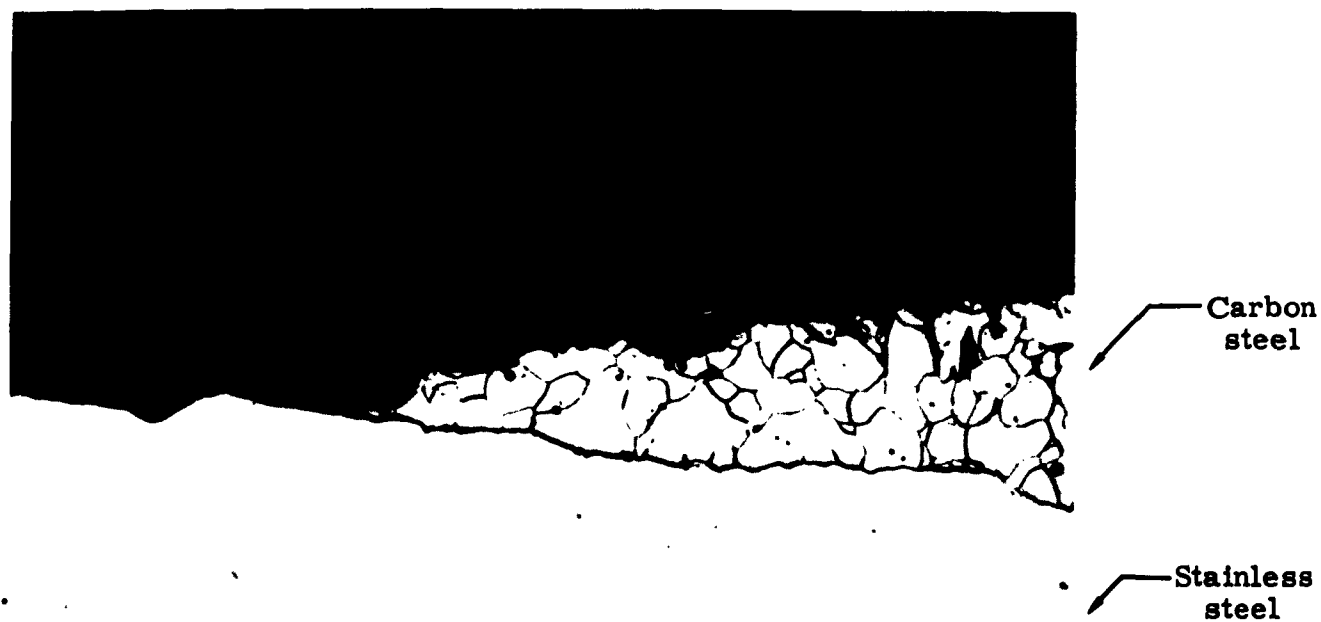
a. Defect in steam phase

b. Defect in water phase

Fig. 26. Photomicrographs of Defected Areas on MIN 16 Tubing  
(Note that the stainless steel was relatively unaffected)

The tubing in MIN 16 was purposely defected by exposing the stainless steel sublayer as is illustrated in Fig. 24. Figure 25 shows one of the defected areas exposed to the liquid phase before cleaning. It was impossible to show a defected area in the vapor phase because of the very heavy layer of corrosion products. Figure 24 shows the tubing after cleaning. The defects and extent of corrosion are clearly visible. Gross amounts of the low carbon steel clad were corroded away. Metallographic sections from the areas of the defects revealed no detrimental effects, as far as the stainless steel was concerned. Typical photomicrographs are shown in Fig. 26. The most striking result of the tests with MIN 15 and 16 was the excellent resistance of the submerged low carbon steel tubing to the unusually severe conditions. This is illustrated in Fig. 24 and also in Fig. 26 which shows that in the liquid phase the tapered carbon steel portion of the defect is still present. In the vapor phase (Fig. 26-b) the portion has completely corroded away.
