REPORT NO. 7-45

EXAMINATION OF ITALIAN PROJECTILES

July 1945

- 47mm A.P. PROJECTILE
- 47mm H.E. PROJECTILE
- 105mm H.E. PROJECTILE
- 120mm COMMON PROJECTILE
- 149mm H.E. PROJECTILE
- 6" H.E. PROJECTILE
- 6" COMMON PROJECTILE

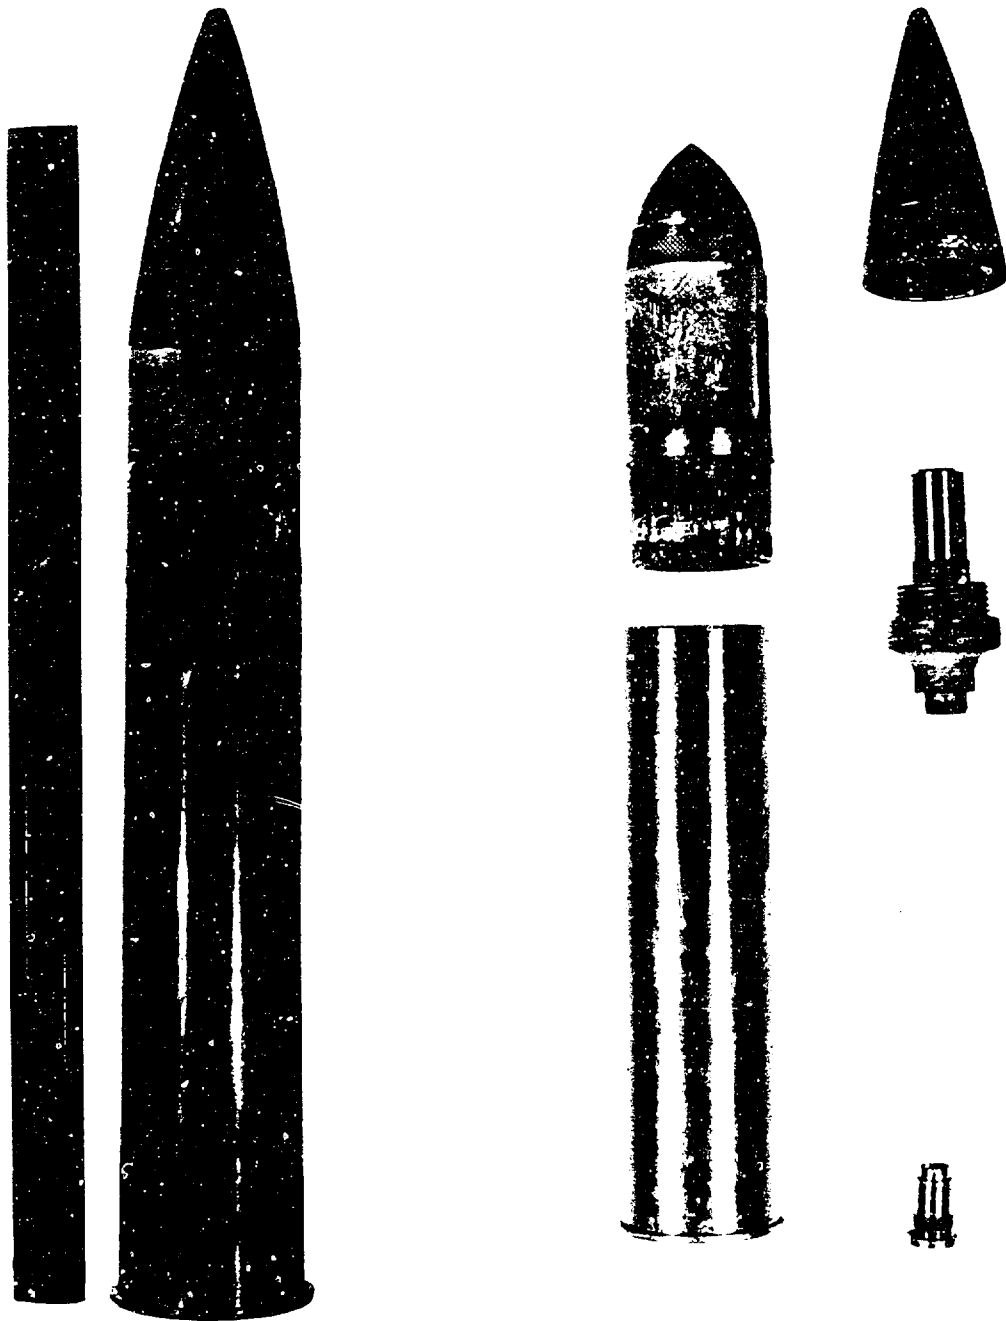
Figure 1

NFG Photo No. 2270 (APL)  
As received and disassembled view of Italian 47mm A.P.  
round. CEE No. 3662.  
15 May 1945

The complete round, as received and disassembled is shown in Figure 1. The projectile is provided with a windshield which is crimped to the nose and with a base plug carrying a base detonating fuze and tracer. The markings found on the round are reproduced in Figure 2. These markings show that the case was manufactured in 1941 but give no indication as to the date of manufacture of the projectile. Colors used to identify the projectile and its loading are also shown in Figure 2.

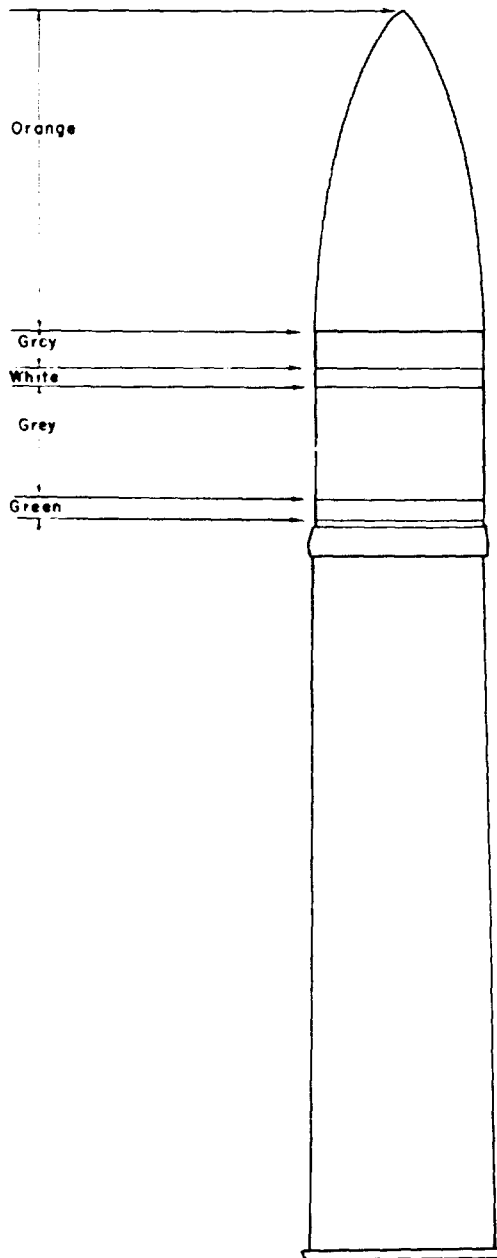
Figure 2  
MARKINGS ON ITALIAN 47mm AP  
PROJECTILE AND CASE

Stenciled

T-P  
DOG. 39

Stamped

B-T

Indistinct Stenciling

Carica da 47 P. Poiv.  
P.C. 3-0, 75x8x110x140 Dr. 173  
4069008-'941'  
DIREZ. D'ARTIGL.-PIACENZA  
NOVEMBRE 9'41

All Markings  
Stamped

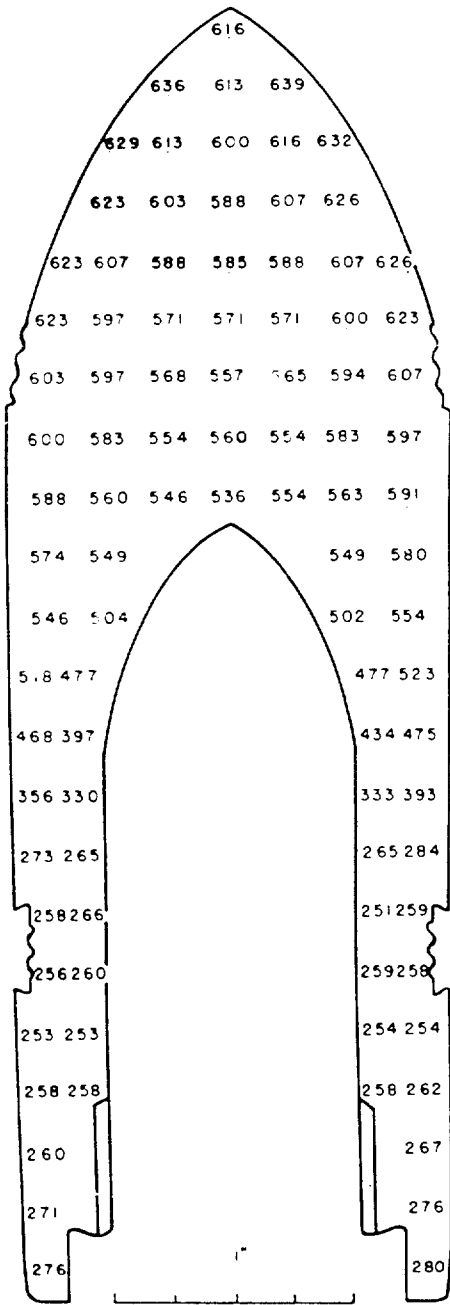
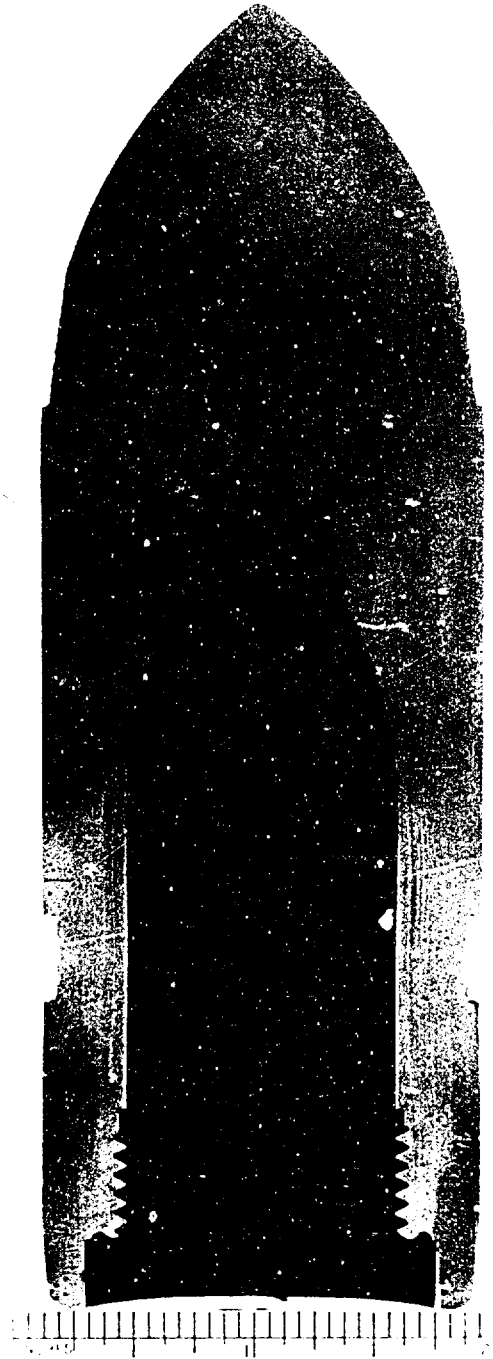
# HARDNESS DISTRIBUTION AND MACROSECTION OF ITALIAN 47mm AP PROJECTILE

Hardness Values: Vickers Pyramid (50 Kg.)  
Etch: Ammonium Persulphate

The projectile body was split longitudinally with an abrasive cut-off wheel and a hardness survey made of the entire cross-section. Figure 3 shows the hardness distribution and macro-etch section of the body. A maximum hardness of approximately 630 VPN (56Rc) has been obtained on the nose of the projectile. The hardness drops off slowly from the nose to a point about a quarter of an inch above the band score where it drops off rapidly to approximately 260 VPN (25Rc) which hardness is maintained throughout the base. The flow lines shown in the macro-etch section indicate that the projectile was forged and machined.

The maximum nose hardness of this 47mm projectile is somewhat lower than the nose hardness of American projectiles of this caliber. The American 37mm and 40mm AP projectiles generally have a nose hardness of from 700 to 750 VPN (60 to 62 Rc), as compared to approximately 630 VPN (56Rc) for the subject projectile.

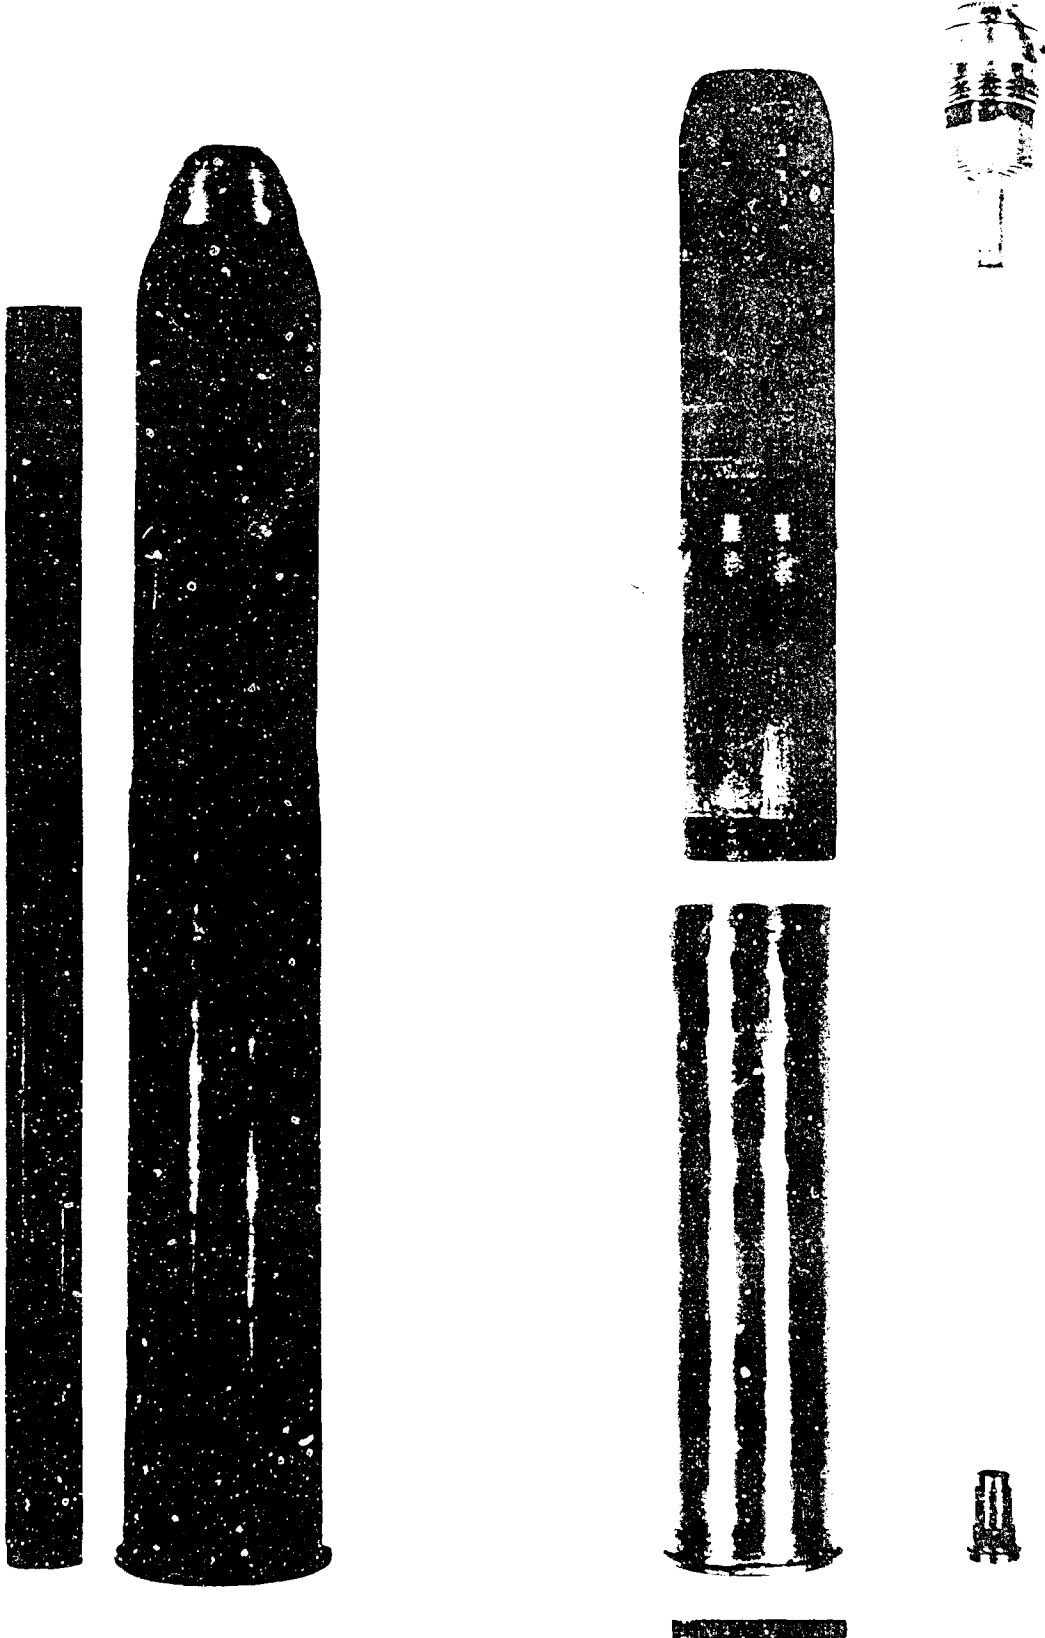
Figure 1

NFG Photo No. 1350 (APL).  
As received and disassembled view of Italian 4.7mm H.E.  
round. CBE No. 3662.  
15 May 1945

The complete round, as received and disassembled, is shown in Figure 1-. The projectile extends into the case nearly half its length, and is fitted with a narrow rotating band near its center. A contact type nose fuze is provided. The markings found on the round are shown in Figure 2 and indicate that the case was manufactured in 1941, but give no indication as to the date of manufacture of the projectile. The colors used to identify the projectile and its loading are also given in Figure 2.

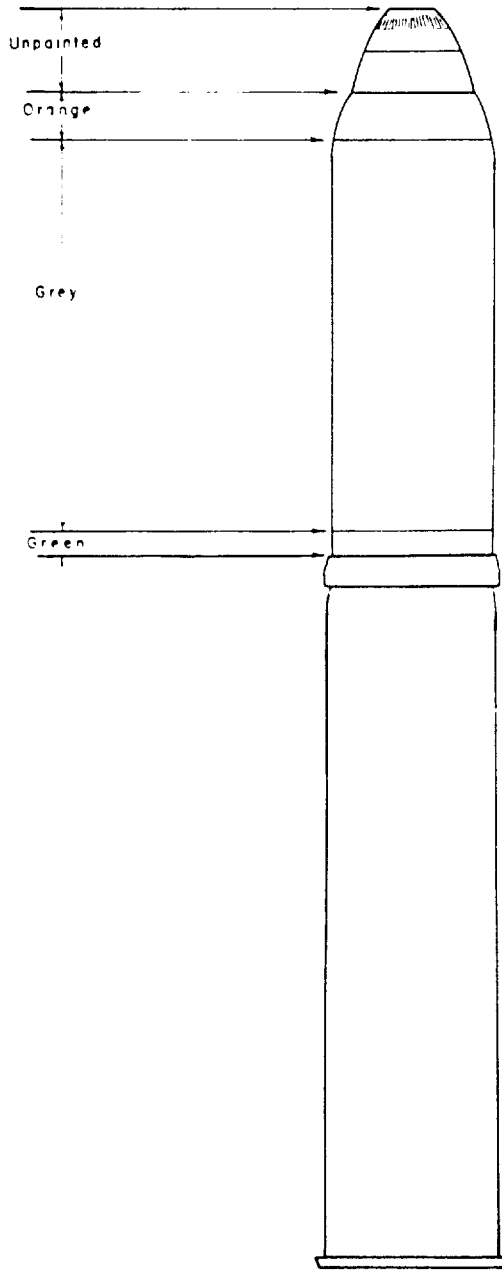
Figure 2  
MARKINGS ON ITALIAN  
47mm HE PROJECTILE

Stamped on Fuze

Stenciled

Industrial Stenciling

Carica da 47/32 Pov. P.C. 403

Mat. 405:011/1940

DIREZ ONE ARTIGLIERIA BOLOGNA 1940

All Markings  
Stamped

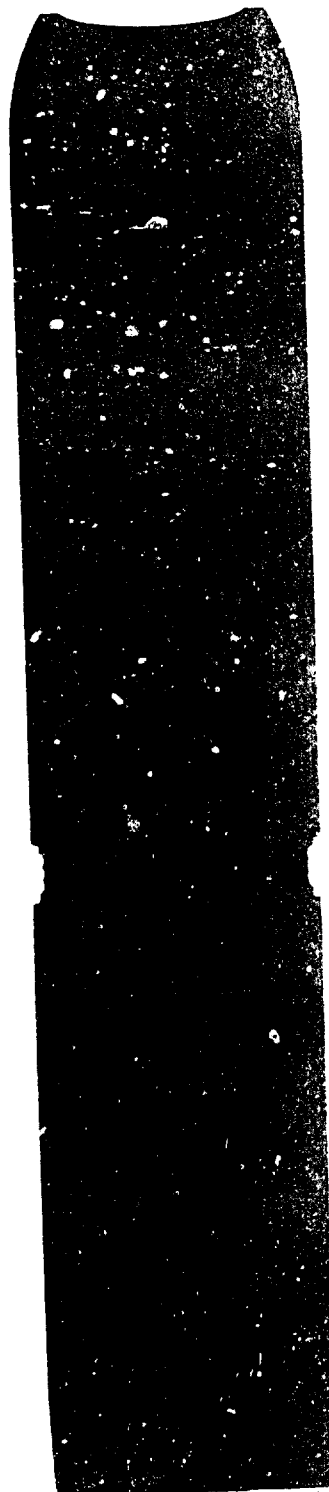
Deep etched section of Italian 47mm H.E. projectile.

The projectile body was split longitudinally and deep etched to reveal the flow lines. Figure 3 shows the etched section and indicates that the projectile was machined from bar stock. A uniform hardness of approximately 92 Rb was obtained along the surface of the body. The microstructure of the projectile body is shown in Figure 4. It consists of fine pearlite and ferrite and has a relatively large number of non-metallic inclusions.

The subject projectile body was manufactured from a plain carbon steel. It was machined from bar stock and was given a single heat treatment probably consisting of an air cool from above the critical temperature.

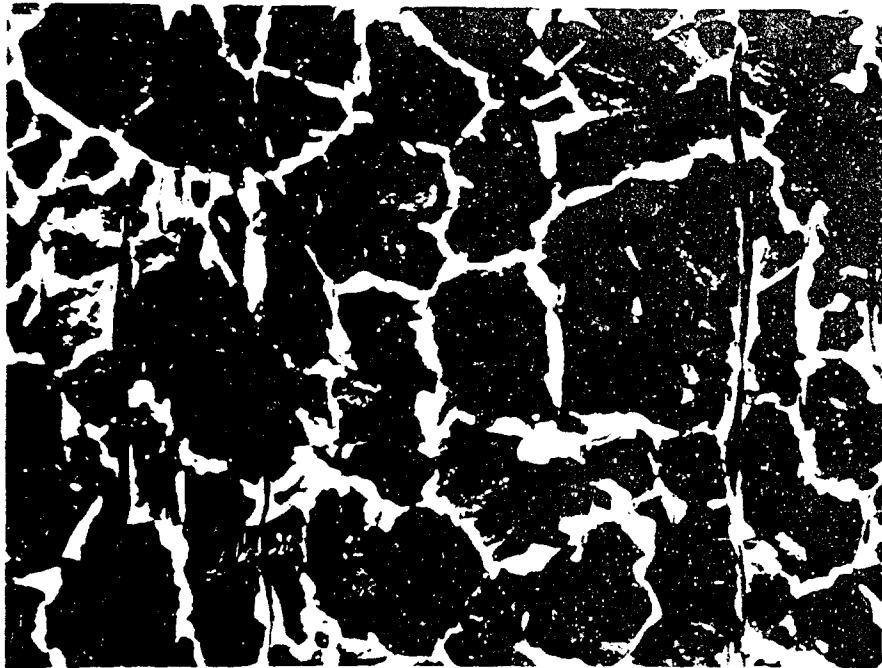
Figure 4

MICROSTRUCTURE OF THE BODY OF  
ITALIAN 47mm HE PROJECTILE

Fine Pearlite and Ferrite

Hardness - 92 Rb      Magnification 250X

Etch - Picral      M493

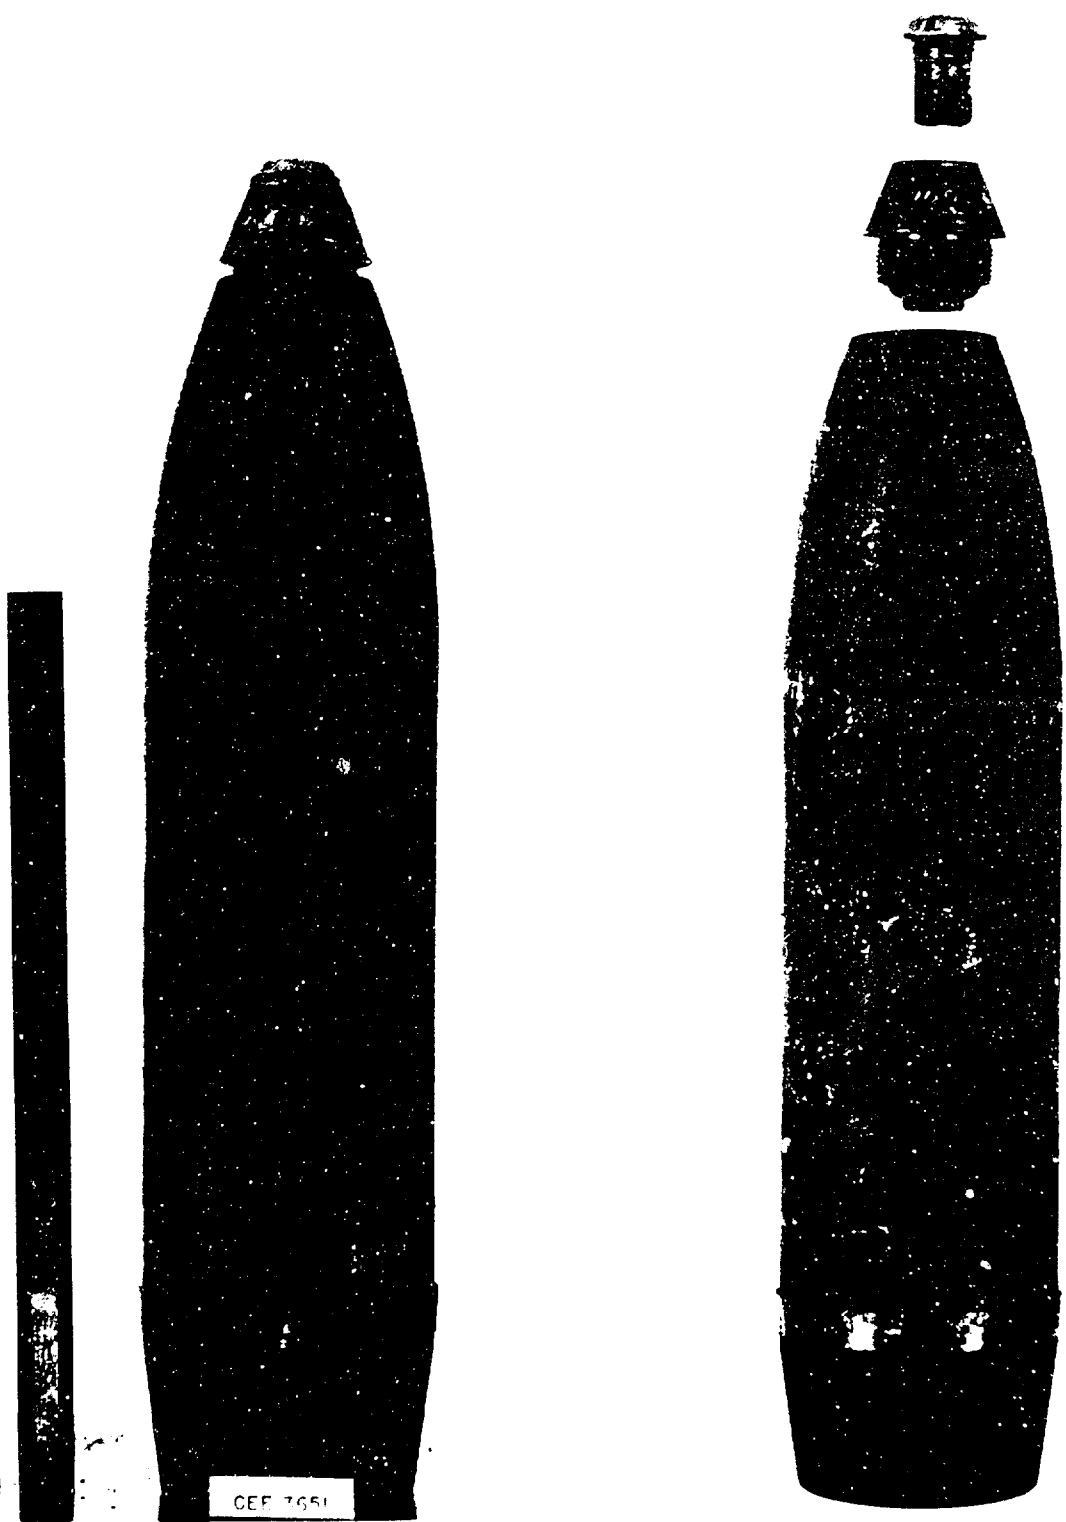
Figure 1 shows the projectile as received and disassembled. A nose plug is provided with a threaded hole in the end for a detonating fuze. The projectile was received with a shipping plug screwed into the fuze hole.- The markings found on the projectile and its identifying coloring are shown in the drawing of Figure 2. There is no opening in the base of the projectile and only a very narrow rotating band is provided.

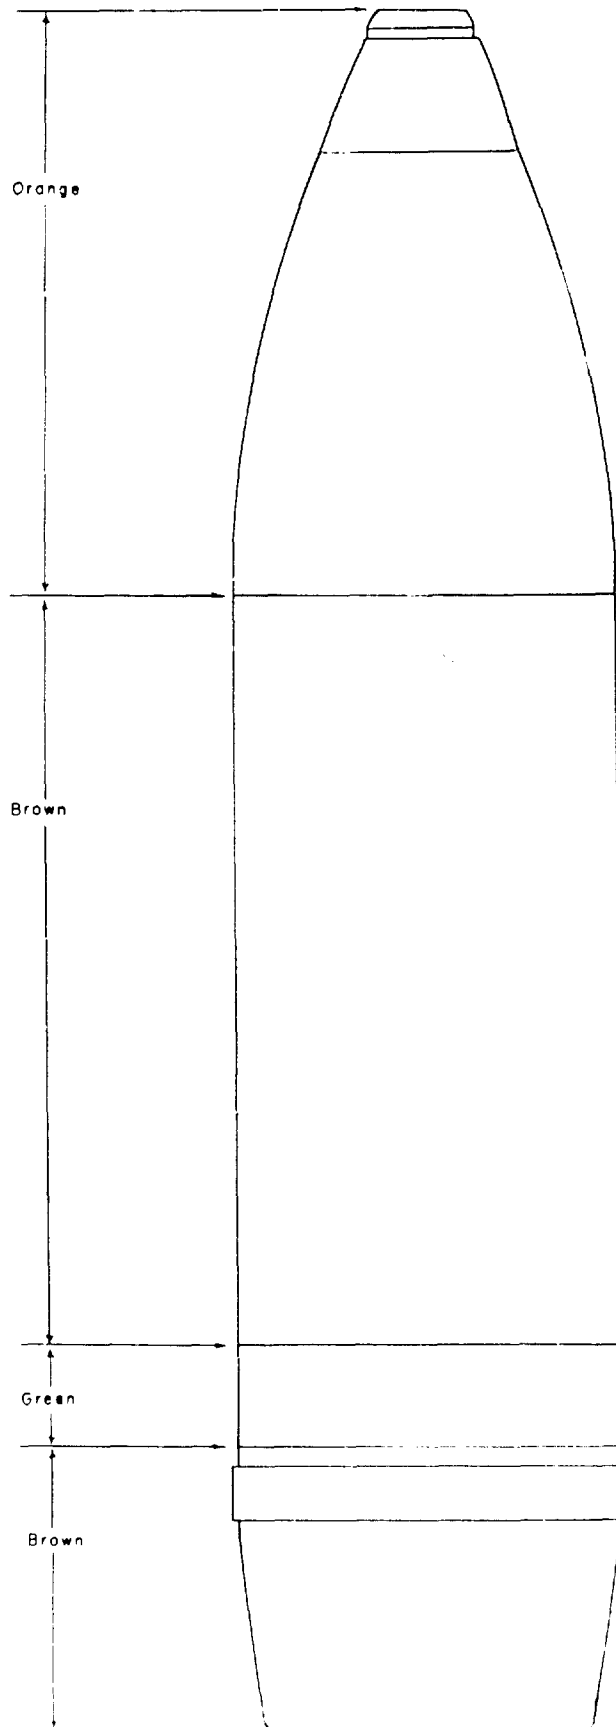
MARKINGS ON ITALIAN  
105mm HE PROJECTILE

Indistinct Stenciling  
MIGL 98

Kg. 16.050  
AMATOLO 80/20  
R.B. - X  
105/78

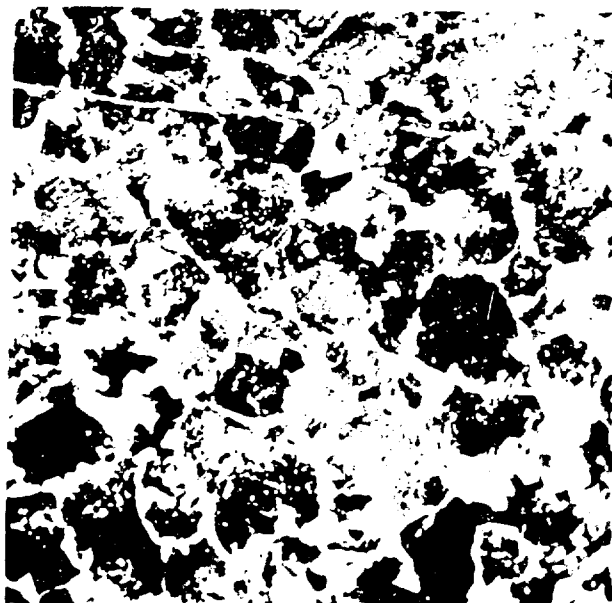
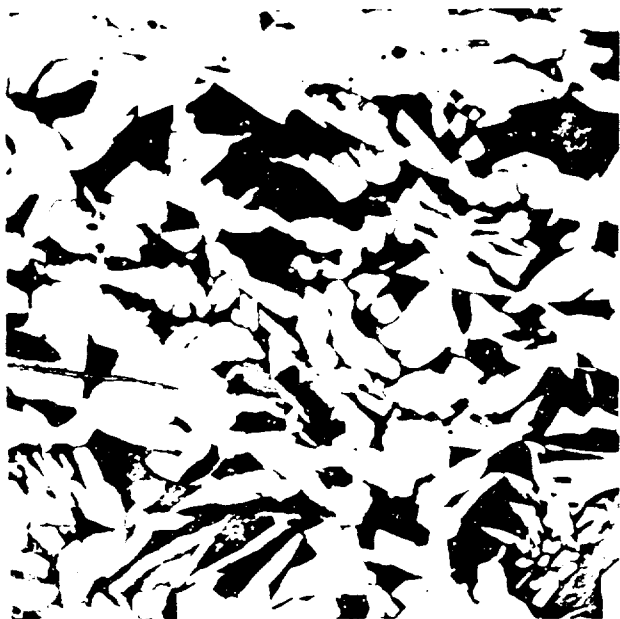
MICROSTRUCTURES OF  
ITALIAN 105mm HE PROJECTILE

BODY Pearlite and  
Ferrite

Hardness - 99 Rb  
Magnification - 250X  
Etch - Picral  
M499

NOSE PLUG Pearlite and  
Ferrite

Hardness - 78 Rb  
Magnification - 250X  
Etch - Picral  
M498

form the cavity. The nose was shaped by forging and then finish machined. A hardness of approximately 99 Rb was obtained on the surface of the projectile body. In Figure 4 is shown the microstructure of the nose plug and body, both consist of ferrite and pearlite, the amount of pearlite present being in proportion to the carbon content of the steel. The nose plug had a uniform hardness of 78 Rb.

A high manganese, free machining, steel has been used in the manufacture of this projectile. It has been manufactured by forging and piercing and has not received any special heat treatment. The microstructure indicates that it was normalized by heating to above the critical temperature and cooling in air. The microstructure, heat treatment and hardness are similar to U.S. Navy projectiles of this type and size.

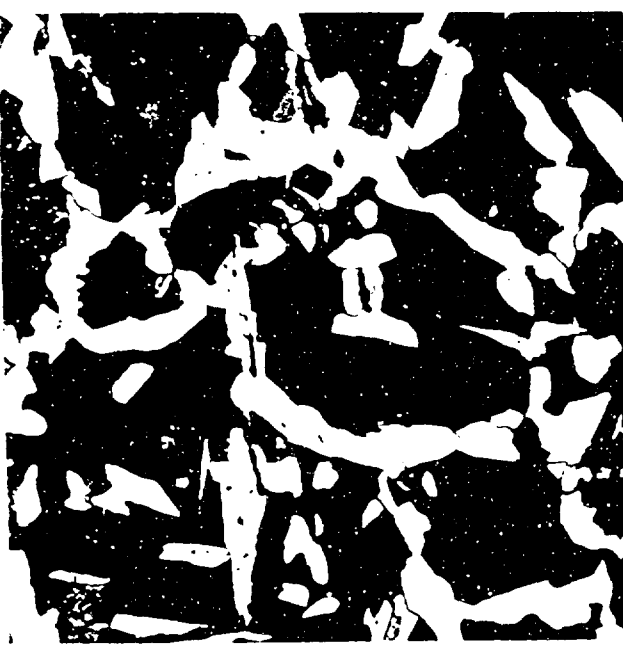
Figure 4

MICROSTRUCTURES OF  
ITALIAN 149mm HE PROJECTILE

BODY      Pearlite

Hardness - 98 Rb  
Magnification - 250X  
Etch - Picral  
M500

NOSE SECTION      Pearlite  
and Ferrite

Hardness - 94 Rb  
Magnification - 250X  
Etch - Picral  
M501

The microstructure of the nose and body are shown in Figure 4. Both nose and body are normalized structures, the microstructure of the body consisting of pearlite, and that of the nose consisting of pearlite and ferrite.

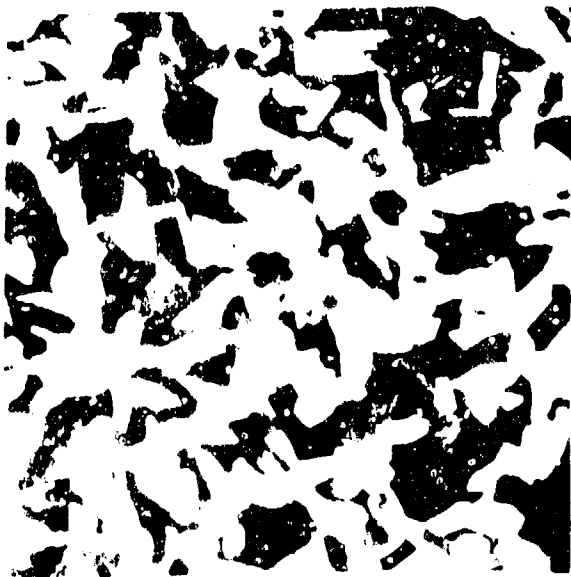
MICROSTRUCTURES OF ITALIAN  
6" HE PROJECTILE

BODY Pearlite and Ferrite

Hardness: 260 VPN  
Magnification: 250 X  
Etch: Picral  
M522

BASE PLUG Pearlite and Ferrite

Hardness: R<sub>p</sub>77  
Magnification: 250 X  
Etch: Picral  
M523

Figure 5 illustrates the microstructure of the body and base plug. Both structures consist of pearlite and ferrite. The fineness of the pearlite and the small amount of pro-eutectoid ferrite in the microstructure of the body suggest that this piece was quenched and tempered. This treatment did not result in high hardness since this steel has low hardenability. The microstructure of the base plug is a typical normalized structure.

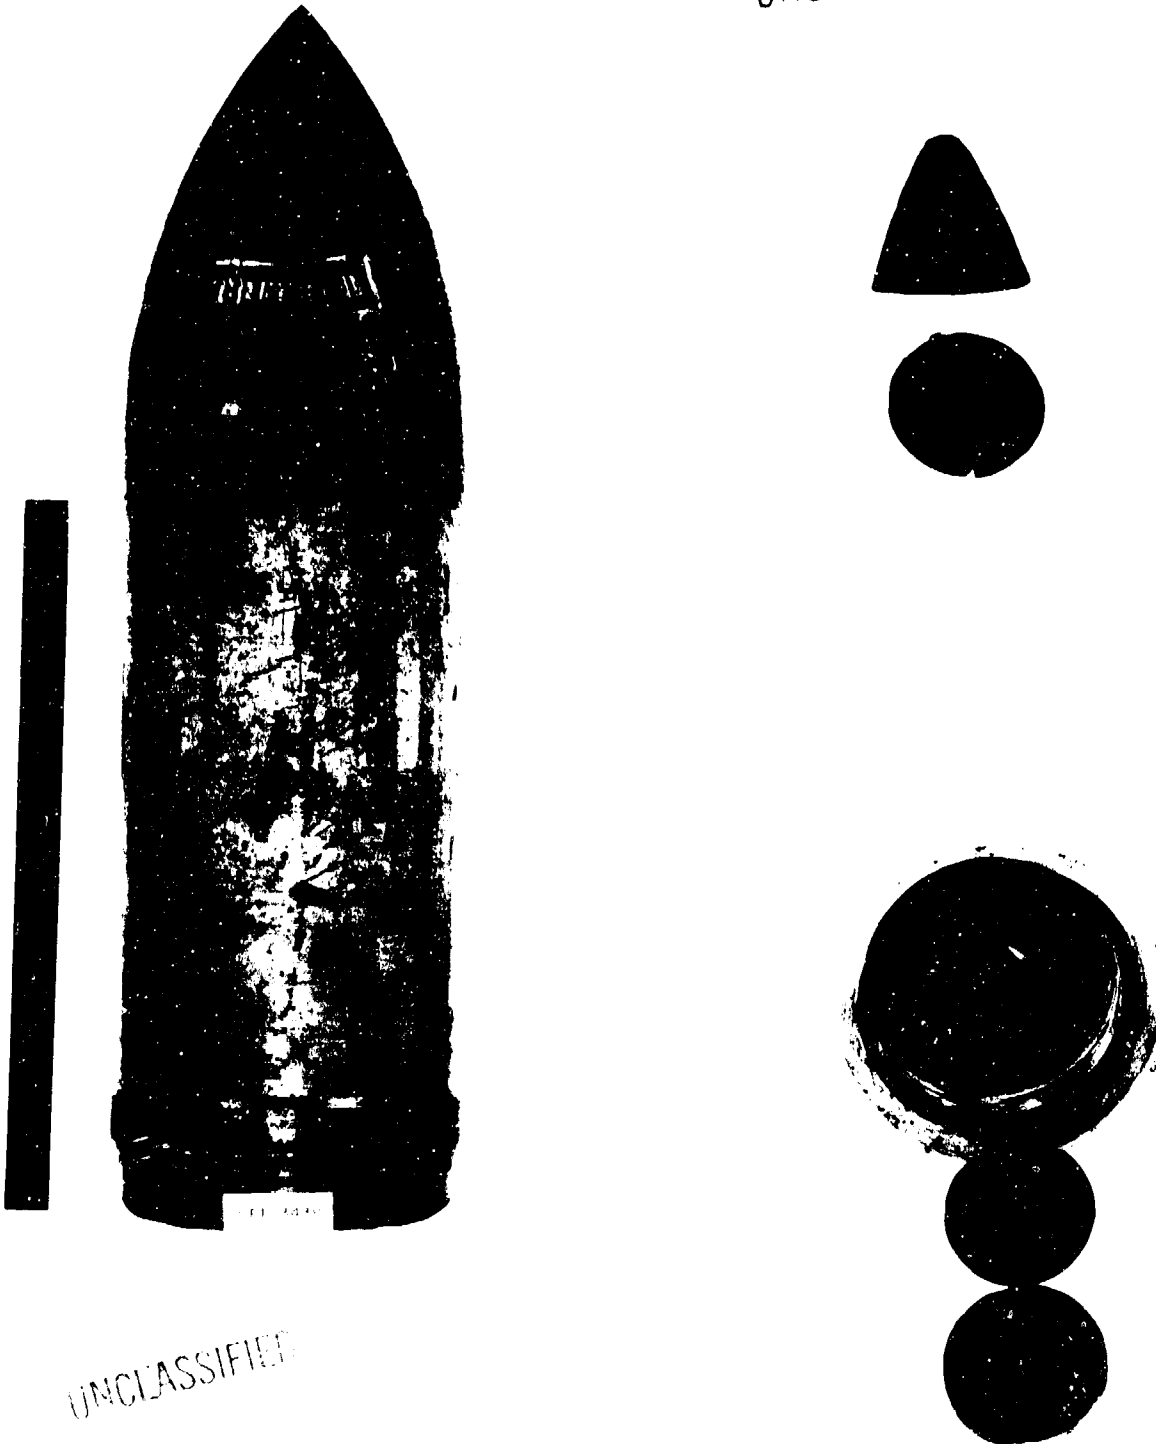
Figure 1  
NPG PHOTO NO. 1403 (APL)  
Italian 6" Common Projectile, CEE No. 3438, as Received  
and Disassembled View.  
15 May 1945

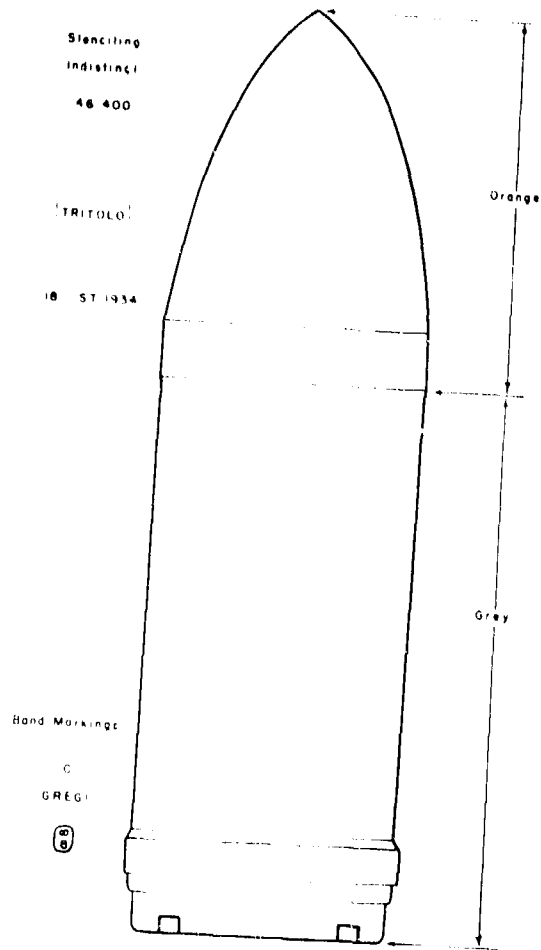
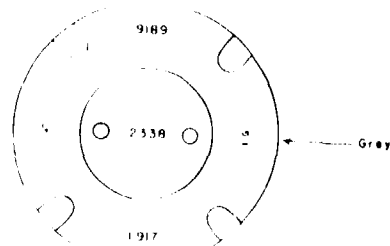
Figure 2  
MARKINGS ON ITALIAN  
6" COMMON PROJECTILE

Markings on Body of Projectile are Stenciled  
Band and Base Markings are Stamped

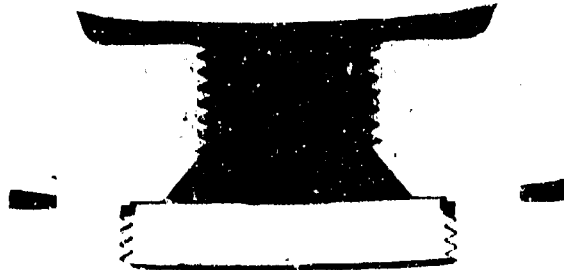
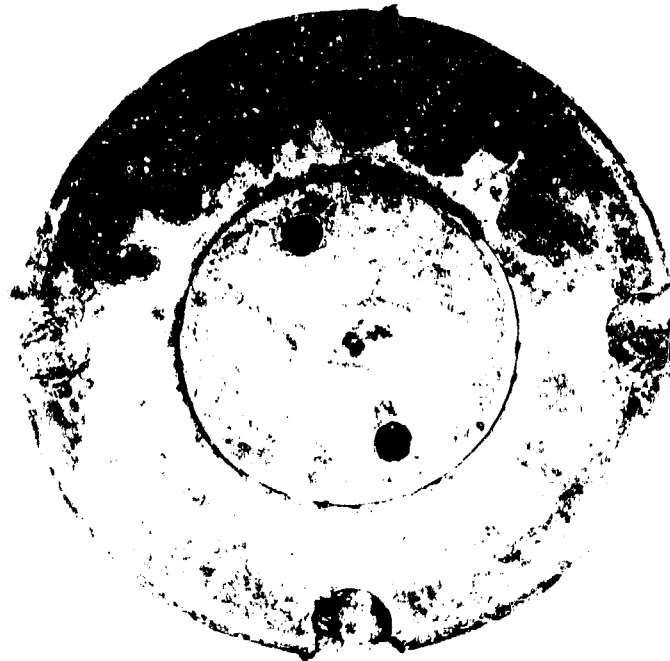
Figure 3  
NPG PHOTO NO. 2557 (APL)  
Bottom View and Deep Etched Section of Base Plug from  
Italian 6" Common Projectile, CEE No. 3438.  
15 May 1945

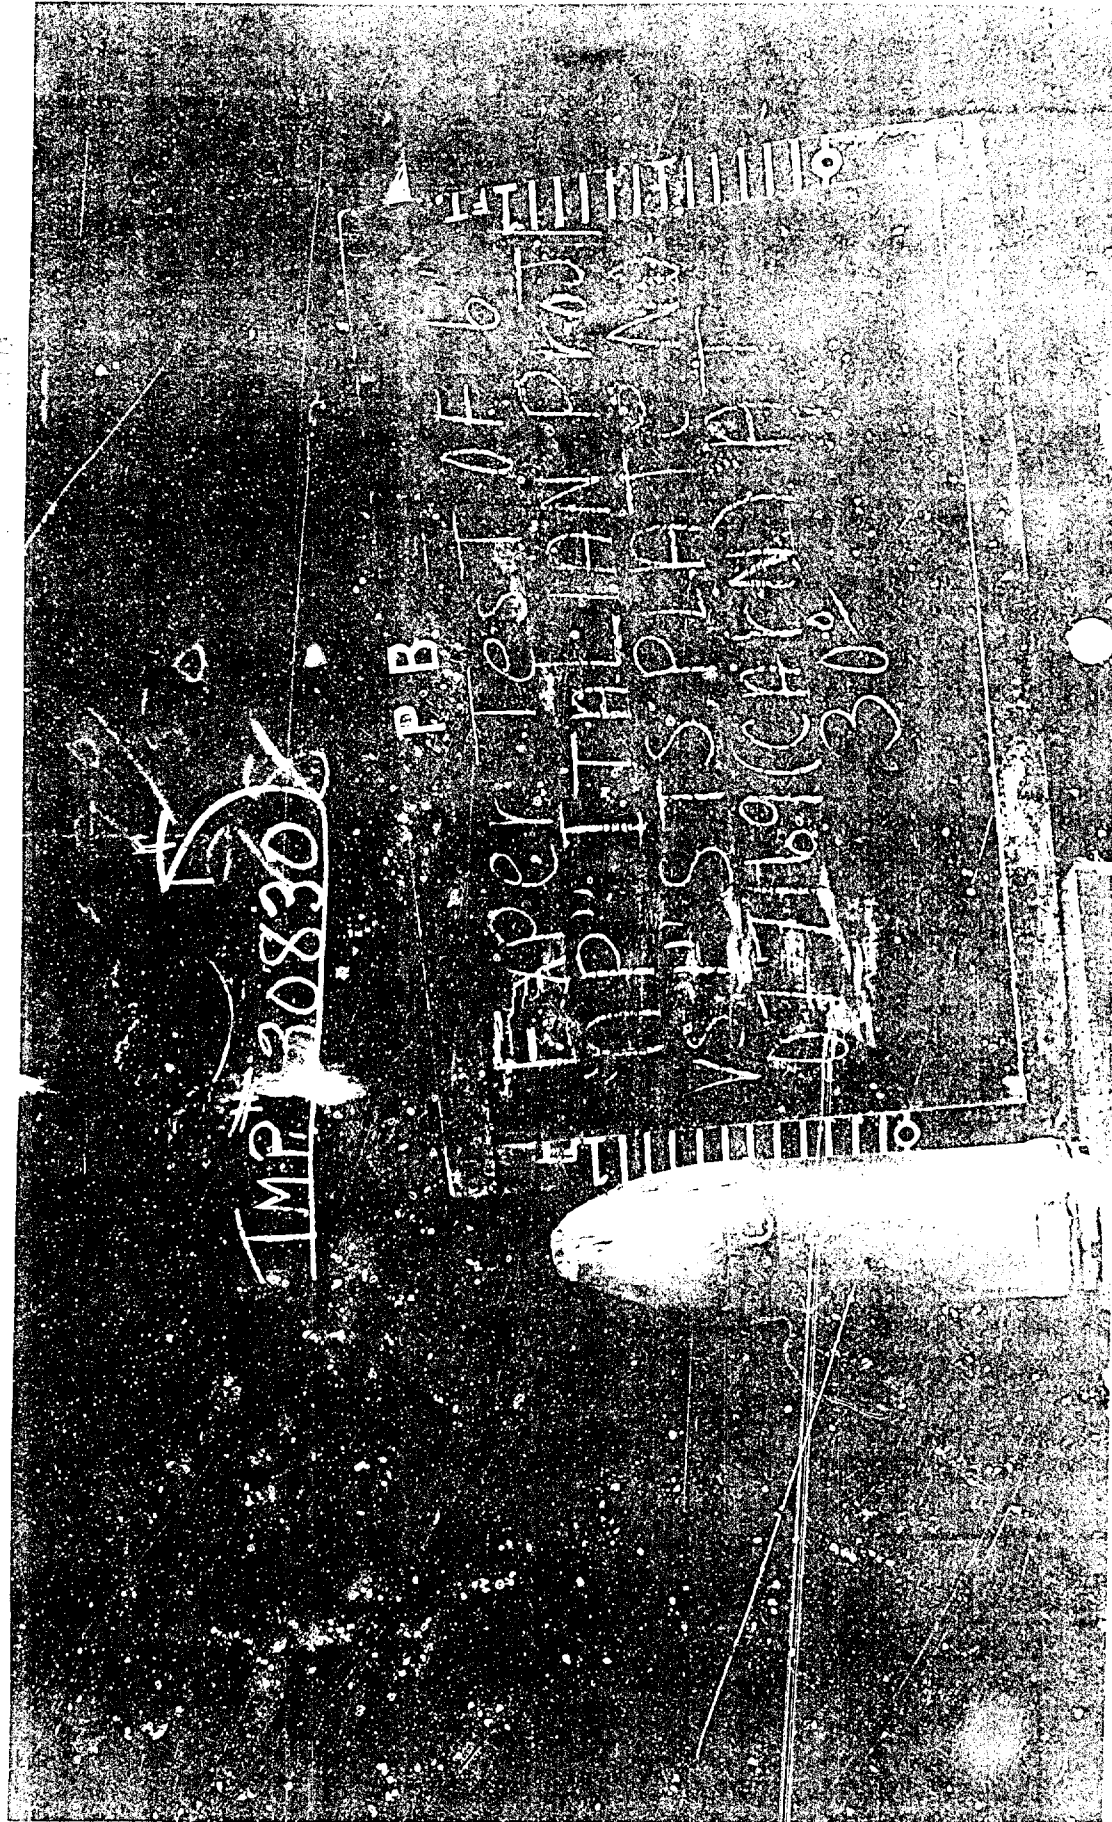
Impact No.  
30530

Remarks  
projectile  
effective  
nose chewed  
and ogive  
gouged.

Details for the ballistic tests are given below. Photographs of the projectiles and plates after impact are shown in Figure 6 and 7.

<u>Round 1</u>	<u>Round 2</u>
NPG Impact No.	30720	30830
Plate Thickness	2.40	0.98
Obliquity	31°20'	29°50'
Striking Velocity	1052 ft/sec	1053 ft/sec
% of Sk.78841	112.5	198.8
Penetration	1/2"	Complete
Dish	1/2"	1"
Impact Dimensions	3" x 5"	6" x 10"
Thru Opening	None	6" x 9-1/2"
Proj. Condition	Completely broken up	Eff., Nose chewed, ogive gouged
	Projectile Wt. 119#, Inert Filler

Two rounds were tested ballistically. The first round was fired against 2-1/2" STS plate at 30° obliquity at a velocity about 10% above the limit velocity of average STS plate vs 6" common projectile Mk.27-7. This round was rejected by the plate completely broken up. Since nothing of value could be learned from further firing under these conditions, the second round was tested against 1" STS plate at 30° obliquity at a velocity greatly in excess of the plate limit. This round penetrated the plate and was effective with the tip of the nose chewed and the ogive gouged. The Mk. 27-7 projectile will remain effective and intact after penetrating considerably more than 2-1/2" STS at 30° obliquity. The test conditions of round 1 are less severe than the acceptance test conditions of the Mk. 27-7 projectile.
