FINAL REPORT ON FINISH AND COATING  
DEVELOPMENT FOR MAULER WEAPON FOD

REPORT NO. RI-TM-65-6

FINAL REPORT ON FINISH AND COATING  
DEVELOPMENT FOR MAULER WEAPON POD

Container Design Branch  
Ground Support Equipment Laboratory  
Directorate of Research and Development  
U. S. Army Missile Command  
Redstone Arsenal, Alabama

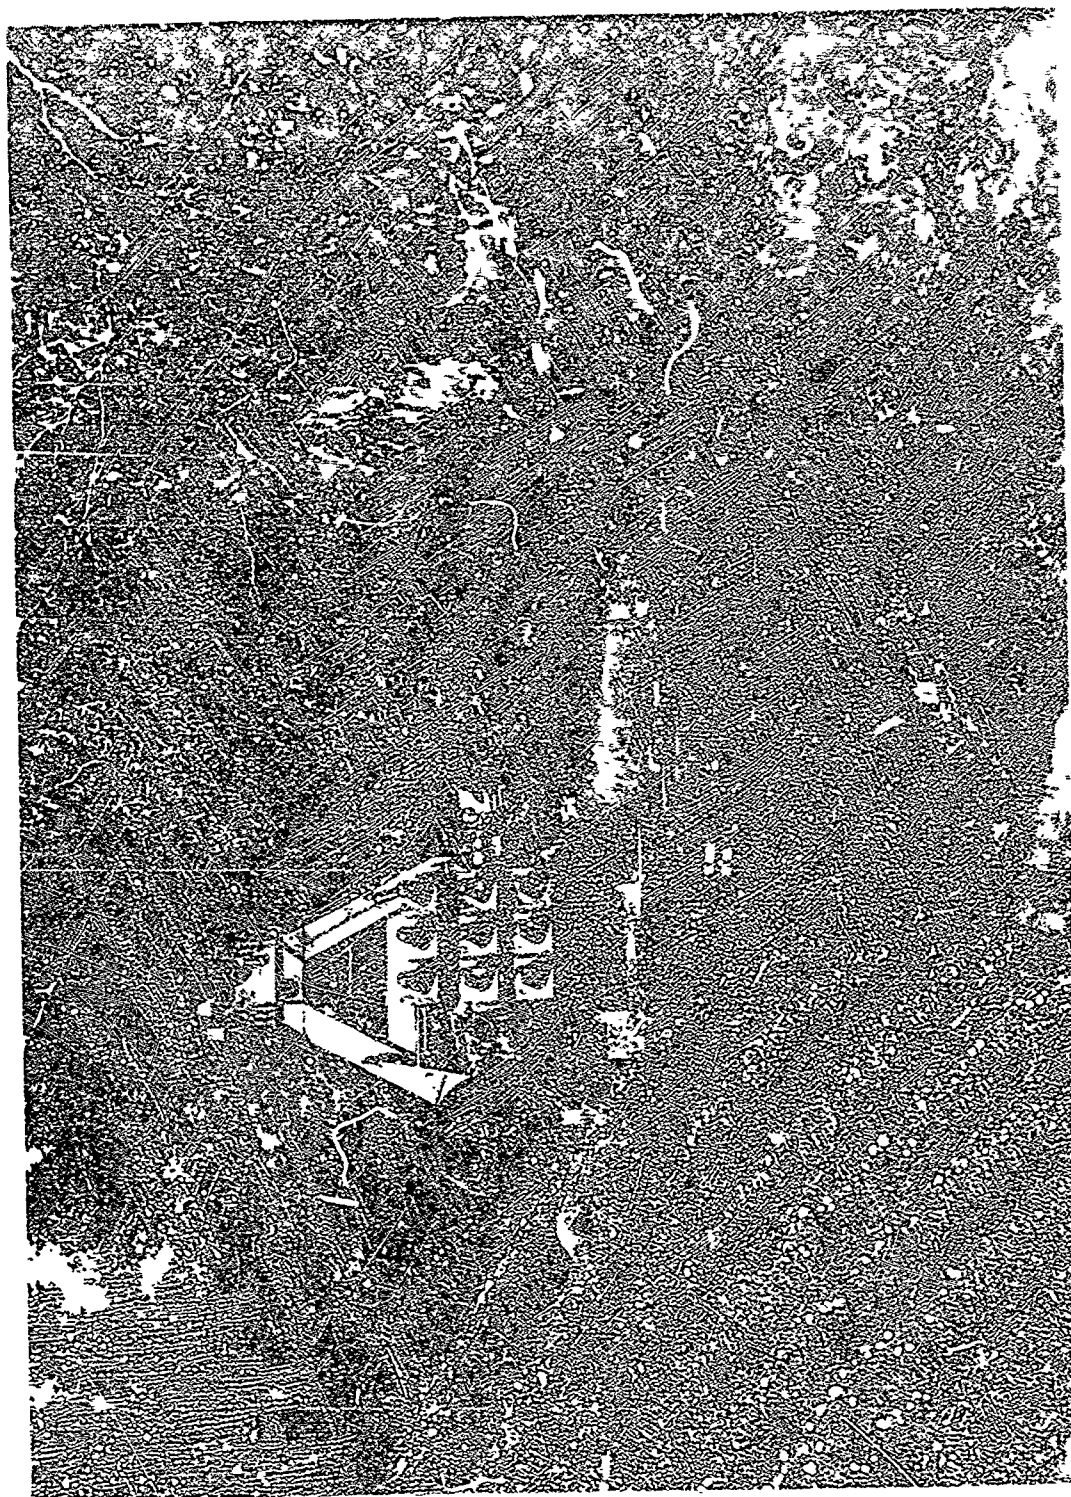
Figure 59. Overall view of Weap
