Final  
 Technical Summary Report  
 of  
RESEARCH AND DEVELOPMENT PROGRAM  
OF  
THERMIONIC CONVERSION OF HEAT TO ELECTRICITY

Volume I

Contract Number NObs-88578  
 Project Serial Number SR007-1201  
 Order Number ARPA 219, Task No. 1 and Task No. 2  
 Program Code Number 3980

GENERAL ELECTRIC COMPANY  
 SPECIAL PURPOSE NUCLEAR SYSTEMS OPERATION  
 VALLECITOS ATOMIC LABORATORY  
 P. O. BOX 846  
 PLEASANTON, CALIFORNIA

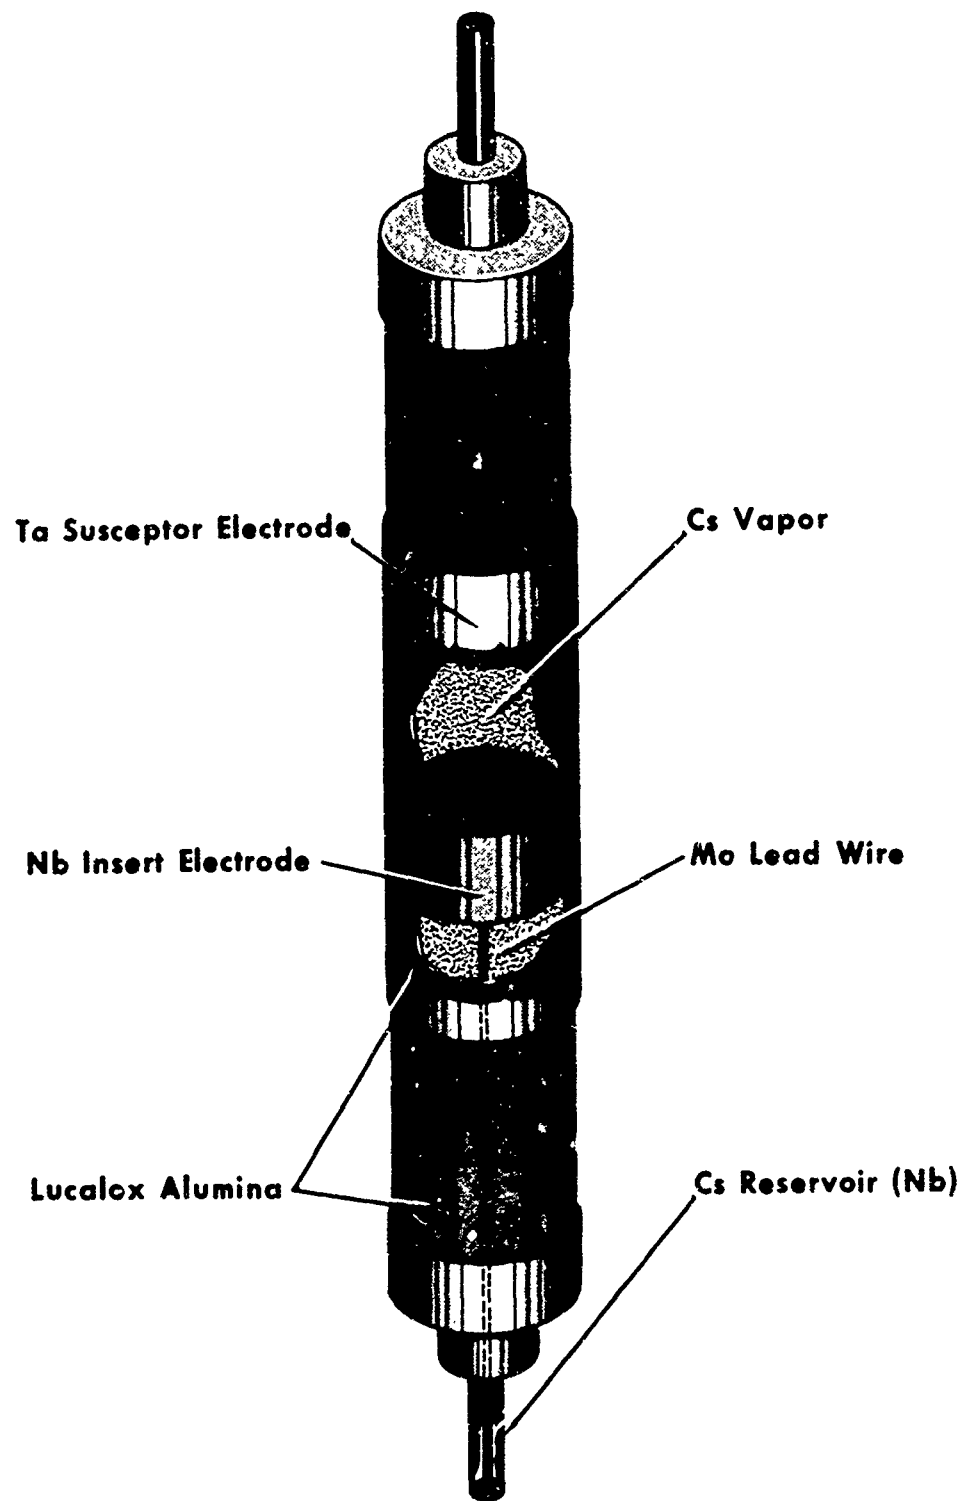
FIGURE II-1. LUCALOX ALUMINA CONFIGURATION FOR CONDUCTIVITY EXPERIMENT

Five tubes of Lucalox alumina were obtained from the Large Lamp Department, General Electric Company. A tube is shown in Figure II-1. The tubes were about 1/2-inch diameter, 0.030-inch wall thickness and 4 inches long. Each end was sealed to a niobium end piece which lead to a 1/8-inch niobium tube about 1 inch long. A 0.394-inch long niobium cylinder was placed in the center of the Lucalox tube to serve as one electrode. The other electrode was a 1.05-inch long coating of tantalum metal applied to the exterior of the tube by flame-spraying. Each tube was checked upon receipt for vacuum tightness by the He mass spectrometer method; all proved leak-free.

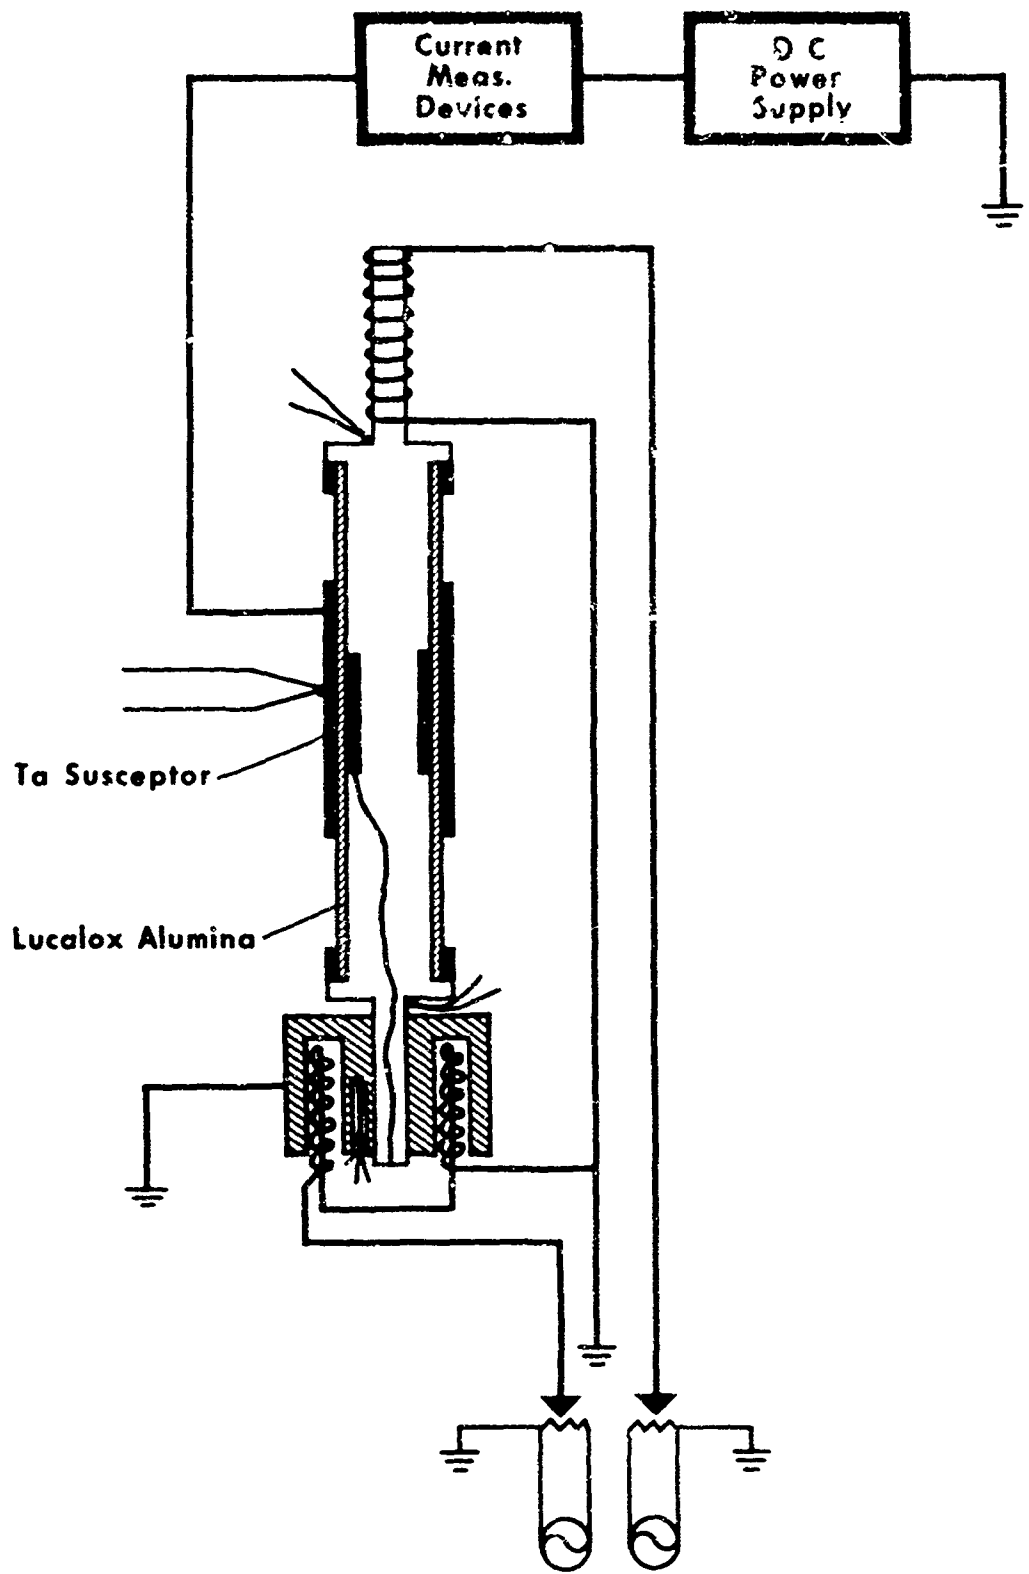
FIGURE II-3. SCHEMATIC OF CONDUCTIVITY EXPERIMENT

Currents above  $10^{-7}$  amp were measured using a potentiometer and a 198 ohm resistor in series with the specimen. Between  $10^{-10}$  and  $10^{-7}$  amp, an electrometer was used. Below  $10^{-10}$  amp, currents could not be measured reproducibly. The error in current measurement was less than 1% above  $10^{-7}$  amp and about 20% between  $10^{-10}$  and  $10^{-7}$  amp. The observed resistance values are given in Figure II-4 for the two specimens. Points on Figure II-4 designated by a letter E are values determined using the electrometer.

The voltage across the specimen was varied between 0 and  $\pm 6.7$  volts using a precision rheostat and batteries; it was varied between -400 and +150 volts using a dc power supply with about 0.01% ripple. Some volt-amp curves are shown in Figure II-5. When the Ta electrode was made positive, a short transient effect was noted with each increase in voltage; the current across the specimen would rise to some initial value and then drop to about 1/2 that value over about 10 seconds (at 1250°C); no further change with time would occur. The curve in Figure 5 labeled 918°C shows non-ohmic behavior typical of that observed for low cesium pressures.

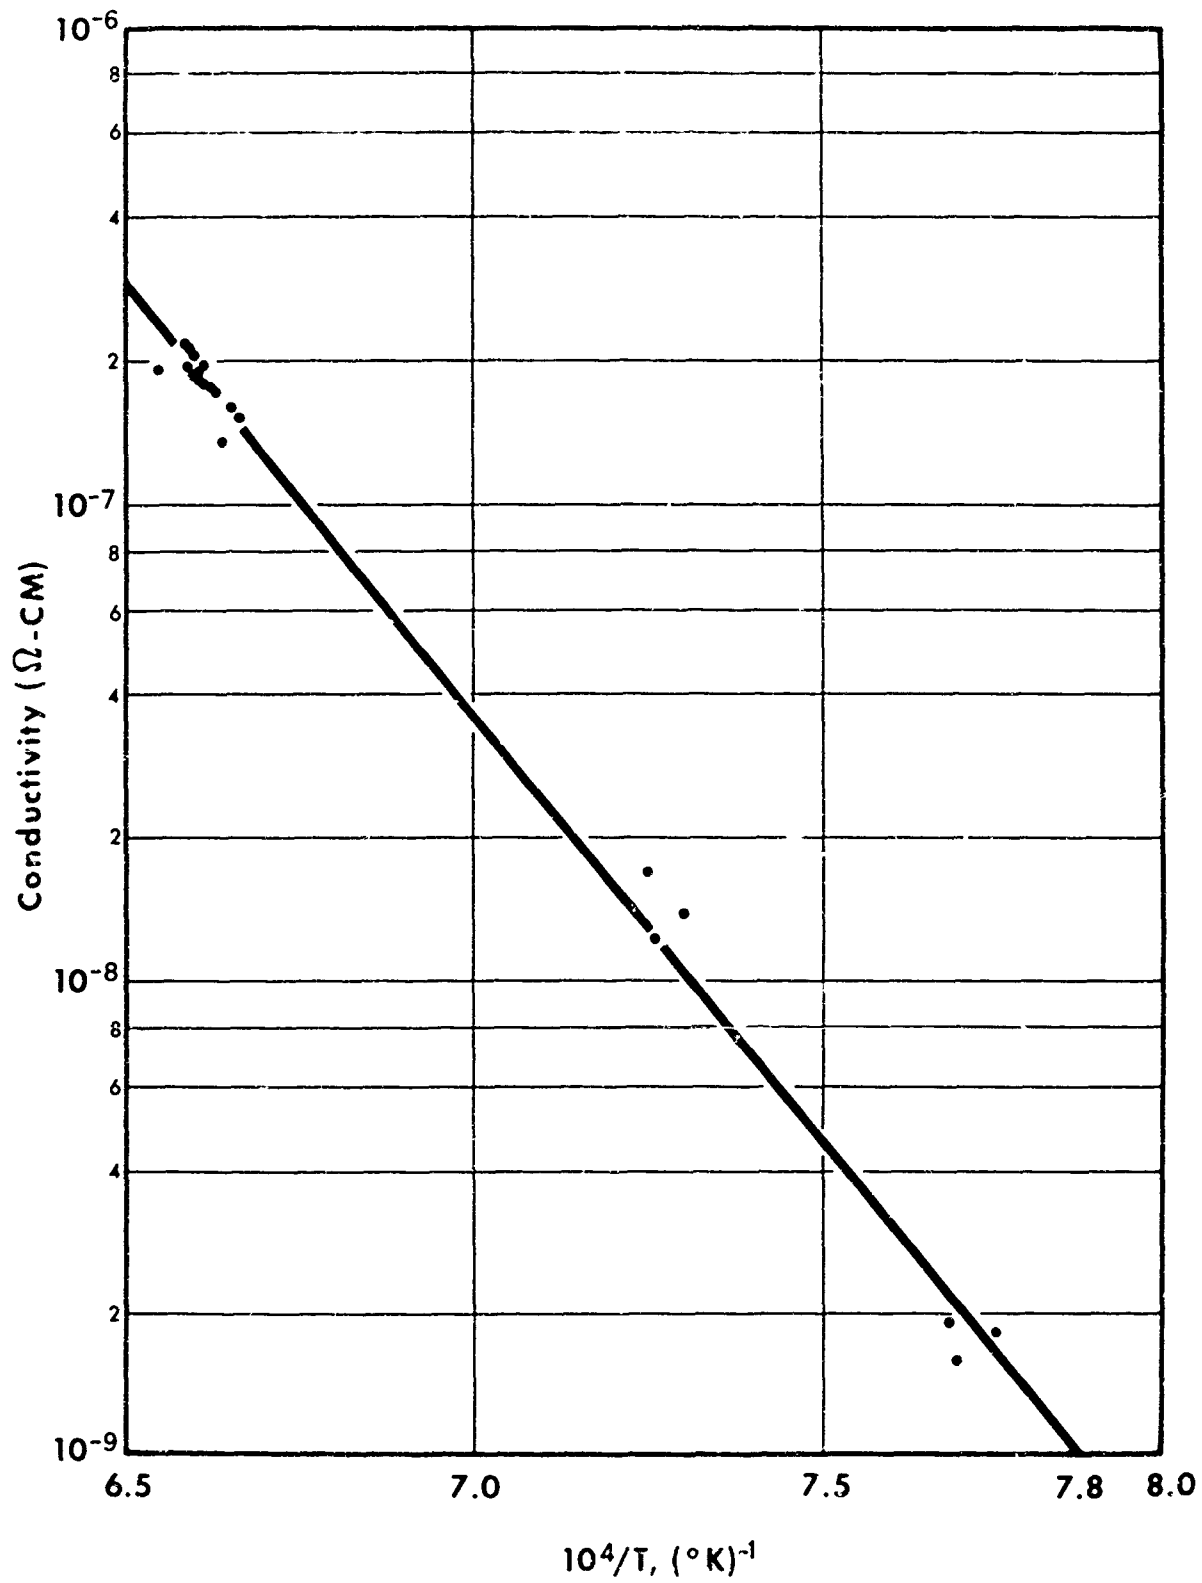
FIGURE II-7. TEMPERATURE DEPENDENCE OF ELECTRICAL CONDUCTIVITY FOR LUCALOX ALUMINA

The activation energy associated with the conductivity of Lucalox alumina (Figure II-7) is 3.55 electron volts between 1020 and 1200°C. The same activation energy (slope) was observed for both Lucalox tubes in the high temperature regime of Figure II-4. The low temperature activation energy from Figure II-4 is 2.32 ev. The high temperature values are similar to those obtained by Pappis and Kingery on polycrystalline alumina under  $10^{-10}$  atmospheres oxygen pressure.<sup>3</sup> The temperature at which transition to the higher activation energy conduction mechanism occurs was observed to be about 1520°C by Pappis and Kingery, while about 1000°C was observed in this study. The difference may be due to lower impurity concentrations in the present specimens; however, Pappis and Kingery did not present detailed analyses of their specimens for comparison.

Assuming this figure to be representative of intrinsic conduction a corresponding band gap of about 11 eV is found. Those authors found no activation energies higher than 3.6 eV for polycrystalline alumina with temperatures up to 1777°C. That observation is confirmed by the present study for temperatures up to 1250°C. The conductivity of polycrystalline alumina was apparently impurity dominated for both studies.

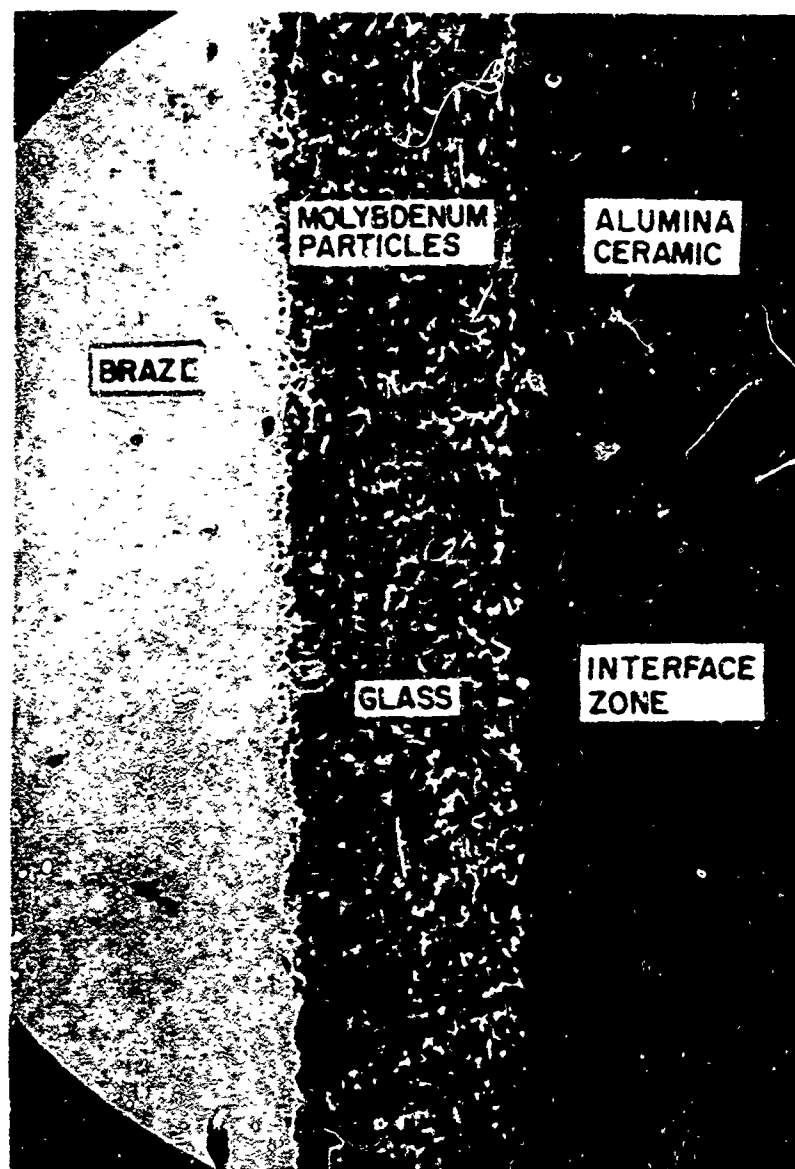
Figure III-1

related to this point as well as other reactions during metallizing have been reported by Cole.<sup>6)</sup> It is the manganese in the above discussed coating, as well as the fluxing oxides present in a so-called high-alumina ceramic, which promote adherence. Consider the specific case of metallizing of a high alumina body having a composition of 96 w/o (weight percent) alumina and 4 w/o other oxides. During sintering of the metallizing coating, the dew point of the hydrogen atmosphere is maintained sufficiently moist to insure oxidation of the manganese. The resulting manganous oxide then reacts: (1) with alumina forming manganese-alumina compounds, and (2) with the fluxing oxides of the ceramic, producing a glassy phase which fills the interstices of the sintered molybdenum coating and serves to strongly lock it to the ceramic. A photomicrograph of such a coating on a high alumina ceramic is shown in Figure III-1. The reaction products mentioned can be seen in this illustration.

Typical Metallized Ceramic

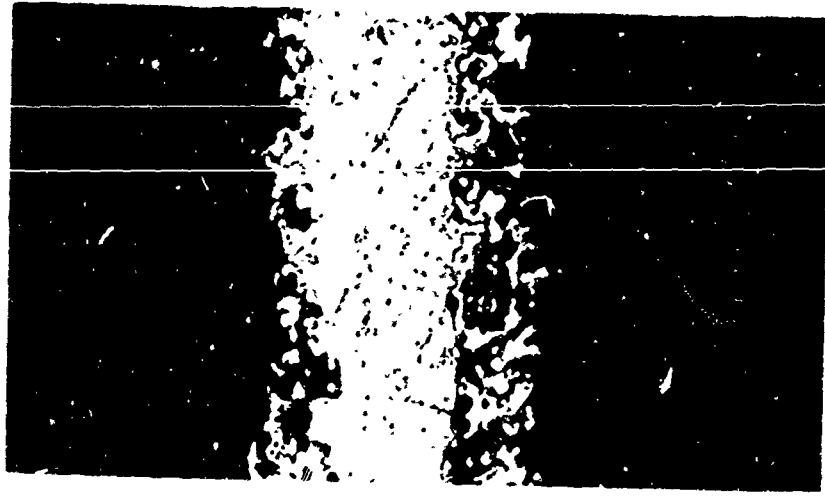
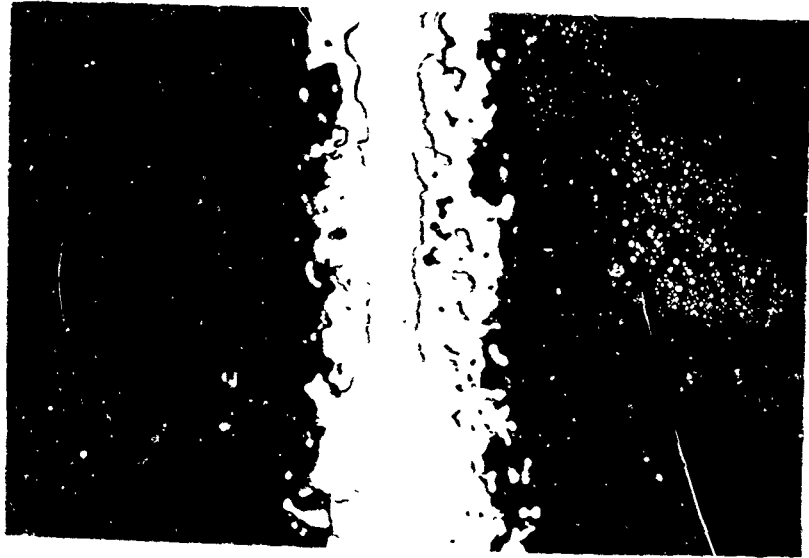
Variations in sintering temperature cause different metallizing interface structures. For example, Figure III-2 shows metallizing mix No. 1 sintered at three different temperatures. In the 1680°C sample, the interface is fractured; in the 1760°C sample, the interface is slightly modified but intact; while the 1855°C sample shows no apparent interface reaction zone.

A      1680°C      Leaker

B      1760°C      Vacuum Tight

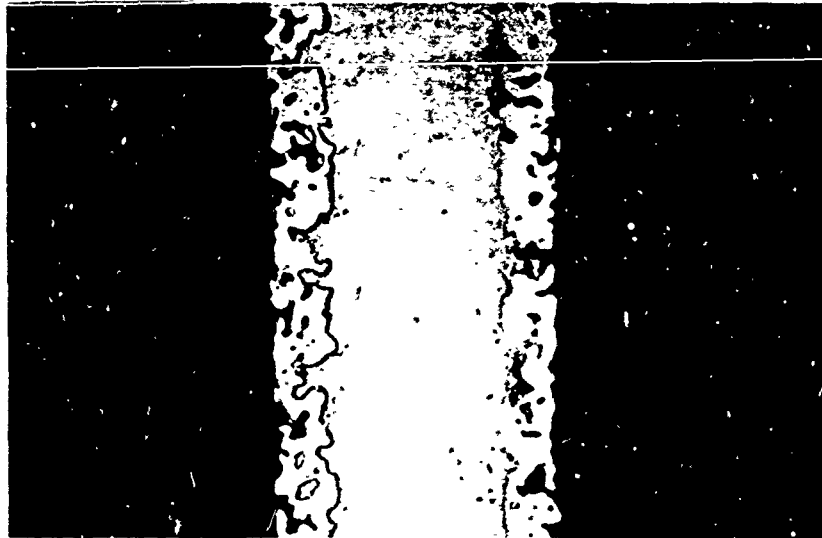
Metallizing mix No. 55 (Figure III-4A) yielded excellent results. A desirably dense metallizing with no apparent interface was produced even at 1800°C.

A                      Mix No. 55                      1800°C                      Vacuum Tight

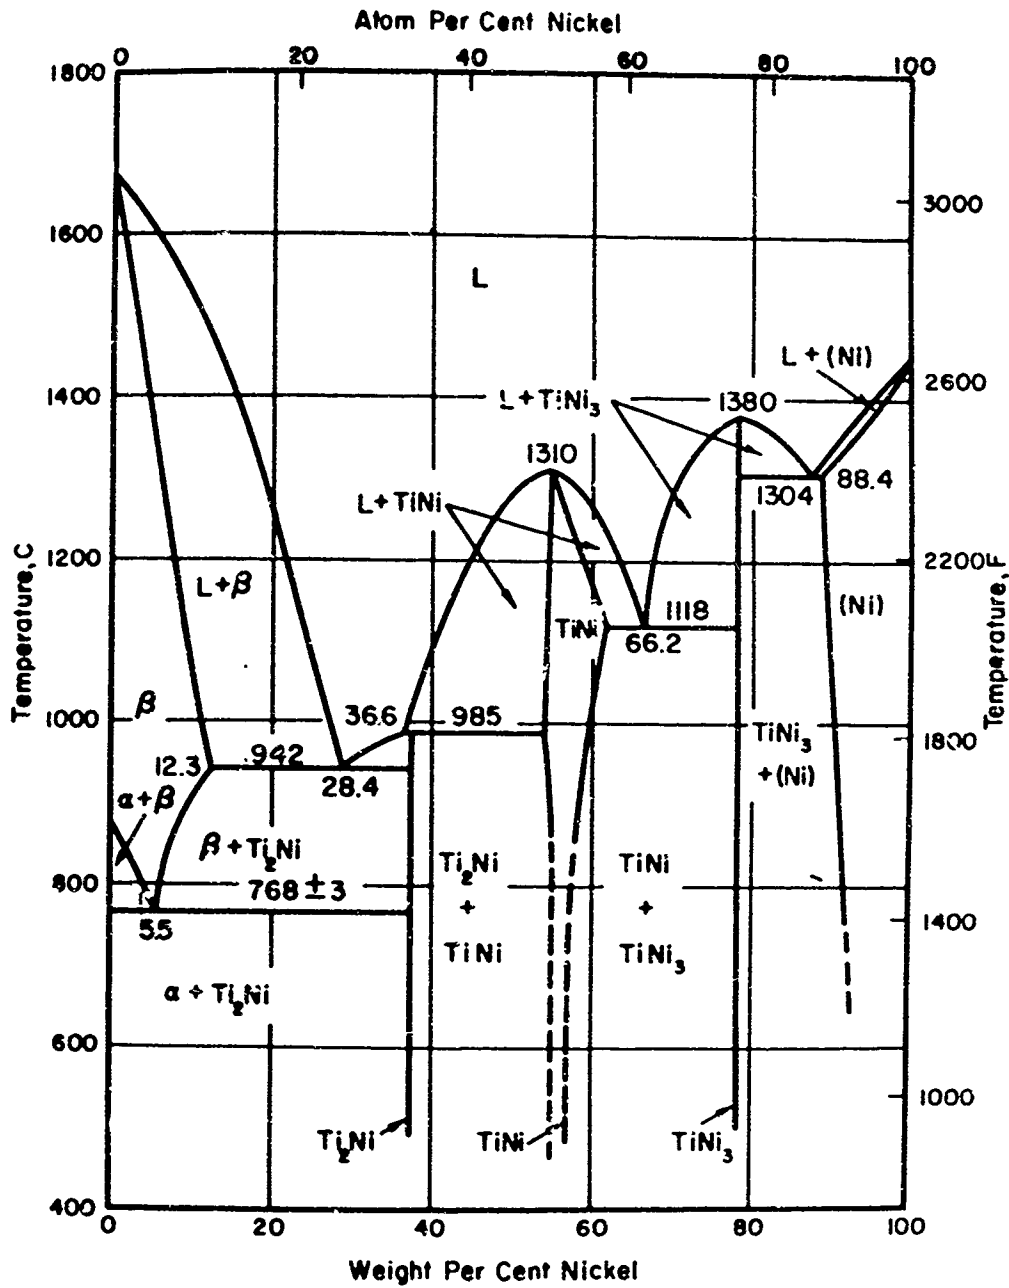
Figure III-8

The titanium-nickel phase diagram, Figure III-8, shows that the first liquid to form would have the composition of the lowest melting eutectic, 71.5 w/o titanium, 28.5 w/o nickel. As the temperature is raised, the melt dissolves more nickel and the composition drifts toward the composition of the brittle intermetallic compound  $Ti_2Ni$ . Figure III-7A shows the structure which is obtained when sealing is performed at a temperature of about  $1070^{\circ}C$ . The region next to the ceramic is predominately  $Ti_2Ni$  and contains many cracks. Equilibrium conditions are not, however, attained in such a seal because of the "infinite" supply of nickel in contact with the melt. This results in a layer of  $TiNi$  adjacent to the  $Ti_2Ni$  layer, at whose surface the aforementioned cracks terminate. A thin layer of  $TiNi_3$  lies between the  $TiNi$  and the Ni washer.  $TiNi_3$  is optically anisotropic and is readily identified using polarized light. Heating a seal to a temperature of  $1180^{\circ}C$ , slightly above the  $1118^{\circ}C$  eutectic, results in the structure shown in Figure III-7B. Here both  $TiNi$  and  $TiNi_3$  are seen, as predicted by the phase diagram.

Titanium-Nickel Phase Diagram<sup>42</sup>

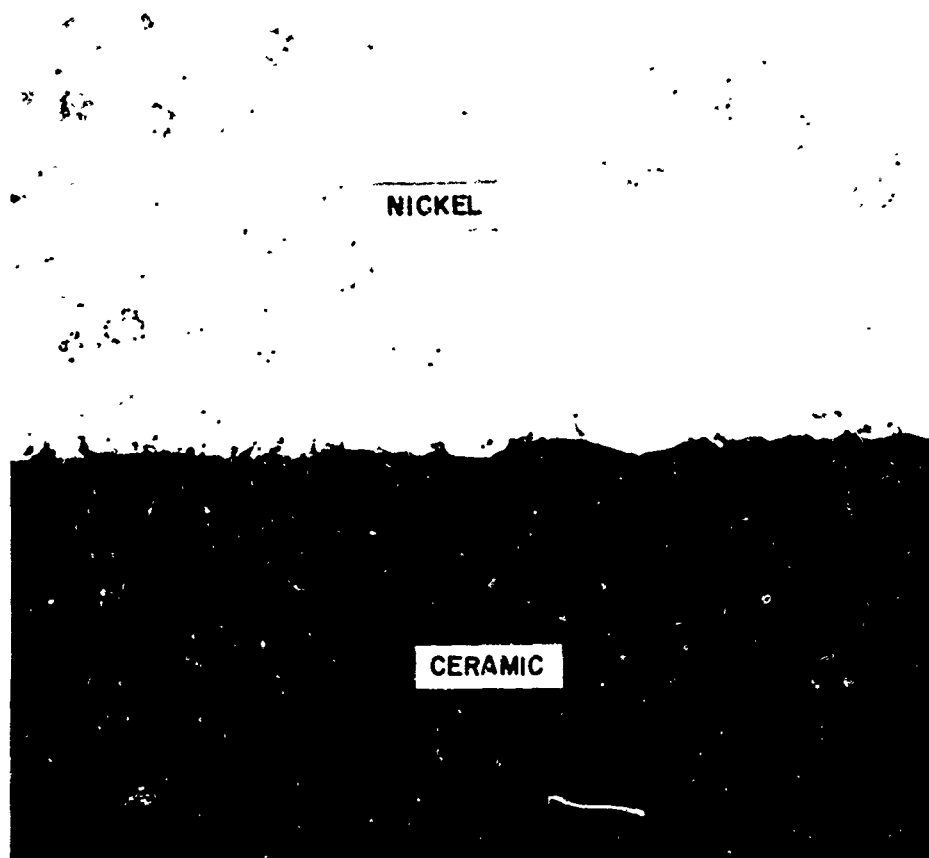
Figure III-11

In summary, the thermal cycling tests show that pure alumina-to-nickel seals (with  $TiNi_3$  at the interface) fail after a relatively few thermal cycles from room temperature to  $900^{\circ}C$ . Failure is believed to result from the mechanical stresses induced by thermal expansion mismatch between alumina, nickel and  $TiNi_3$ . Similar seals (to pure sintered alumina as well as 97-percent alumina) also fail when exposed to  $900^{\circ}C$  for long periods of time and generally show solutioning of the

Failure of Seal at Surface of Ceramic (500X)

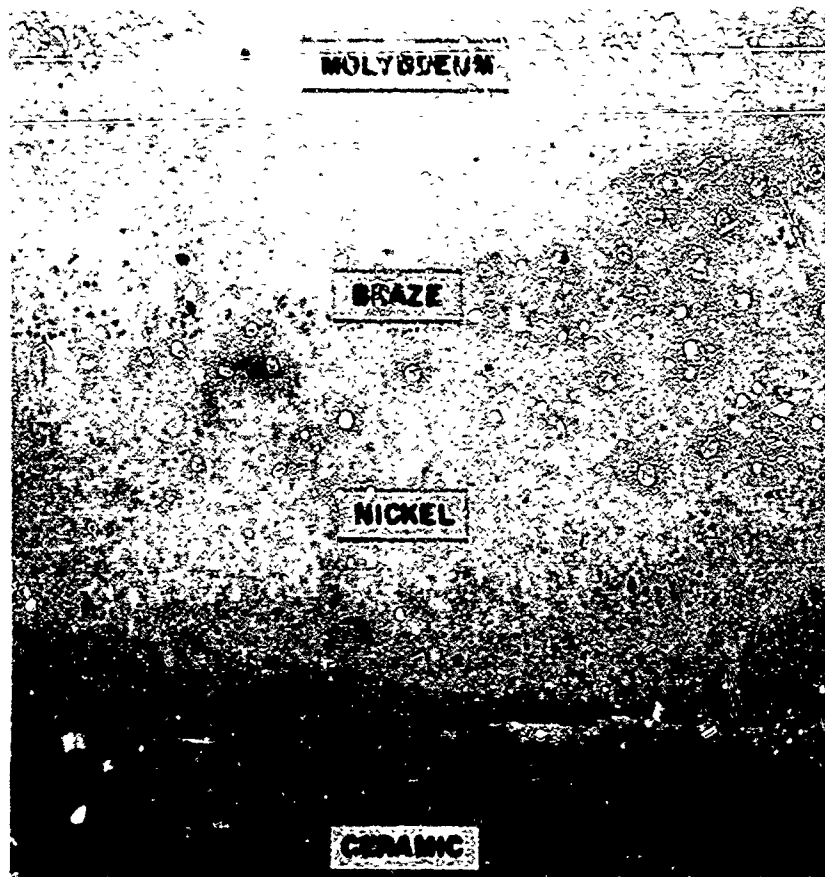
Figure III-12 is a photomicrograph of a vacuum-tight nickel buffer washer seal of A-923 to molybdenum after 20 cycles to  $900^{\circ}C$  showing the  $TiNi_3$  layer at the ceramic-nickel interface and the wide braze region between the nickel and the molybdenum. Figure III-13 shows a similar seal to tantalum. Although cracks were visible in the wide multiphase region between the nickel buffer washer and the tantalum as well as in the  $TiNi_3$  layer, the seal checked leak tight after 20 cycles. Life testing of several seals of each type to  $1075^{\circ}C$  resulted in no failures among the seals to molybdenum but total failure of the seals to tantalum. Figure III-14 is a photomicrograph of one of the vacuum-tight seals to molybdenum after 240 hours at  $1075^{\circ}C$ . Loss of the  $TiNi_3$  layer at the interface, due to solutioning by the nickel buffer washer, can be seen, as can the changes which occurred in the braze region between the nickel buffer washer and the molybdenum. Figure III-15 shows one of the seals to tantalum which failed. Diffusion at the interface between the nickel buffer washer and the

Alumina-to-Molybdenum Seal with Nickel Buffer Washers  
After 20 Thermal Cycles to 900°C (500X)

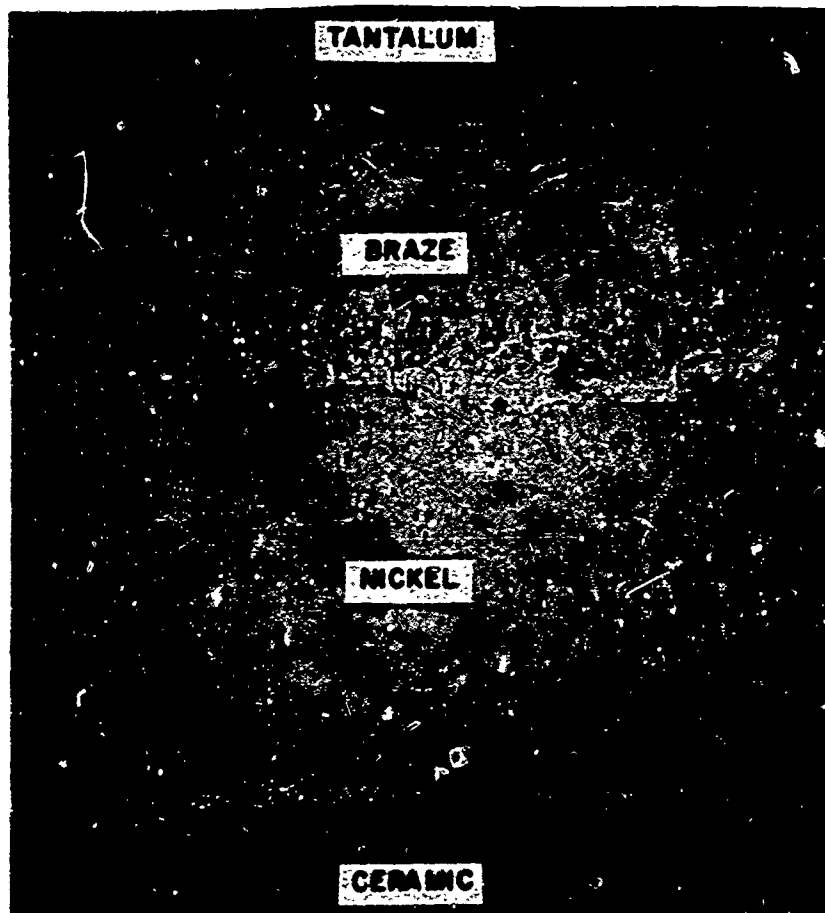
Figure III-13

Alumina-to-Tantalum Seal with Nickel Buffer Washers  
After 20 Thermal Cycles to 900°C (500X)

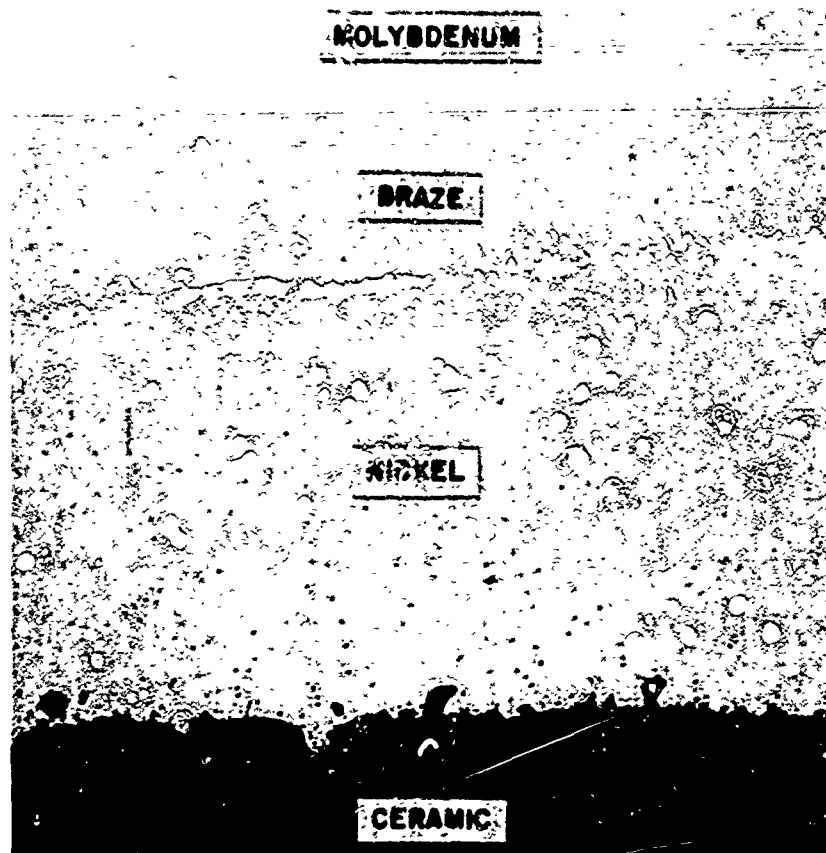
Figure III-14

Alumina-to-Molybdenum Seal with Nickel Buffer Washers  
After 240 Hours at 1075°C (500X)

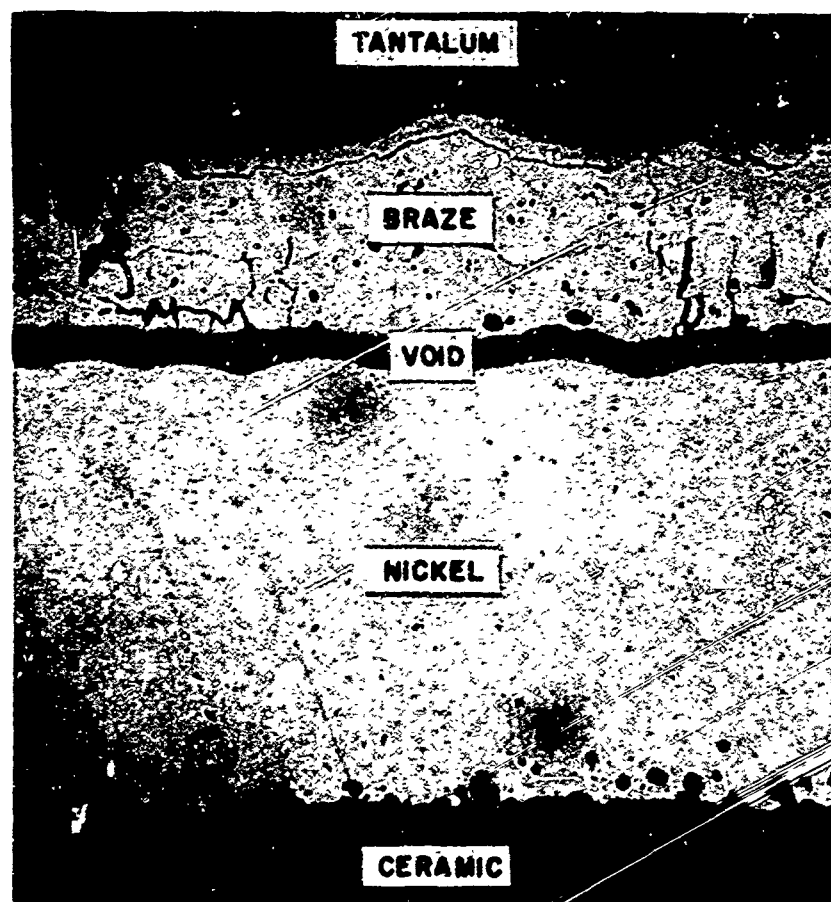
Figure III-15

Alumina-to-Tantalum Seal with Nickel Buffer Washers  
After 240 Hours at 1075°C (500X)

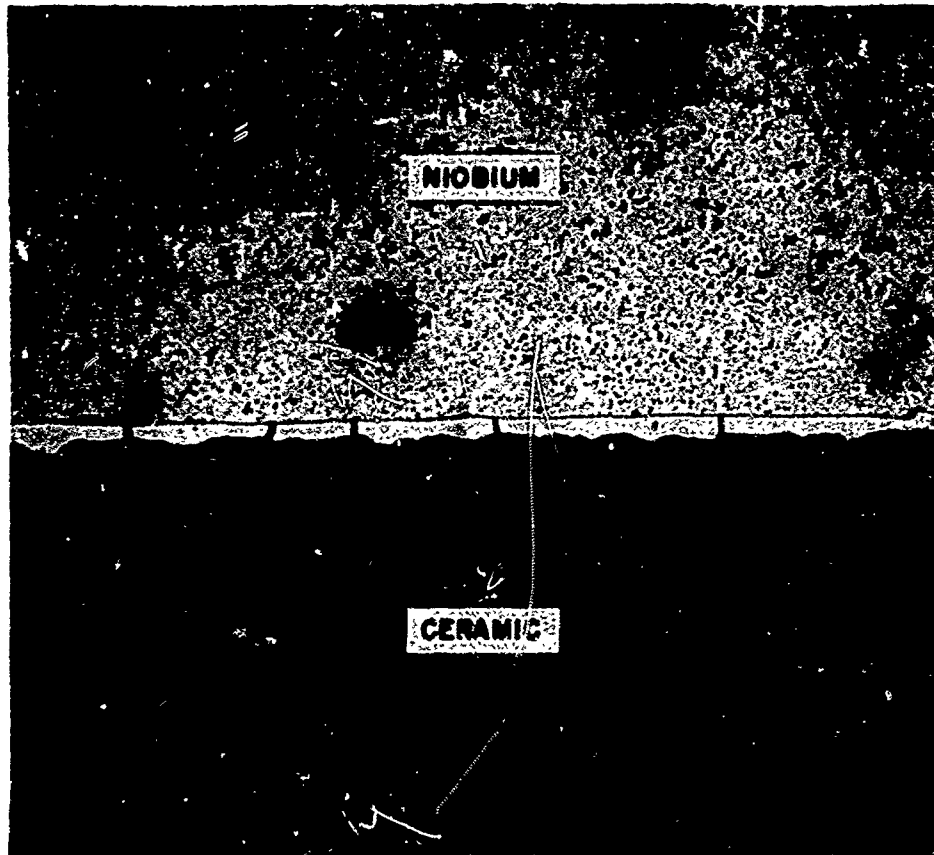
Alumina-to-niobium seals were prepared with many different time-temperature sealing conditions in order to assess the effect of sealing parameters on seal strength, vacuum tightness, and structure of the alloy which was formed. Figure III-16 is a photomicrograph of a seal which was made at a temperature of  $1430^{\circ}\text{C}$  with a two-minute soak. Seals made at other temperatures and with soak times up to ten minutes looked virtually identical. Although all of the polished sections showed many cracks through the intermetallic layer, all were vacuum tight. The width of the cracks which appear in the photomicrographs has been exaggerated by etching and, as mentioned previously, it is possible that these cracks are formed during preparation of the polished section. Since the phase equilibrium diagram for the nickel-niobium system is incomplete (see Figure III-19), identification of the intermetallic compounds formed at the interface was not attempted. Microhardness measurements were made, at the midpoints of the intermetallic layer and the niobium washer, on seals prepared with different time-temperature conditions. Sealing conditions ranged from  $1270^{\circ}\text{C}$  for two minutes, through  $1416^{\circ}\text{C}$  for ten minutes, to  $1433^{\circ}\text{C}$  for two minutes. Knoop hardness (10-gram load) of the several layers was virtually identical in all of the seals which were measured and averaged 150 KHN in the

Alumina-to-Niobium Seal Made at a Temperature of  
1430°C (500X)

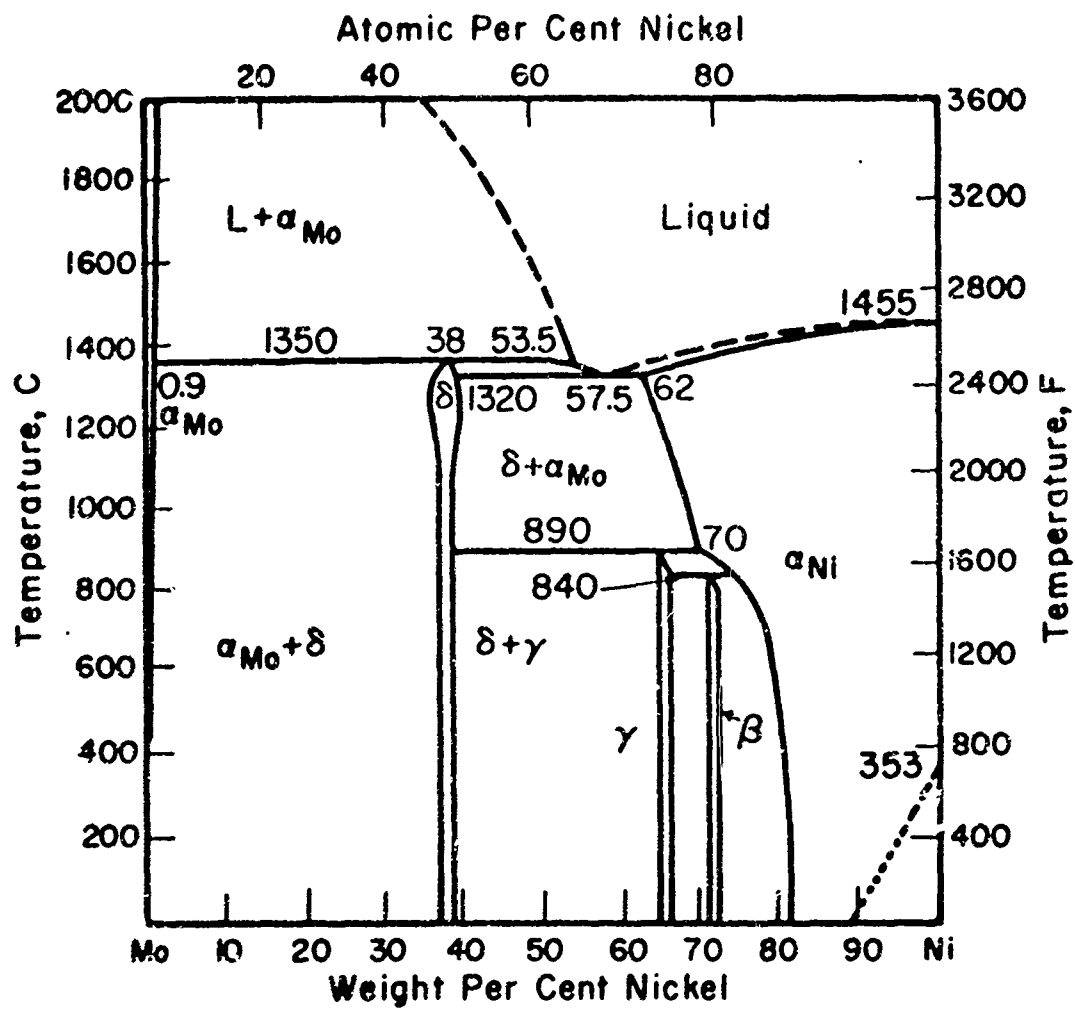
Figure III-18

Molybdenum-Nickel Phase Diagram<sup>22</sup>

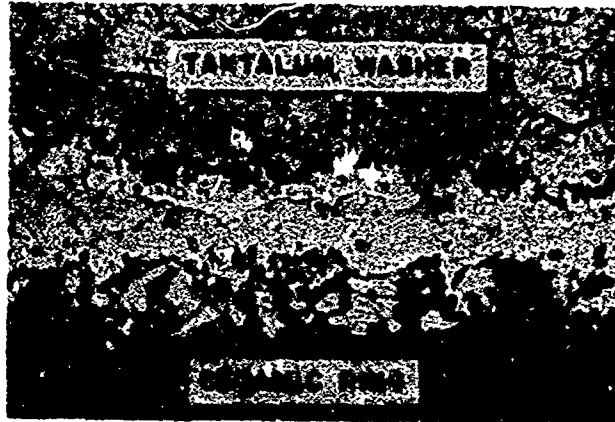
Figure III-24

Braze diffusion bonding using a nickel shim can be used to develop near ideal bonds between the refractory metals and alumina ceramics metallized with the metallizing developed during this program. Since these seals appear to be only limited in temperature by the structural members themselves, they should be capable of much higher service temperatures than the 1000°C employed for cesium corrosion testing and

8 TNA brazed 1500<sup>o</sup>C, 5 min, .0001 in. Ni (500X)

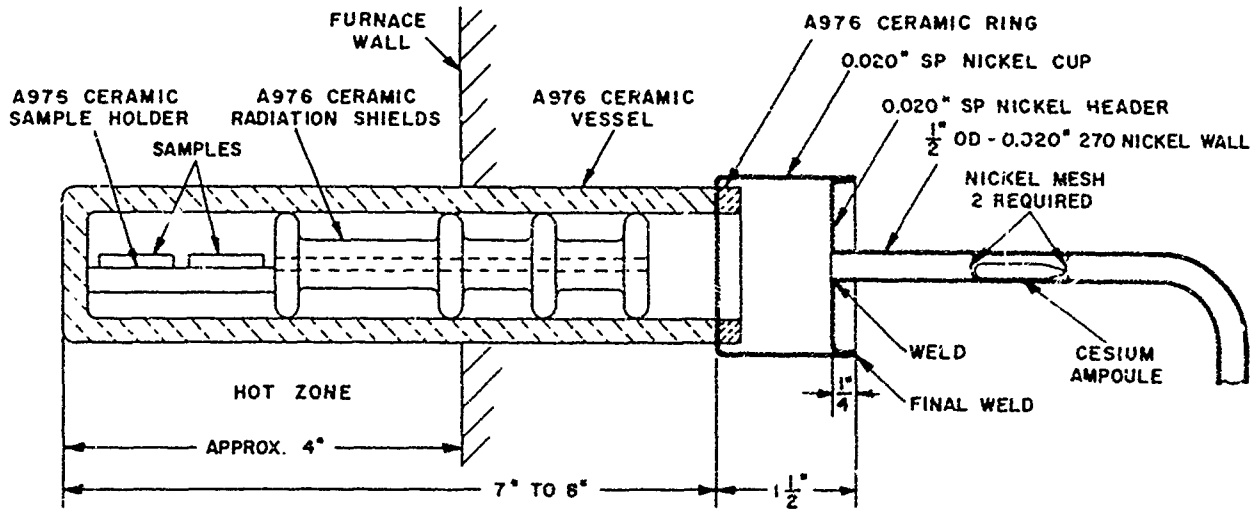
Figure III -25

Schematic Cross-Section of Ceramic Test Vessel

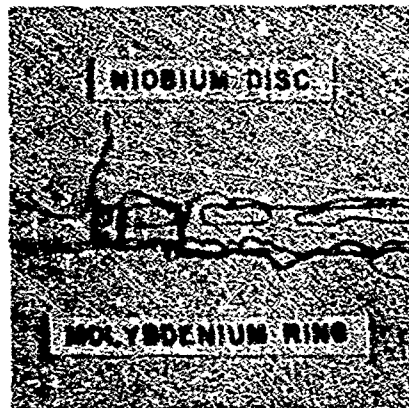
Before (250X) After  
2 CNM brazed approx. 1300°C, 2 min., .0005-inch nickel shim

Before After  
1 CNA brazed approx. 1200°C, 10 min., .0005-inch nickel shim

Remarks: No apparent attack. Note change in microstructures due to the prolonged holding at the test temperature.
