REPORT NUMBER 158

# AIRCRAFT FABRICATION, ASSEMBLY, AND INSPECTION

XV-5A Lift Fan  
Flight Research Aircraft  
Contract No. DA 44-177-TC-715

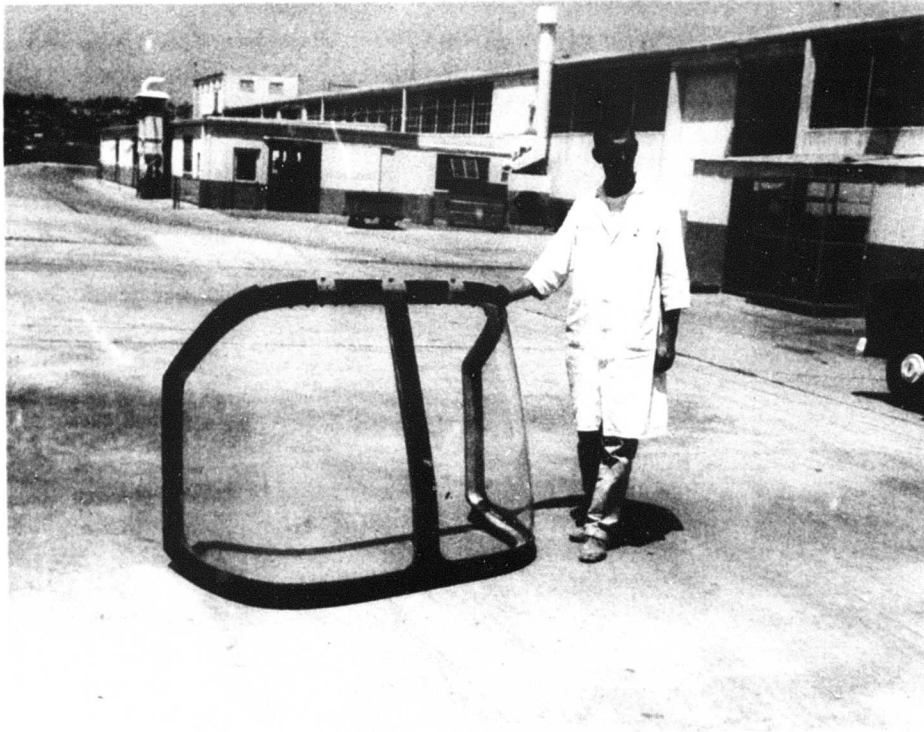
Figure 18 Cockpit Canopy

Another significant use of reinforced Fiberglas laminates is the cockpit canopy shown in Figure 18. The frame of the canopy utilizes U-shaped channels filled with low density plastic foam.
