Report 1928

**EXPERIMENTAL MODEL,
MARGINAL-TERRAIN ASSAULT BRIDGE AND ARMORED
PERSONNEL CARRIER TRANSPORTER AND LAUNCHER**

April 1968

**U. S. ARMY MOBILITY EQUIPMENT RESEARCH AND DEVELOPMENT CENTER
FORT BELVOIR, VIRGINIA**

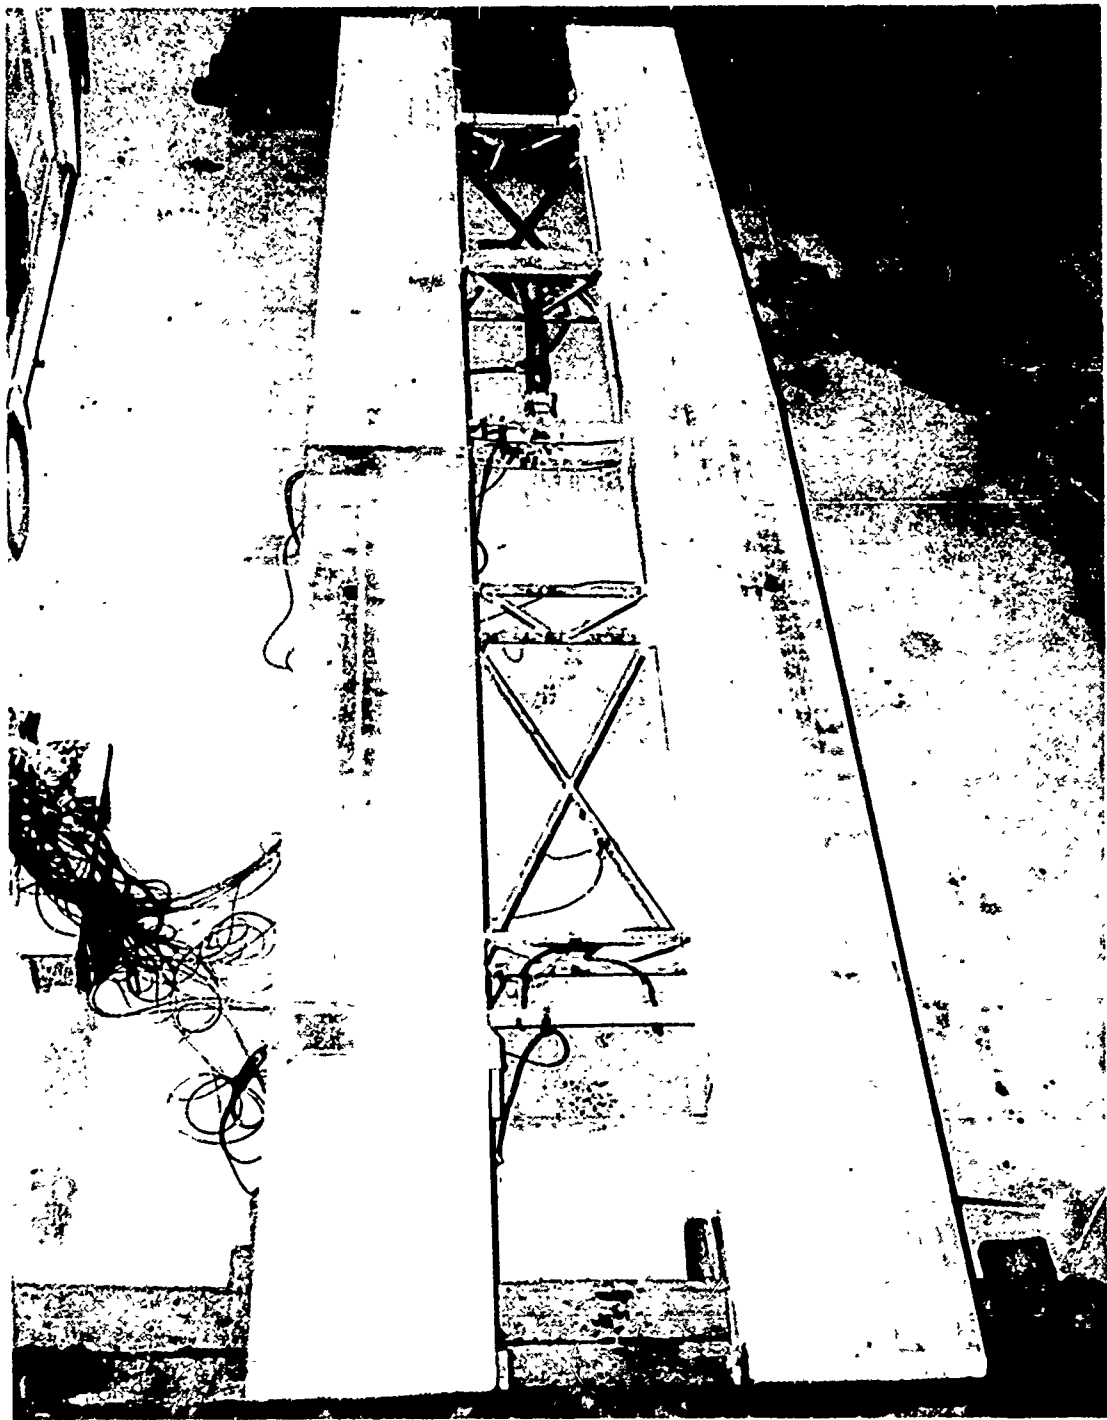
N8903

Fig. 1. Overall view of bridge set up for dynamic traffic test.

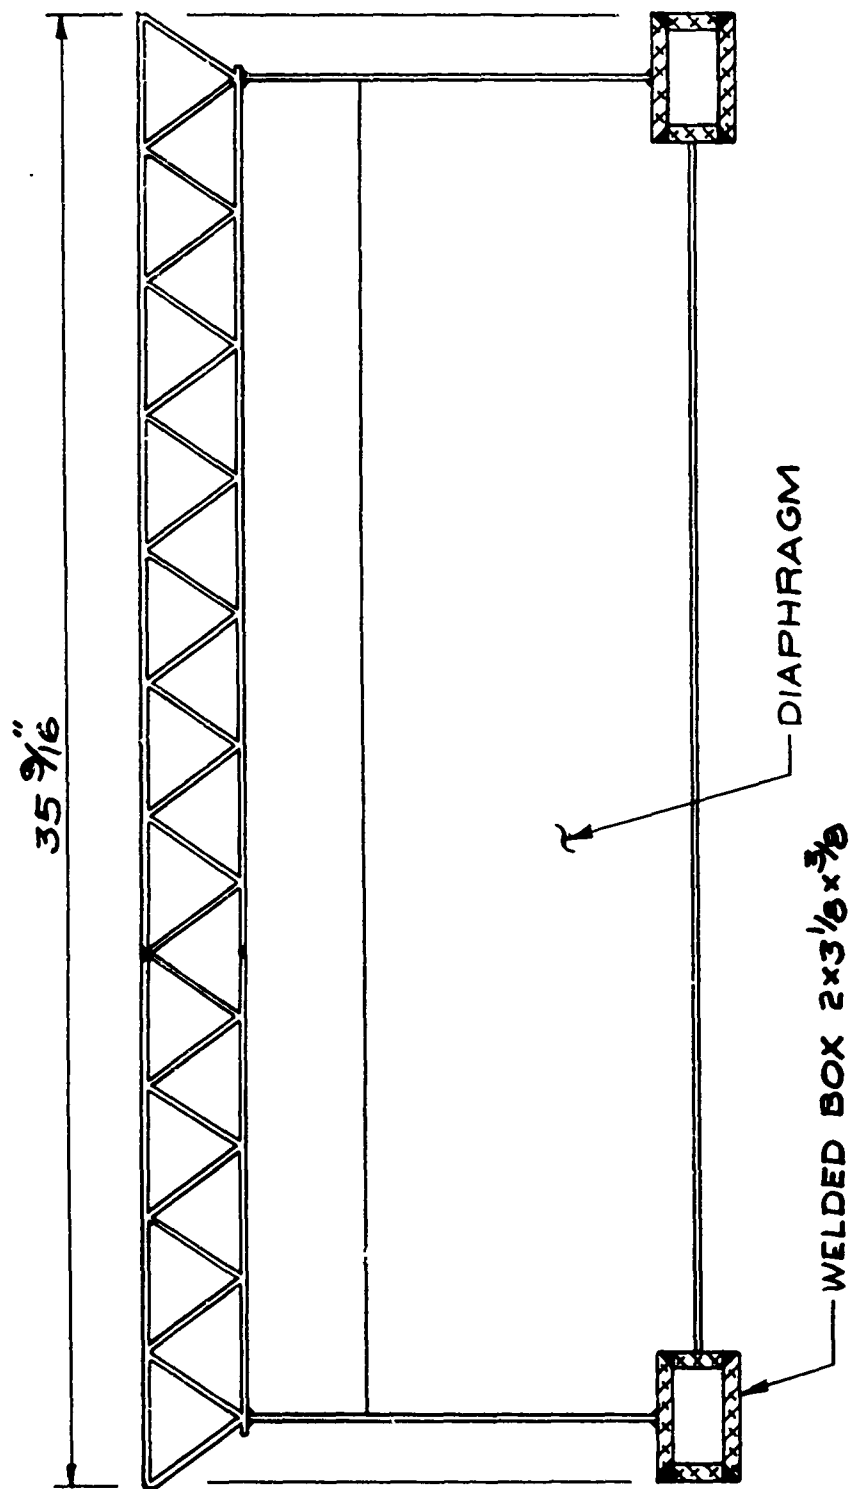
Fig. 2. Typical tread cross-section.

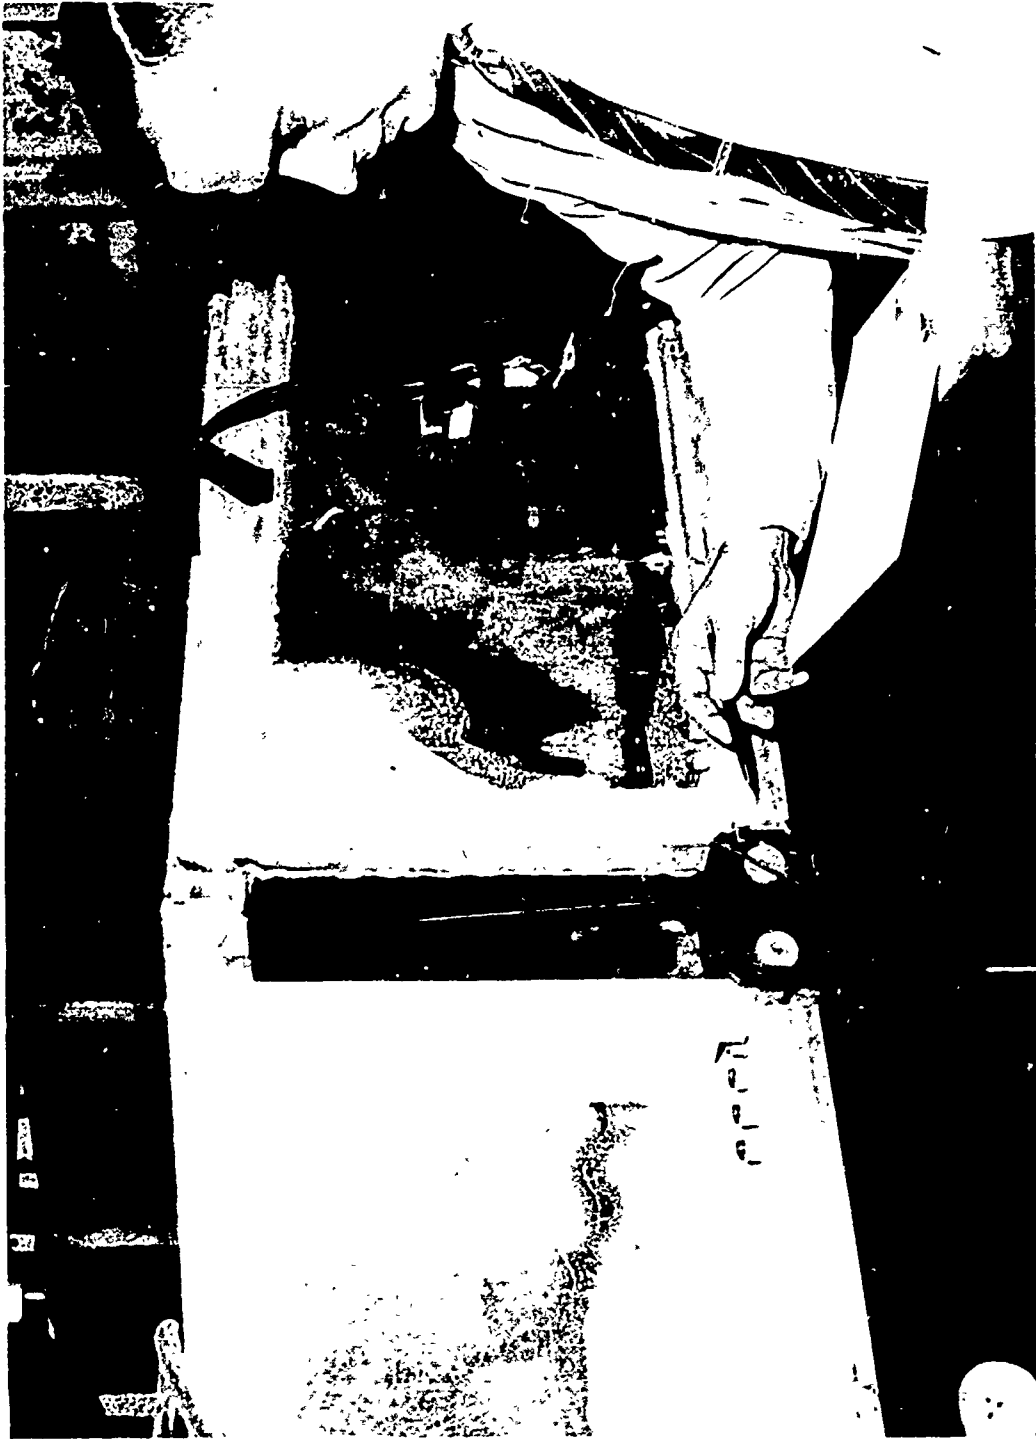
N8581

Fig. 3. Two-centered, noneccentric hinge.

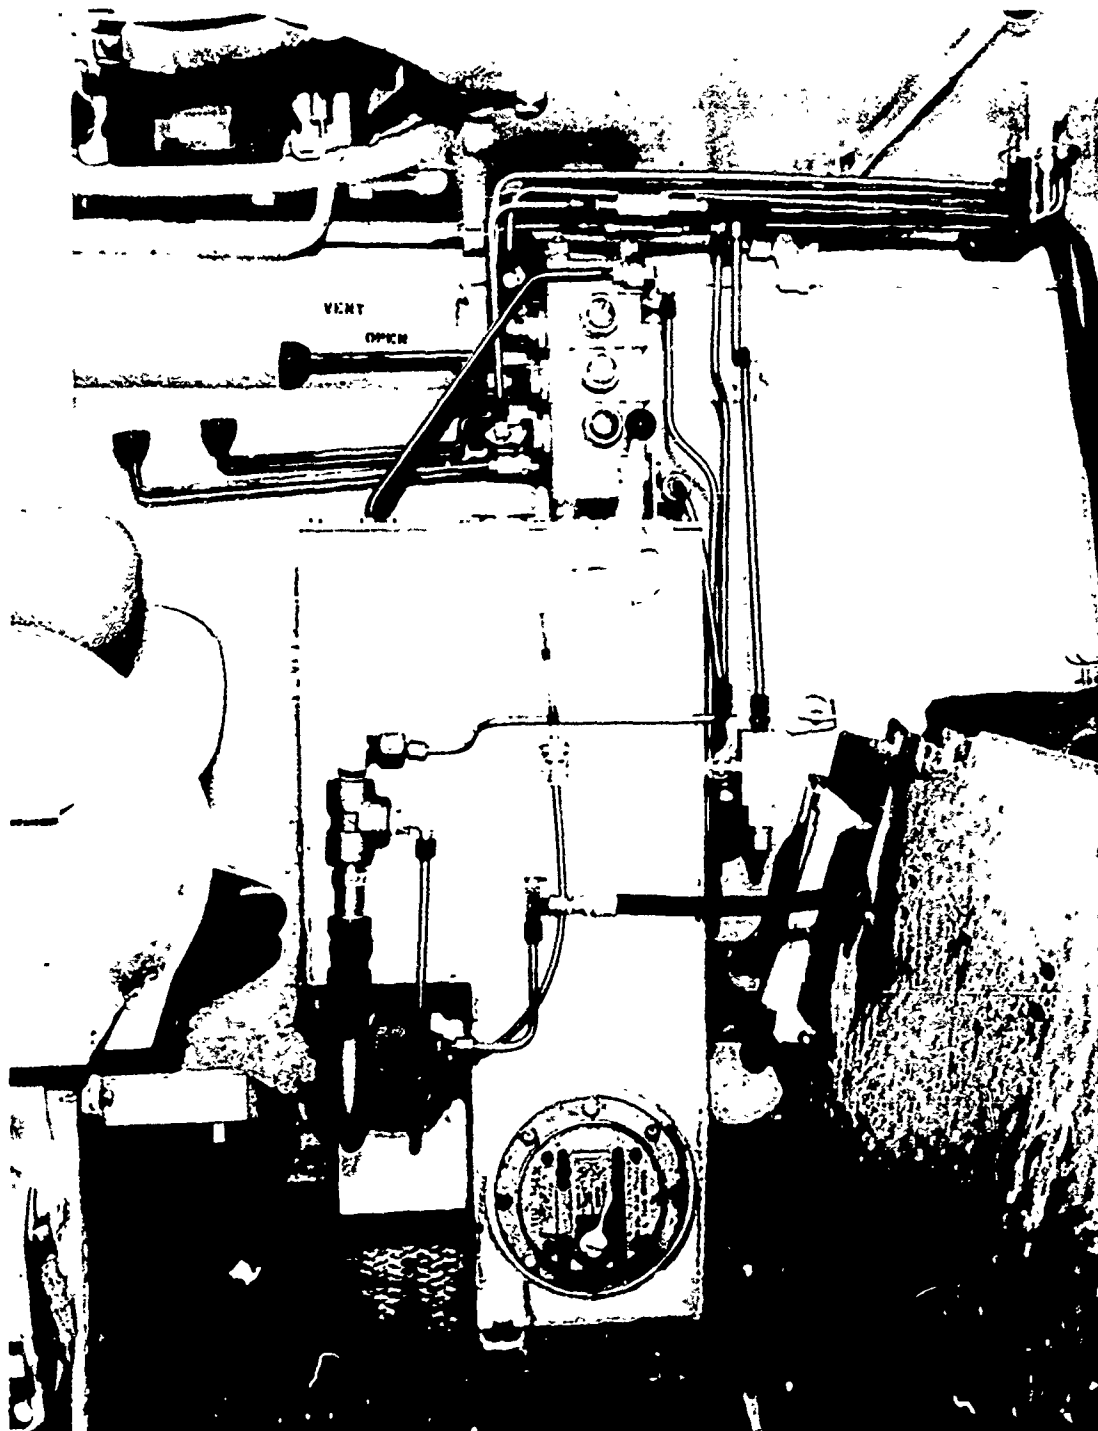
P7707

Fig. 6. Hydraulic power unit installation and controls.

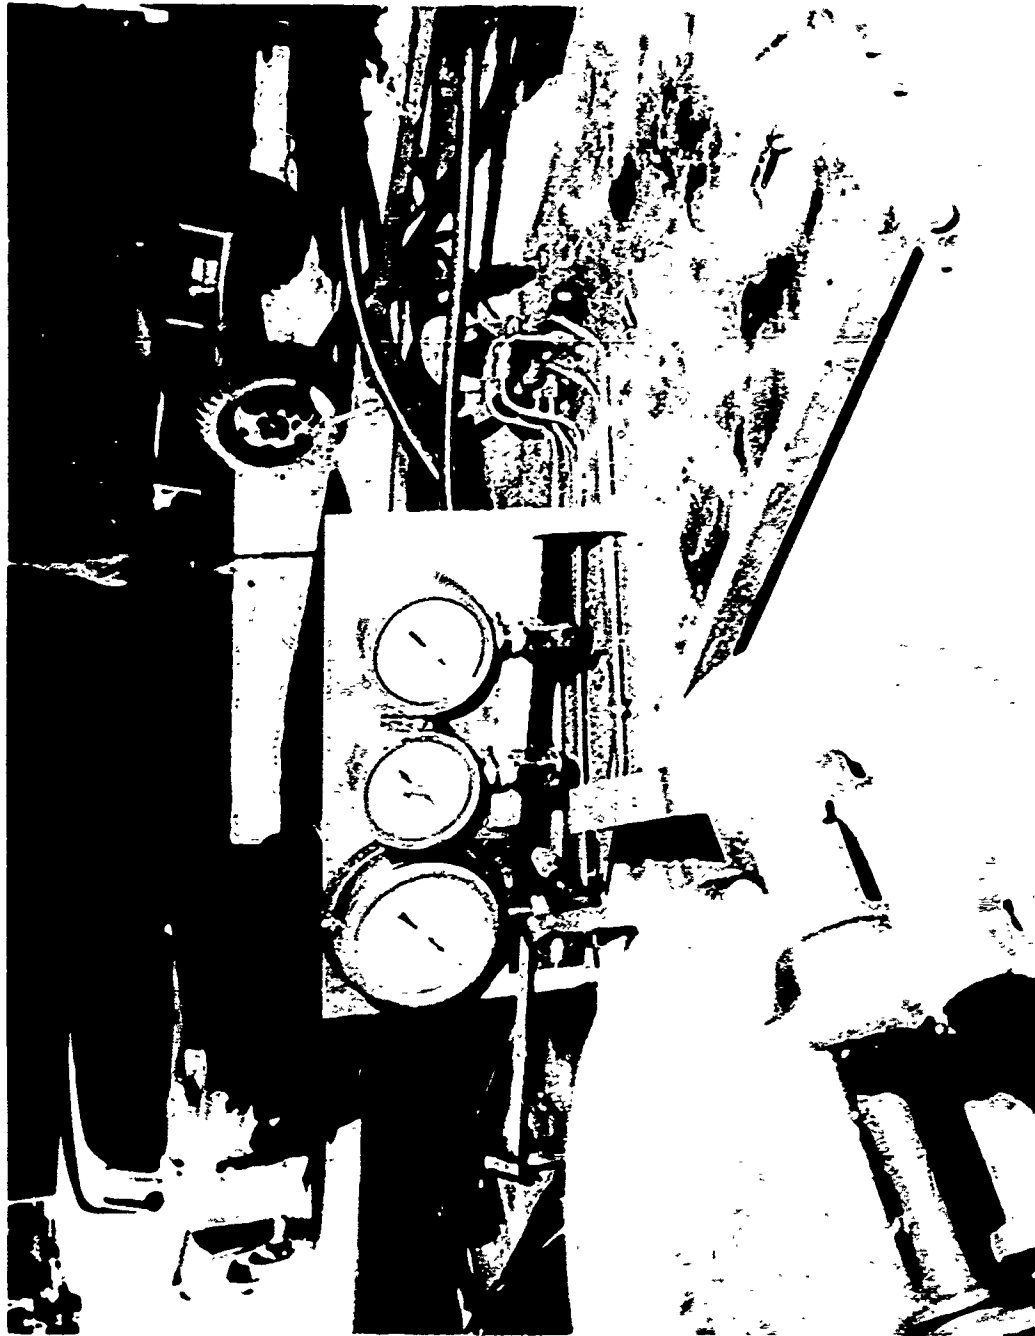
P1776

Fig. 7. External piping and hydraulic test gages.

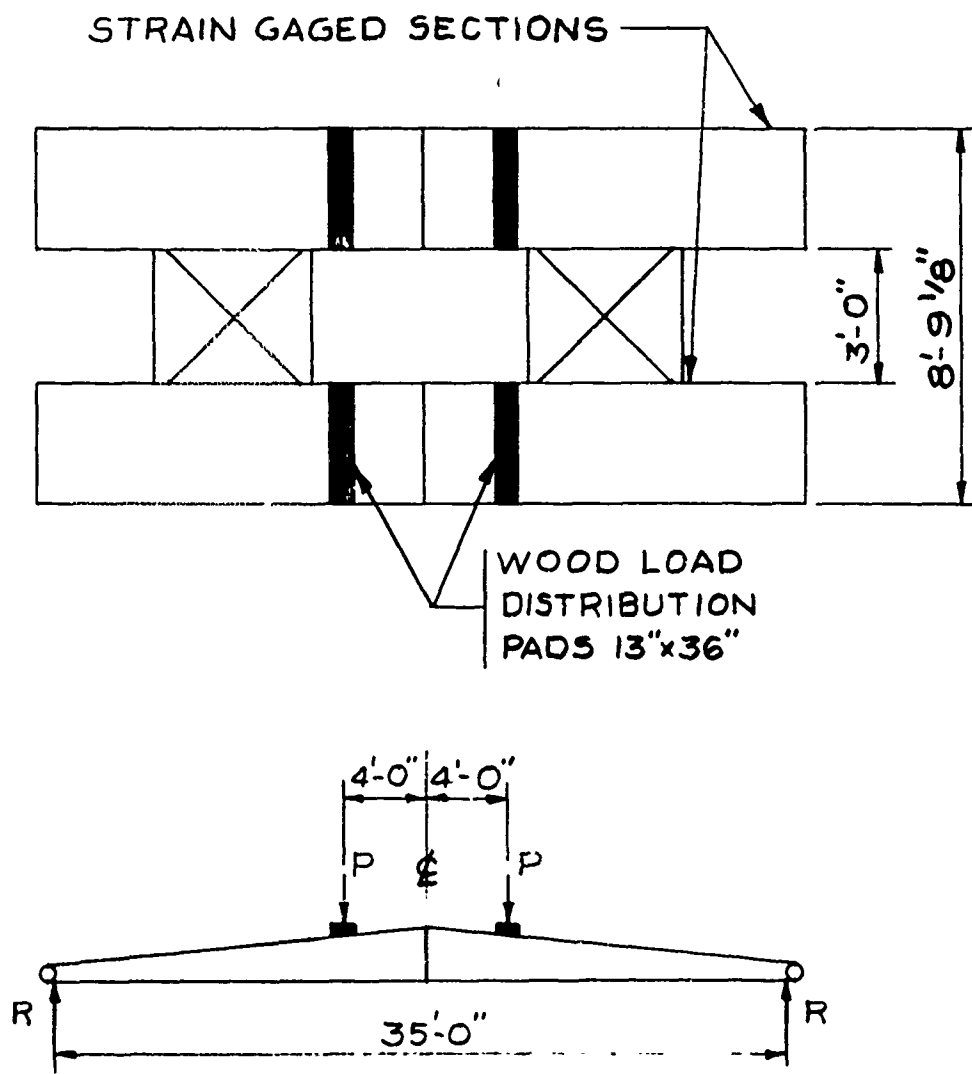
Fig. 10. Load Position 1.

Strain gage readings were taken for five different loading conditions. Figures 10 through 14 show the positions of the loads.

On the initial loading at load position 1 (Fig. 10), the transverse welds in the bottom chord of each tread section failed while the load was increased from P equals 22,000 pounds to P equals 24,500 pounds. The failure was through the weld metal which showed necking before failure. Examination of the fracture showed high porosity throughout the weld. It should be noted that these welds are not in the design but were an expedient so that the experimental model could be built with available plate material. These box sections on a production unit will be one-piece extrusions and, therefore, not subject to transverse welds (Fig. 2). It should also be noted that the 6061-T6 extruded aluminum deck was also an expedient: an available section which will be replaced in production by a 2-inch-thick extrusion of similar shape in 7005-T53 aluminum. This alloy change gives an increase in yield strength to a minimum of 44 ksi and a reduction in cross-sectional area of approximately 5 percent. It also lowers the neutral axis of the tread section, thus lowering the maximum achieved stress at a given load. The welded yield strength is approximately 100 percent higher than welded 6061-T6.

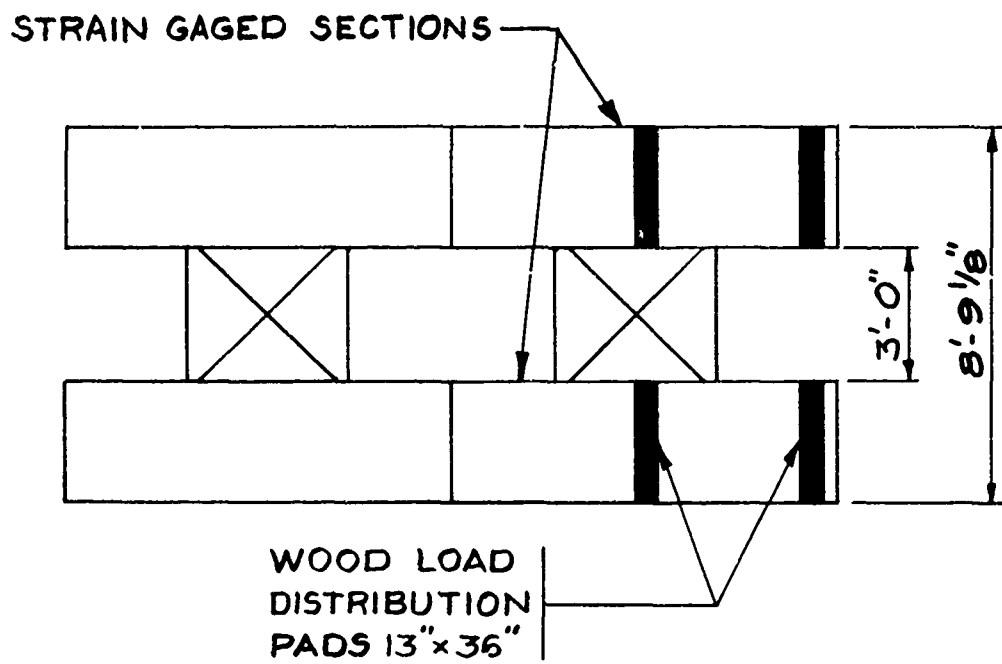
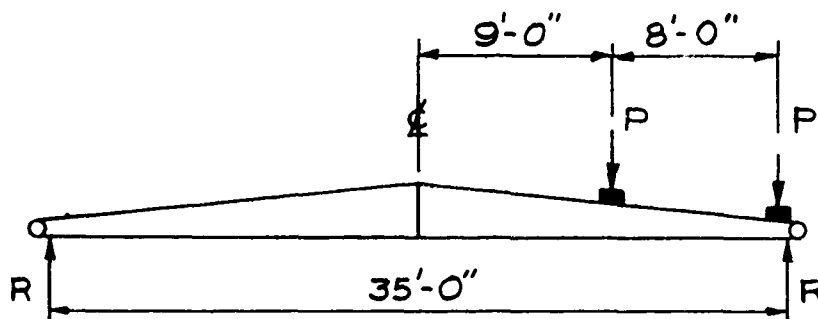
Fig. 11. Load Position 2.

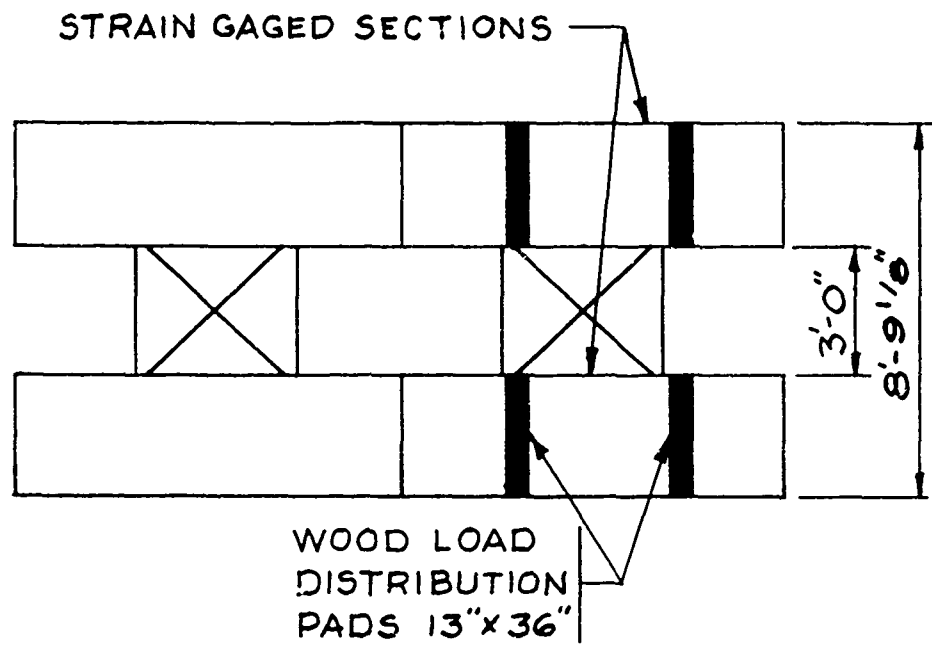
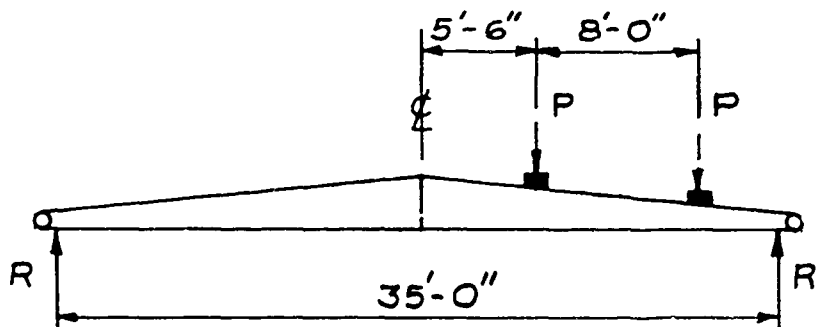
Fig. 12. Load Position 3.

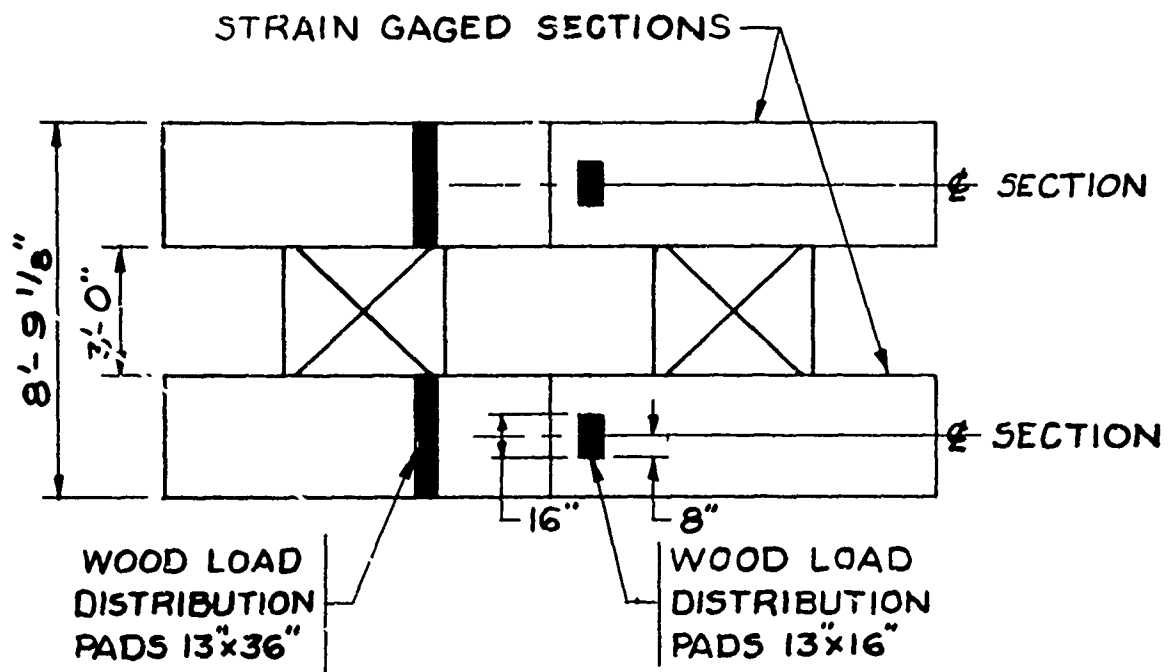
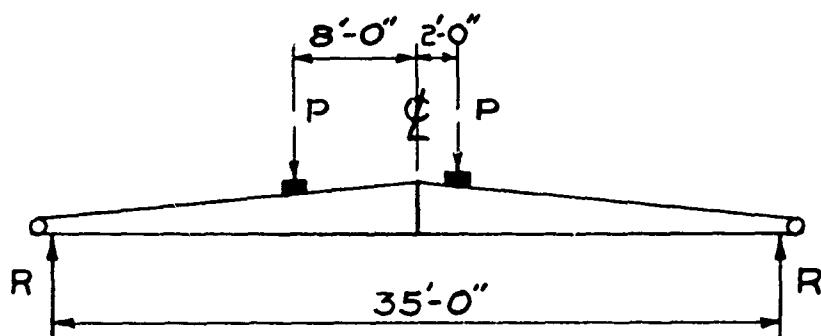
Fig. 13. Load Position 4A.

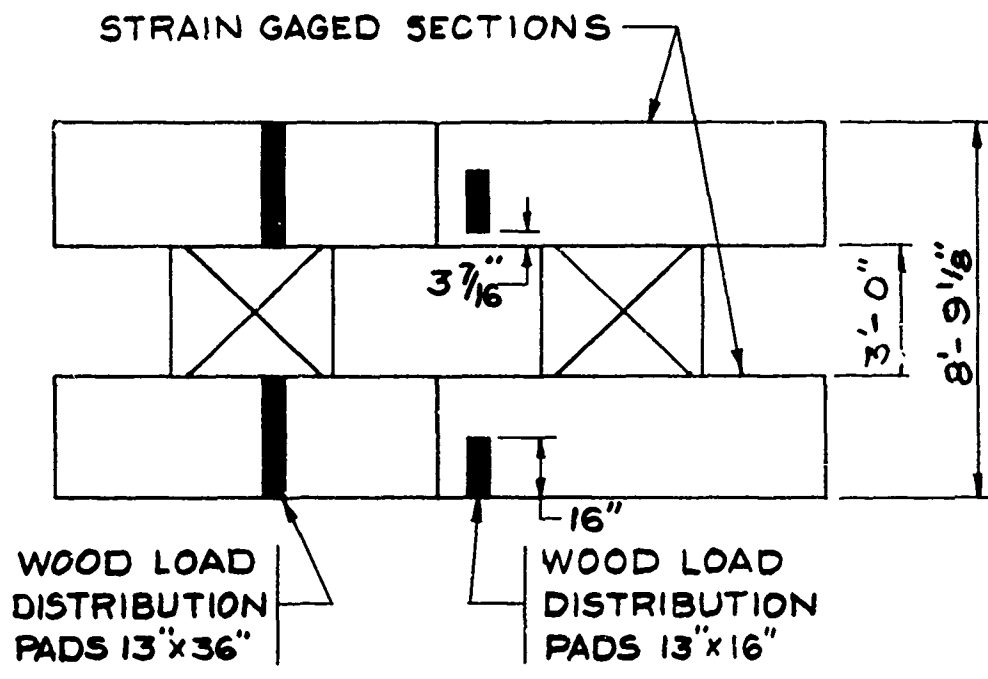
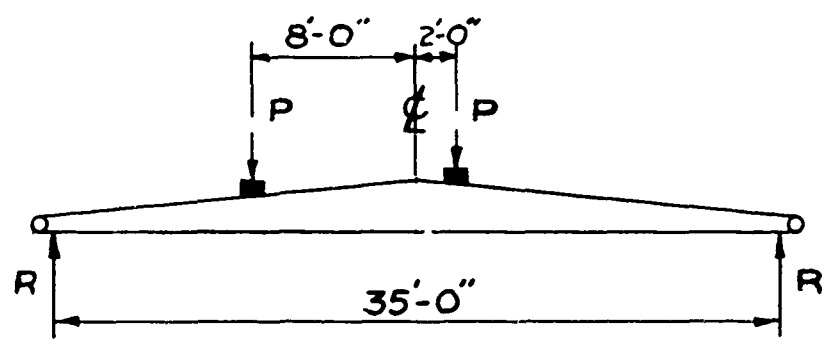
Fig. 14. Load Position 4B.

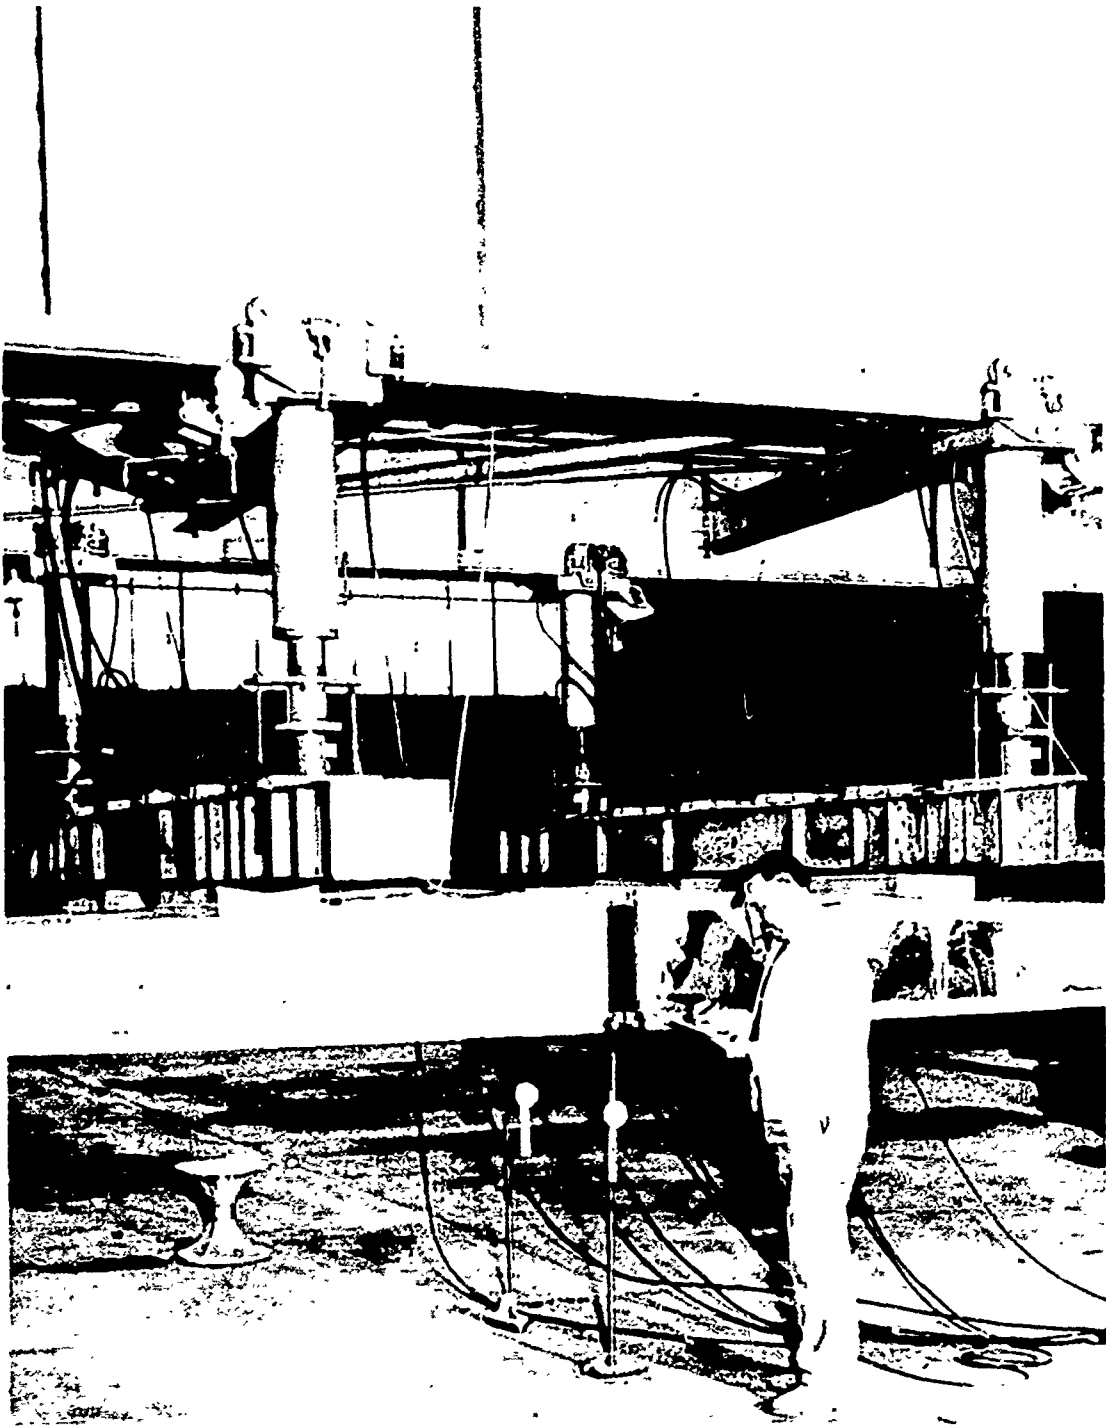
N8448

Fig. 15. Recording deflection at centerline of bridge for load position 1.

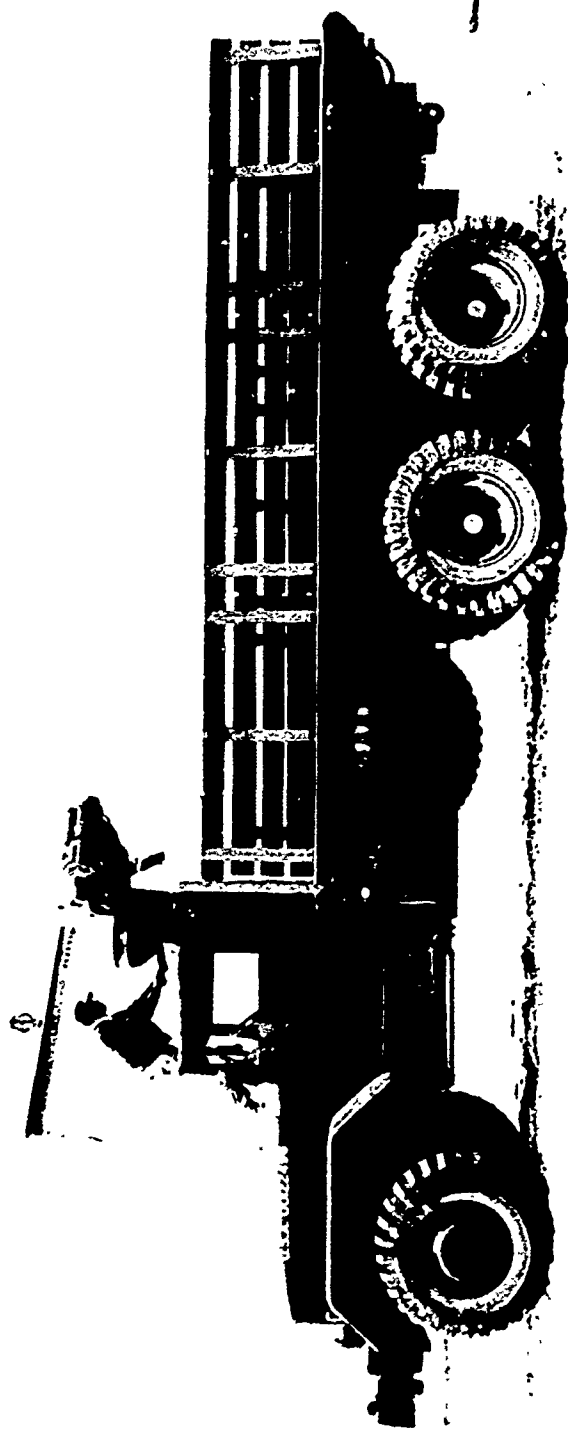
C3197

Fig. 16. Five-ton bridge truck, class 22.

The wheeled vehicle was an M-139 bridge truck loaded to a gross weight of 44,000 pounds (Fig. 16). Crossing speeds were limited to a crawl because only the inside, dual wheels of each rear axle were on the bridge. This created an extreme condition of weight (Class 22) and eccentricity, but the stresses show no areas of concern and the stress levels were well within the limits of proportionality (Table VII). Runs 1 and 2 show variations in different crossings, while run 3 shows the static stresses with the center of gravity (C.G.) of the vehicle at the centerline of the bridge.

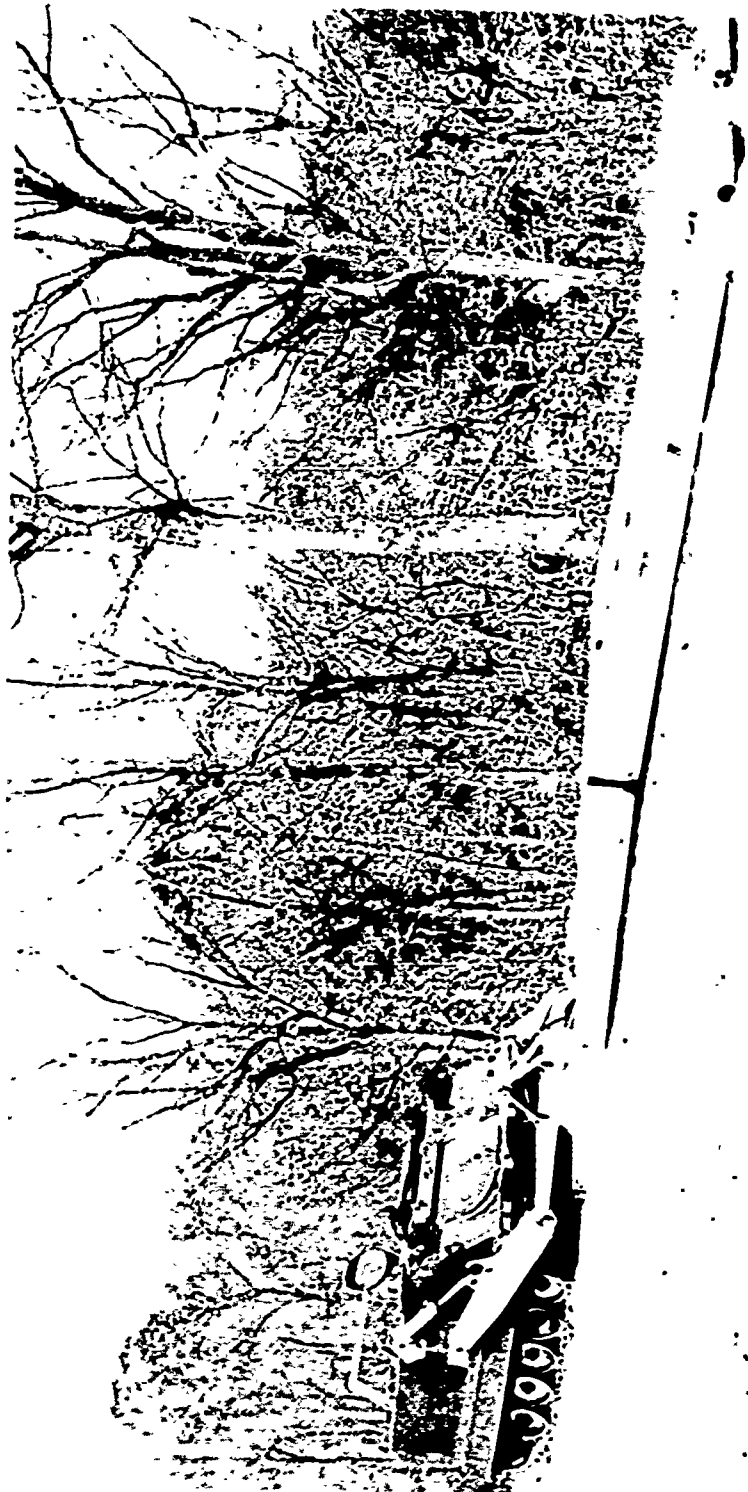
N10767

Fig. 17. Launcher attached to bridge.

The bridge was attached to the launcher and raised to the travel position (Figs. 17, 18, 19, and 20). The launcher with bridge attached was then driven into the water to establish its swimming capability (Fig. 21). Several trials were made with ballast placed at the rear of the vehicle; however, a better attitude was achieved with a combination surfboard-float placed at the front of the vehicle (Fig. 22).

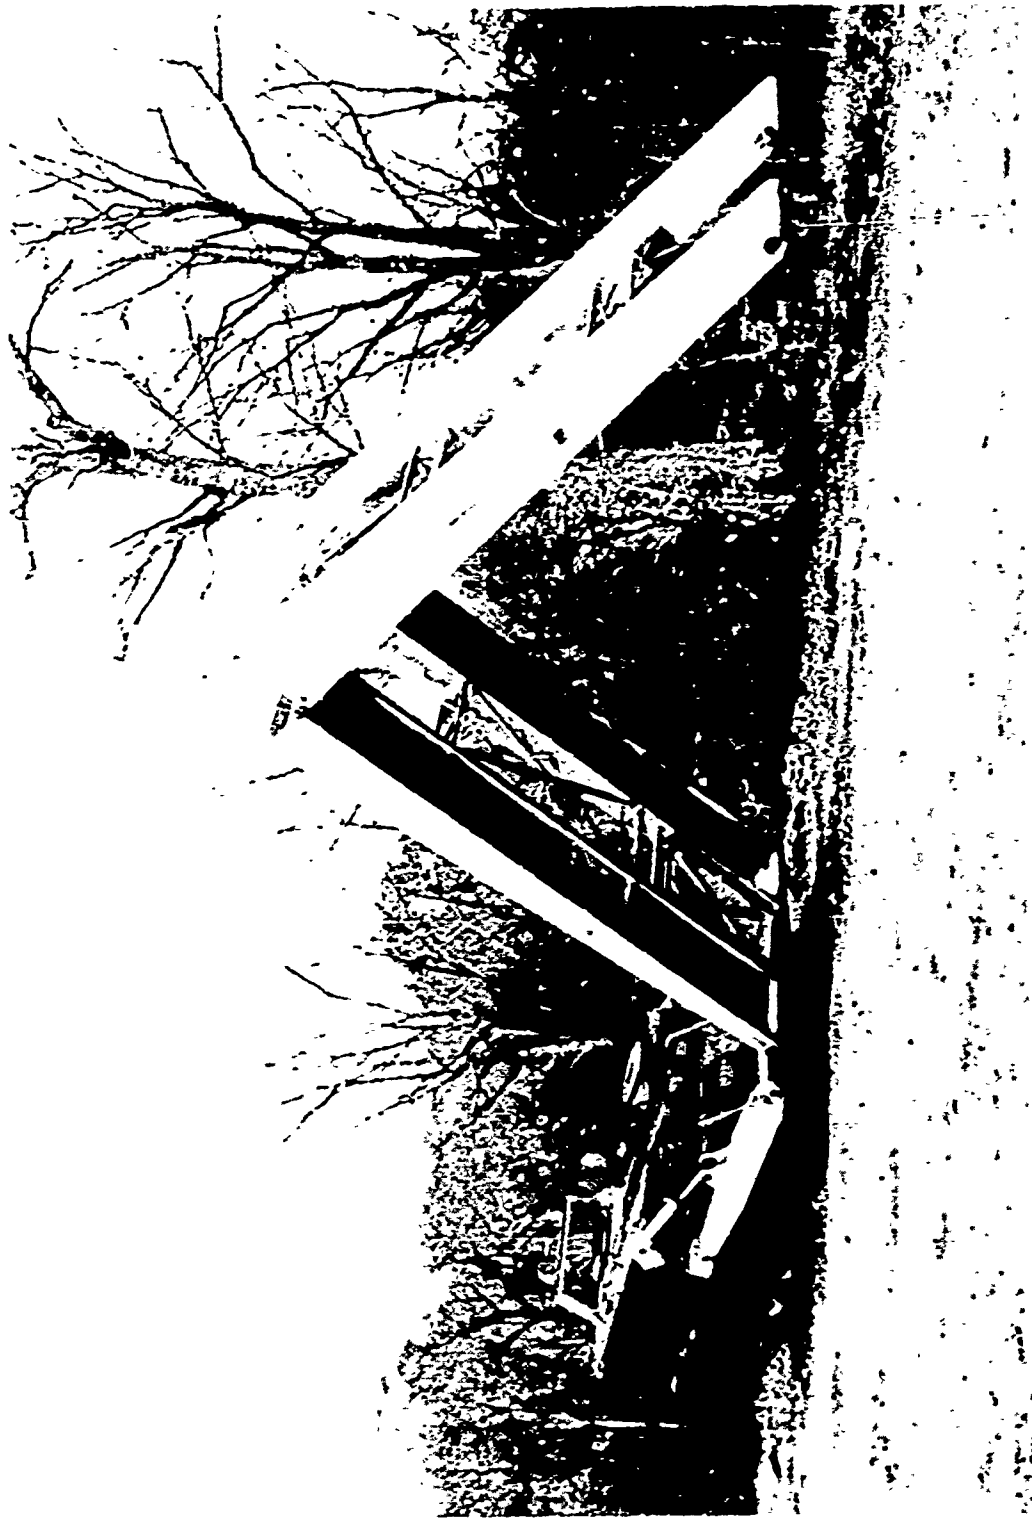
N10765

Fig. 18. Launcher retrieving bridge.

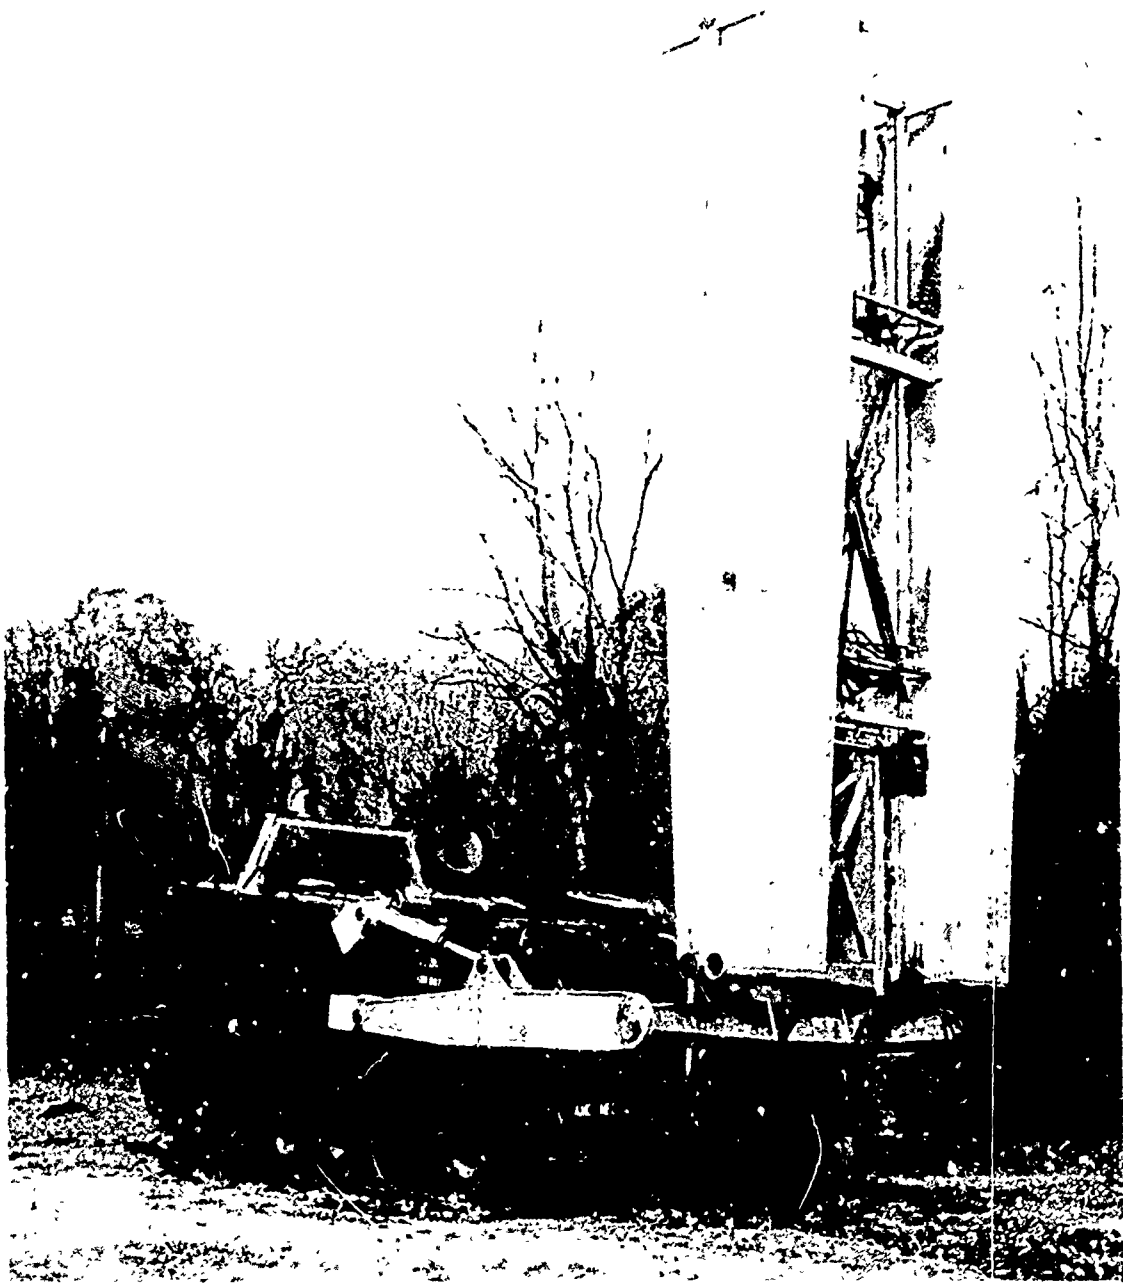
N10766

Fig. 19. Launcher with bridge at vertical while retrieving.

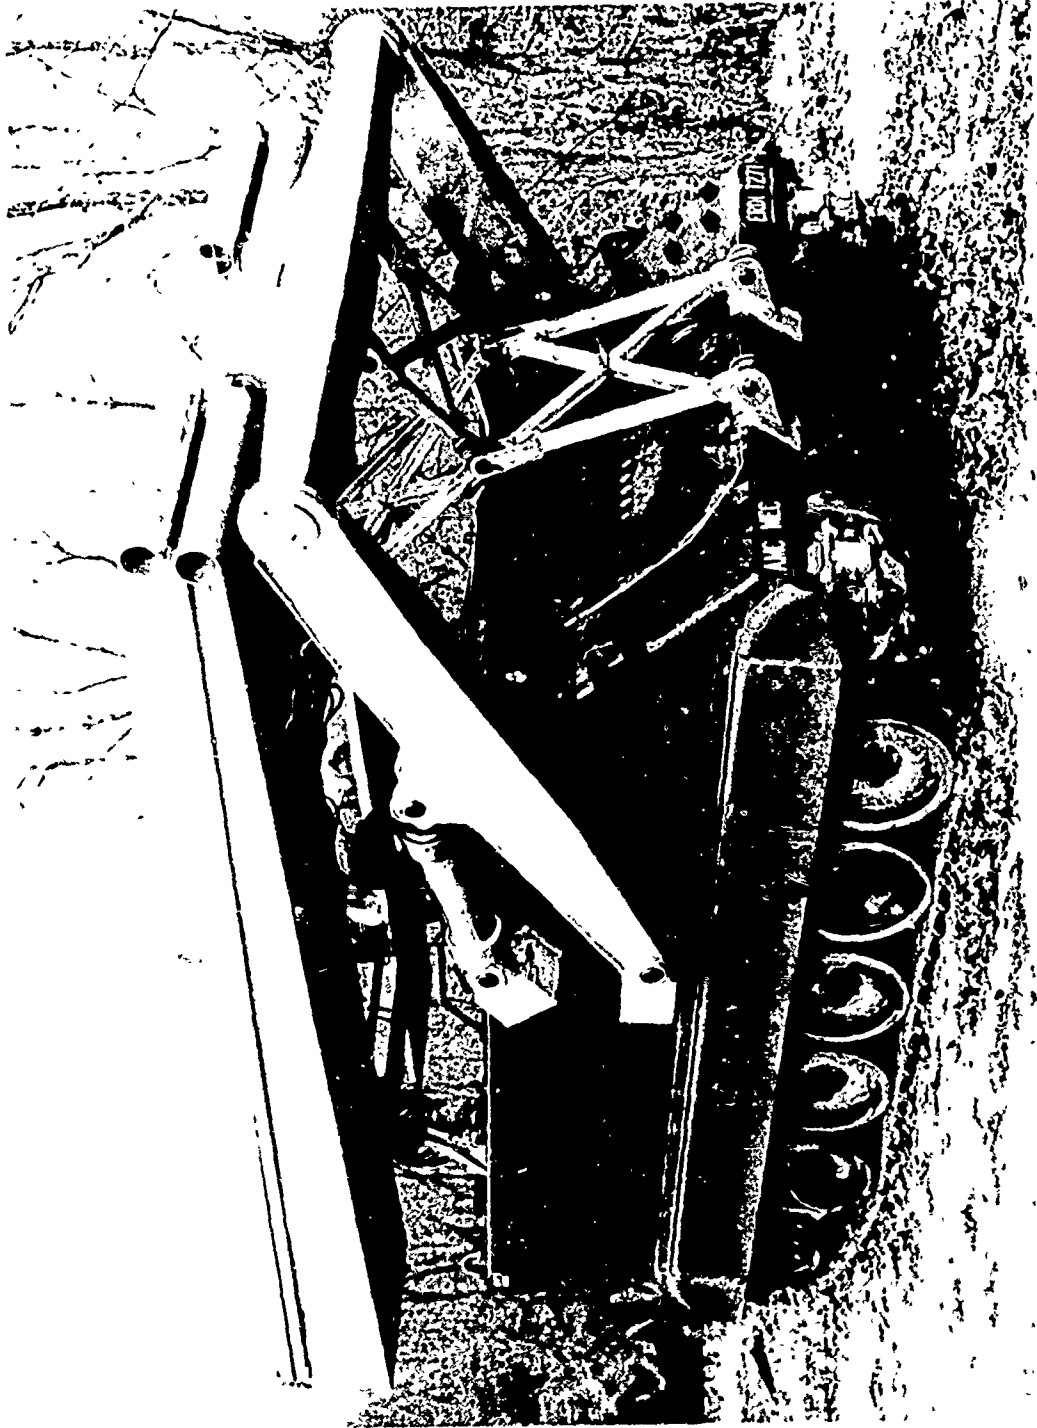
N10768

Fig. 20. Launcher with bridge in carrying position.

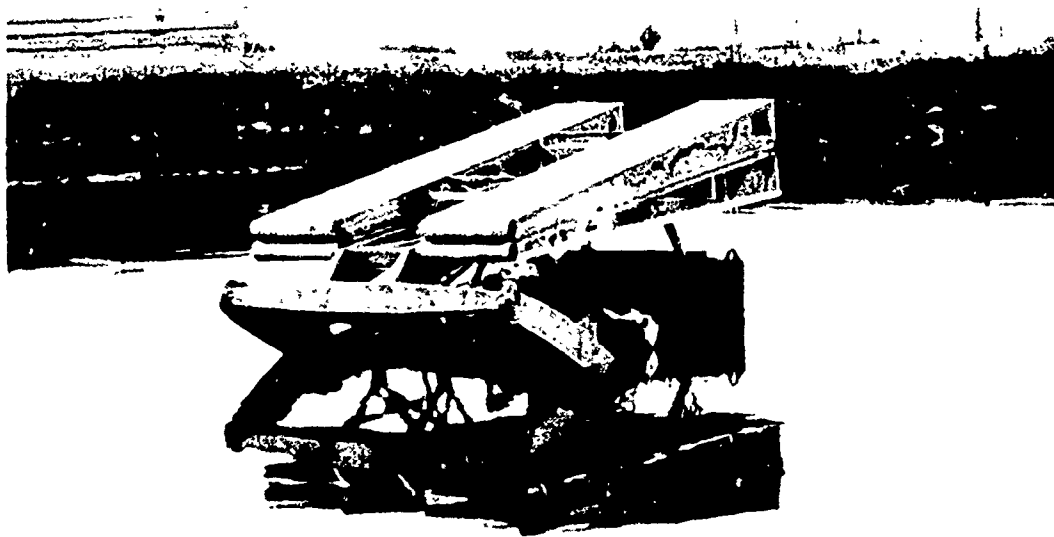
N10771

Fig. 21. Static floating attitude without ballast or surfboard-float.

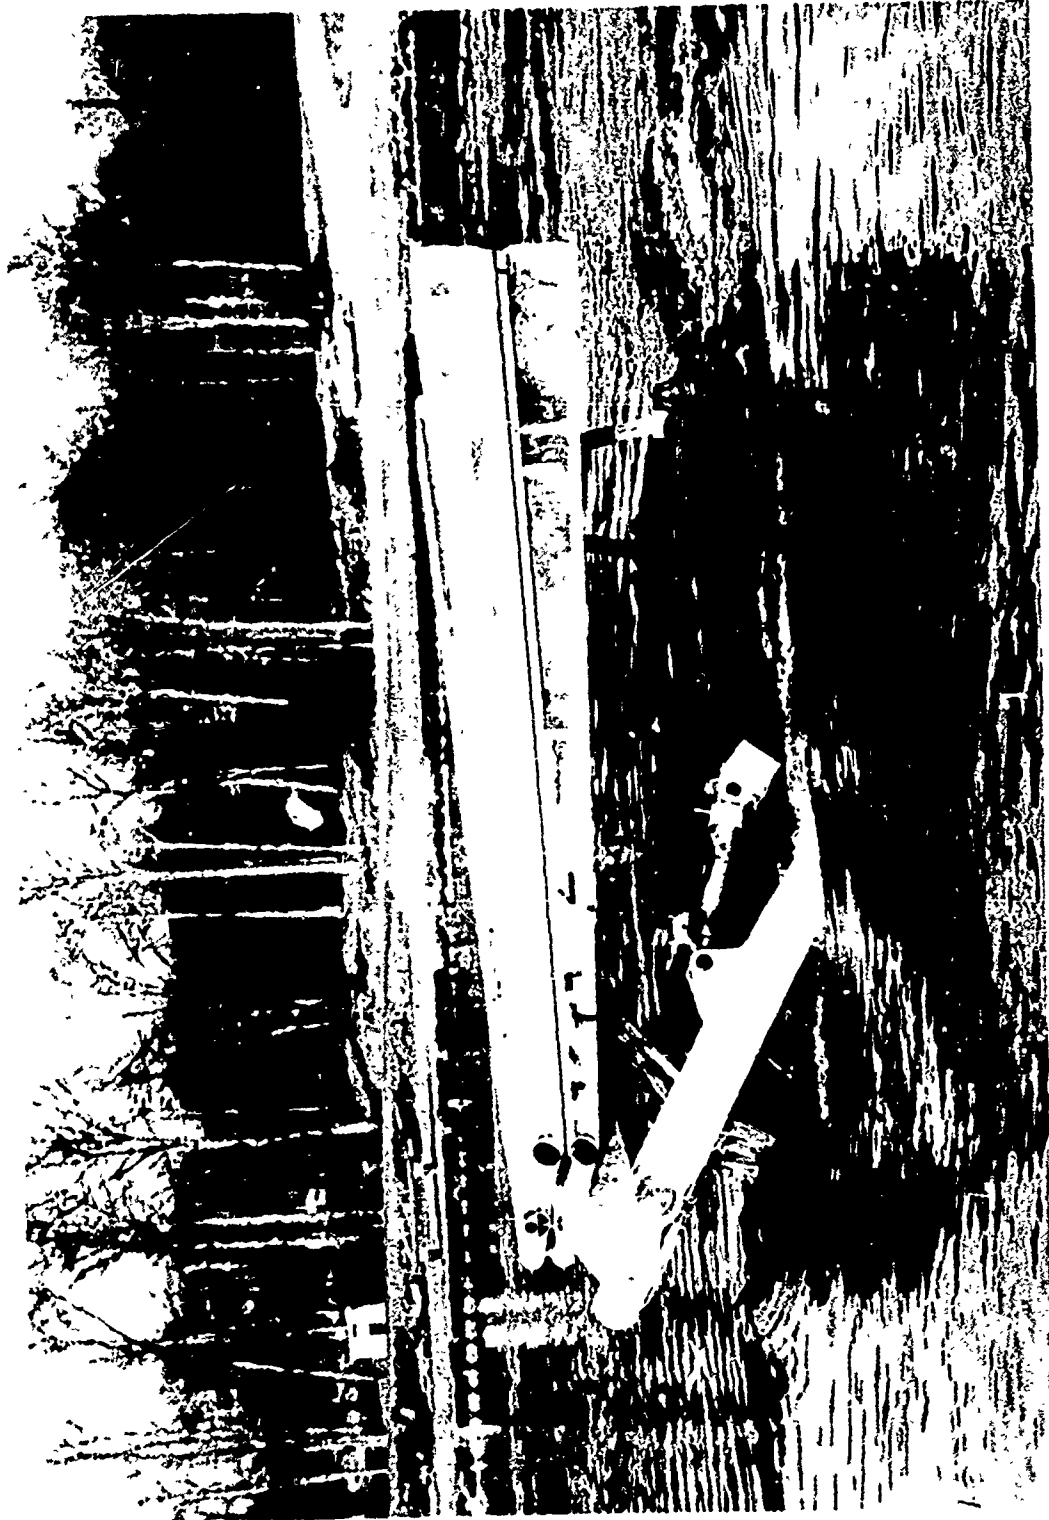
N1118

Fig. 22. Unit at full speed using combination surfboard-float.
