Report 1928

**EXPERIMENTAL MODEL,
MARGINAL-TERRAIN ASSAULT BRIDGE AND ARMORED
PERSONNEL CARRIER TRANSPORTER AND LAUNCHER**

April 1968

**U. S. ARMY MOBILITY EQUIPMENT RESEARCH AND DEVELOPMENT CENTER
FORT BELVOIR, VIRGINIA**

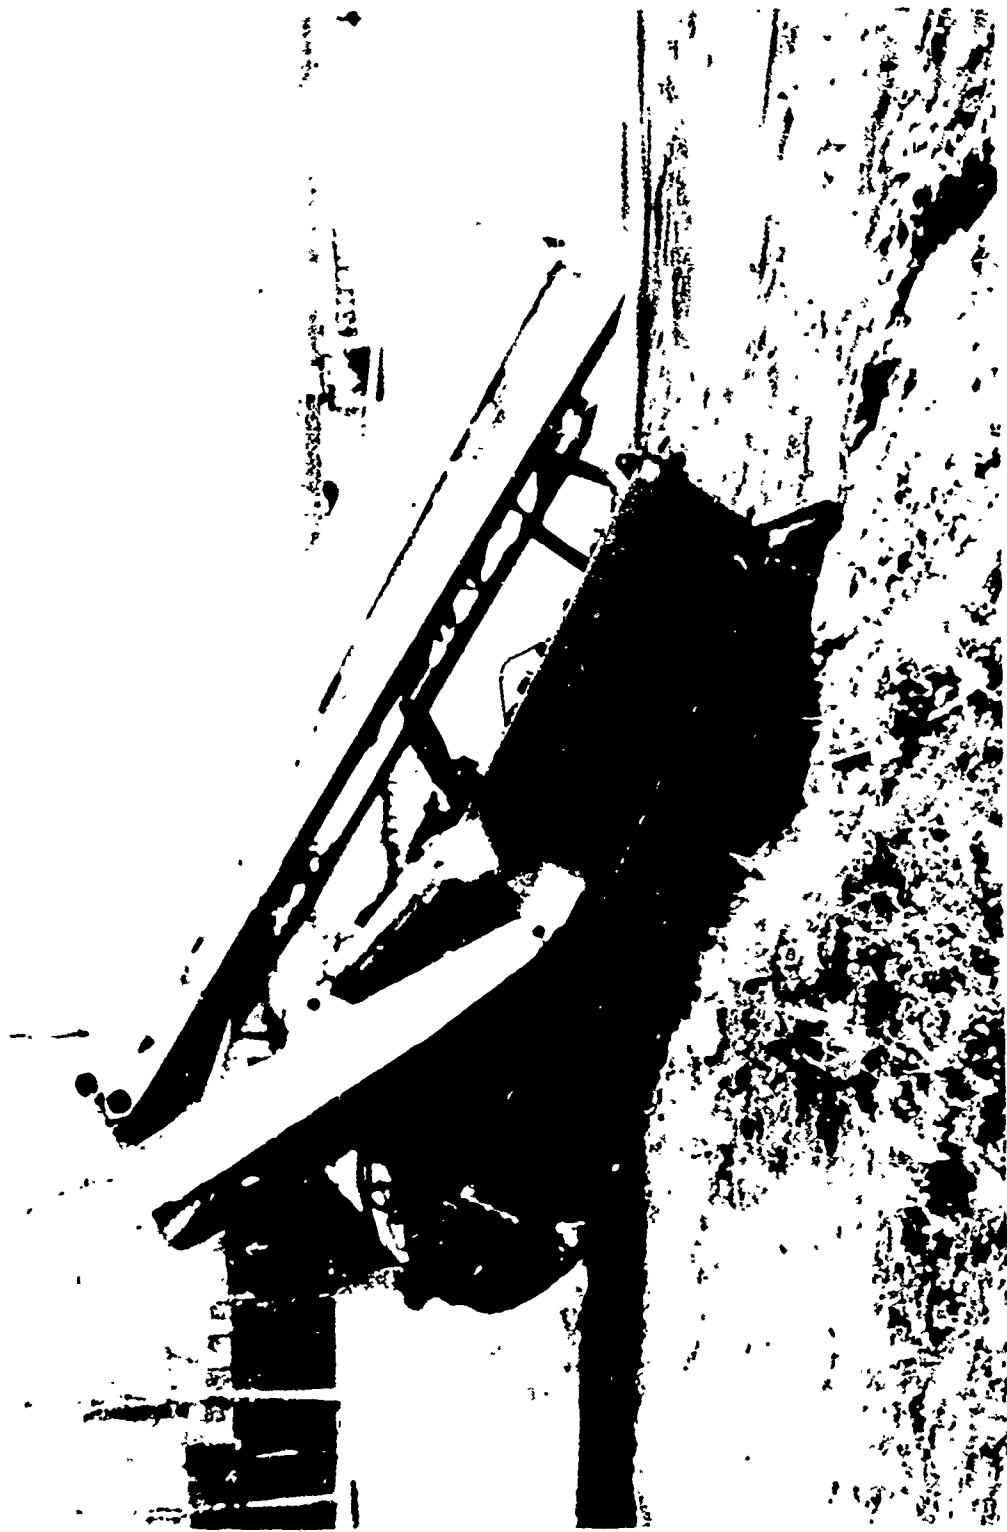
P1830

Fig. 7. Exit from water up sharp incline.

Water operation included 26 hours of swimming and 125 entrances to and exits from the water. Entry and egress conditions varied from a gently sloped concrete ramp to a sharp drop off (Fig. 23).

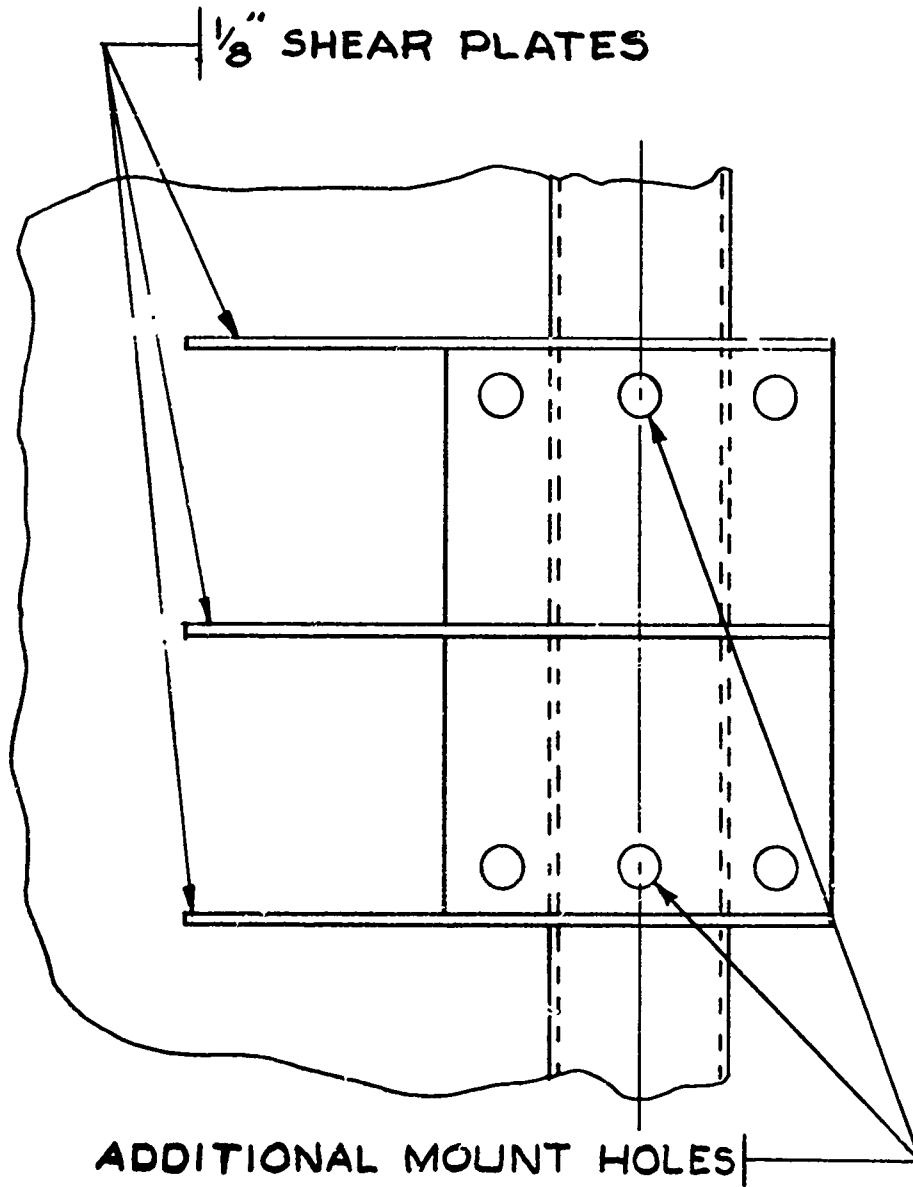
Fig. 25. Modified link beam mount.

During the initial stages of cycling, yielding occurred in the channel legs at the mounts for the cylinder beam and link beam. Elongation of the bolt holes was also noted. Shear plates 1/8-inch thick were added as well as four more bolts per beam. Fig. 25 shows the revised mount for the link beam. The cylinder beam mounts were similarly modified. Both areas were subjected to more than 1000 cycles without further evidence of distress.

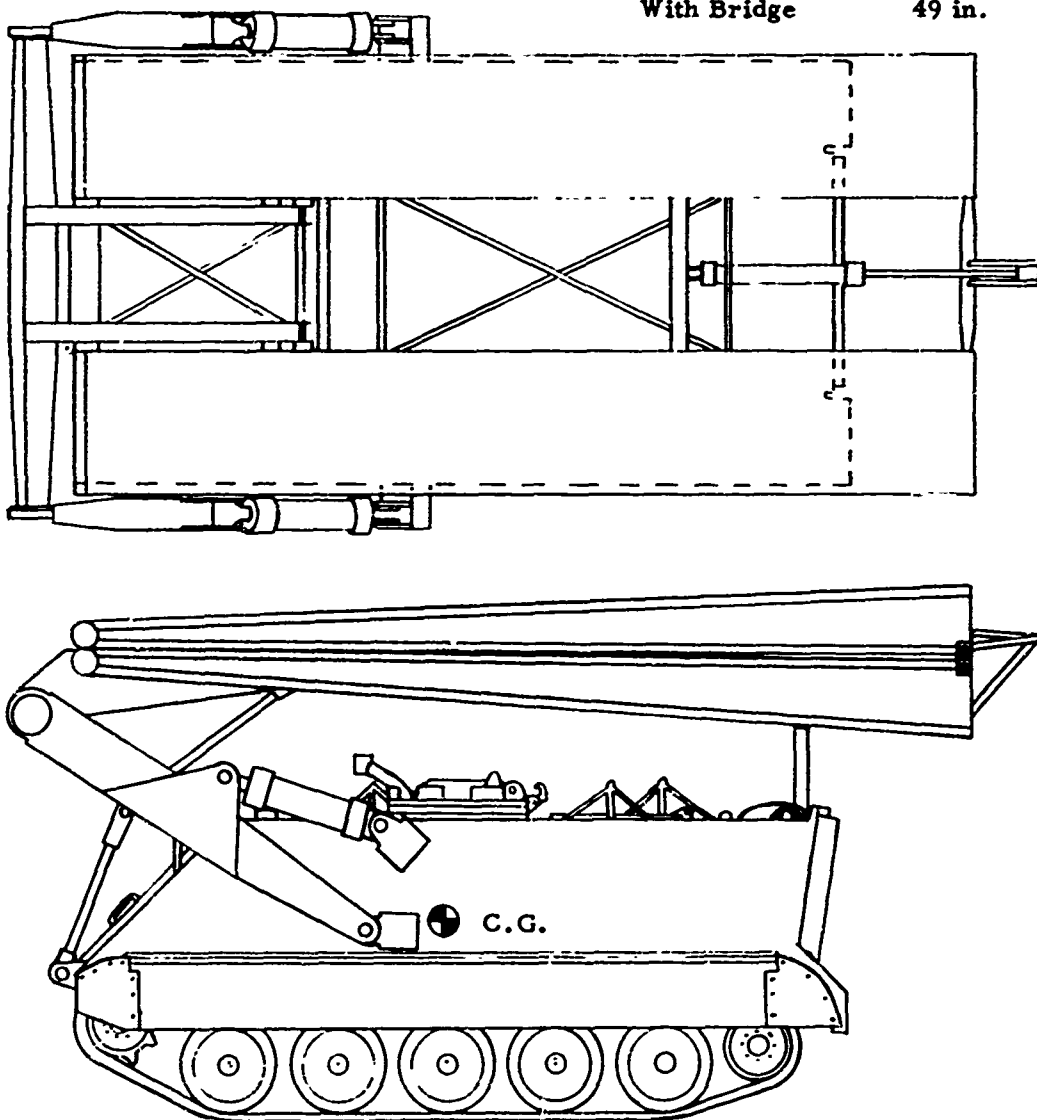
Fig. 27. General data.

- (b) With bridge 24⁹/₁₆ inches
- (6) Center of Gravity (from noseline)
 - (a) Horizontal
 - 1. Without bridge 83-1/2 inches
 - 2. With bridge 90 inches
 - (b) Vertical
 - 1. Without bridge 38 inches
 - 2. With bridge 49 inches

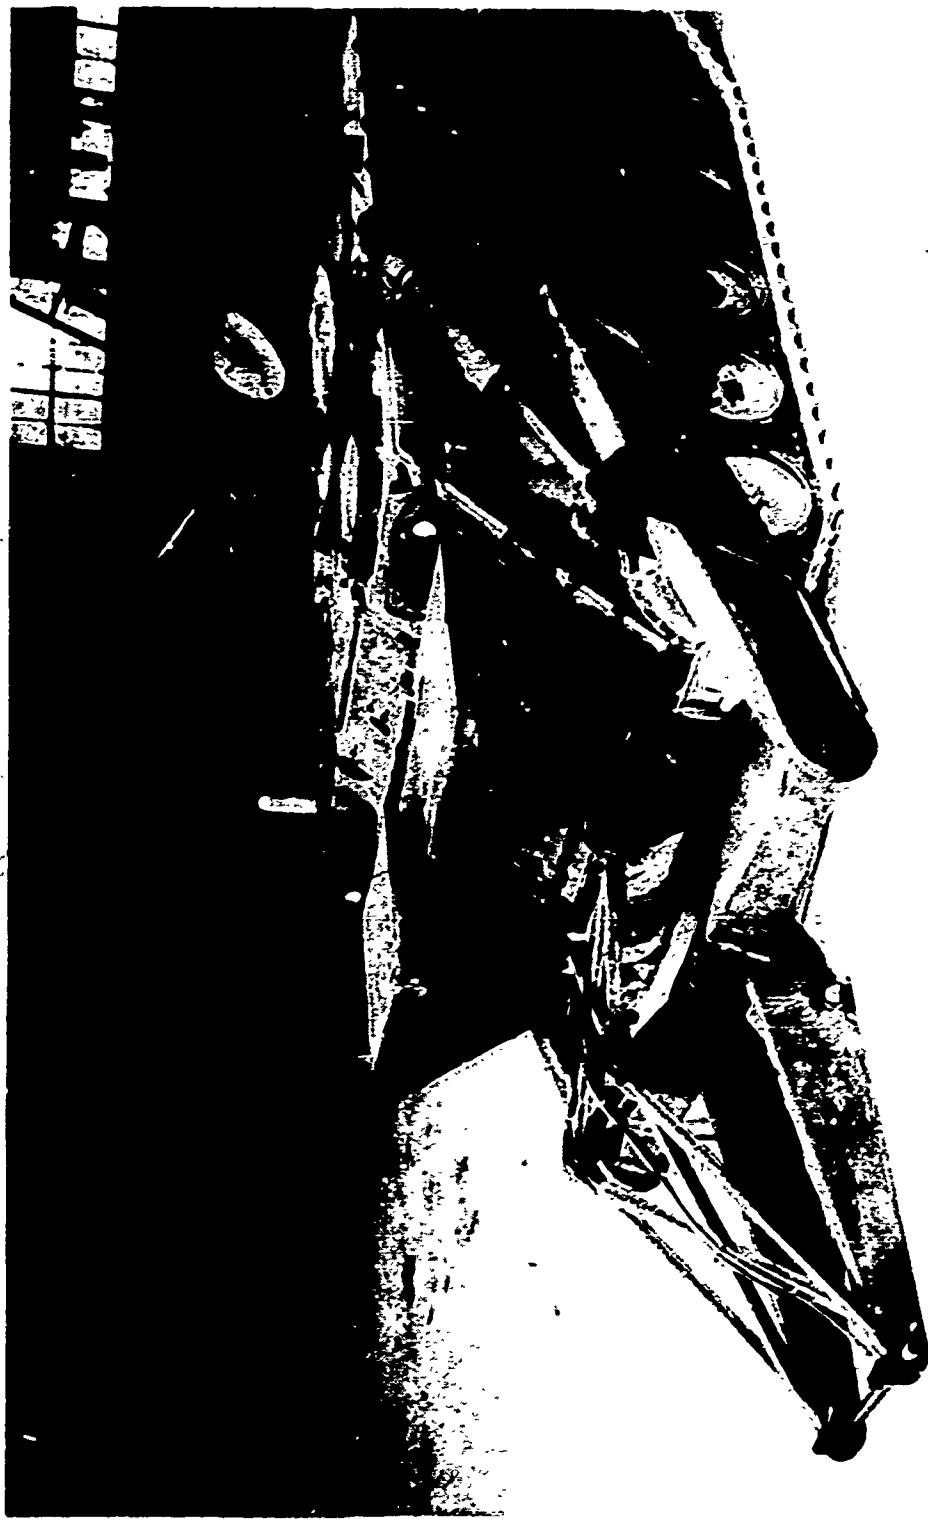
P7901

Fig. 28. Final surfboard-float arrangement.

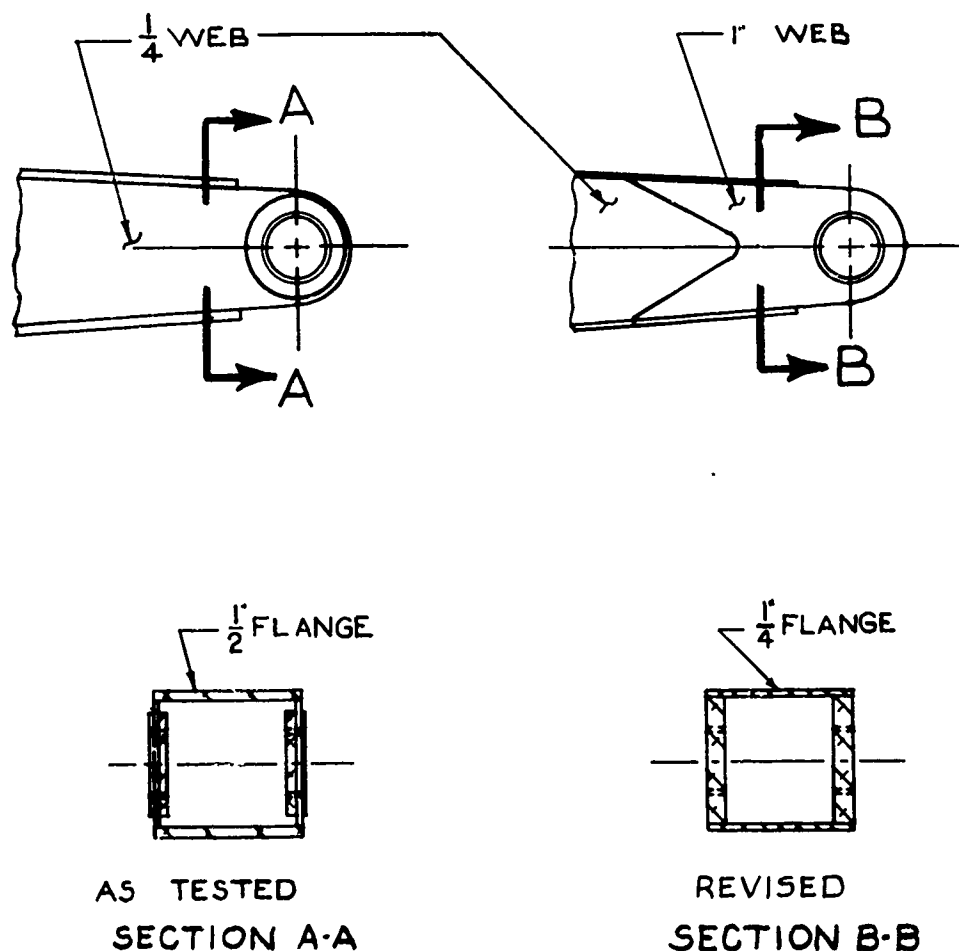
Fig. 30. Revised launching beam.

This limited data and the nonavailability of complete characteristics of the alloy did not allow a conclusive failure theory. There was speculation that the fracture was the result of flexural fatigue aggravated by a stress concentration at the end of the flange (Fig. 30).

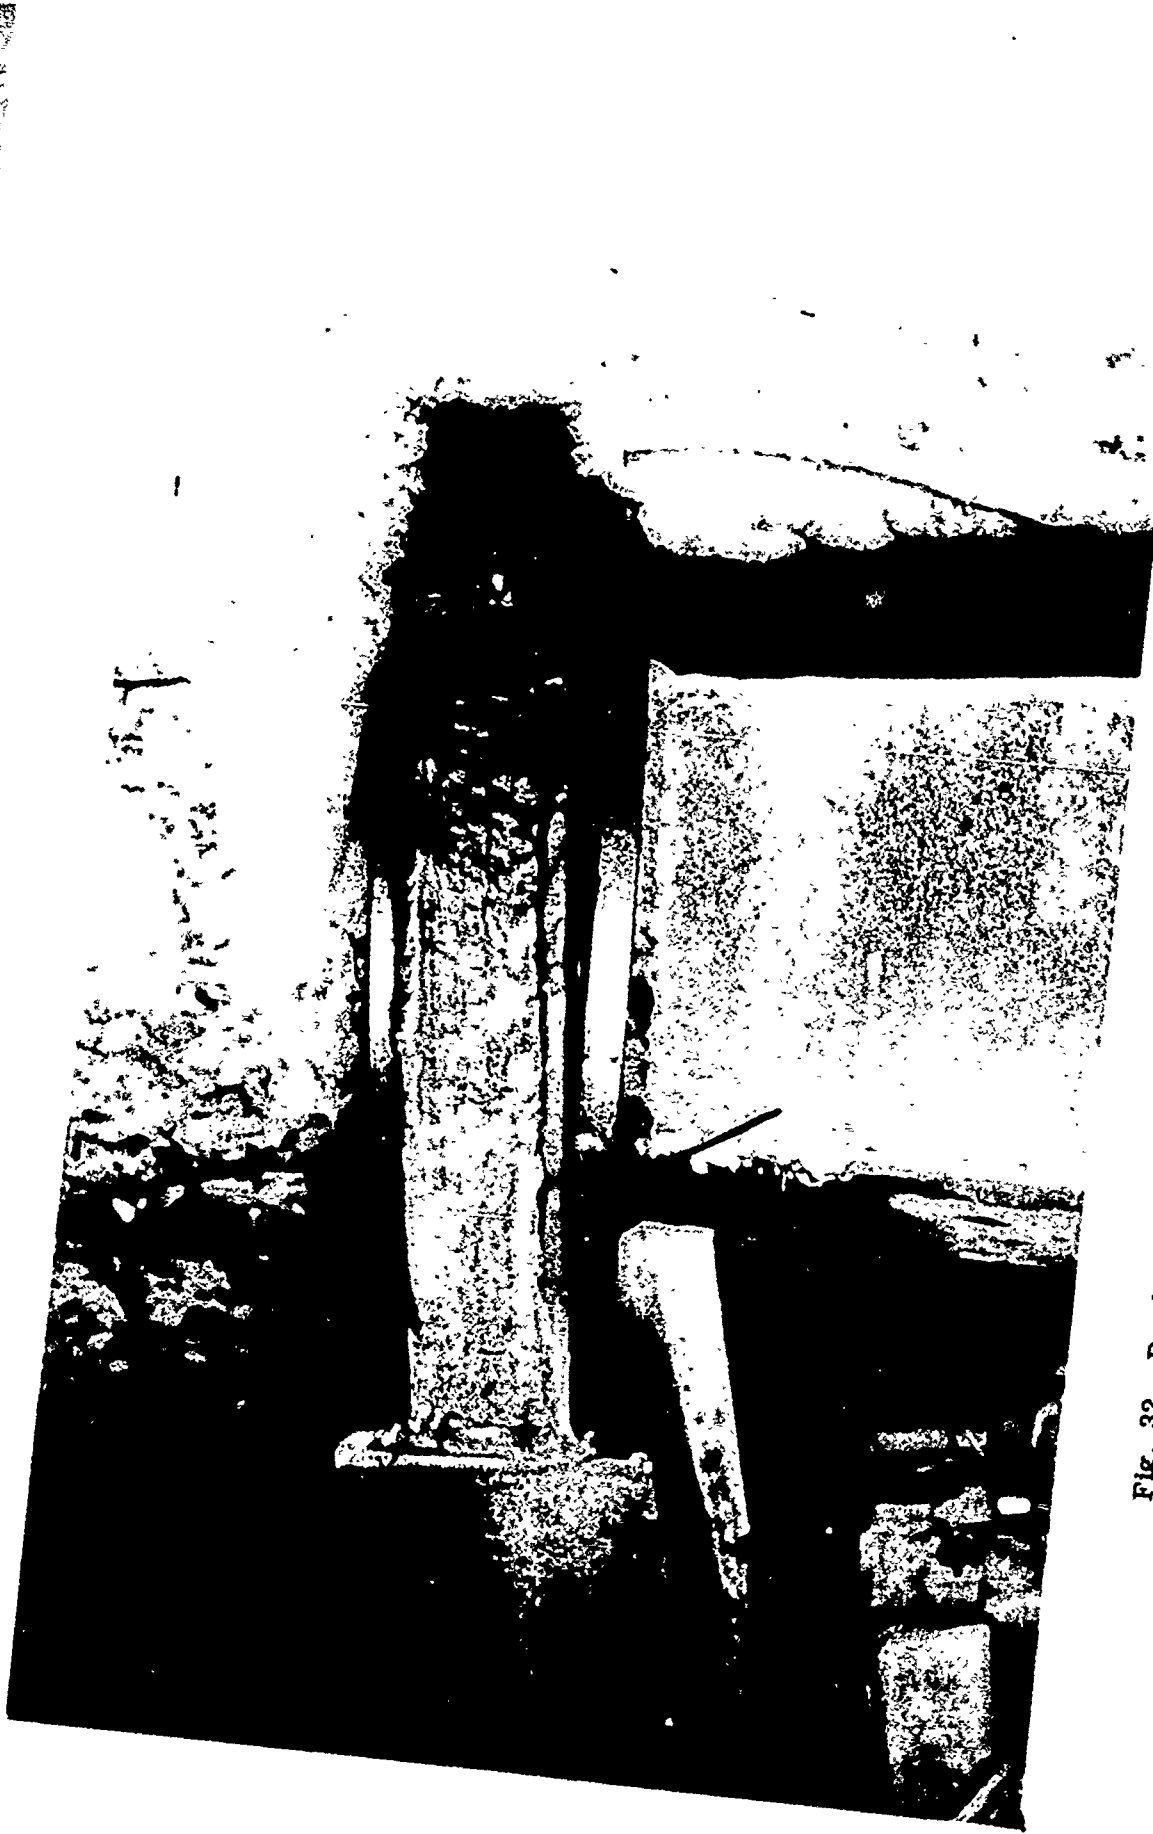
Fig. 32. Bending of crossbeam end plate and trunnion pin. P5778

The failure caused racking of the mechanism (Fig. 31) and bent the end plate and trunnion mount on the left end of the tongue-frame crossbeam (Fig. 32). The racking action gave a permanent set in torsion to the rotating link. The link was cold straightened by a press, and the end plate and trunnion were cold straightened by driving. The crushed end of the launching beam was replaced with 1/2-inch web plates; the unfailed, left-side, launching-beam webs were stiffened with 1/4-inch plates. This arrangement still required the use of 1/2-inch-thick bearing plates to be welded on at the pinhole. For cost reduction and ease of fabrication, the web plates on a production model would be 1 inch thick (Fig. 30). The 1/2 inch webs were strain gaged during subsequent testing (Gage No. 48, Table X).

After 945 cycles, the left end plate of the crossbeam sheared (see arrow, Fig. 32). No other damage was sustained, and the plate was rewelded with a larger weld. The right end plate was also rewelded as insurance against a similar failure. No other action was taken since the failure was precipitated by bending caused during the launching-beam failure and subsequent straightening during repair.

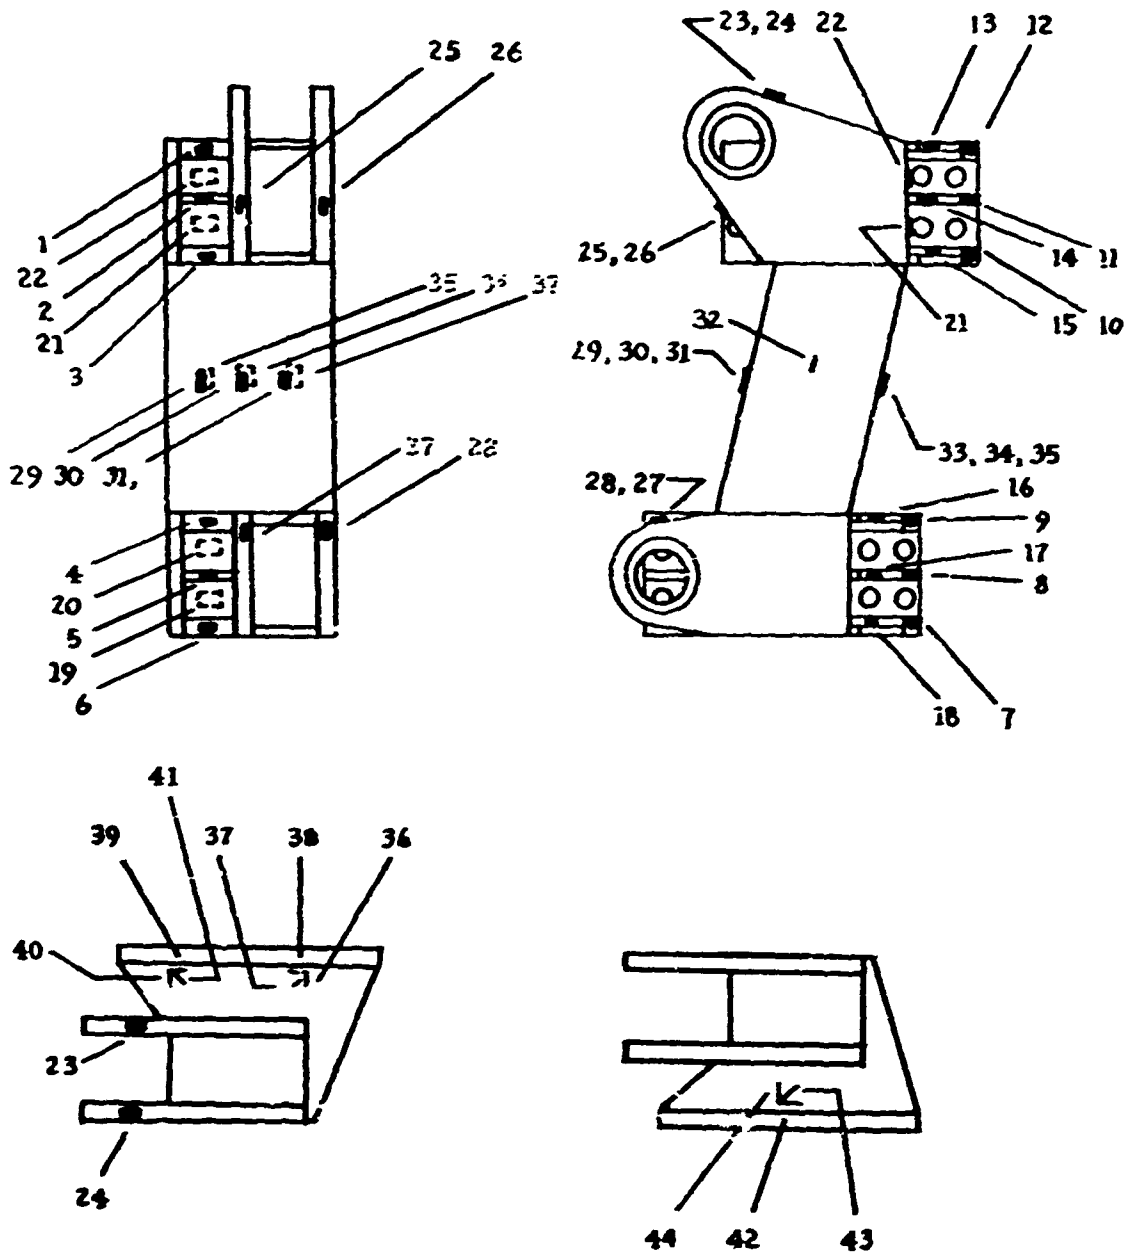
Fig. 35. Strain gage locations.

Dynamic stress recordings were made for the same non-shock, shock, and sideslope shock conditions as before; results of these tests appear in Table X (Strain gage locations are shown in Fig. 35). A rosette placed on the welded mount was gage numbers 45, 46, and 47. The rosette was located on the bottom of the lower mount adjacent to the connecting weld and approximately 3 inches behind the forward edge. Gage number 48 was placed on the centerline of the launching beam in front of the mount pin. This was the area that previously failed under compression. The recorded stresses for the 1/2-inch webs gave no further insight to failure in the 1/4-inch webs.

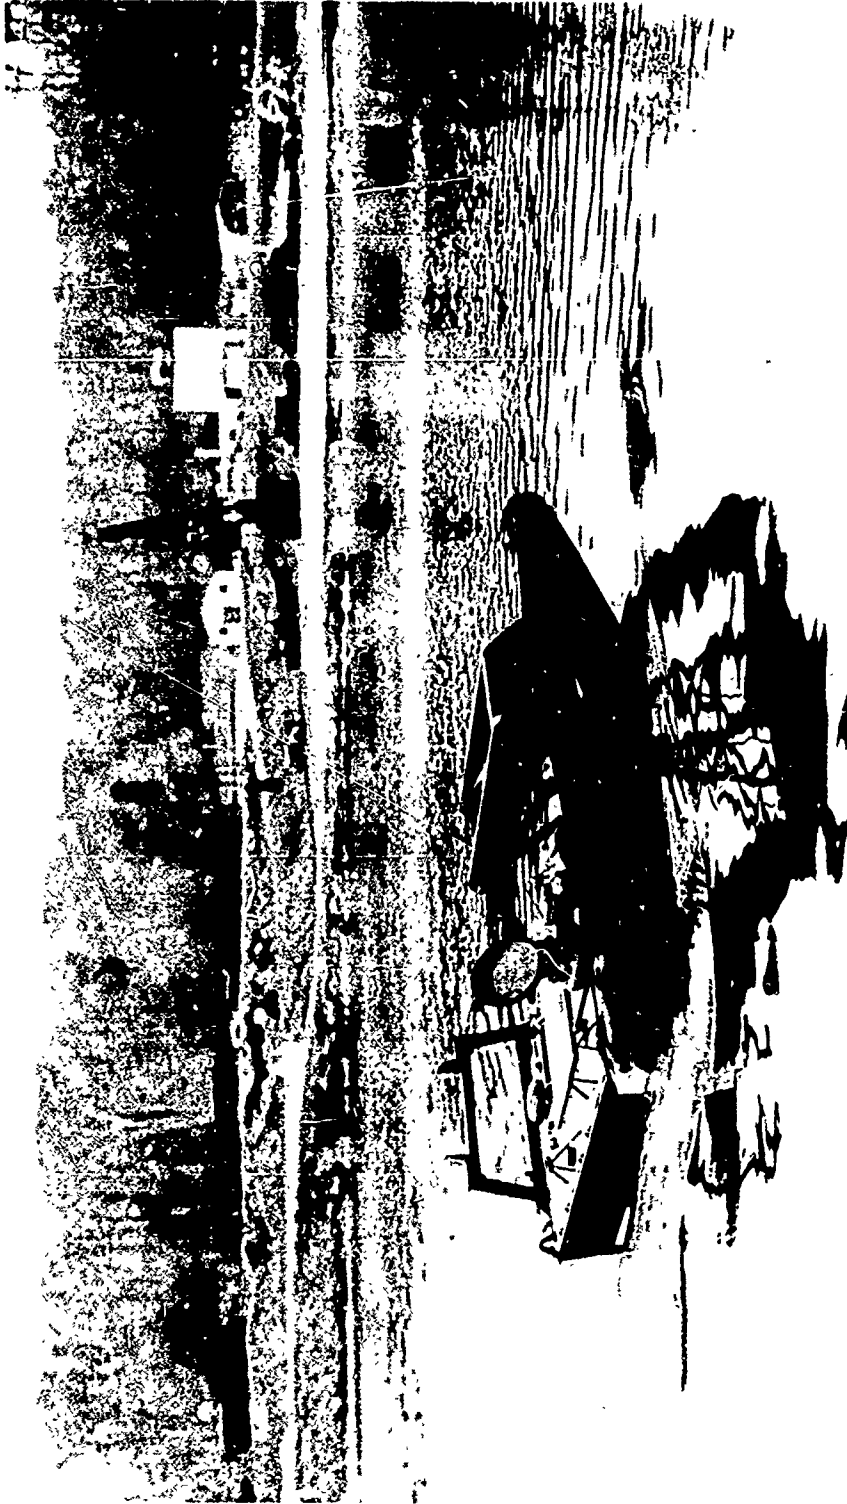
P11448

Fig. 36. The M-113A1 launcher, without bridge, at full speed.
