AFCRL-69-0375

## AIR-LAUNCHED WINDSONDE

Stephen F. Rohrbough and Lyie E. Koehler  
Honeywell Inc.  
Systems and Research Division  
Research Department  
St. Paul, Minnesota 55113

### FINAL REPORT

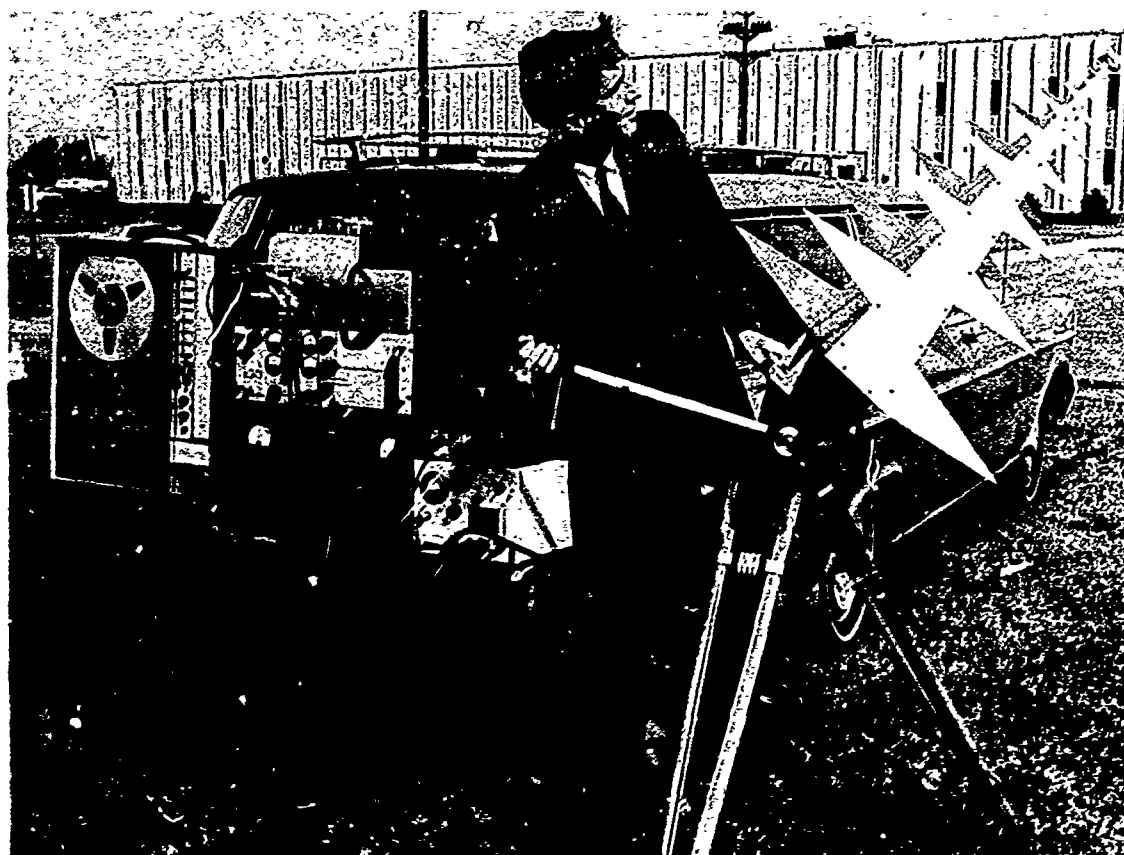
Figure 17. Windsonde Aircraft Test Ground Station

At the ground stations, Nems-Clarke telemetry receivers were again used in conjunction with the GMD equipment. Receiver outputs were fed simultaneously to a 10-kHz low-pass filter, a 14-kHz bandpass filter and an a-m detector, and a 22-kHz telemetry subcarrier discriminator. Outputs of these three devices (the pickoff "1" signal, roll-sensor output and pickoff "2" angle, respectively) were recorded. A block diagram of the receiving schemes is shown in Figure 16 and Figure 17 is a photograph of the ground station.

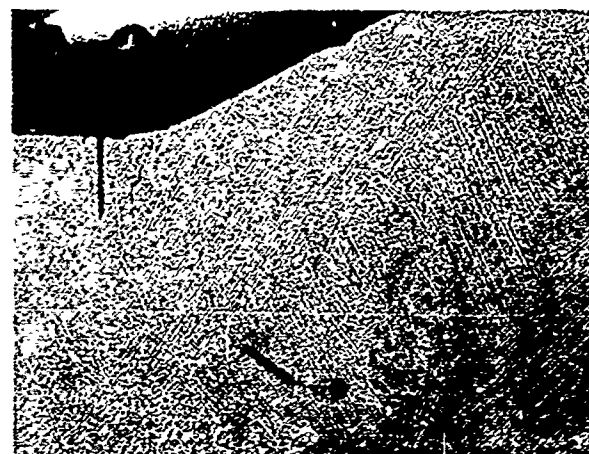
Figure 22. Sonde Ejection Sequence for April 1969 Flight

Each of the three drops went off successfully (see Figure 22). On the first drop, the radar was able to track the parachute as it left the plane but was unable to see the sonde fall from the parachute. On the second drop, sonde 4, the radar saw the parachute as it left the plane and was able to follow the sonde as it fell to the ground. On sonde No. 5, the radar was unable to locate the sonde, and only tracked the parachute. Sonde No. 3 had no gyroscope signal; the other two units appeared to have good data all the way. Permission was obtained from mission control personnel allowing the ground station operators to look for the sondes. However, they were unable to find either the sondes or their parachutes and protective tubes.
