# THE HUMMINGBIRD XV-4B VTOL RESEARCH AIRCRAFT PROGRAM

Lockheed Georgia Company  
Marietta, Georgia

October 1969

TECHNICAL REPORT AFFDL-TR-69-75

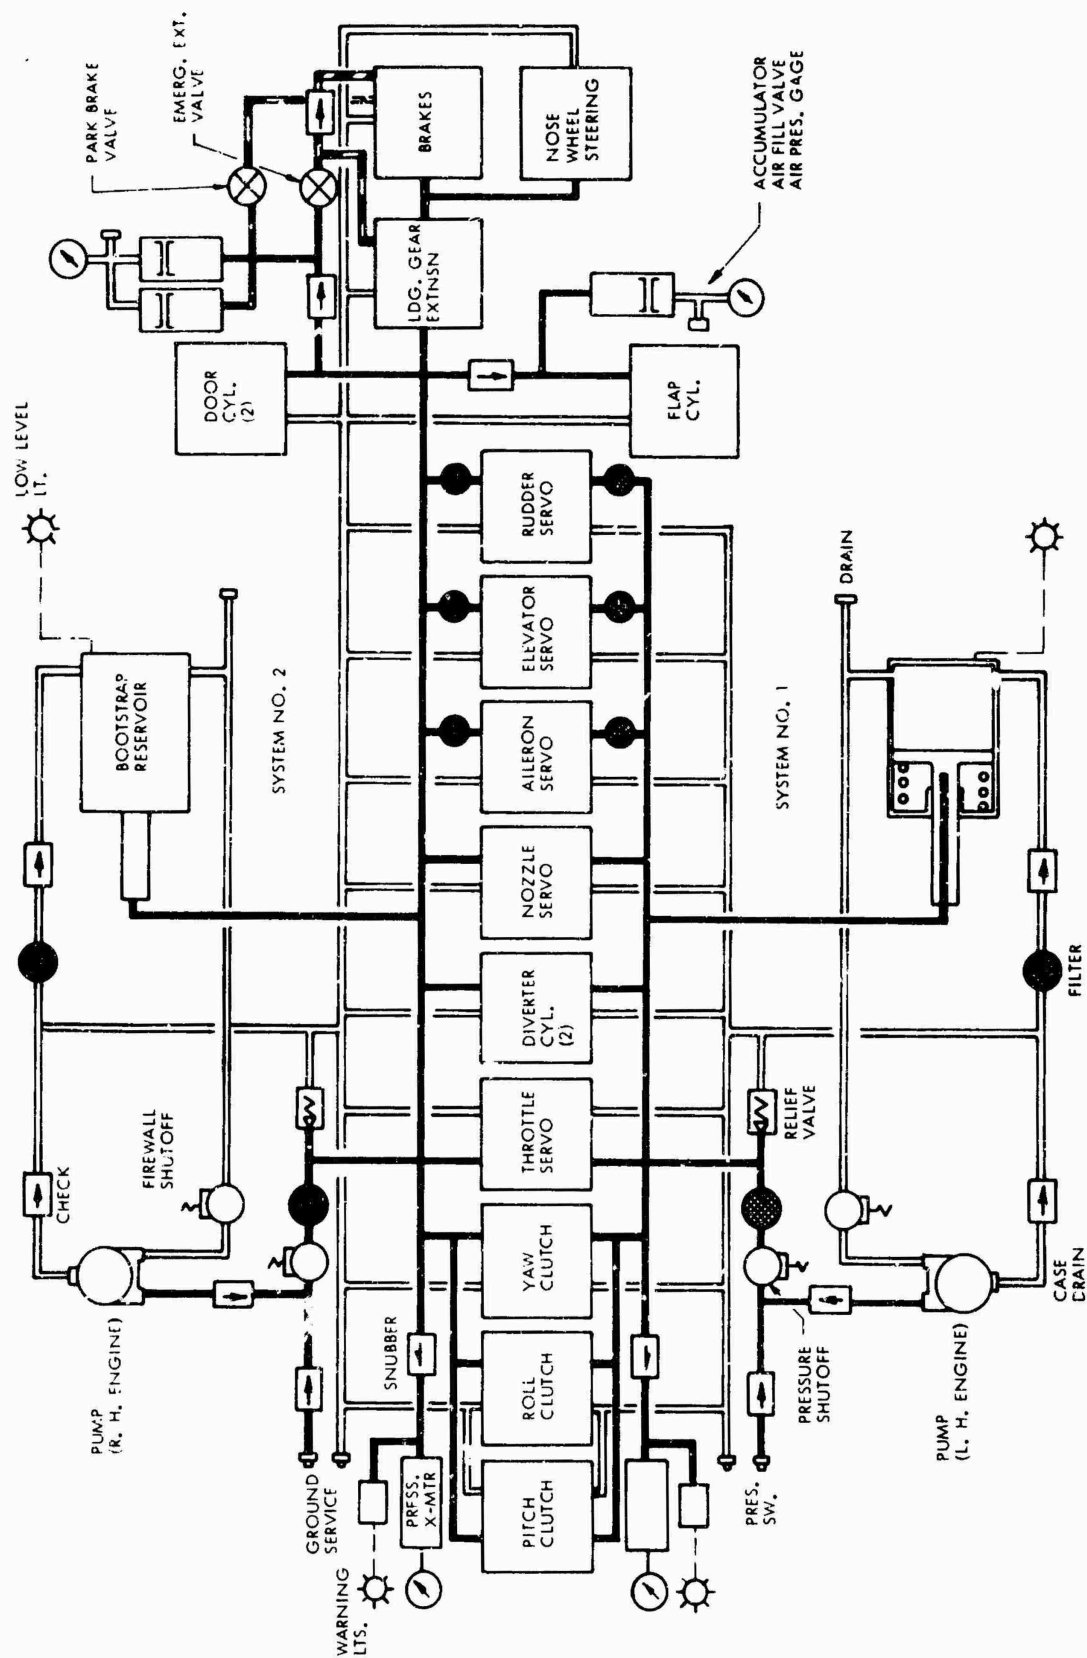
Because of the requirements placed on the primary flight control system and its proper operation, considerable emphasis was placed on minimizing and controlling fluid contamination. All system filters had a 2 micron nominal and 8 micron absolute rating. In addition to the pump pressure and suction line filters, in-line units were placed in the pressure line of each flight control actuator. These actuators also came with 40 micron strainers in each pressure port. As a design goal, system cleanliness was to be maintained at the Class III level recommended by SAE Committee A-6.

FIGURE 9 - HYDRAULIC SCHEMATIC

To minimize system heating effects with all engines operating in the VTOL mode, components and lines were concentrated over the forward and aft fuel tank. In addition a portion of the lines were routed through the fuel tank to effect heat transfer to the fuel and eliminate the necessity for coolers.

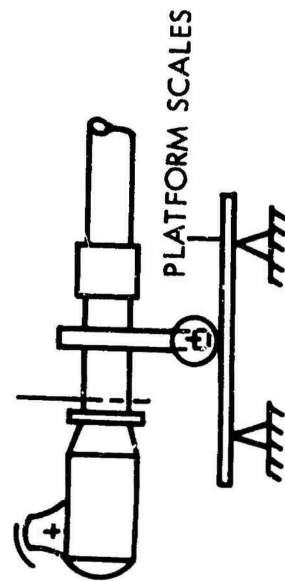
FORCE MEASURING SYSTEM FOR TEST VALVE CONFIG. NO'S. 1 & 2

The test setup used in both the development and calibration tests is shown schematically in Figure 32. Test instrumentation in the air supply line includes a square-edged orifice with static pressure taps and a thermocouple probe for measuring airflow rate. For the forward pitch and aft pitch/yaw valves a wall static pressure piezometer ring was installed in the air supply duct just upstream of the valve attachment flange for the purpose of determining an effective total pressure based on the measured airflow rate, static pressure, temperature, and flow area of airflow entering the valve.

\*COMPARABLE LOAD CELL FOR HORIZONTAL LOADS NOT SHOWN

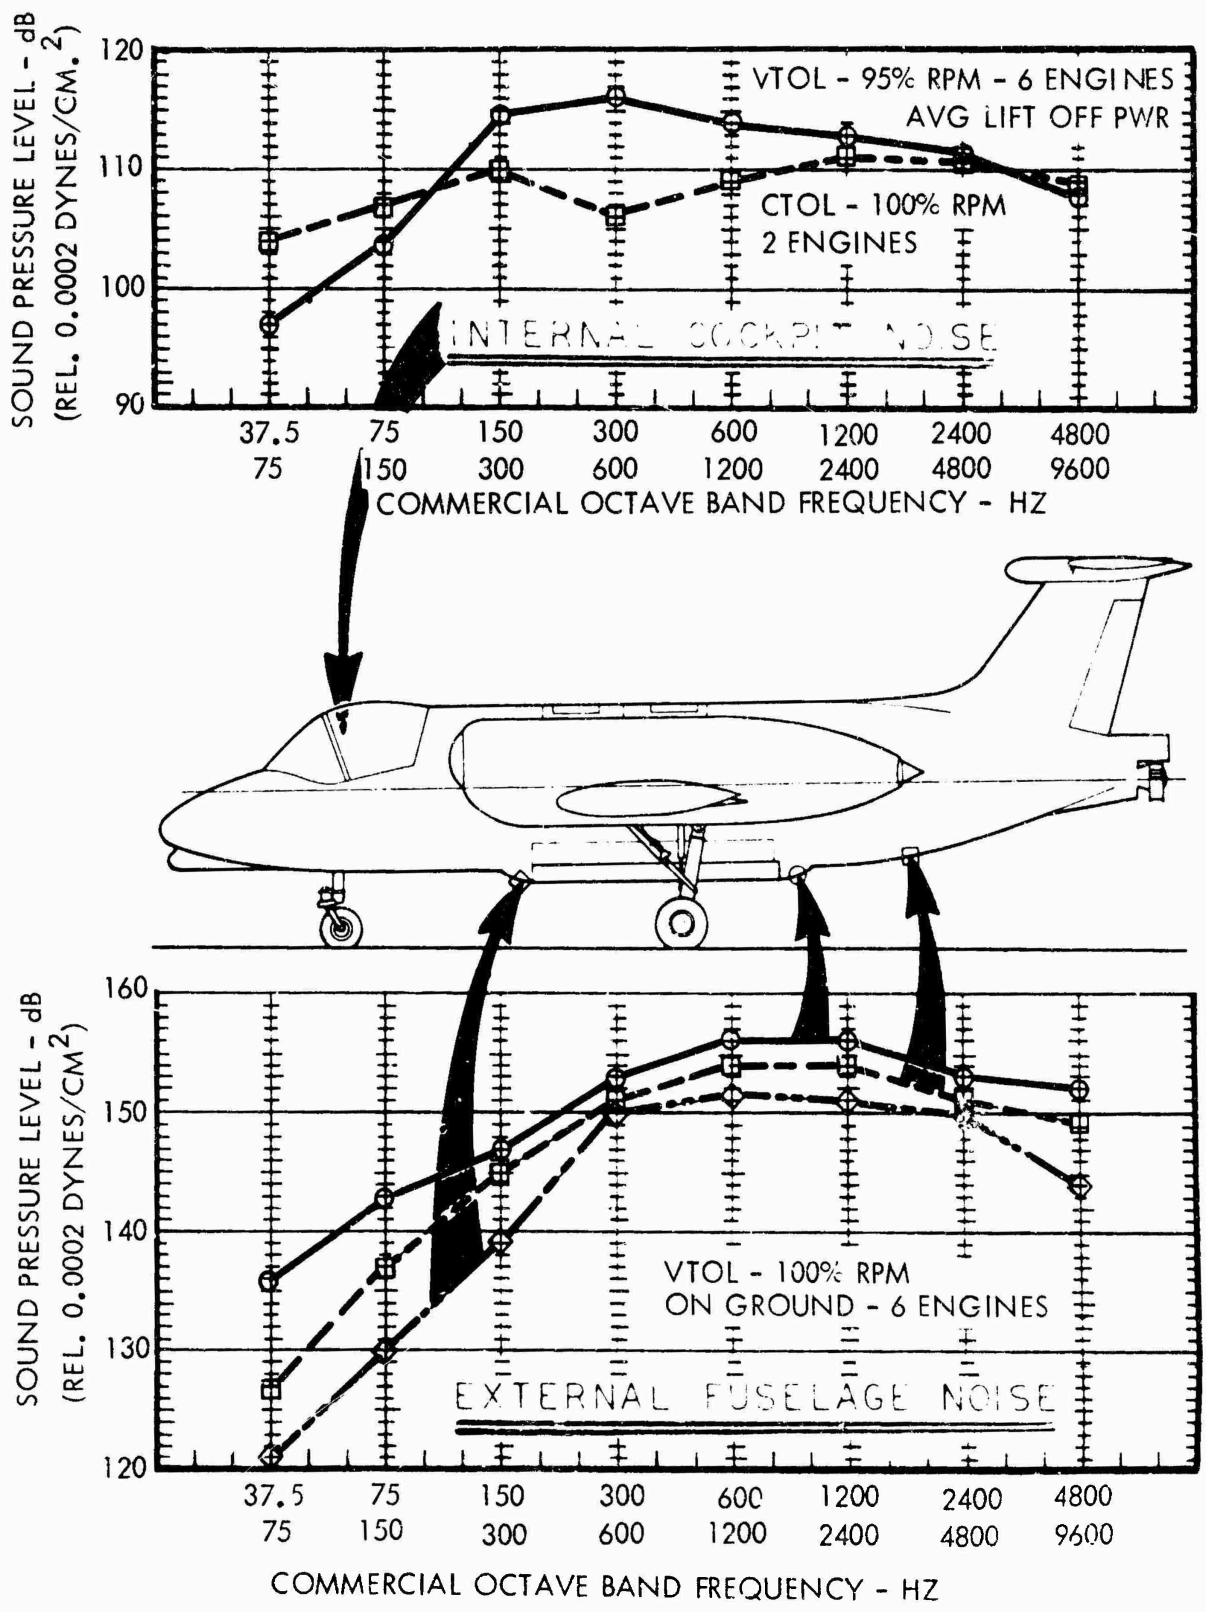
FIGURE 39 - MEASURED NOISE LEVELS
