RDTR NO. 164  
MARCH 1970

# **MK 45 AIRCRAFT PARACHUTE FLARE OPTIMIZATION PROGRAM**

## **EVALUATION OF EXPERIMENTAL PARACHUTES AND PARACHUTE MATERIALS**

**FLIGHT TEST SERIES NO. 2**

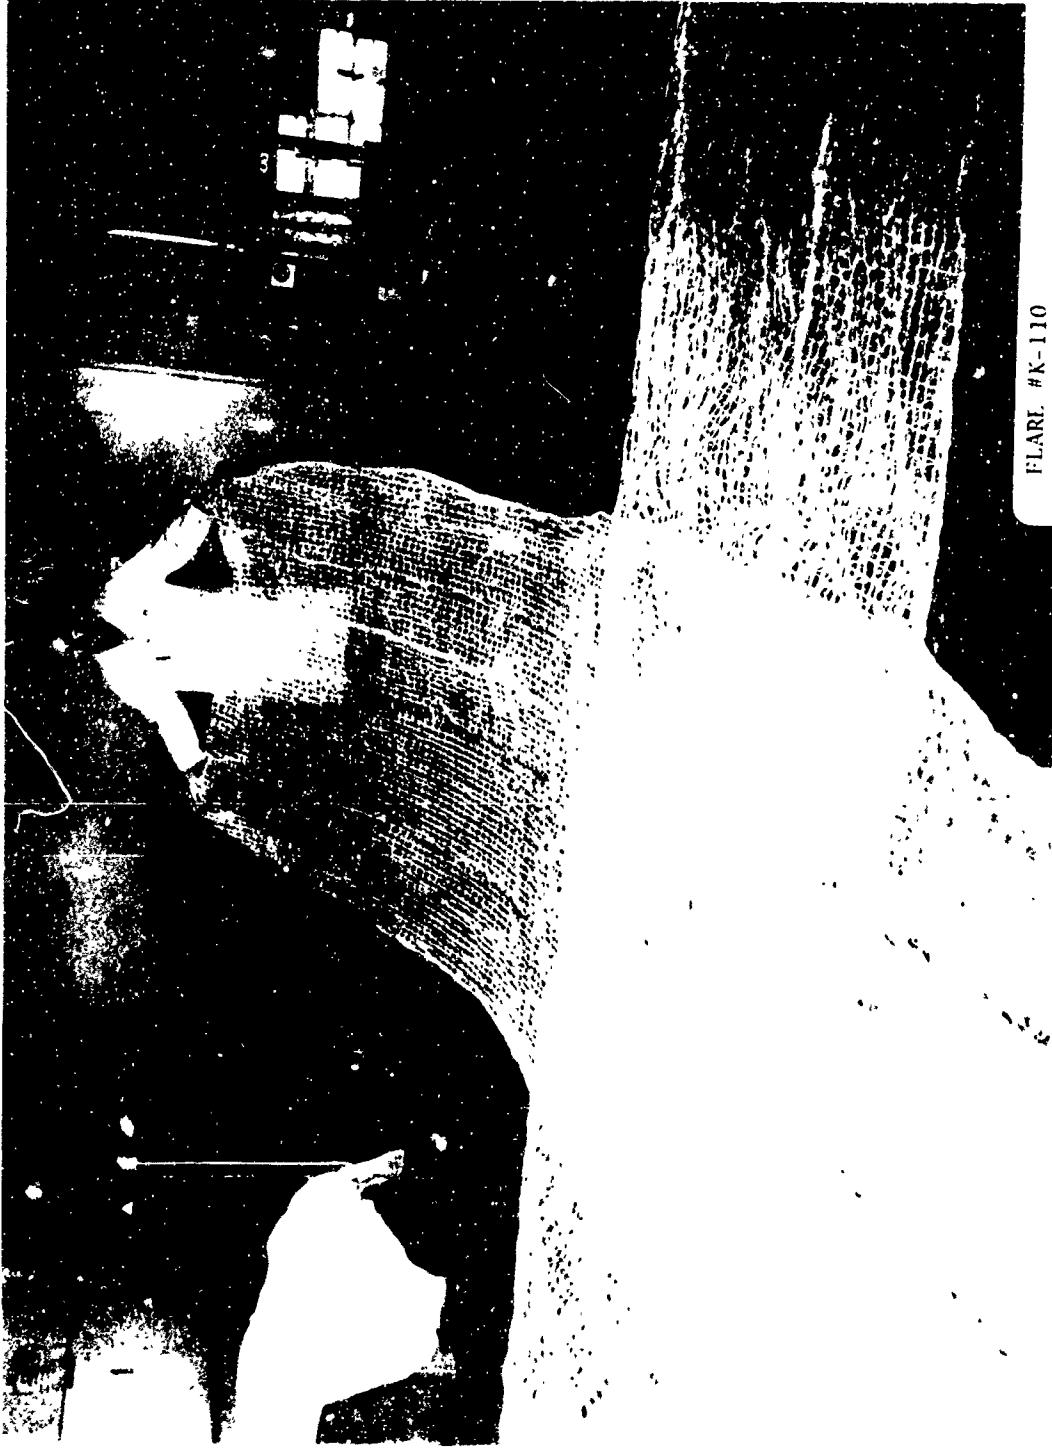
FLARE #K-110  
350 KIAS - 500 FT FUZE SETTING  
CROSS DESIGN WITH MYLAR/DACRON FLARE  
CLOTH  
DEPLOYED AT 220 FT/SEC

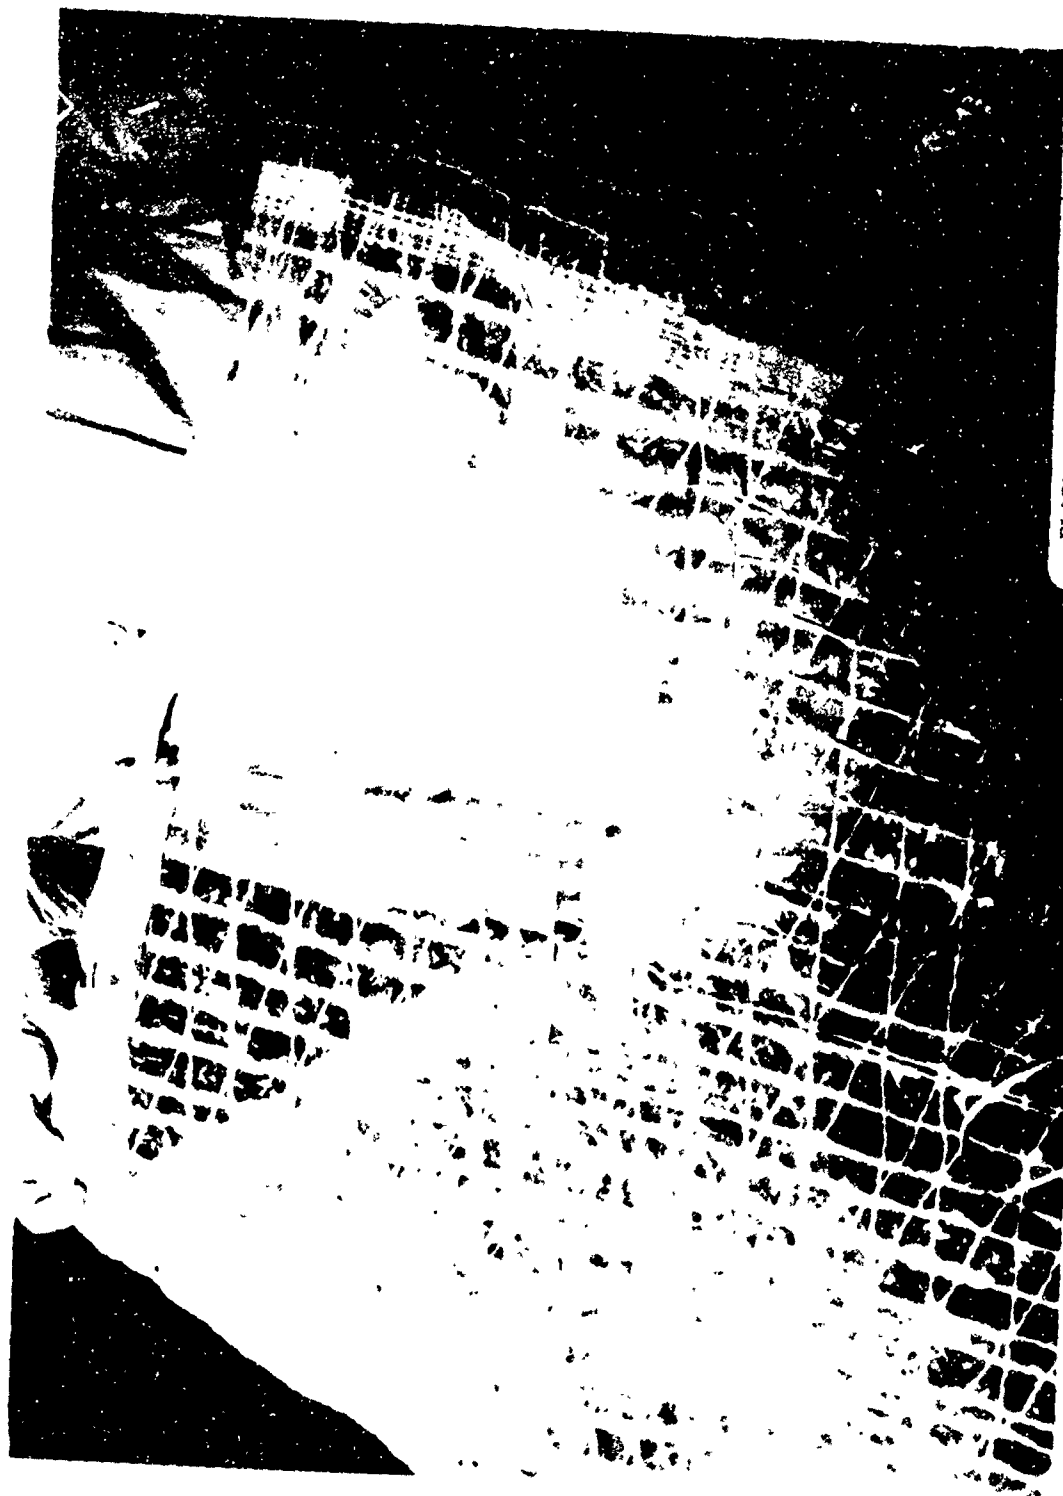
FLARE NO. K-110 - 350 KIAS  
500 FT. FUZE SETTING  
CROSS DESIGN WITH MYLAR/DACRON FLARE  
CLOTH  
DEPLOYED AT 220 FT/SEC

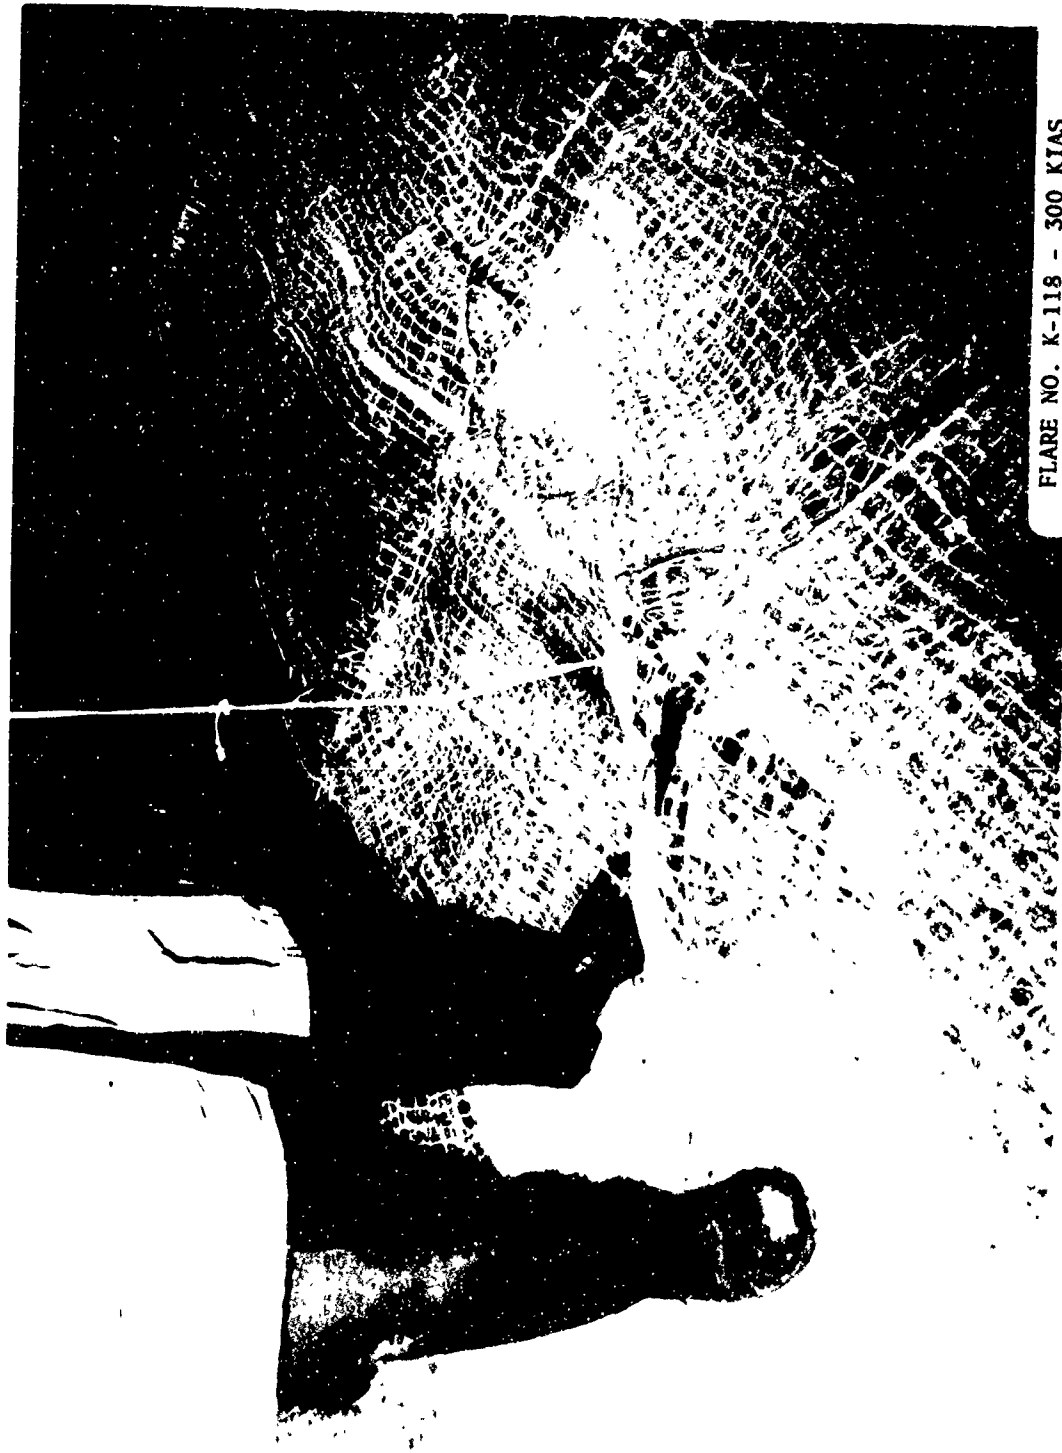
FLARE NO. K-118 - 300 KIAS  
500 FT. FUZE SETTING  
CROSS DESIGN MYLAR/DACRON FLARE CLOTH  
SHOWS DAMAGE WHERE DEPLOYMENT BAG  
IS ATTACHED - DEPLOYED AT 220 FT/SEC

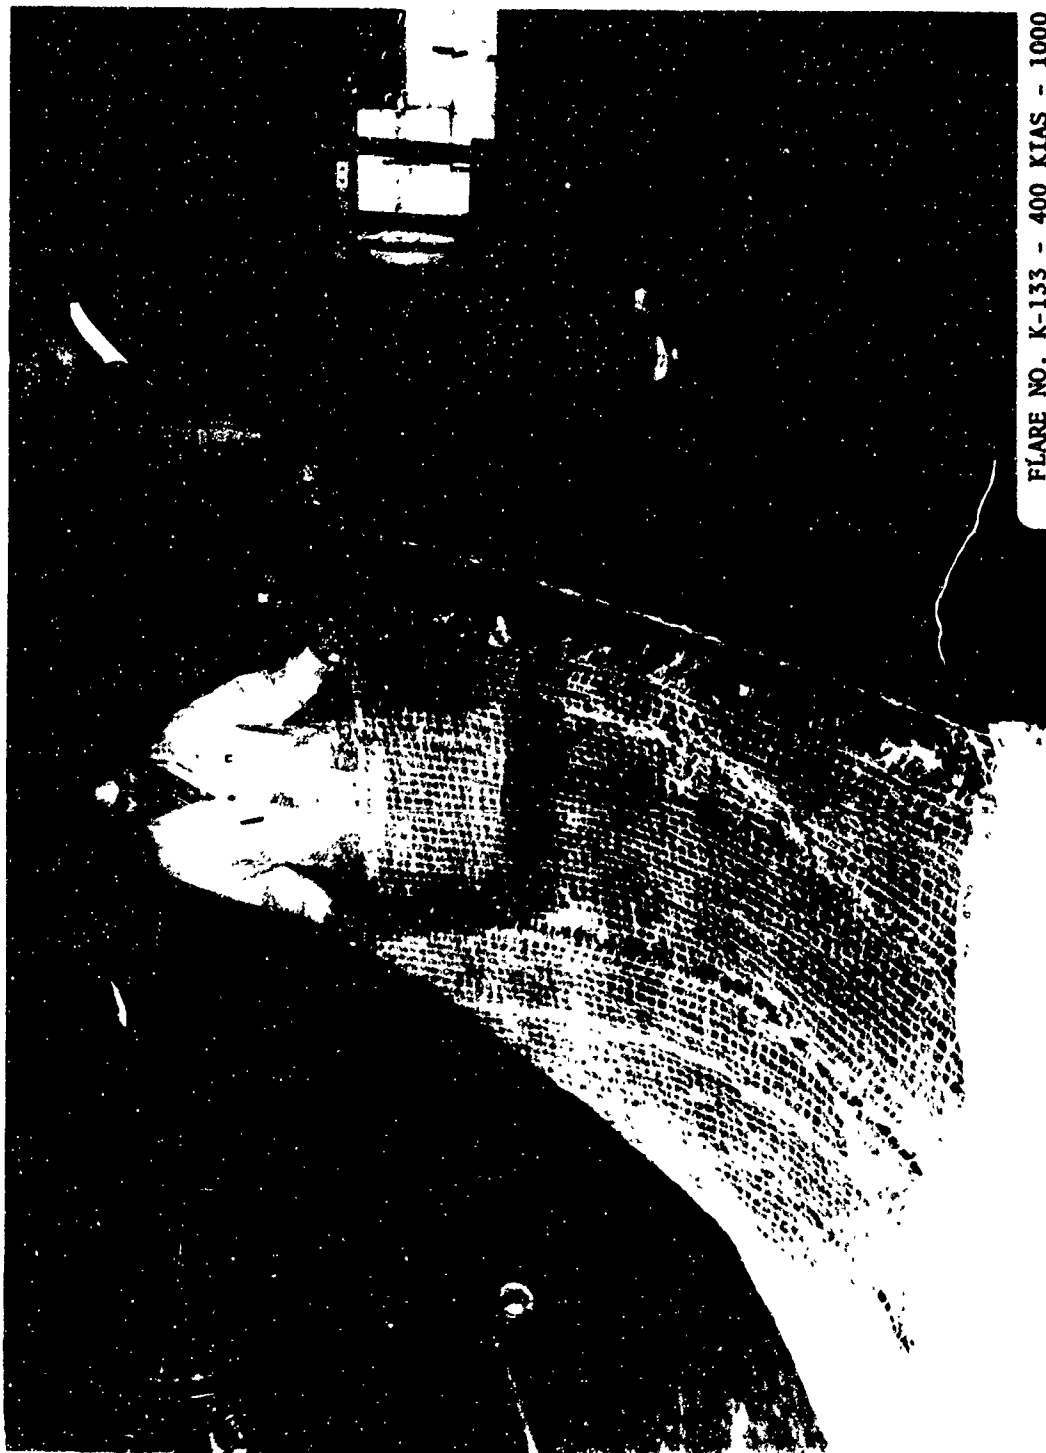
FLARE NO. K-133 - 400 KIAS - 1000 FT.  
FUZE SETTING - CROSS DESIGN MYLAR/  
DACRON FLARE CLOTH - SHOWS TAPE PULLED  
LOOSE & OTHER TAPE DAMAGE TO ONE GORE.  
DEPLOYED AT 210 FT/SEC

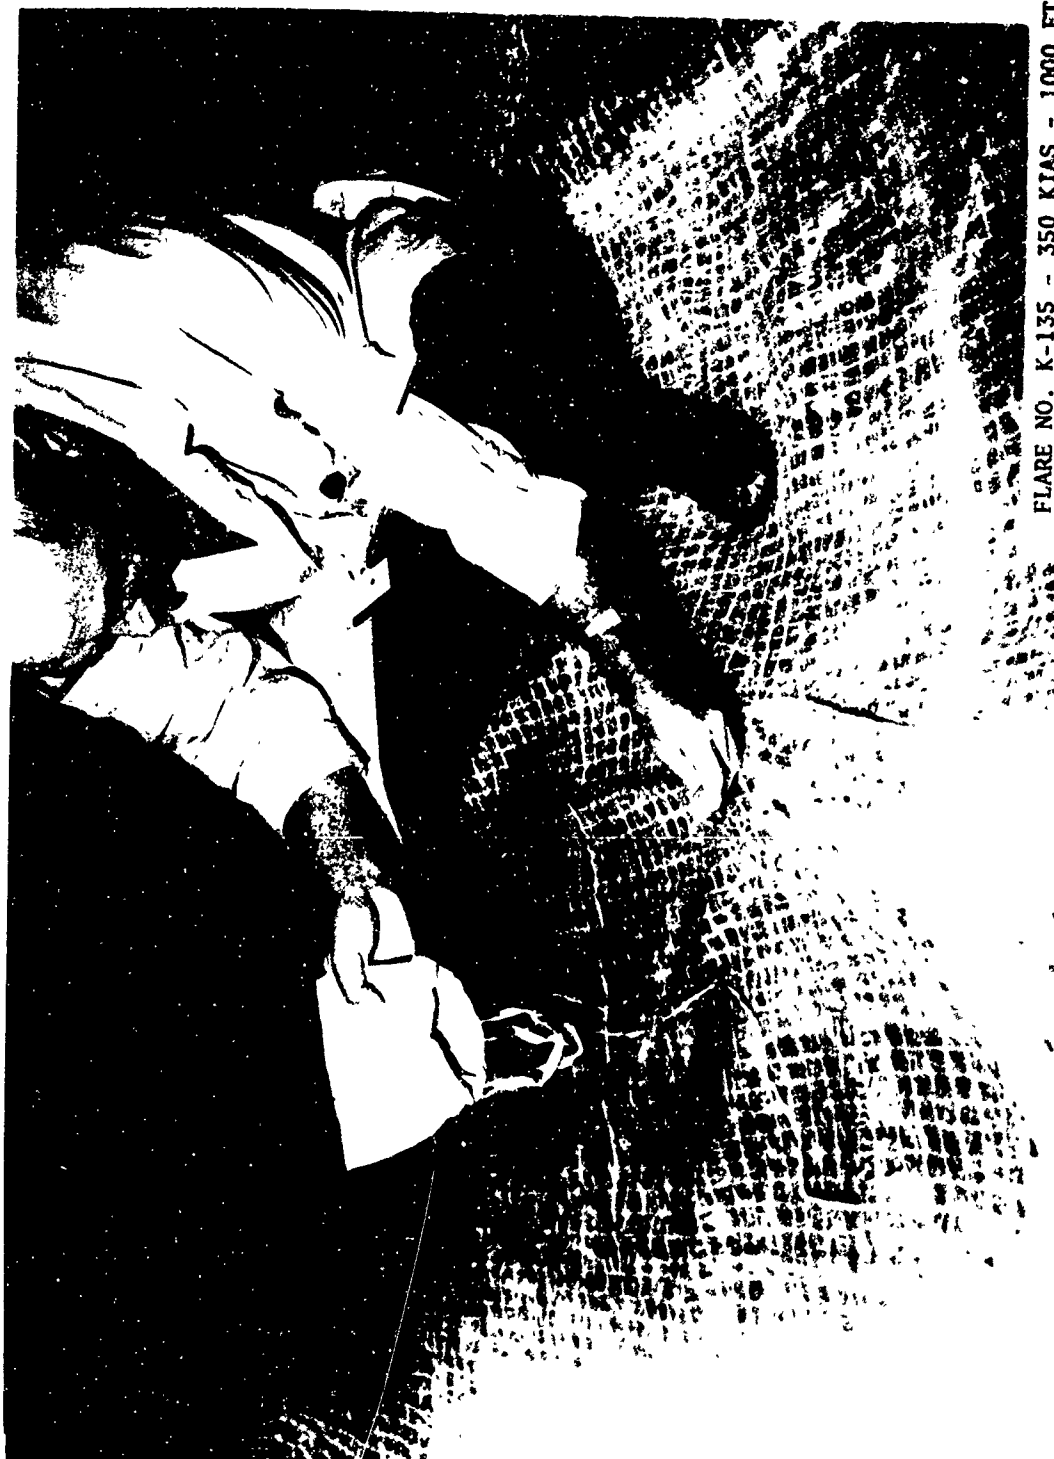
FLARE NO. K-135 - 350 KIAS - 1000 FT  
FUZE SETTING - CROSS DESIGN MYLAR/  
DACRON FLARE CLOTH - SHOWS DAMAGE WHERE  
DEPLOYMENT BAG IS ATTACHED -  
DEPLOYED AT 205 FT/SEC.

| EXPERIMENTAL PARACHUTE TESTS | | | | | | | | | | | |
|---|---|---|---|---|---|---|---|---|---|---|---|
| K-135 | " | " | " | 9.7 | 205 | 10.2 | 10.9 | 175 | 184 | C | Damaged Chute. 150 seconds to impact. |

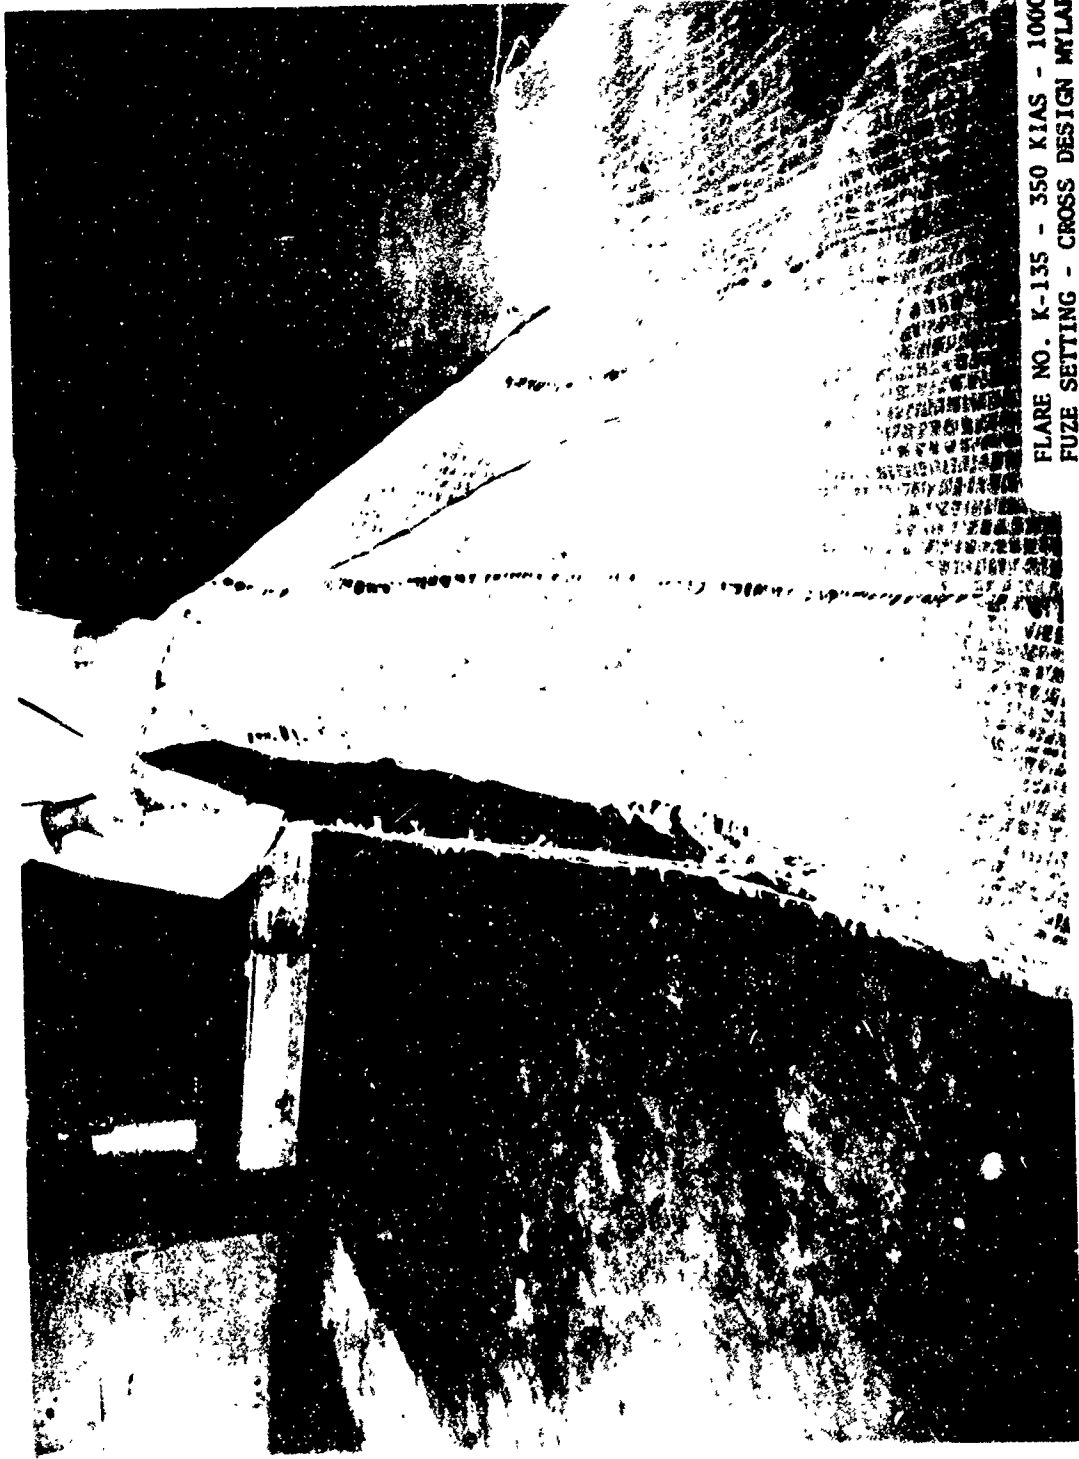
FLARE NO. K-135 - 350 KIAS - 1000 FT.  
FUZE SETTING - CROSS DESIGN MYLAR/  
DACRON MATERIAL - SHOWS WHERE TAPE  
TORE LOOSE ON ONE GORE -  
DEPLOYED AT 205 FT/SEC

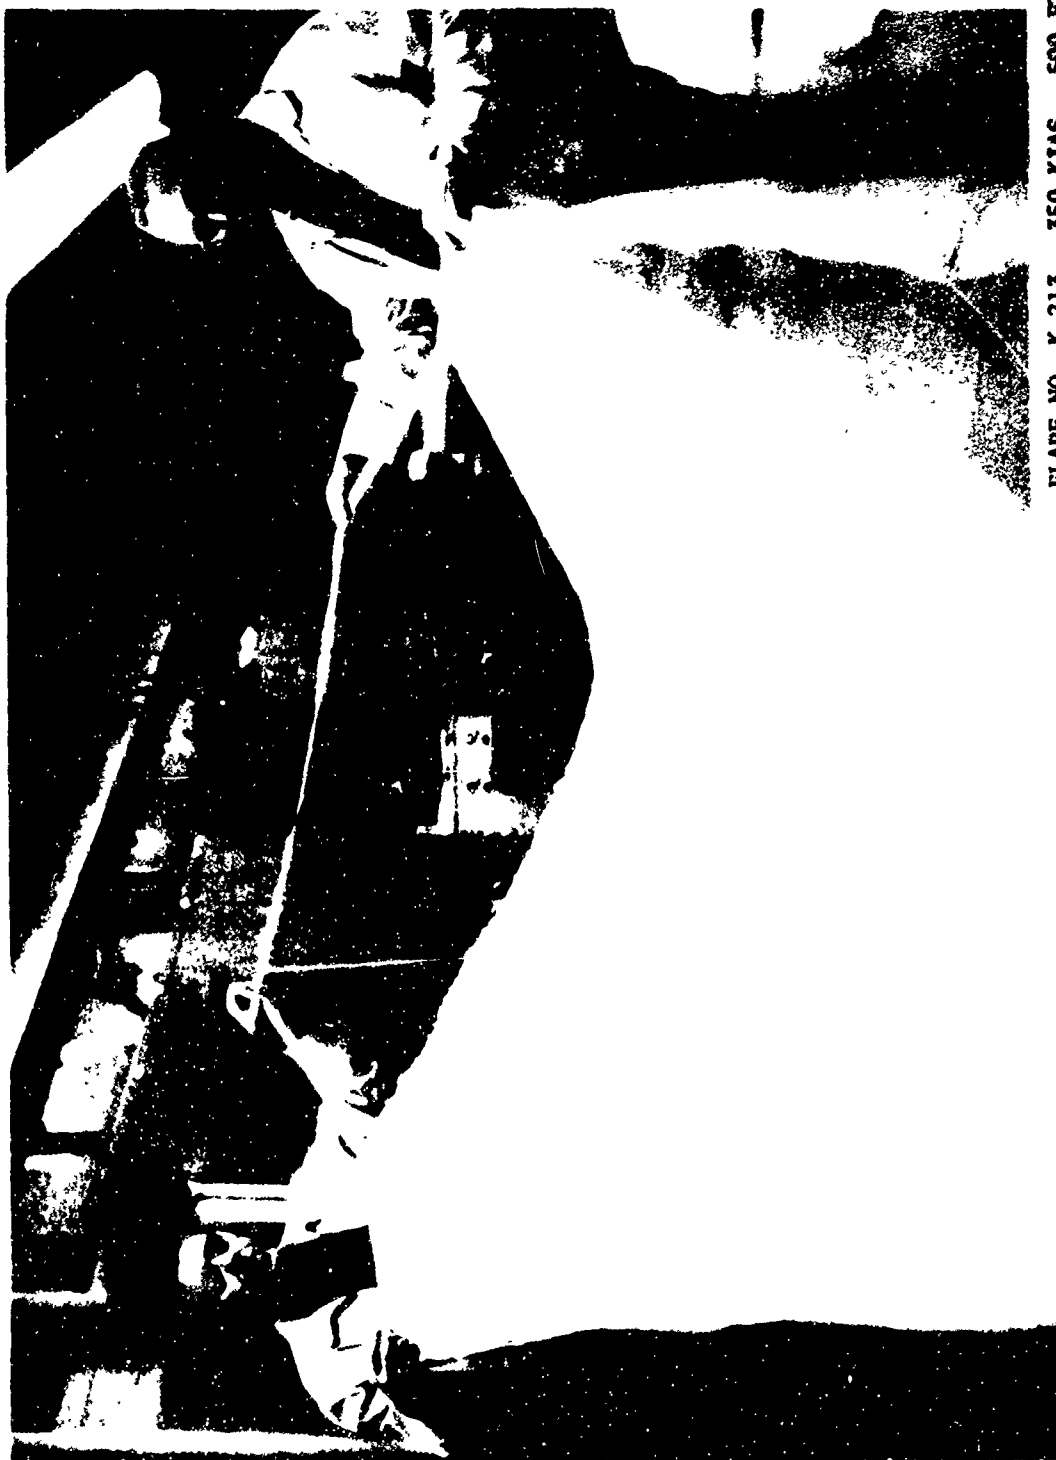
FLARE NO. K-213 - 350 KIAS - 500 FT.  
FUZE SETTING - FLAT CIRCULAR DESIGN  
CEREX FLARE CLOTH - SHOWS DAMAGE TO  
ONE CORE -  
DEPLOYED AT 215 FT/SEC

(c) One flare released at 350 (KIAS) with 500 ft. fuze setting, deployed chute at 195 ft/sec. The cloth on this chute tore about 1 inch above the top stitching in the hem tape, a distance of approximately 4 feet around the periphery of the chute.

(1) A potential strength problem was found in the present MK 45 parachute configuration when the Cerex cloth was substituted for present woven nylon cloth. Although only one chute failure was found, it was at a deployment velocity of only 215 ft/sec. It should be noted that a 350 KIAS aircraft release and a 3.5 sec.

| FLARE TYPE | PUZE SETTING | AIRCRAFT LAUNCH SPEED (KIAS) | PARACHUTE LAUNCH TO EJECTION VELOCITY | LAUNCH TO CHUTE OPENING | IGNITION TO CHUTE DUMP | IGNITION TO CHUTE DUMP | TOTAL BURNING TIME (SEC) | RATE OF DESCENT (AVE) * | REMARKS |
|---|---|---|---|---|---|---|---|---|---|
| K-213 | " | " | 6.4 | 215 | 7.4 | 7.0 | 193 | C | Stable. 4 Ft. Tear in Chute along Bottom Hem Seam. Early Exp. Bolt. Finished Burning on Ground. |

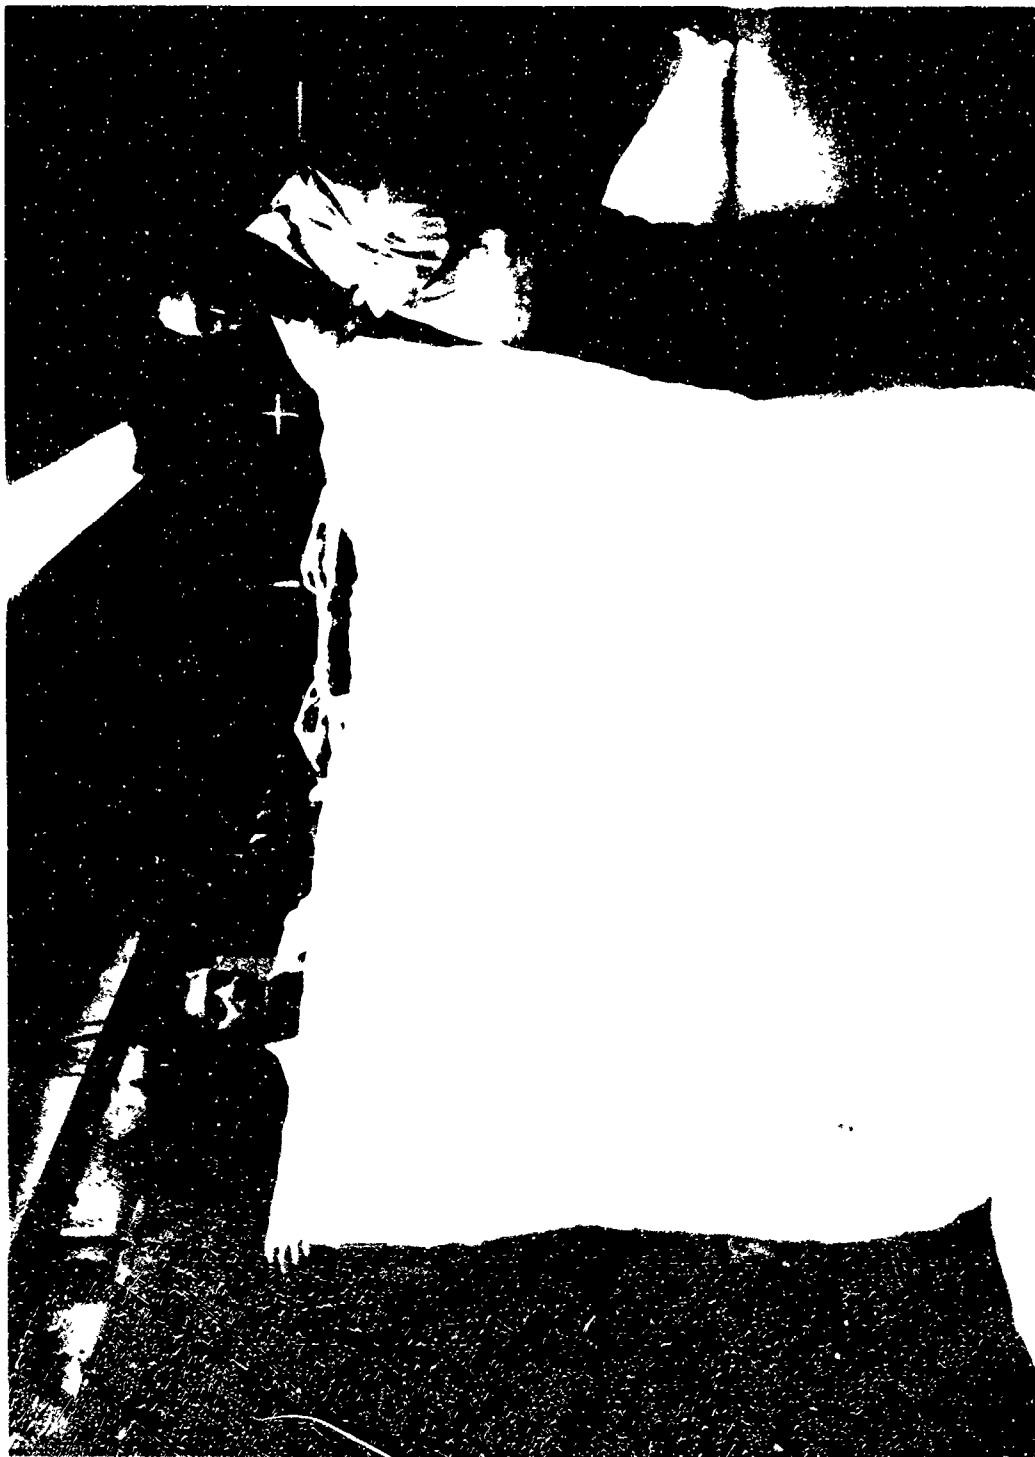
FLARE NO. K-247 - 450 KIAS - 504 FT  
FUZE SETTING - CROSS DESIGN CORDON FLARE  
CLOTH - SHOWS DAMAGE TO ONE GUN -  
DEPLOYED AT 215 FT/SEC

(2) The Cross parachute fabricated of the same Cerex cloth performed very well. Slight damage (hem tears) was found on two chutes which were deployed at 205 and 215 ft/sec. This damage was very minor and it is felt that it is not a problem at present. This chute and material had very good stability  $\pm 5^\circ$  from vertical axis in most cases. This chute exhibited a much slower corrected average descent velocity 5.14 ft/sec vs. 8 ft/sec for the production MK 45 chute, a 36% reduction.

| FLAME TYPE | NO | CHUTE | LAUNCH SPEED (KIAS) | LAUNCH SETTING | LAUNCH ALTITUDE (KIAS) | LAUNCH TO CHUTE VELOCITY | LAUNCH TO CHUTE IGNITION | LAUNCH TO CHUTE OPENING | LAUNCH TO CHUTE DUMP | LAUNCH TO CHUTE BURNING TIME (SEC) | LAUNCH TO CHUTE DESCENT (AVE)* | REMARKS |
|---|---|---|---|---|---|---|---|---|---|---|---|---|
| K-247 | " | " | " | 7.2 | 215 | 8.0 | 8.0 | 197 | 211 | 211 | C | Stable. |
