USAAMRDL TECHNICAL REPORT 71-37

**DESIGN AND EVALUATION
OF ADVANCED HIGH-SPEED FUEL PUMP**

By
Harry T. Johnson

CONTRACT DAAJ02-69-C-0072
BATTELLE
COLUMBUS LABORATORIES
COLUMBUS, OHIO

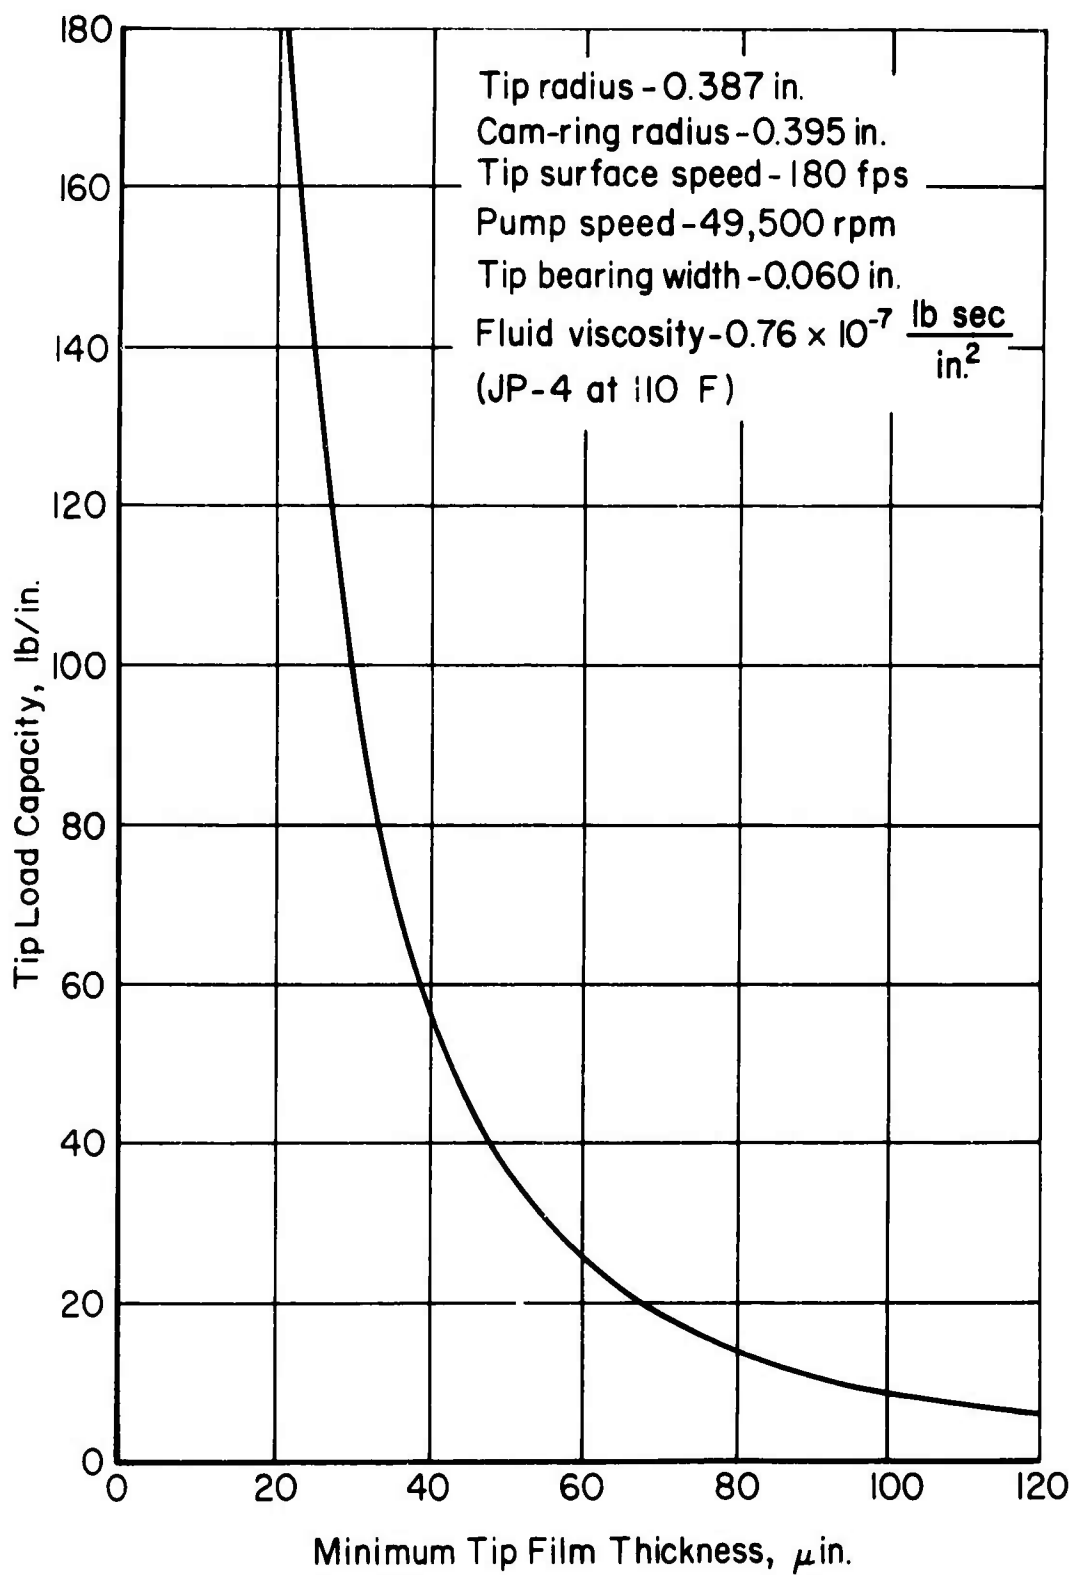
Figure 15. Tip Theoretical Load Capacity at 180 FPS.

The 0.387-inch tip radius and the 0.395-inch cam-ring radius produces a $\delta = 24$ microinches for the fuel-pump tip-bearing design. The resulting theoretical load capacity for a tip surface speed of 180 fps is shown in Figure 15. This bearing design is extremely stiff within the anticipated operating film-thickness range; and a bearing is provided that operates at a nearly constant film thickness over a wide range of loads. This bearing performance is obtained at all angular positions of a vane during the pumping cycle, and it is possible to achieve this condition only because the cam-ring radius of curvature is constant. The minimum theoretical film thickness anticipated for the fuel-pump design was 26 microinches, and it occurs on the inlet port at 49,500 rpm. The bearing load support at this point is 122 lb/in. of bearing length.
