AMMRC TR 71-59

OXIDATION BEHAVIOR OF A
COMPLEX DISILICIDE COATING-
Ta-10W ALLOY SYSTEM AT
TEMPERATURES OF 1700 TO 2700 F

MILTON LEVY and JOSEPH J. FALCO
METALS DIVISION

December 1971

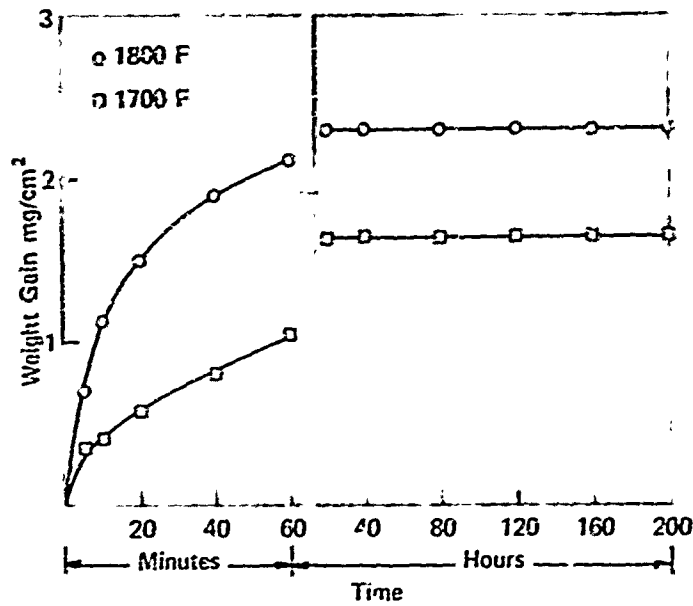
Figure 3. OXIDATION CURVES OF A COATED REFRACTORY ALLOY IN THE TEMPERATURE RANGE OF 1700 F TO 1800 F.

At 1700 to 1800 F, Figure 3, oxidation proceeds parabolically for the first few hours after which it exhibits no further weight gain. This indicates that the protective film formed over the coating during the initial oxidation is maintained throughout the entire run of 200 hours. Figure 4 is a photograph of the coated alloy oxidized at 1700 F for 20 minutes in air. A cracking pattern is observed in the lighter areas. It has been amply demonstrated that large stresses are present in metal-oxide systems during and after oxidation which can

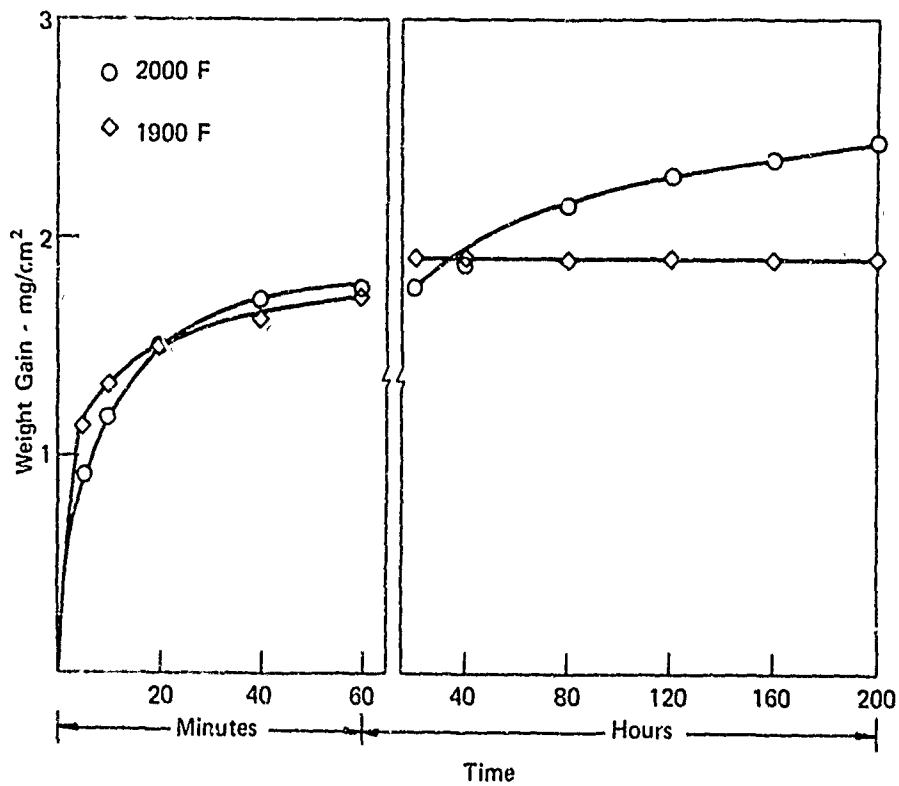
Figure 6. OXIDATION CURVES OF A COATED REFRACTORY ALLOY IN THE TEMPERATURE RANGE OF 1900 F TO 2000 F. 19-066-1023/AMC-71

Figure 6 contains oxidation curves at 1900 and 2000 F where the initial segments of both curves are parabolic followed by linear portions. At 1900 F, the linear portion represents no further weight gain; while at 2000 F, there is an increase in weight. In both cases, complete protection is afforded the substrate alloy for 200 hours.

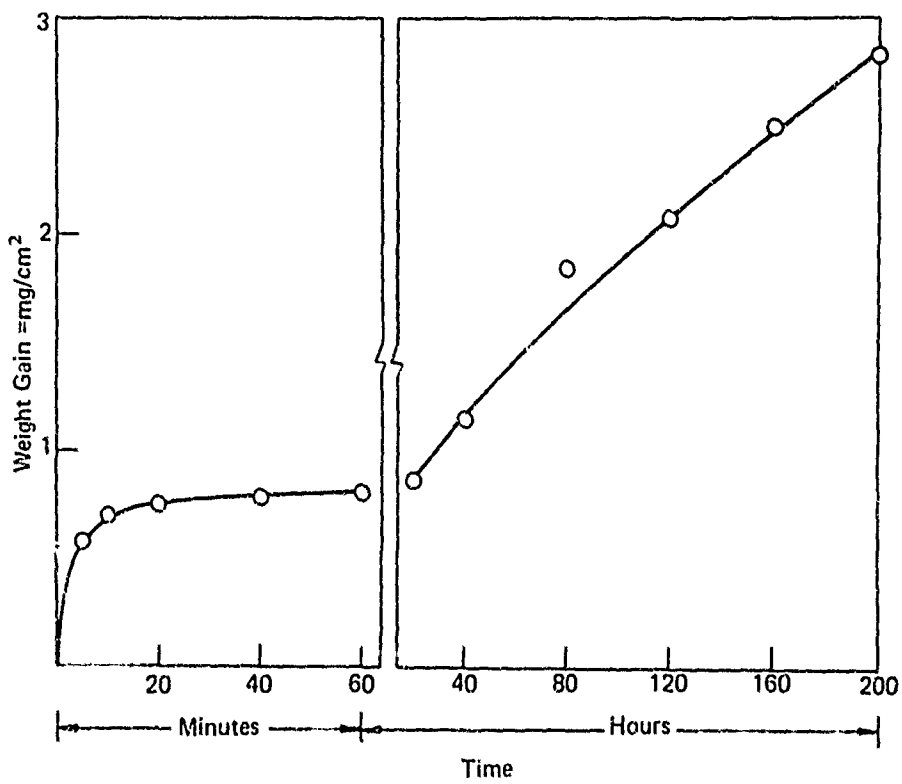
Figure 7. OXIDATION CURVE OF A COATED REFRACTORY ALLOY AT 2100 F. 19-066-1022/AMC071

Figure 7 shows that oxidation at 2100 F follows the parabolic growth law, and complete protection is afforded the substrate alloy by the coating. Some volatilization of oxidation products may be occurring at this temperature since the initial oxidation rate is less than observed at 2000 F. At this temperature (2100 F) the outer protective layer first takes on a glazed appearance. Fitzer's report that disilicide coatings for molybdenum take on this glassy appearance at 2400 F. The lower temperature we report may be due to the complex composition of our coating system. In addition to Mo and Si, the coating contains Ti, V, and W which may lower the melting point of the glassy-like compounds formed and have the beneficial effect of allowing self-healing to take place at lower temperatures. Figure 8 which is a photomicrograph of the coated alloy oxidized at 2100 F along with electron-microprobe analysis shows that the outer glassy layer consists mainly of SiO_2 containing <0.1 wt % Ta, 7.4 wt % W, <0.1 wt % Mo, 1.6 wt % Ti, and 1.9 wt % V in solution (Point A), and small amounts of TiO_2 as a separate phase. This is more readily seen in Figure 9 which magnifies the oxide layer by a factor of 5. Pure SiO_2 (cristobalite) could not be present as a glassy or molten phase at 2100 F since its melting point is 3120 F. X-ray diffraction scans show the presence of an unknown compound which electron microprobe analysis identified as an oxide containing mainly silicon along with the aforementioned elements in much smaller amounts. Note in Figure 8 that the outer protective layer has bridged a crack that has formed in the adjacent porous layer of mixed disilicides (reservoir). There appears to be no significant changes in the reservoir and diffusion layers other than some slight diffusion of tantalum into the reservoir layer (Points 3 and 4). As noted by Points 11, 12, and 13, no diffusion of the coating elements into the substrate Ta-10W alloy was found.

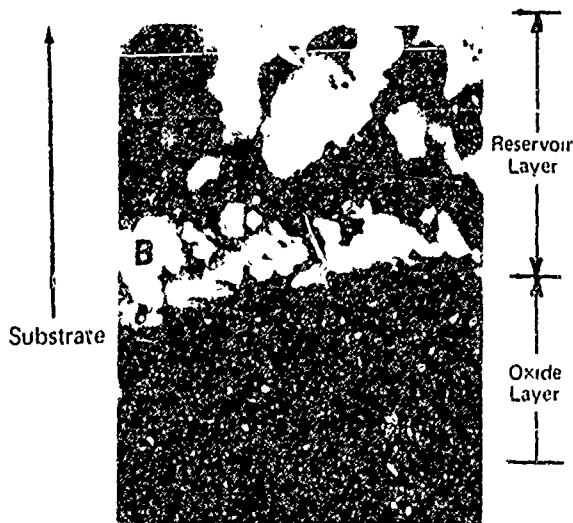
Figure 9. MICROPROBE ANALYSIS OF COATED REFRACTORY ALLOY AFTER 200 HOURS OF AIR OXIDATION AT 2100 F. Mag. 1000X.

Point	Identification	Si	Ta	W	Mo	Ti	V
B	TiO ₂	4.5	0.3	8.7	<0.1	35-40	0.4
C		20-25	<0.1	9.0	<0.1	1.2	<0.1
D	SiO ₂	40-50	0.1	0.9	<0.1	1.4	0.8

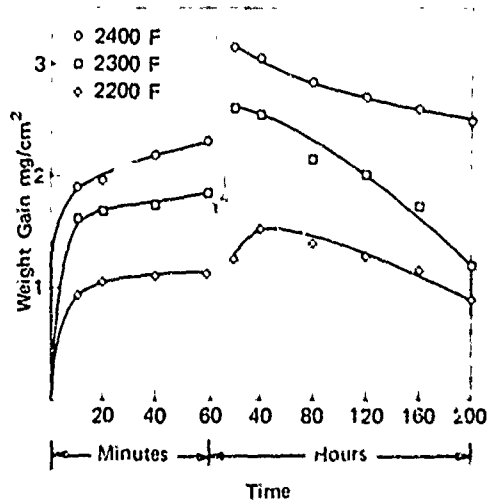
Figure 10. OXIDATION CURVES OF A COATED REFRACTORY ALLOY IN THE TEMPERATURE RANGE OF 2200 F TO 2400 F.

In this temperature range, oxidation rates increase with increasing temperature as shown in Figure 10. At each temperature, after one hour of oxidation, the oxidation rates decrease with time, particularly at 2300 F probably due to volatilization. Spectrographic analysis of the effluent gases, which were passed through a scrubber containing 10% Na OH, showed that silicon was present in fairly large amounts and Mo, W, and V in lesser amounts and Ti in a trace amount. The electron microprobe analysis for the coated alloy oxidized at 2300 F shown

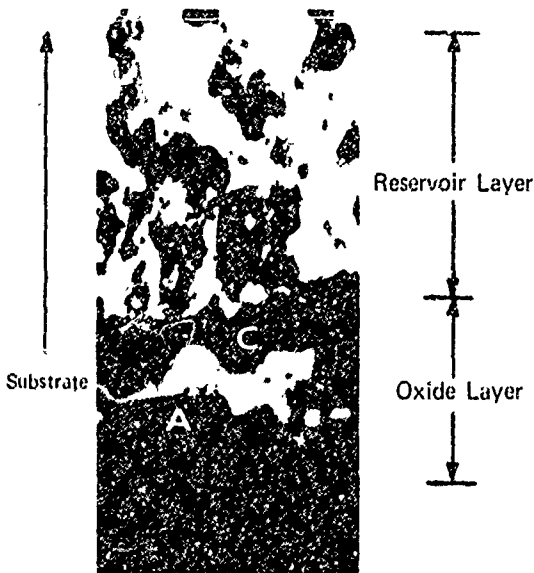
Figure 12. MICROPROBE ANALYSIS OF COATED REFRACTORY ALLOY AFTER 200 HOURS OF AIR OXIDATION AT 2300 F. Mag. 500X.

Point	Identification	Si	Ta	W	Mo	Ti	V	Distance μ
A	SiO ₂	20-25	0.1	3.1	0.1	2.6	0.4	270
B	TiO ₂	1.0	0.3	4.3	0.3	55-60	0.3	265
C	SiO ₂	35-40	0.1	0.1	0.1	2.9	0.1	260

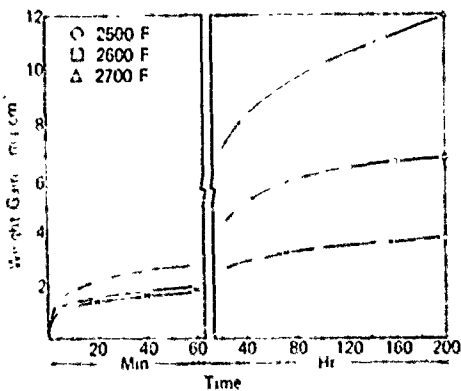
Figure 13. OXIDATION CURVES OF A COATED REFRACTORY ALLOY IN THE TEMPERATURE RANGE OF 2500 F TO 2700 F.

Figure 13 shows that the parabolic rate law still holds in the range 2500 to 2700 F, and oxidation rates increase with increasing temperature. The marked increase in oxidation rate at 2700 F after the first hour indicates that the protective limit of the coating is being approached. However, complete protection was afforded the substrate alloy for the entire run. Some volatilization has probably occurred but is considered to be minor since a net weight gain of 12 mg/cm² at 2700 F is noted. This relatively small change in weight again attests to the excellent protective properties of the coating system.

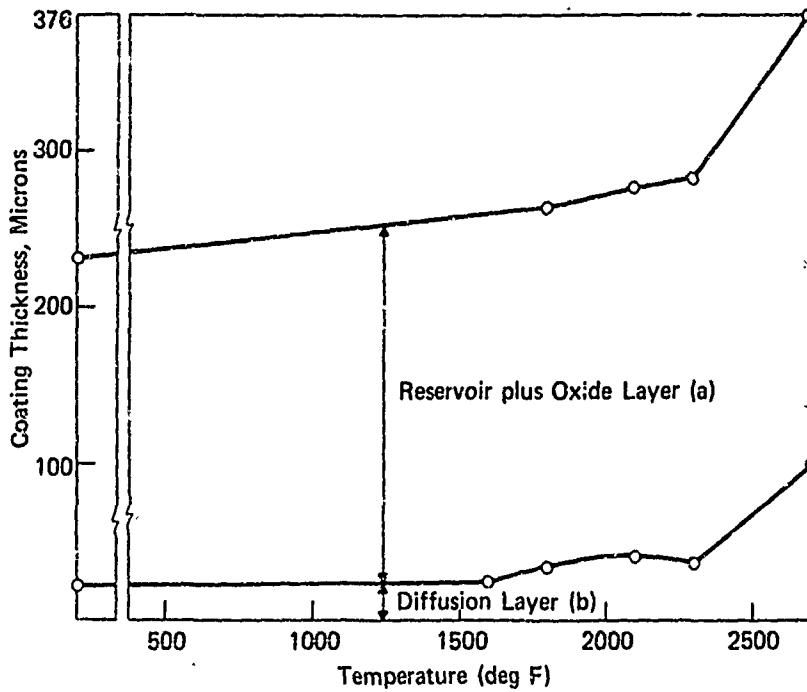
Figure 16. CHANGE OF COATING THICKNESS WITH TEMPERATURE.
19-066-943/AMC-71

reservoir (porous) and outer protective layers vary with temperature after 200 hours of oxidation. Both coating layers generally increase in thickness with increasing temperatures, particularly above 2300 F.

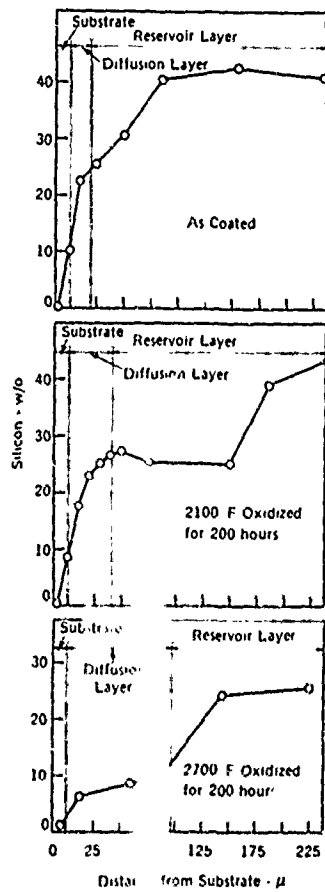
Figure 17. DIFFUSION OF SILICON IN THE COATING SYSTEM
19-066-1020/AMC-71

Figure 17, the plot for silicon, shows that the silicon concentration decreases in both reservoir layer and diffusion layer and at the interface between substrate and diffusion layer as the coated alloy is oxidized at 2100 and 2700 F. Some silicon has penetrated into the substrate alloy at 2700 F.

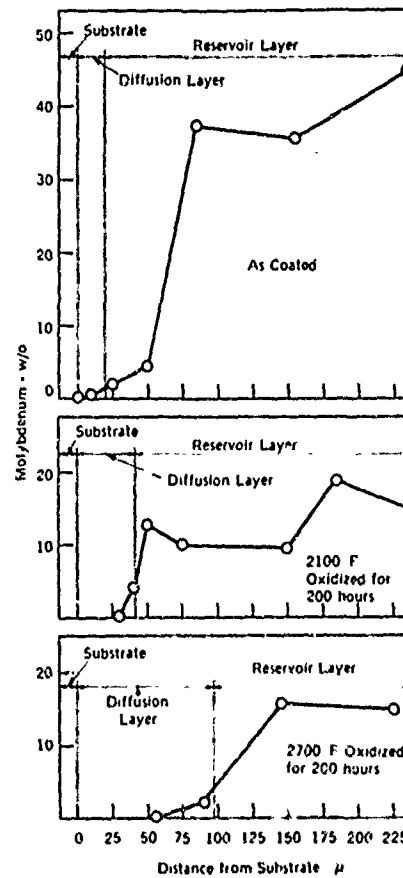
Figure 18. DIFFUSION OF MOLYBDENUM IN THE COATING SYSTEM
19-066-1019/AMC-71

The molybdenum plot, Figure 18, shows that molybdenum concentrations as high as 45 wt % were present in the as-coated condition in the reservoir layer. After oxidation, the molybdenum concentration increased markedly in the reservoir layer. There was little effect in the diffusion layer where the molybdenum concentration was low, and none was present at the interface of substrate and diffusion layer.

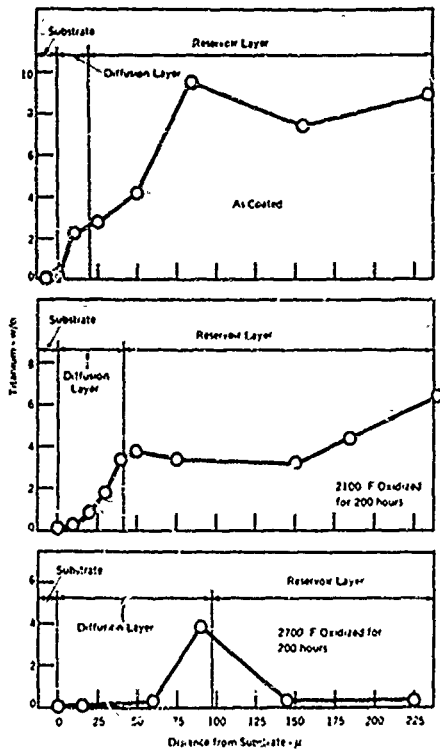
Figure 19. DIFFUSION OF TITANIUM IN THE COATING SYSTEM

Titanium also decreases significantly in the reservoir layer as a result of oxidation (see Figure 19). There was a slight increase of titanium in the diffusion layer and only very small amounts were present at the substrate-diffusion layer interface. At 2700 F, the titanium clusters at the interface between the diffusion and reservoir layers. Figure 20 shows that vanadium behaved similarly to titanium.

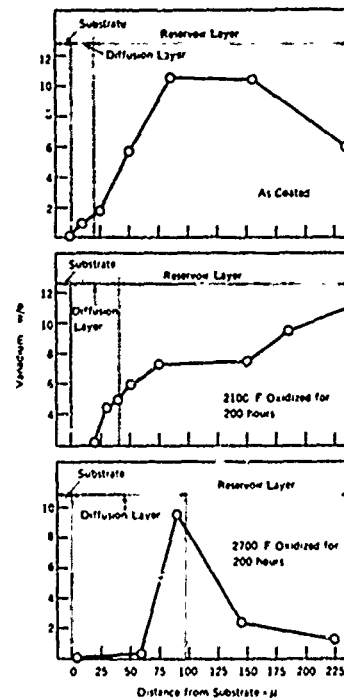
Figure 20. DIFFUSION OF VANADIUM IN THE COATING SYSTEM

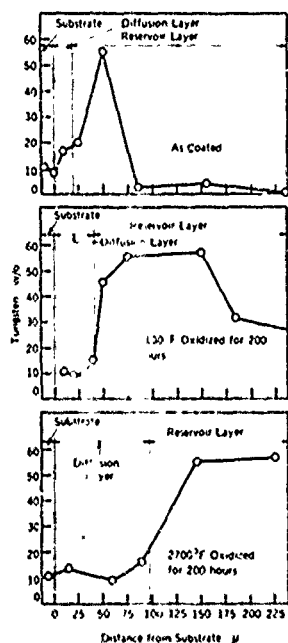
Figure 21. DIFFUSION OF TUNGSTEN IN THE COATING SYSTEM

In the as-coated condition, tungsten is concentrated in the reservoir layer close to the diffusion layer, also in the diffusion layer and, of course, it constitutes 10% of the substrate alloy (see Figure 21). Oxidation causes the tungsten to be more uniformly dispersed in the reservoir layer (55%), while the amount of tungsten in the diffusion layer decreases. Therefore, tungsten is diffusing from the diffusion layer into and throughout the reservoir layer.

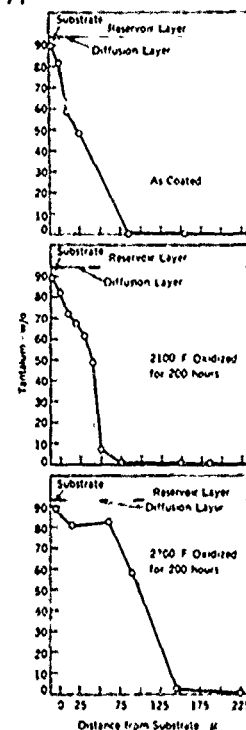
Figure 22. DIFFUSION OF TANTALUM IN THE COATING SYSTEM

Figure 22 shows that tantalum, in the as-coated and under oxidizing conditions clusters mainly at the substrate/diffusion layer interface, and in the diffusion layer. At 2700 F, there is some diffusion of tantalum (0.9 wt %) up to 225 μ from the substrate into the reservoir layer. Diffusion of tantalum from the substrate into the diffusion layer contributes to the broadening of the diffusion layer noted at 2700 F.

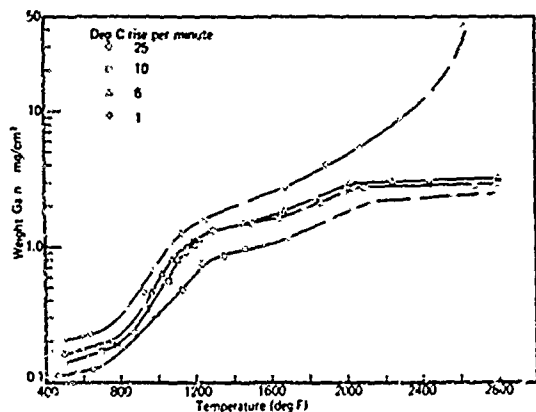
Figure 23. EFFECT OF HEATING RATES ON THE OXIDATION OF A COATED REFRACTORY ALLOY FROM ROOM TEMPERATURE TO 2800 F.
19-066-176/AMC-70

Since we reported¹ that the complex disilicide coatings are susceptible to pesting in the temperature range 1400 to 1600 F it seemed advisable to establish the minimum heating rate at which the coating could safely traverse the pesting range without deleterious effects. Accordingly, oxidation runs were made at heating rates of 1, 6, 10, and 25 C rise per minute from ambient to 2800 F. The results were plotted in Figure 23. Failure of the coating occurred only at the slowest heating rate of 1 C rise/minute. In the temperature range 800 to 1300 F where the slope of the curves is greatest, low temperature oxides are forming, whereas high temperature oxides are forming between 1500 and 2100 F. Since the exposure time is longer at a 1 C rise/minute heating rate at a given temperature, the opportunity for the formation of the lower temperature oxides is optimized, but failure occurs due to pesting. Therefore, higher temperature oxides must be present to alleviate pesting. Although high temperature oxides have formed to some extent during this run, it appears that damage to the intercrystalline structure of the coating during its exposure in the pesting range has progressed beyond the point where self-healing by the high temperature oxides formed can repair the damage.

High temperature oxides are completely formed at 2100 F, suggesting that this would be the most advantageous temperature to preoxidize the coating system before subjecting it to peasting temperatures. A coated specimen which was preoxidized at 2100 F for 5 hours and then subjected to peasting conditions afforded excellent protection for 200 hours. After 200 hours of oxidation, the coating had a uniform glazed appearance which is preferred over the specimen preoxidation treatment at 1900 F reported previously by the authors.
