EXPERIMENTAL INVESTIGATIONS OF A  
FIN PROTUBERANCE PARTIALLY IMMERSED  
IN A TURBULENT BOUNDARY LAYER AT MACH 5

Naval Ordnance Laboratory  
Silver Spring, Maryland

NOLTR 72-33

21 January 1972

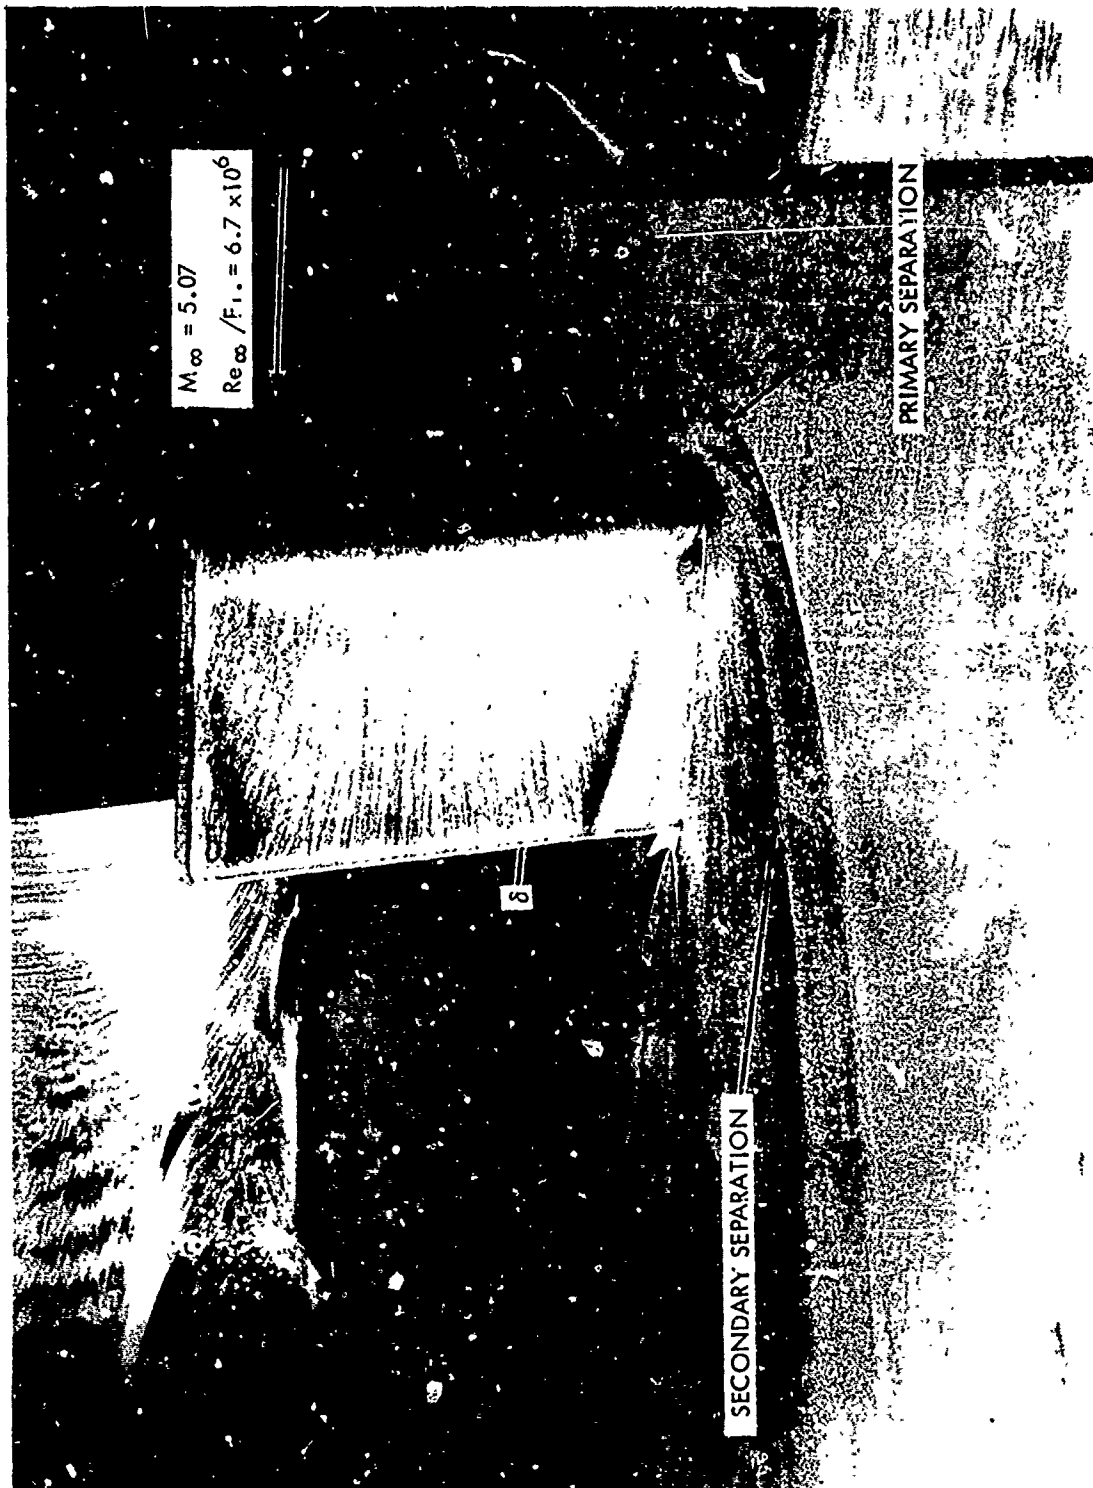
FIG. 9 OIL SMEAR TEST IN SUPERSONIC TUNNEL NO. 2

Several runs were made in Tunnel No. 2 in an attempt to obtain higher quality Schlieren photographs than were originally obtained in the first phase of work in the Boundary Layer Channel (reference 5). To check the two-dimensionality of the flow on the flat plate, one test was conducted using the oil smear technique with the aluminum flat plate painted black for better contrast. A photograph taken during the test (Figure 9) shows the flow patterns as found in the earlier tests in the Boundary Layer Channel. Initial or primary flow separation upstream of the fin is apparent as the sharp oil ridge developed on the flat plate. A more subtle line marks the point of so-called secondary separation. A region of very high shear is indicated on the flat plate immediately upstream of the leading edge of the fin as well as on the very bottom leading edge of the fin (by the fact that nearly all of the oil has been swept away). This region was shown in reference 5 to experience the maximum heating on the flat plate. The regions of oil accumulation on the fin within the boundary layer (the edge of which is indicated in Figure 9) is associated with vortices which exist in the fin-flat

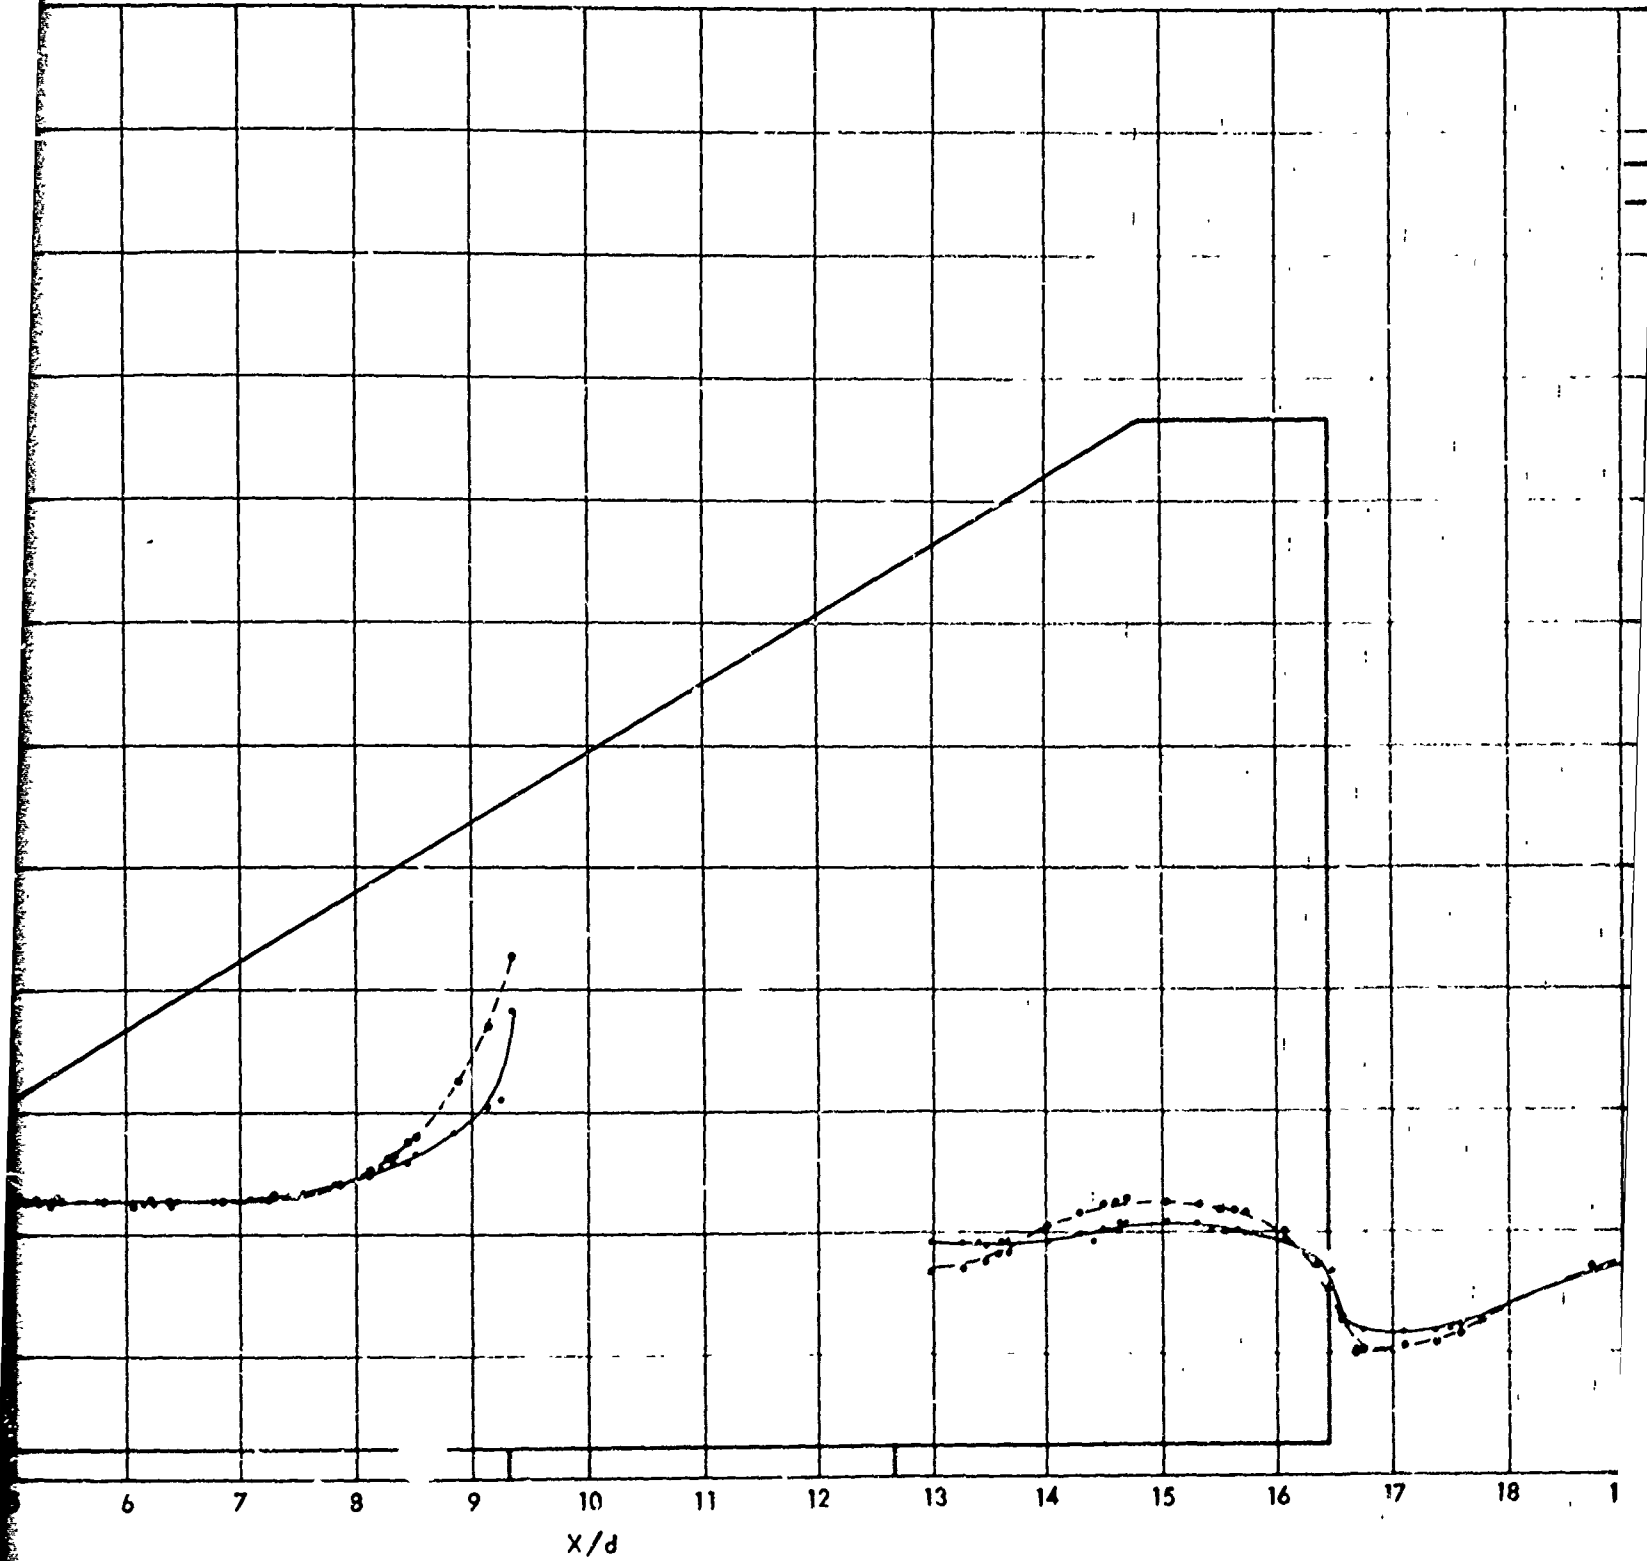
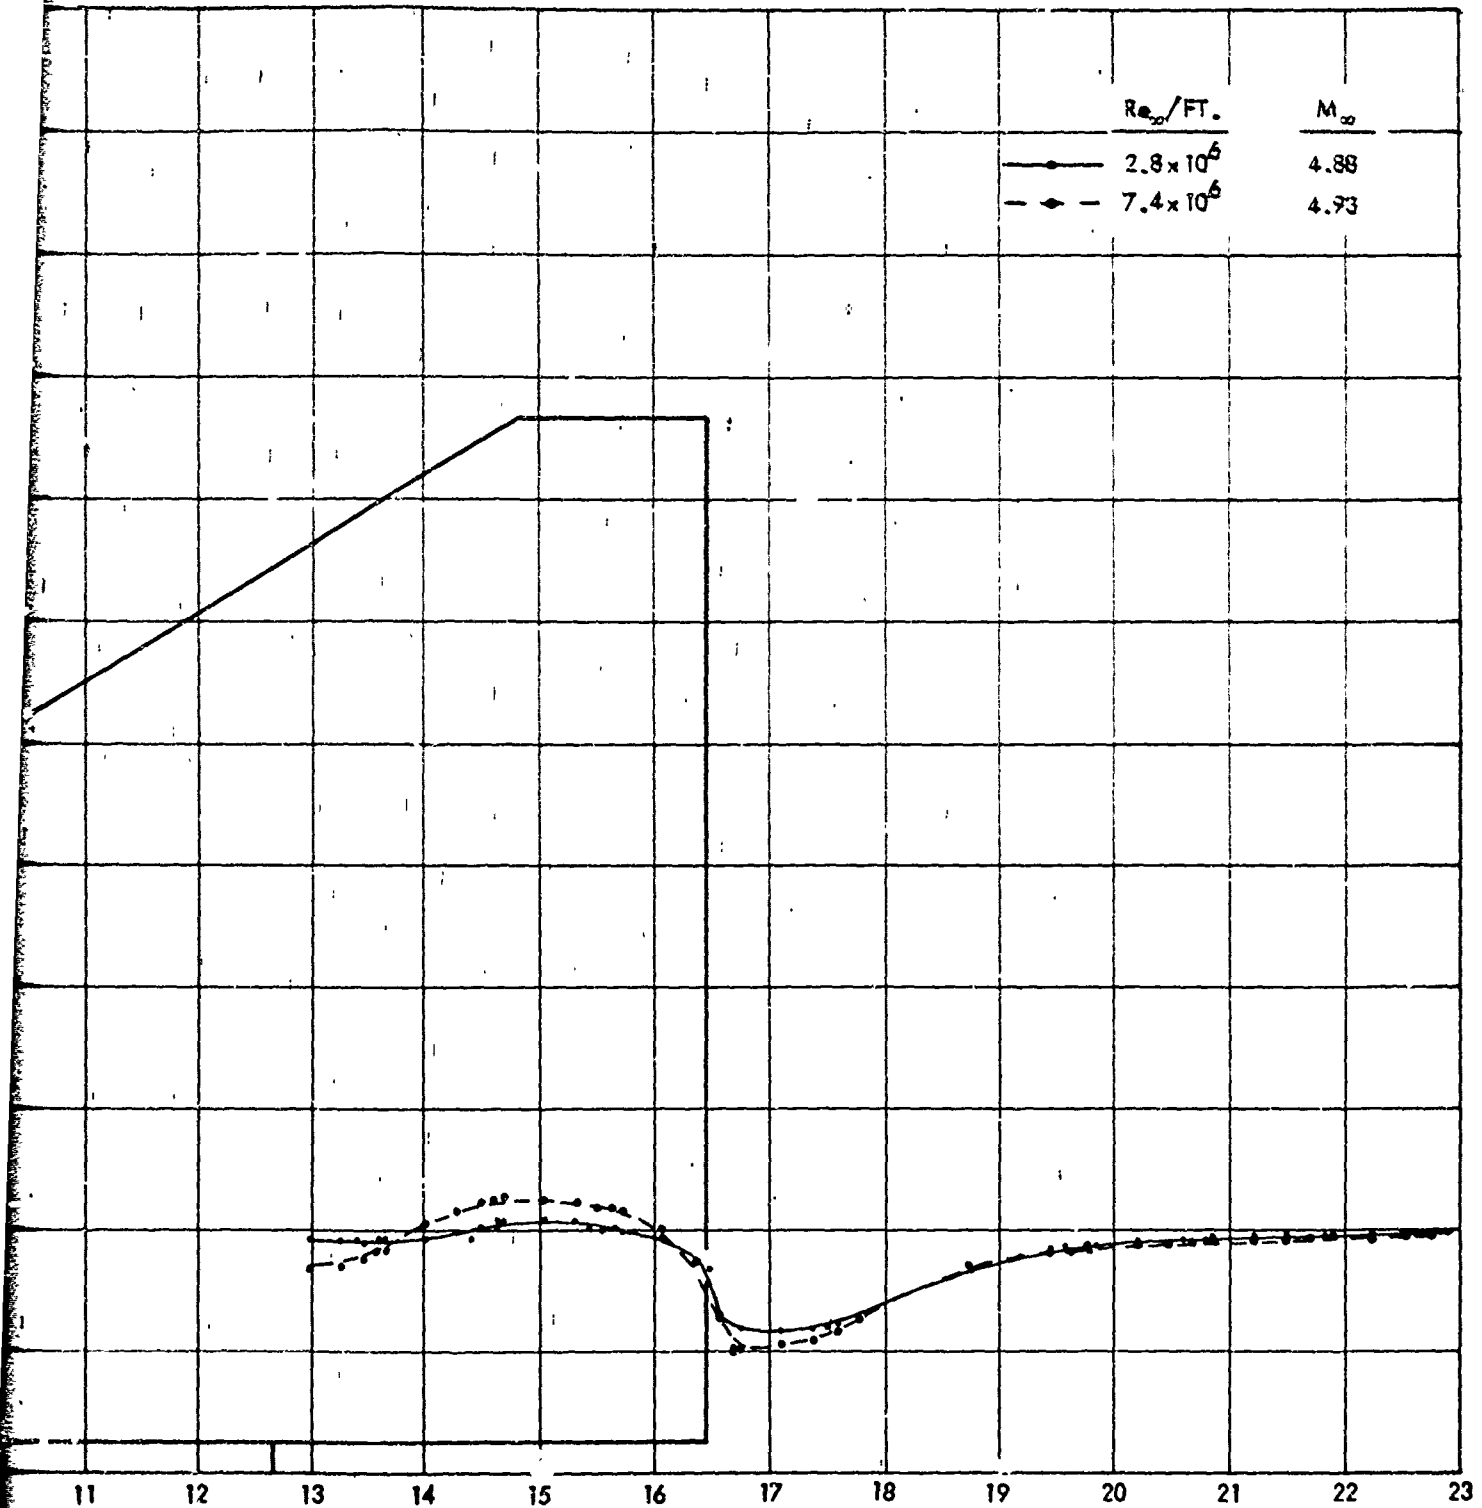
FIG. 16 B 60° SWEPT FIN WITH 0.125 INCH CLEARANCE GAP

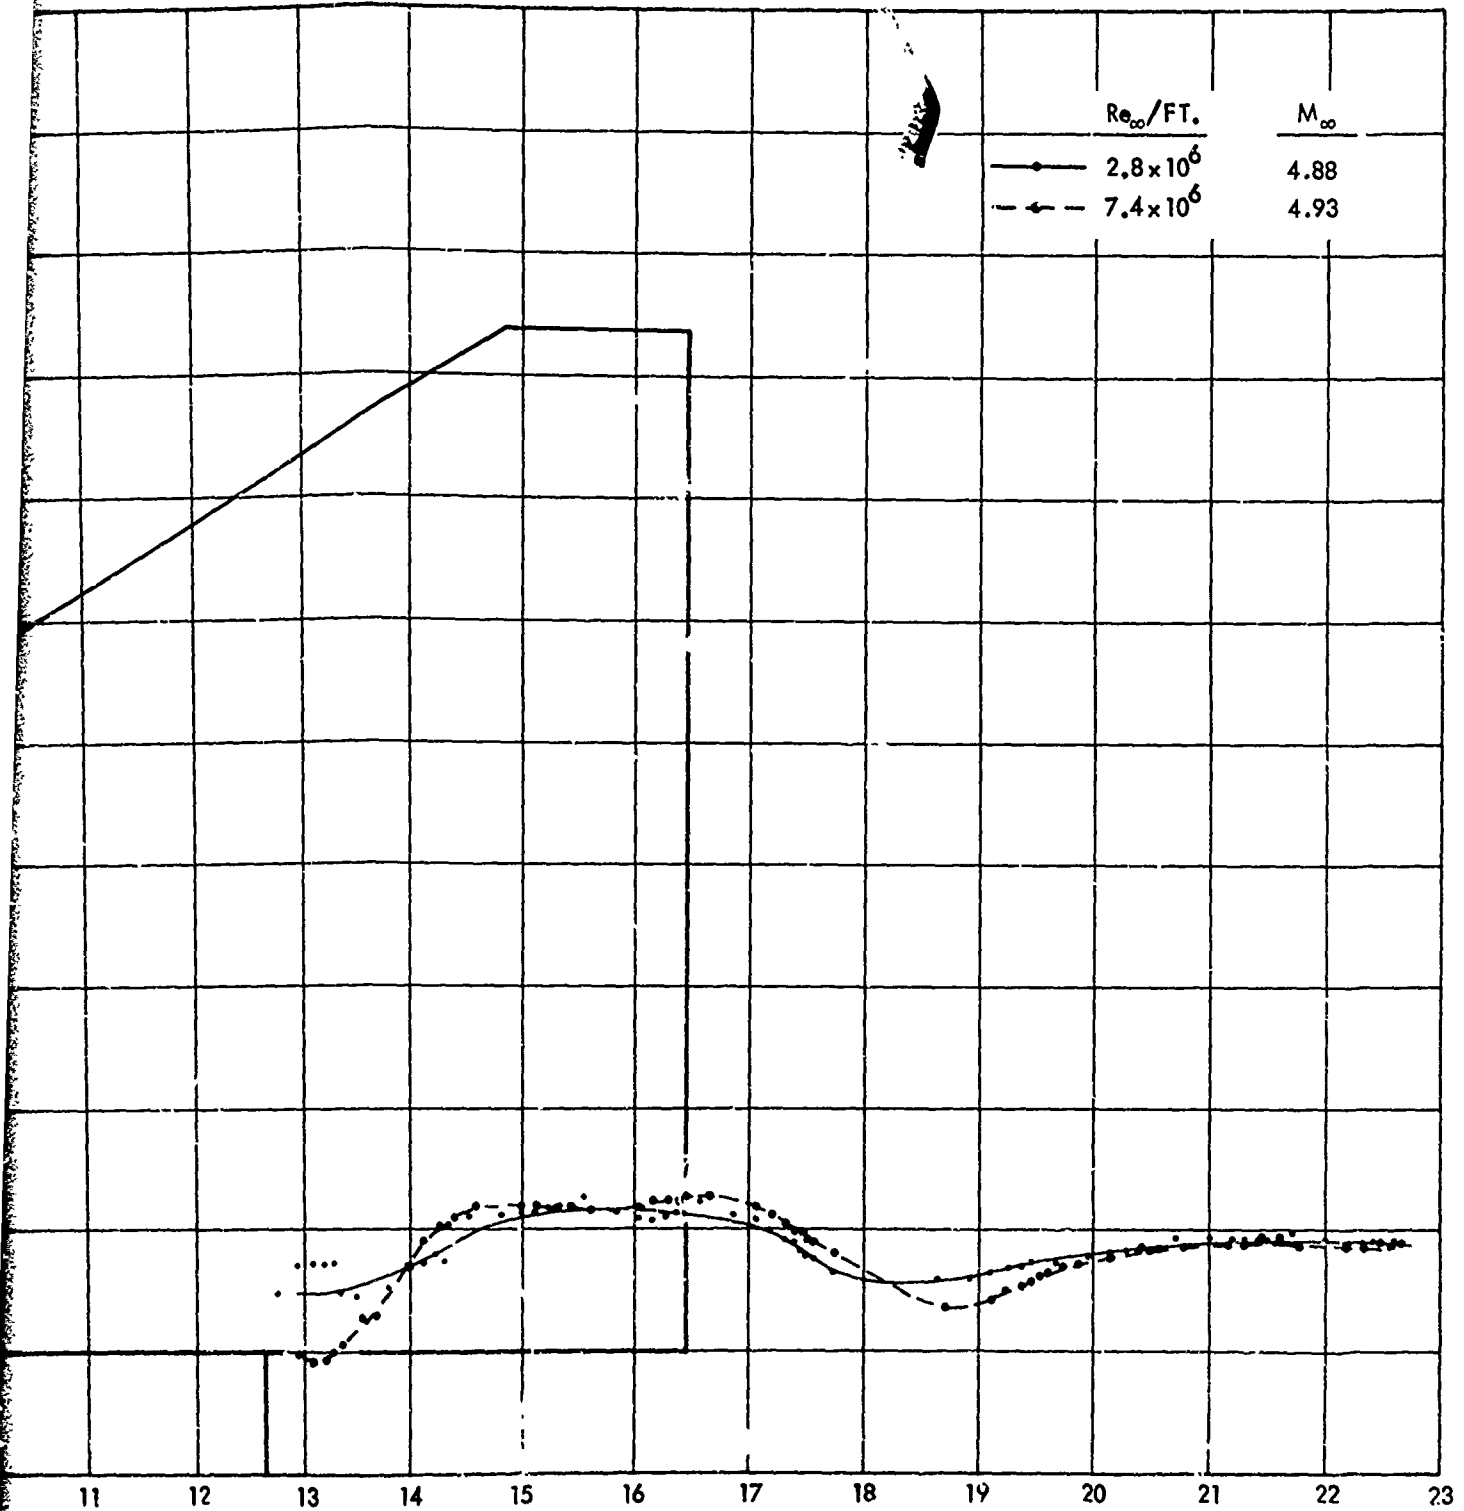
FIG. 16D  $60^{\circ}$  SWEPT FIN WITH 0.50 INCH CLEARANCE GAP

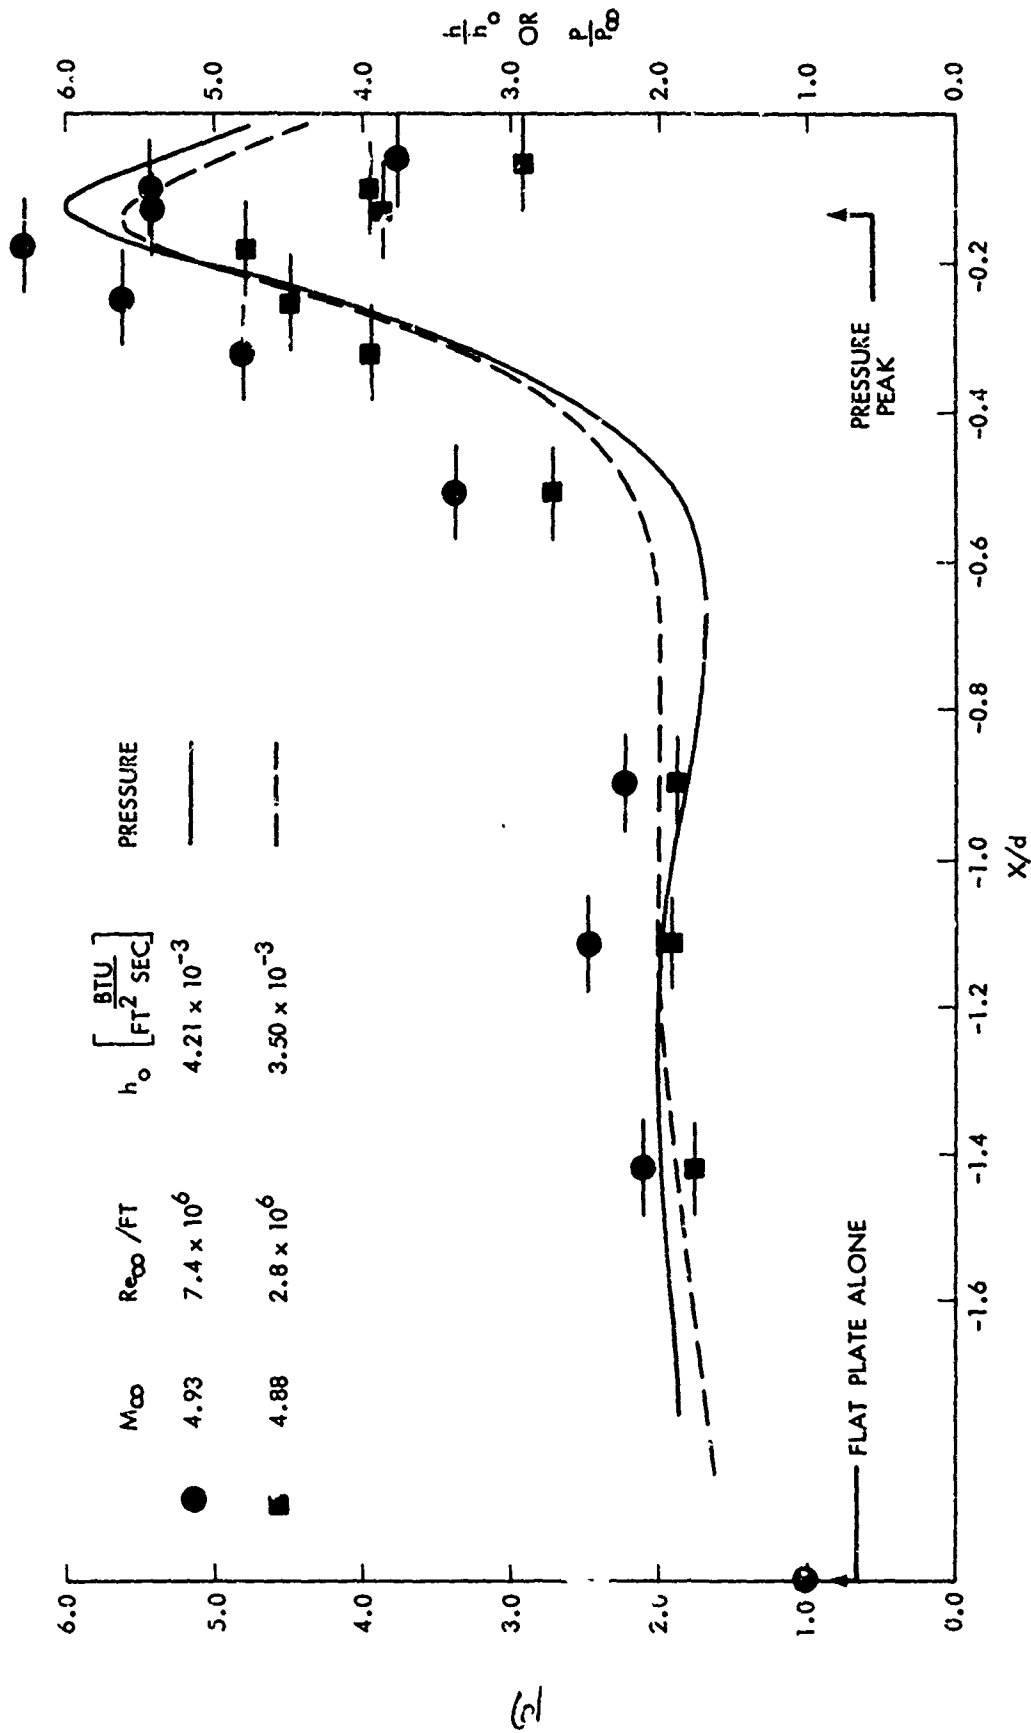
FIG. 20 HEAT TRANSFER DATA IN REGION AHEAD OF AN UNSWEPT FIN

The first several tests were conducted with no fin in place so as to measure the heat transfer coefficient,  $h_o$ , for the flat plate alone. Then a series of tests were conducted in which the fin was translated to various positions relative to the differential thermocouple. The size and position of the differential element relative to the fin at one particular location is shown by the white square in Figure 18. From each test conducted, a particular  $h$  was found from a plot similar to Figure 19. The results of these tests are presented in Figure 20 where the absolute values of  $h_o$  are also given. Superposed on this figure are the pressures measured in this region. From these data a peak heating rate is measured at a point slightly upstream of the pressure peak. The probable cause of this anomaly will be discussed subsequently. The peak heating rates are in the range of values which have been measured previously by Burbank, et. al. (reference 11) in the region immediately upstream of a right circular cylinder mounted on a flat plate. An apparent Reynolds number effect is evident in the present data, but this effect must be interpreted in light of the thermal boundary layer history effects to be discussed below.

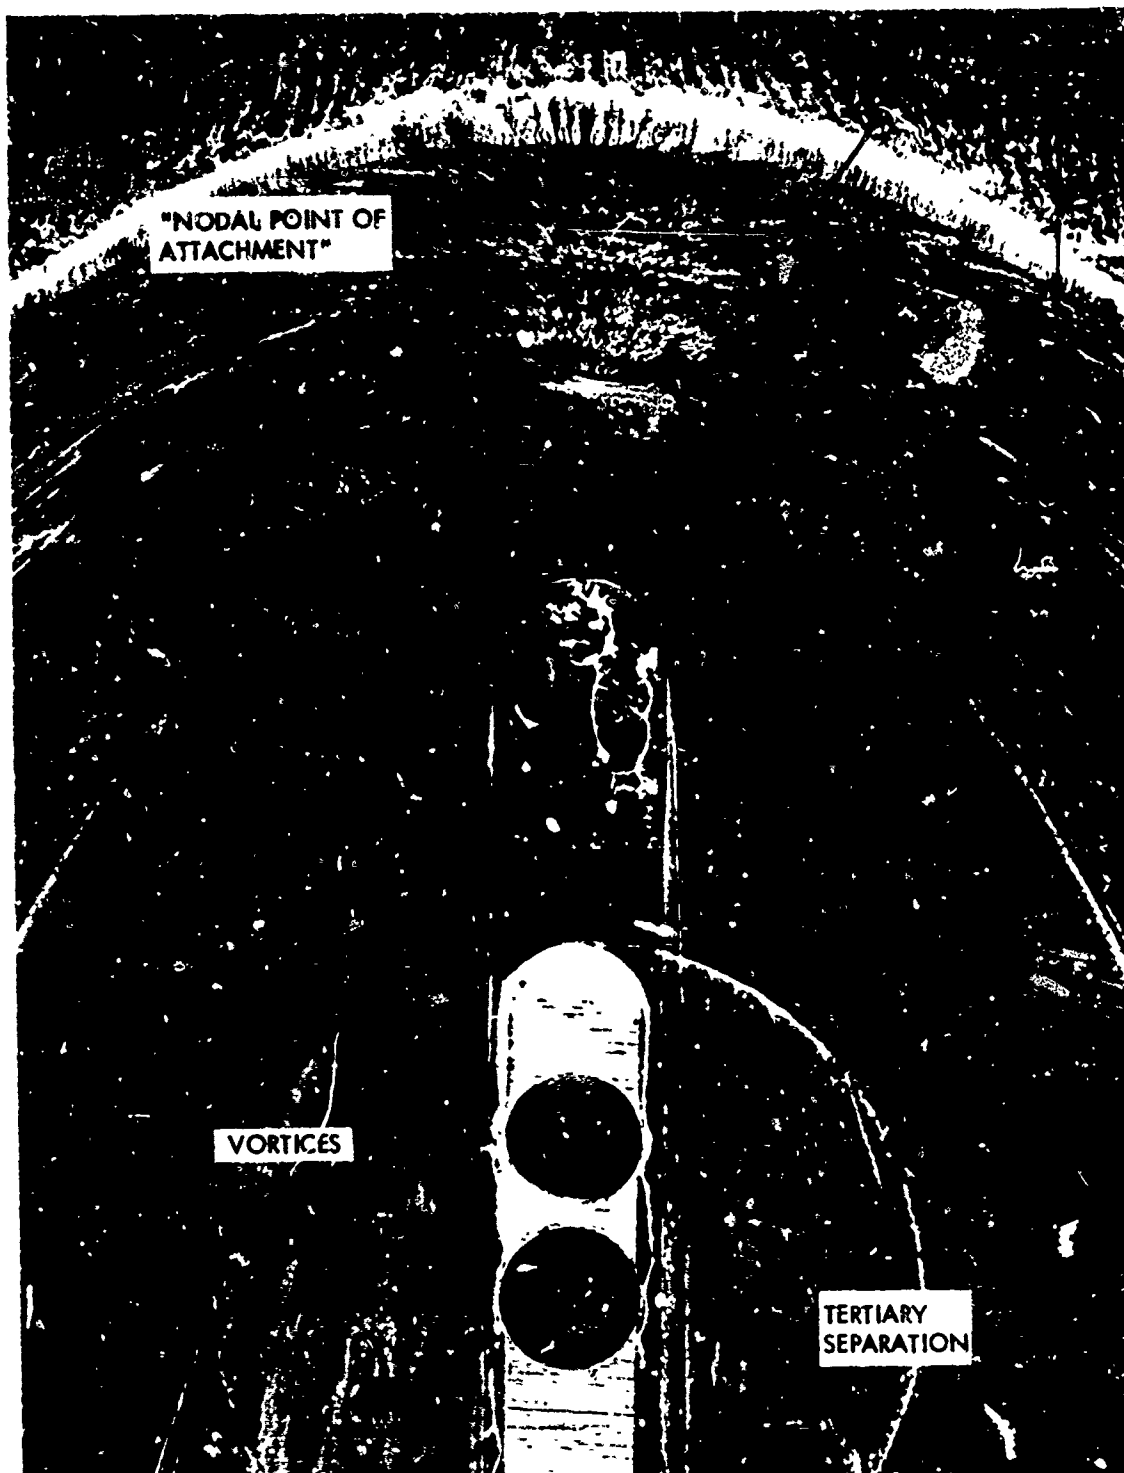
FIG. 22b ENLARGED VIEW-UPSTREAM OF UNSWEPT FIN

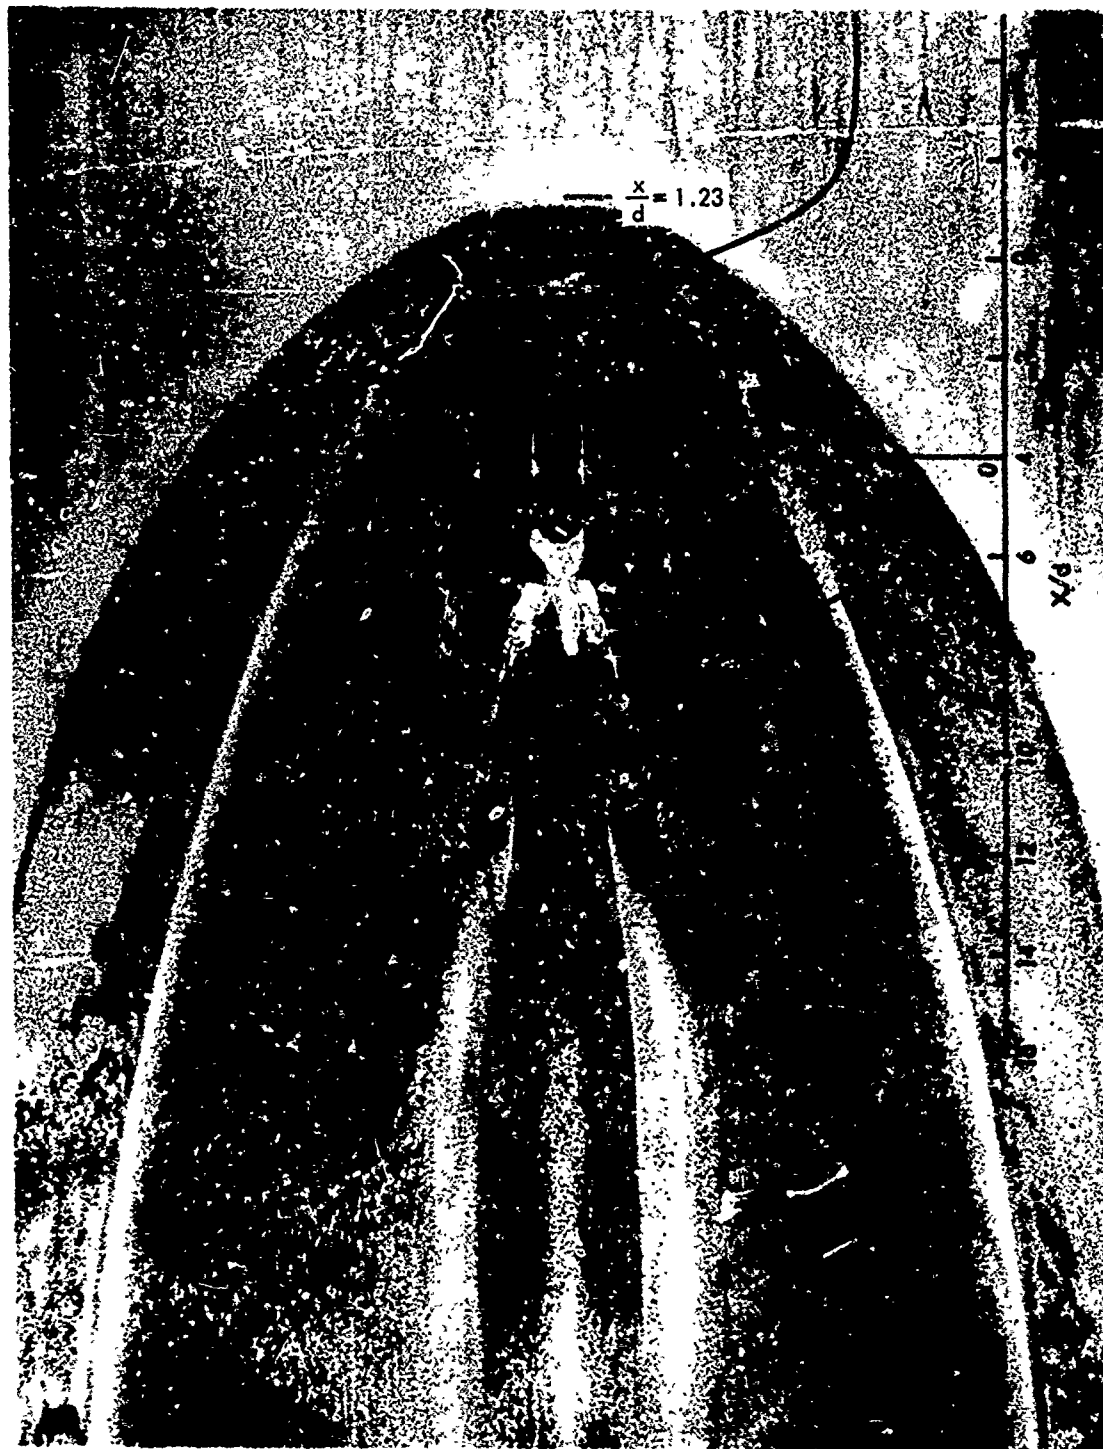
FIG. 26a UNSWEPT FIN WITH 0.5" CLEARANCE GAP

FIG. 26b ENLARGED VIEW-UNSWEPT FIN WITH 0.5" CLEARANCE GAP

Figures 23 to 26 show the oil patterns for the same conditions except that a clearance gap has been introduced under the unswept fin. The loss in clarity from Figure 22 is attributed in part to the lower shear forces at test condition 1 and in part to the thicker application of the oil mixture in the remaining tests. The initial tests using the 0.075-inch clearance gaps were plagued with various problems such as misalignment of the gap spacer (Figure 24) and oil splattering during channel shut down (Figure 25). After design and fabrication of the flat plate pressure model, larger (1.63 inches) spaces locked in alignment to the fin became available. The yawing plug was glued to the flat plate to cure the latter problem and a final oil smear test was conducted using the 0.50-inch spacer. The oil pattern of this test is shown in Figures 26a and 26b. Despite

Increasing the gap size produced a rather noticeable change of the flow field in the wake region of the fin. This was also noted in the pressure data of Figure 13. A superposition of the pressure data on Figure 26a clearly indicates how regions of varying shear flow shown by the oil smears correspond to the variation in the pressure distribution. An enlarged view of the oil pattern produced with the 0.5-inch spacer is shown in Figure 26b. Again the type of flow structure apparent in Figure 23b is to be observed here. Now however, it appears that a "stagnation line" has developed just ahead of the spacer.

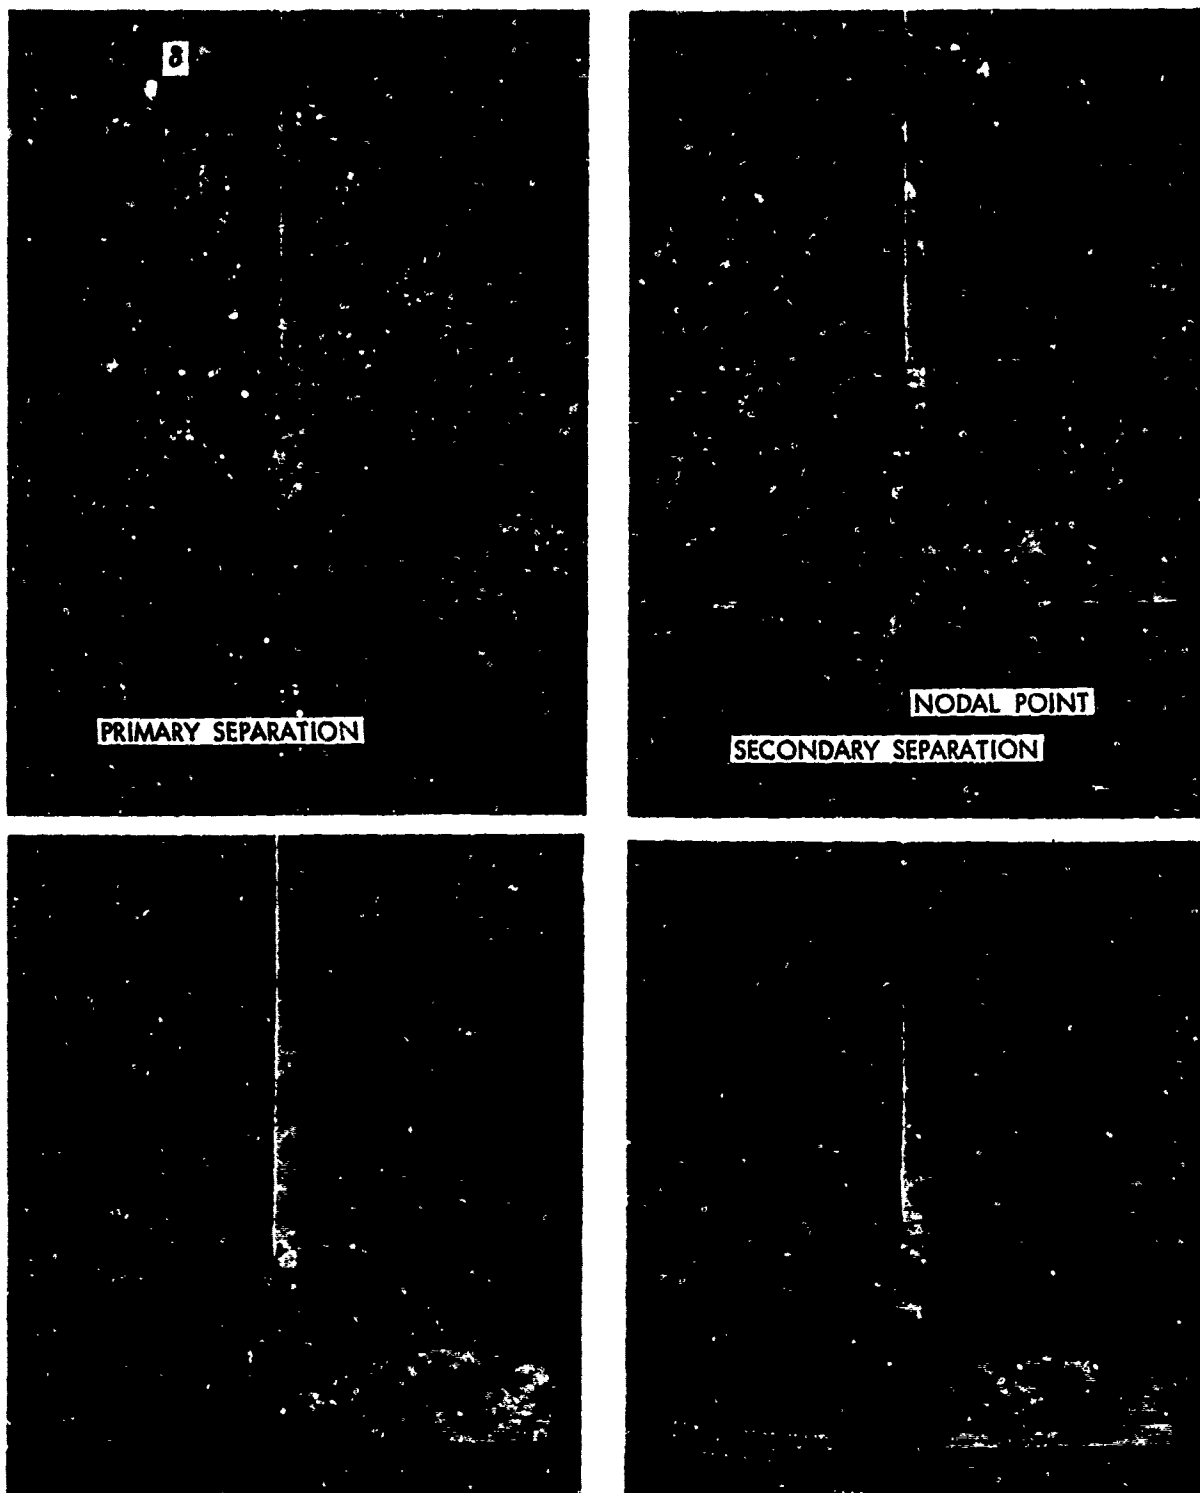
FIG. 33c FIN WITH 0.50 INCH CLEARANCE GAP

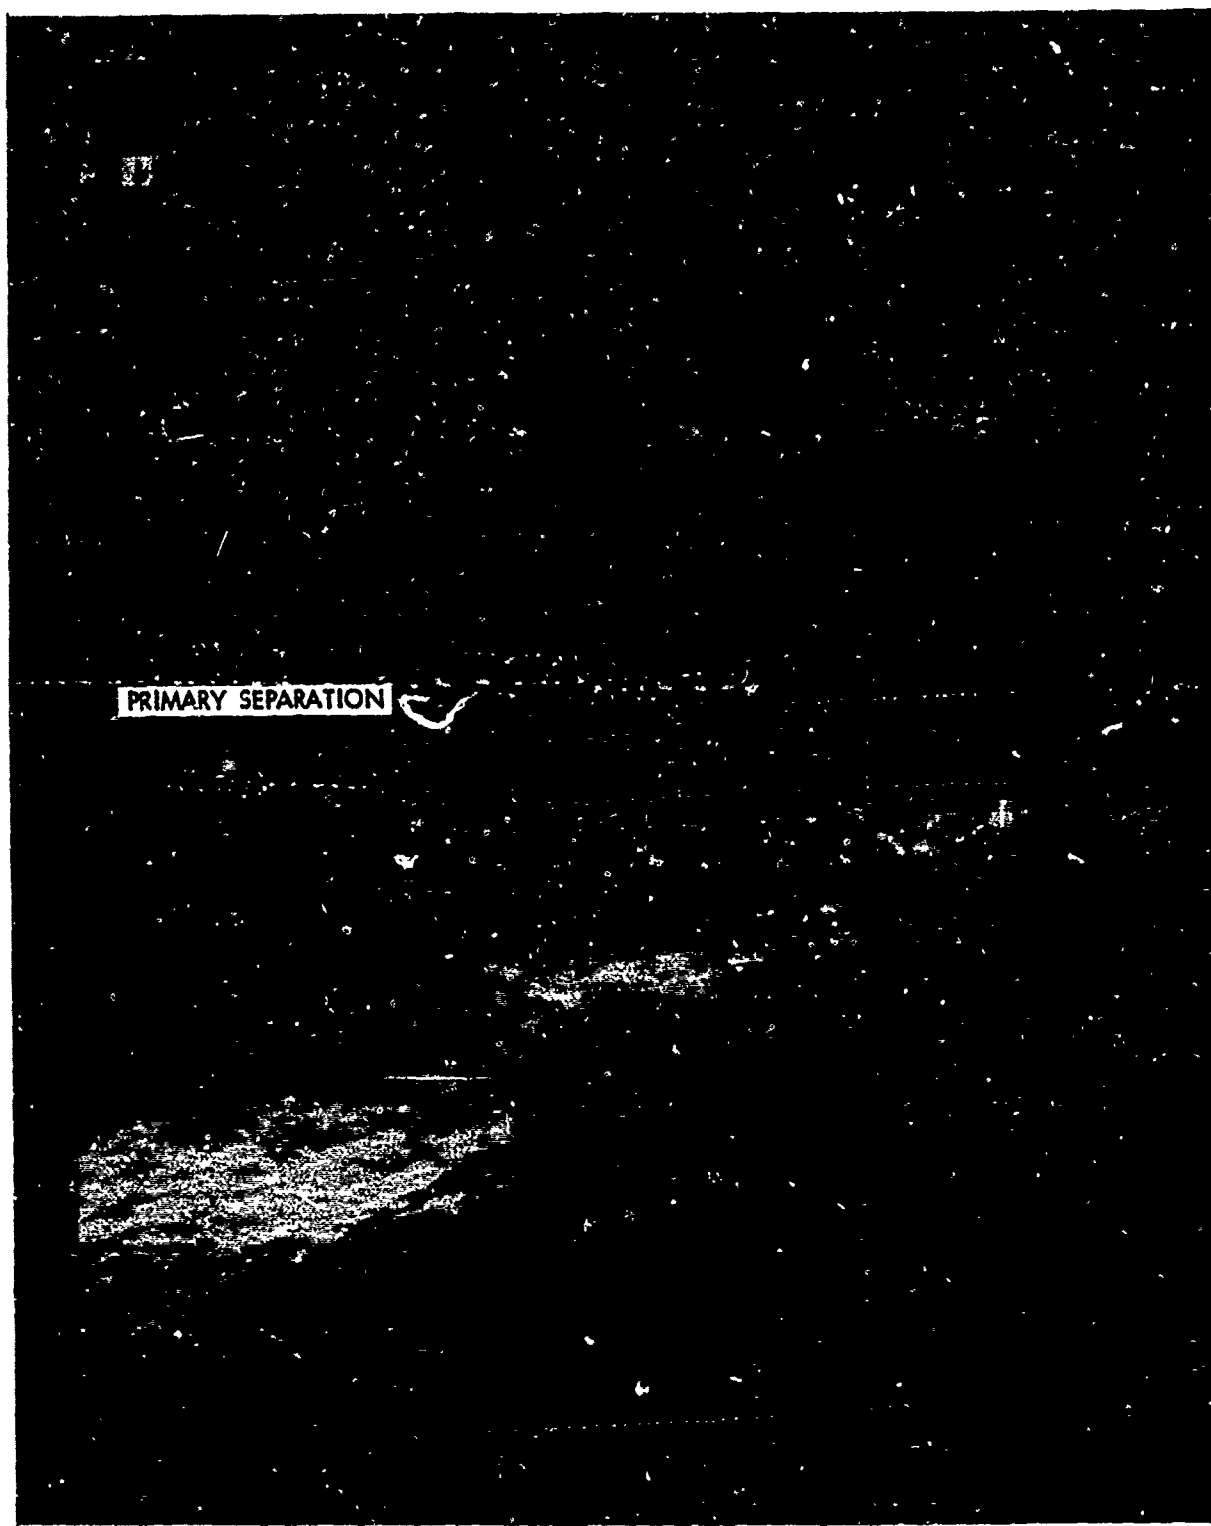
FIG. 34a SCHLIEREN PHOTOGRAPHS OF THE FLOW FIELD UPSTREAM OF A 60°  
SWEPT, CYLINDRICALLY BLUNT FIN
