TECHNICAL REPORT

71-53-ES

THAILAND HILL AND MOUNTAIN SLOPE ANALYSIS:  
DESIGN AND TESTING CONSIDERATIONS

Earth Sciences Laboratory  
U.S. ARMY NATICK LABORATORIES  
Natick, Massachusetts  
01760

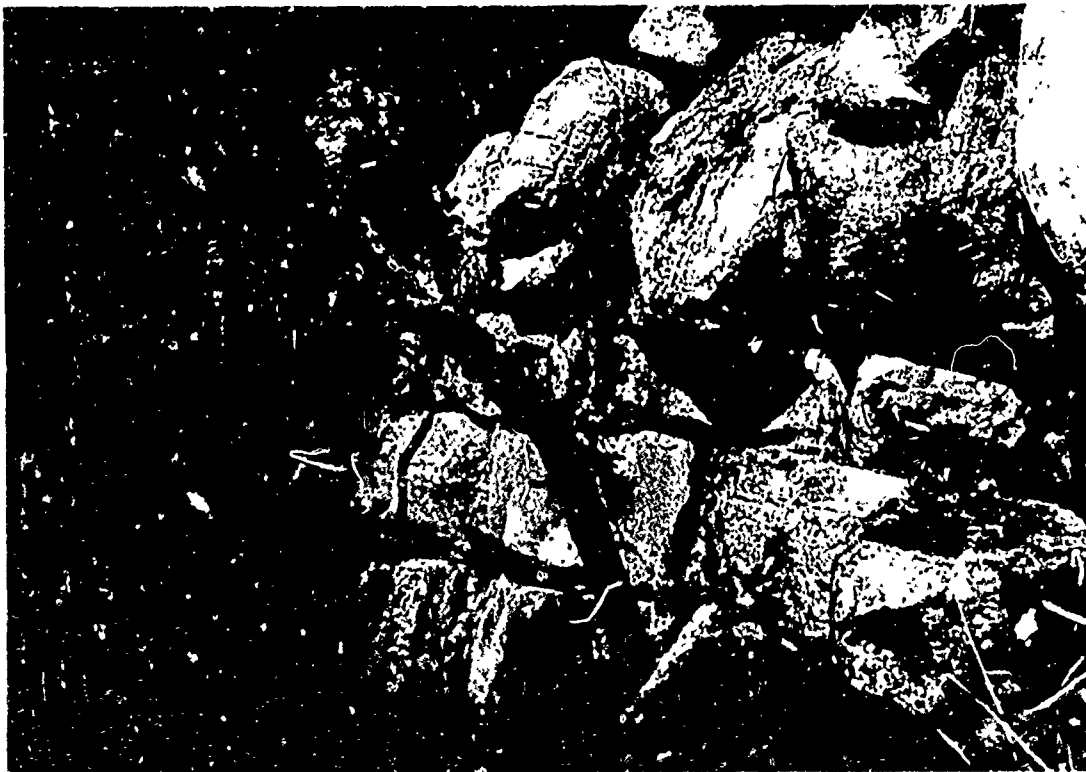
Figure 4. Khorat study area: Cap rock of the Khorat escarpment. Picture taken from site #2 of traverse #58.

- (1) A cap rock overhanging from a few feet to as much as 15 feet.
- (2) A nearly vertical cliff, 10 to 15 feet high with large rock blocks at the base of the cliff ranging in size from a large suit case to a large American automobile (Figs. 4, 5, and 6).
- (3) A continuous cover of the above mentioned rock blocks.

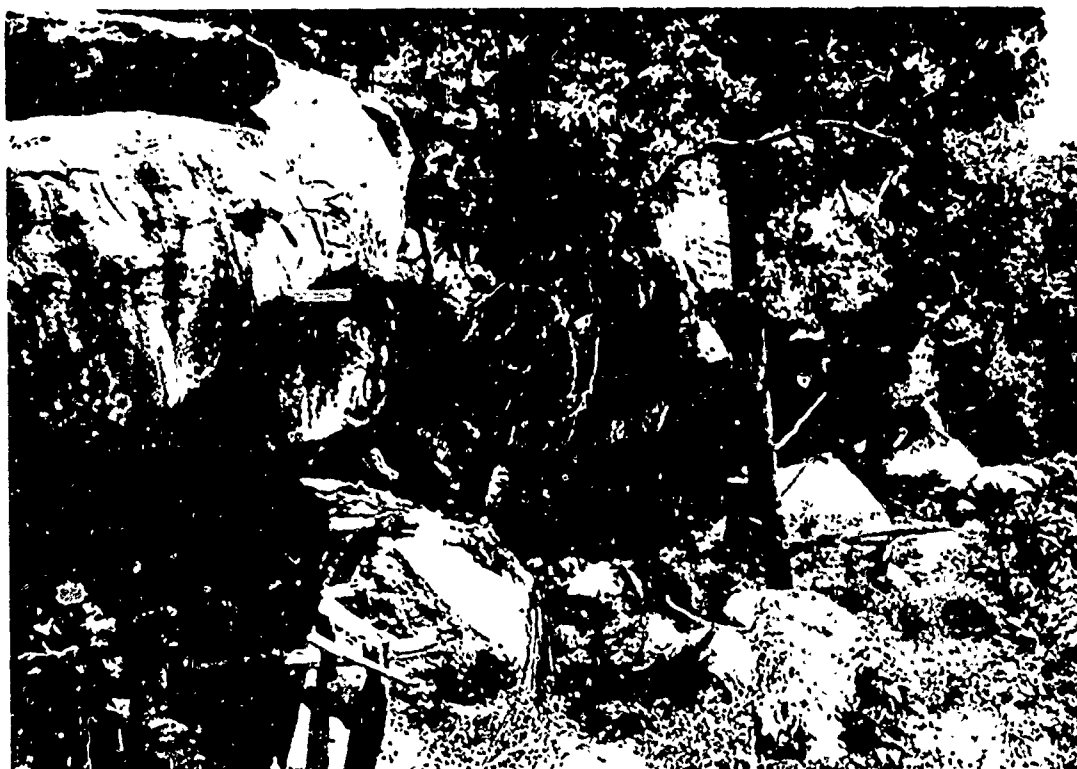
Figure 5. Khorat study area: Militarily significant cave-like cap-rock site. Cap rock is 15 to 20 feet thick at this point. The slope gradient below the base of the cap rock is 40 degrees. Picture shows site #24 of traverse #53.

For guerilla-type forces these overhanging cap-rock sections are excellent for shelter, storage, observation, and gun sites. From these sites a small force of men with little equipment could control the movement of troops, supplies, and vehicles over the main highway (No. 23, the Friendship Highway) through the escarpment area. The cave-like overhanging cap-rock site shown in Figure 5 has a commanding view (Fig. 2) of a long stretch of the Friendship Highway between Khorat and its Friendship Airfield and Bangkok.

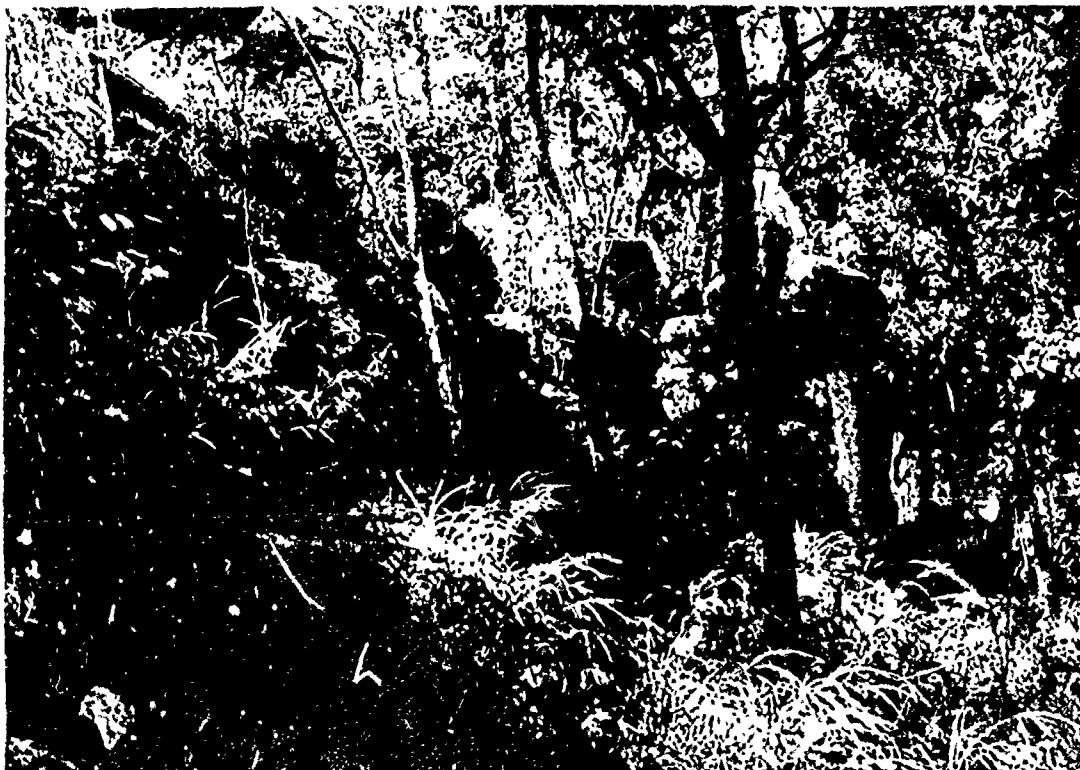
Figure 7. Khorat study area: Escarpment cap rock and slope below the cap rock. Vertical face of cap rock and 38 degree slope below the cap rock at site #17 of traverse #51.

Below the cap-rock zone, ease of off-road movement by men and vehicles increases with distance downslope from the cap-rock zone. Figures 7, 8 and 9 are a series of photographs that show slope gradients and surface conditions at three, higher to lower elevations, sites (17, 7 and 5) along traverse #51. Traverse #51 is located a few miles east of the Friendship Highway (PLATE I). Slope gradients for the three sites (17, 7 and 5) are respectively 38, 6 and 11 degrees.

There are marked differences in rock size and percentage of the surface covered by rocks on the slope below the cap-rock zone. On each of the three photographs (Figs. 7, 8 and 9), it is obvious that the frequency and size of rocks are obstacles to the mobility of men and vehicles. In Figures 8 and 9 the approximate percentage of the surface covered by rocks is 60 to 80 percent. The rocks in Figure 8 range in size from a suit case to a little larger than a standard government desk. The rocks in Figure 9 range in size from a typewriter to a large footlocker.

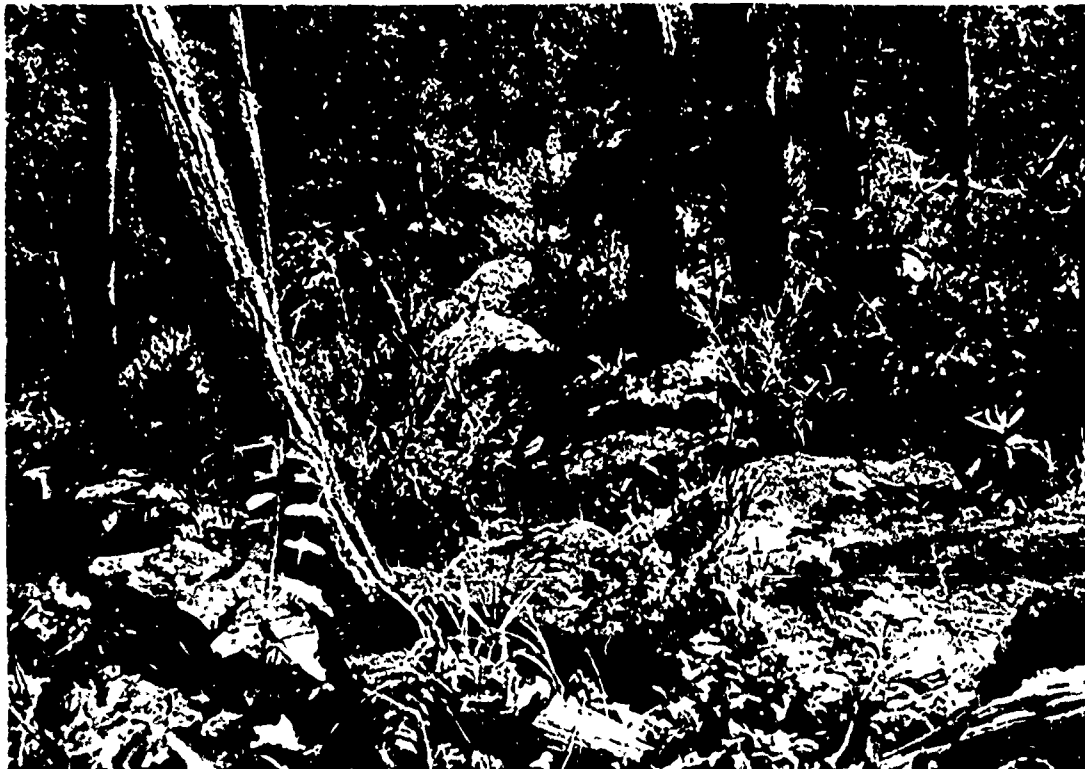
Figure 8. Khorat study area: Sandstone rocks on slope below the cap rock. The majority of the rocks range in size from a large suit case to a little larger than a standard size government office desk. The rocks cover 60 to 80 percent of the 6 degree slope near site #7 of traverse #51.

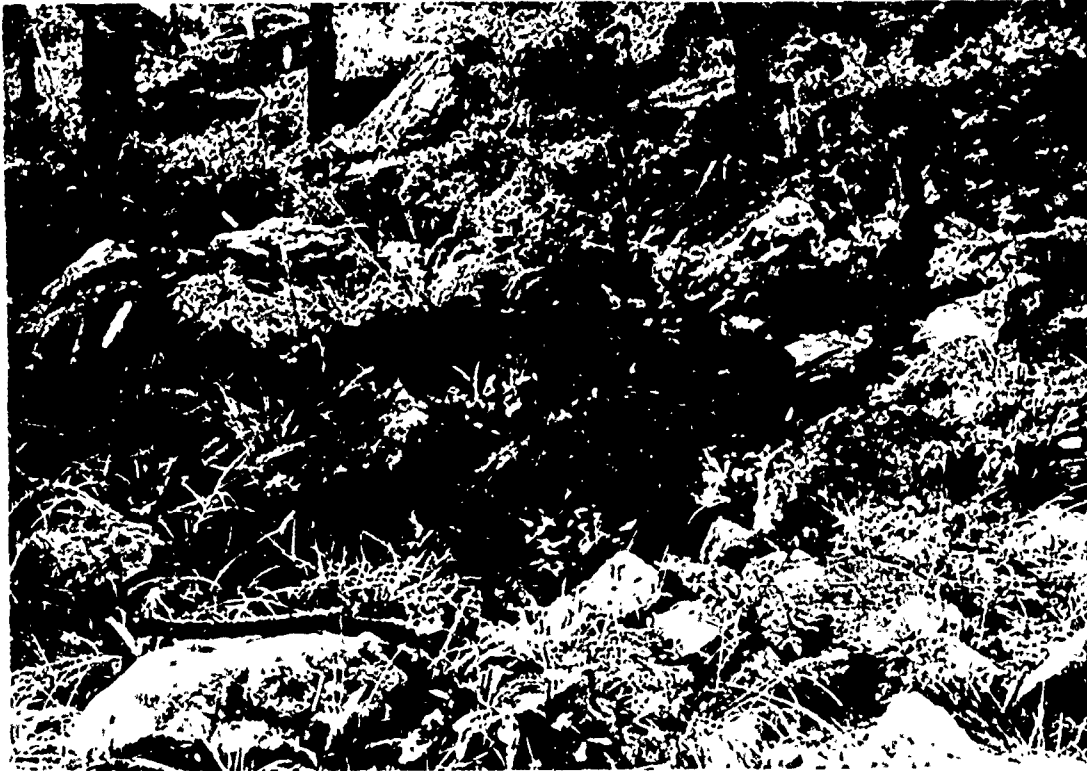
Figure 9. Khorat study area: Sandstone rocks on slope below the cap rock. The majority of the rocks range in size from a typewriter to a footlocker. The rocks cover 60 to 80 percent of the 11 degree slope segment near site #5 of traverse #51.

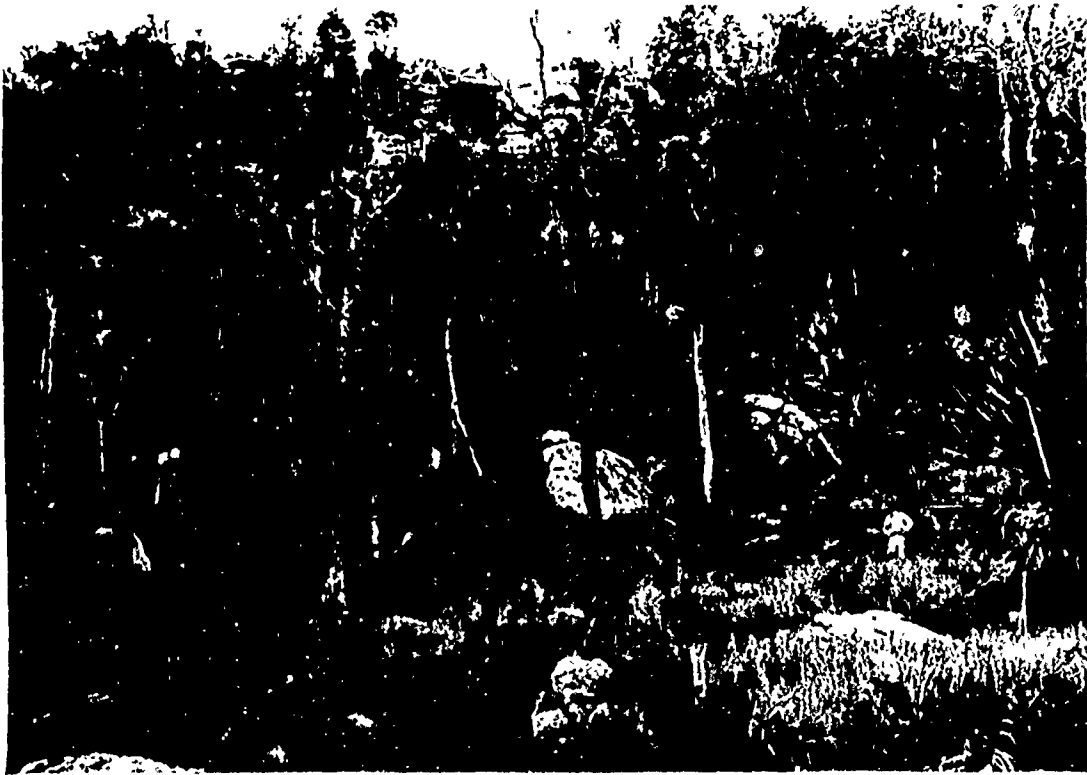
Figure 11. Khorat study area: Rocks on escarpment slope above firing range. Slope in the foreground below trees is 18 degrees; in the tree zone, it is 27 to 30 degrees. Picture shows part of slope for traverse #58.

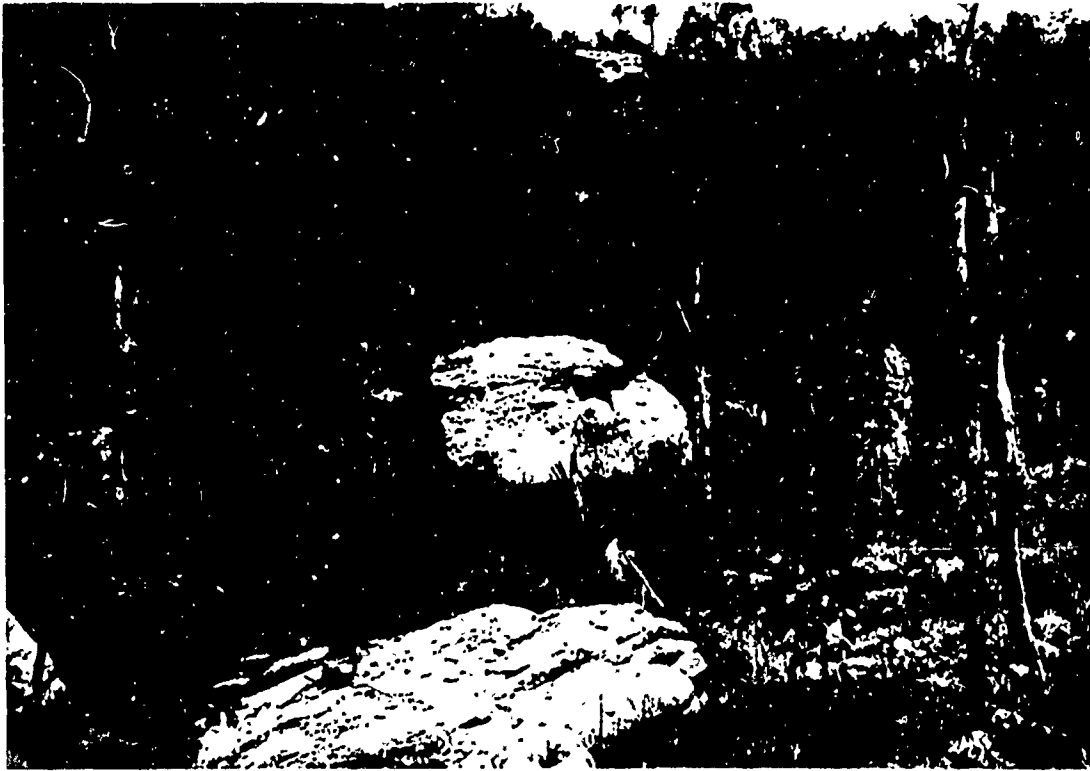
Figure 12. Khorat study area: Rocks on escarpment slope above firing range. Slope in the foreground is 23 degrees; in the tree zone, it is 27 to 38 degrees. Picture shows part of traverse #60, above site #12.

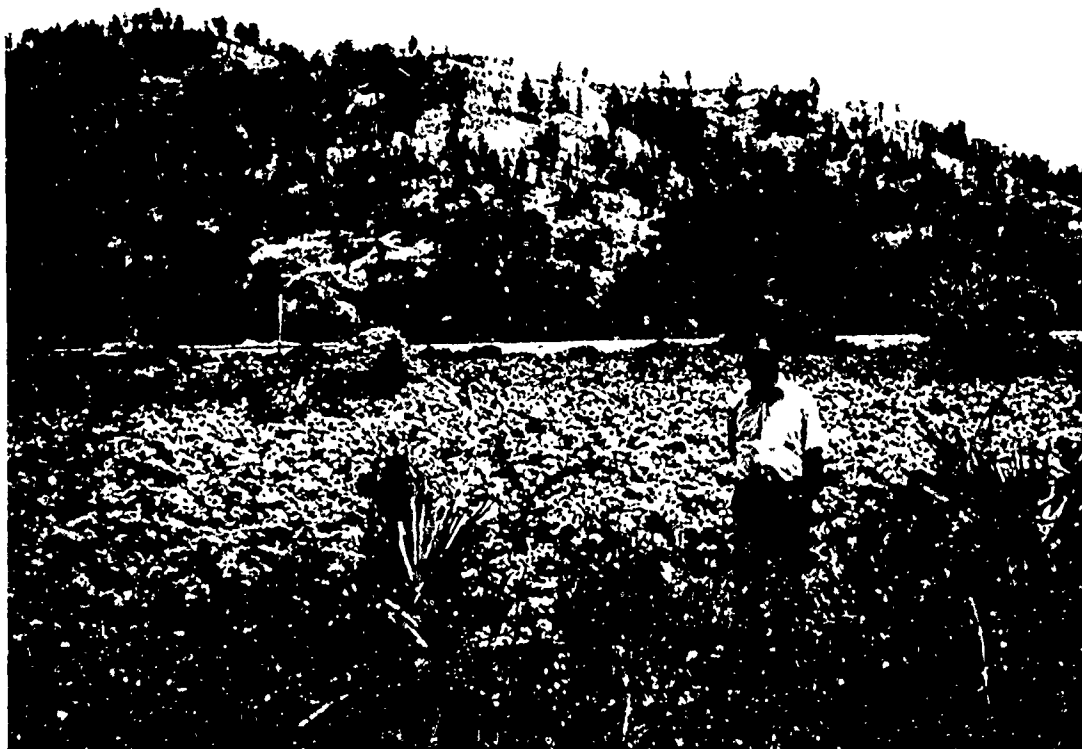
Figure 14. Kanchanaburi study area: Sharp break-in-slope at base of Khao Uai. Picture shows broad view of Khao Uai, the hill on which traverse #1 was made.

These hills and mountains rise abruptly from the relatively flat surface underlain by alluvium and colluvium (Figs. 14, 15 and 16). There is a distinct break-in-slope where the colluvium abuts the base of the slope. The break-in-slope is from around 4 to 6 degrees up to about 12 to 15 degrees.

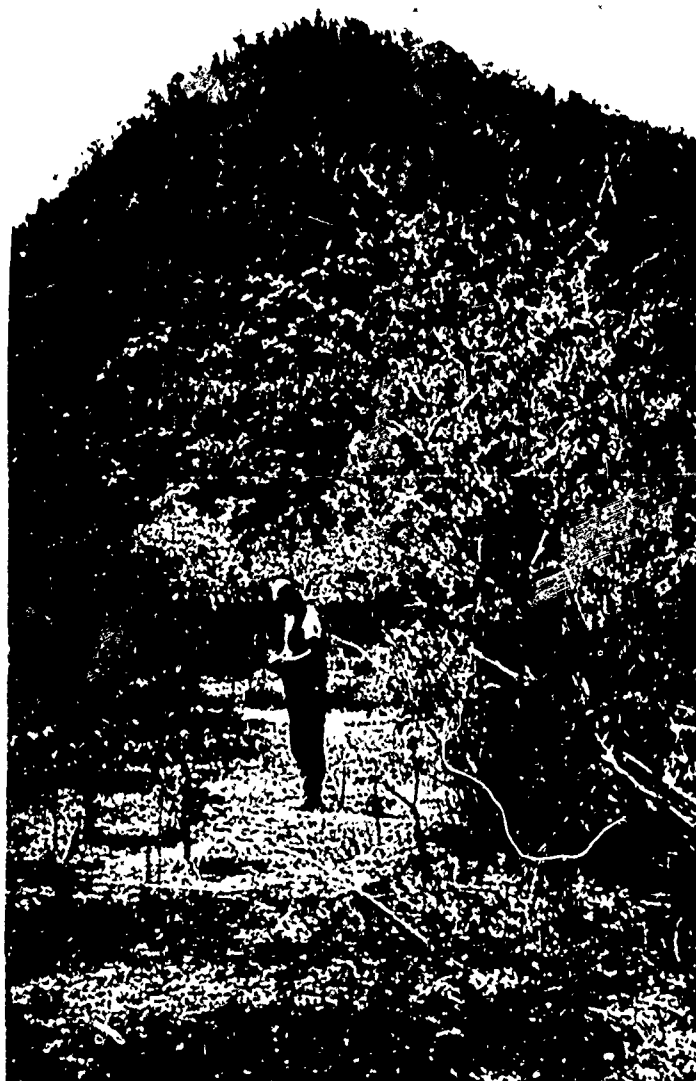
Figure 15. Kanchanaburi study area: Sharp break-in-slope at base of Khao Tong. Picture shows broad view of Khao Tong which is the mountain for traverse #5. Slope in foreground is 1 degree.

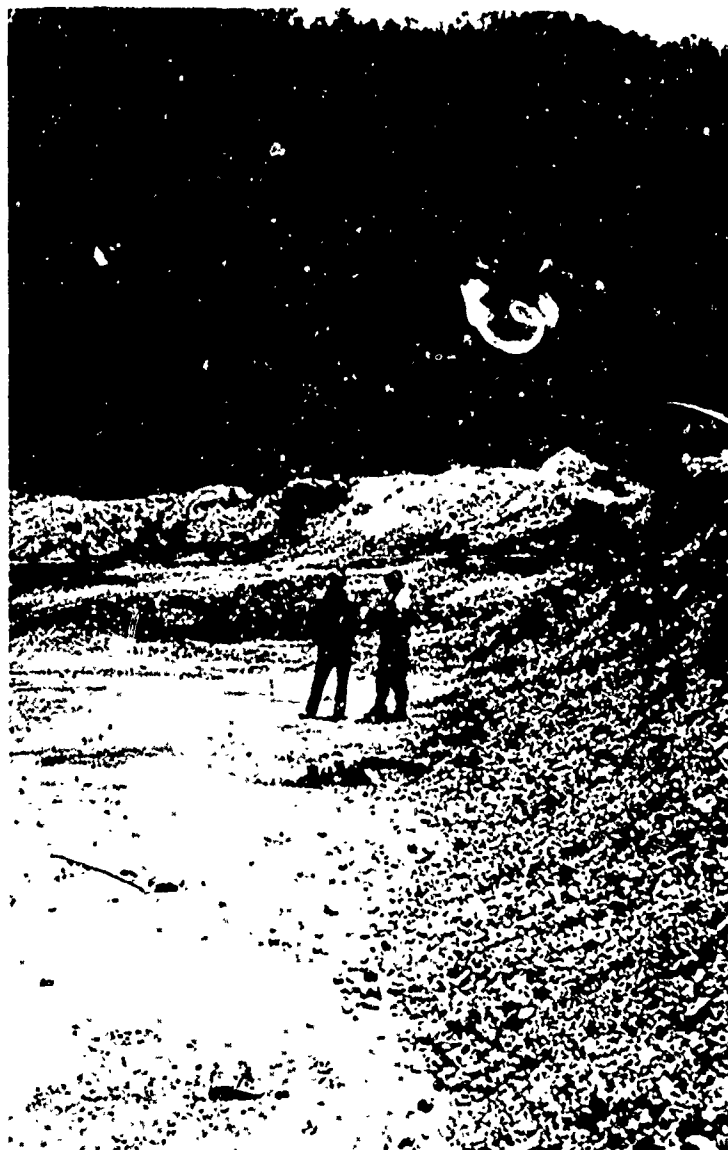
Figure 16. Kanchanaburi study area: Thick deposit of alluvial and colluvial material transformed into laterite at the base of Khao Tong.

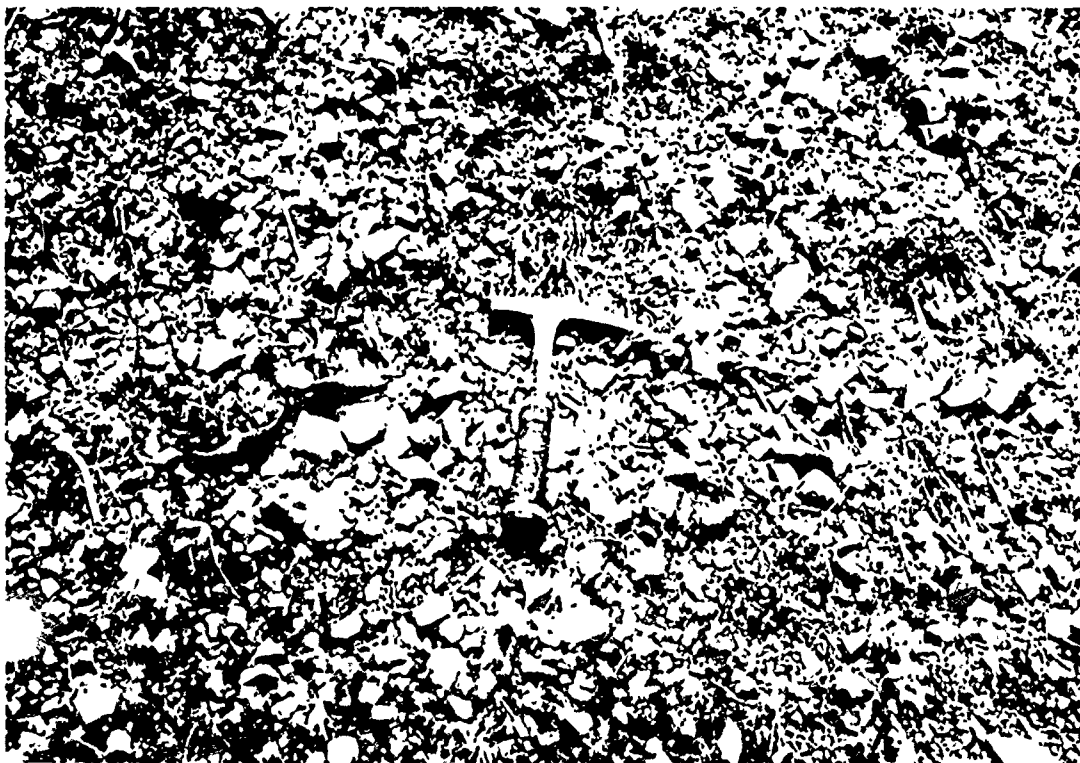
Figure 17. Kanchanaburi Study area: Pebble-covered hard soil of Khao Uai slope. Picture shows pebble-covered 19 degree slope at site #10 of traverse #1.

The Khao Uai slopes on which traverses #1 through #4 were conducted would present problems to both men and vehicles, but for different reasons. These slopes have a hard soil surface over large sections of the hills. Some of the sections are 100 percent covered with small subangular quartzitic pebbles ranging in size from about 1/4 to 4 inches square (Fig. 17). The combination of the hard surface

and subangular pebbles makes footing treacherous. Traversing many segments of these slopes is like walking on a ramp scattered with marbles. Members of the field crew lost their footing and fell several times in spite of wearing the Tropical Combat Boot with the treaded sole and heel.

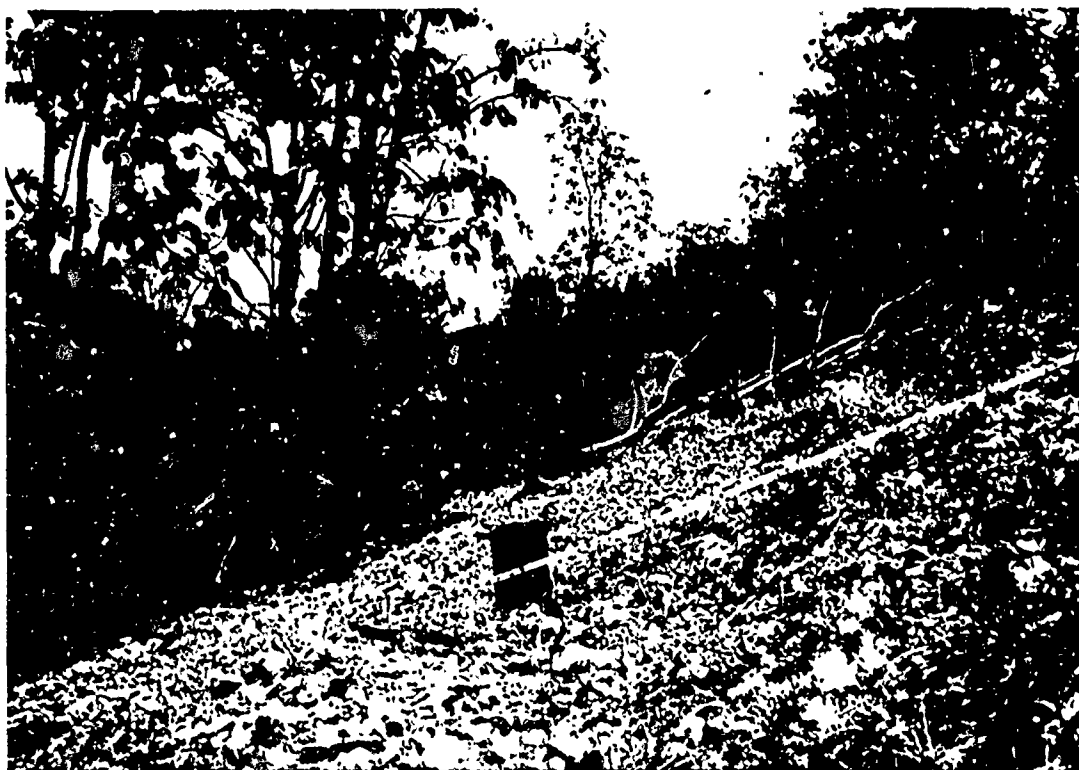
Figure 18. Kanchanaburi study area: Quartzitic pebble-covered terracettes on Khao Uai. Pebble-covered terracettes on slopes of 19 to 28 degrees between sites #10 to #13 of traverse #1.

The second condition or feature not conducive to ground vehicle mobility across these slopes are zones of small irregular terracettes. They are step-like features that vary in size and spacing. Length is from 2 to 3 feet to about 20 feet; tread is about 1 to 3 feet; and the rise from about 6 inches to around 3 feet (Fig. 18). Terracettes are common on slopes ranging between 15 to 25 degrees.

These terracettes would cause problems for vehicles and their occupants. Some vehicles would get hung-up attempting to traverse these features. The vehicles that did not get hung-up might be damaged by the bouncing effect. Moreover, the bouncing effect would make it difficult, if not impossible, for the driver to maintain control unless the vehicle speed is very slow.

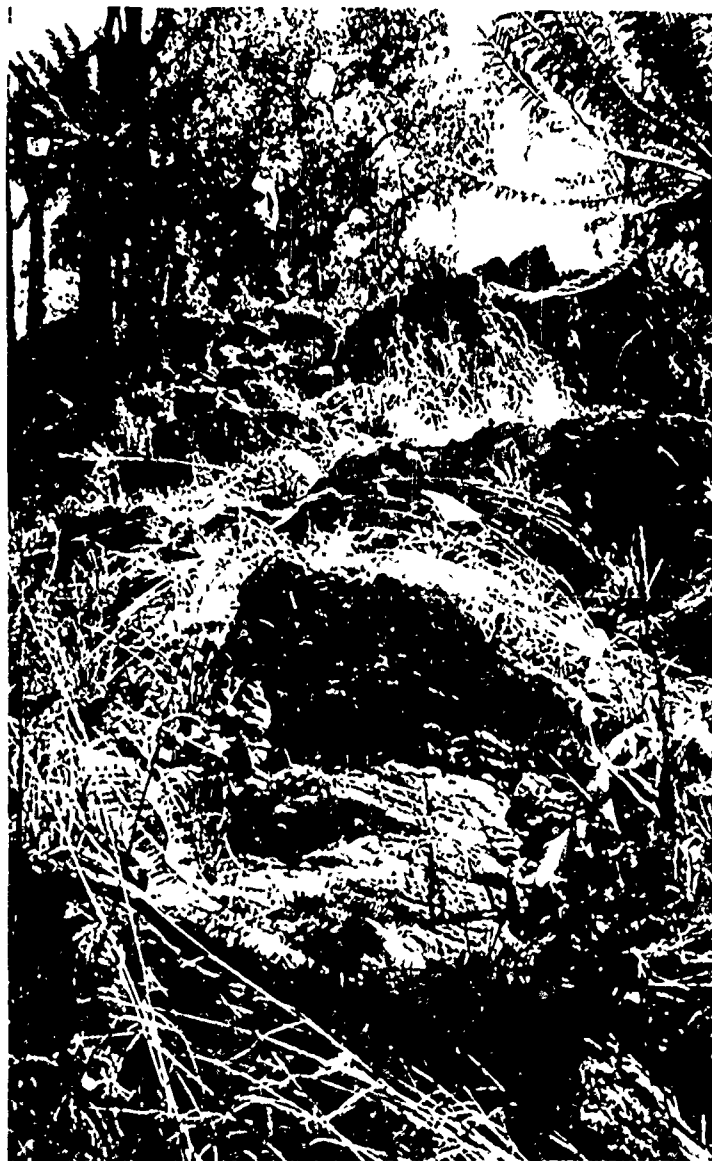
Figure 19. Kanchanaburi study area: Limestone outcrops and rocks on slopes of Khao Noen Prang. Six to eight feet vertical limestone outcrops on 34 degree slope between sites #42 and #43 of traverse #9.

Surface conditions of different slopes underlain with the same rock type also varies considerably. Figures 19 and 21 show two slopes underlain with limestone. Figure 19 shows many outcrops, some with 6 to 8 foot vertical sides; there is very little loose rock on this 34 degree slope. Figure 21 shows few outcrops, but the 30 degree slope is about 75 percent covered with rocks ranging in size from about 4 inches square to about 1 by 1 by 2 feet.

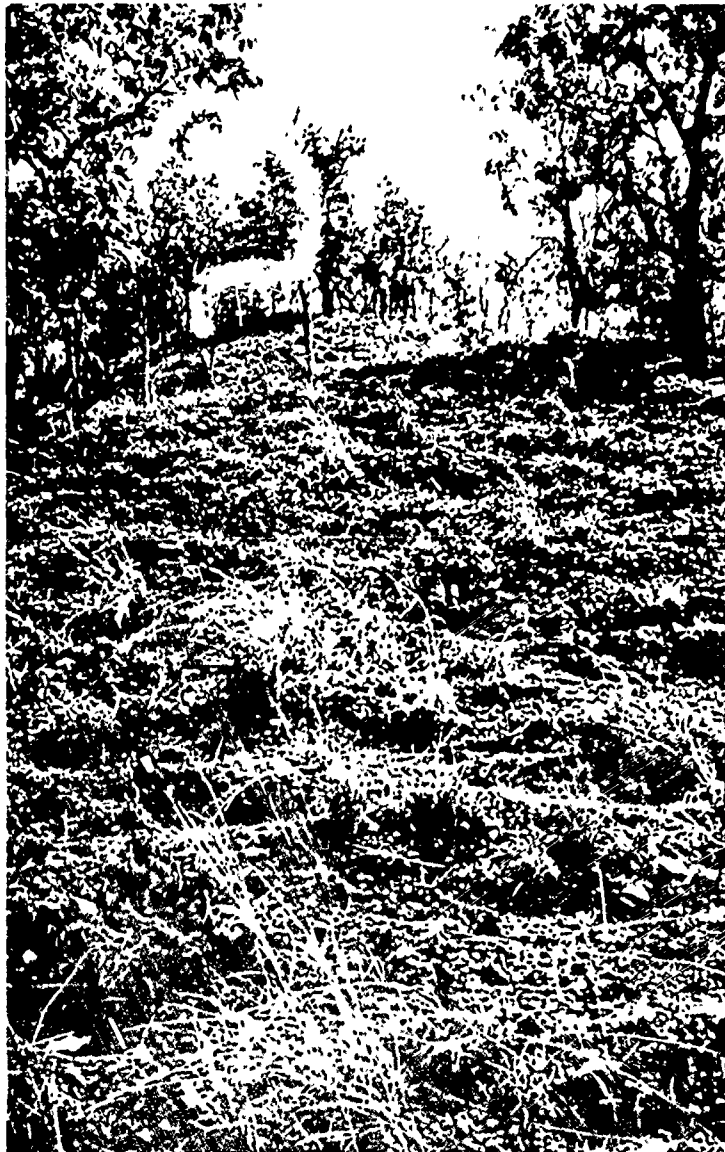
Figure 20. Kanchanaburi study area: Relatively rock-free slope on Khao Noen Prang. Relatively rock-free 28 degree slope between sites #41 and #42 of traverse #9.

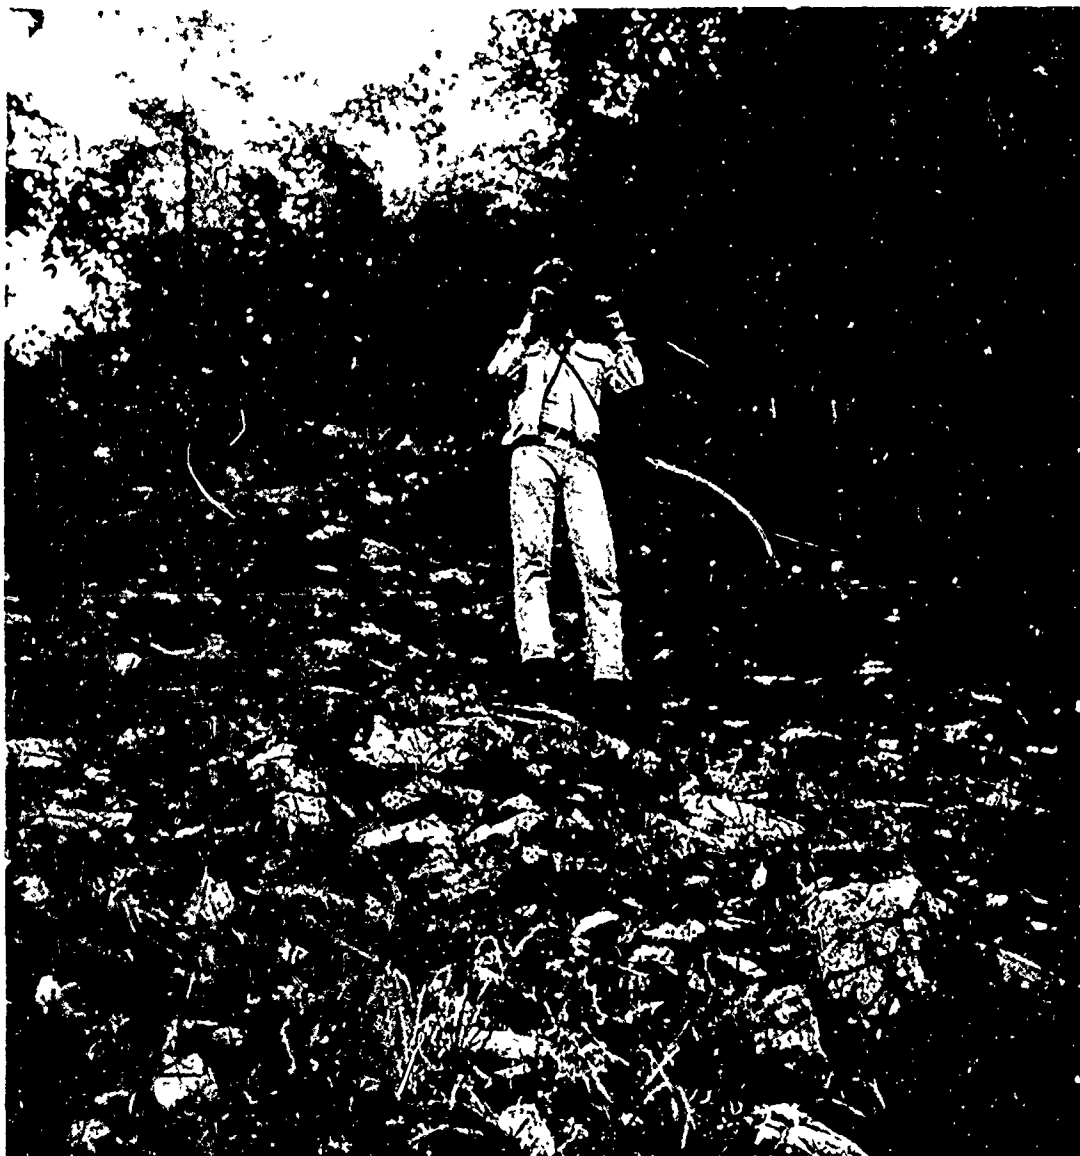
Figure 21. Kanchanaburi study area: Limestone rock-covered slope on Khao Phu Lan. Thirty degree slope about 75 percent covered with limestone rocks ranging in size from about 4 inches square to about 1 by 1 by 2 feet near site #16 of traverse #55.

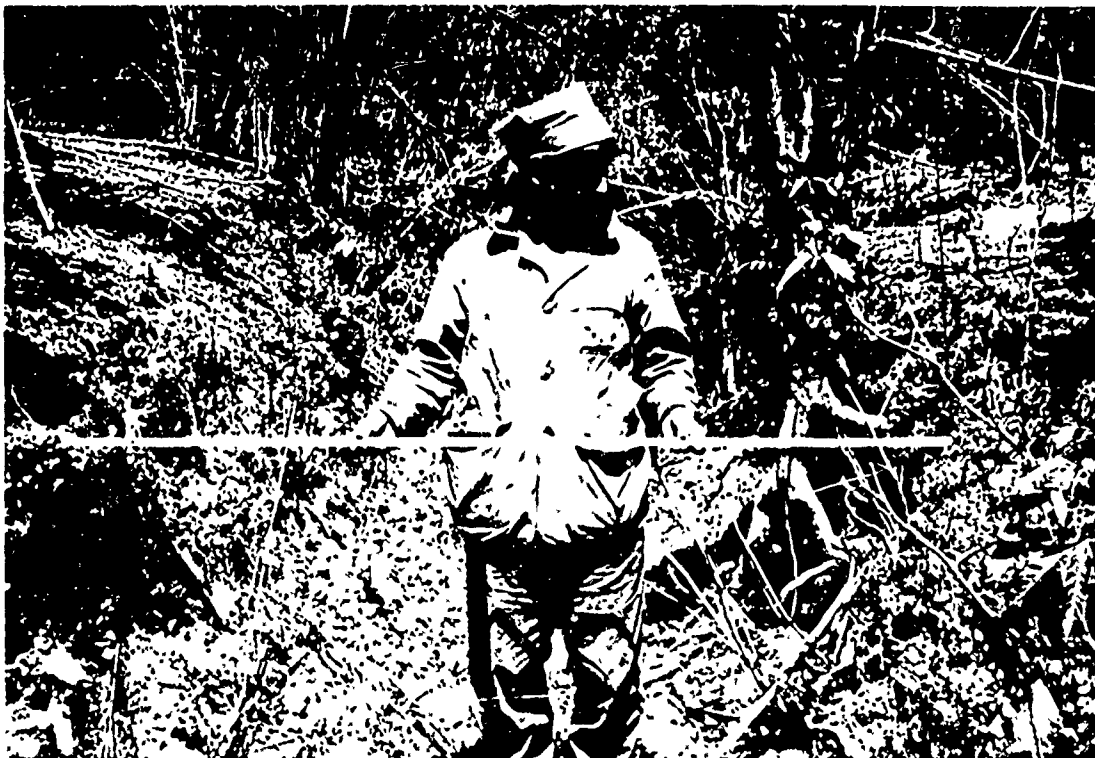
Figure 22. Kanchanaburi study area: Intermittent stream channel cut into colluvial material between closely spaced hills. Channel is a short distance from base of hill for traverse #7.

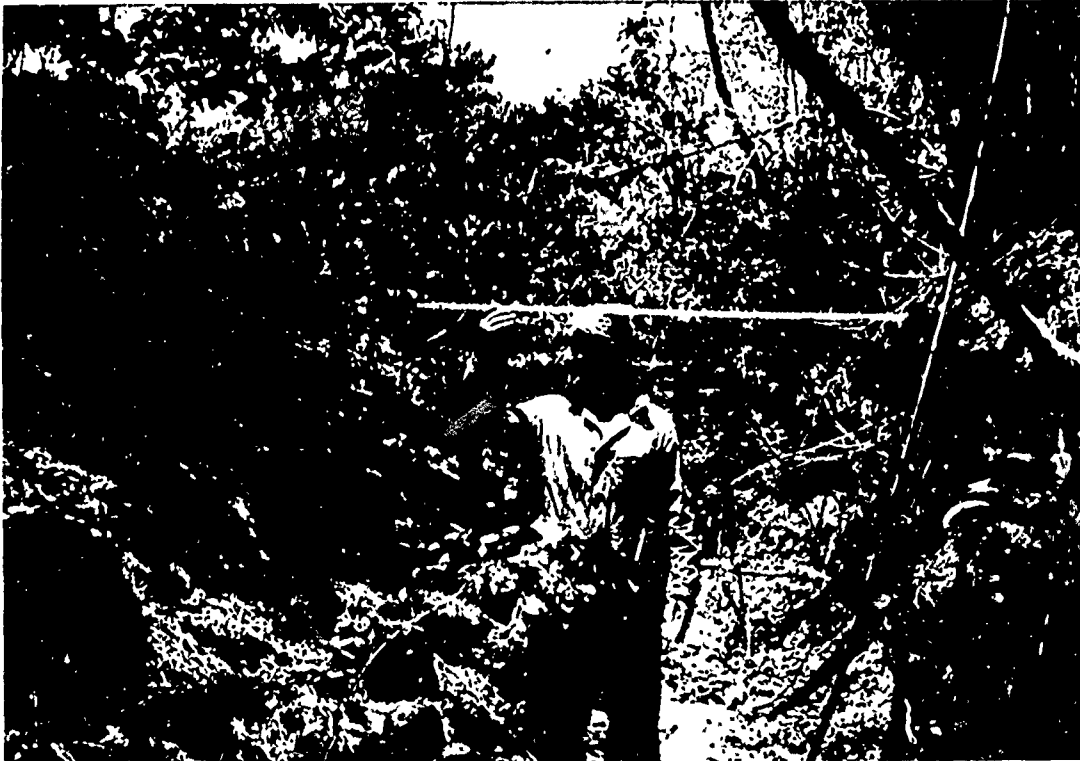
Figure 23. Kanchanaburi study area: Intermittent stream channel cut into colluvial material between closely spaced hills. Channel is a short distance from lower end of traverse #8.

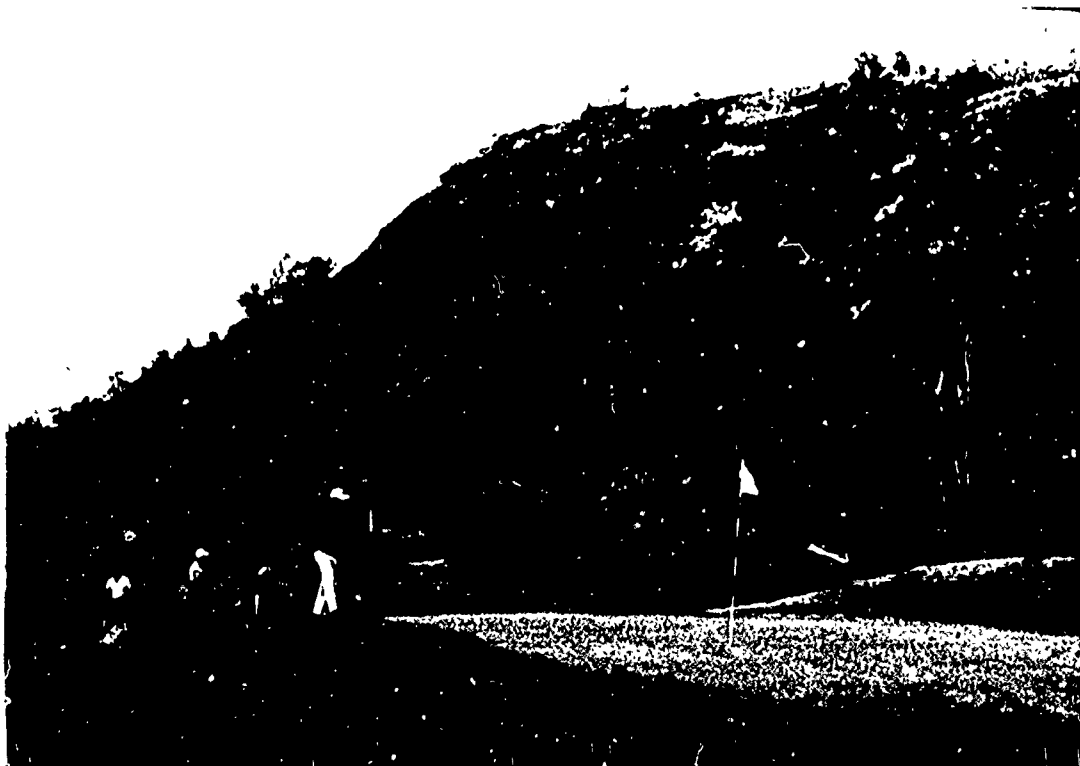
Figure 26. Hua Hin study area: Sharp break-in-slope at base of hill.

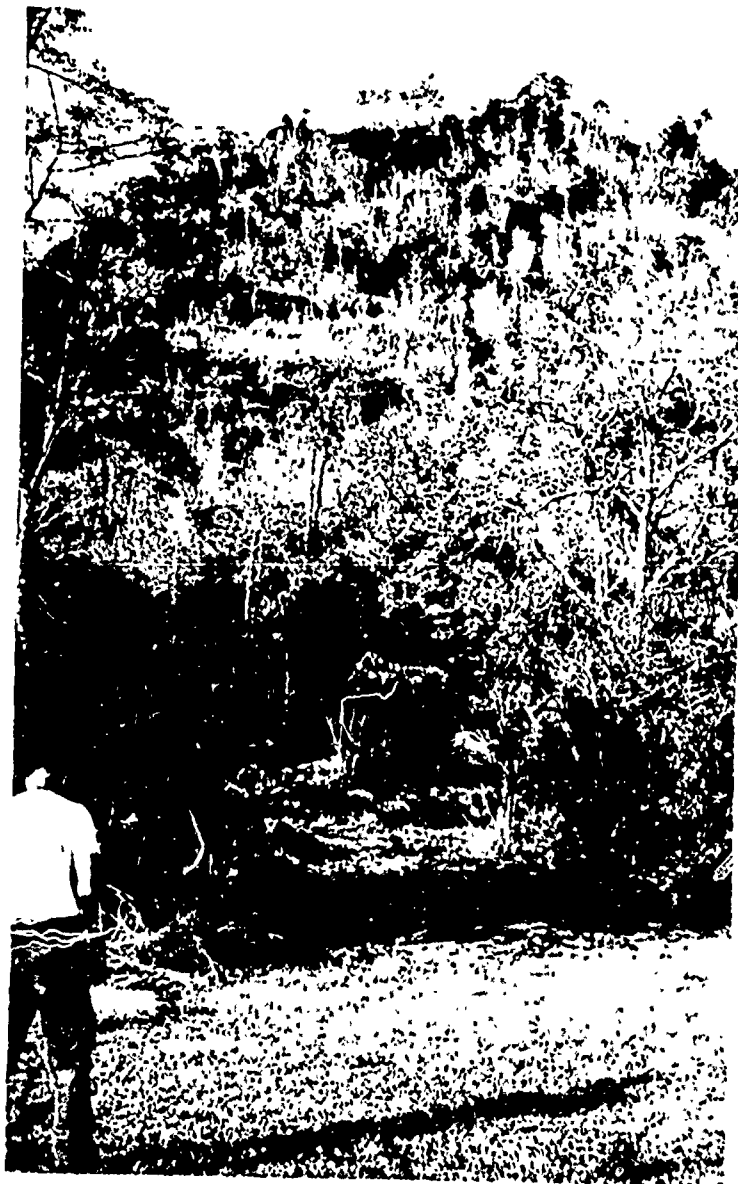
Figure 27. Hua Hin study area: Sharp break-in-slope at base of hill.

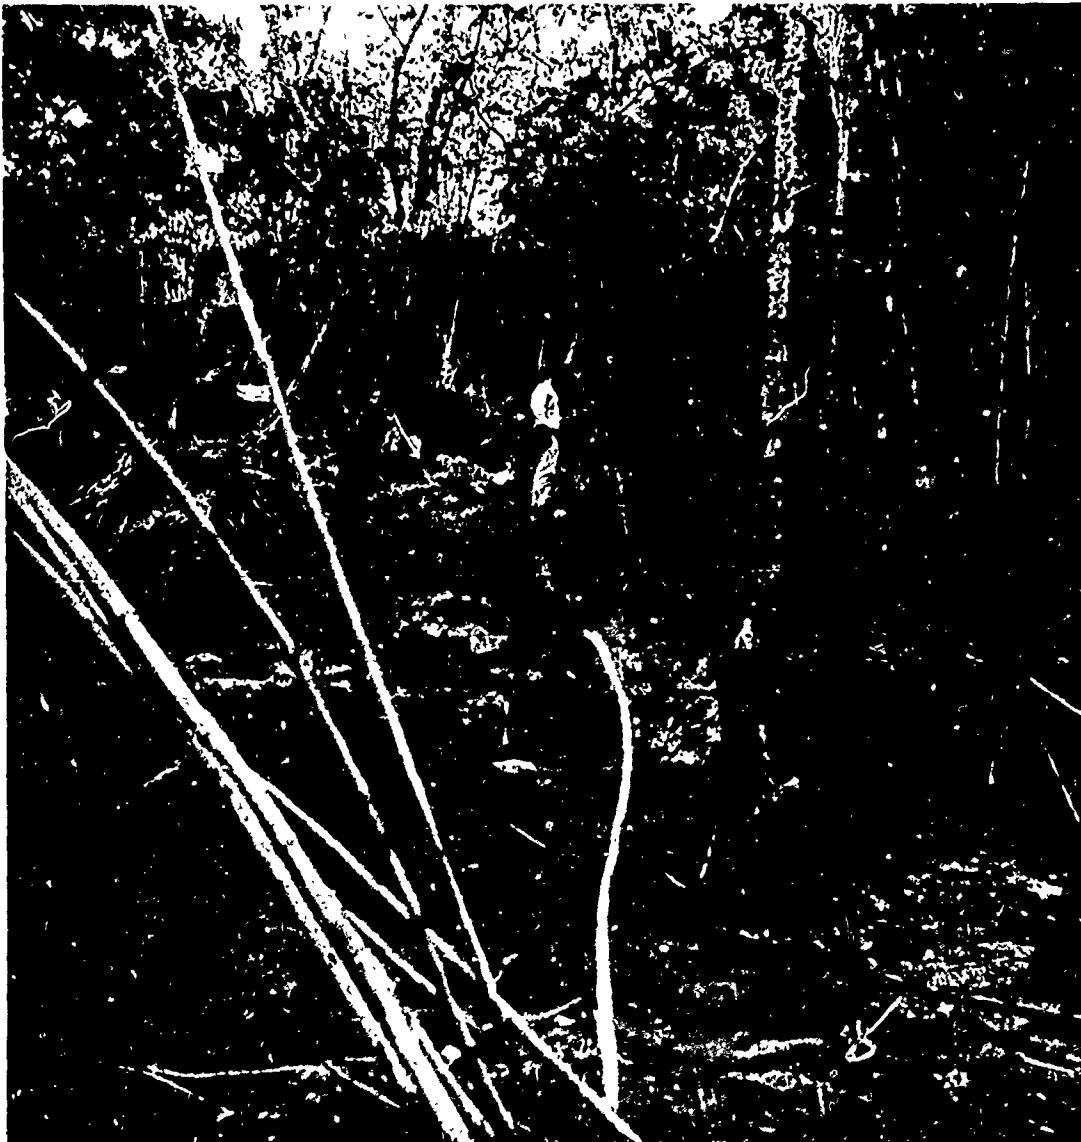
Figure 28. Hua Hin study area: Large rocks and outcrops near bottom of hill for traverse #51. The majority of the rocks range in size from a typewriter to a standard size government office desk. The slope is 18 degrees near site #5 of traverse #51.

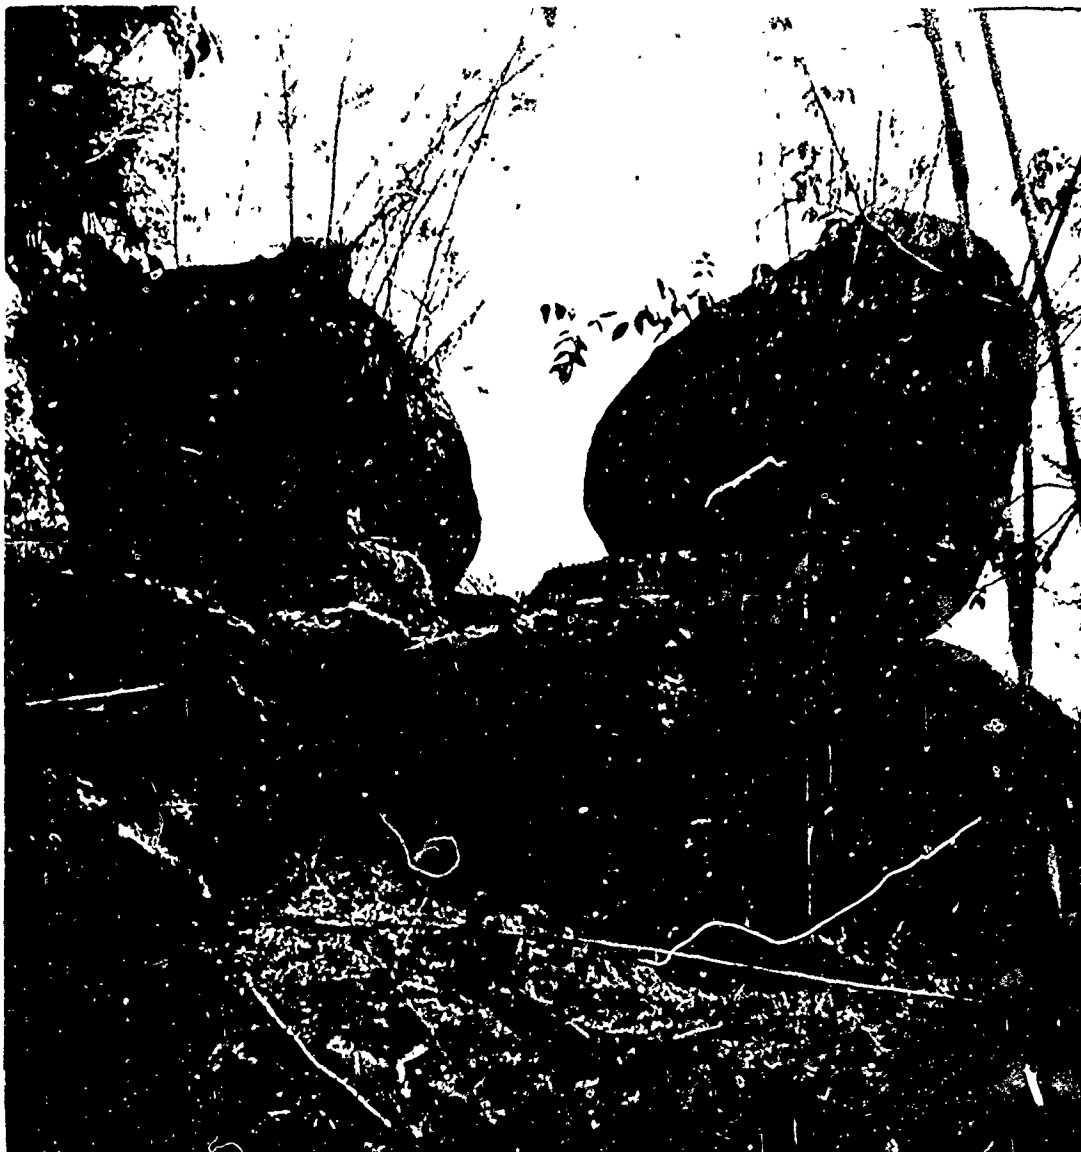
Figure 29. Hui Hin study area: Large rocks and outcrops at crest of hill. Rocks and outcrops at crest of hill on which traverse #54 was made.

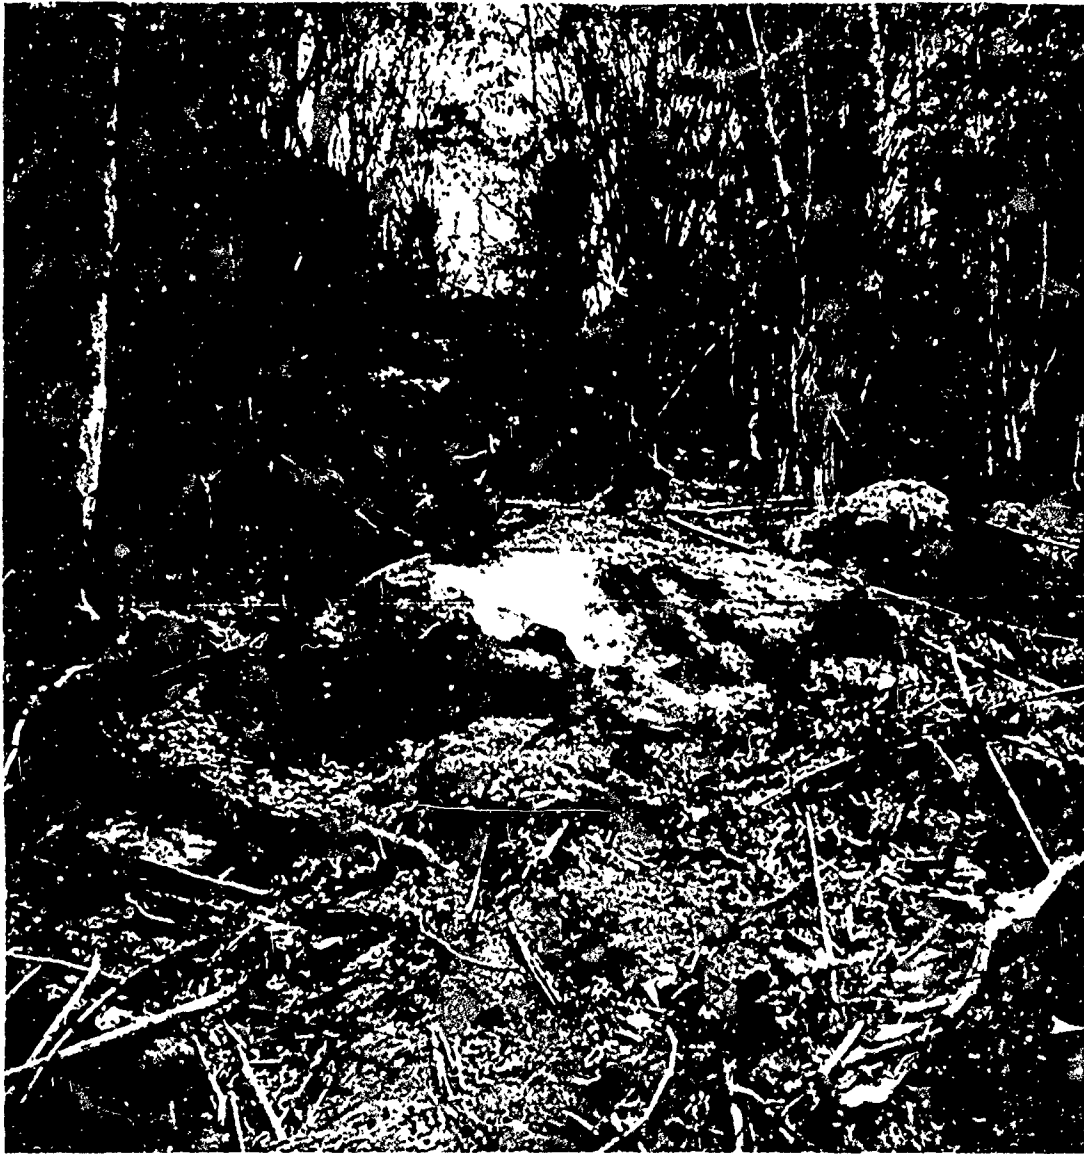
Figure 30. Hua Hin study area: Large rocks and outcrops near top of hill. Large rocks and outcrops cover about 75 to 90 percent of the surface near the upper limit of traverse #59.
