TECHNICAL REPORT

71-53-ES

THAILAND HILL AND MOUNTAIN SLOPE ANALYSIS:  
DESIGN AND TESTING CONSIDERATIONS

Earth Sciences Laboratory  
U.S. ARMY NATICK LABORATORIES  
Natick, Massachusetts  
01760

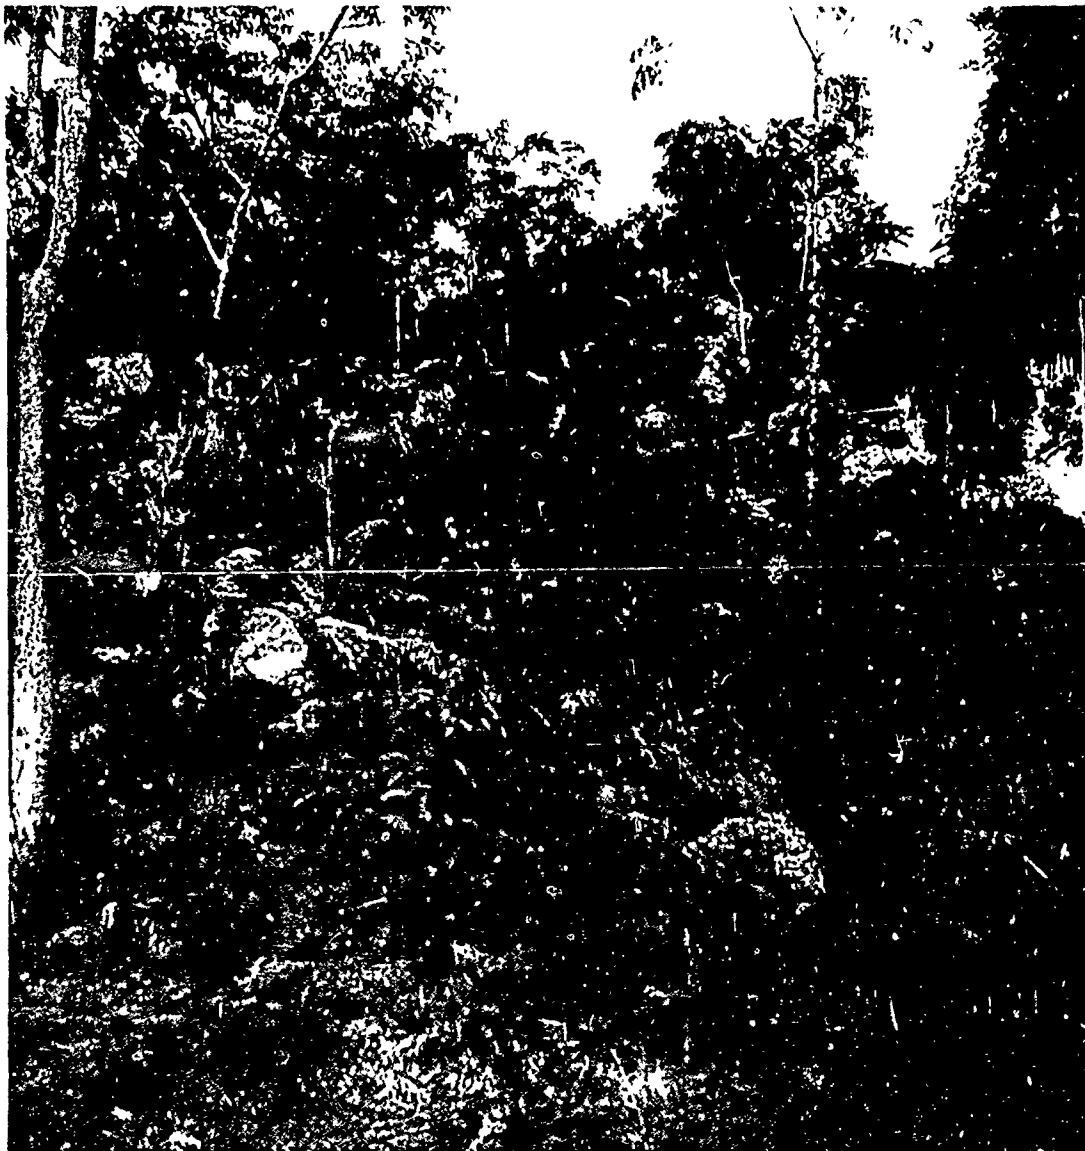
Figure 31. Hua Hin study area: Large rocks and outcrops on 10 degree slope segment. Large rocks and outcrops on 10 degree slope segment at site #15 of traverse #72.

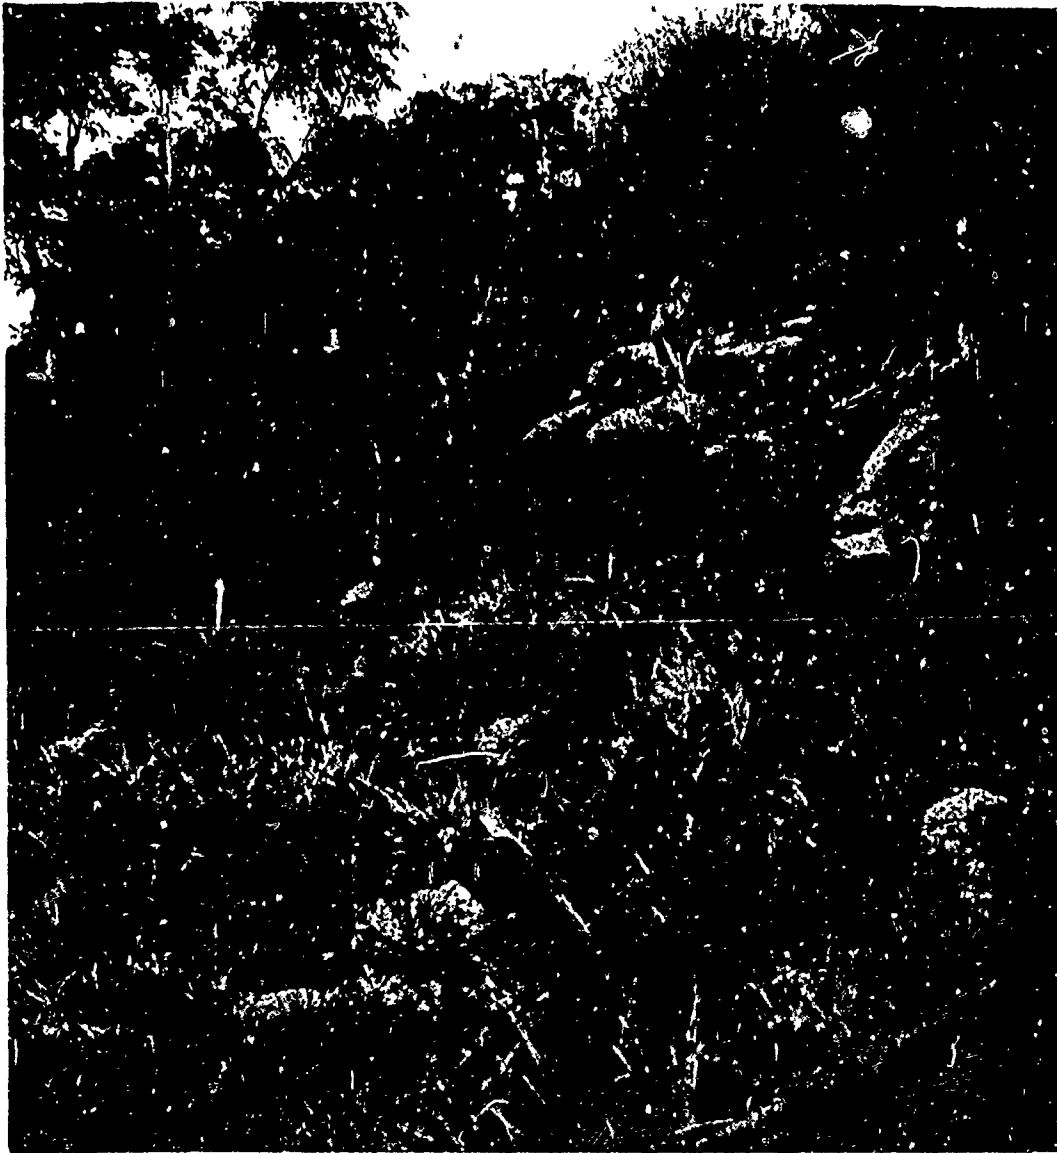
Figure 32. Hua Hin study area: Large rocks and outcrops on 18 degree slope segment. The majority of the rocks and outcrops range in size from a small suit case to a small size foreign car. The slope segment is near site #23 of traverse #73.

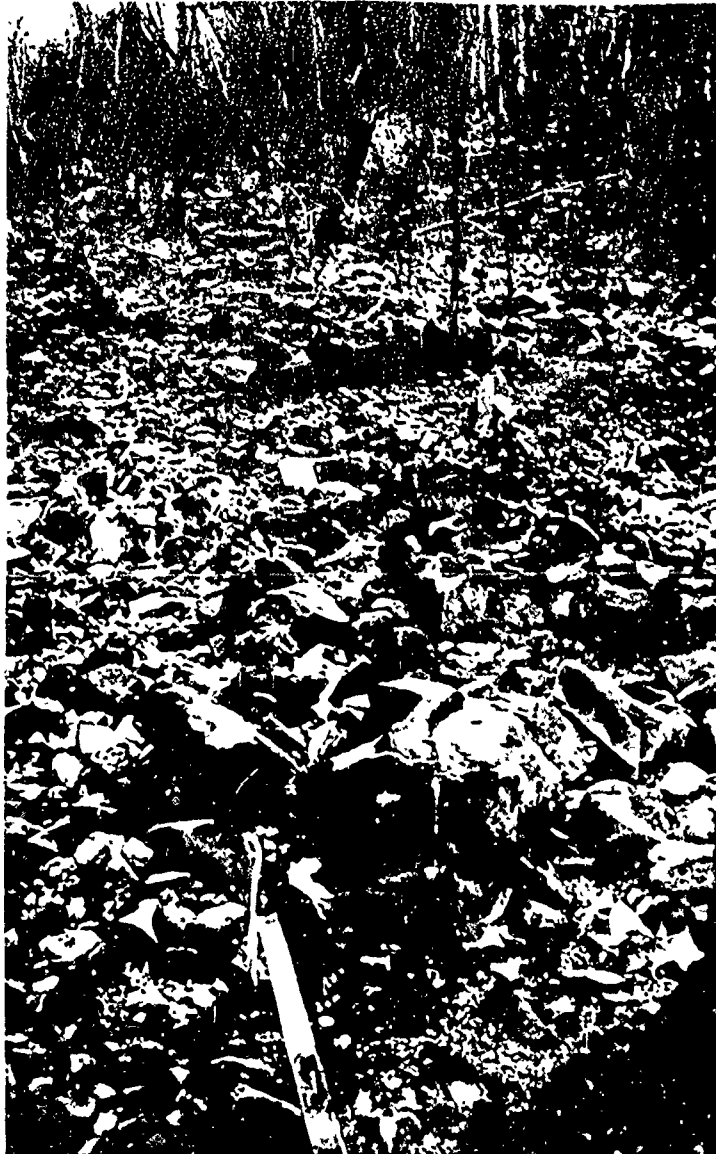
Figure 33. Hua Hin study area: Segment of slope covered with small sandstone rocks. Twenty-three degree gradient slope segment nearly 100 percent covered by small rocks between sites #25 and #26 of traverse #15. This slope had recently been burned over. Many of the rocks had fresh surfaces where they had been split open by the intense heat of the fire.

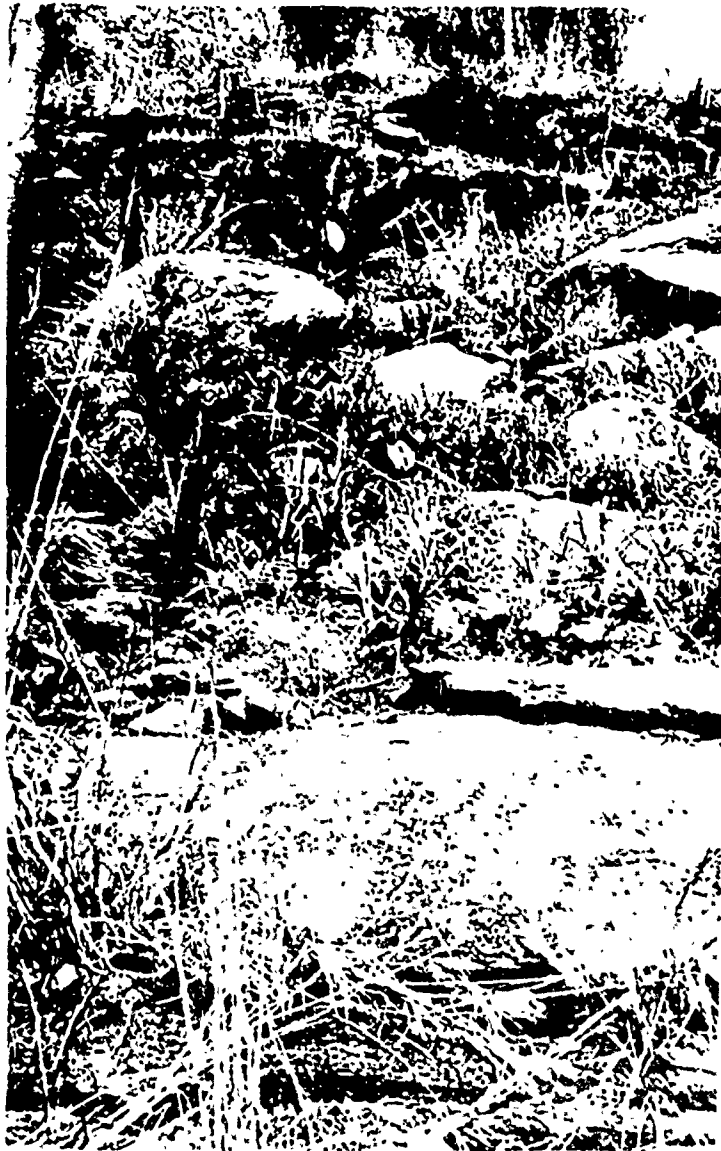
Figure 34. Hua Hin study area: Large rocks and discontinuous cliffettes on a 34 degree slope segment. Picture shows surface features on slope between sites #9 and #10 of traverse #21.

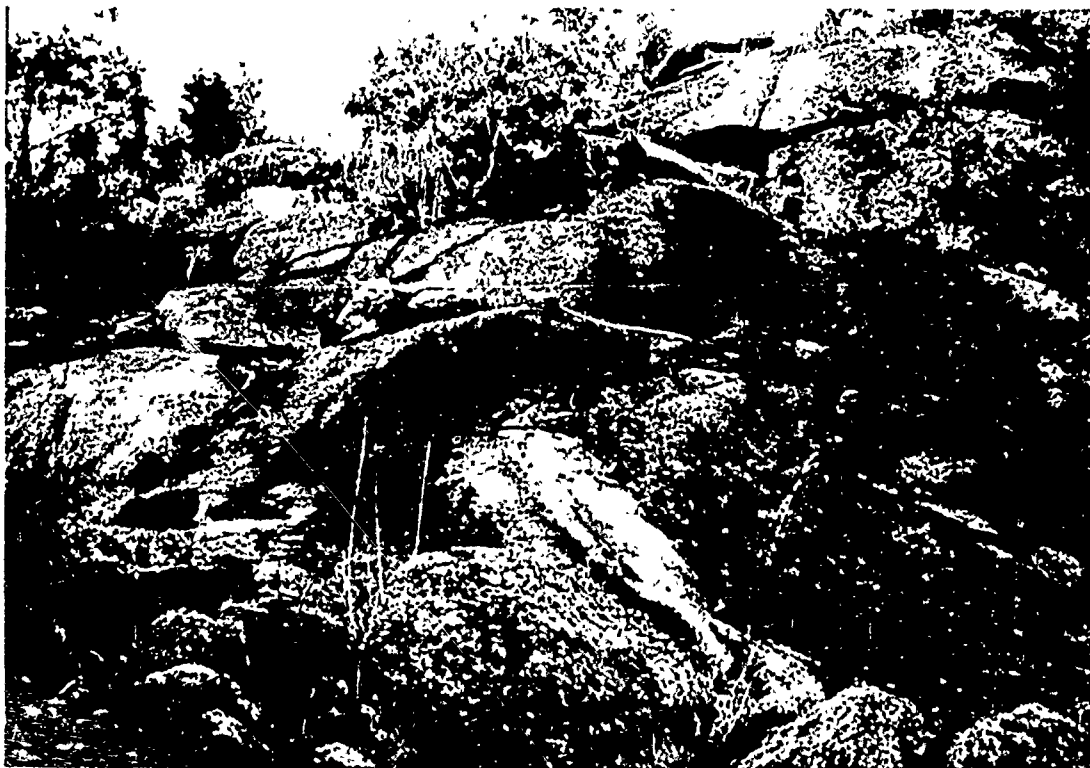
Figure 35. Hua Hin study area: Large granite blocks, outcrops, and discontinuous vertical to nearly vertical cliff-ettes on a 31 degree slope segment. Picture shows surface features at site #6 of traverse #76.

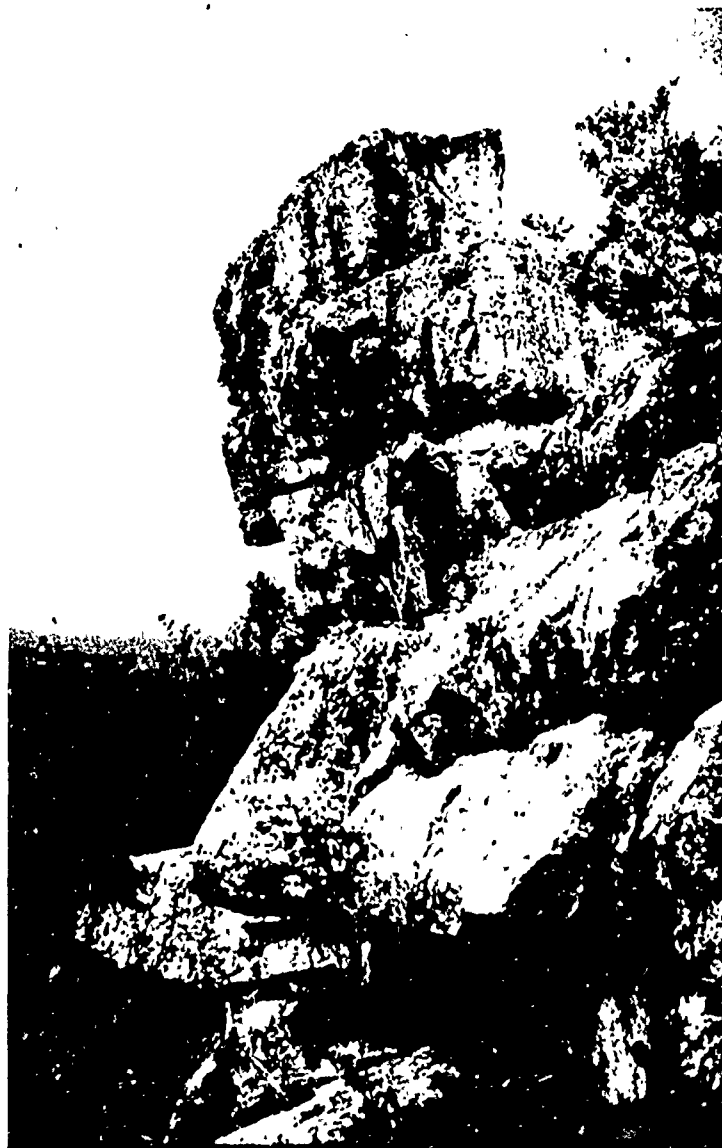
Figure 36. Hua Hin study area: Massive quartz ridge crest with nearly vertical to vertical and overhanging sections. Narrow quartz ridge crest between traverse #77 and #78.

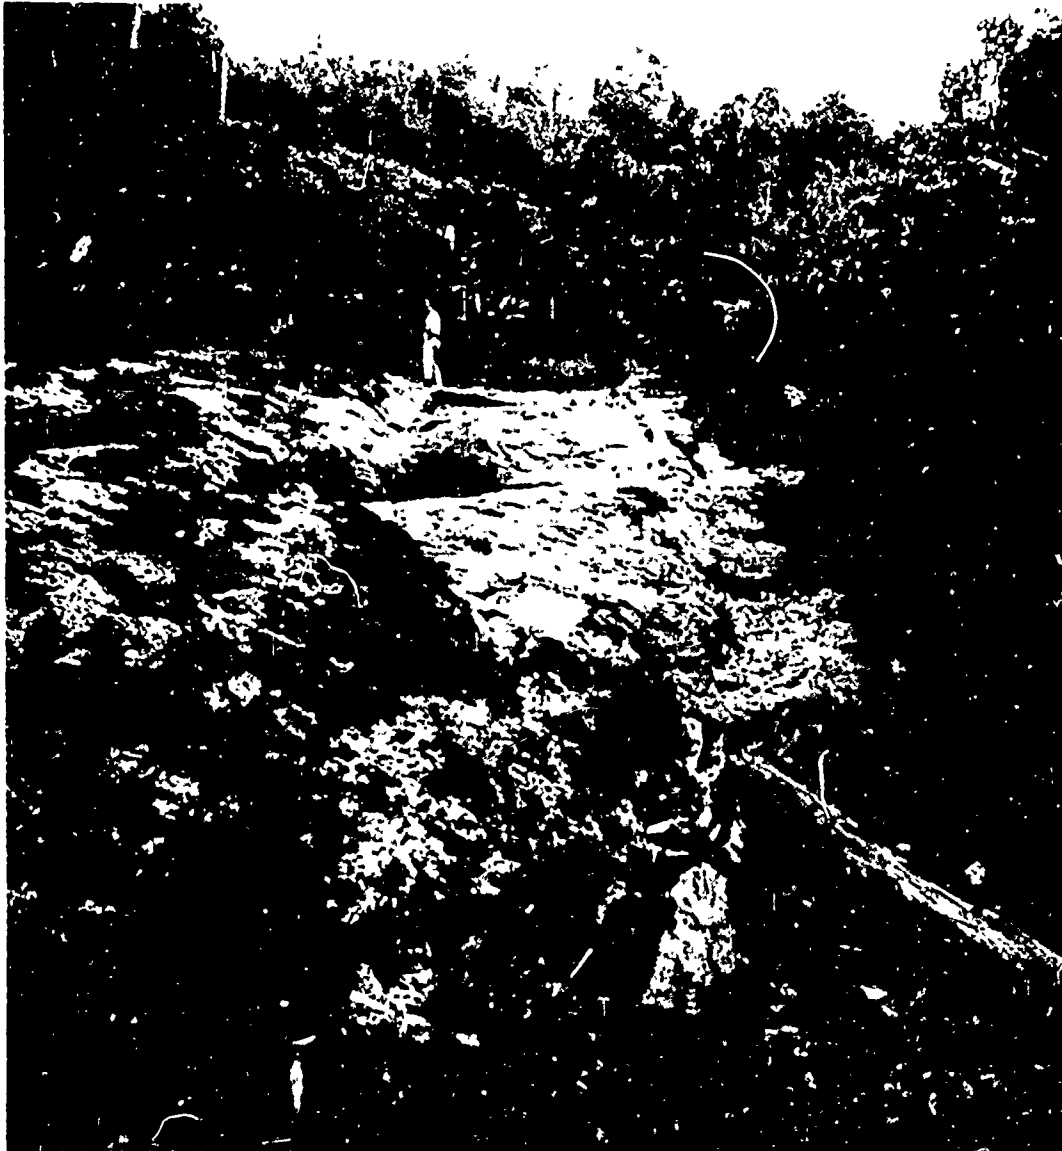
Figure 38. Ranong study area: Mountain slope with granite surface and tropical rain forest vegetation. Picture shows part of traverse #61; bedrock surface is near site #13, and the gradient is around 15 degrees through this section.

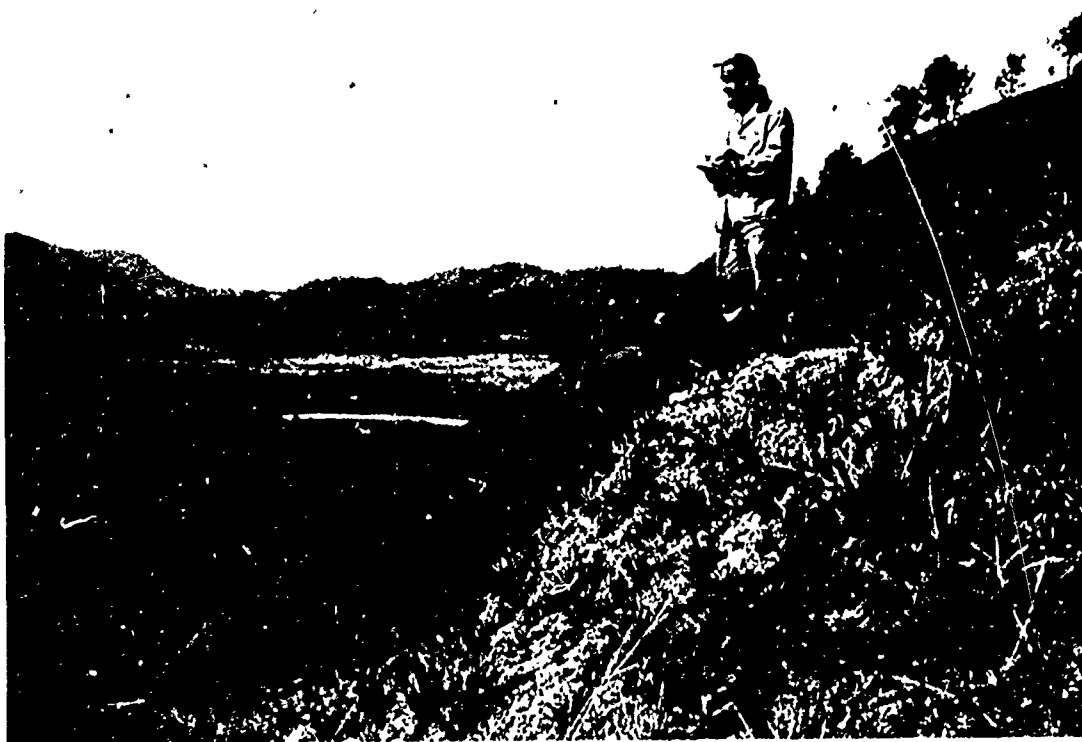
Figure 39. Ranong study area: Steep hill slope with terracettes on west side of the main highway. Terracettes on a 29 degree slope at site #36 of traverse #1. Mountains in background are granitic and on the east side of the main highway.

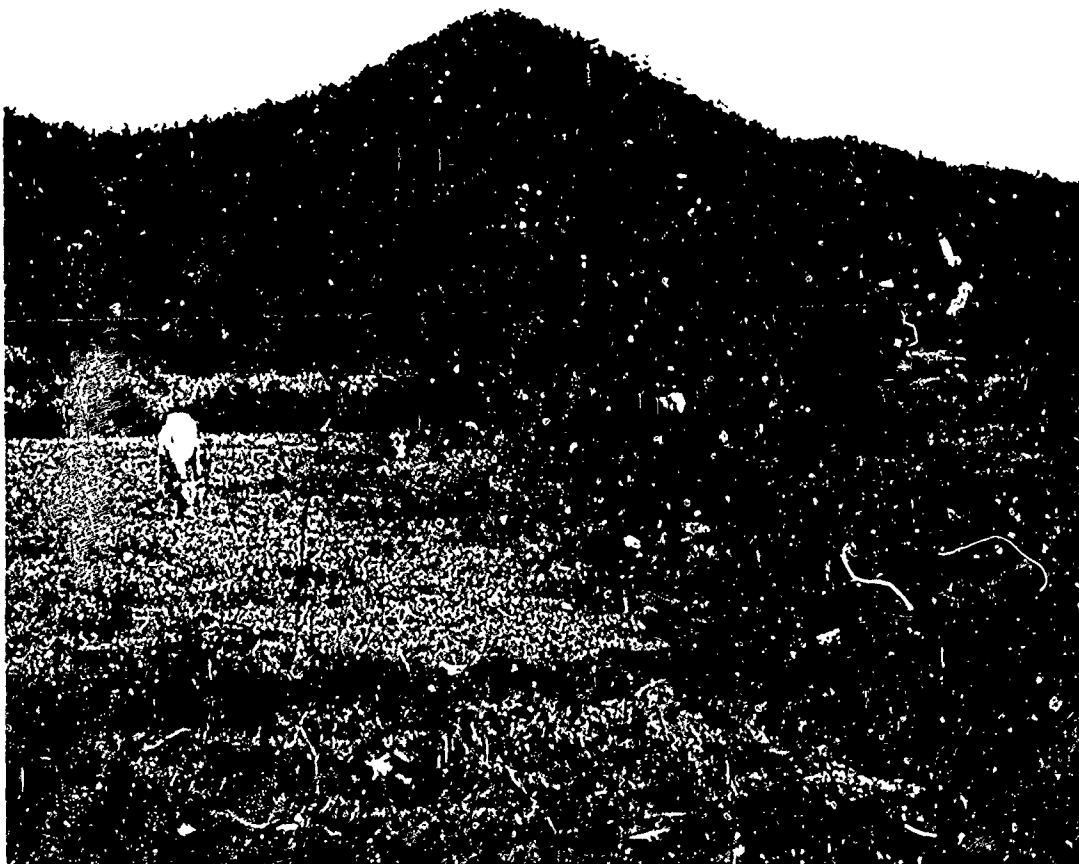
Figure 42: Chiang Mai study area: Quartzitic hills with marked break-in slope at base of hill on eastern margin of Chiang Mai Valley.

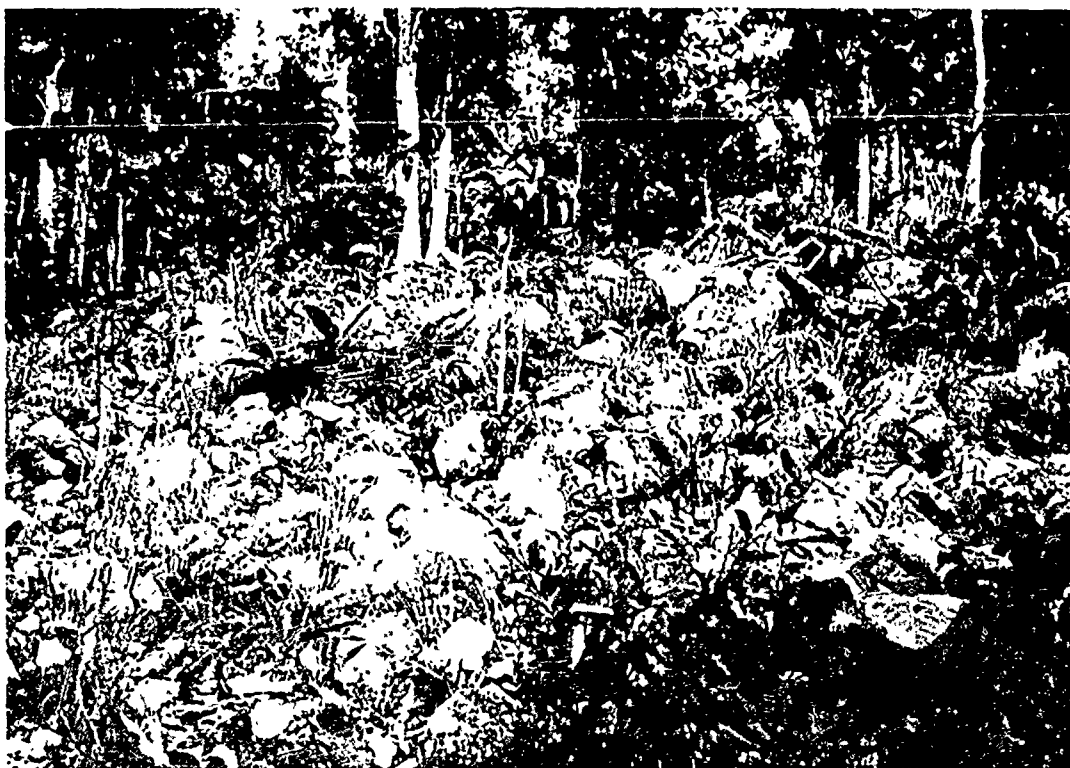
Figure 43. Chiang Mai study area: Quartzitic outcrops and rocks on a 20 degree slope segment. The majority of the outcrops and rocks on this slope segment range in size from about 6 inches square to about 5 feet square.

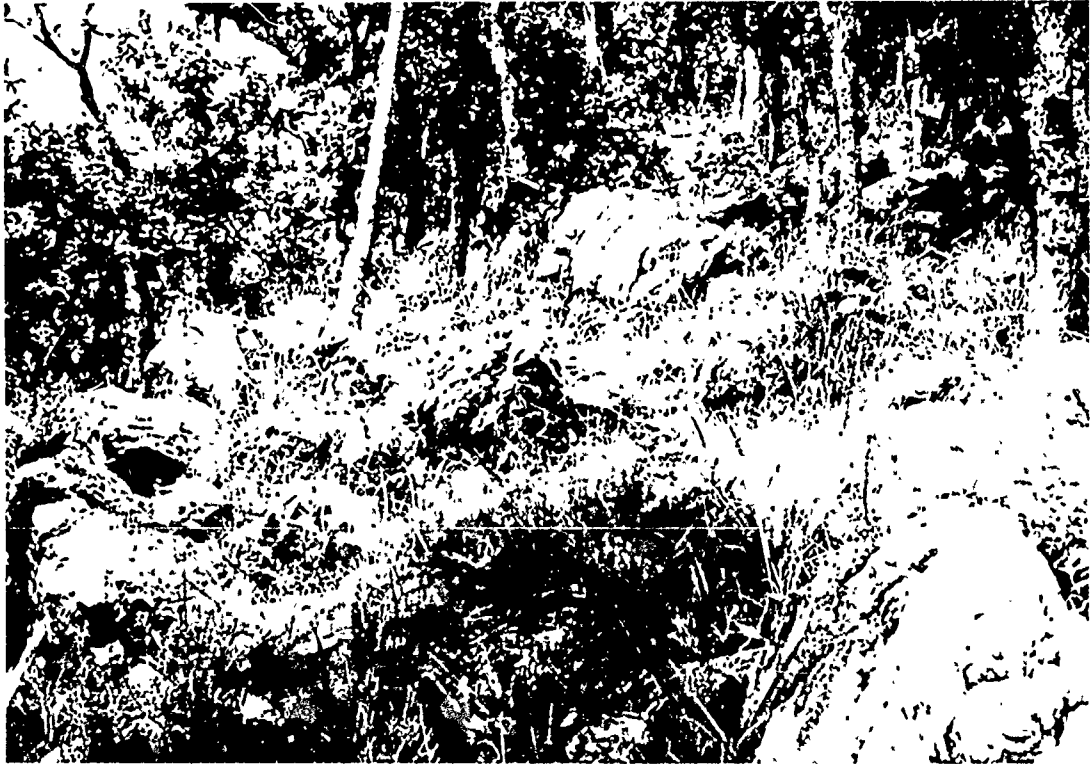
Figure 44. Chiang Mai study area: Quartzitic outcrops and rocks on a 25 degree slope segment. The majority of the outcrops and rocks on this slope segment range in size from a large suitcase to a standard size government office desk. This slope segment is near site #21 of traverse #61.

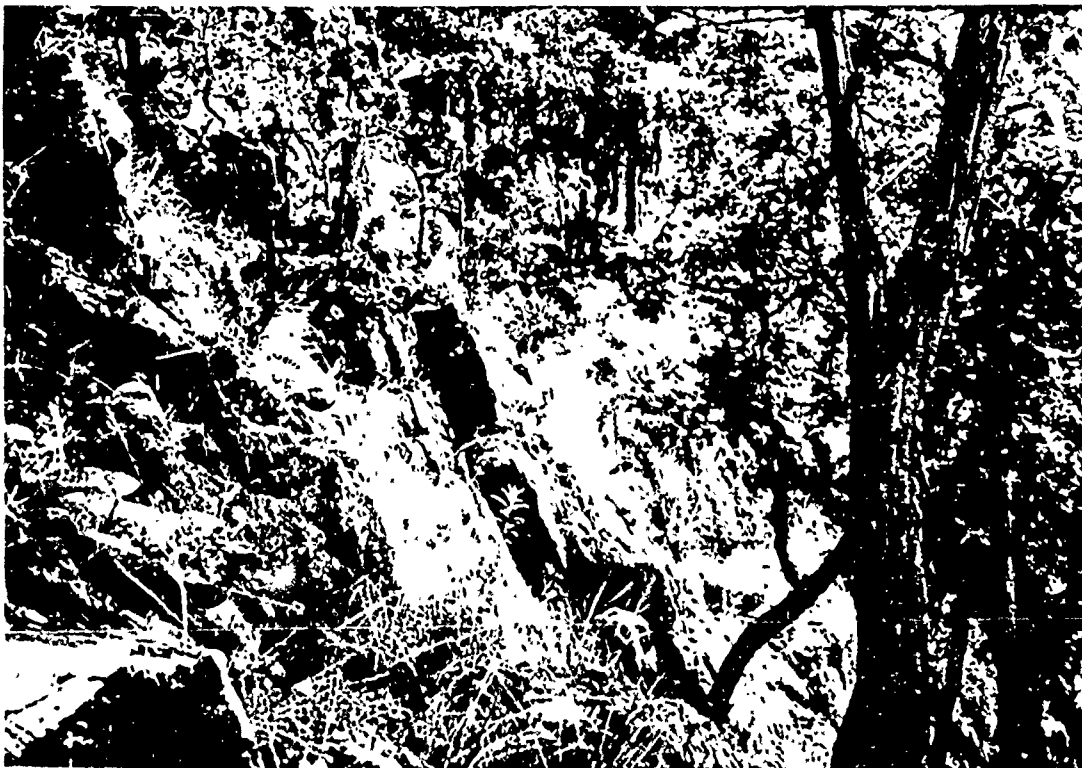
Figure 45. Chiang Mai study area: Five feet high quartzitic cliffettes on a 41 degree slope segment. This slope segment is near site #6 of traverse #62.

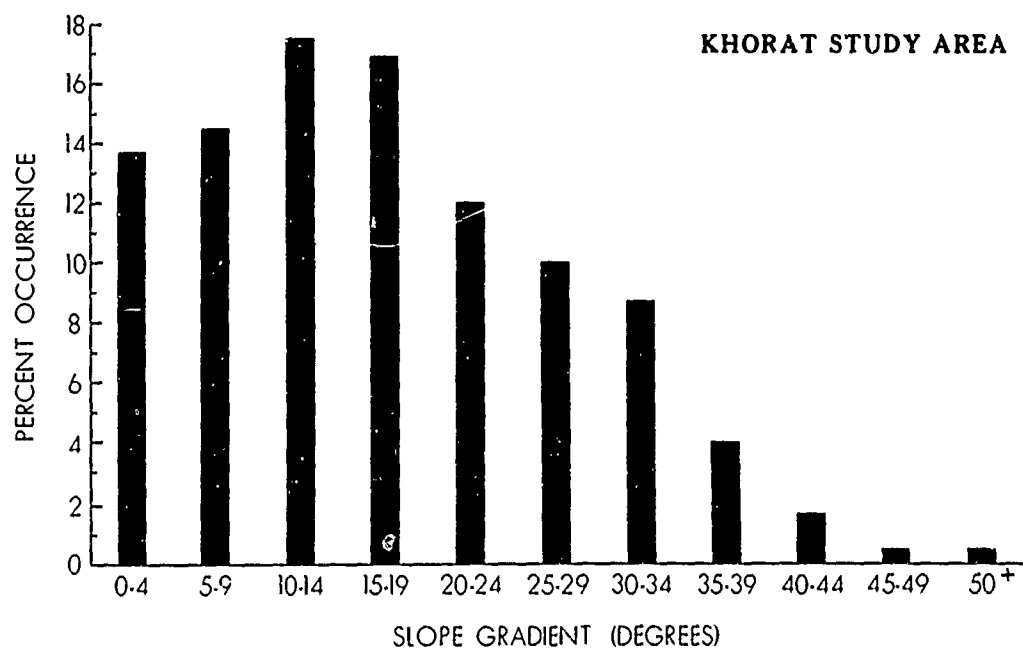
# PERCENT OCCURRENCE OF SLOPE GRAD
