FAA Technical  
Report No. FS-70-601-120A

# THE EFFECTS OF 2,2 DICHLOROVINYL DIMETHYL PHOSPHATE (DDVP) USED AS AN AIRCRAFT DISINSECTANT

James W. Ross, Jr.  
Flight Standards Technical Division  
FAA Aeronautical Center  
Oklahoma City, Oklahoma

December 1971  
Final Report

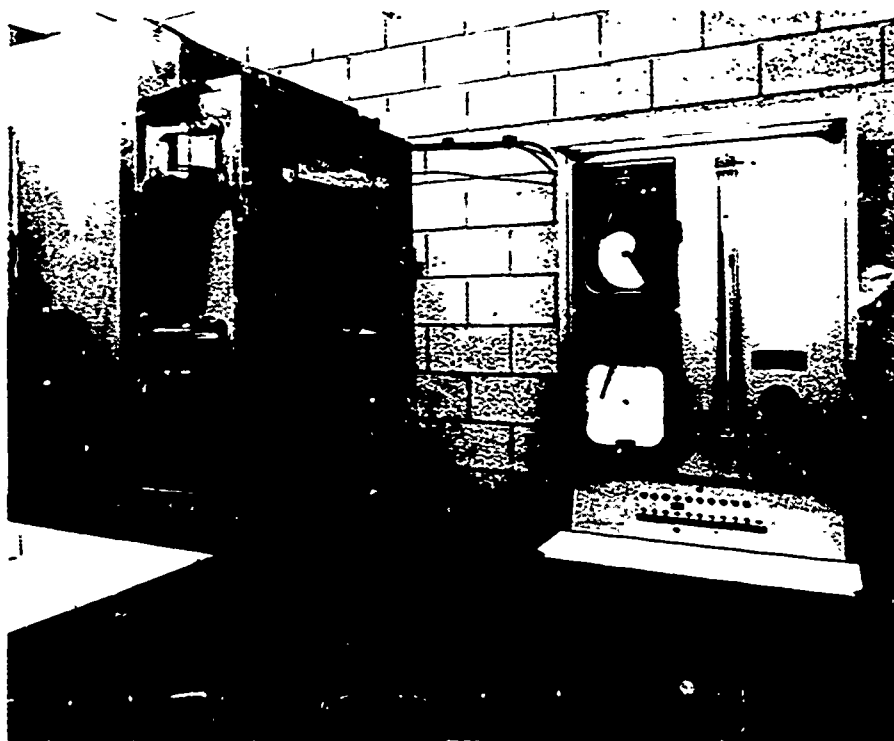
- 5.2.1 The avionics testing was conducted at the FAA Aeronautical Center, Oklahoma City, Oklahoma, using the Tenny Environmental Chamber shown in figure 5-1. The chamber served as a means of simulating conditions in an aircraft. Air flow through the chamber was regulated to provide a 4-minute air exchange rate. This rate is considered typical of modern jet aircraft. Pressure altitude was also regulated from ground level (1,280 feet) to 8,000 feet.

FIGURE 5-1: AVIONICS TEST CHAMBER

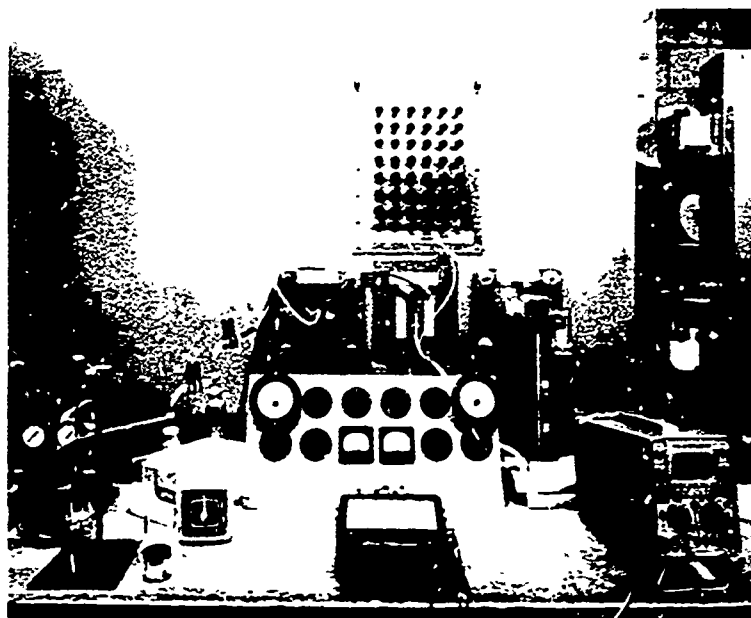
5.2.2 The system used for dispensing DDVP into the avionics test chamber was designed by TDL personnel. TDL also provided air sampling equipment for monitoring the DDVP/air concentration in the chamber. The arrangement of these units is shown in figure 5-2.

FIGURE 5-2: AVIONICS TESTING-DDVP DISPENSING UNIT AND MONITORING EQUIPMENT

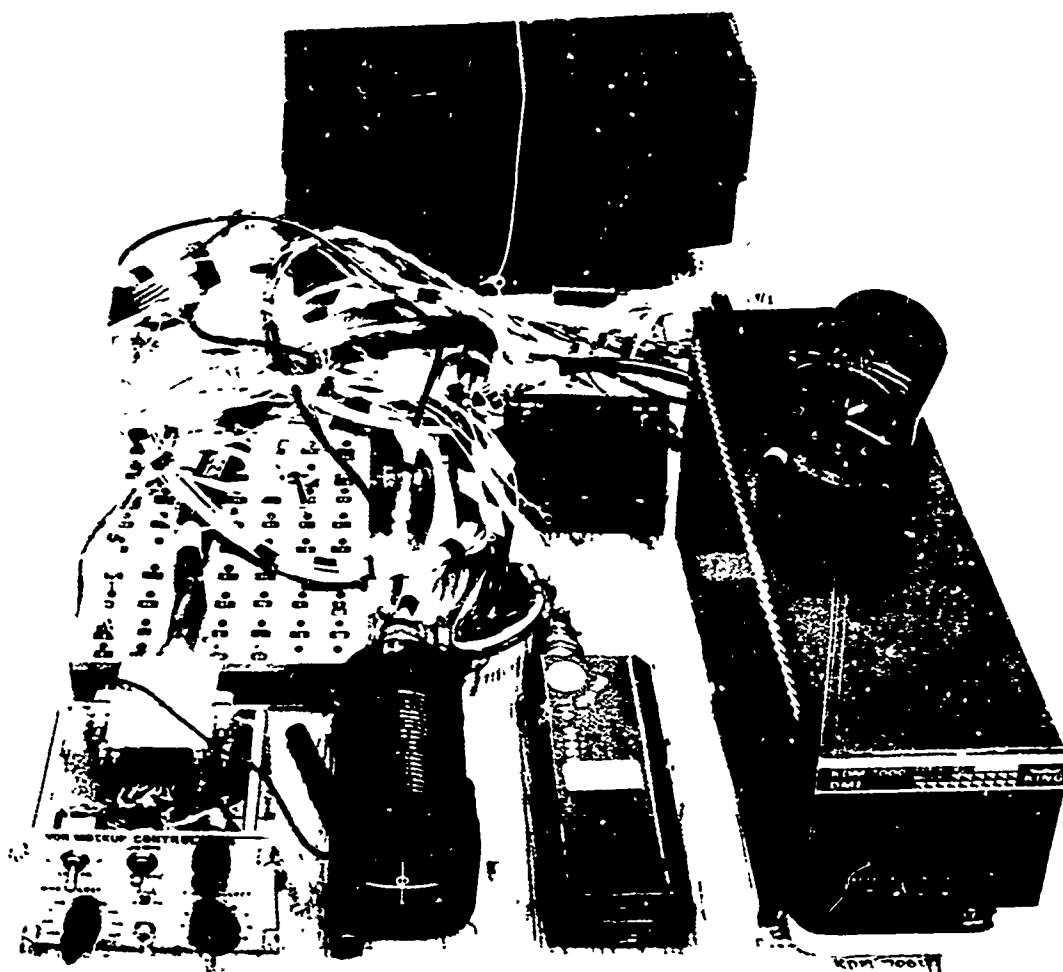
5.2.4 The avionics equipment tested is shown mounted on a plywood base plate in figure 5-3. Positioning of the equipment within the test chamber is shown in figure 5-4.

FIGURE 5-3: AVIONICS TESTING-TESTED COMPONENT ARRANGEMENT

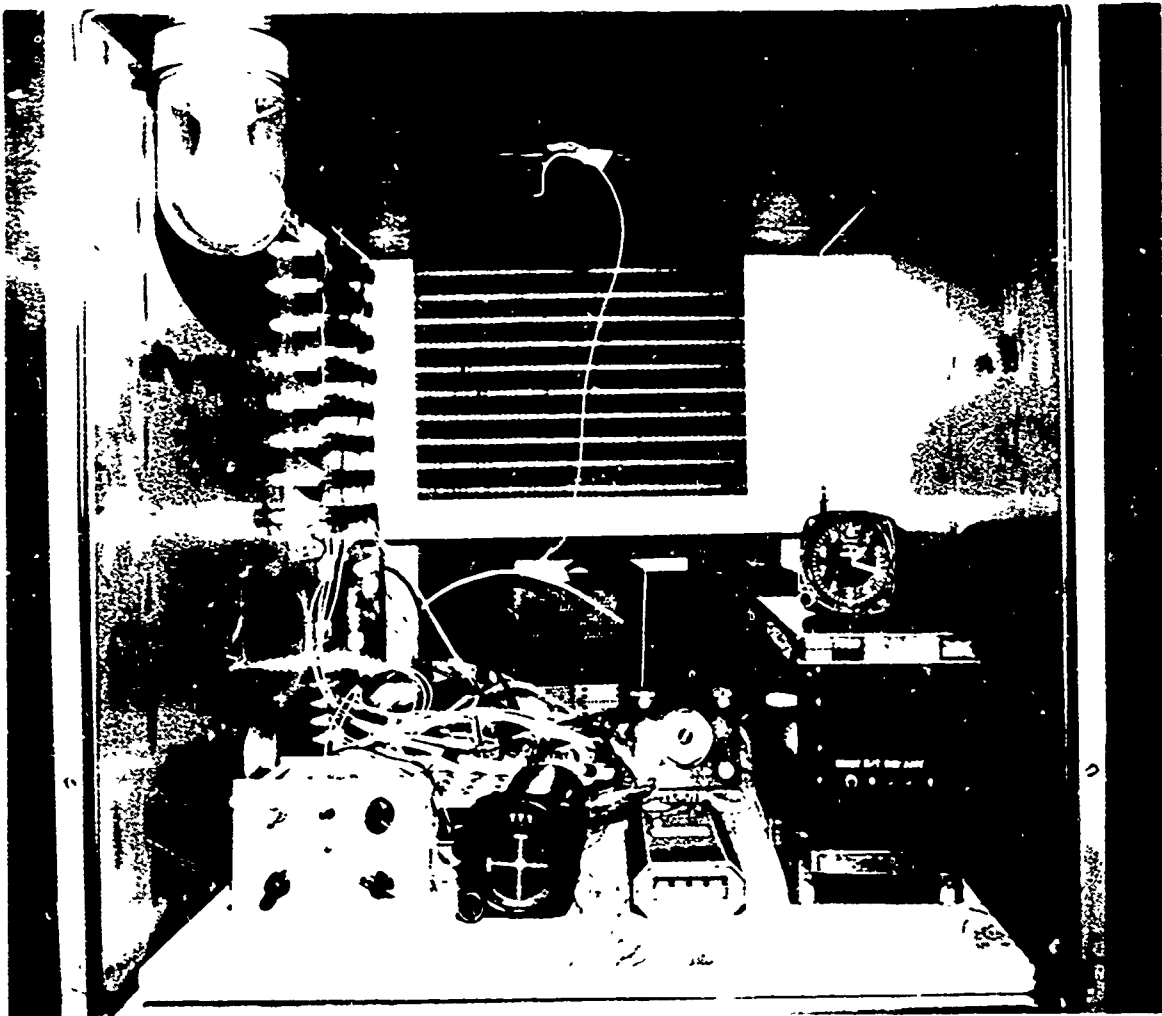
FIGURE 5-4: AVIONICS TESTING-EQUIPMENT ARRANGEMENT IN TEST CHAMBER

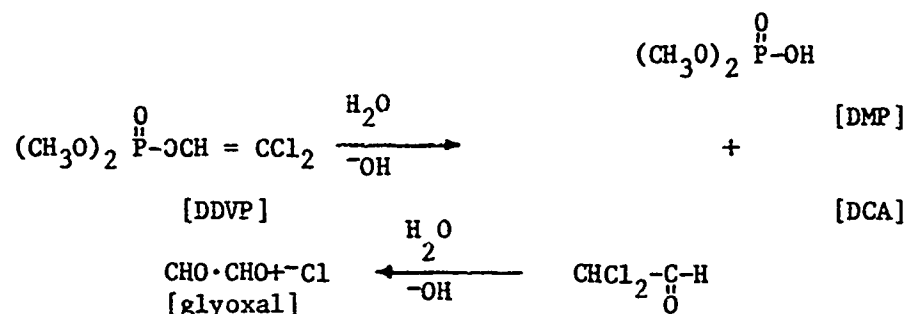
- 6.2.2 Under basic conditions, DDVP is hydrolyzed (reacts with water) rapidly to form dimethyl phosphate (DMP) and dichloroacetaldehyde (DCA).<sup>7,8</sup> The DCA is then decomposed further to form glyoxal and chlorides, as illustrated in the following equation:

### DDVP HYDROLYSIS - BASIC

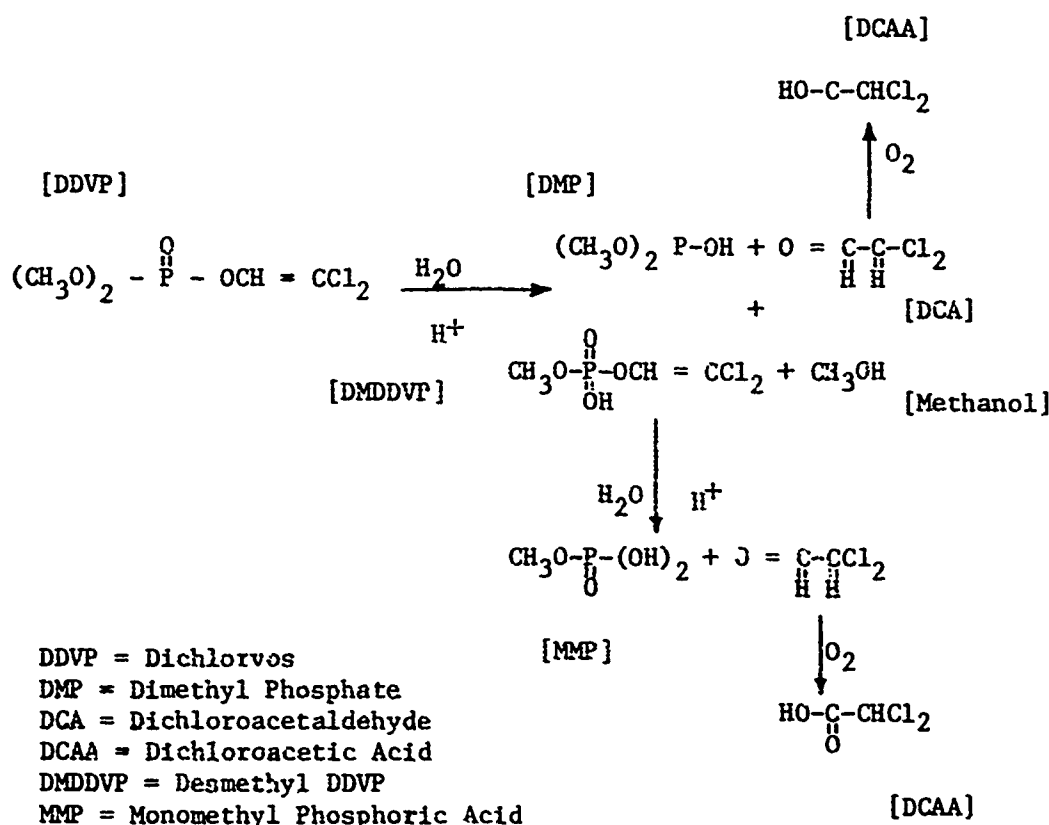
6.2.3 Under acidic conditions, the hydrolysis proceeds slowly giving principally DMP and DCA. Desmethyl DDVP [ $\text{CH}_3\text{O} \cdot \text{HO} \cdot \text{P}(\text{O}) \cdot \text{OCH} : \text{CCl}_2$ ] is also produced which further decomposes to monomethyl phosphoric acid and DCA.<sup>8</sup> Oxidation of the DCA will also occur under certain conditions to form dichloroacetic acid (DCAA). This process is illustrated by the following formula:

### DDVP HYDROLYSIS - ACIDIC

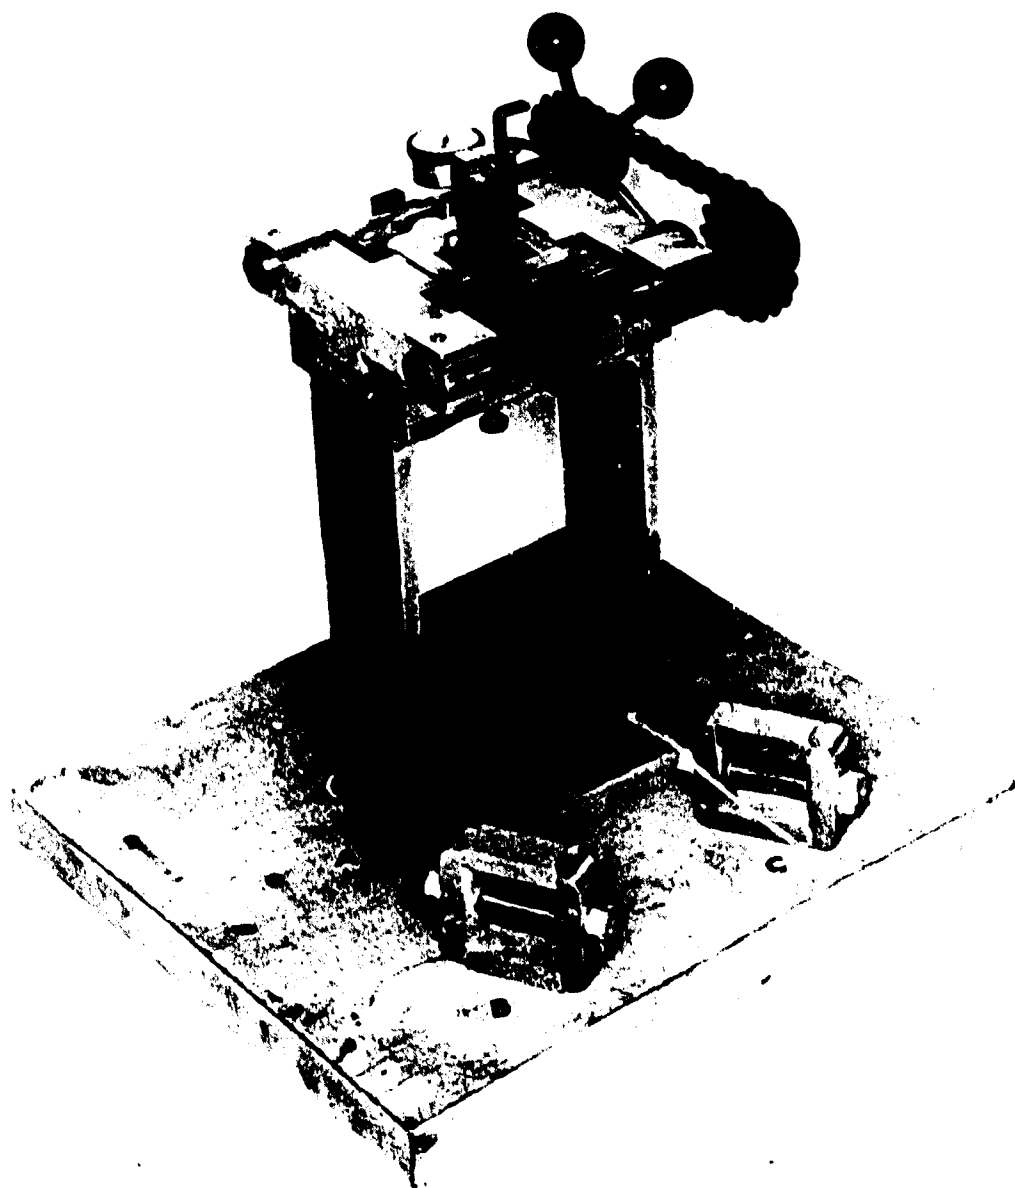
FIGURE 6-1: FIXTURE AND ASSEMBLIES FOR STRESSING ROUND TENSILE SPECIMENS  
[NASA TMX-64617]

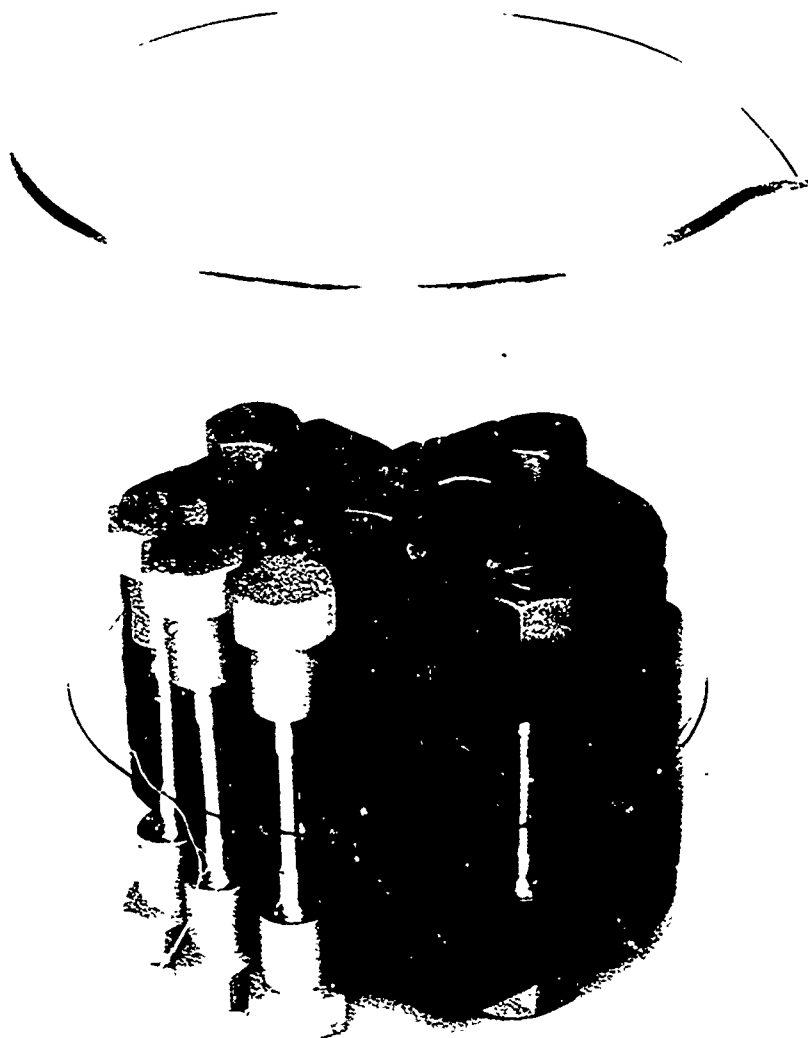
FIGURE 6-2: STRESS CORROSION  
EXPOSURE METHOD  
[NASA TMX-64617]

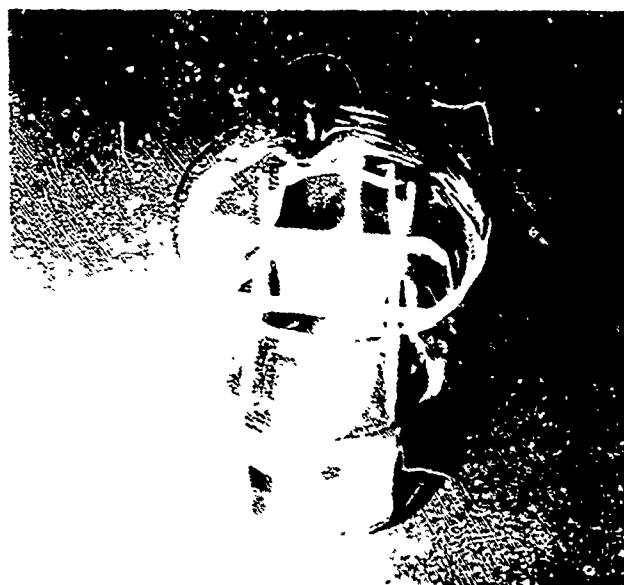
- 6.3.24 A typical test setup for the electrochemical tests is shown in figure 6-3. Figure 6-4 shows the electrochemical and "weight loss" tests in progress.

FIGURE 6-3: ELECTROCHEMICAL CORROSION TEST SETUP

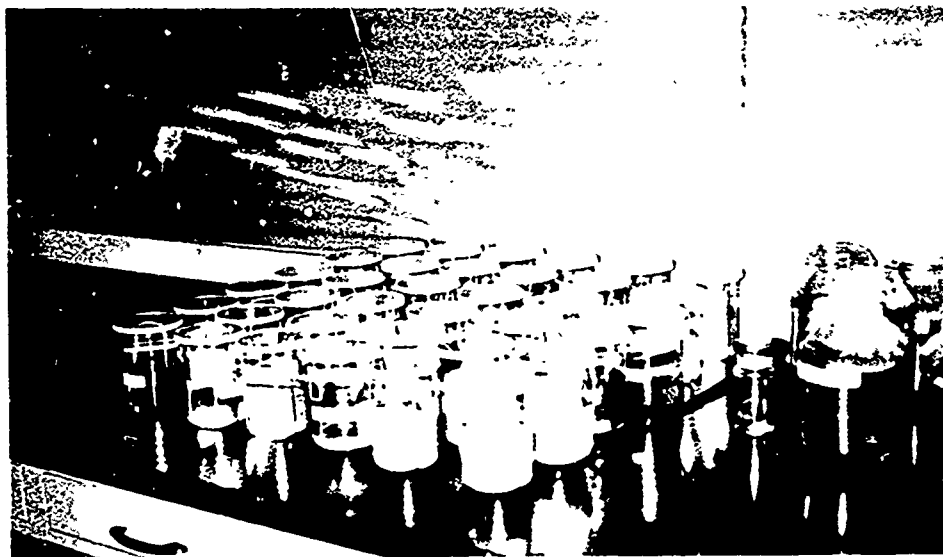
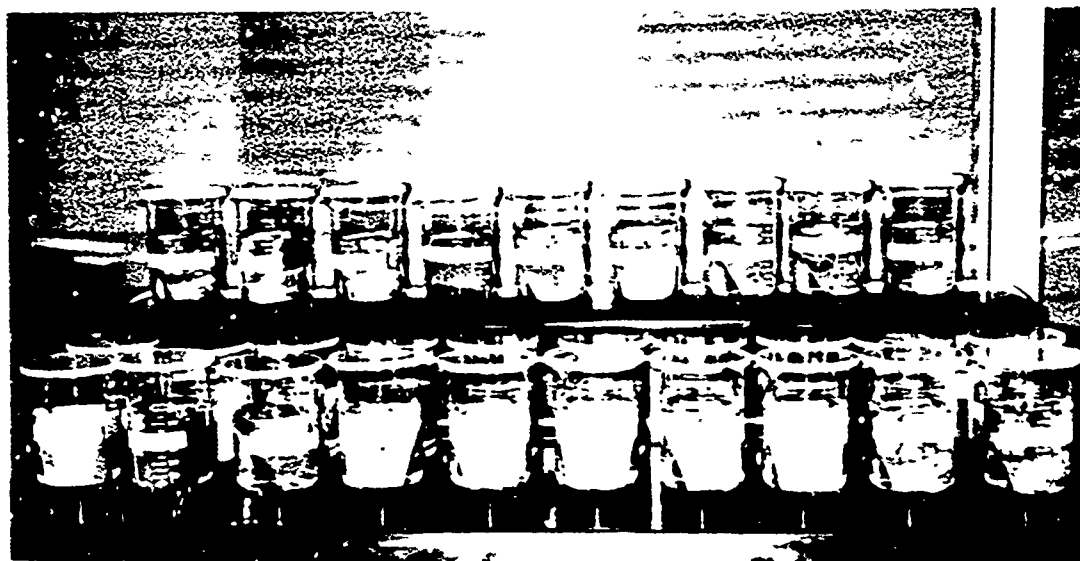
FIGURE G-4: DDVF CORROSION TESTING AT TINKER AFB, OKLAHOMA

(a) Electrochemical Tests

(b) Weight Loss Tests

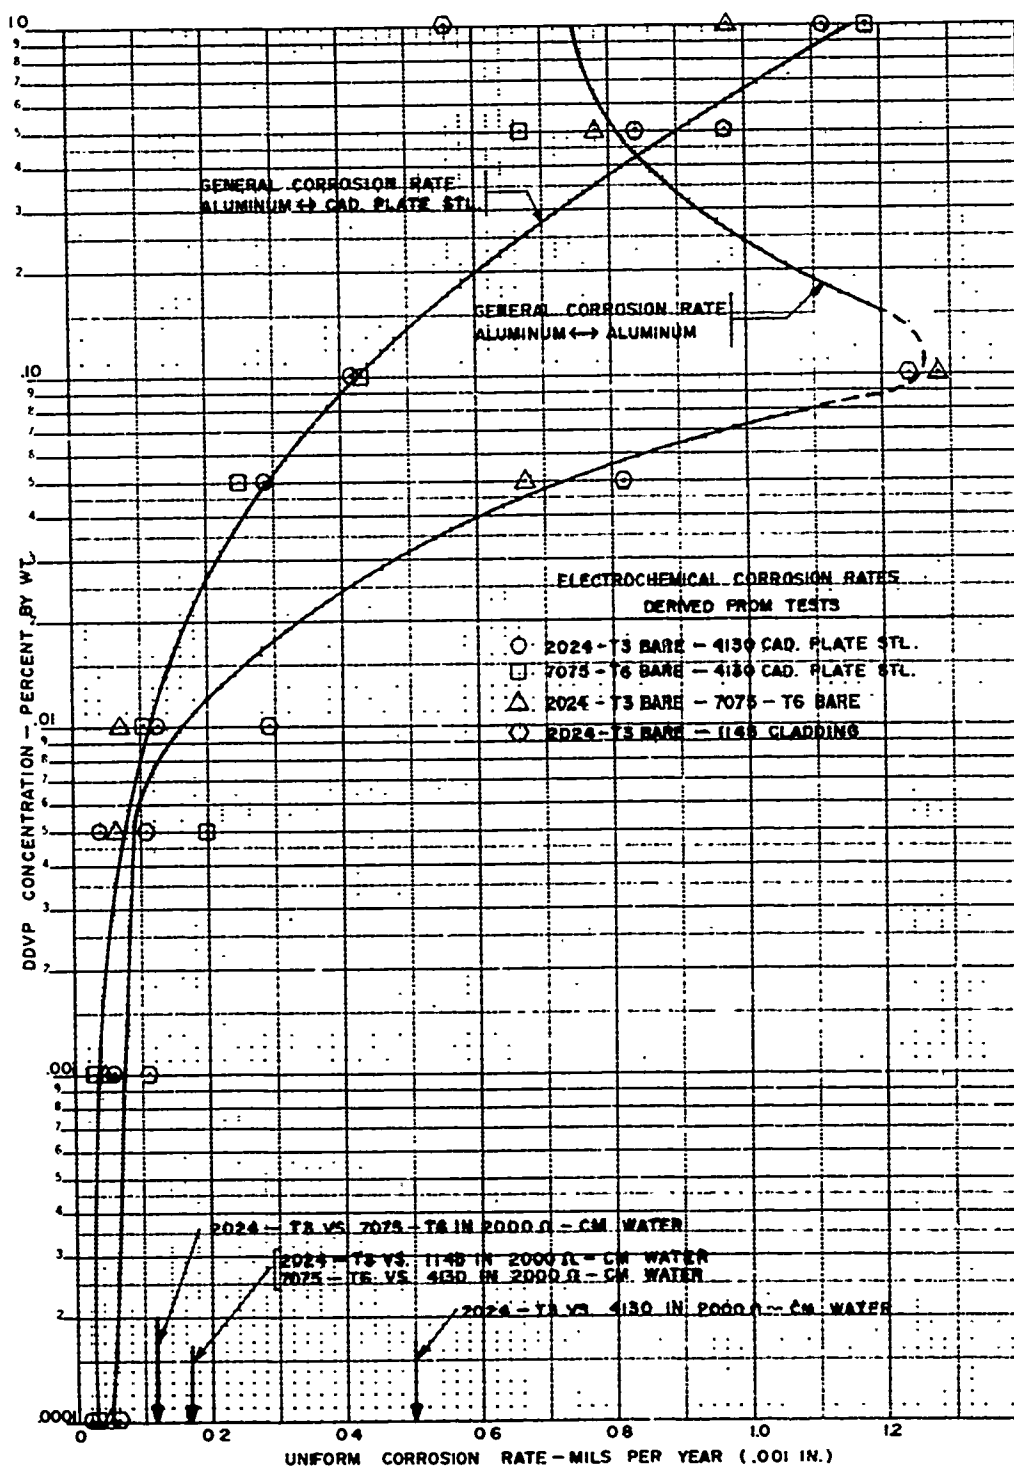
FIGURE 6-5: ELECTROCHEMICAL CORROSION RATES FOR DDVP CONCENTRATIONS - Experimental

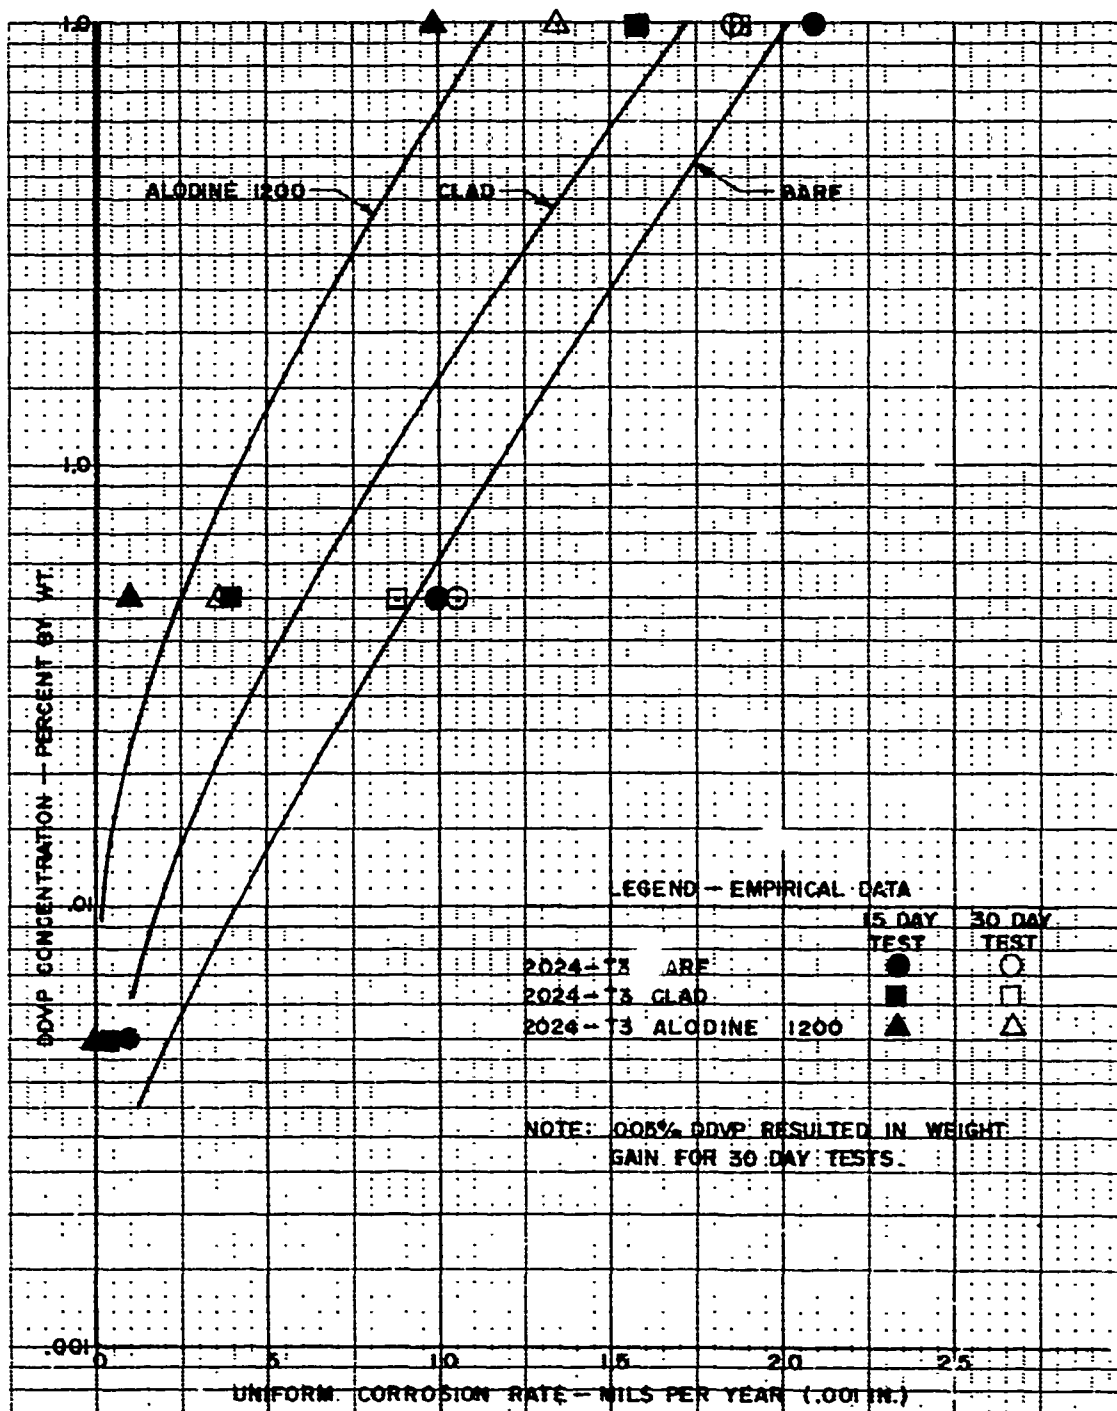
FIGURE 6-6: 2024-T3 ALUMINUM - CORROSION RATE VS. DCVP CONCENTRATION - EFFECTS OF PROTECTIVE COATINGS. [DCVP Wt. Loss Corrosion Tests]

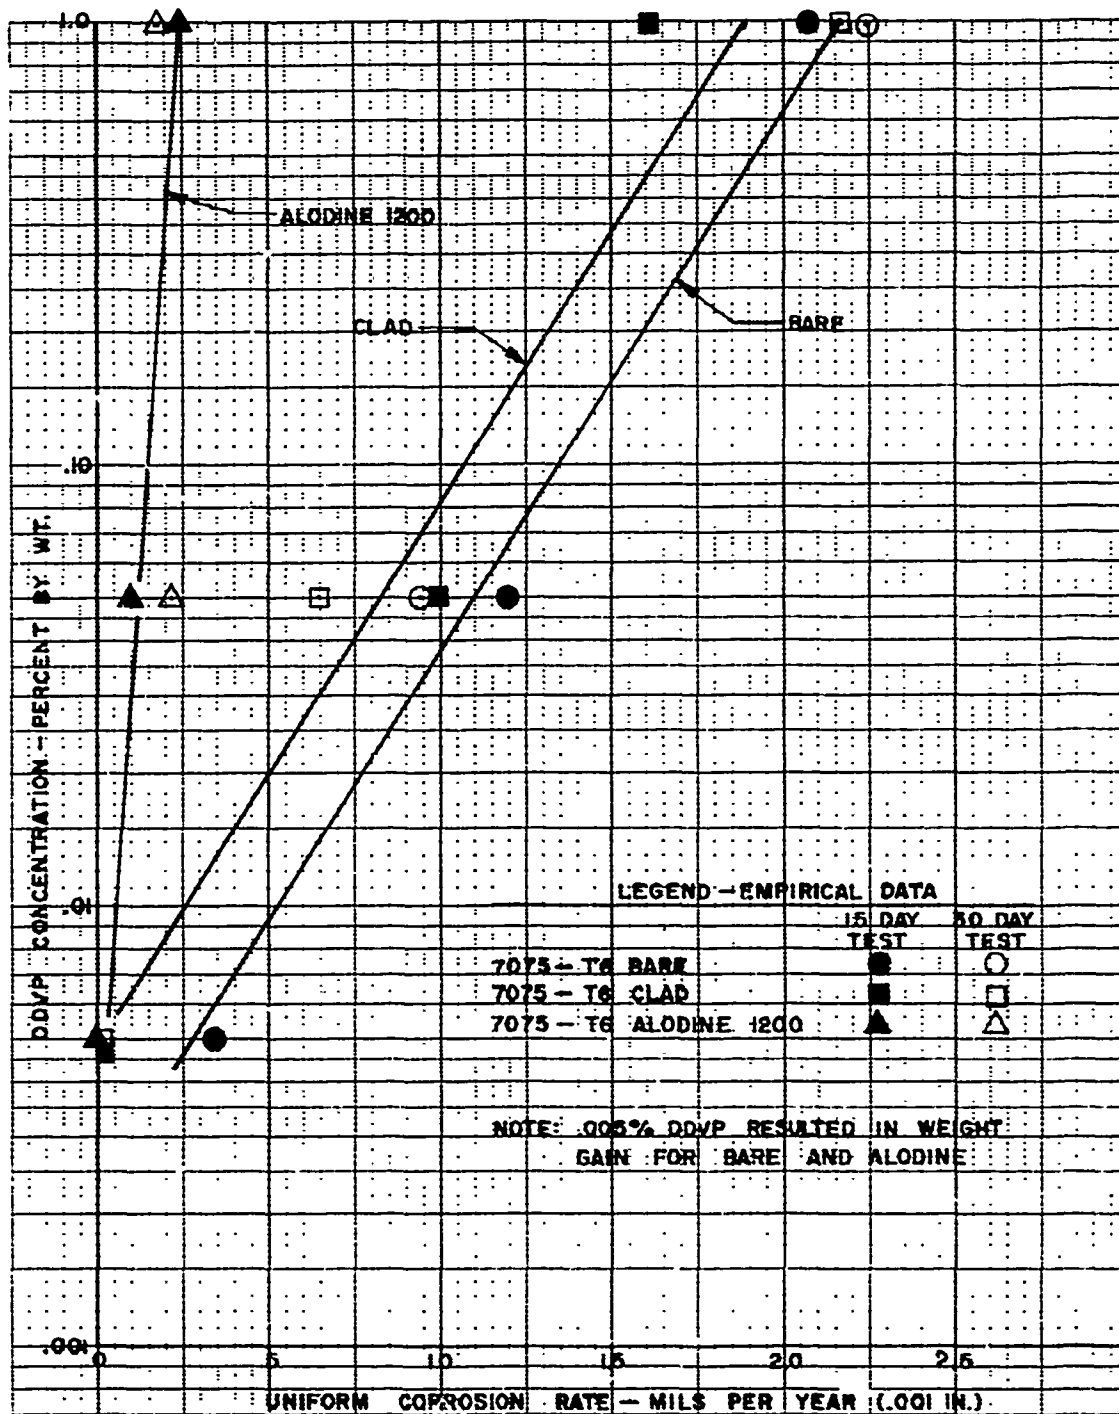
FIGURE 6-7: 7075-T6 ALUMINUM - CORROSION RATE VS. DDVP CONCENTRATION - EFFECTS OF PROTECTIVE COATINGS. [DDVP Wt. Loss Corrosion Tests]

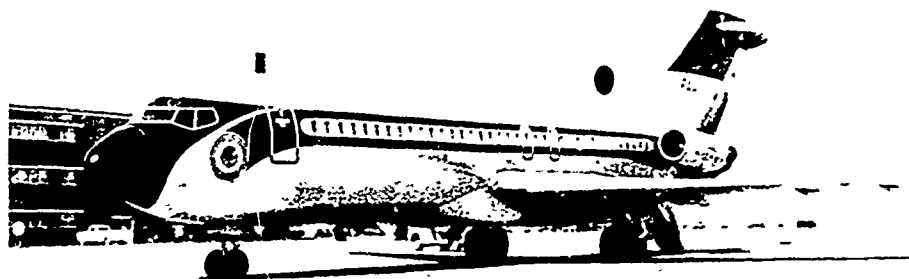
- 6.4.4 All DDVP flight testing was conducted in the FAA's Boeing 727 aircraft shown in figure 6-6. This aircraft is based at the FAA Aeronautical Center. It is operated by the FAA Academy for flight training purposes. Use of the aircraft for DDVP testing was limited to the normal flight training schedule on a non-interference basis. Consequently, the DDVP testing was incorporated with scheduled cross-country area navigational training flight. These flights were selected because commercial routes and flight profiles were followed, and three to four takeoffs and landings at commercial airports were involved. This combination offered representative airliner environments plus the opportunity to investigate the consequences of successive disinsections.

FIGURE 6-8: DDVP FLIGHT TEST AIRCRAFT FAA B-727

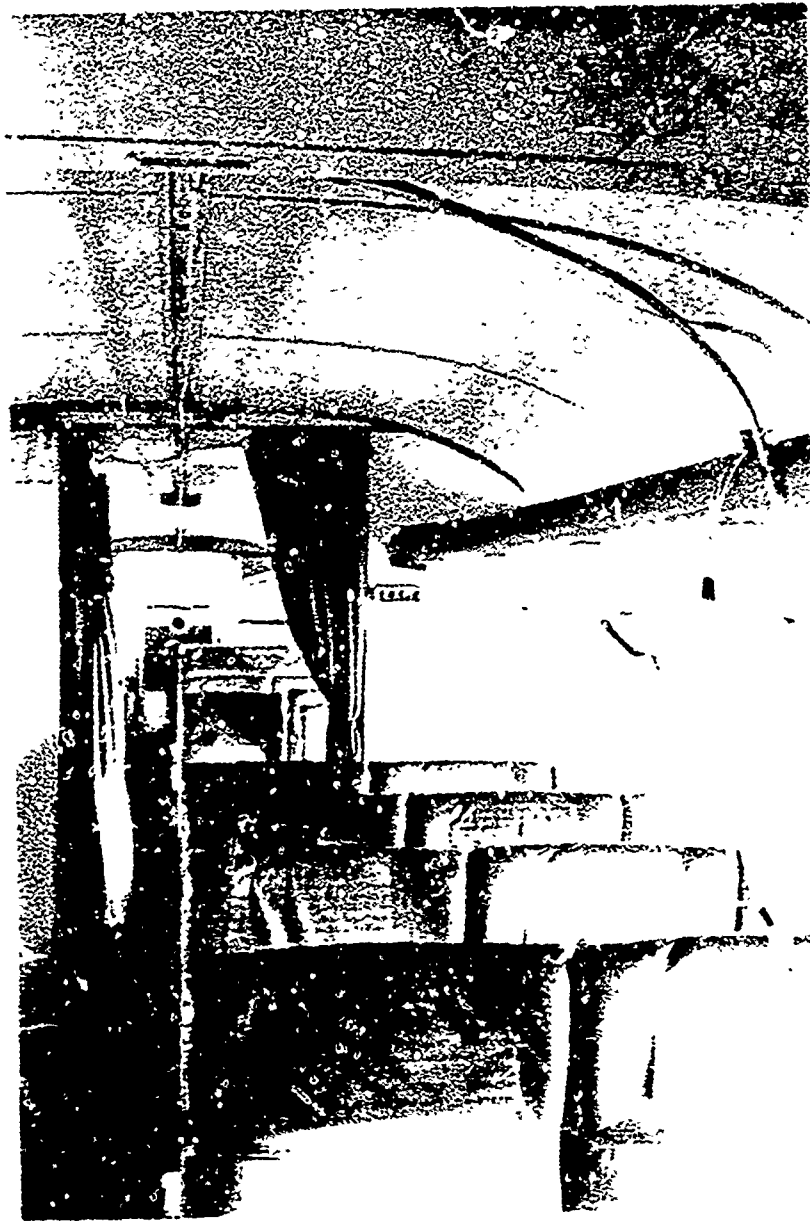
6.4.6 Configuration of the FVA B-727 cabin was representative of an air carrier configuration with a full complement of seats, galleys, coat closets, etc., as shown in figures 6-9 and 6-10.

FIGURE 6-9: DDVP FLIGHT TEST CABIN CONFIGURATION LOOKING AFT

6.4.7 Figures 6-9 and 6-10 also show the arrangement of the DDVP dispensing manifold suspended from the cabin ceiling centerline. This manifold extended from station 440 to station 1100 with orifices every 40 inches. The manifold was electrically heated to approximately 130°F while DDVP was being dispensed.

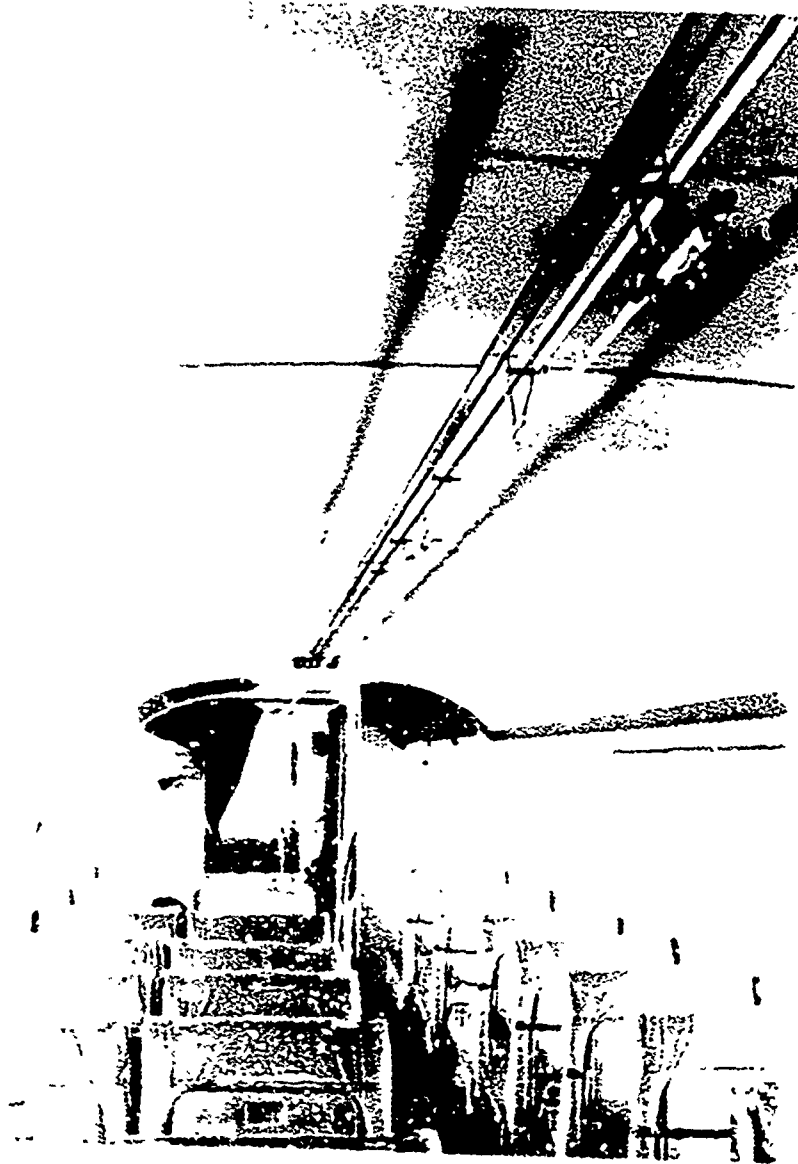
FIGURE C-10: DDVP FLIGHT TEST CABIN CONFIGURATION LOOKING FORWARD

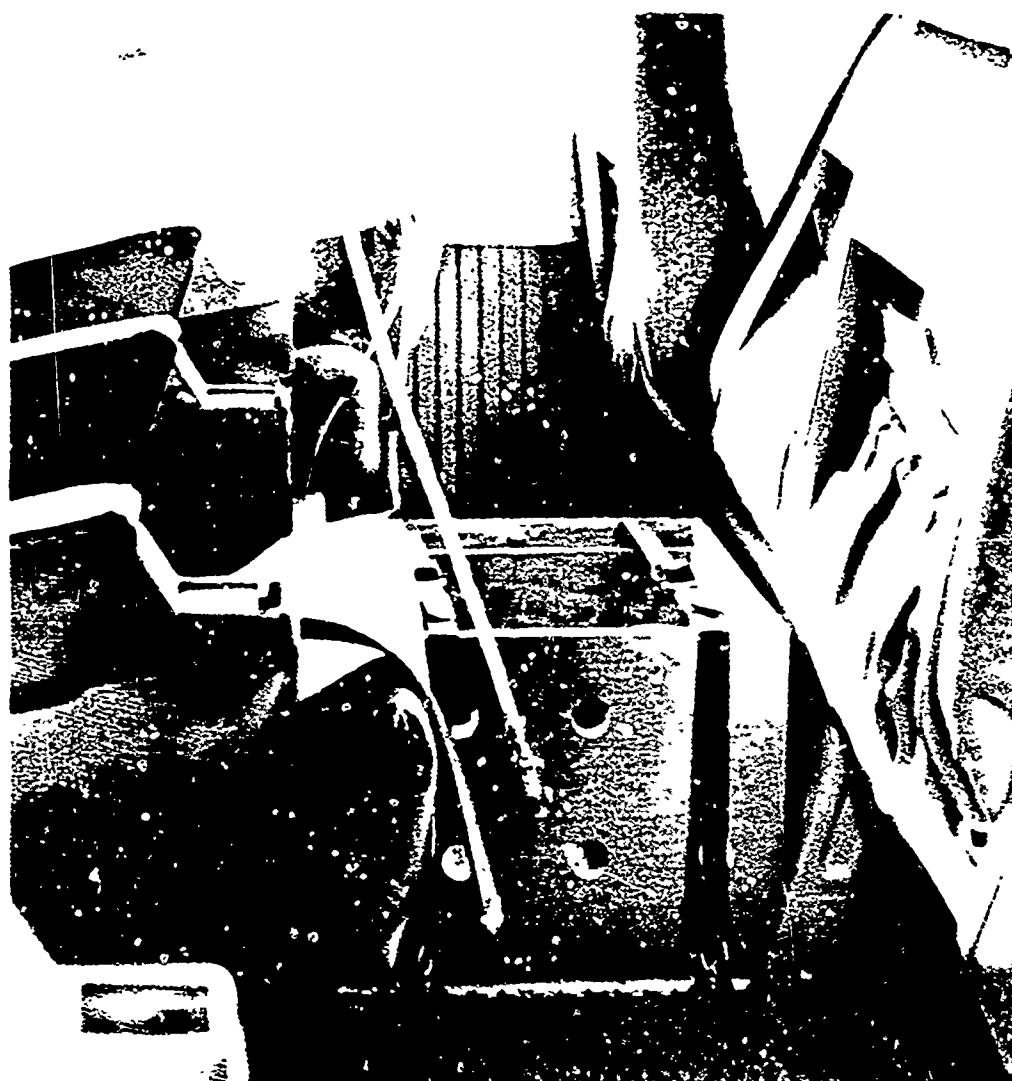
6.4.8 For the first 4 flight tests, the manifold was supplied by a 3 psi compressor at station 440. Compressor and Teflon tube connection to the manifold are shown in figure 6-11. Data from the first 4 flight tests indicated that the DDVP charge in the dispensing cartridge could be reduced and still obtain an effective disinsection. Consequently, the dispensing system was modified to use a higher volume pump supplying the manifold with lower temperature air at mid-cabin, using reduced charge cartridges. The modified compressor and cartridge arrangements are shown in figures 6-12 and 6-13, respectively. This aspect of the flight test data is discussed further in the "Mass Balance Studies."

FIGURE 6-11: DDVP FLIGHT TEST - COMPRESSOR AND CONNECTION TO MANIFOLD

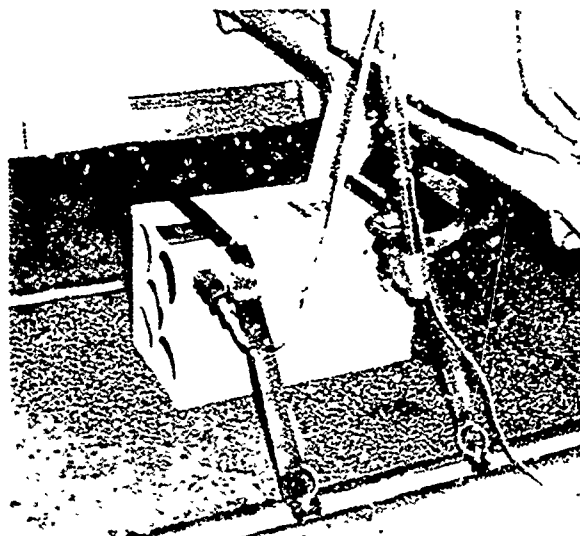
FIGURE 6-12: DDVP FLIGHT TEST - MODIFIED COMPRESSOR

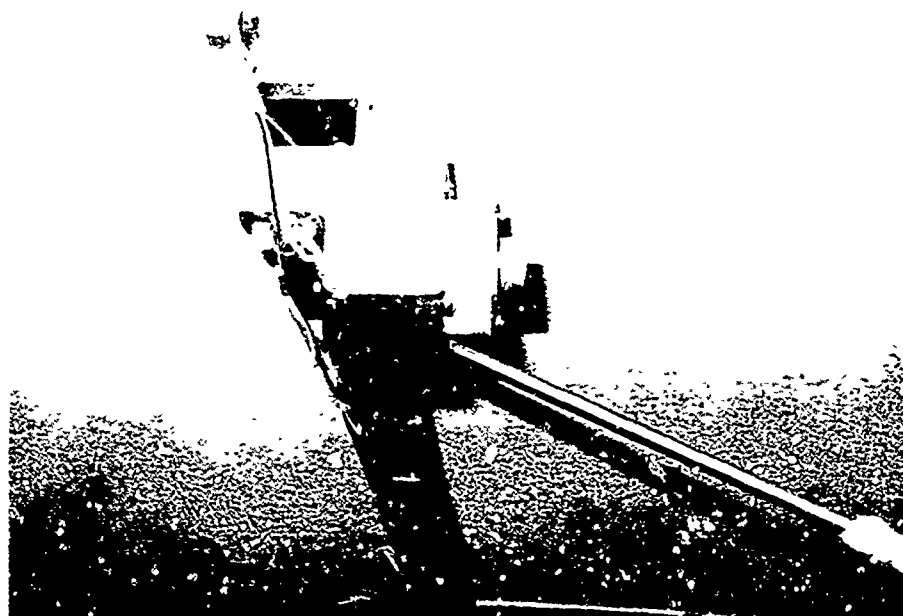
FIGURE 6-13: DDVP FLIGHT TEST - MODIFIED CARTRIDGE  
AND MANIFOLD CONFIGURATION AT MID CABIN

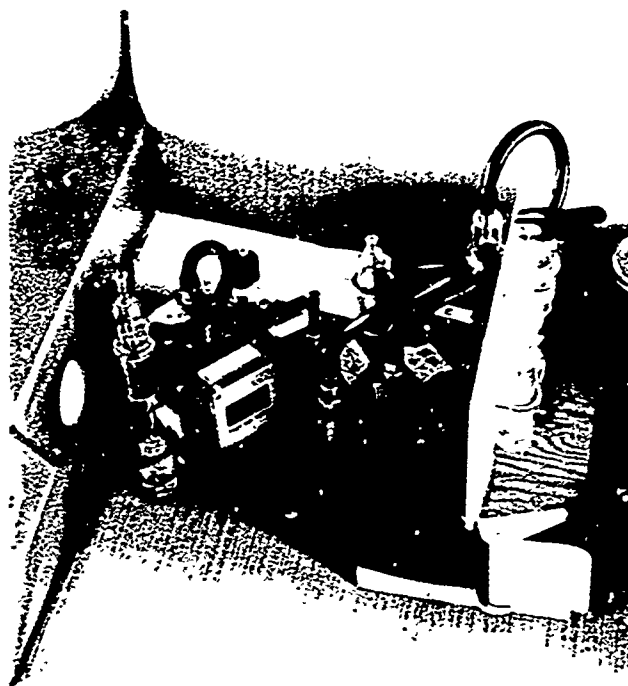
- 6.4.9 Impinger air sampling was the method used to monitor DDVP/air concentrations and measure chloride content of cabin air. When a measure of only DDVP was taken, a single impinger and pump were used with soltrol as the DDVP solvent. This method was considered 95% to 98% efficient. When a measure of chloride was desired, three impingers were connected in series to a single air pump. The first two impingers contained soltrol to remove at least 99% of the DDVP. The third impinger contained water as the chloride solvent. Typical configurations of the single and triple impingers are shown in figure 6-14.

FIGURE 6-14: DDVP FLIGHT TEST - TYPICAL AIR IMPINGER CONFIGURATION:  
1 TRIPLE-2 SOLTROLS & 1 WATER, 2 SINGLE-1 SOLTROL EACH

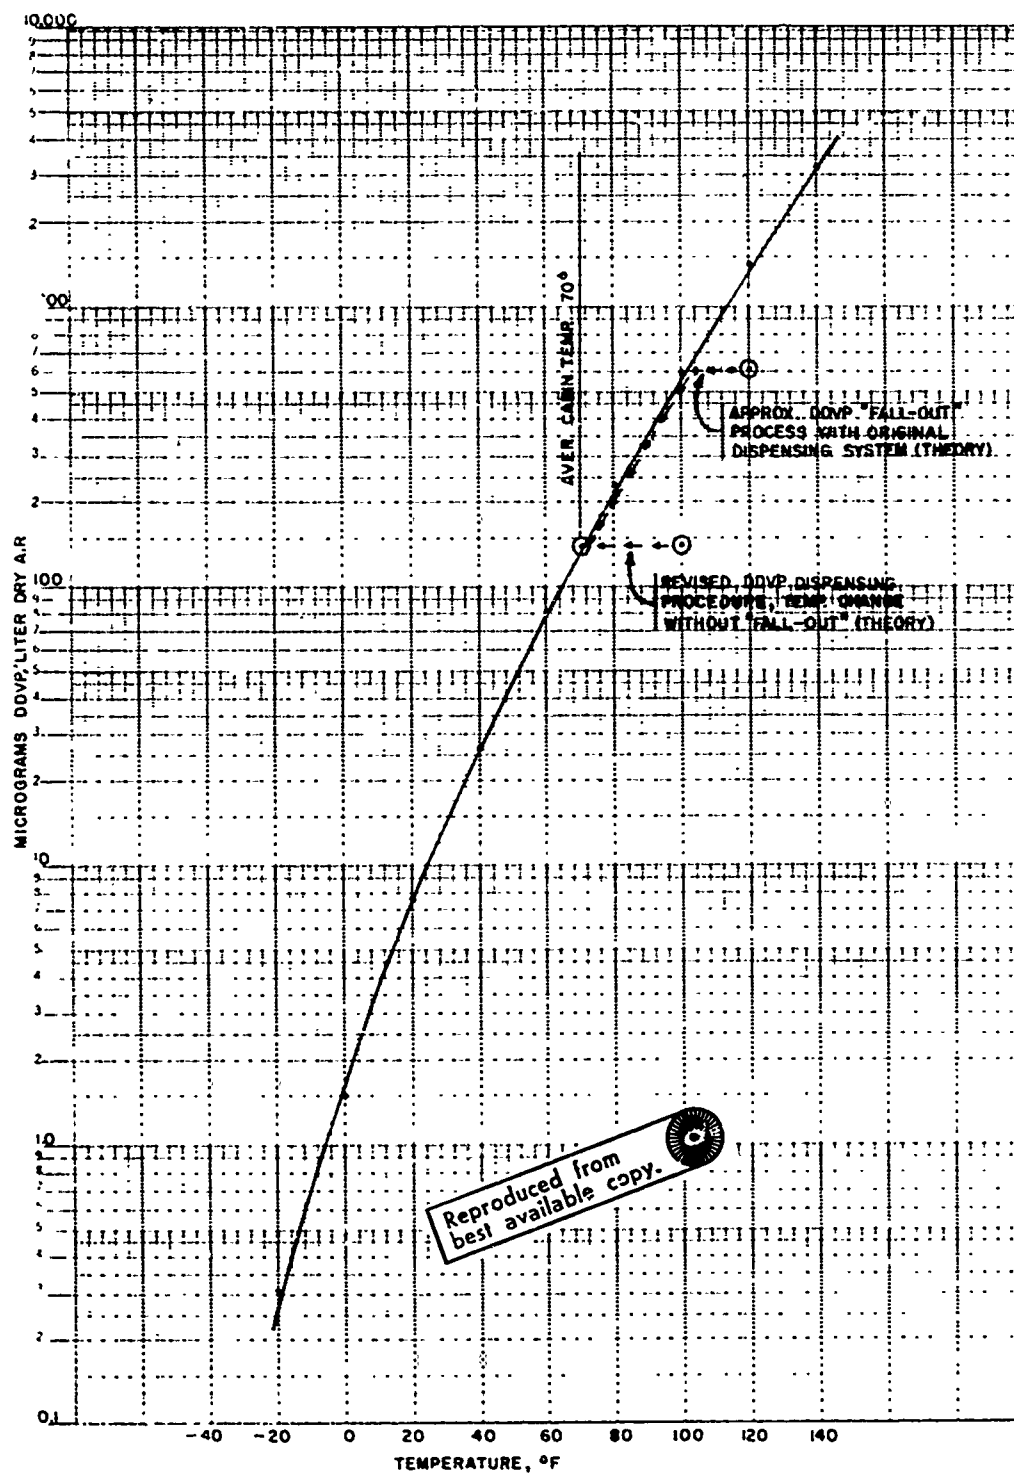
FIGURE 6-15: DDVP SATURATION VS. TEMPERATURE  
[USPHS-CDC-TJL]

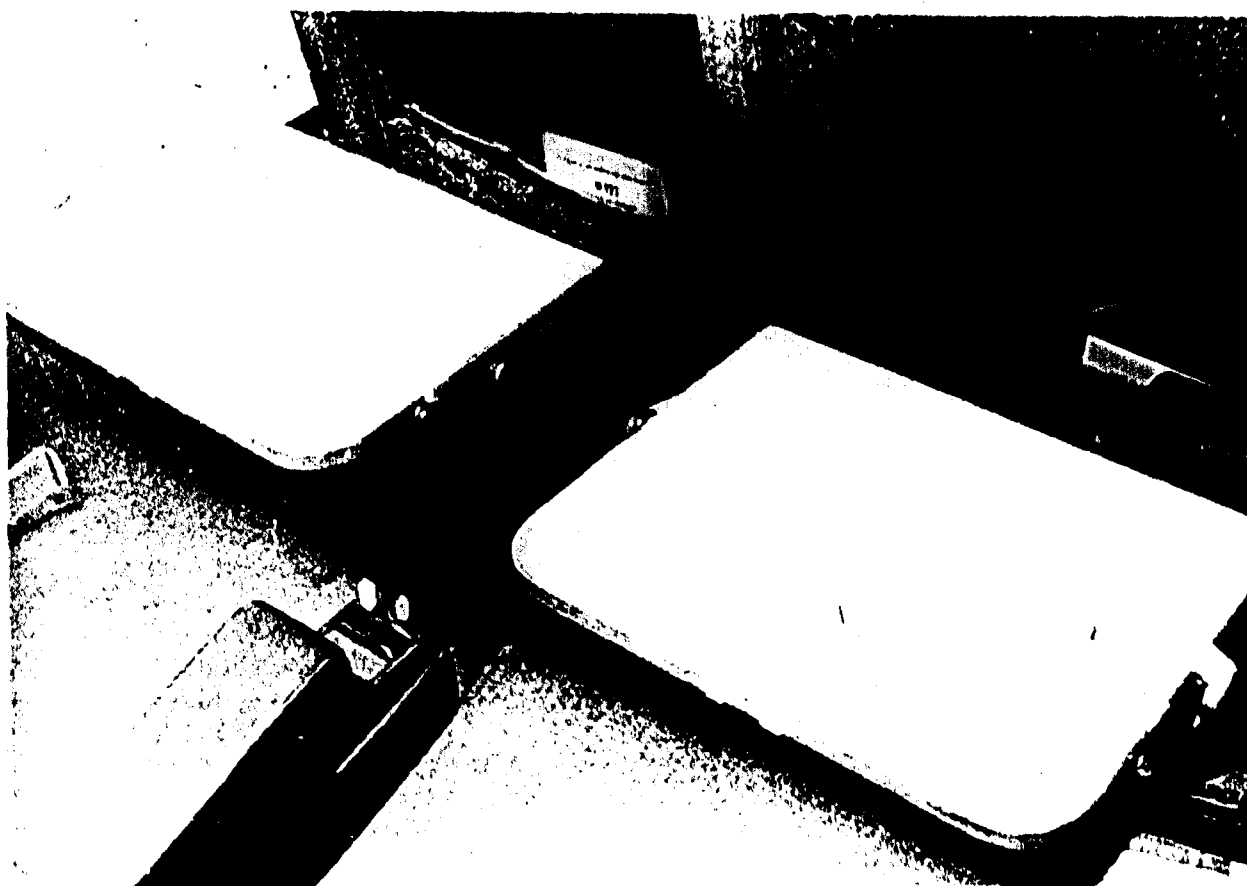
FIGURE 6-16: DDVP FLIGHT TEST-TYPICAL ARRANGEMENT OF FILTER PAPER TESTS

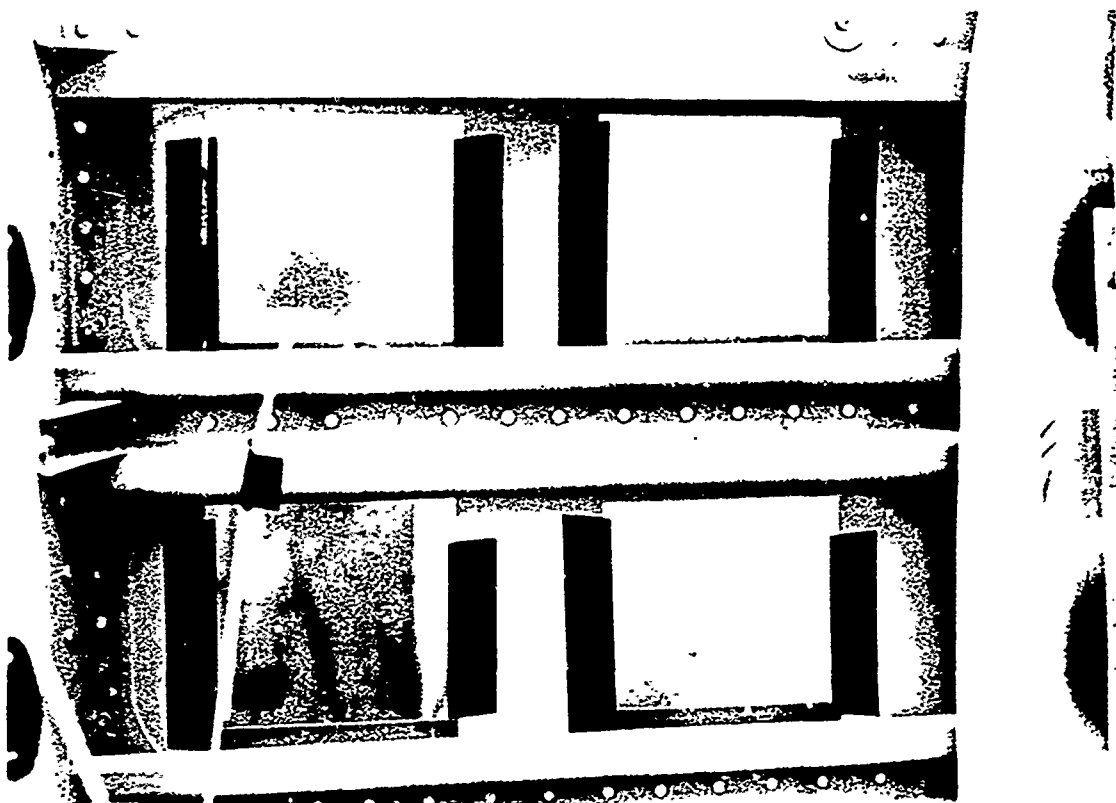
FIGURE 6-17: DDVP FLIGHT TEST-COLD PLATE TESTS - STATION 670

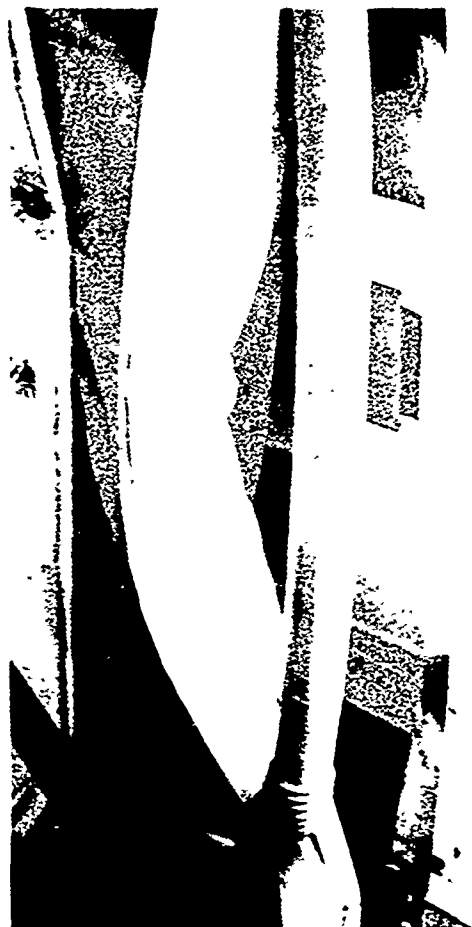
FIGURE 6-18: DDVP FLIGHT TEST-COLD PLATE TESTS - STATION 1120
