FAA Technical  
Report No. FS-70-601-120A

# THE EFFECTS OF 2,2 DICHLOROVINYL DIMETHYL PHOSPHATE (DDVP) USED AS AN AIRCRAFT DISINSECTANT

James W. Ross, Jr.  
Flight Standards Technical Division  
FAA Aeronautical Center  
Oklahoma City, Oklahoma

December 1971  
Final Report

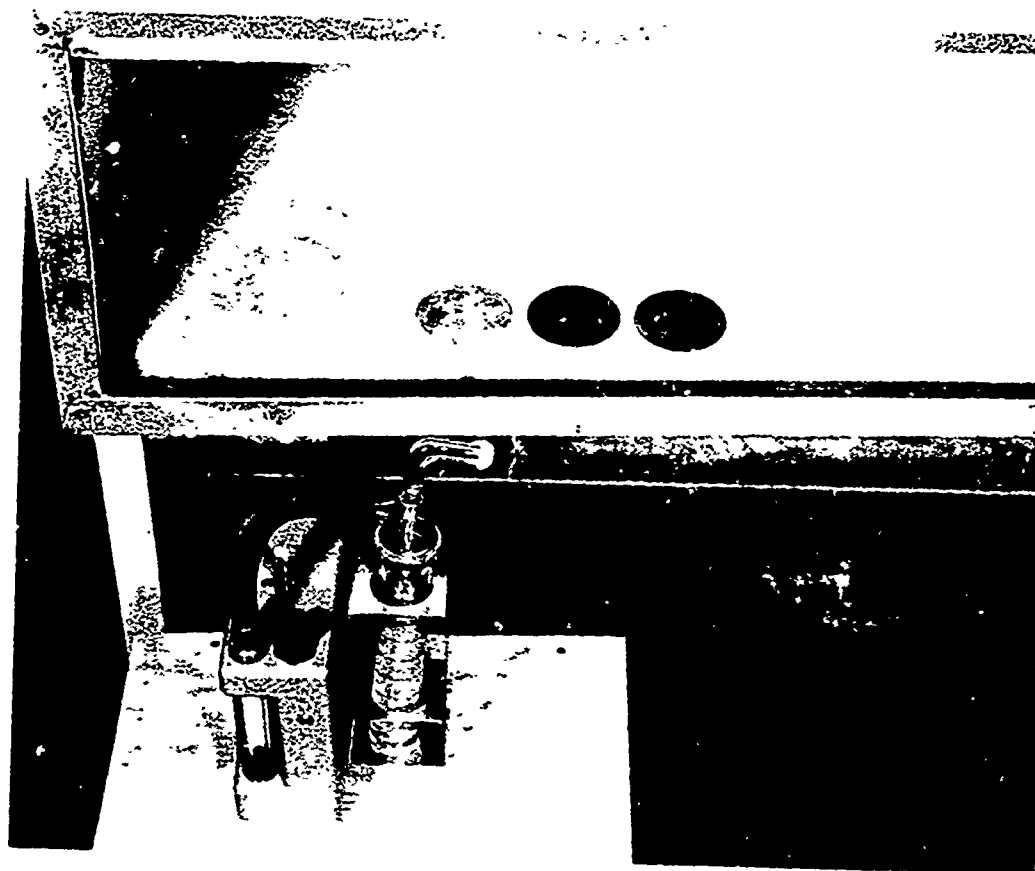
sink similar to the aircraft fuselage skin. Panel temperatures were 10-18°F. Aluminum discs were exposed in triplicate as the tool for collecting frost samples. One disc was weighed to determine the amount of frost accumulated (1ml H<sub>2</sub>O = 1 gr. H<sub>2</sub>O). The other two discs were rinsed with acetone immediately after exposure to minimize evaporation. The frost accumulated on the weighed disc was assumed to equal the frost accumulated on the other two discs, and DDVP deposit concentrations were calculated accordingly. A typical arrangement of the frosted discs is shown in figure 6-19.

FIGURE 6-19: DDVP LAB FROST DEPOSITION  
ARRANGEMENT OF TEST PLATES ON CHILLED PANEL

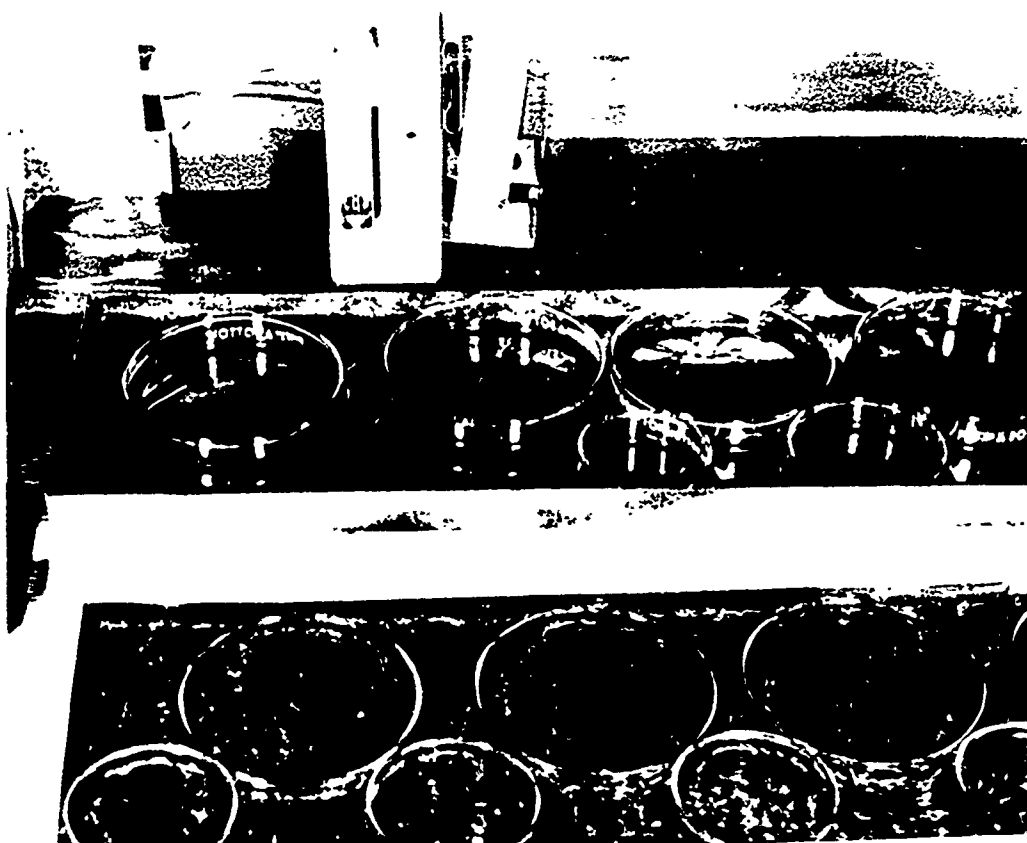
6.4.50 The spectrum deposition survey in free standing water was accomplished by exposing measured amounts of chilled water (40°F) concurrent with the frost deposition survey. The sample water was placed into duplicate petri dishes which were placed in an ice cooled pan for each DDVP exposure. The possibility of increased DDVP deposition by agitated water was explored, but a difference in the data of static and agitated water deposits was indistinguishable. Deposition in both cases was approximately proportional to the exposed surface area. Consequently, data runs were made with static water samples only. The exploratory test setup for static and agitated water exposure is shown in figure 6-20; the data run setup for the static water was identical.

FIGURE 6-20: DDVP LAB DEPOSITION  
CHILLED WATER SAMPLE ARRANGEMENT FOR EXPLORATORY STATIC AND AGITATED WATER

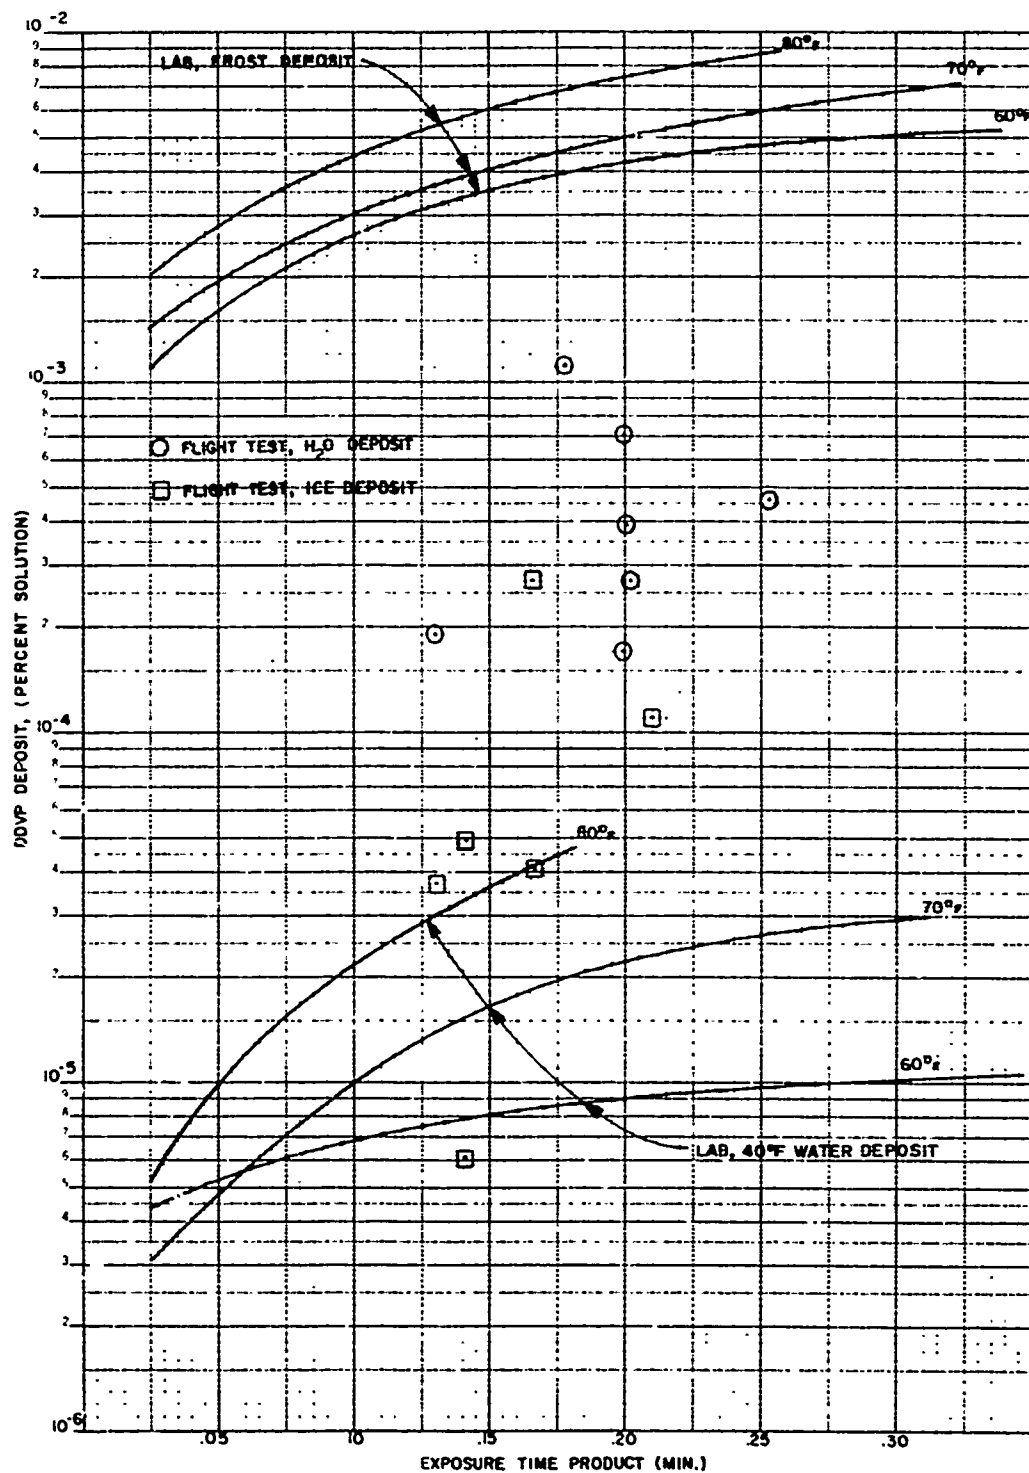
6.4.56 A comparison of the cold plate data with the lab deposition data lends more credence to the cold plate data. As shown in figure 6-21, the majority of the flight test deposits fall between the lab frost and lab water deposits. This aspect indicates that the variable

FIGURE 6-21: DDVP DEPOSITION IN MOISTURE EXPERIMENTAL SPECTRUM
