IMPACT STRENGTH AND TOUGHNESS OF FIBER  
COMPOSITE MATERIALS

Lawrence J. Broutman, et al

Illinois Institute of Technology

Technical Report No. 1

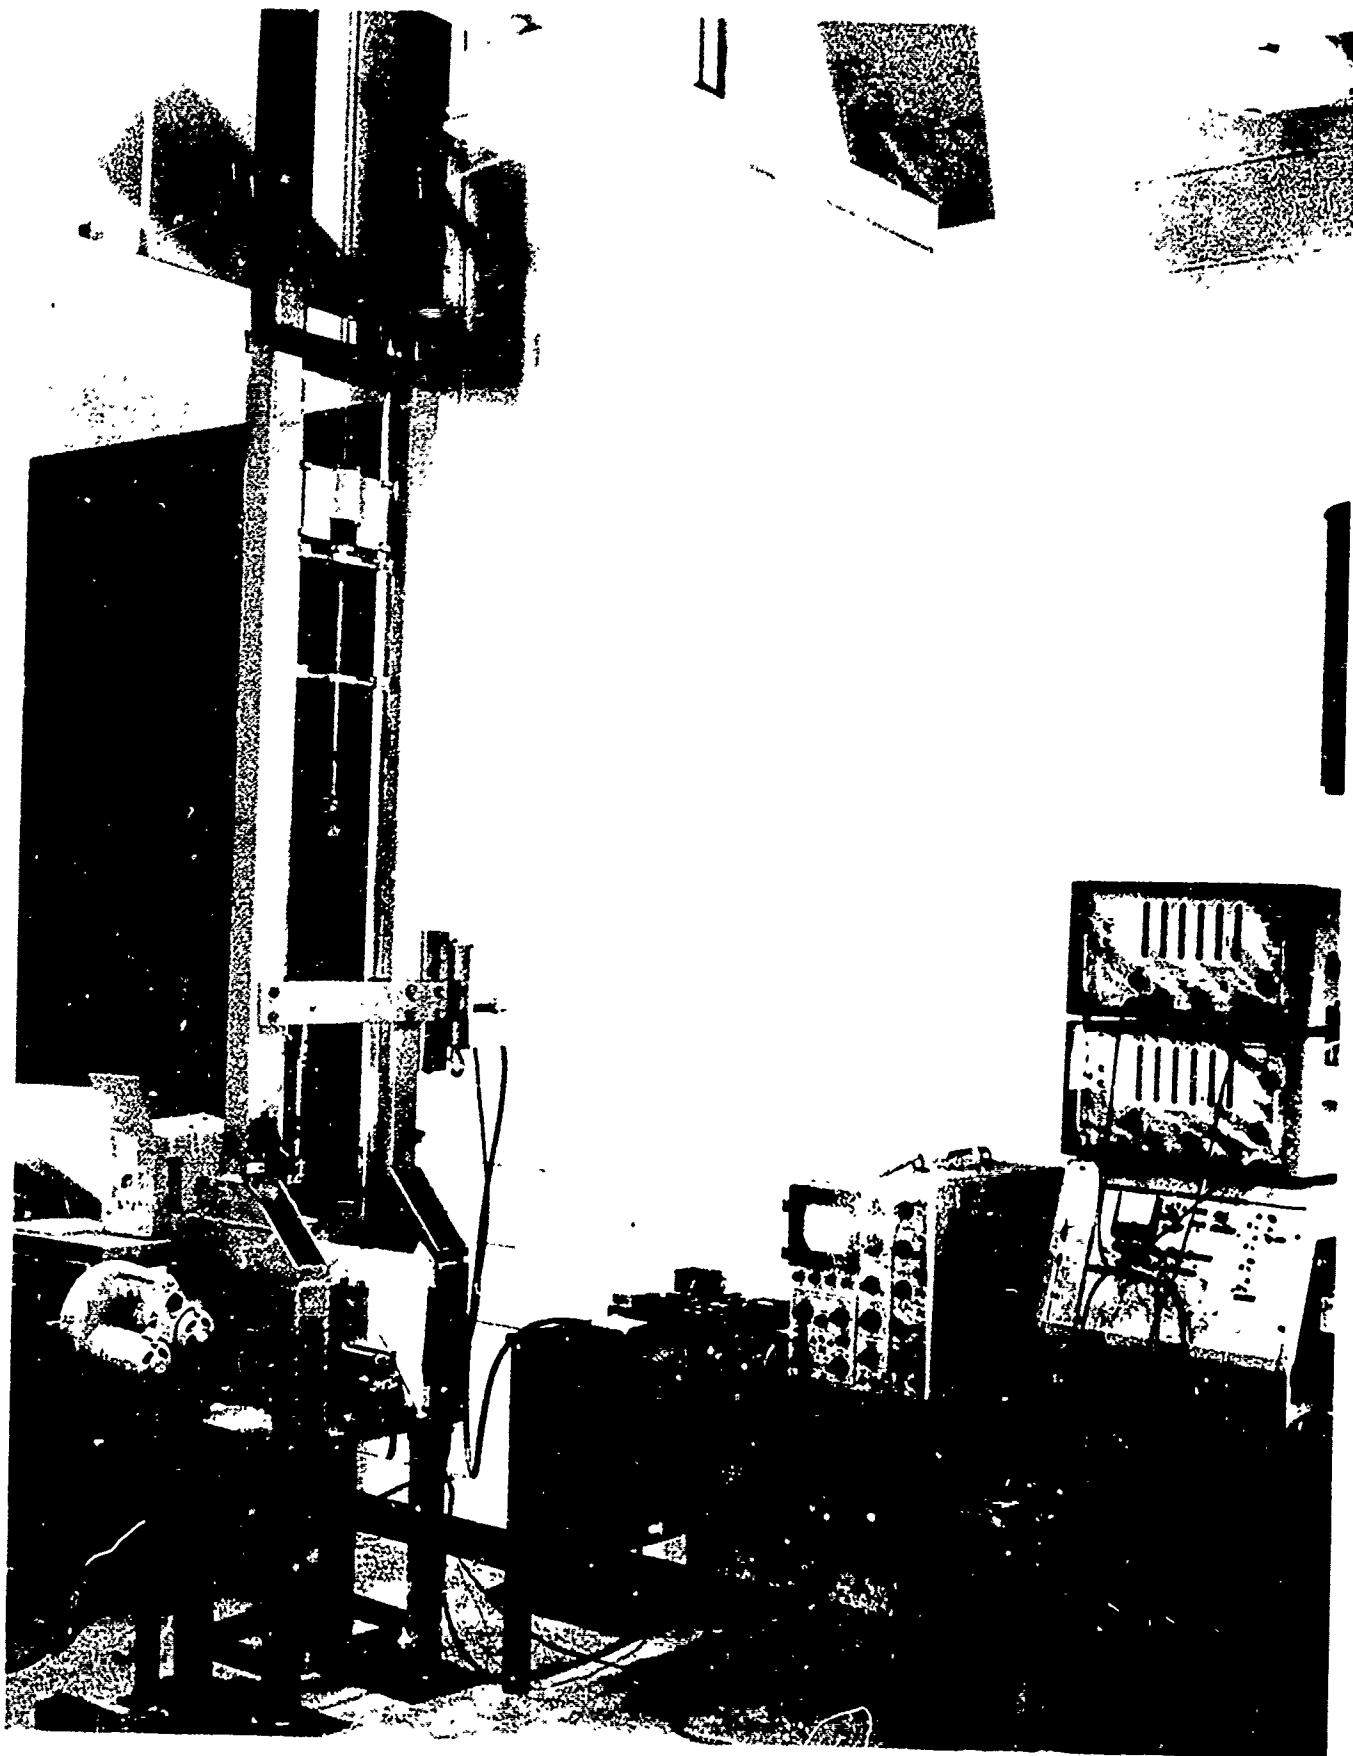
Figure 2 View of Drop Weight Impact Apparatus

The apparatus which was constructed to perform impact tests in bending is shown schematically in Fig. 1 and in a photograph in Fig. 2. The apparatus consists of a tubular frame 12 feet high with stainless steel guides attached to it. A drop weight with two cross members is capable of moving with a minimum of friction in the vertical direction. Teflon tips at the ends of the cross members insure the weight will stay in

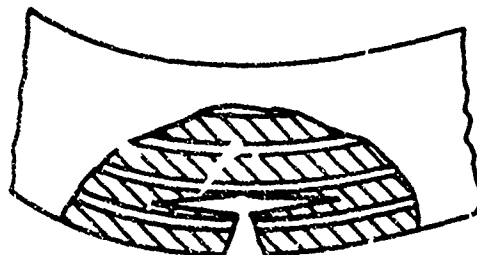
Figure 19 Suggested Failure Modes for Unidirectional and Cross-ply Laminates

Consider the loading of a beam supported at both ends, with a span long enough to create a tension failure mode on the tension side of the beam. The suggested failure modes for cases A, B and C are shown in Fig. 19.

Case A. The material is unidirectional, but consists of layers. The impact applied suddenly on the beam causes the beam to deflect (after the stress waves have decayed). As the loading continues a failure of the outer layer occurs at the mid point where the stress is maximum (or near it, at the weakest point). The crack tip propagates through the matrix material until it reaches the next layer of fibers and is arrested there. As the fibers in the first layer were broken a high shear stress exists in the matrix between these two layers which initiates cracks running to both sides parallel to the layers. Since the stress is decreasing toward the supports, the cracks will be

Case B. The material is a cross ply laminate with the lamination planes in the horizontal direction. The same mechanism is valid here, except that there are less layers to arrest the propagating crack. Since in the unidirectional case, delamination did not occur at every layer, in the cross ply case approximately the same number of branching cracks occur as in the unidirectional composite. Hence the amount of energy absorption is almost identical in both cases.

Case C. The material is a cross ply laminate with the lamination planes in the vertical direction. In this case, the crack front is not straight as there are weak layers in the thickness where it can propagate easily. These weak layers let the crack surround the other layers and fracture the fibers without arresting the crack propagation. Thus we get a clean cut through the material, as can be seen in Fig. 16, without branching of cracks to the sides, and with a low level of energy absorption.
