NAVIGATION CHANNEL IMPROVEMENT,  
GASTINEAU CHANNEL, ALASKA; HYDRAULIC  
MODEL INVESTIGATION

TECHNICAL REPORT H-72-9

# NAVIGATION CHANNEL IMPROVEMENT GASTINEAU CHANNEL, ALASKA

Hydraulic Model Investigation

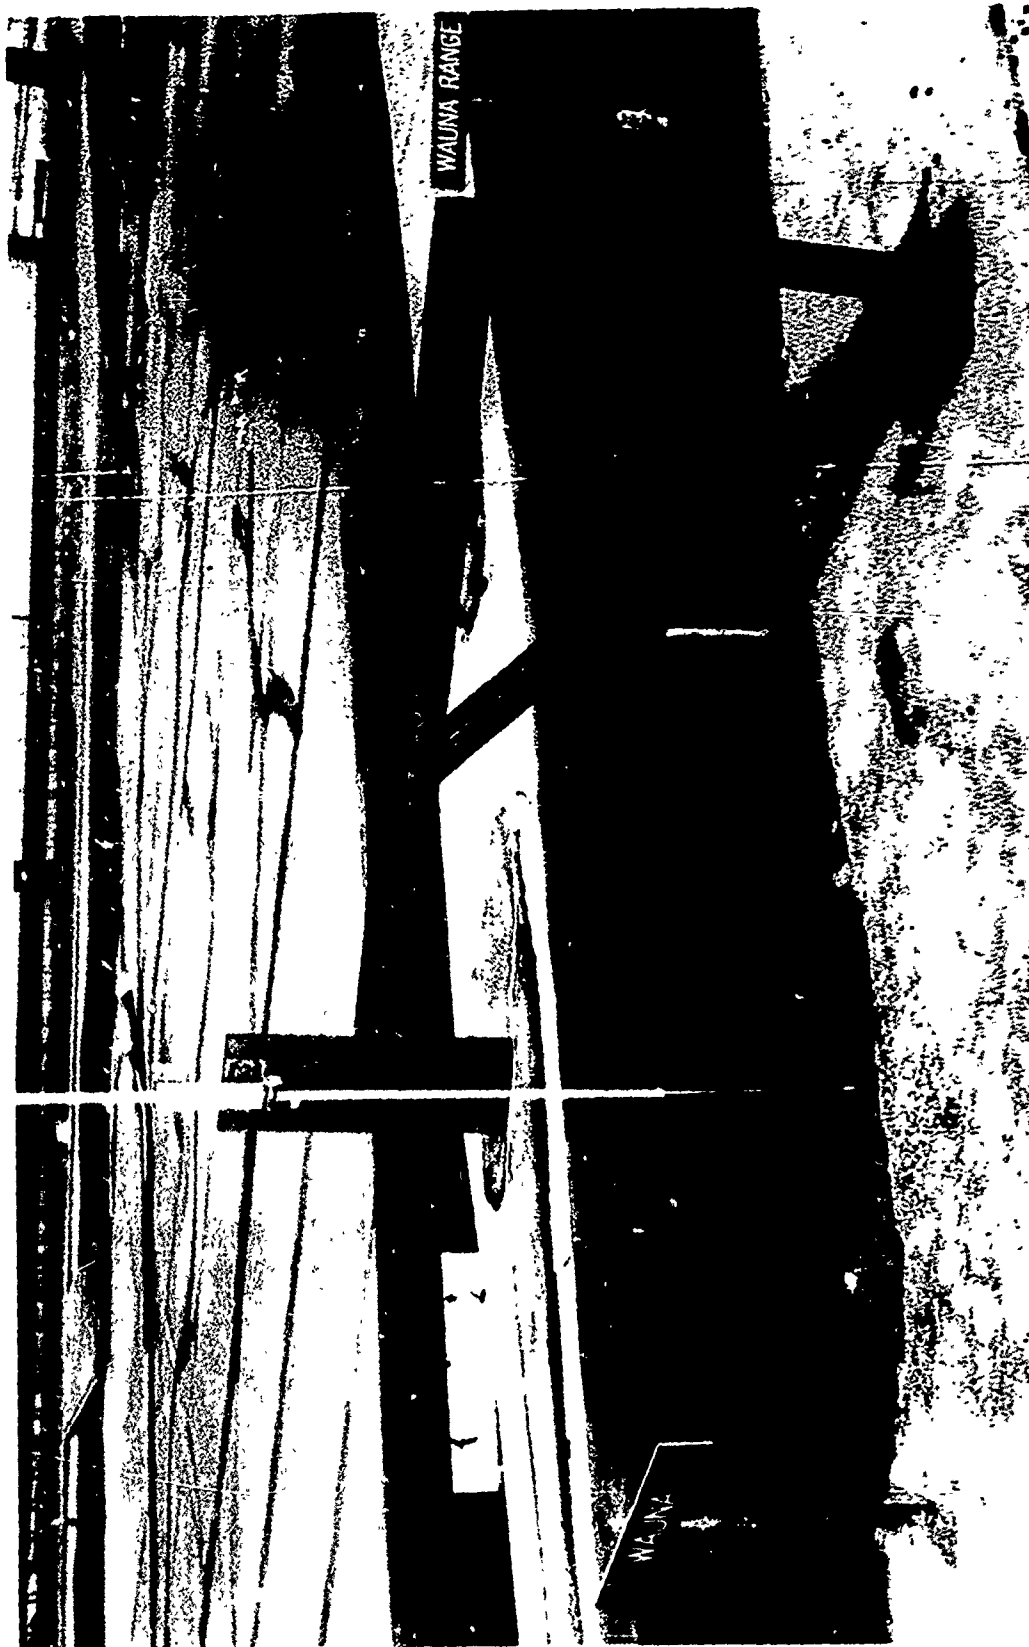
PHOTO 3

POINT GAGE

18. Permanently mounted point gages (photo 3) were installed at the locations of the four recording tide gages used for collection of field tide data (fig. 3). The model gages were graduated in 0.001 ft (0.1 ft prototype) and were used to measure tidal elevations throughout the model. Portable point gages were used to measure tidal elevations at other points as required.

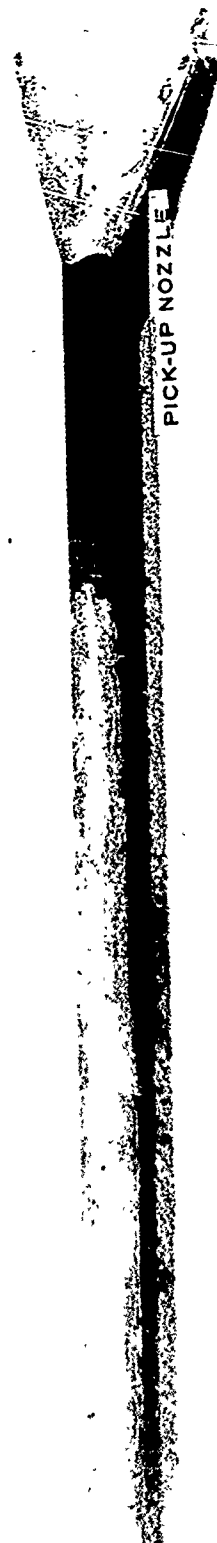
PHOTO 7

SHOALING APPARATUS

23. Shoaling was reproduced in the model by injecting granulated polystyrene plastics. Known volumes of the shoaling material were hand-placed at predetermined locations in the model before and during each shoaling test. At the end of the model test, the shoaling material deposited within the limits of the navigation channel was recovered by suction using a flared nozzle connected by hose to an aspirator (or hydraulic ejector) (photo 7); the material was then measured volumetrically.
