ENGINEERING EVALUATION OF DEPTH-SOUND
SPEED MEASURING SET AN/BQH-1 MANU-
FACTURED BY DYNA-EMPIRE CORPORATION,
GARDEN CITY, NEW YORK. CONTRACT NOBSR-
75772

Navy Underwater Sound Laboratory
New London, Connecticut

10 March 1961

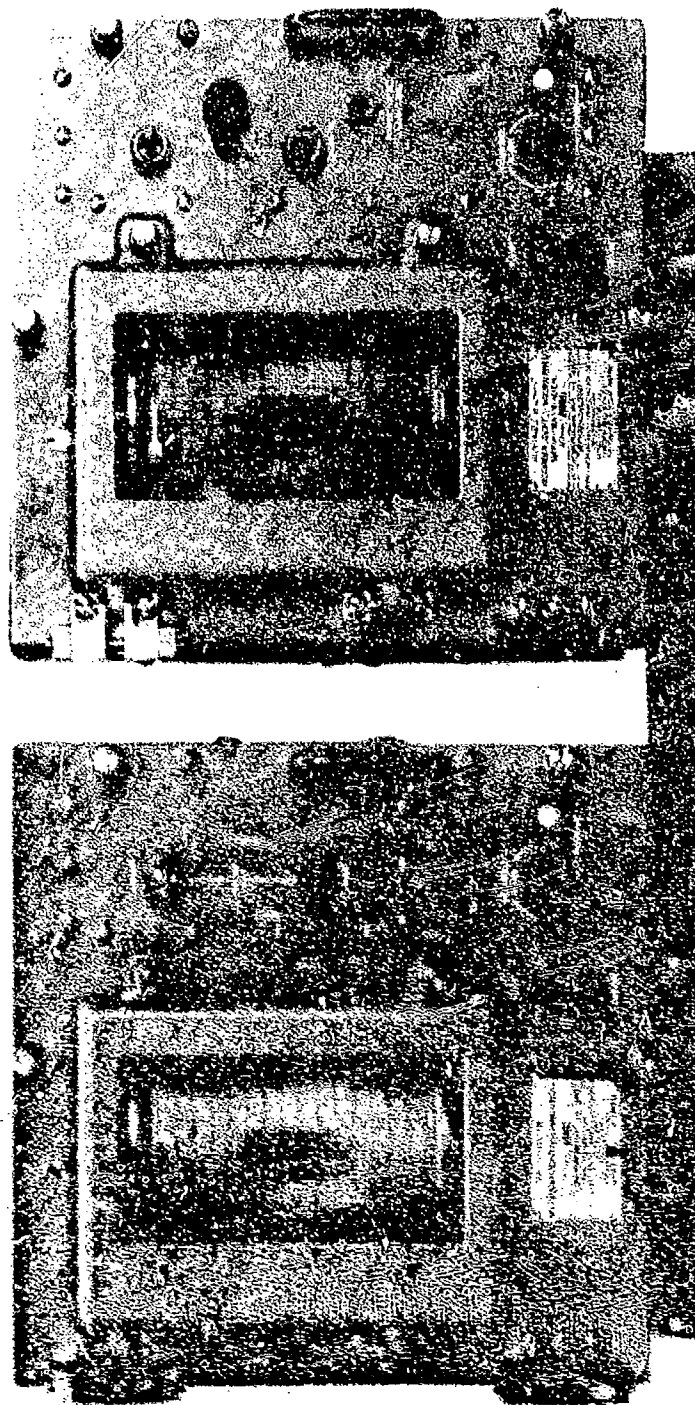
Fig. 1 - Left: The NO-112/Model Remote Depth-Sound System Receiver
 Right: The NO-112/Model Depth-Sound System Receiver

Illustrations of these units may be seen in Figs. 1, 2, and 3.

The depth element connects to the submarine pressure line, and its output is used to position the pen-drive servo system. On the recording chart, the sound velocity is presented on the horizontal axis and the depth on the vertical axis. A remote recorder is included as a unit of this equipment.
