NICHROME RESISTOR PROPERTIES AND RELIABILITY

ROME AIR DEVELOPMENT CENTER

JUNE 1973

RADC-TR-73-181  
Final In-House Report  
June 1973

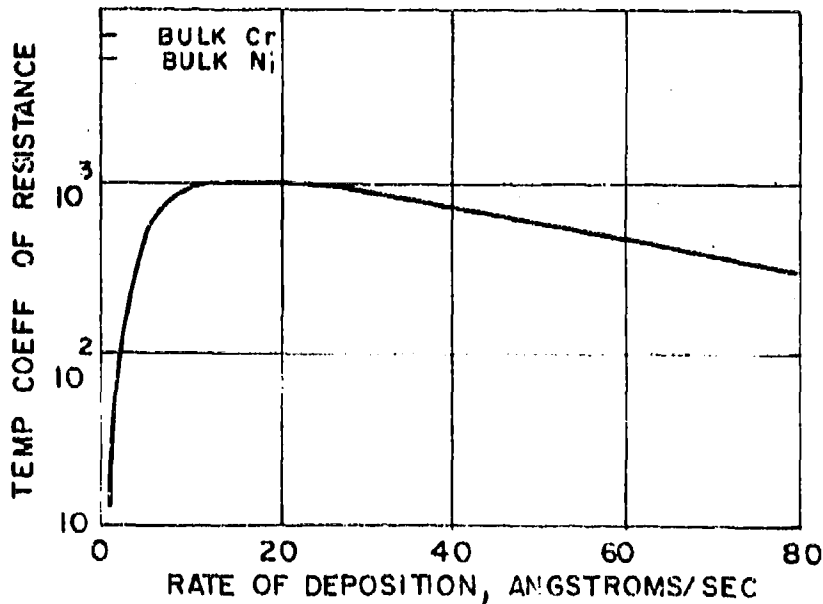
Figure 2

Temperature Coefficient of Resistance  
for 100-150 Ohms/Square Nichrome Films  
Evaporated from an 80Ni:-20CR Source  
at  $5 \times 10^{-4}$  Torr

This is due to the incorporation of oxides of nickel and chromium. When the composition becomes one of nichrome particles dispersed in a dielectric medium, the TCR will become negative. The variation of TCR with deposition rate reflects a Ni/Cr ratio change in the film as well as different oxide content. Chromium sublimes at a lower temperature than nickel melts. Lower evaporation rates favor increased chromium content. If the same source is used over and over, the relative amount of chromium will become depleted giving higher nickel contents for the same rate. This fact was shown by Lakshmanan<sup>(16)</sup>. The TCR variation with number of depositions from the same source is best shown in a publication by Taylor<sup>(17)</sup>. Since the exact graph depends on the exact system and materials used, it is sufficient to indicate that the TCR became increasingly positive with succeeding depositions. In the early depositions the chromium content is high. It falls with succeeding depositions. The TCR behavior is a good indication that the more reactive chromium is rapidly oxidized, and actually, to a large extent, is contained in the film as an oxide. Double oxides of nickel and chromium with a spinel structure have been detected by electron diffraction. According to Dushman<sup>(18)</sup> the structure of nichrome films is a dispersion of  $Ni_{0.7}Cr_{0.3}$  in a matrix of  $Cr_xO_y$ . For this reason the pressure, composition of the residual atmosphere, and the rate of deposition have a tremendous effect on TCR.

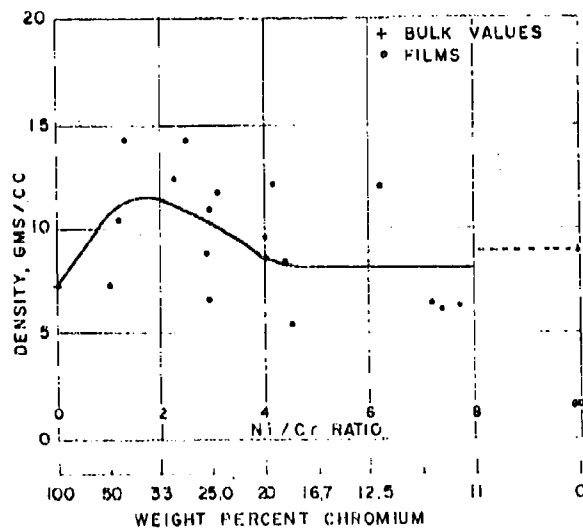
Figure 9

# Density versus Nichrome Composition

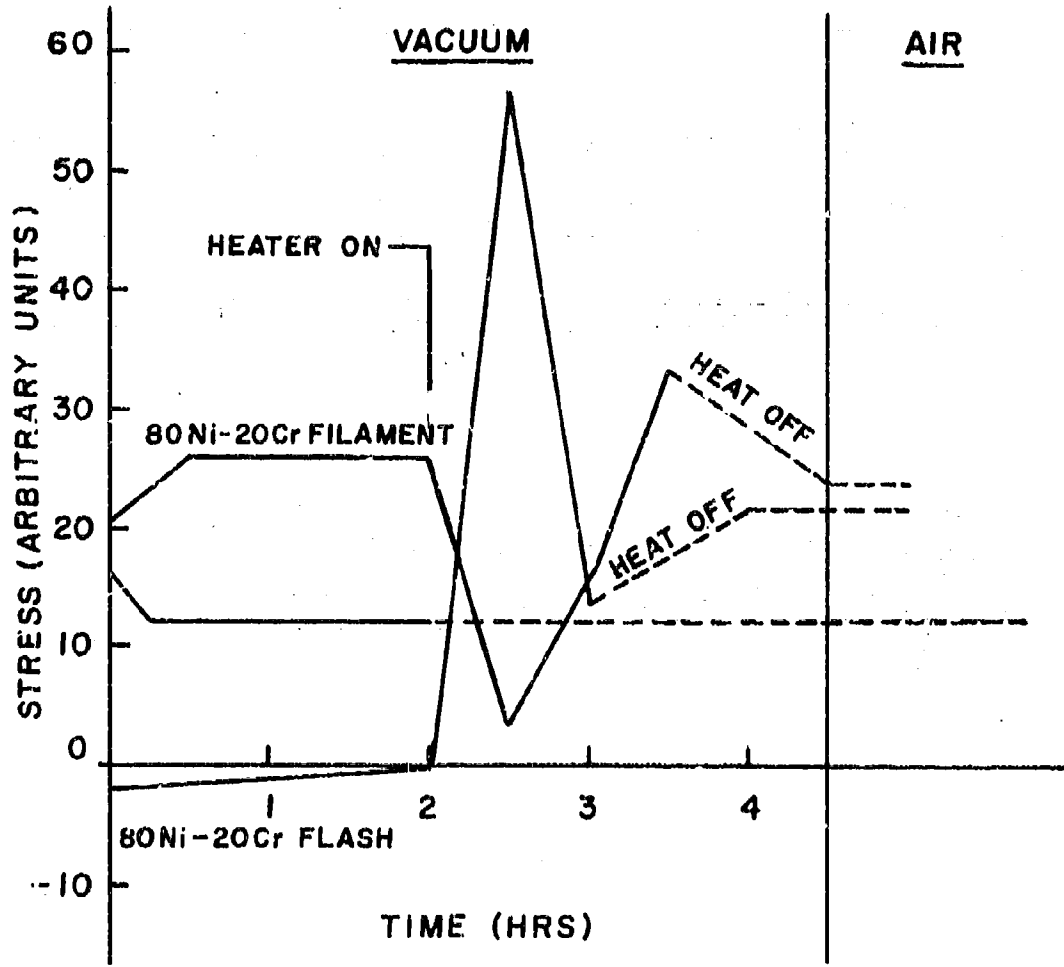
FIGURE 12

## STRESS IN NICHROME FILMS

At the instant of deposition the filament evaporated film had a high tensile stress, while the flash evaporated film was in slight compression. Upon cooling the filament evaporated film changed slightly; the flash evaporated films did not change. Upon subsequent heating via infrared lamps and cooling to room temperature, both types of films stabilized at a moderate tensile stress. The measurements were made in vacuum, but virtually no change was seen upon exposure to air. This information is plotted in Figure 12. The most stable films are deposited at substrate temperatures between 250 and 350°C. Sheet resistivities should be kept below 200 ohms per square. Recently, a paper by Rairden, Neugebauer and Sigsbee<sup>(28)</sup> suggests that a barrier layer between nichrome and gold would be advisable where gold contacts are used. This is because the resistance of gold on chromium metallization will increase and then decrease during heating because of interdiffusion. The activation energy for the process is about 1.1 ev. If held at 400°C, the maximum resistance is reached in about 2 hours for quartz or oxidized silicon substrates, and about 0.2 hours for glass substrates. After 100 hrs at 400°C the chromium will have been completely transported through the gold film. Adherence to the quartz or thermally grown SiO<sub>2</sub> will have been completely destroyed. The chromium is removed by oxidation at the surface.

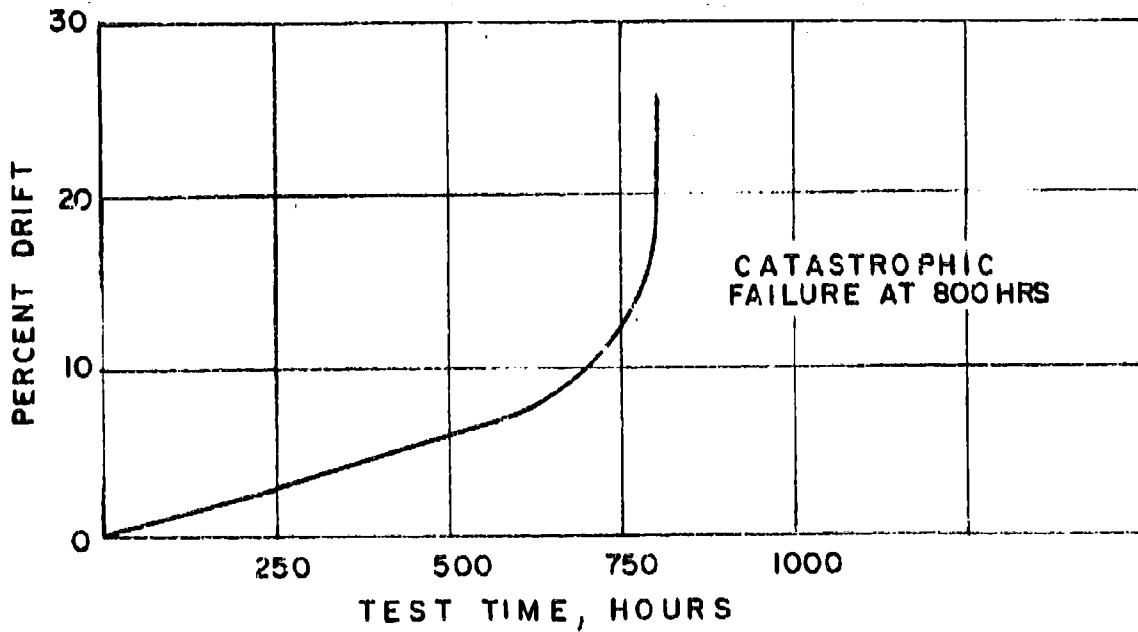
Figure 14  
Nichrome Resistors-Temperature Humidity-Power  
Testing- MIL-STD-202, Method 106A Power From 0-11 W/IN<sup>2</sup>

Room temperature, following conditioning at 50% uncontrolled R.H.-  
24 hours.  
Figures 13 and 14 give the results of the tests. Figure 13 gives assurance that the resistors were good under elevated temperature conditions. Figure 14 shows that all resistors on test failed the temperature-humidity-power test catastrophically at 800 hours.

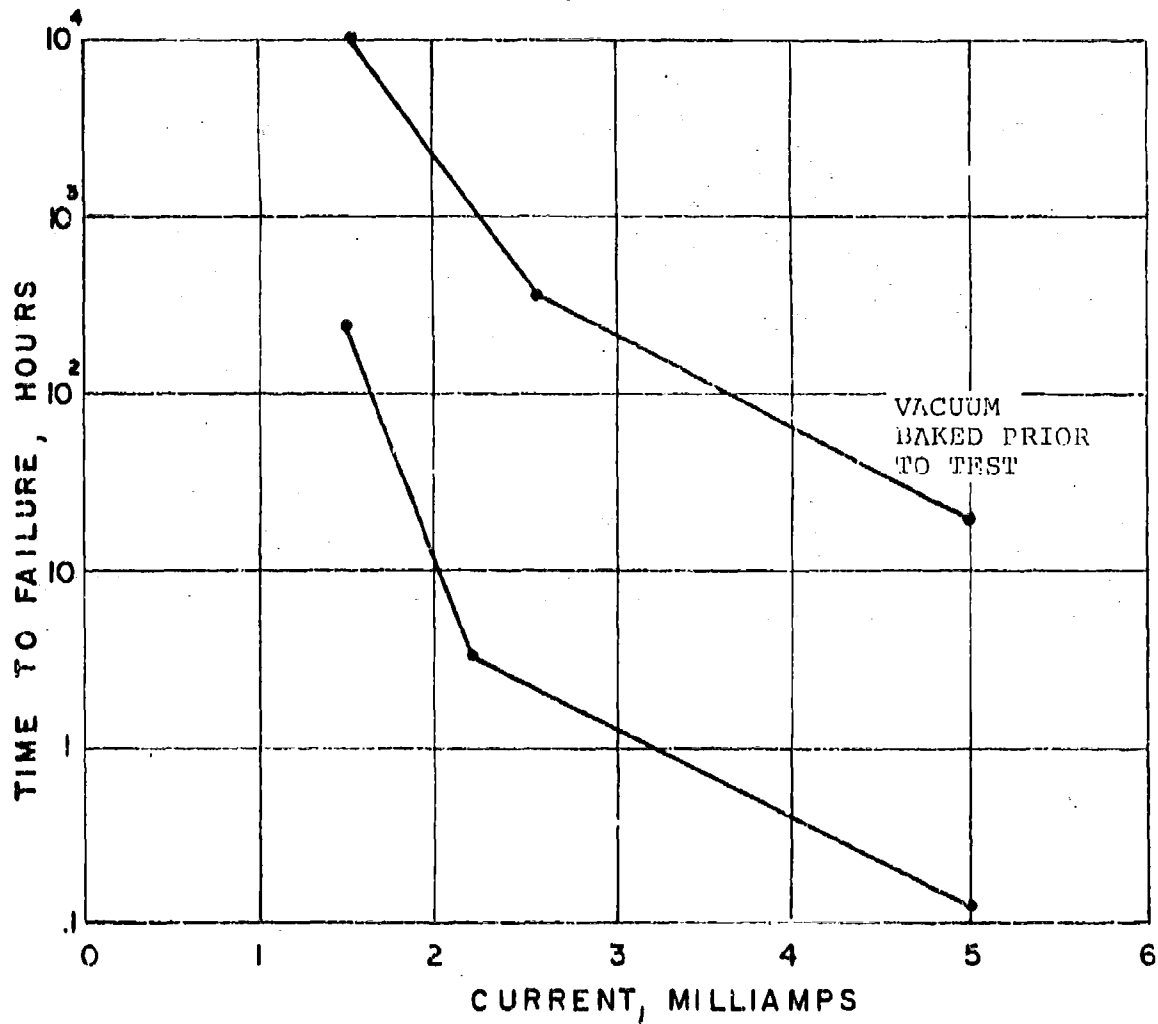
Time to Failure as a Function of  
Current for 12, 20K Ohm Resistors

Information on electrochemical corrosion of nichrome films was provided to us by an industrial laboratory<sup>(30)</sup>. In one test, constant currents were passed through six, 20,000 ohm resistors held at 70°C. Two were operated at 5 ma, 2 at 2.5 ma and 2 at 1.5 ma. The time to failure as a function of current is shown in Figure 15. These resistors were potted in black epoxy. Also shown in Figure 15 are results from 6 similar resistors baked in

vacuum at 100°C for 65 hours prior to testing at 70°C in a normal humidity environment. Obviously, increased current accelerates the failures and vacuum baking retards the time to failure. Another test on 80 hybrid circuits employing thin film nichrome resistors was conducted in accordance with MIL-E-5272C (ASC) Humidity Test. The procedure was:

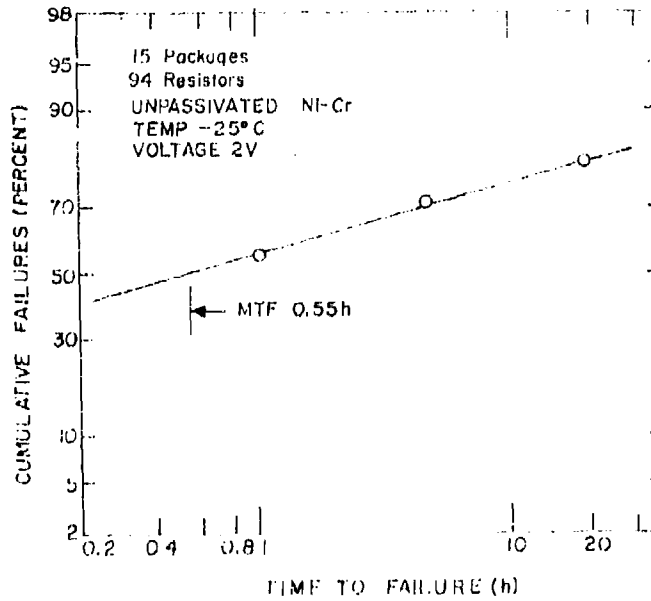
Figure 20

Cumulative Percent Failure vs. Time for Unpassivated NiCr Resistors in Ceramic Flatpacks, Operated at -25°C Ambient
